Report of Geotechnical Investigation  
Dam Safety Assessment of Coal Combustion  
Surface Impoundments  
Georgia Power  
Plant Yates, Newnan, GA

AMEC Project No. 3-2106-0174.0400

June 2010

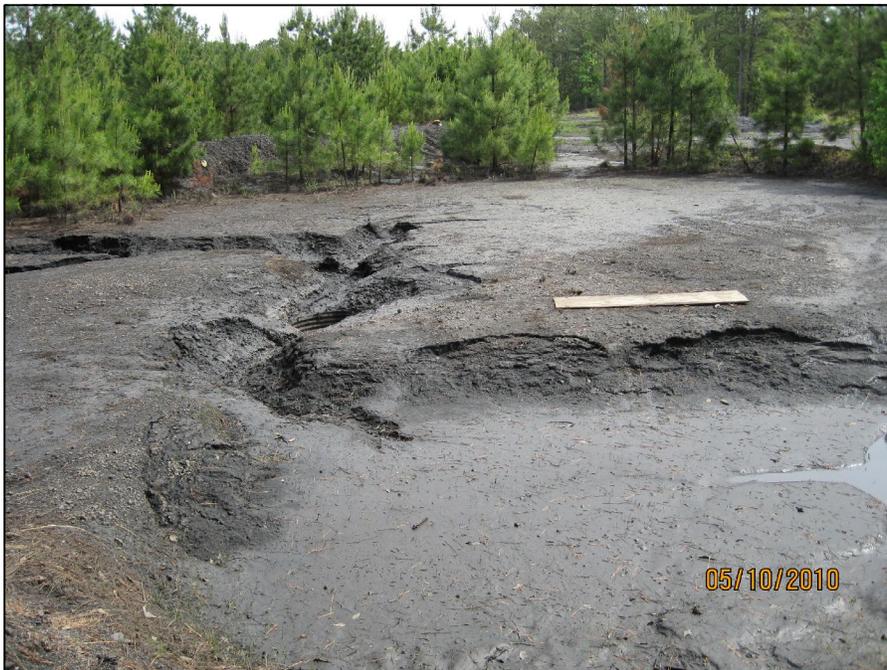
**1-2**  
**LOOKING OUT INTO ASH POND #1, 48-INCH DIAMETER CMP OUTLET**

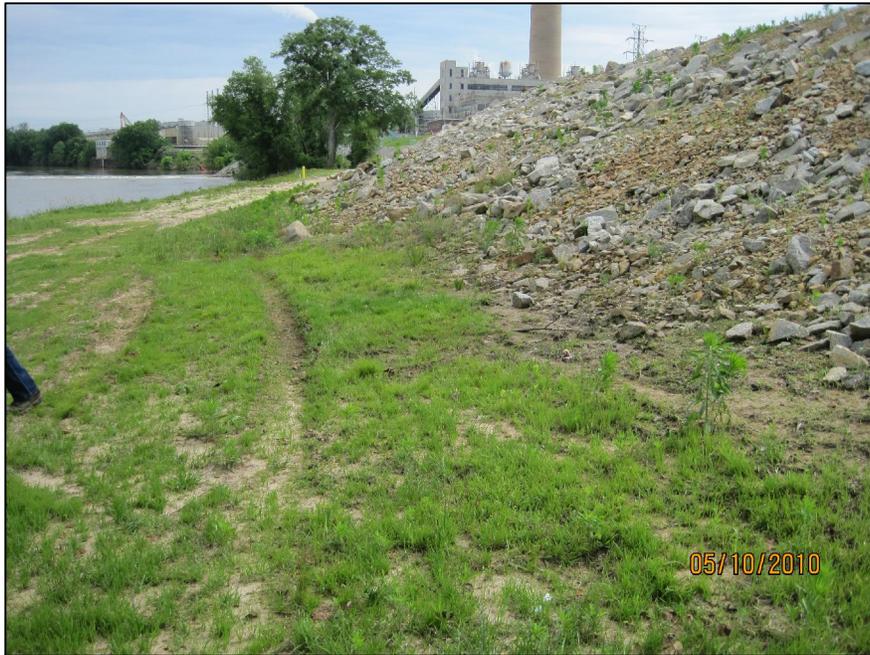
**2-9**

**WET AREA AT TOE NEAR RIGHT ABUTMENT OF MIDDLE DOWNSTREAM SLOPE**

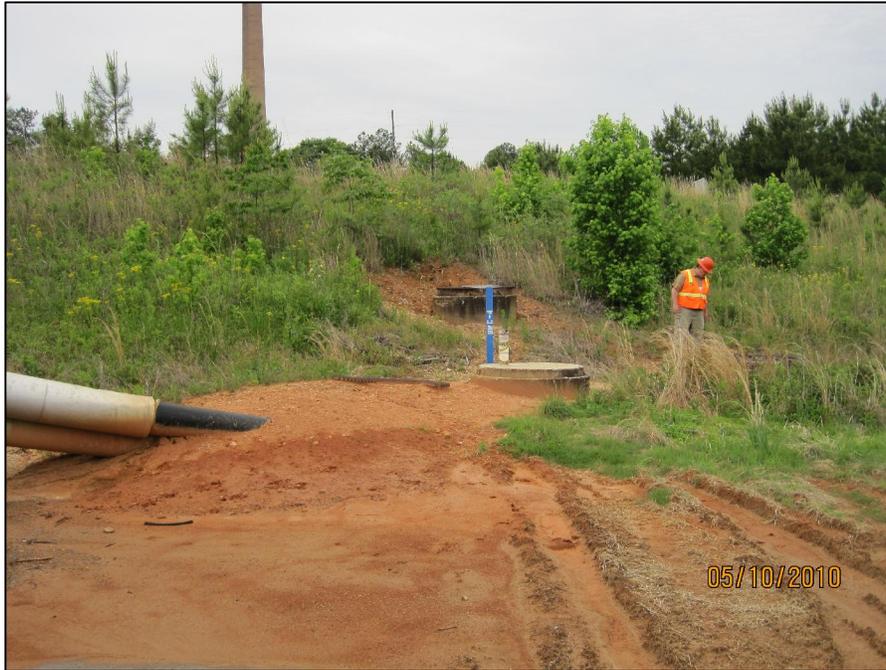
**GP-3**

**WELL LOCATED TO THE EAST AND BELOW LOWER BASIN**

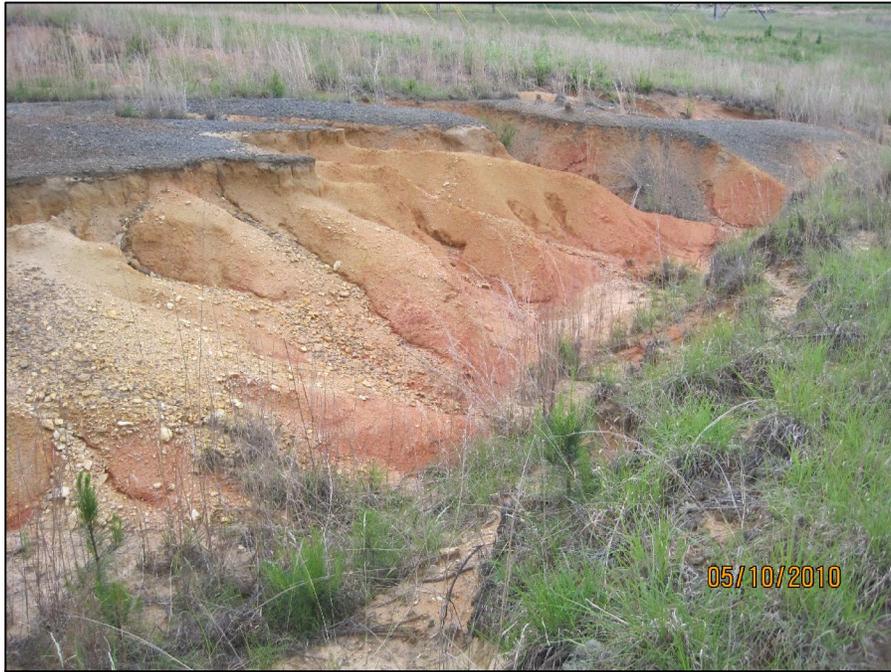
**A-3**

Ash Pond A is breached at the right abutment by an open channel ditch. Severe erosion of the ditch was noted in the embankment area and downstream (photo A-3). Due to this open-channel breach at the right abutment, Ash Pond A was considered to not have any freeboard. There was not visible outlet control structure.
