Report of
Dam Safety Assessment of Coal Combustion
Surface Impoundments
Georgia Power
Plant Yates, Newnan, GA

AMEC Project No. 3-2106-0174.0400

December 2010

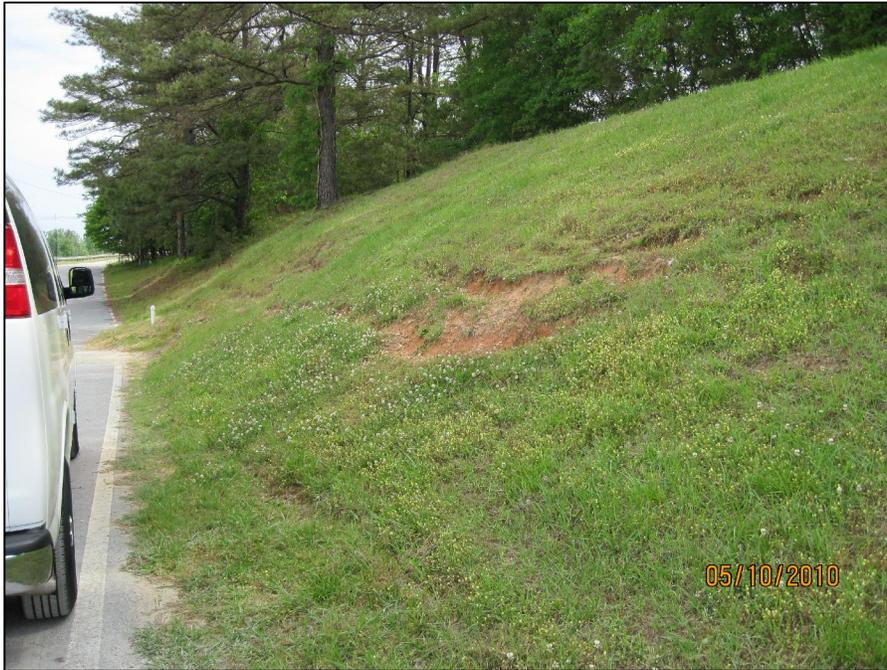
Ash Pond 1 has a cross-valley configuration, and according to site operations and design drawings (YAT-API 10), the embankment was constructed on the west side in a north to south alignment. An asphalt to gravel road is located on the downstream embankment along the west side of the pond. Minor rutting and trees growing on the embankment slope were observed on the slope above the road (photo 1-1). Toward the north end of the west side of Ash Pond 1, there is a flatter area of the downstream embankment next to the road. Piles of debris and bare to sparsely vegetated areas were observed in this area (photo 1-6). The downstream embankment slopes west of the road and to the north of the cooling towers were noted to be steep with bare/sparse areas of vegetation (photo 1-7). A new piezometer was noted on the south end of the west side of the pond, where the downstream embankment meets the road (photos 1-4). We understand a seep problem was encountered by a maintenance crew excavating in this area. The seep was investigated and addressed by installation of a "graded aggregate reverse filter" (YAT-API-67). The upstream embankment and portions of the interior of the pond were densely wooded with trees that ranged in size from generally less than 2 inches to 18 inches in diameter. Several larger trees were observed in these areas (photos 1-5).

1-1
RUTTING ON DOWNSTREAM SLOPE

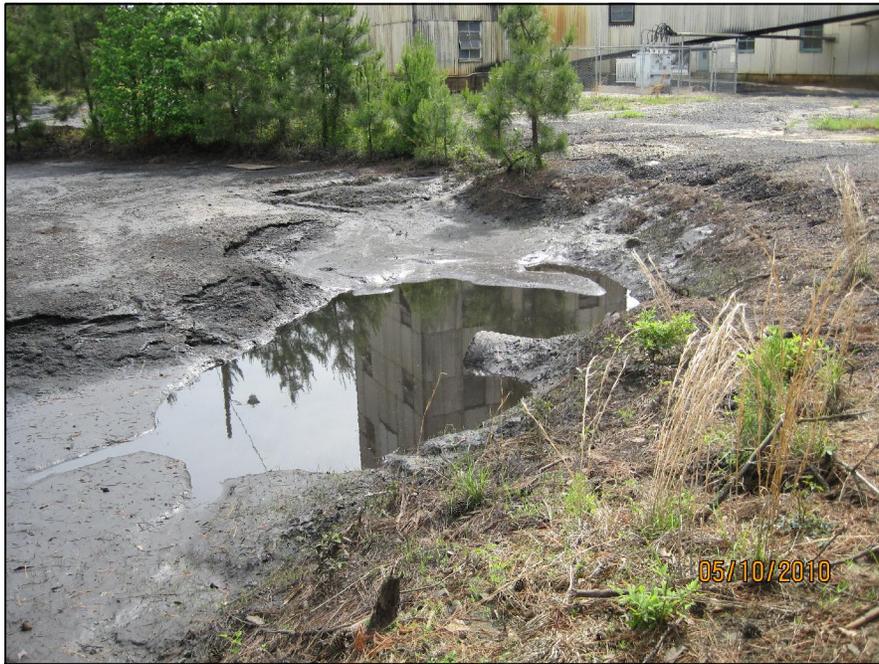
1-3

PONDED WATER AND DITCH INLET FROM COAL PILE

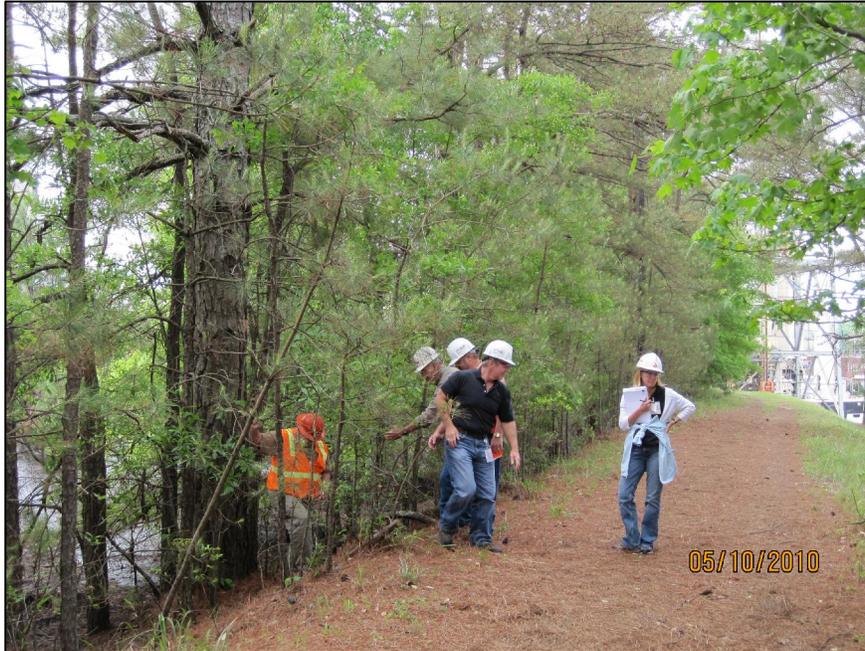
1-5

TREES IN UPSTREAM SLOPE, GENERALLY SMALL (<2) TO 18 IN. DIA., ONE OF LARGEST =23 IN. DIA., ENTIRELY WOODED ON UPSTREAM SLOPE AND MOST OF INTERIOR

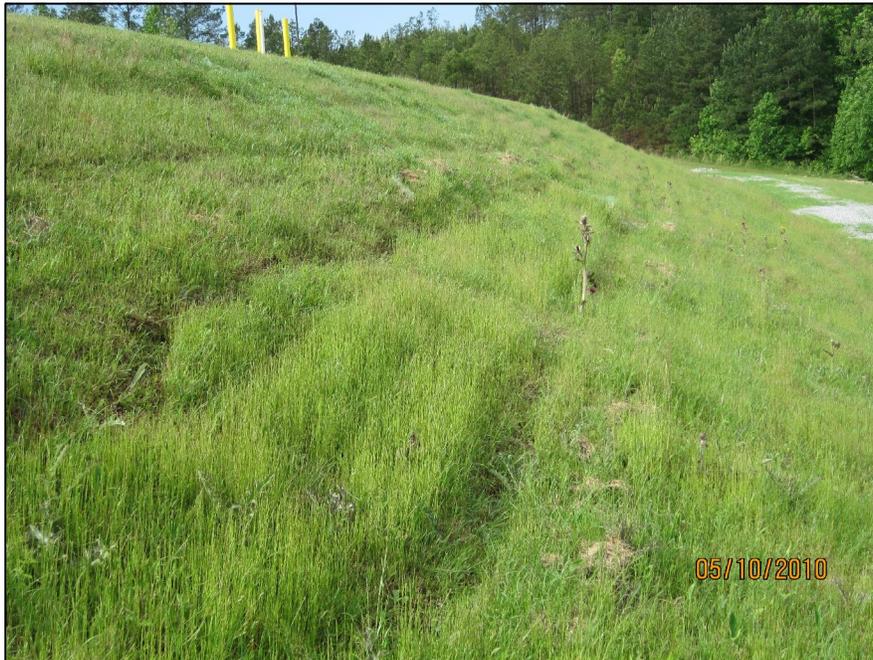
(photo 2-7). The bench is generally covered with grass and no deficiencies were observed (photo 2-5 and 2-6). The lower slope was covered with stone. The stone was noted to have a wide range of sizes from small, 1-1/2 inch diameter gravel to 12 inch rocks. The shape of the slope was irregular in areas as the placement of the sizes of stone on the slope appeared random with the stone mixed or grouped and others dumped over the slope (photos 2-6 and 2-9). At the toe of the lower slope near the left abutment, a wet area was observed (photo 2-9). We understand this area has been investigated and is being monitored by Georgia Power. No other wet areas or seeps were observed on the lower slope. At the toe of the slope, at the right abutment, a silted-in drainage pipe outlet was observed (photo 2-8). The area below the toe of the slope was noted to be silted over from recent heavy rains (photo 2-6). The bank of the Chattahoochee River (photo 2-6 and 2-9) is located about 25 feet from the toe of the slope and it is armored with stone filled gabion baskets as an erosion protection blanket to the top of the bank. A couple of small holes were observed at the top of the slope behind the blanket. We understand repairs, for undercutting behind the river bank armor due to animal burrows and flooding, are part of the on-going routine maintenance for the dam.

UPPER DOWNSTREAM SLOPE, RUTTED AREAS FROM MOWING

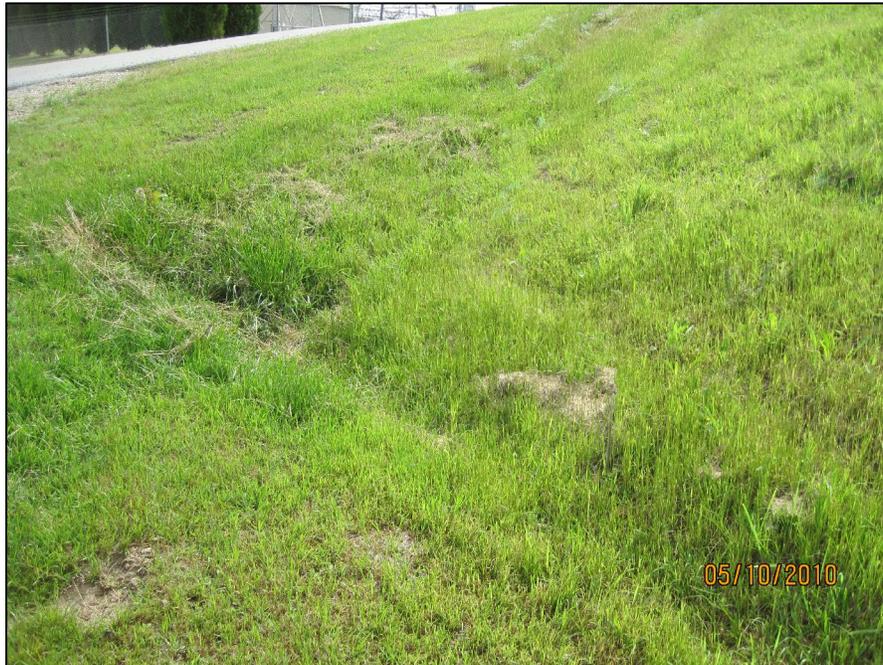
2-7

The Ash Pond 2 dam is a cross-valley structure that exhibited approximately 5 feet of freeboard during the site visit. The visible upstream embankment and crest of the dam (photo 2-10) was assessed as being in good condition. The downstream embankment slope has one bench and two slopes. The upper slope is covered with grass. Ruts and hummocks apparently caused by lawn-mowing equipment were observed along the upper slope (photo 2-5). A depression, possibly caused by drainage, was observed at the toe of the upper slope at the right abutment

LOW SPOT ON BOTTOM OF UPPER DOWNSTREAM SLOPE AT LEFT ABUTMENT

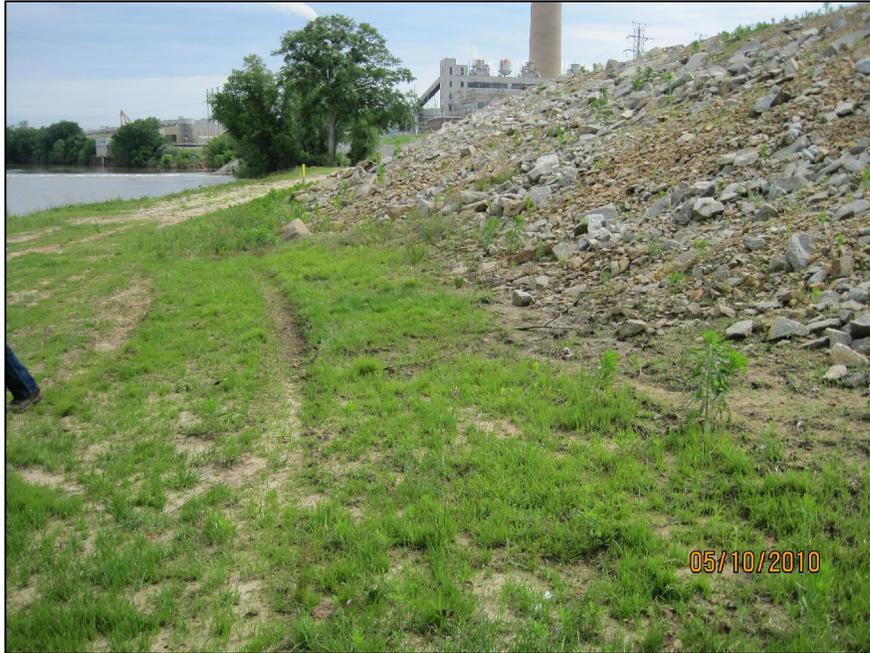
2-9

WET AREA AT TOE NEAR RIGHT ABUTMENT OF MIDDLE DOWNSTREAM SLOPE

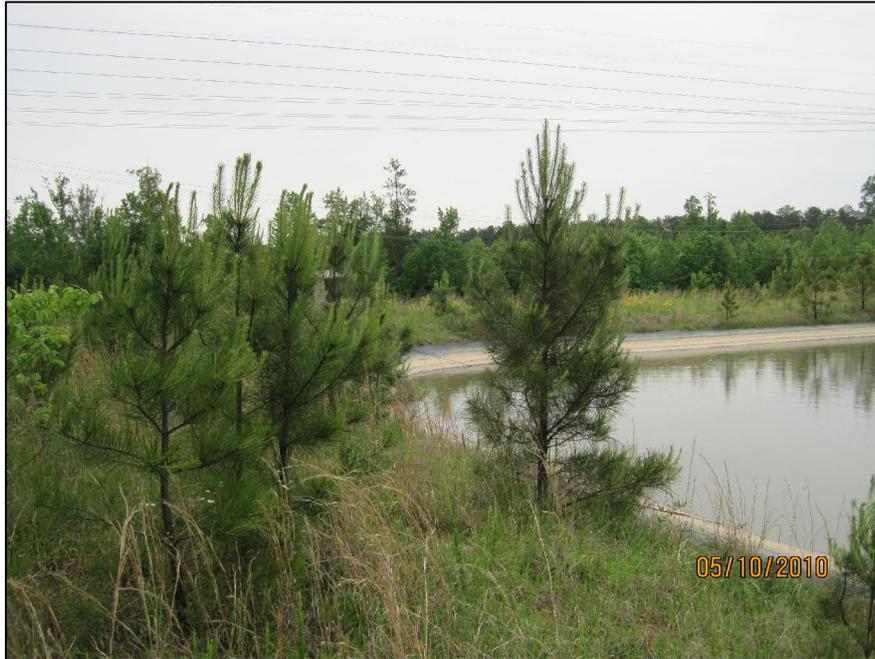
GP-7
TREES AT EDGE OF LOWER BASIN

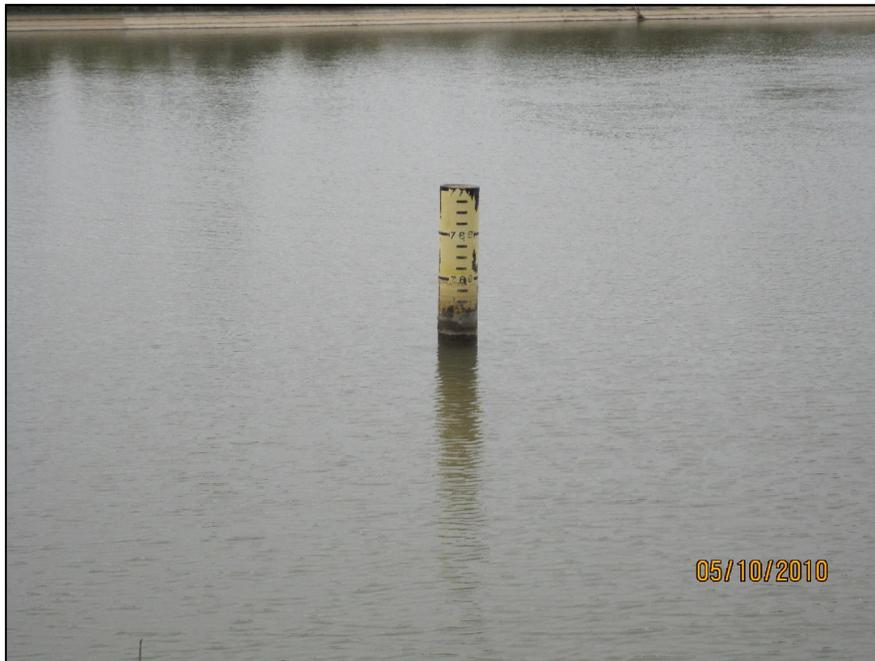
trees up to four inches in diameter were observed on the embankments to the north and east of the pond (photo GP-8).

GP-8
GAGE FROM WEST SIDE (ROAD) OF LOWER BASIN INDICATES APPROX. ELEV. 766.5

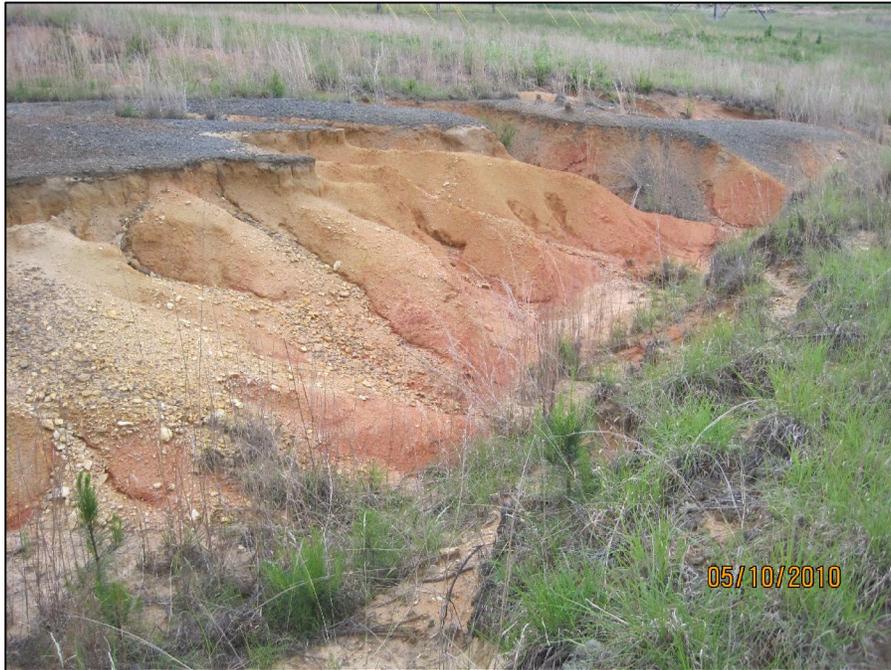
A-3

Ash Pond A has a discharge channel at the left abutment; severe erosion of the ditch was noted in the embankment area and downstream (photo A-3). Due to this open-channel ditch at the left abutment, Ash Pond A was considered to have no freeboard. There was no visible outlet control structure. Georgia Power reports that the erosion was repaired shortly after the site visit.

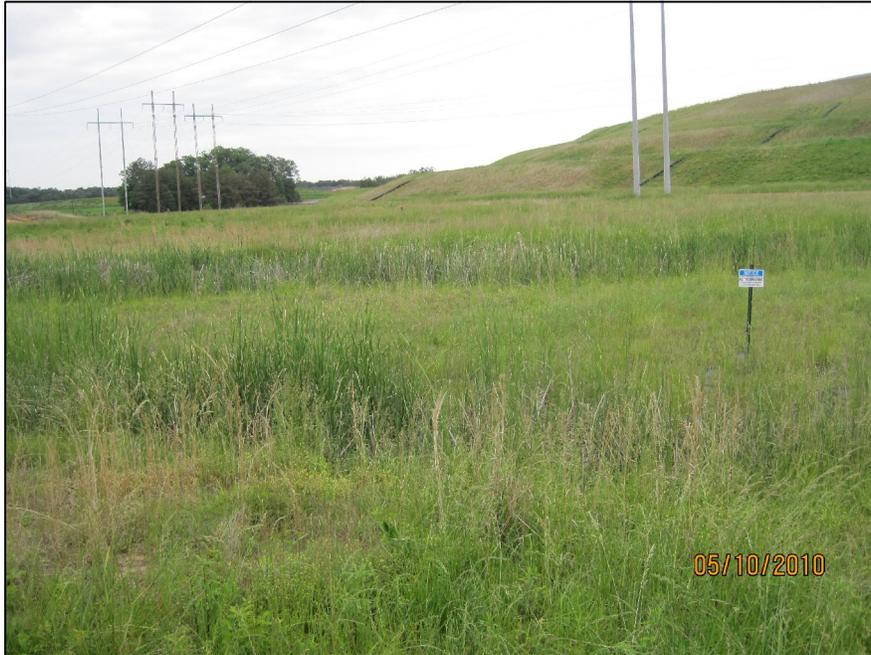
C-1

LOOKING EAST ACROSS POND C, ASH UP TO FULL HEIGHT, NOT CAPPED, INCLUDED UNDER SOLID WASTE PERMIT

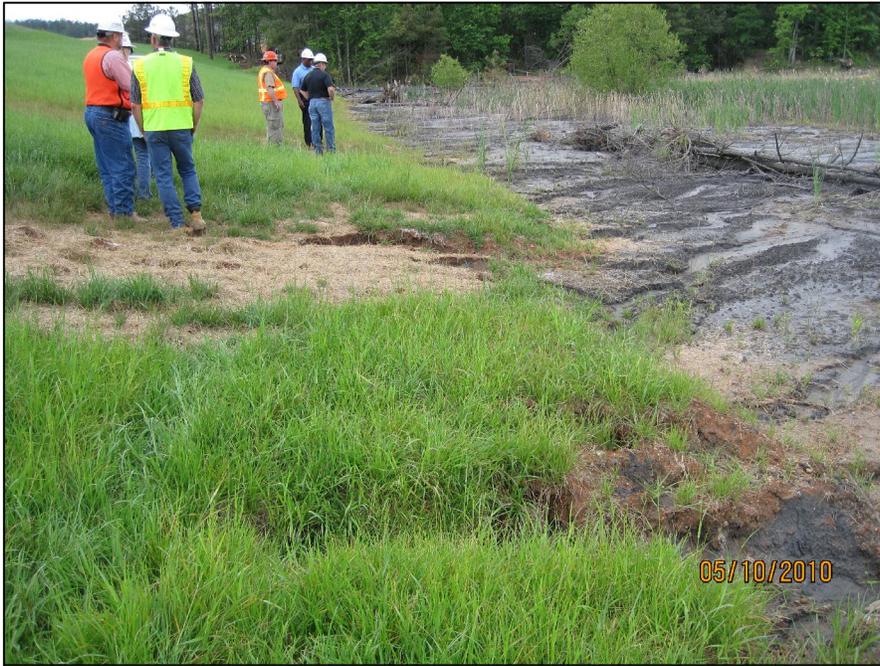
B`-3

EROSION AT TOE OF NORTH SIDE OF DOWNSTREAM SLOPE NEXT TO POND B
