**Coal Combustion Waste Impoundment  
Round 5 - Dam Assessment Report**

*Lansing Smith Plant (Site #07)*

*Ash Pond Embankments  
Gulf Power Company  
Southport, Florida*

**July 2010**

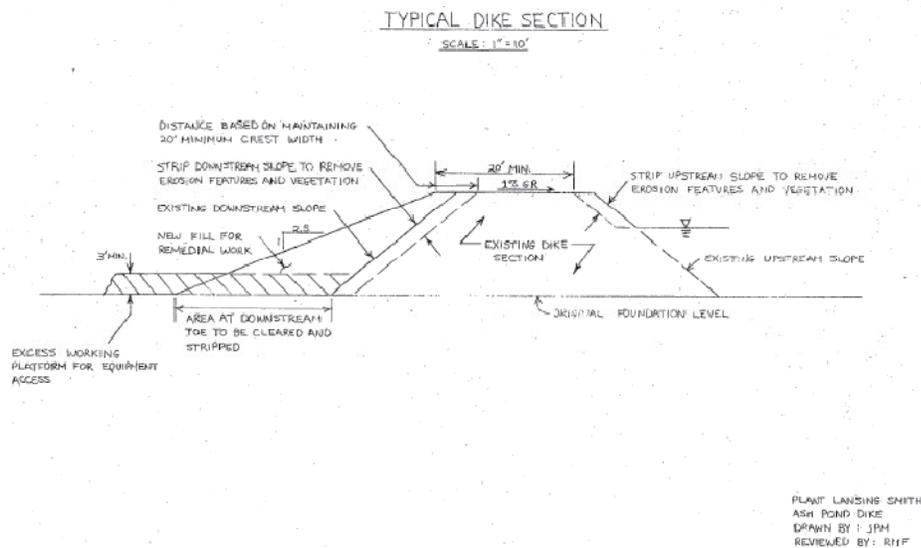
**Figure 4.1.2 a: Ash Pond Impoundment Remedial Work Cross-section**

There are multiple references describing some remedial work that needed to be done to the Ash Pond Dike. The figure below shows a cross section of the plans to remediate the dike (see Appendix A: Doc 05 – Remedial Work Dike Section). No documentation was provided on the construction or tests results of this work.

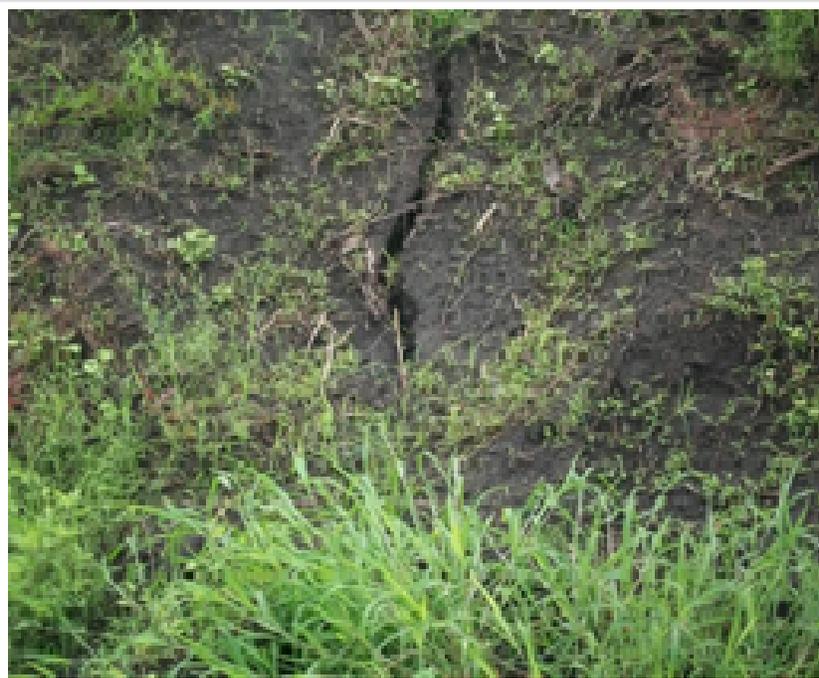
There were signs of surficial sloughing particularly along the northeastern embankment downstream slope. Widespread rill erosion, surface sloughing, and downstream sediment deposition was found along downstream slopes. Wetlands and the recycle water channel are located along the downstream toe of the embankments.

Rill erosion along downstream slope of west embankment.

Vegetation shall be cut or mowed on as needed basis to prevent large woody-stemmed vegetation from establishing. A plan of action needs to be established to handle the maintenance of surficial sloughing, crest depression and rill erosion when observed.

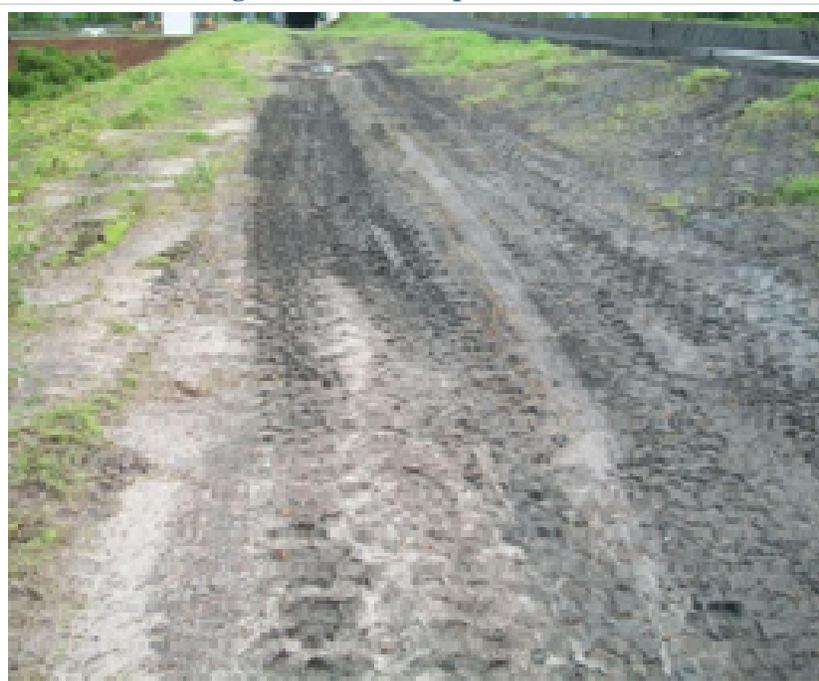
Water ponding on west embankment buttress.

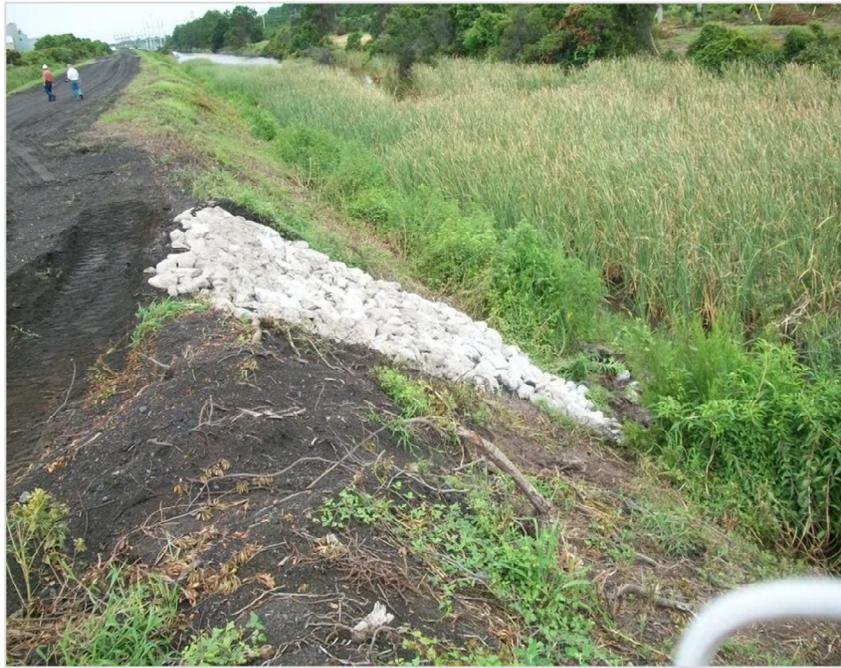
Rip rap repair on downstream slope of north embankment

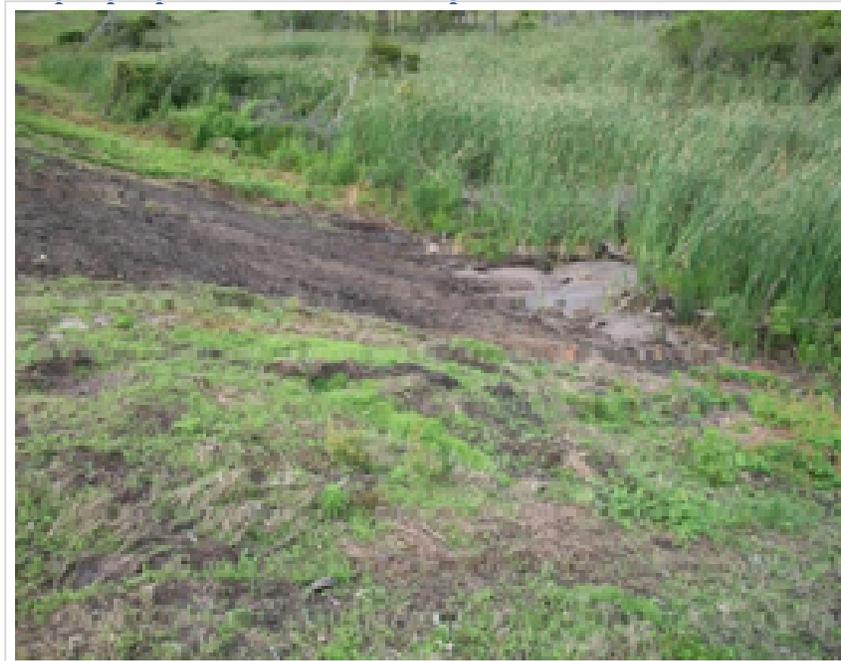
Recently fixed sloughing on west embankment.

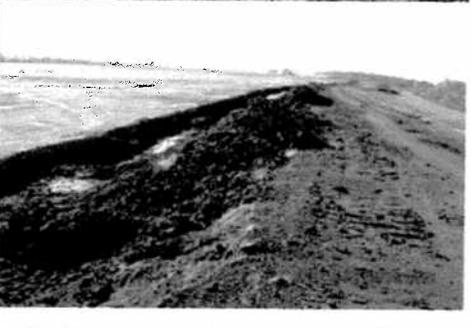
3	West Ash Pond Dike - Showing downstream berm after clearing, facing south. Marshy area to the right and area of seepage circled.

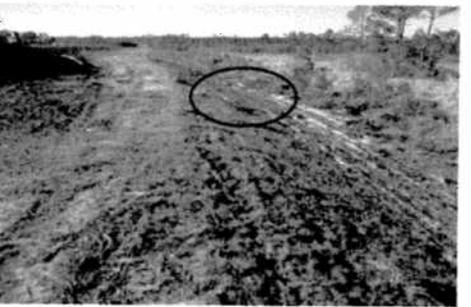
4	West Ash Pond Dike - Close-up of area of seepage circled in Photo 3 above.

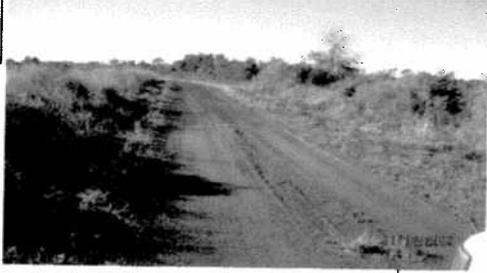
2	Vegetation on the downstream slope of the South Dike. This condition made inspection of the downstream slopes extremely difficult and unsafe for inspection. Ash Pond is to the left.

- The inspection team was not able to complete a thorough inspection due to heavy wooded vegetation along the downstream slopes. It was recommended to have all woody vegetation removed from embankment;

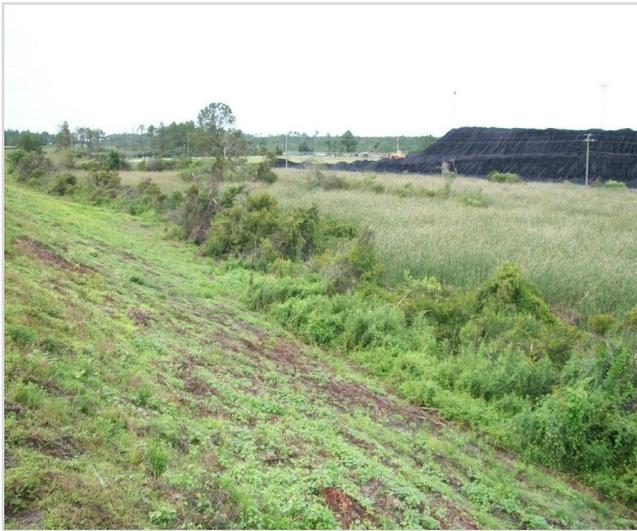
Photo 6  
West embankment buttress fill (Old road bed) ponding water

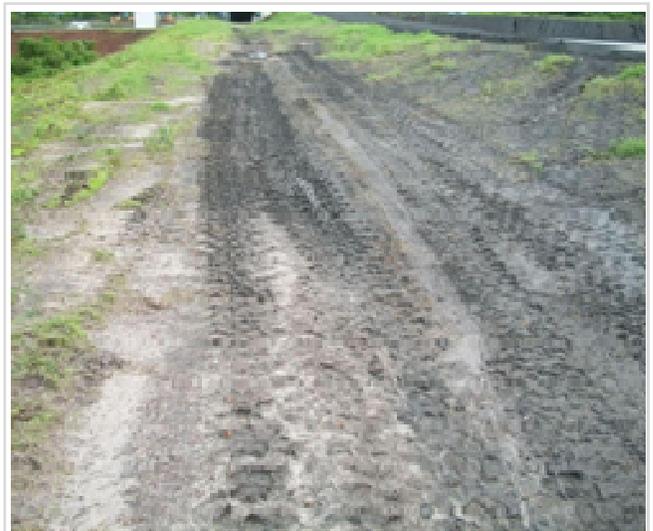
Photo 7  
Rilling on slope of West embankment

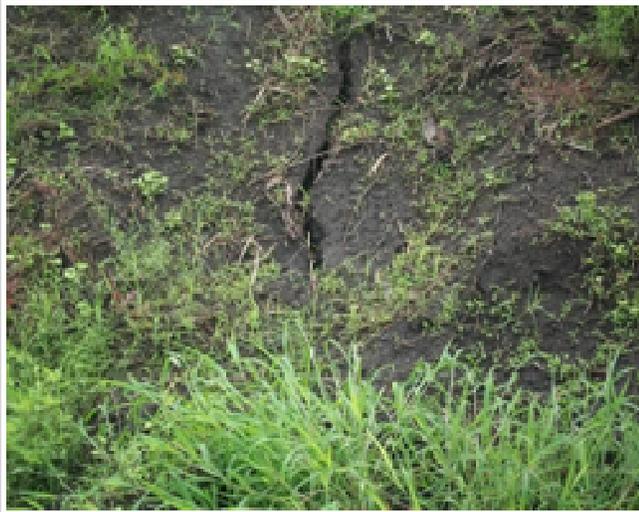
Photo 8  
Recently fixed Sloughing on West embankment

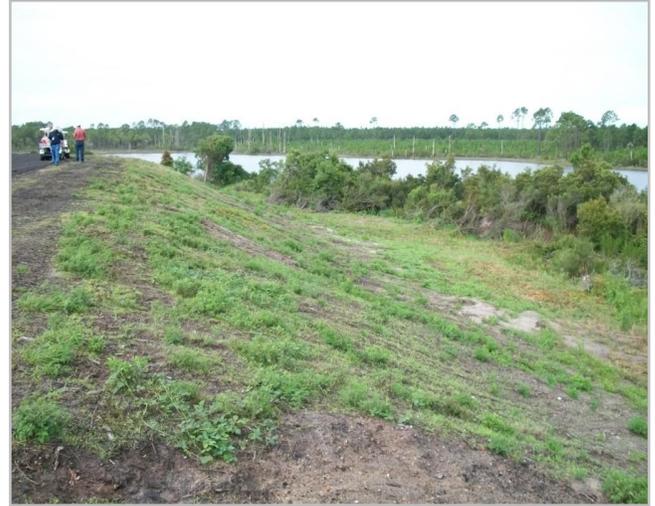
Photo 13  
West embankment at South West corner – looking North note slope rilling

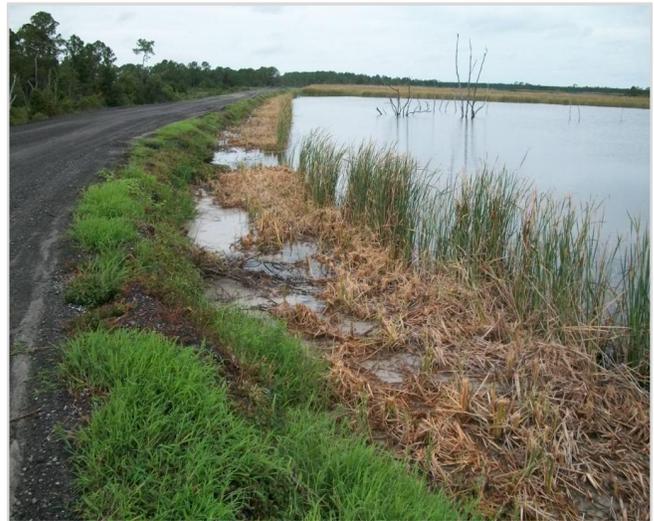
Photo 26  
Cattails recently trimmed on East embankment interior
