ASSESSMENT OF DAM SAFETY OF COAL COMBUSTION SURFACE IMPOUNDMENTS – DRAFT REPORT

Gulf Power Plant Crist Pensacola, Florida

Prepared for
*U.S. Environmental
Protection Agency
Washington, D.C.*

October, 2012
Revision 1, November 2013

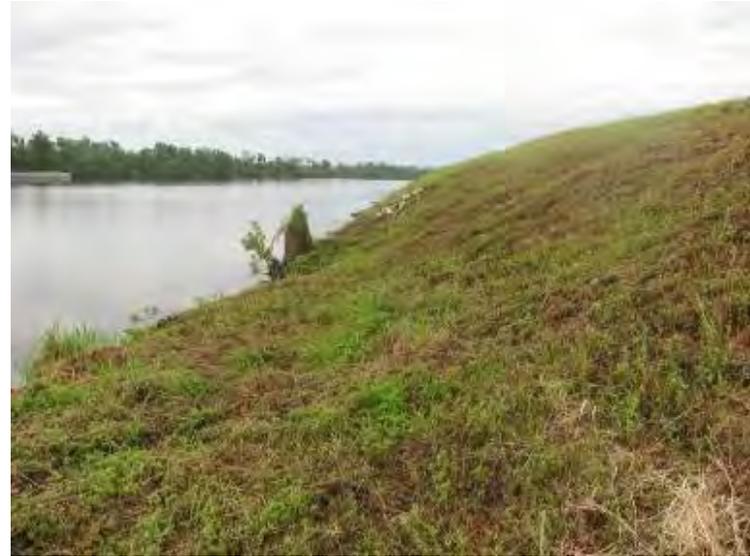
Photo 6: View of exterior slope of Ash Pond north embankment looking east.

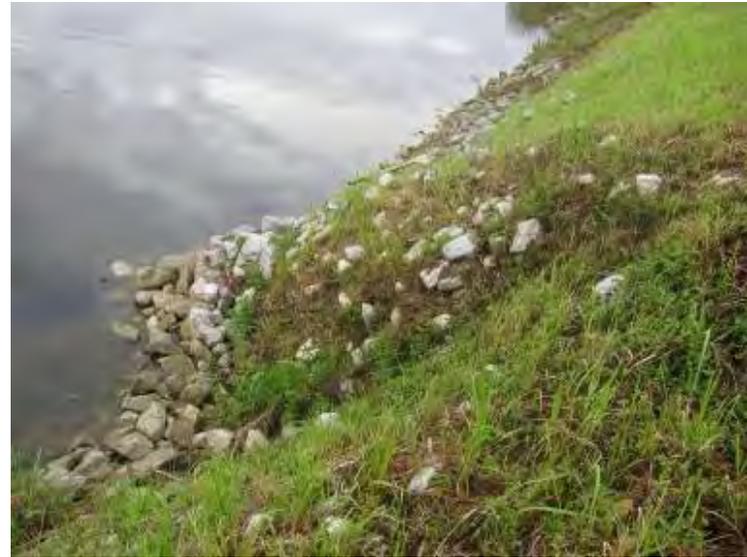
Photo 10: Erosion at toe of northeast embankment exterior slope looking southeast.

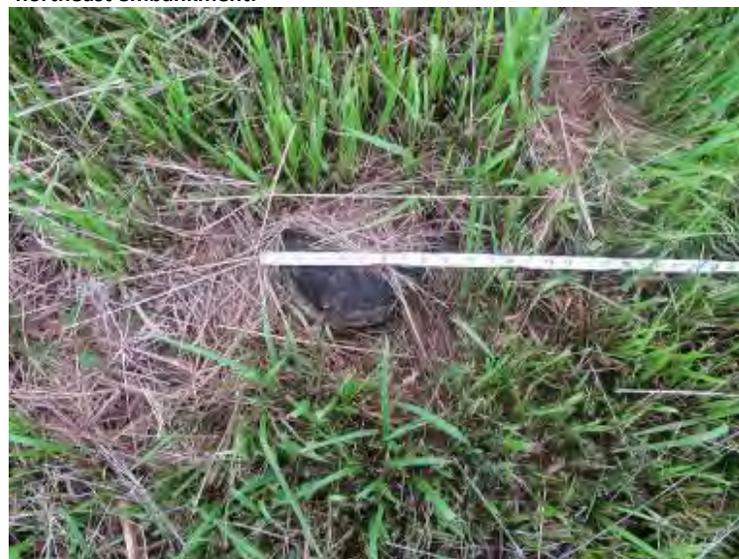
- ✓ Two tree stumps approximately 6 and 18 inches in diameter were observed on the exterior slope of the northeast embankment.
 - ✓ Significant erosion and scarps were observed on the southeast embankment's interior slope, near the south corner of the pond.

Photo 19: Exterior slope of Ash Pond along northeast embankment showing scarp with sand fan at toe of slope looking northwest.

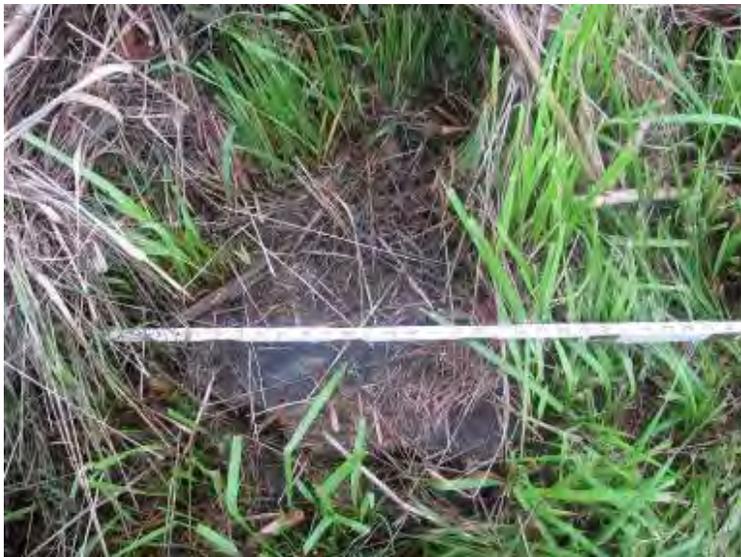
Photo 21: Tree stump found on exterior slope of Ash Pond.

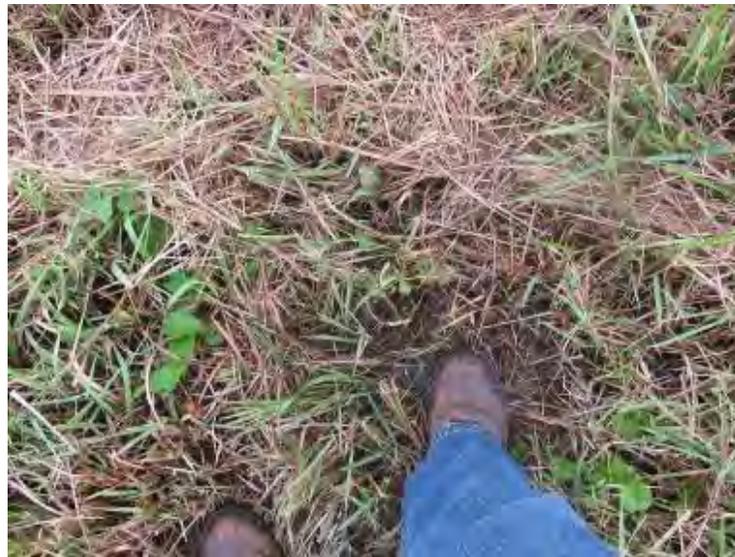
Photo 22: Area of saturation along exterior toe of slope of Ash Pond near southeast corner.

- Regular monitoring is essential to detect and monitor seepage and to reduce the potential for failure. If seepage areas are observed, services of a qualified engineer should be retained by Gulf Power to assess the area of seepage and recommend remedial actions.

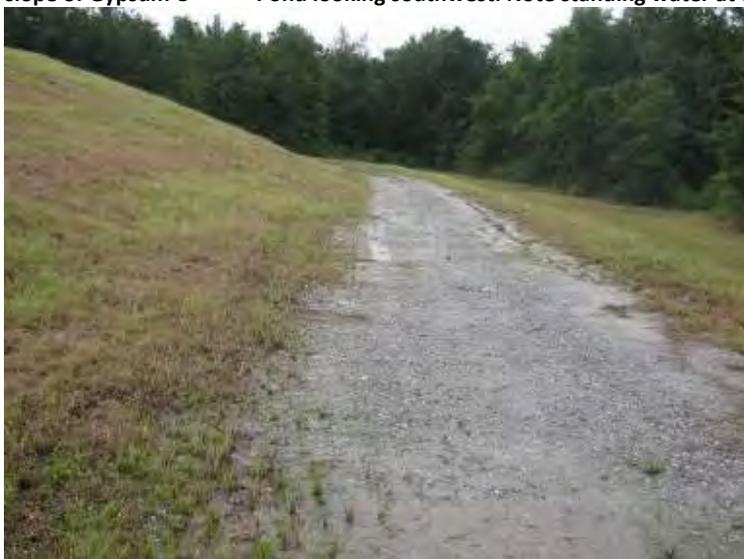
- ✓ Areas of possible seepage were observed near the toe of the southwest embankment and at the toe of the east embankment.

Photo 111: Perimeter road/maintenance bench at toe of southwest slope of Gypsum O Pond looking southwest. Note standing water at toe.

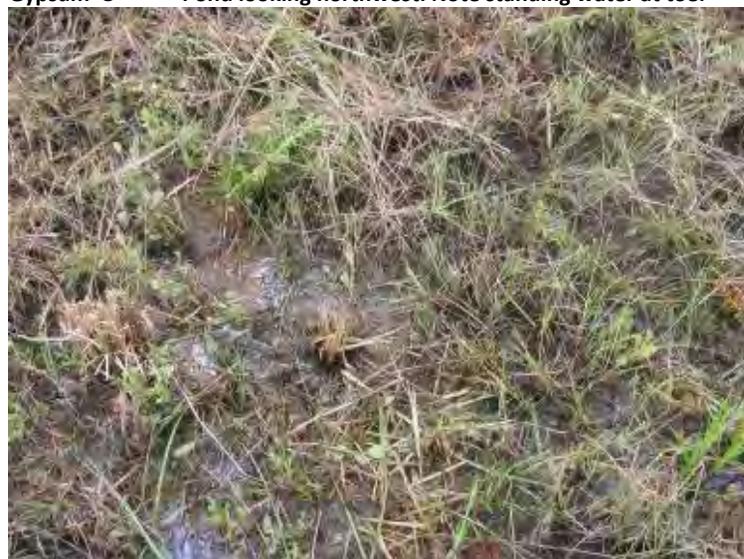
Photo 112: Close-up of wet area/possible seepage at toe of southwest Slope of Gypsum O Pond.

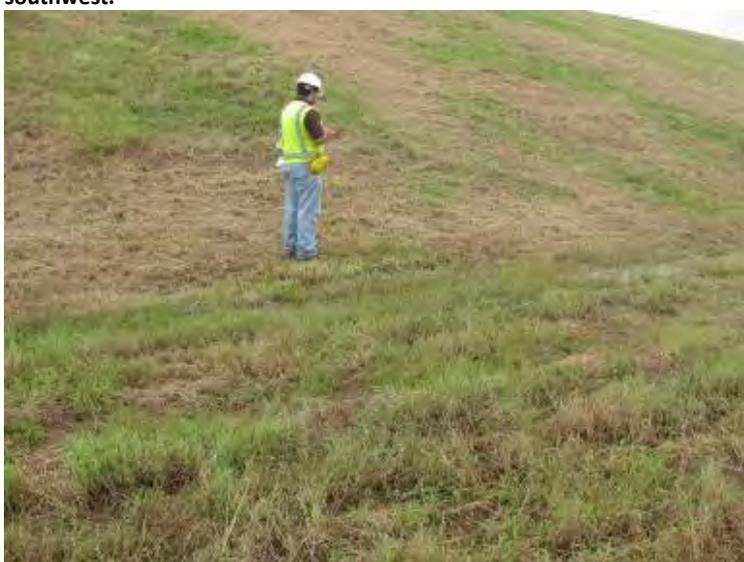
Photo 115: General view from toe of exterior slope on southwest side of Gypsum Pond looking east. Note area of wet area at toe of slope.

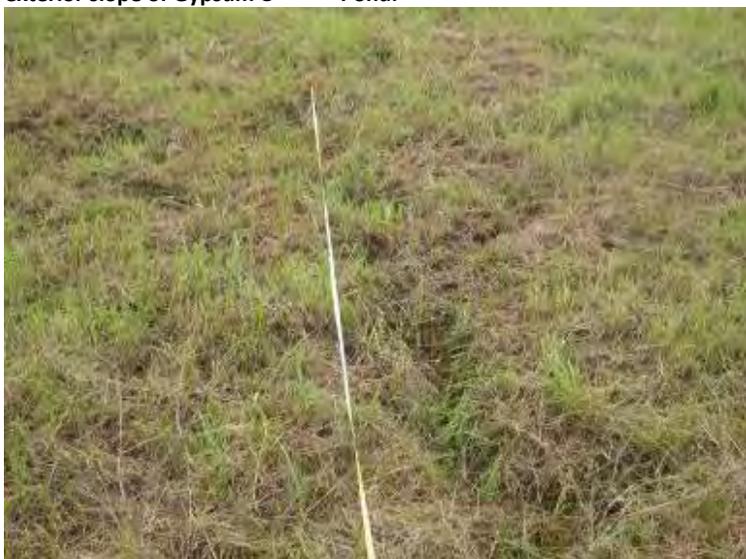
Photo 131: 16-foot long rill on north exterior slope of Gypsum Pond (Depth x Width ~ 1 foot, respectively). Note adjacent, parallel 5-foot long rill.

- Erosion rills – Erosion rills were observed on the northwest, southwest, and southeast interior slopes of the Ash Pond and on the north exterior slope of the Process Sedimentation Pond. Structural fill should be placed and compacted in the rills and graded to adjacent existing contours. These areas should be covered with sod or hydro seed to establish vegetative cover.

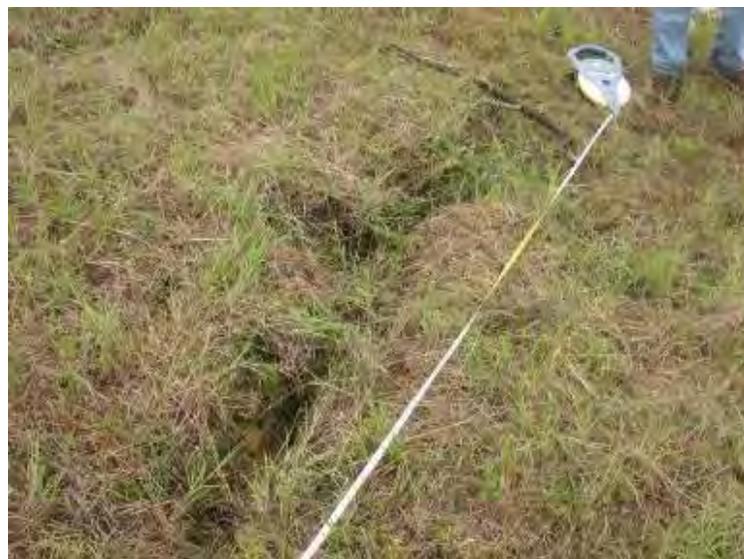
- CDM Smith observed the following during our site assessment of the Process Sedimentation Pond:
 - ✓ Areas of surface erosion and erosion rills were observed on the exterior slope of the northeast embankment.

Photo 132: Approximate 16-foot long rill erosion on north exterior slope of Process Sedimentation Pond (Depth x Width ~1 foot, respectively).

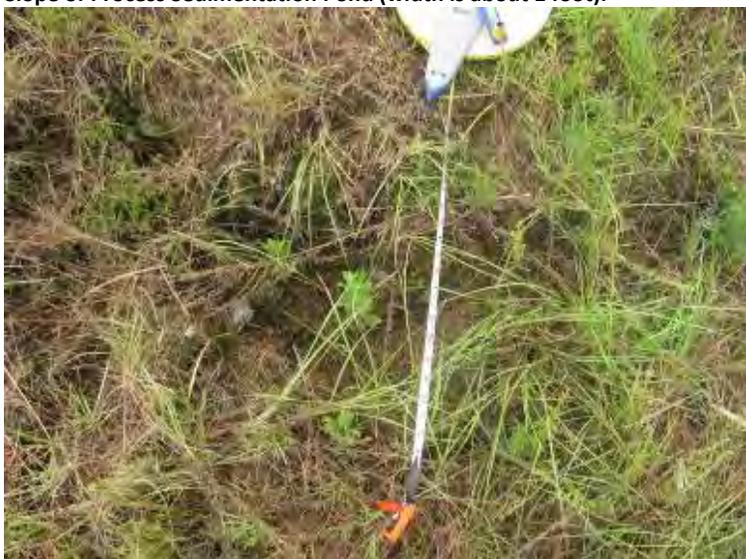
Photo 135: Rill located on north exterior slope of Process Sedimentation Pond (typical of six).

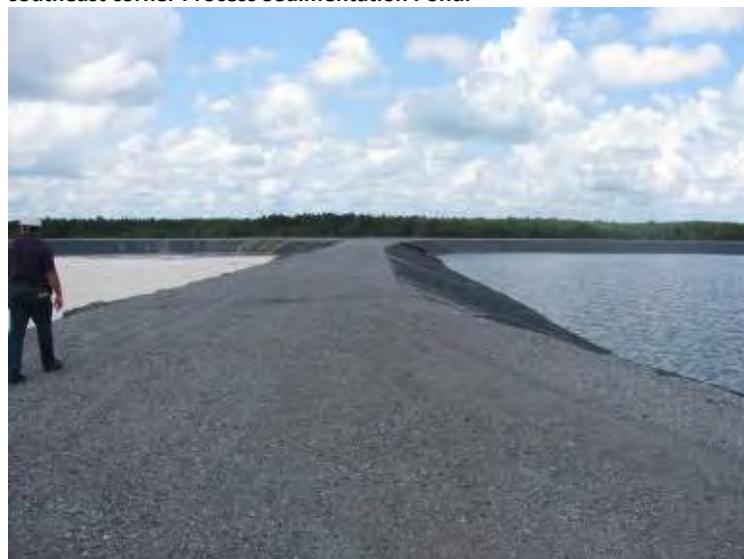
Photo 164: Intermediate embankment between Gypsum Pond and Process Sedimentation Pond looking northwest.
