ASSESSMENT OF DAM SAFETY OF COAL COMBUSTION SURFACE IMPOUNDMENTS – FINAL REPORT

**Gulf Power
Plant Scholz
Sneads, Florida**

May 2014
Revised July 10, 2014

CDM Smith Project No.:
93083.1801.044.SIT.SCHOL

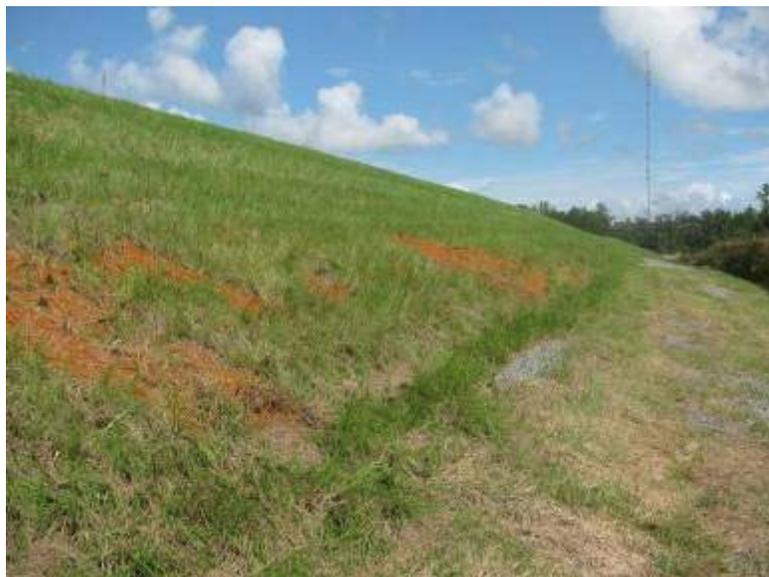
Upper East Pond: The Upper East Pond's normal pool elevation is approximately 128.0 feet, approximately 3.7 feet above the normal pool of the Upper Middle Pond. Some areas on the east embankment appear to be recently backfilled and repaired. Based on plant personnel comments, shallow erosion rills have occurred in these areas. Some areas of dampness were observed at the toe of exterior slope of the east embankment. It was difficult to determine if these wet areas were caused by seepage or the previous day's rain. An animal burrow was observed on the north embankment.

Photo 45: Upper East Pond – East embankment exterior toe of slope looking north. Note recently repaired/backfilled areas where prior erosion had occurred.

Erosion rills, scarps, and rutting: CDM Smith recommends that structural fill be placed and compacted in the rills and scarps and the repaired areas graded to meet the adjacent existing contours. After slope restoration, it is recommended that the exposed surface of the embankment be stabilized with sod or hydroseeded to restore vegetation cover on exterior embankment slopes. After slope restoration of the interior embankment slopes, it is recommended to stabilize the exposed surface of the embankment with riprap consisting of a heterogeneous mixture of irregular-shaped rocks placed over the compacted fill and a geotextile fabric.

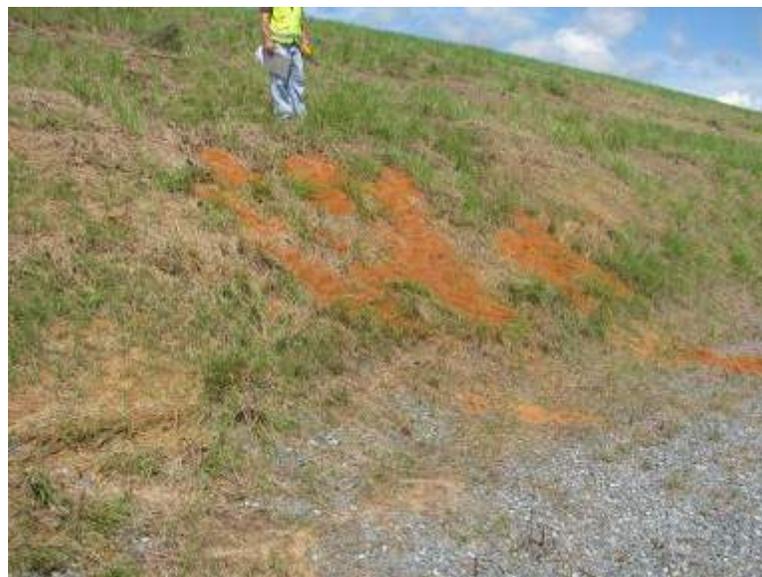
Photo 48: Upper East Pond – East embankment exterior slope looking north. Note recent repair of erosion rills.

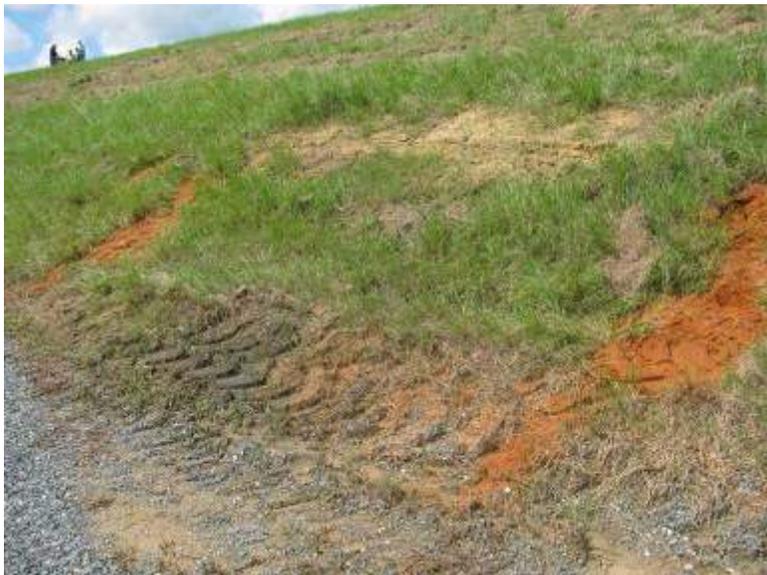
Gulf Power's monitoring program is inadequate. Areas of possible seepage were observed on exterior slope of the east embankment of the Upper East Pond. Although no detrimental conditions or indications of potential embankment failure were observed during CDM Smith's visual assessment, regular monitoring is essential to detect and monitor seepage and to reduce the potential for failure.

Photo 49: Upper East Pond – East embankment exterior slope looking west. Note saturated area at toe of slope.

Seepage: Areas of possible seepage were observed on exterior slope of the east embankment of the Upper East Pond. Regular monitoring is essential to detect and monitor seepage and to reduce the potential for failure. To monitor the nature of the possible seepage conditions, CDM Smith recommends Gulf Power develop a regular surveillance program to monitor areas of seepage and potential seepage to evaluate the rate, volume, and turbidity of flow emerging from the embankment slopes.

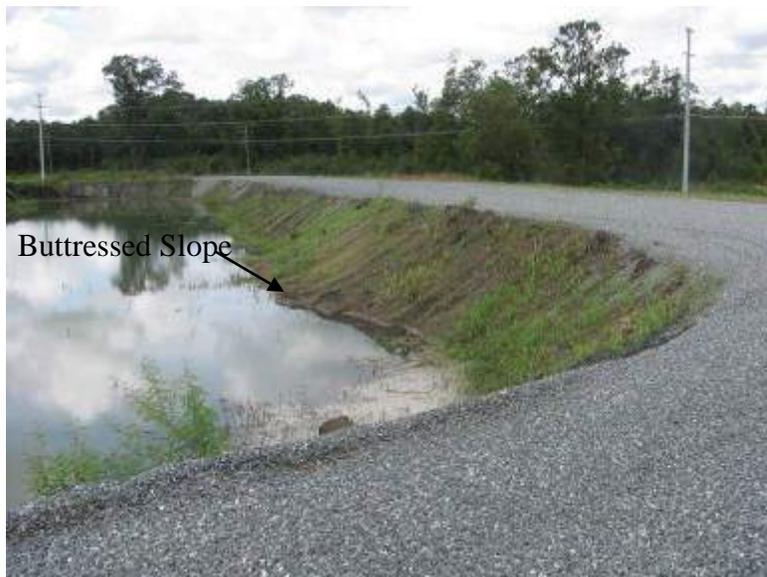
Photo 53: Upper East Pond – North embankment interior slope looking west. Note buttressed slope from previous repairs.

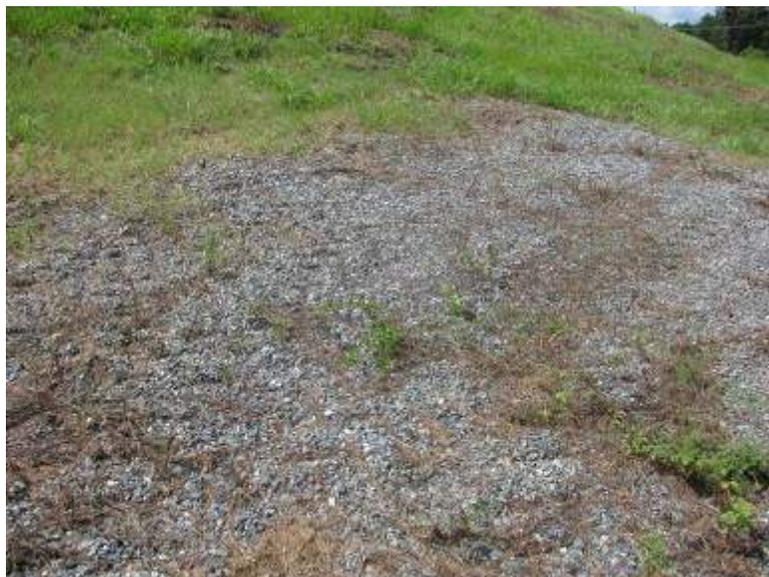
Current maintenance and operation procedures appear to be adequate. There was no evidence of previous spills and release of impounded coal ash slurry within or outside the plant property. Repairs on the Upper East Pond north embankment to mitigate seepage discovered during a regular inspection were performed in October, 2010 and appear to have mitigated the condition. Seepage in any other areas has not been reported by Gulf Power.

Photo 61: Upper East Pond – North embankment exterior slope, repair of seepage area.

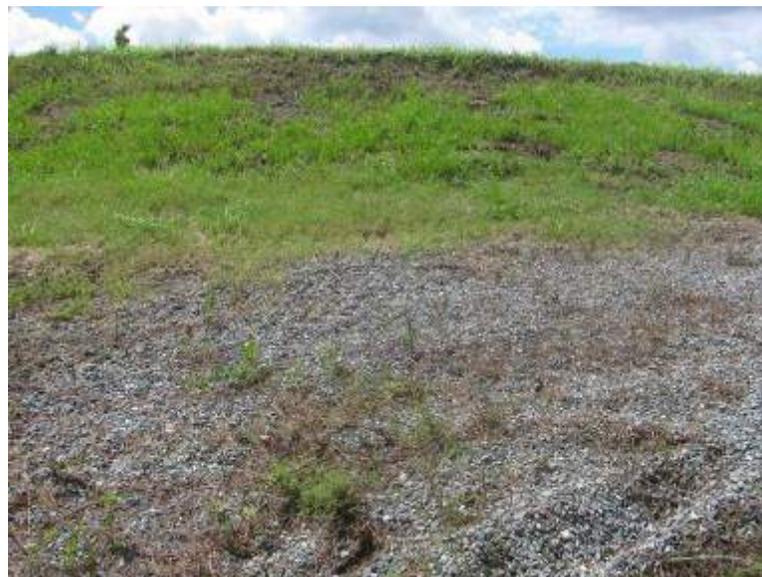
Photo 62: Upper East Pond – North embankment exterior slope, Repaired area where seepage from pond had previously occurred at toe of slope.

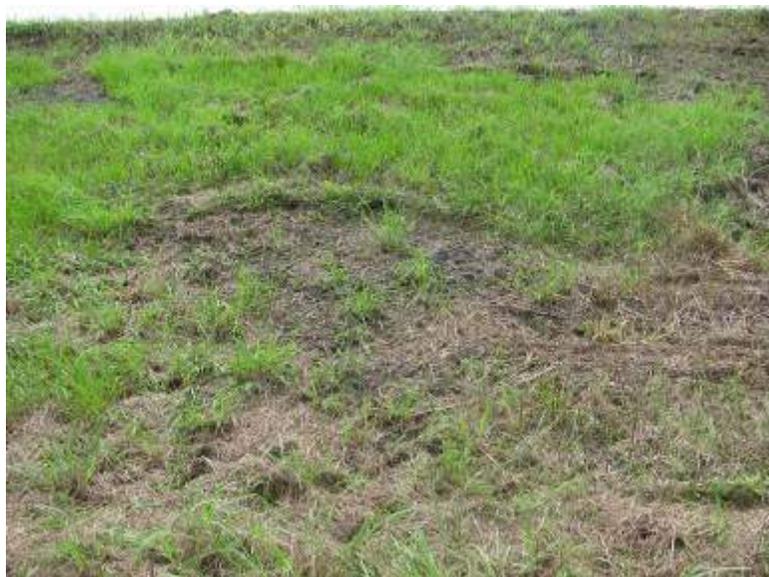
Photo 63: Upper East Pond –North embankment toe of exterior slope looking south. Note saturation at toe of slope.
