COAL ASH IMPOUNDMENT SITE ASSESSMENT DRAFT REPORT

Coal Creek Station Great River Energy Underwood, North Dakota

KLEINFELDER PROJECT NUMBER 118953-1

June 21, 2012

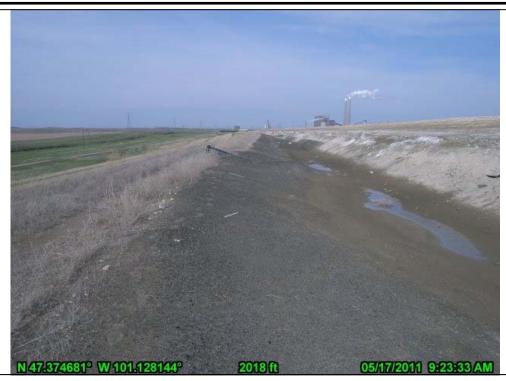
1-Ash Pond 92 Upper Drainage Ditch (looking west)

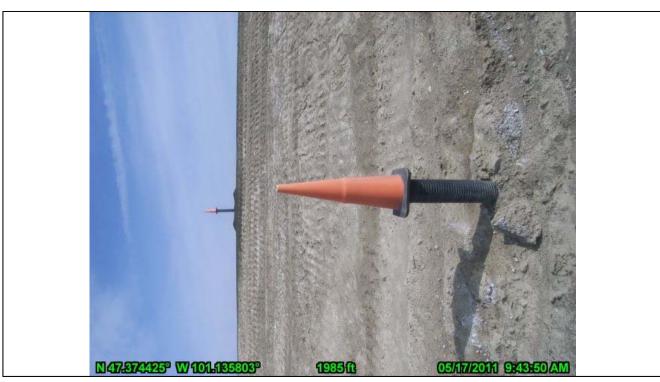
8-Ash Pond 92 Upslope View of Piezometers (looking north)

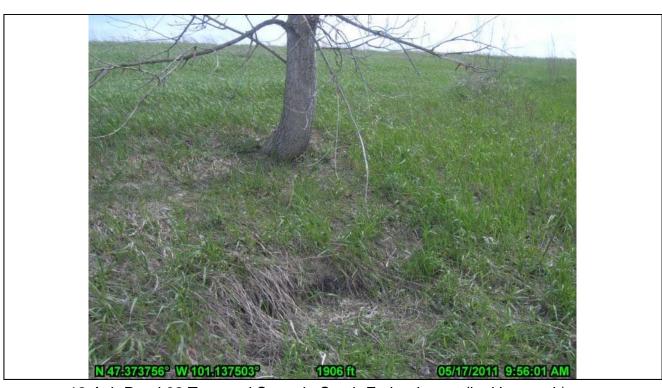
- The embankment toe was located along a drainage ditch on both the south and west sides. It did not appear that any noticeable seepage was occurring along the south side, but that condition would be difficult to detect with ponded stormwater water present. The west side ditch is intended to collect storm runoff and Upstream Raise underdrain seepage, and shallow, clear water was present in the ditch during the site assessment.
- There were woody bushes and small isolated trees at the toe of the embankment of the impoundment at a few locations on the south side. These should be removed to prevent them from spreading further up the slope.

12-Ash Pond 92 Tree and Scarp in South Embankment (looking north)

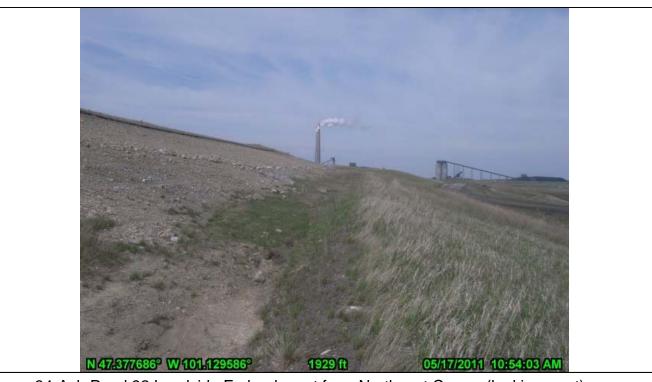
Overall, the downstream slope was in Satisfactory condition. Photos 3, 5, 10, 15, 16, 24, 34, and 35 show the conditions of the downstream slope. Specific observations include:

34-Ash Pond 92 Landside Embankment from Northeast Corner (looking west)

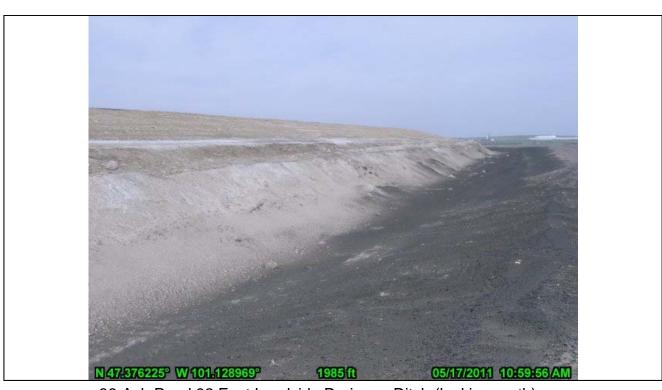
36-Ash Pond 92 East Landside Drainage Ditch (looking north)

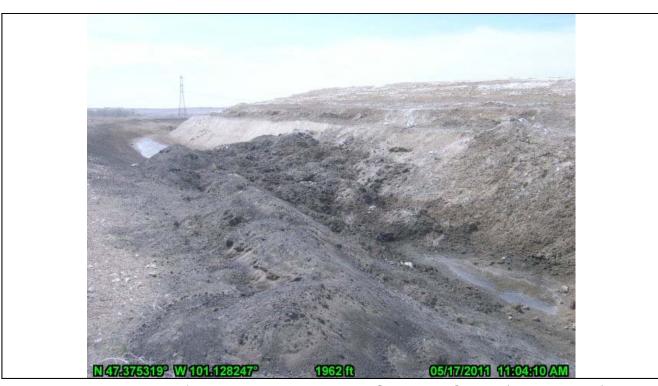
38-Ash Pond 92 Pile of Ash in Drainage Ditch on Southeast Corner (looking north)

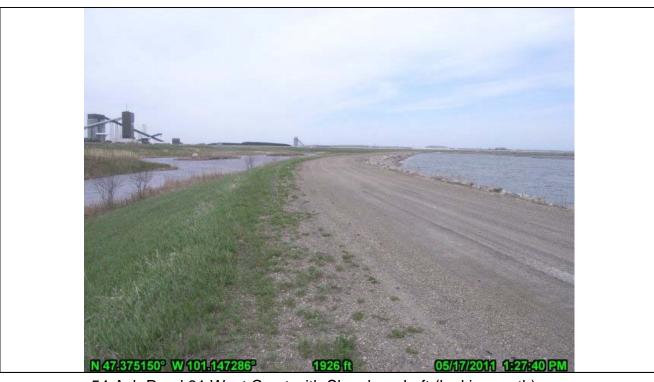
Overall, the crest of the impoundment was in Satisfactory condition. Photos 54, 60, and 61 show the condition of the crest. Specific observations include:

54-Ash Pond 91 West Crest with Slough on Left (looking north)

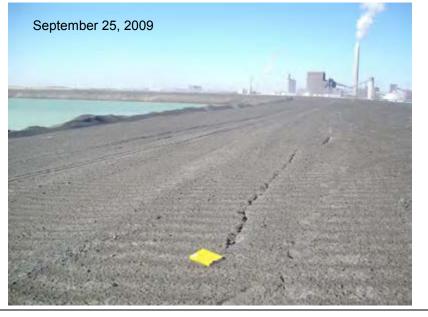
Crack in Bottom Ash on Crest – North Side (looking west)

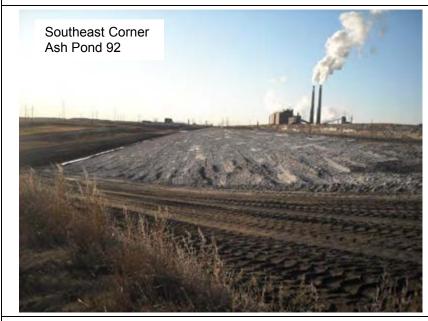
Fly Ash Exterior Slope 1 of 3– South Side (looking west)
