**COAL ASH IMPOUNDMENT
SITE ASSESSMENT FINAL REPORT**

**Coal Creek Station
Great River Energy
Underwood, North Dakota**

KLEINFELDER PROJECT NUMBER 118953-1

October 31, 2012

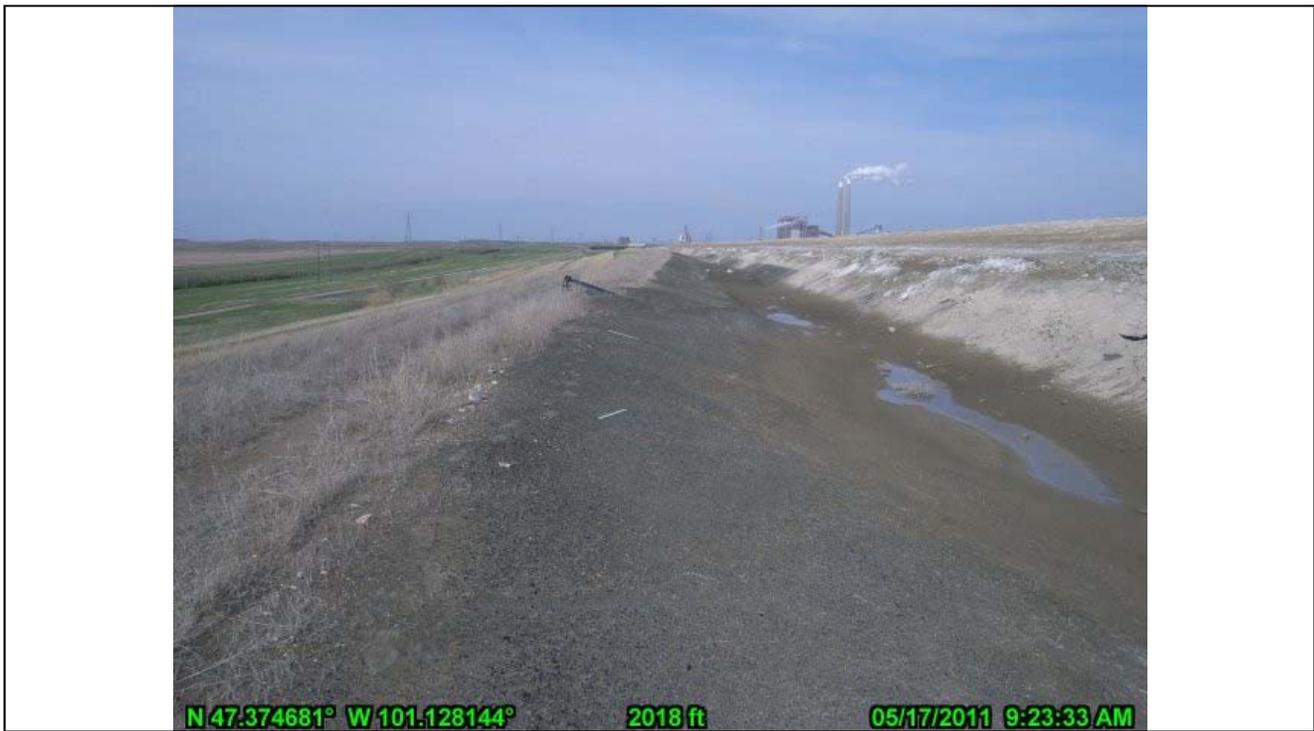
1-Ash Pond 92 Upper Drainage Ditch (looking west)

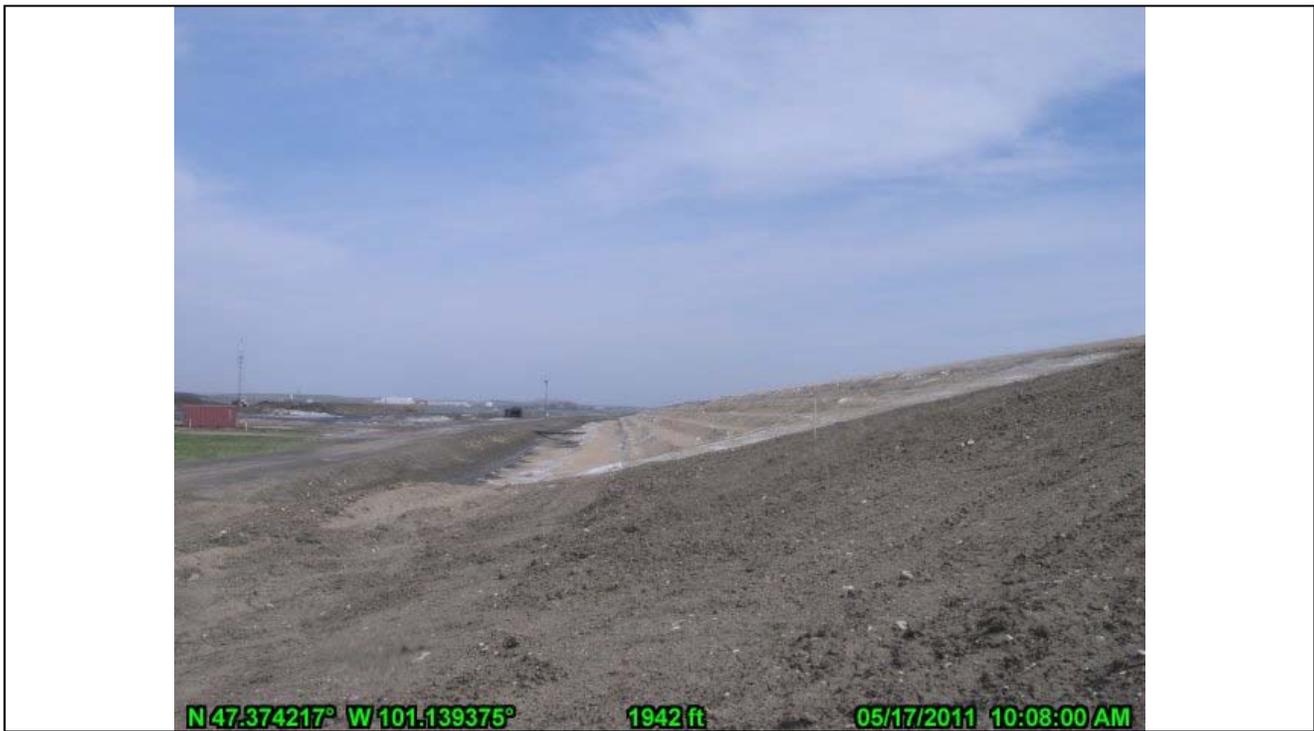
15-Ash Pond 92 West Landside Slope (looking north)

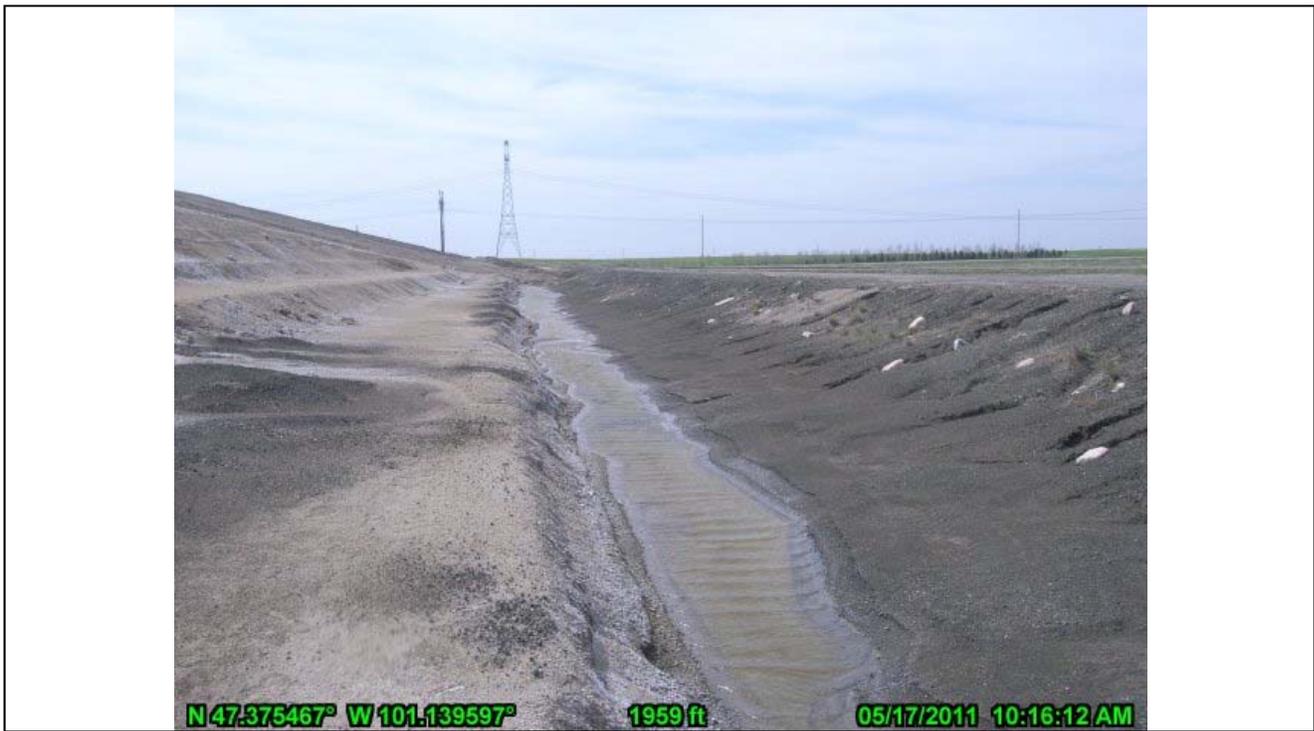
17-Ash Pond 92 Ditch on West Toe (looking south). Ash Pond 91 Embankment on Right

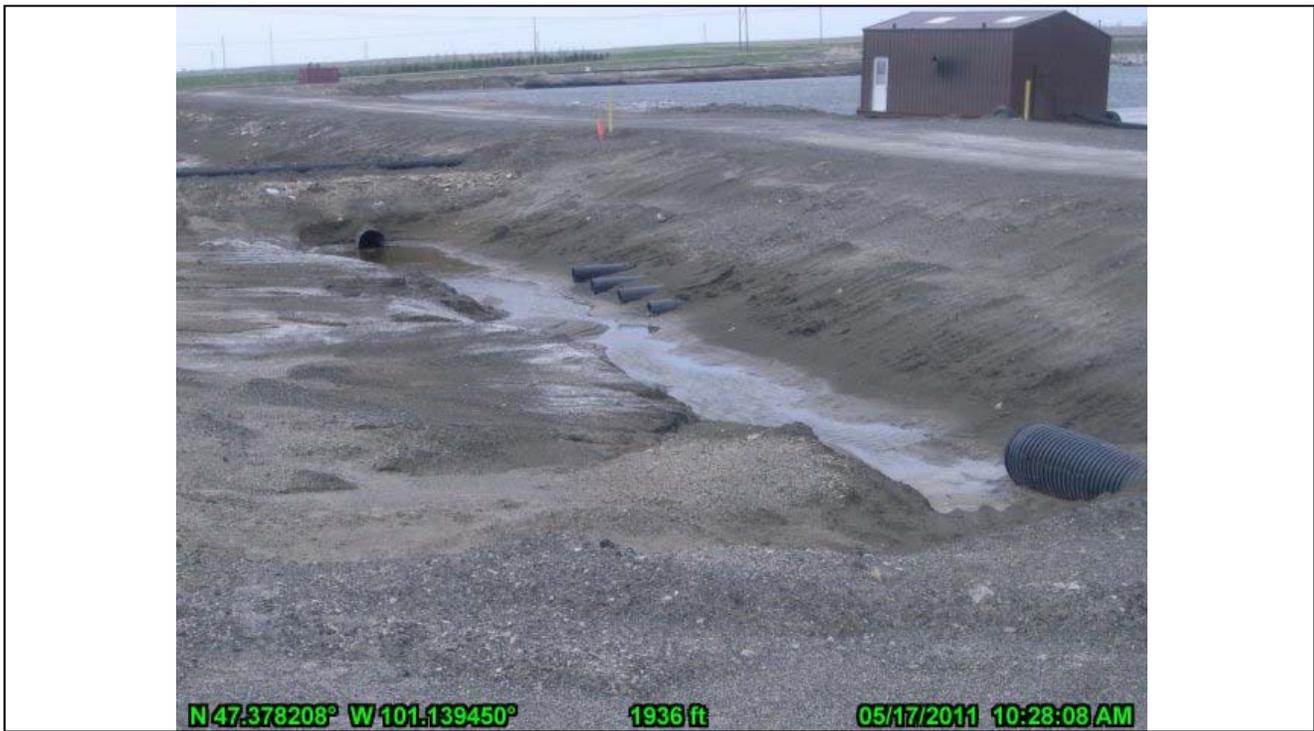
23-Ash Pond 92 Drainage Culverts on West Toe (looking south)

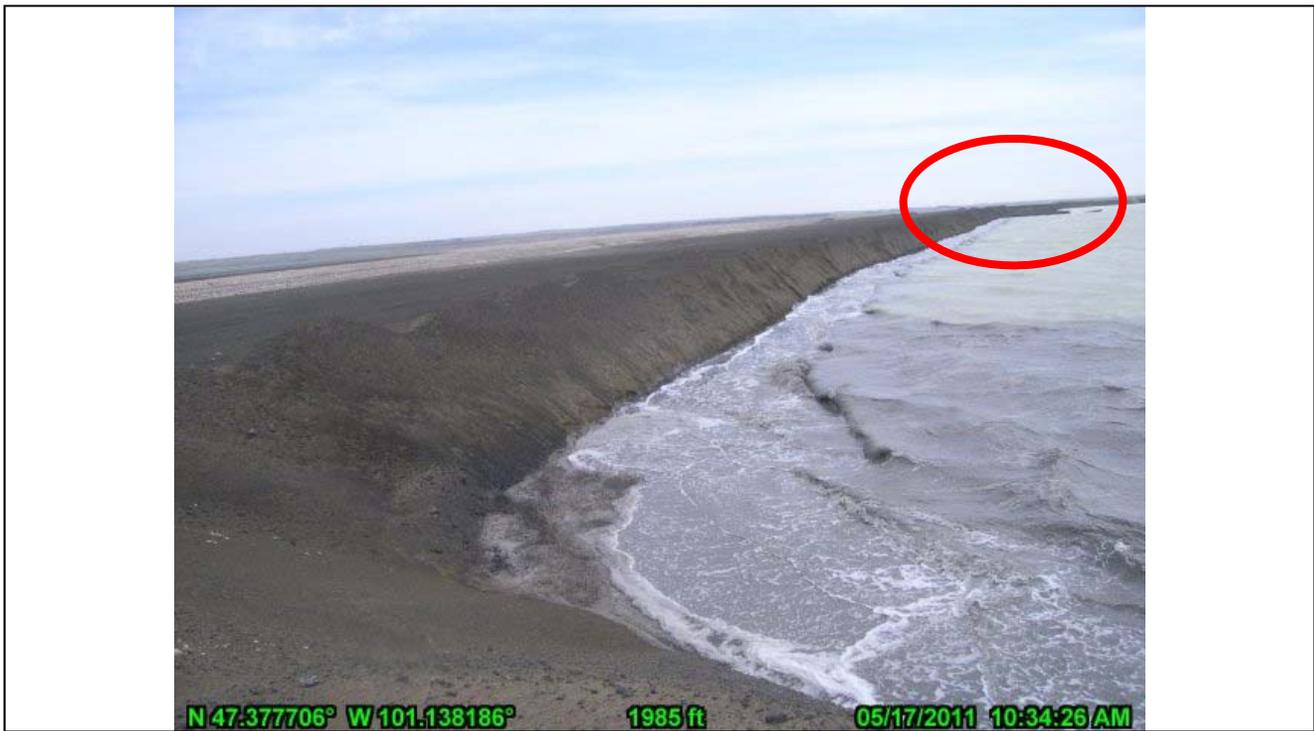
27-Ash Pond 92 Waterside Embankment at NW Corner (looking east). Pipe is Discharging Into Pond in Background.

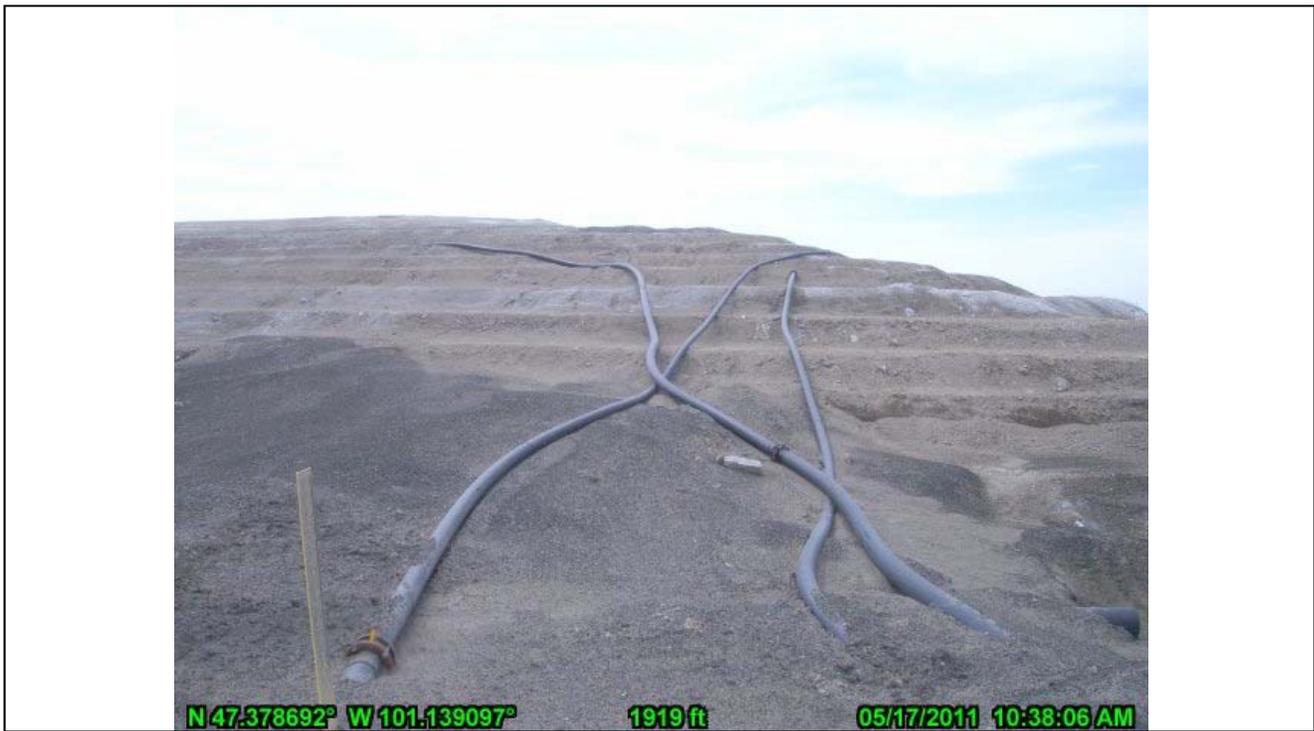
29-Ashpond 92 Movable Inlet Pipes on Northwest Corner (looking south)

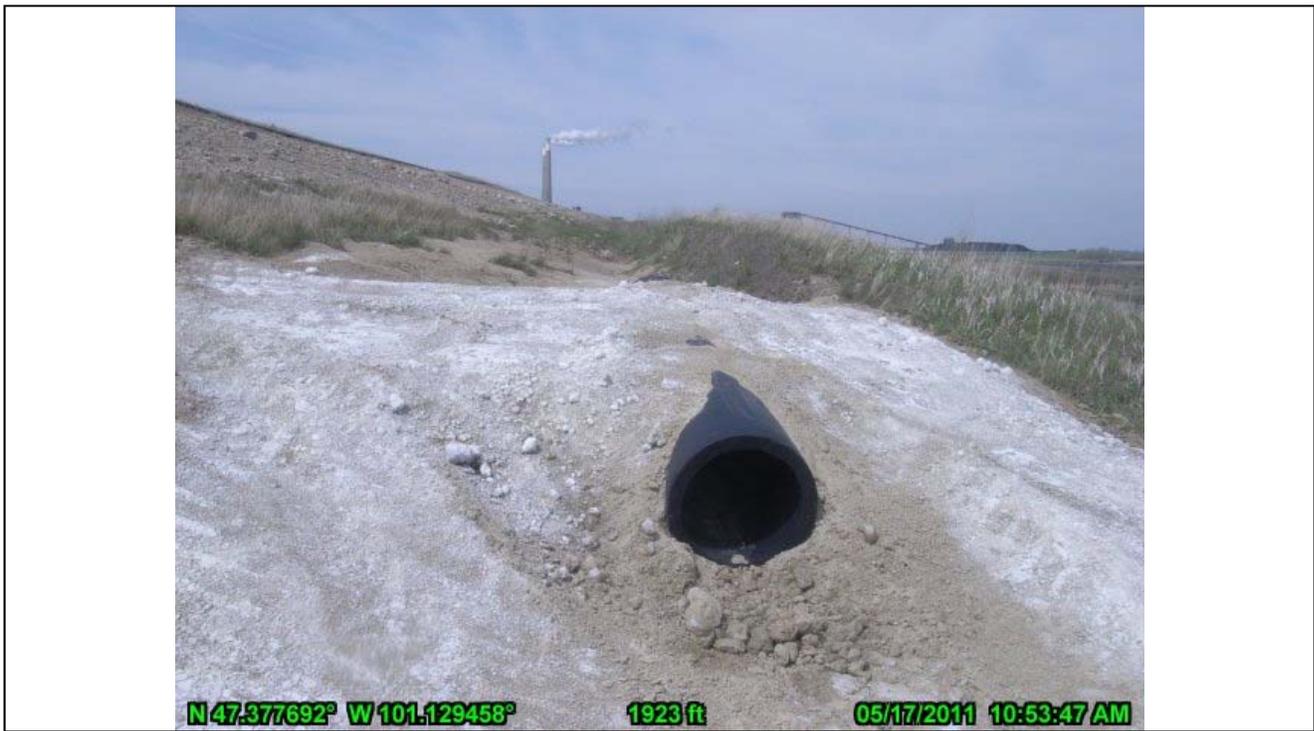
33-Ash Pond 92 18" Drainage Pipe on North Embankment Upper Ditch (looking west)

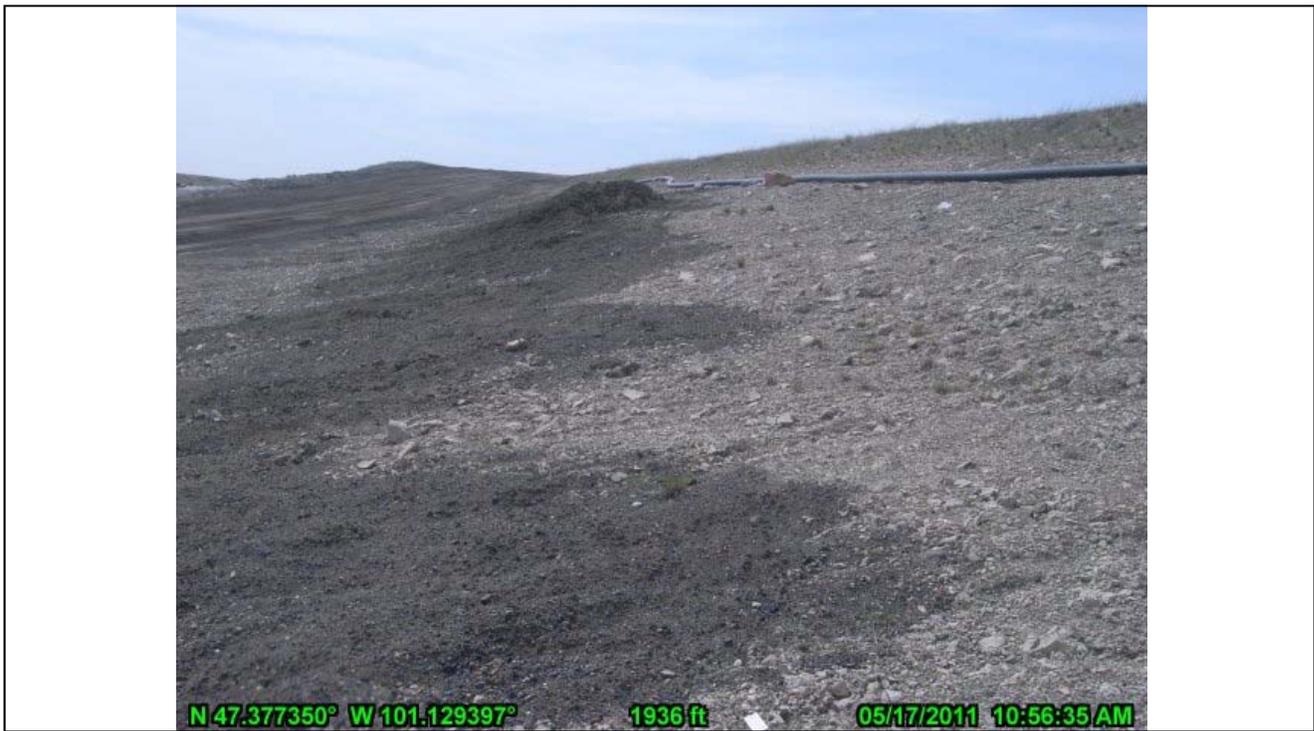
35-Ash Pond 92 East Landside Embankment (looking south)

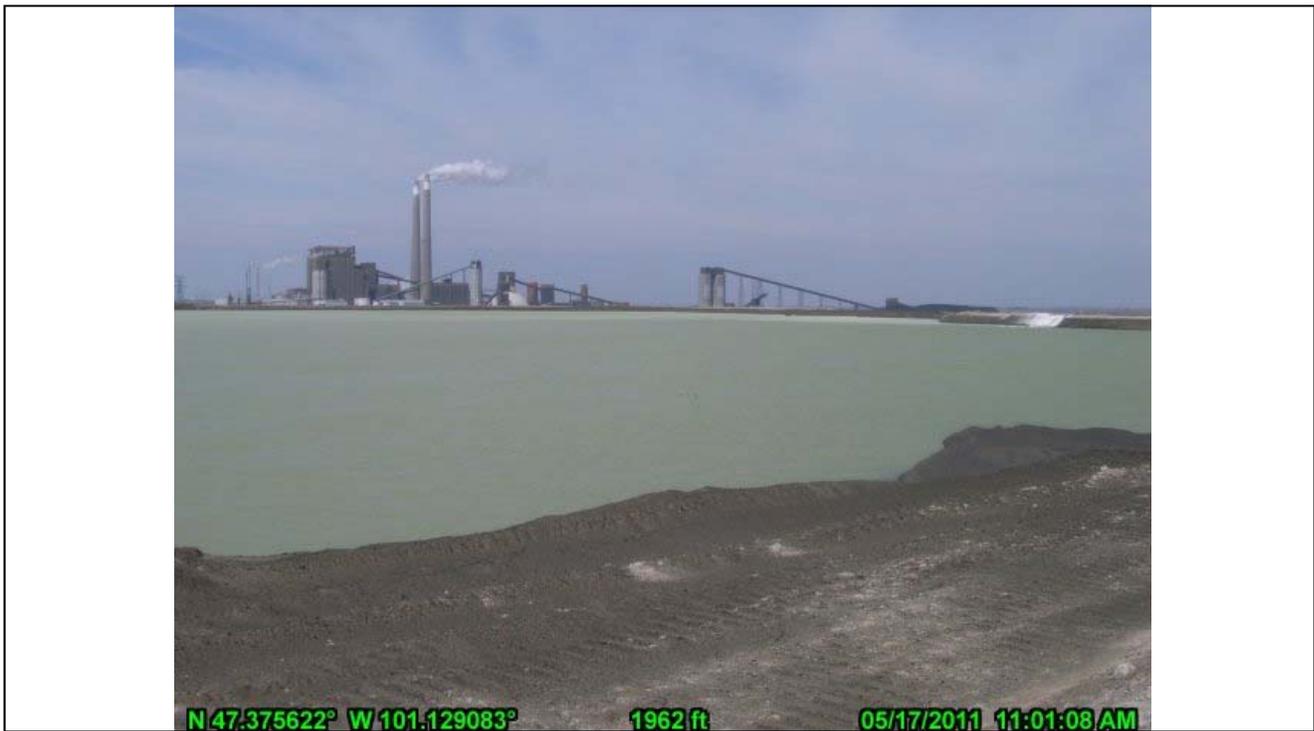
37-Ash Pond 92 View from Crest on Southeast Corner (looking west)

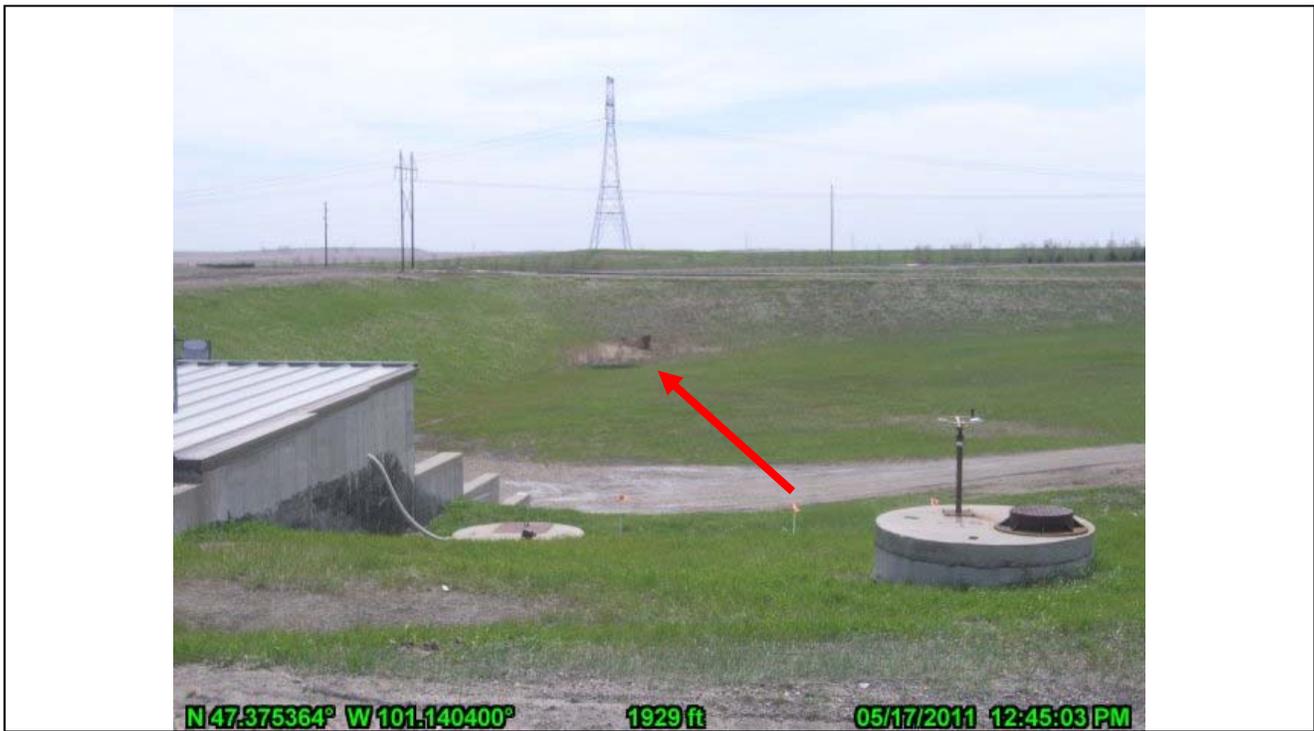
39-Detention Basin and Gate at Southeast Corner of Ash Pond 91 (looking south)

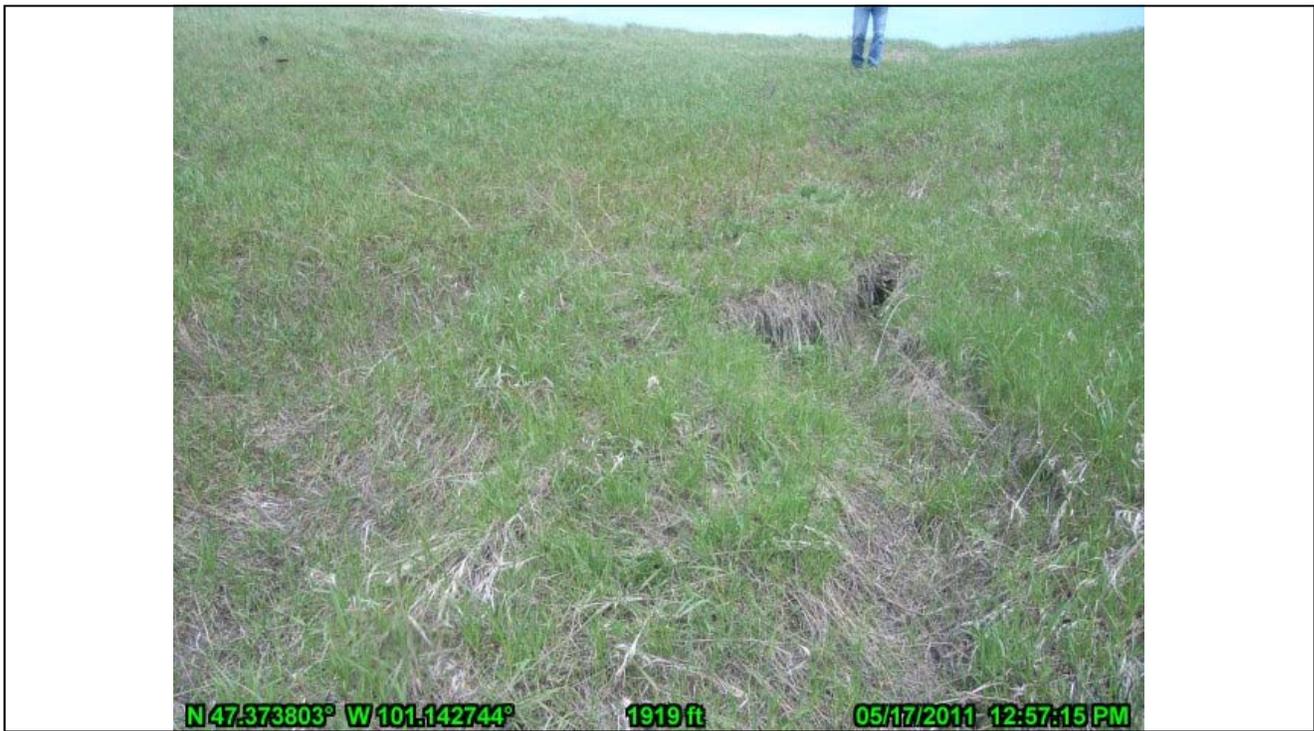
43-Ash Pond 91 Landside Erosion near Ramp Groin (looking northeast)

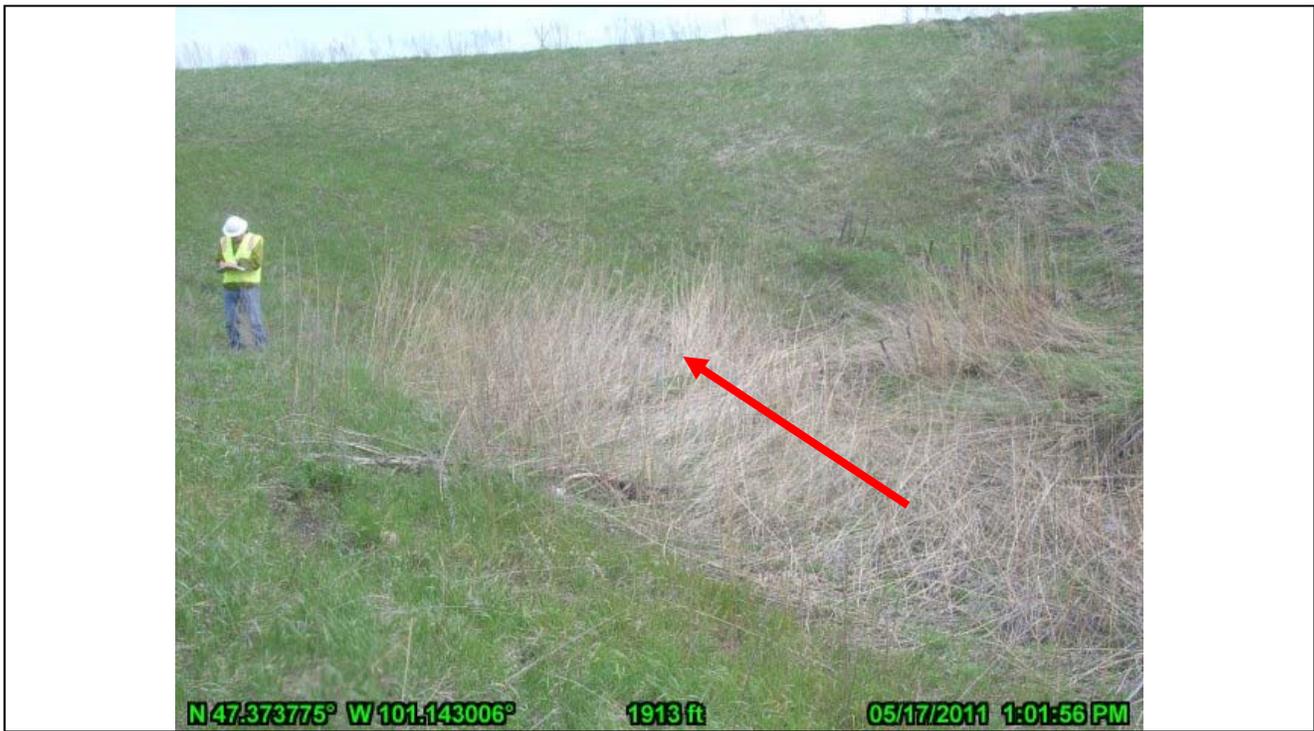
45-Ash Pond 91 Southern Landside Toe and Culvert Under Ramp (looking east)

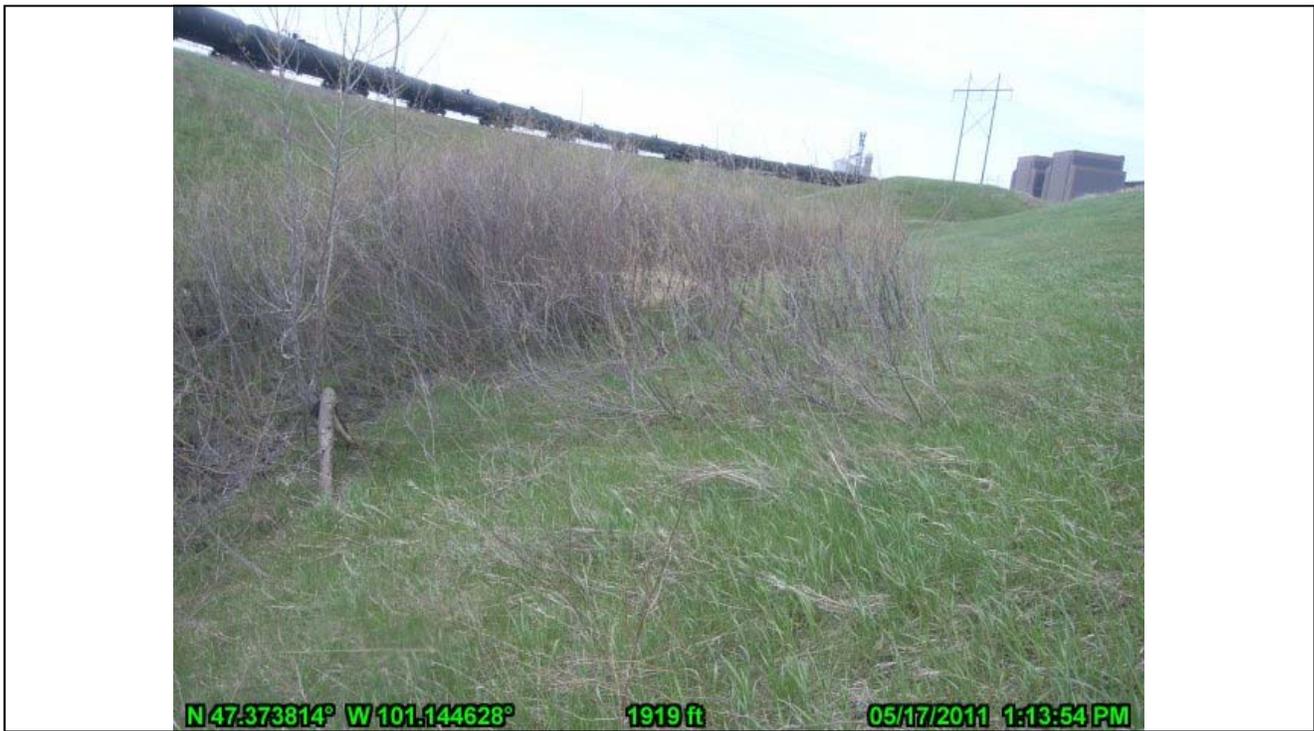
49-Ash Pond 91 Vegetation on Landside Toe (looking west)

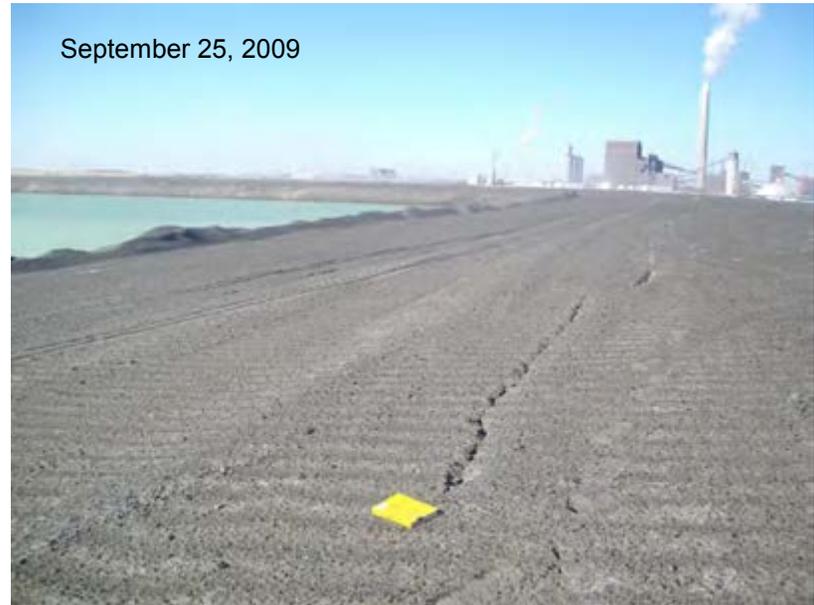
Crack in Bottom Ash on Crest – North Side (looking west)

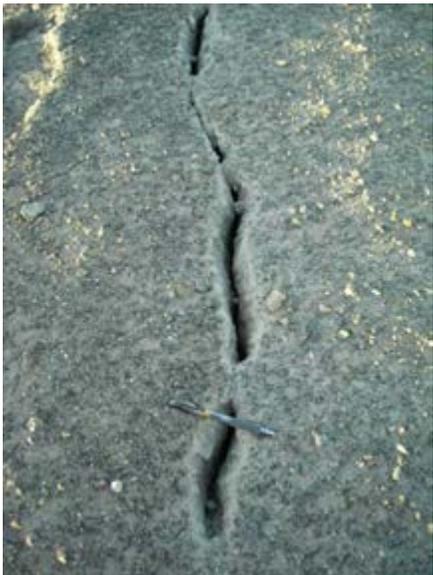
Crack in Bottom Ash on Crest – West Side

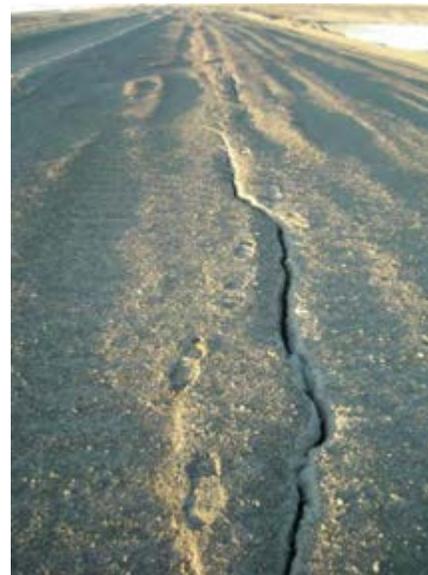
Crack in Bottom Ash on Crest – West Side

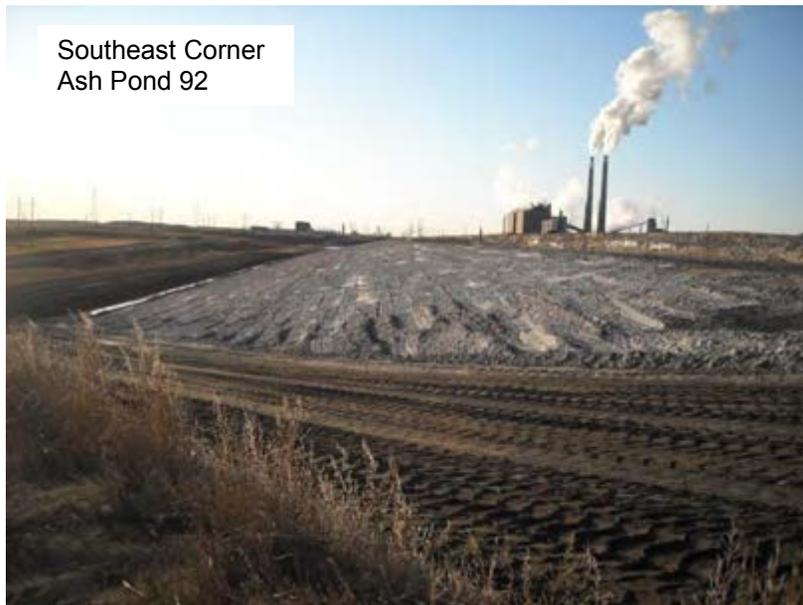
Fly Ash Exterior Slope 1 of 3– South Side (looking west)
