**COAL ASH IMPOUNDMENT
SITE ASSESSMENT DRAFT REPORT**

**Stanton Station
Great River Energy
Stanton, North Dakota**

KLEINFELDER PROJECT NUMBER 118953-2

May 10, 2012

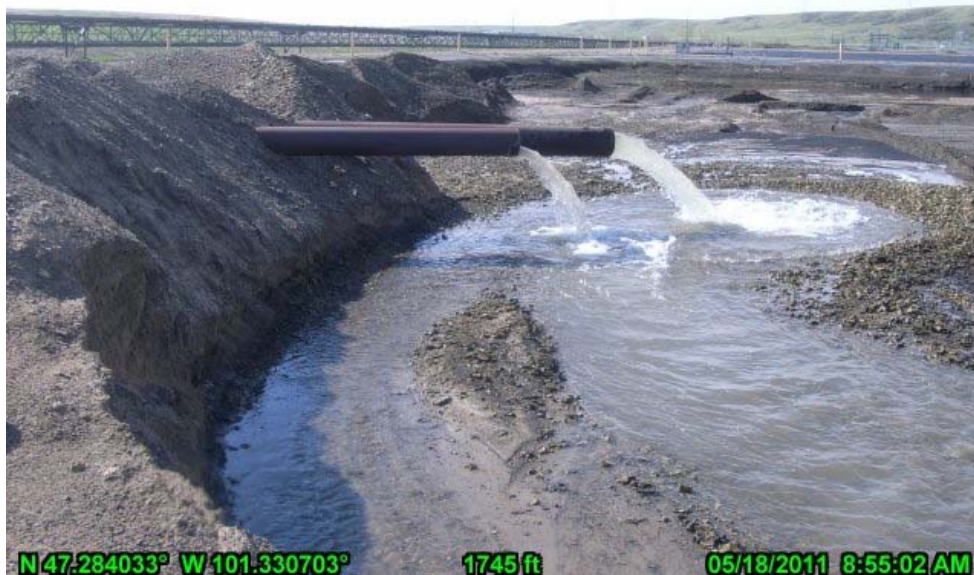
Inflow into the North Ash Pond is by slurry pipes directly from the plant. Bottom ash and other constituents of coal combustion are slurried into the pond at the northeast corner in two 12-inch (est.) steel pipes, as shown on photo 1. From the inlet location the slurry gradually dewateres and the water then collects on the opposite (southwest) part of the pond and eventually decants into the Center Drainage Pond for disposal to the Missouri River (discussed previously and below). The steel inlet pipes appear to be in satisfactory condition.

1-North Ash Pond 12" and 16" Steel Pipe Inlets (looking south)

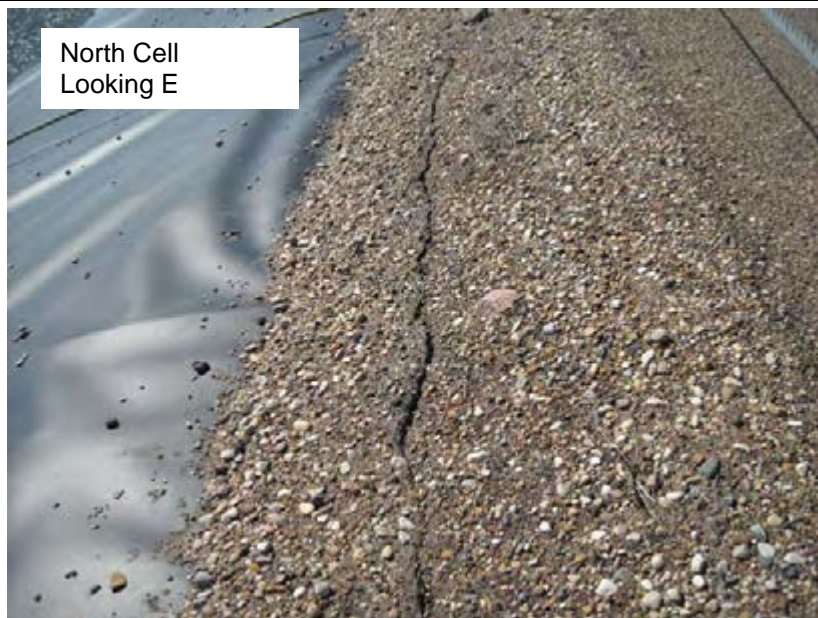
Crack in Shallow Cover over Anchor Trench (021)

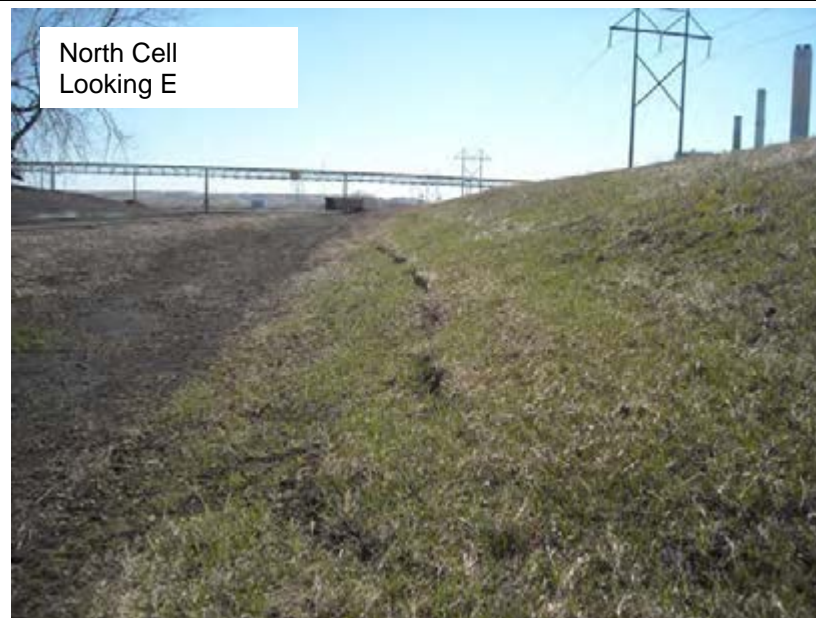
Steepened Toe of North Downstream Slope (023)

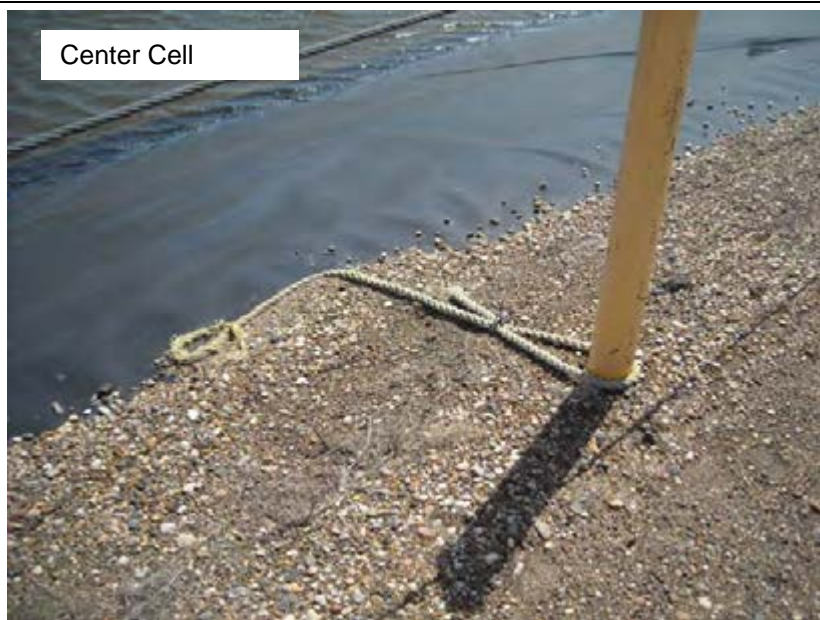
Damaged/Broken Egress Safety Rope (045)

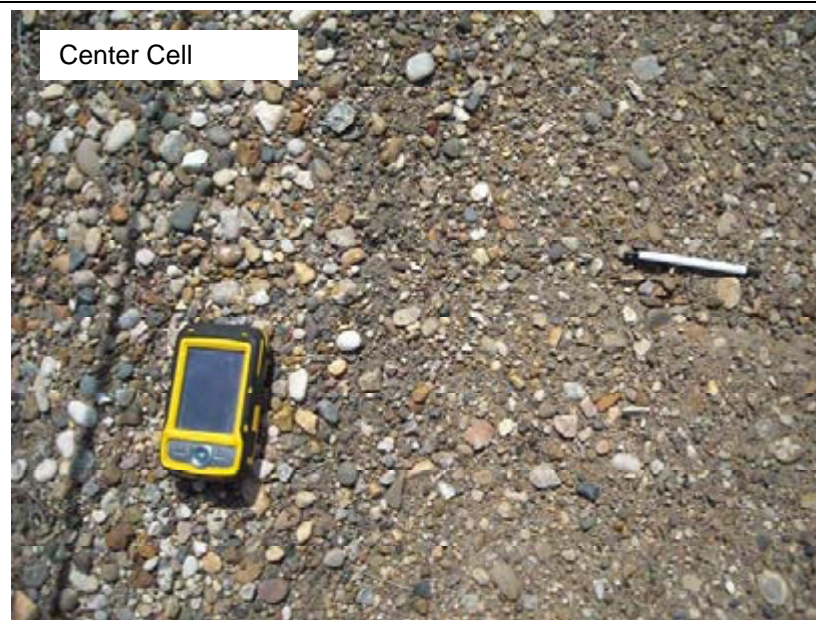
Slight Crack Across West Berm (046)

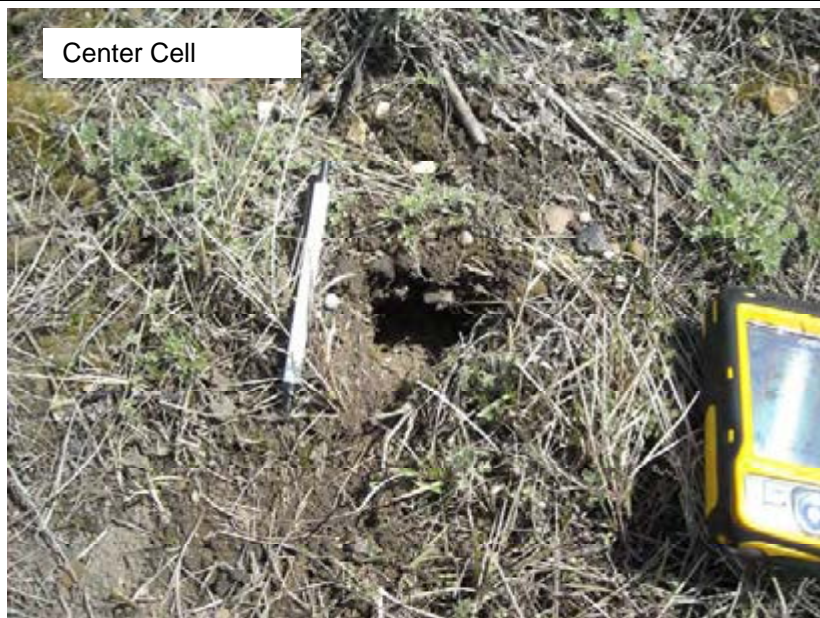
Small Animal Burrow on West Downstream Slope (048)
