COAL ASH IMPOUNDMENT SITE ASSESSMENT FINAL REPORT

**Stanton Station
Great River Energy**

KLEINFELDER PROJECT NUMBER 118953-2

October 26, 2012

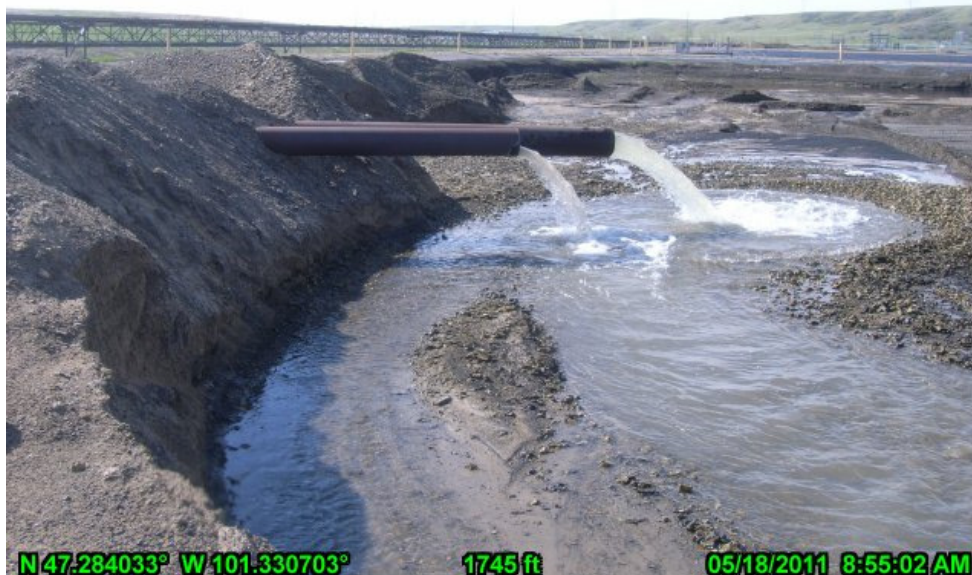
- No major depressions, erosion, or rutting was noted on the impoundment crest.
- Transecting the crest near the northeast corner with minimal cover are two bottom ash sluice lines. Photo 1 shows these sluice lines.
- Sluice pipe structure support columns for the pipeline that runs along the east lower bench of the North Ash Pond and the Center Drainage Pond rest on small concrete foundation pads that penetrate the crest in multiple locations, as shown in Photo 2.

Inflow into the North Ash Pond is by slurry pipes directly from the plant. Bottom ash and other constituents of coal combustion are slurried into the pond at the northeast corner in two 12-inch (est.) steel pipes, as shown on Photo 1. From the inlet location the slurry gradually dewateres and the water then collects on the opposite (southwest) part of the pond and eventually decants into the Center Drainage Pond for disposal to the Missouri River (discussed previously and below). The steel inlet pipes appeared to be in satisfactory condition.

1-North Ash Pond 12" and 16" Steel Pipe Inlets (looking south)

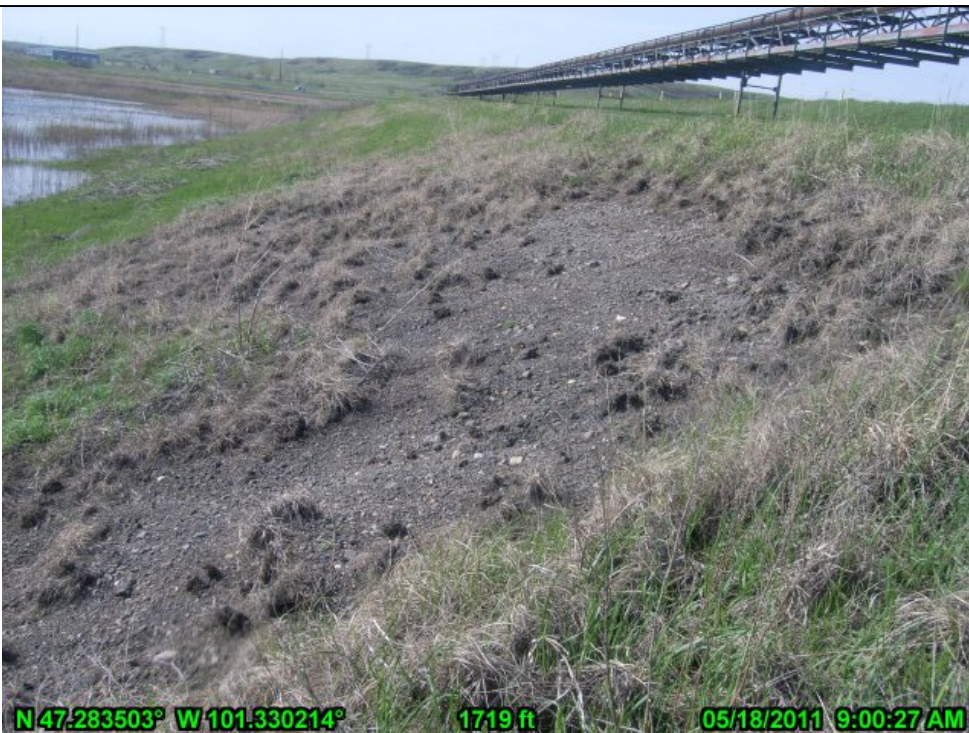
- The slopes were well vegetated and appeared stable.
- The east embankment had a small erosion-related scarp feature on the slope. While that condition did not appear to present an imminent threat to the embankment stability, the area should be repaired and revegetated to prevent progressive failures. It should be noted that the scarp shown in Photo 4 occurred due to a small leak in September 2010 resulting from a loose fitting in the overhead slurry pipeline. The slurry leak caused minimal surface erosion due to a relatively low flow and multiple layers of plant monitoring that detected the leak in sufficient time to shut off flow very quickly. The issue was initially considered as a potential failure mode. However, after discussing the incident with plant personnel and considering the low flow rate in the pipe, intermittent use of the pipe, multiple pipeline flow controls, and extensive monitoring of the facility, the probability of an embankment failure occurring was judged to be essentially zero. Further, the pipe joint malfunction and subsequent leak occurred prior to ash slurry being deposited into the impoundment, and therefore was considered an operational malfunction and not an uncontrolled release from the impoundment.

4-Landside Erosion on Original East Embankment
from Sluice Pipe Leak (looking south)

1. Repair embankment scarps and sloughs by July 1, 2013.
2. Maintain a log of maintenance and other activities at the impoundments and supporting facilities by July 1, 2013.
3. Update the Operation and Maintenance (O&M) Manual for the impoundments and the facility by July 1, 2013.

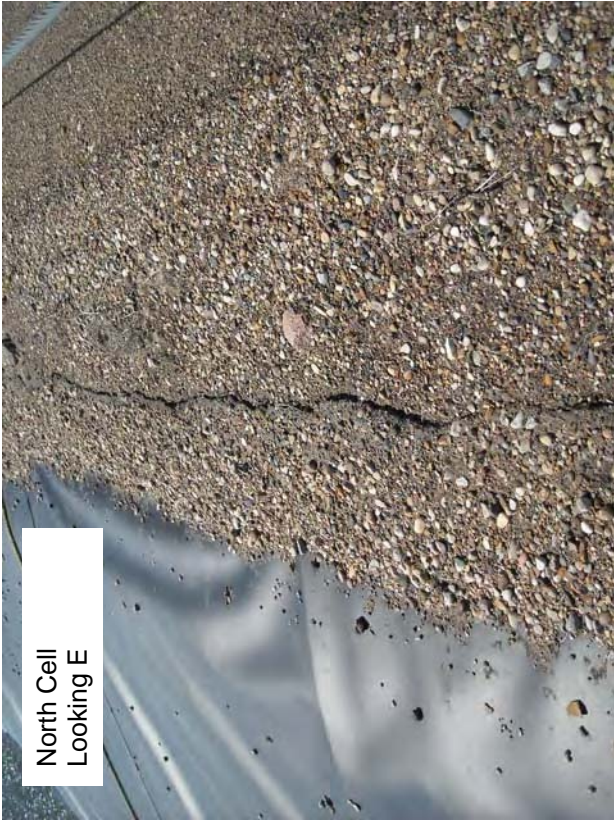
| <div>Crack in Shallow Cover over Anchor Trench (021)</div> <div>A close-up photograph of a concrete surface, likely a dam or outlet structure, showing a significant crack running horizontally across the frame. The surface is covered with small, dark, irregular patches, possibly mold or debris.</div> | <div>Steepened Toe of North Downstream Slope (023)</div> <div>A photograph showing a steep, grassy slope. In the background, there are industrial structures, including a tall chimney and a power line tower, under a clear blue sky.</div> |
