Comments on Draft report on Hoosier Energy- Frank E. Ratts Generating Station

Re: AMEC Earth & Environment, Inc., *Draft Report of Dam Safety Assessment of Coal Combustion Surface Impoundments, Hoosier Energy, Frank E. Ratts Generating Station, Petersburg, Indiana, September 2010.*

**SUBJECT:** Review Comments on Draft AMEC Dam Safety Report  
Ratts Generating Station, Petersburg, IN

#### PHOTOS FROM JANUARY 14, 2011 (BY RANDY MILLS, SCS ENGINEERS)

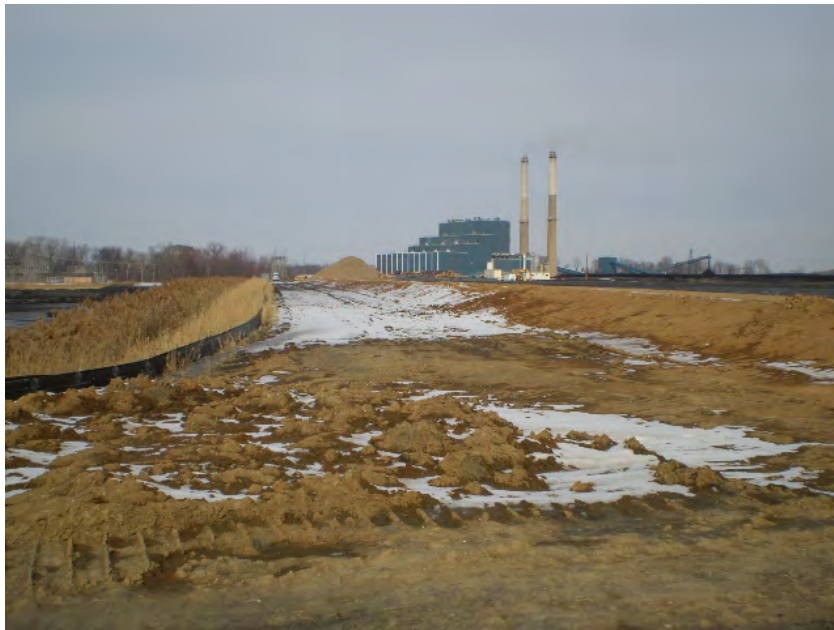
Photo 1: Pond 4 (Fly Ash Pond) Looking North from SE

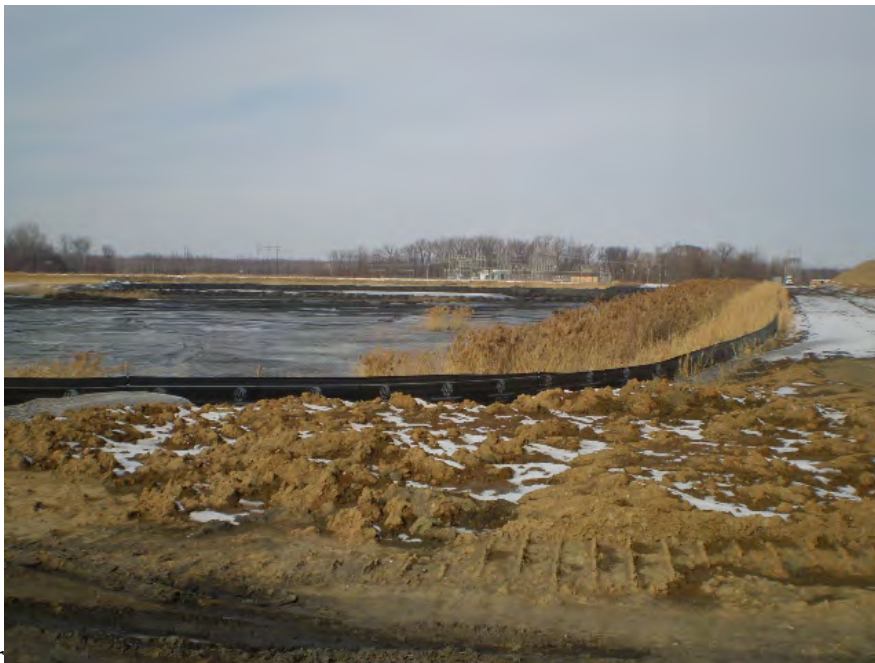
Photo 2: Pond 4 (Fly Ash Pond) Looking Northwest from SE Corner

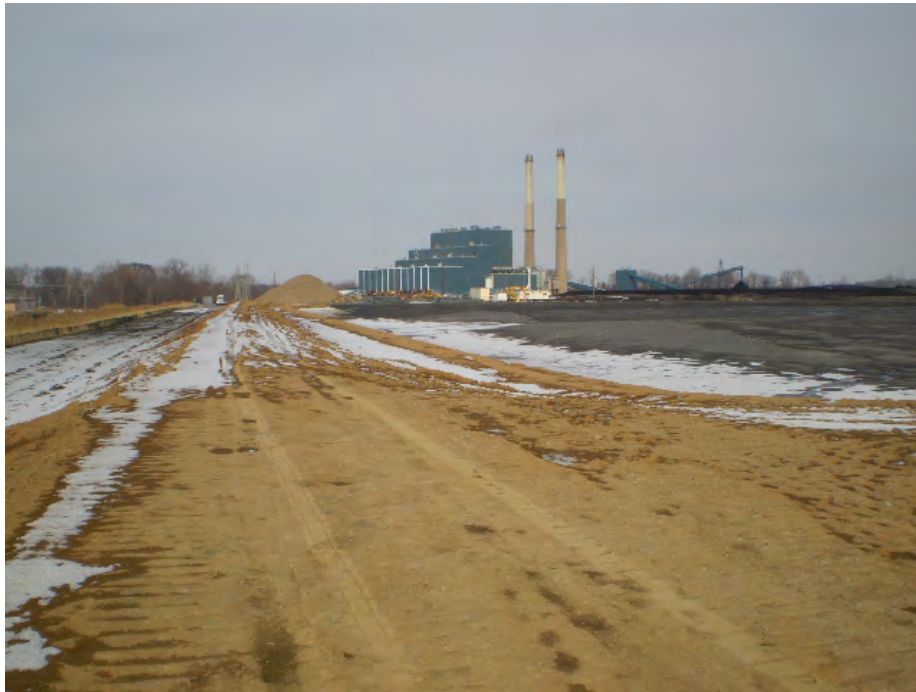
Photo 5: Ponds 2 and 3 Looking North from SE Corner of Pond 4

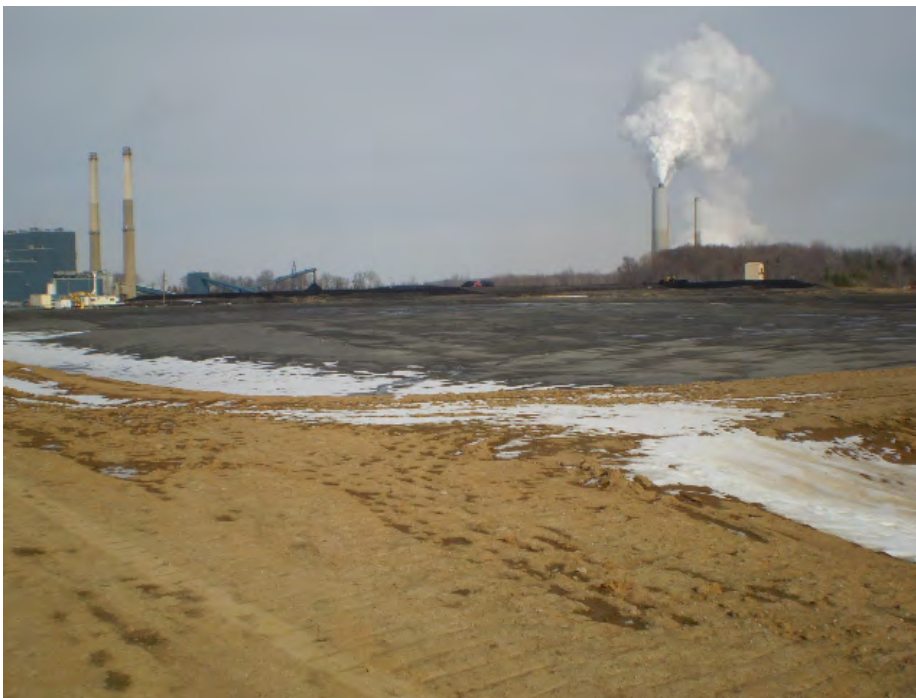
Photo 6: Ponds 2 and 3 Looking Northeast from SE Corner of Pond 4

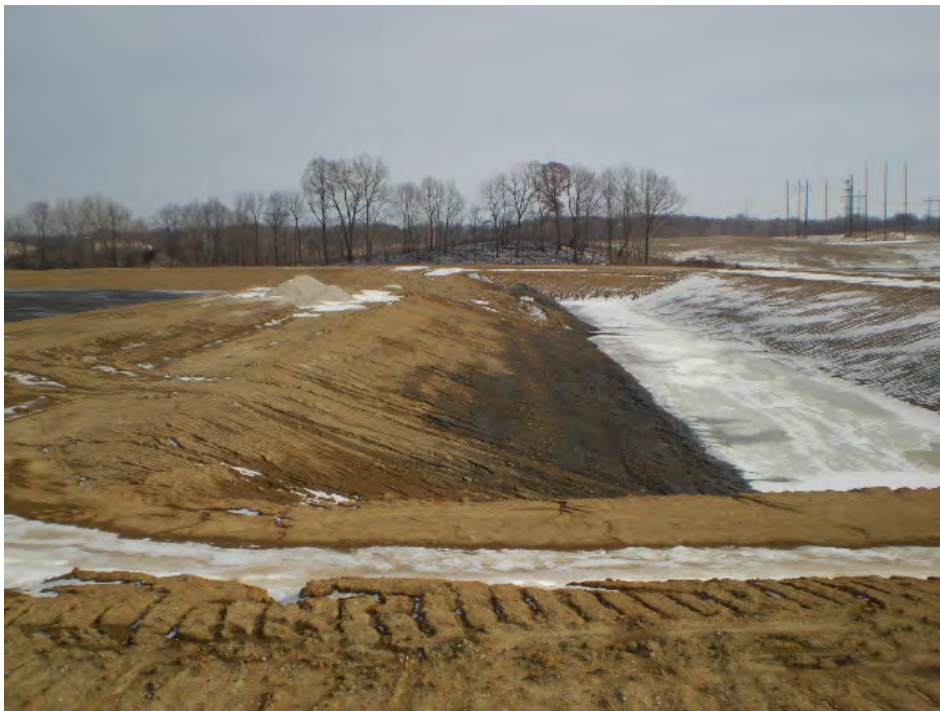
Photo 8: Ponds 2 and 3 Looking East from SE Corner of Pond 4

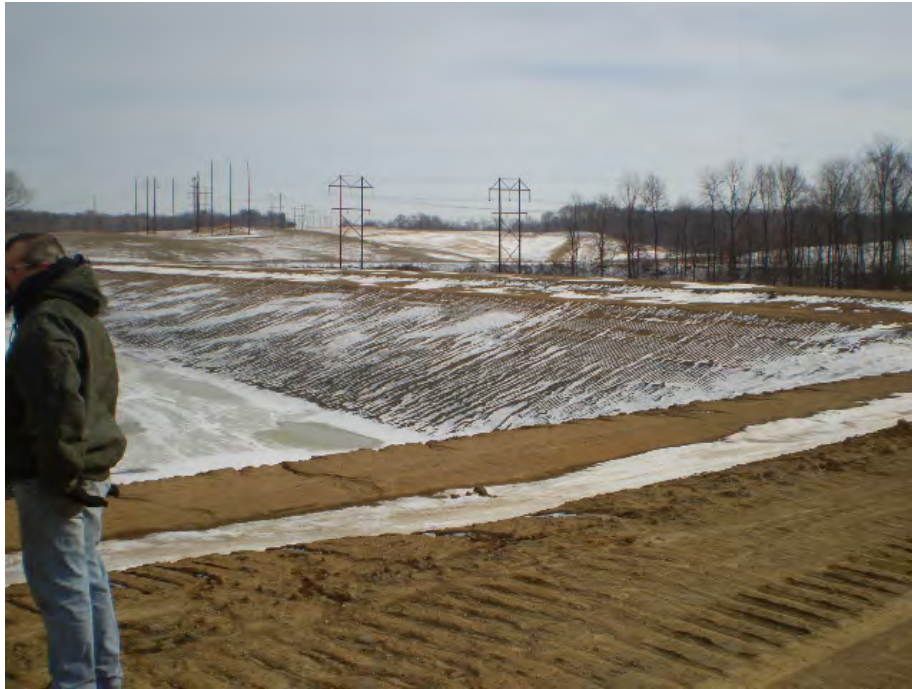
Photo 9: Ponds 2 and 3 Looking Southeast from SE Corner of Pond 4

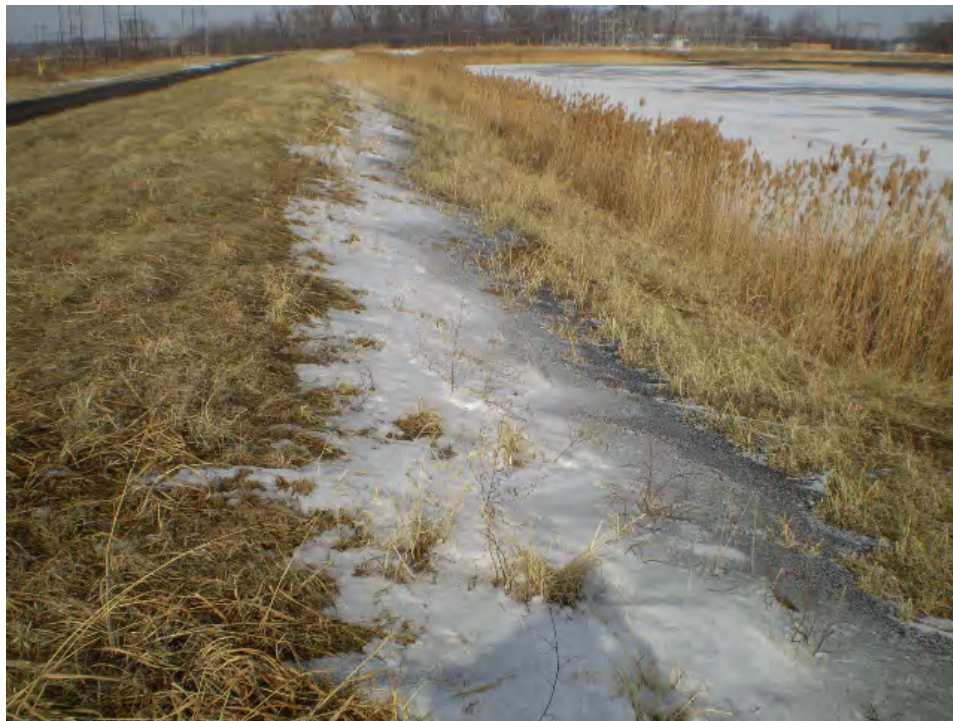
Photo 15: Inner Side of Pond 4 West Inner Berm

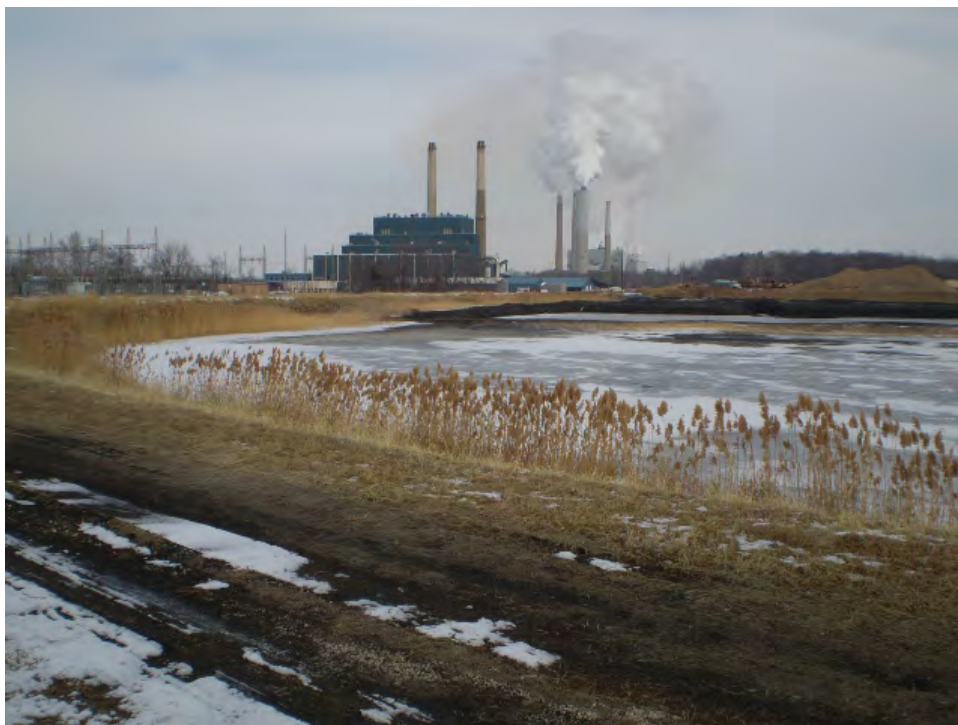
Photo 16: Northeast Corner of Pond 4

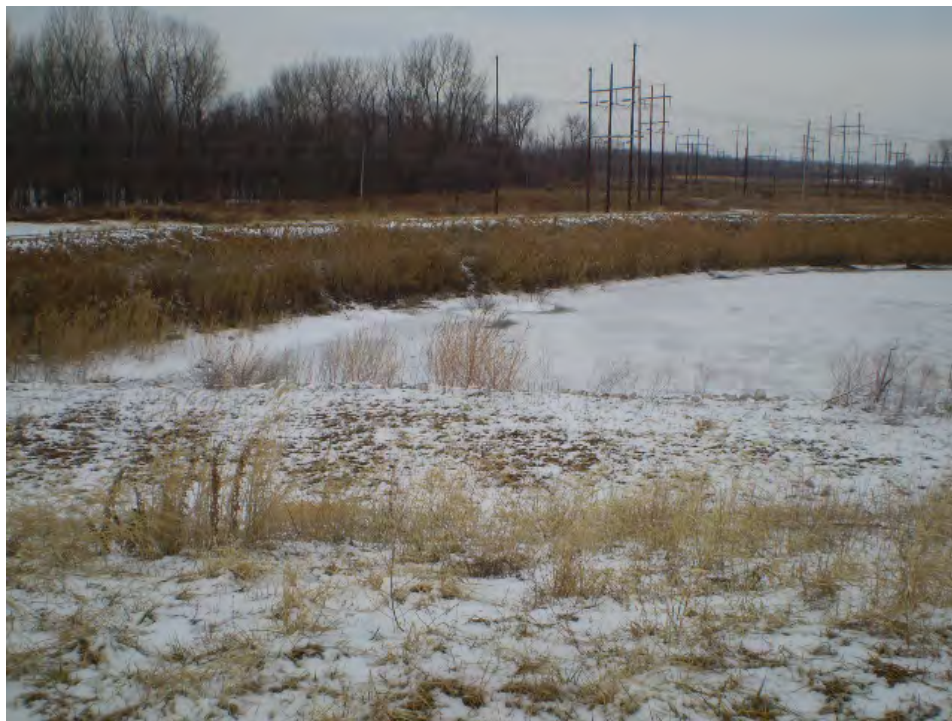
Photo 18: Settling Basin at North End of Pond 4

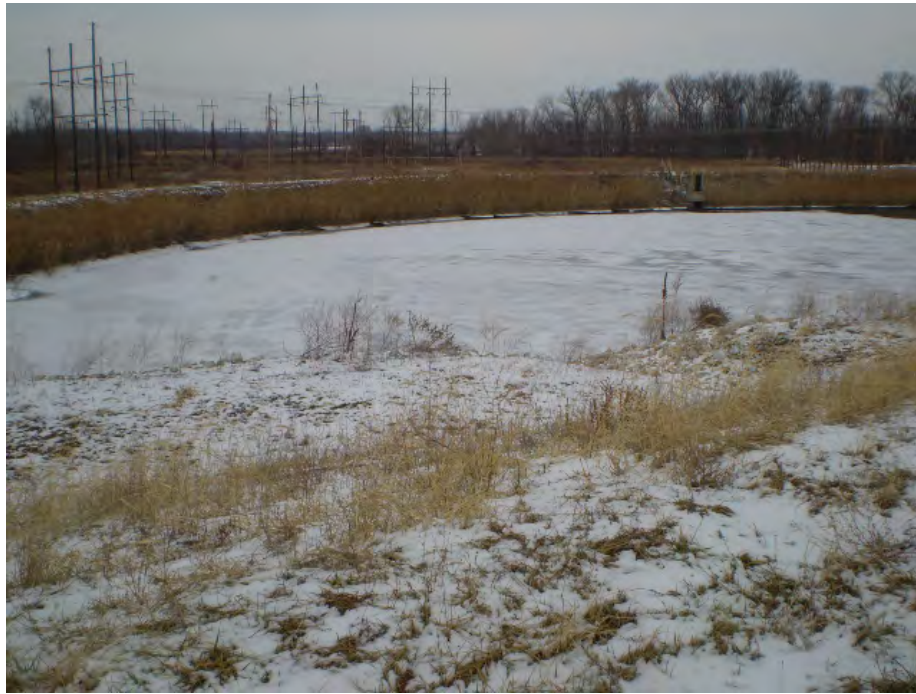
Photo 19: Settling Basin at North End of Pond 4

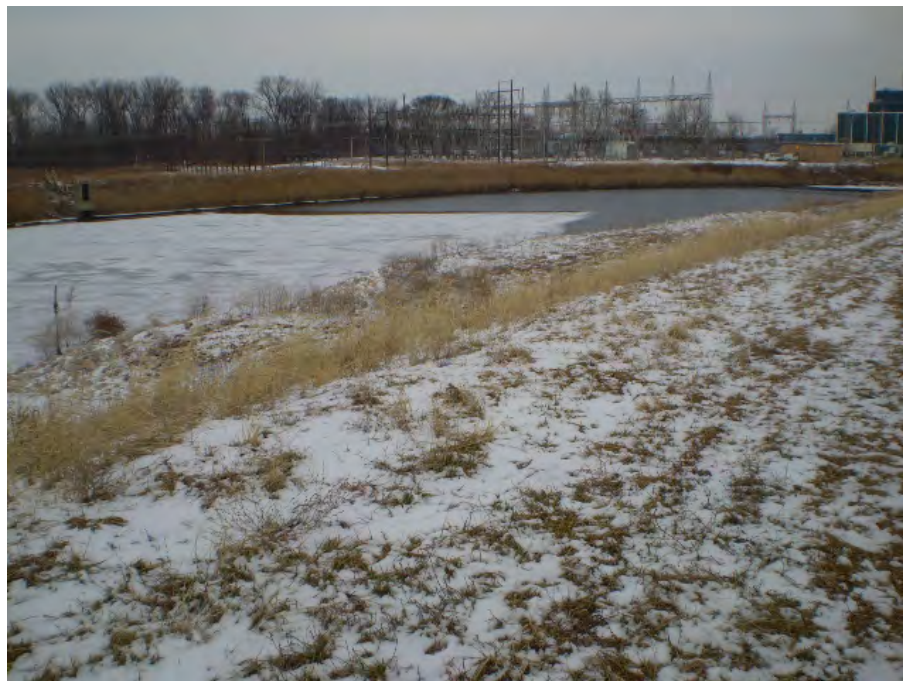
Photo 20: Settling Basin at North End of Pond 4
