Specific Site Assessment for Coal Combustion Waste Impoundments at Intermountain Generating Station

Delta, Utah

April 2011
Project 092884

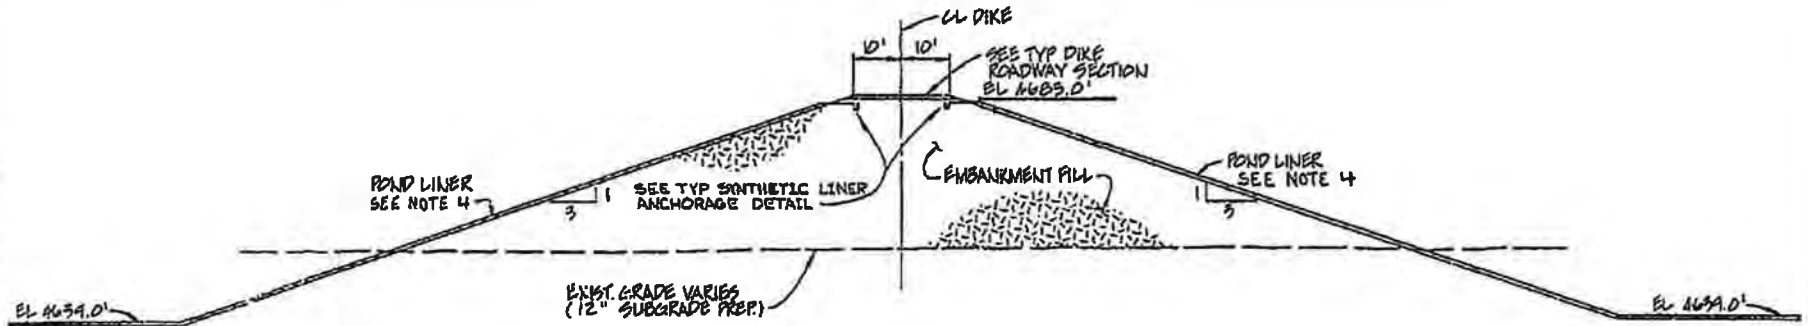
SECTION 1
SCALE: 1" = 20'

BOTTOM ASH BASIN SECTION

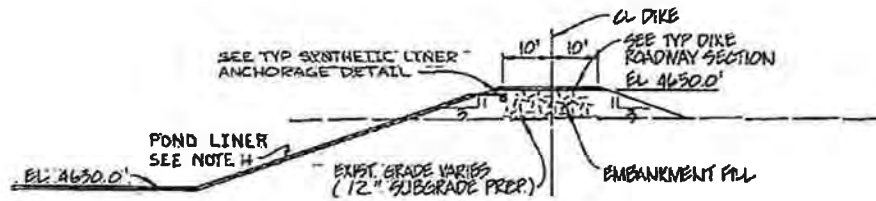
SECTION 5
SCALE: 1" = 20'

WASTEWATER HOLDING BASIN SECTION

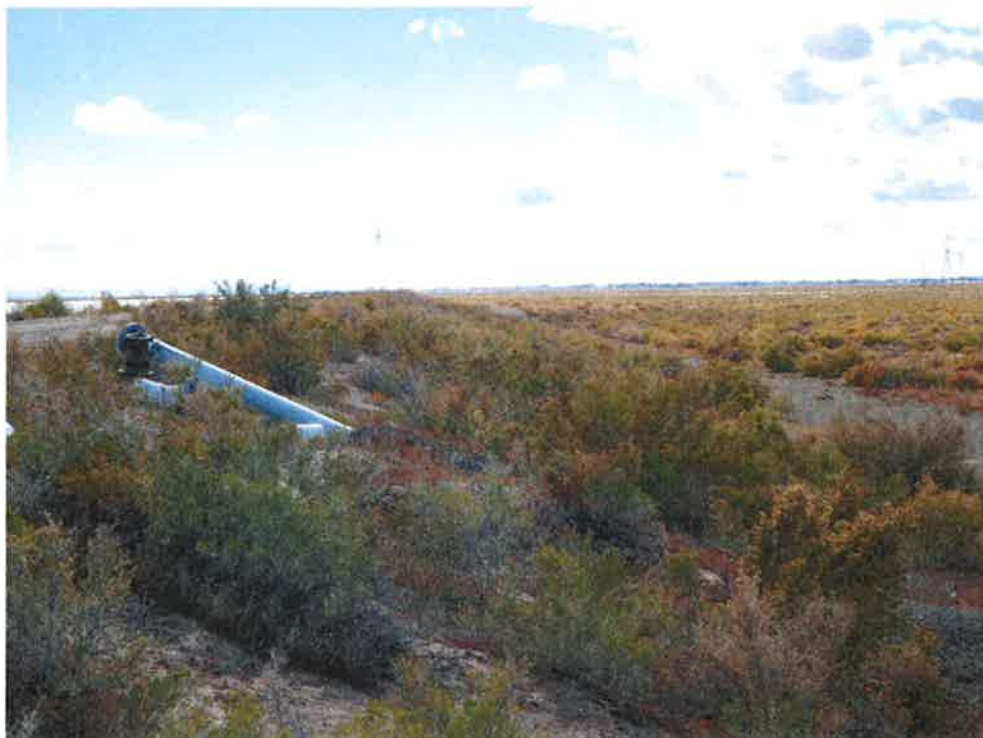
Photo 12: Wastewater Holding Pond, looking south at west dike downstream slope.

Basin are sparsely covered with vegetation consisting of greasewood shrubs, wheat grass and other native vegetation. The downstream slopes showed no signs of significant erosion. However, minor erosion rill on the downstream slope of the Wastewater Holding Basin west embankment was observed, most likely due to surface runoff.

The dams and outlet works facilities associated with the CCW impoundments at the IGS were found to be in satisfactory condition. No visual signs of instability, movement or seepage were observed. The Wastewater Holding Basin west embankment slopes show signs of minor erosion from surface runoff and a few small animal burrow holes.

We recommended IPSC personnel develop and document formal inspections of the CCW impoundments, at a minimum to be performed annually by plant staff. We recommend a brief daily check inspection be conducted by IPSC personnel and that a written record be maintained for the monthly inspections being conducted by IPSC personnel. Also, continue efforts to repair minor erosion rills observed on the embankment slopes. Due to the lack of erosion protection, minor erosion rills should be repaired promptly to prevent extensive damage to the embankment slopes.

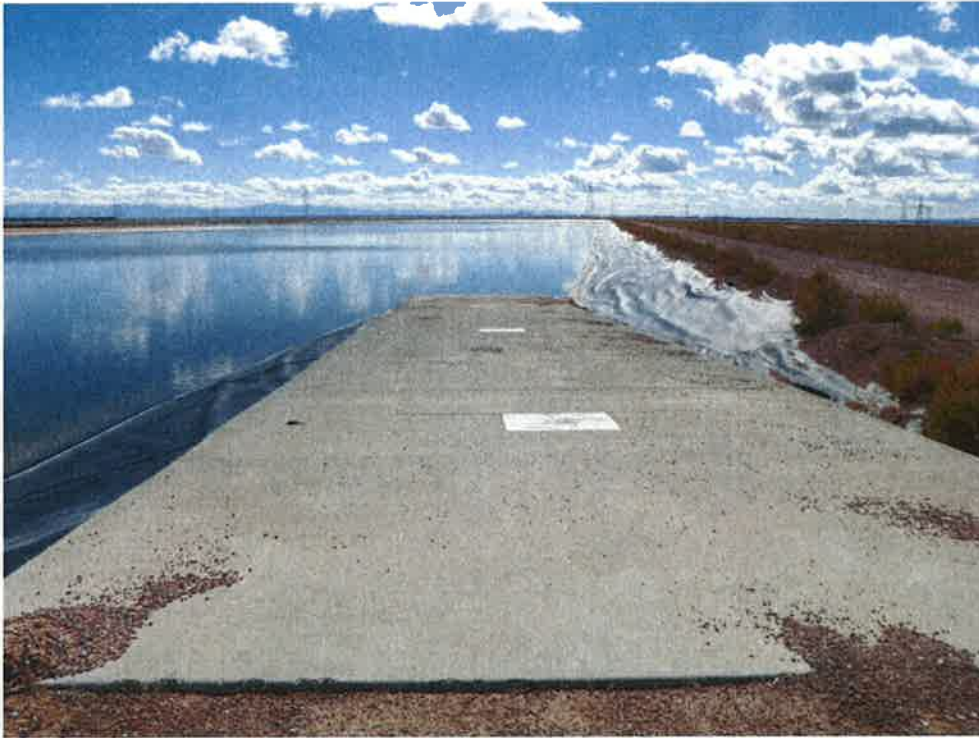
Photo 13: Wastewater Holding Pond, looking south at west dike entrance ramp, note ramp gage.

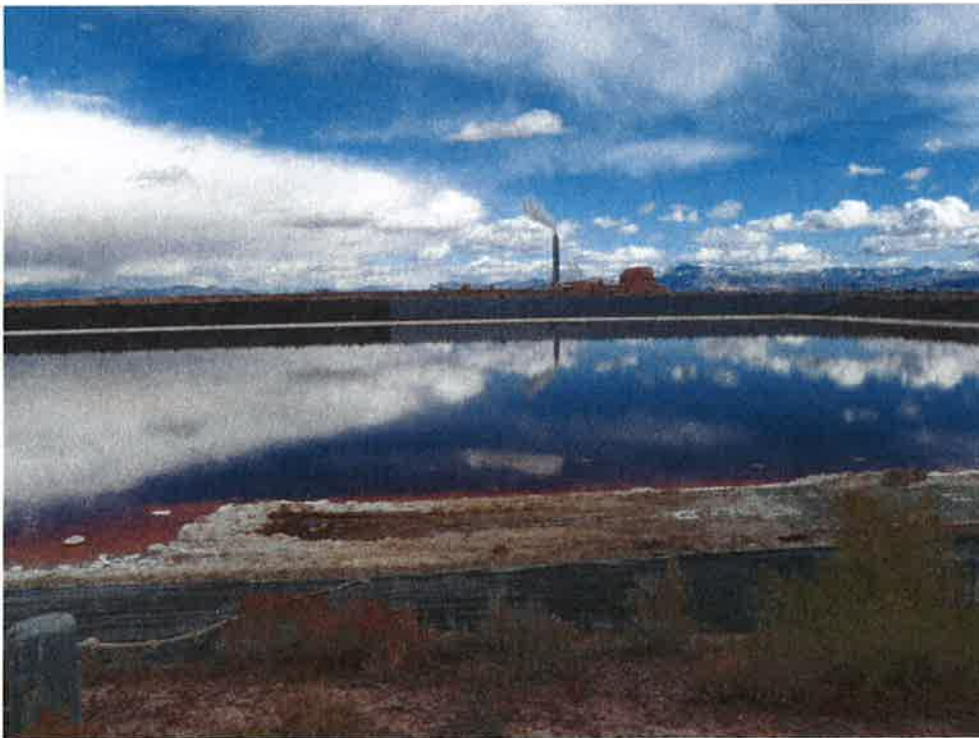
Photo 44: Evaporation Pond #2, looking east at reservoir area and upstream liner, note considerable salt accumulation.
