DRAFT
**Specific Site Assessment for
Blue Valley Power Station
North and South Fly Ash
Ponds and Bottom Ash Pond**

Independence, Missouri

December 2010
Project Number: 092884

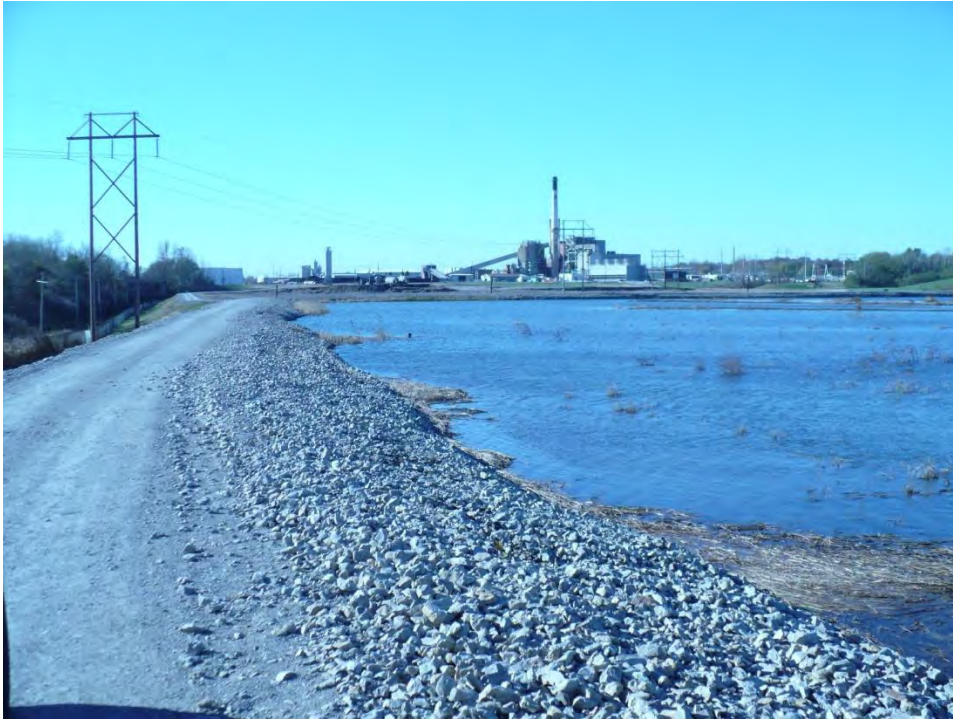
The crest of the dike at the North Fly Ash Pond appeared to be in good condition (see Photo 1). No signs of cracking, settlement, movement, erosion or deterioration were observed during the assessment. The crest appears to be well-drained and no standing water was observed. The dike crest surface is generally composed of gravel road base material that traverses the length of the dike for vehicle access.

Photo 1: Looking south along the east dike of the North Fly Ash Pond.

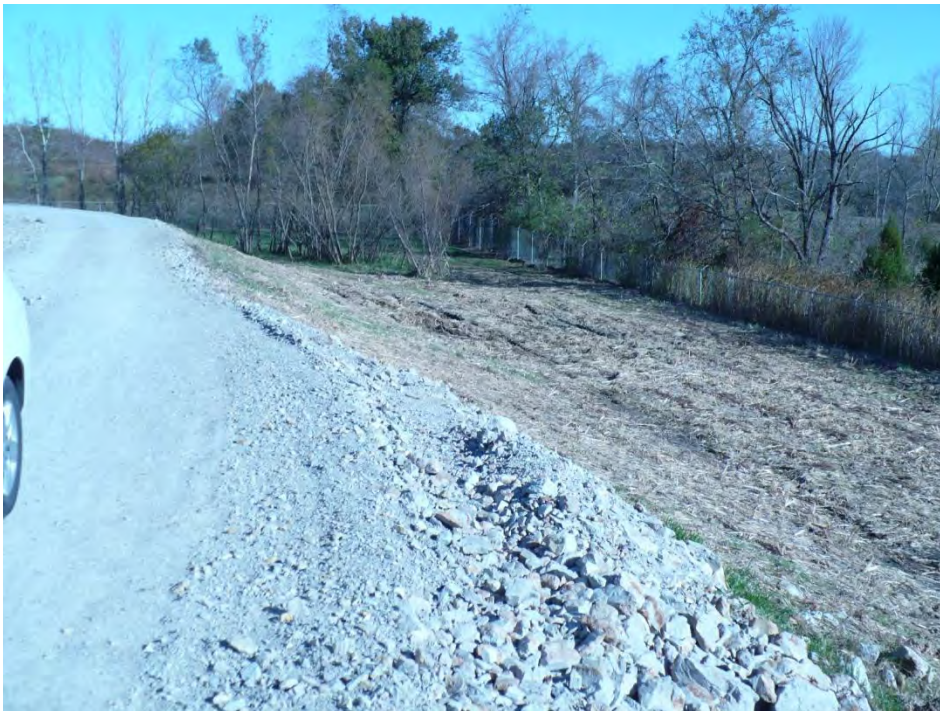
The dams and outlet works facilities associated with the impoundments at the Blue Valley Power Station were generally found to be in satisfactory condition. No visual signs of instability, erosion, movement were observed. However, there are wet areas within a storm water drainage ditch that runs along the toe of the east dike of the North Fly Ash Pond. The wet areas may be due to standing water within the drainage ditch, however they could also be seepage from the toe of the dike. Further evaluation should be conducted to determine the source of water in the wet areas.

**Photo 2: The north east corner of the North Fly Ash Pond dike.
Note possible seepage occurring at dike toe.**

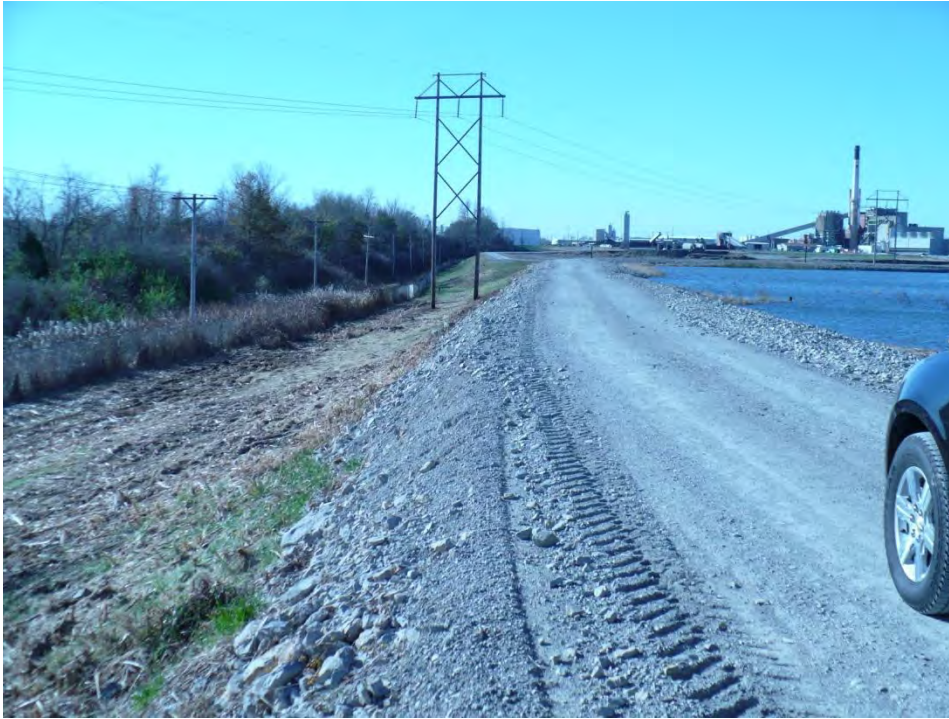
Photo 3: Looking south along the east dike of the North Fly Ash Pond. Note possible seepage occurring at the dike toe.

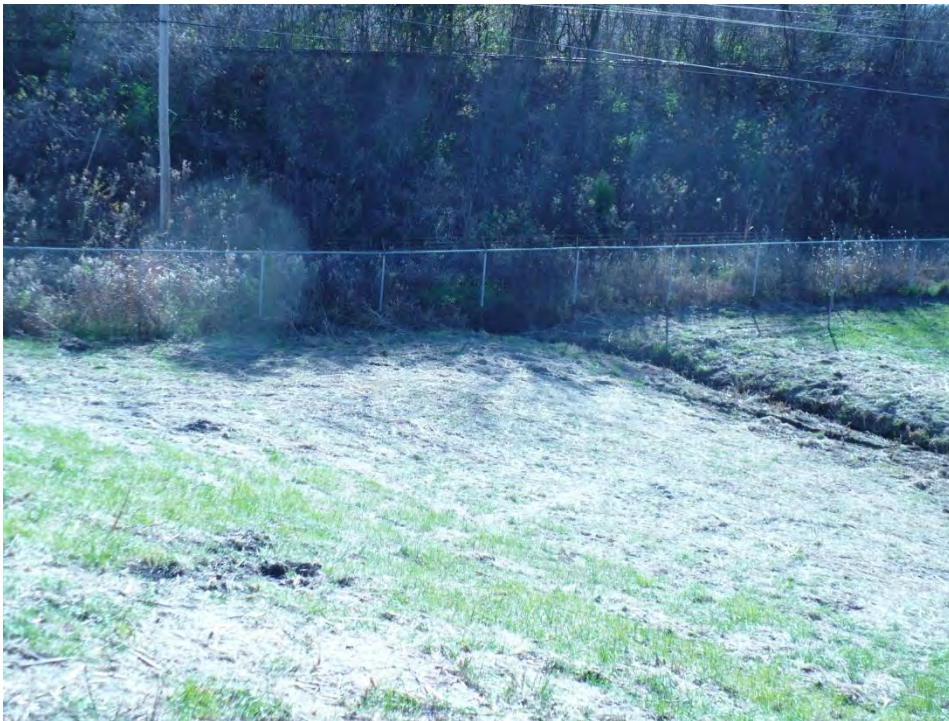
Photo 4: Looking east from the North Ash Pond dike at the abandoned railroad embankment. Site storm water is discharged to a 48 inch diameter culvert.

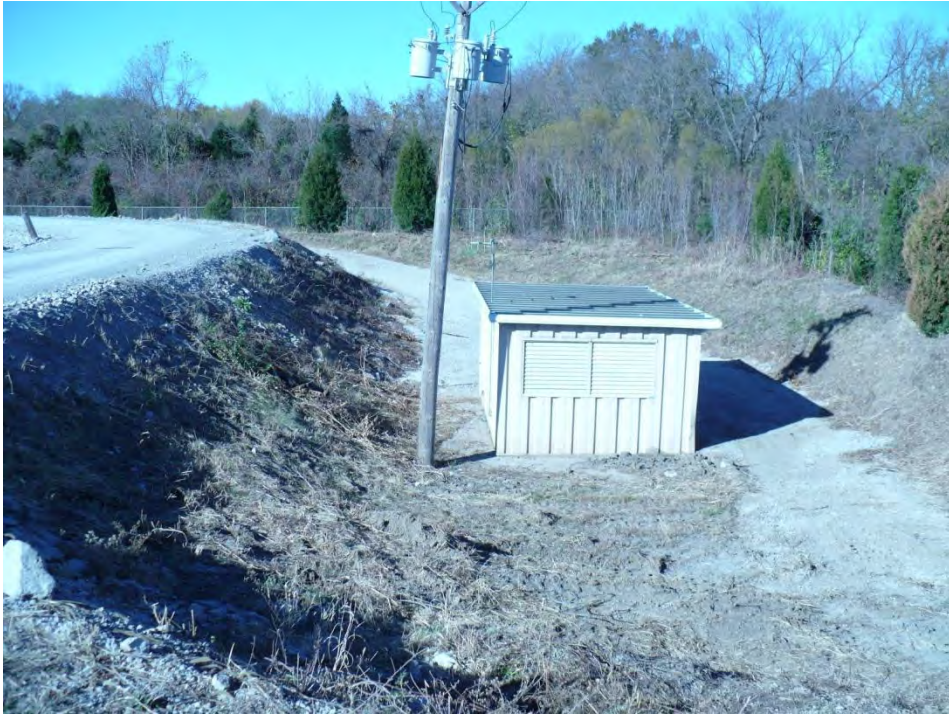
Photo 5: Return water pump house at north end of the Bottom Ash Pond.

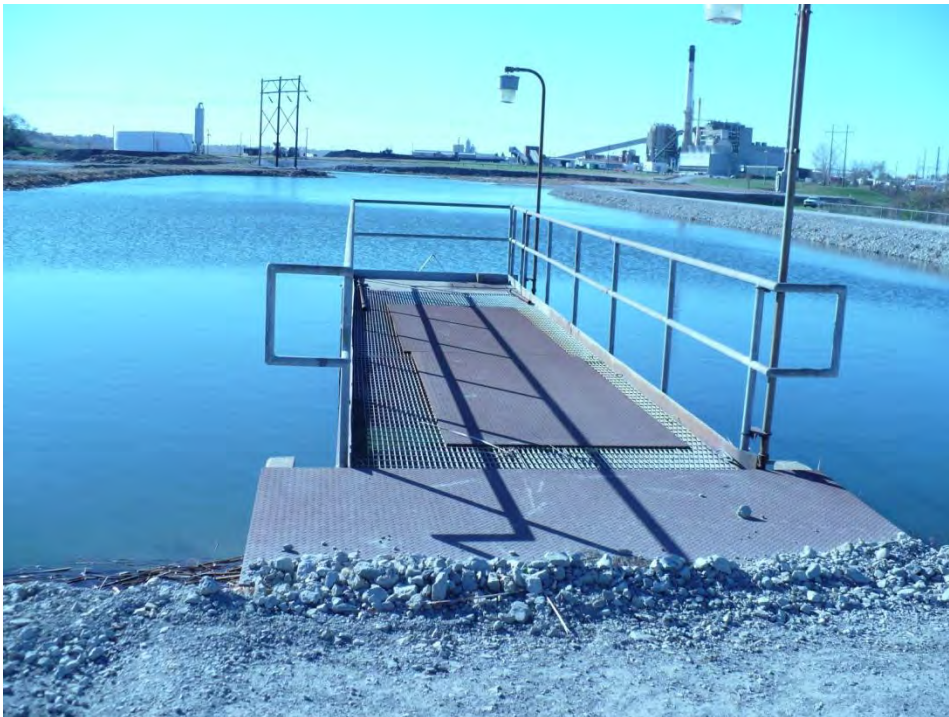
Photo 6: The Bottom Ash Intake Structure at the north end of the Bottom Ash Pond.

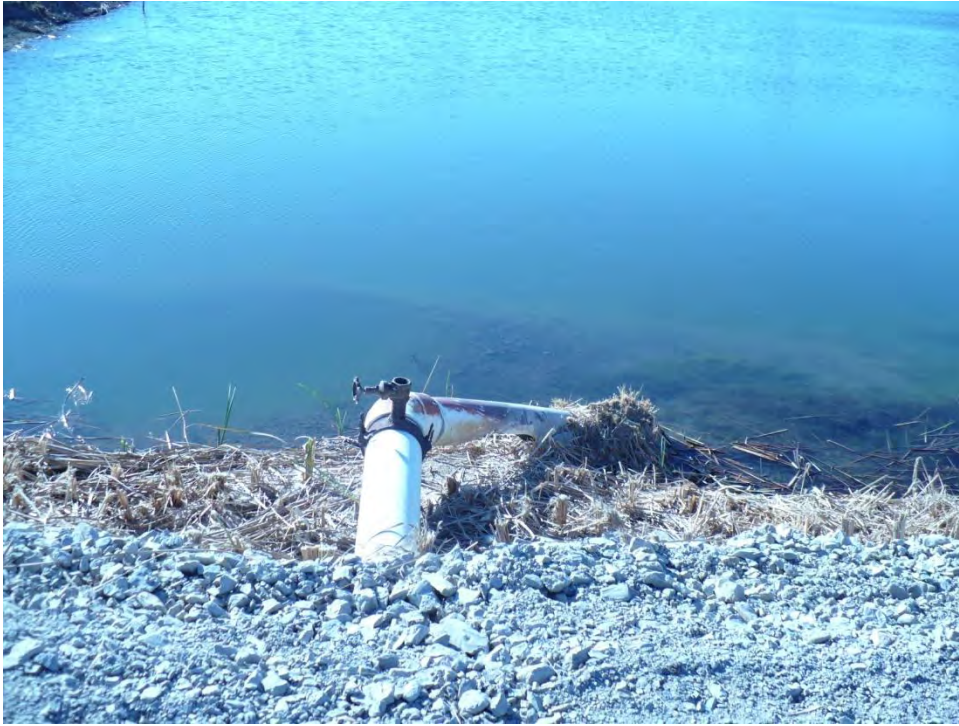
The outlet structure consists of an 8-inch diameter PVC pipe and appears to be in good condition. The invert for the overflow pipe is at elevation 768.0 feet. Currently, there is no active flow through the outlet structure.

Photo 7: The overflow outlet from the North Flyash Pond into the Bottom Ash Pond.

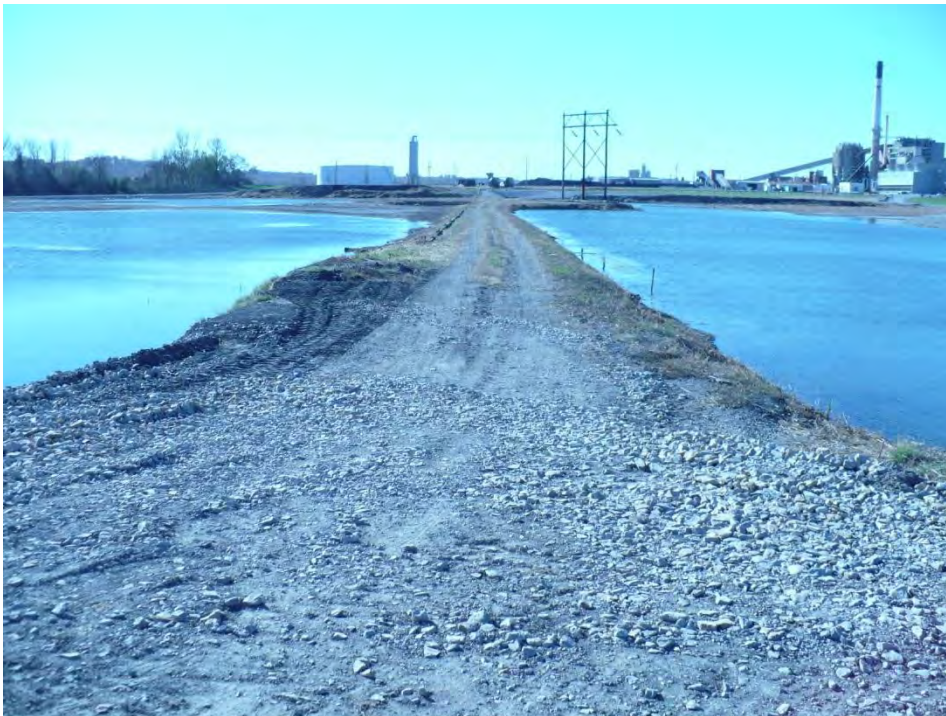
Photo 8: Looking south at the dike that separates the Bottom Ash Pond (right) from the South Fly Ash Pond (left).

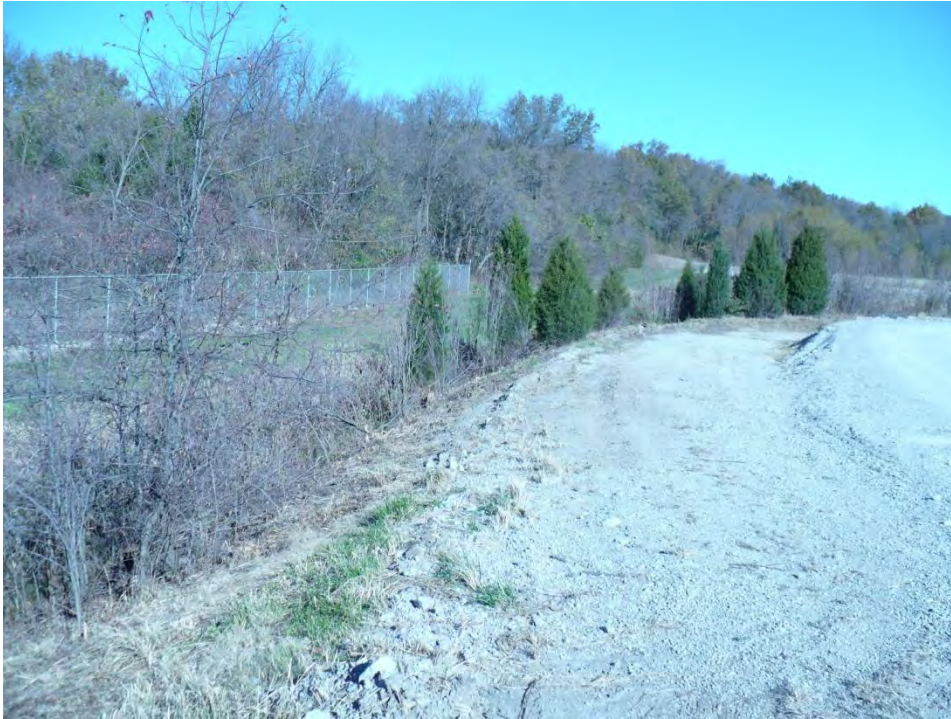
The downstream slopes of the dike at the Bottom Fly Ash Pond have well-established grass growth, which provides some erosion protection. No scarps, sloughs, depressions or other indications of slope instability or signs of erosion were observed during the inspection of the impoundment. A few small trees were noted to be growing on the slope of the pump house access road (see Photo 9). At this time, these trees do not present a concern, however consideration should be given to their removal.

Photo 9: Trees on slope of pump house access road slope at the northwest corner of the Bottom Ash Pond

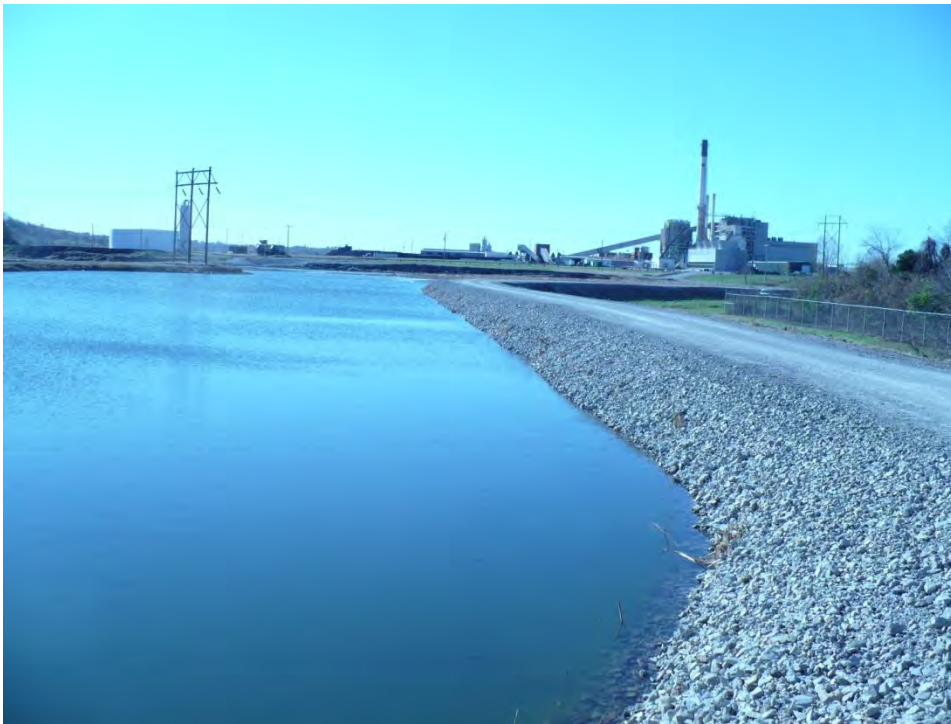
The crest of the dike at the Bottom Ash Pond appeared to be in good condition (see Photos 10 and 15). No signs of cracking, settlement, movement, erosion or deterioration were observed during the assessment. The crest appears to be well-drained and no standing water was observed. The dike crest surface is generally composed of gravel road base material that traverses the length of the dike for vehicle access.

Photo 10: Looking south at the Bottom Ash Pond west dike. Taken from the northwest corner of the Bottom Ash Pond.

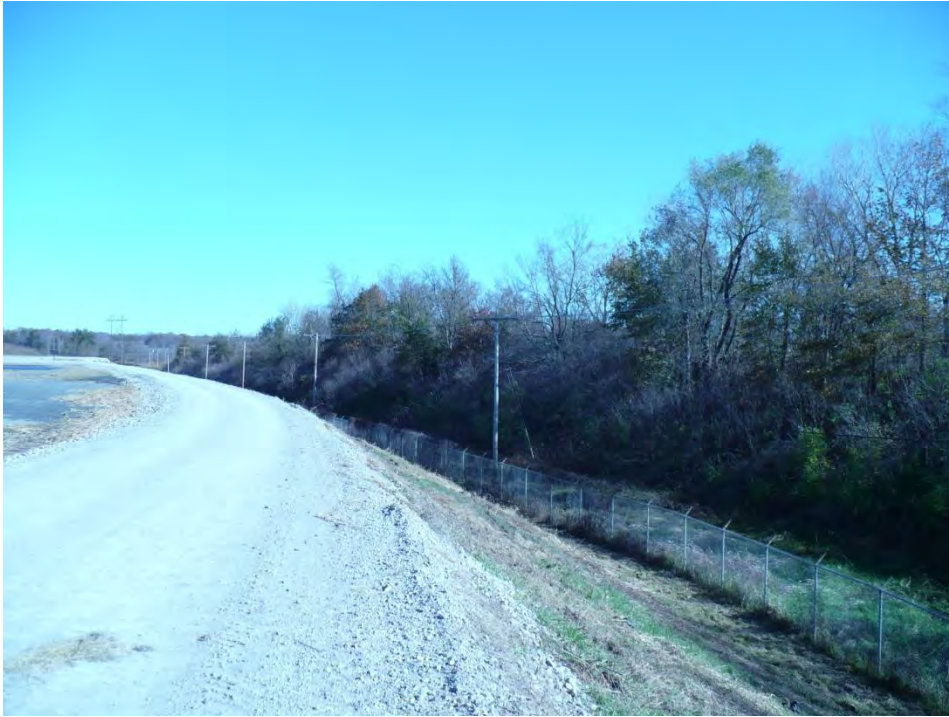
The downstream slopes of the dike at the South Fly Ash Pond have well-established grass growth, which provides some erosion protection (see Photo 11). No scarps, sloughs, depressions or other indications of slope instability or signs of erosion were observed during the inspection of the impoundment.

Photo 11: Looking north at the east dike of the South Fly Ash Pond.

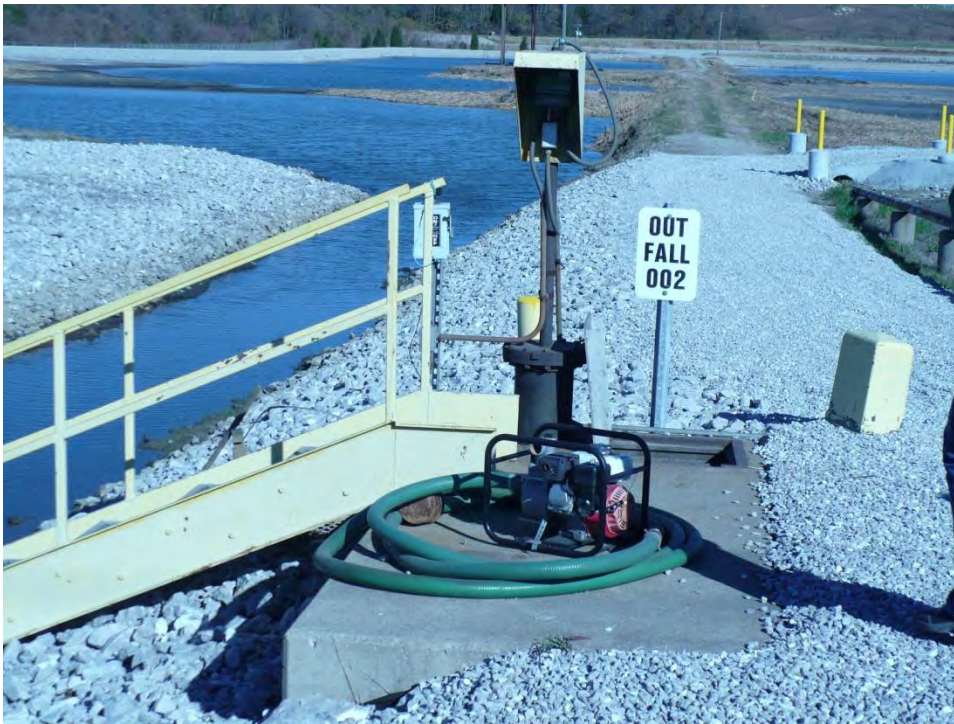
The outlet structure appears to be in good working condition and consists of a 12-inch diameter steel welded pipe discharging into a 12-foot long by 4-foot wide concrete vault that empties into the sanitary sewer system. There was a small amount of debris at the trash rack, but did not restrict flow into the outlet. The channel from the pond to the outlet was riprap and free flowing.

Photo 12: Outfall 002 and associated channel which is the outlet from the Bottom Ash Pond into the sanitary sewer system.

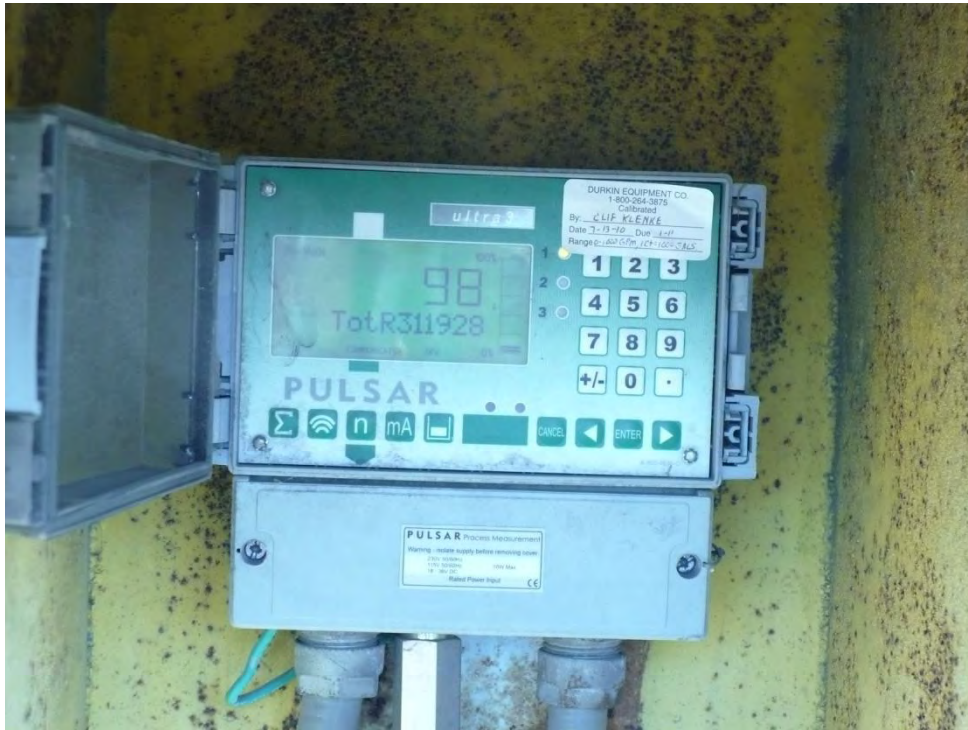
Photo 13: The flowmeter to monitor the discharge from the Bottom Ash Pond into the sanitary sewer system.

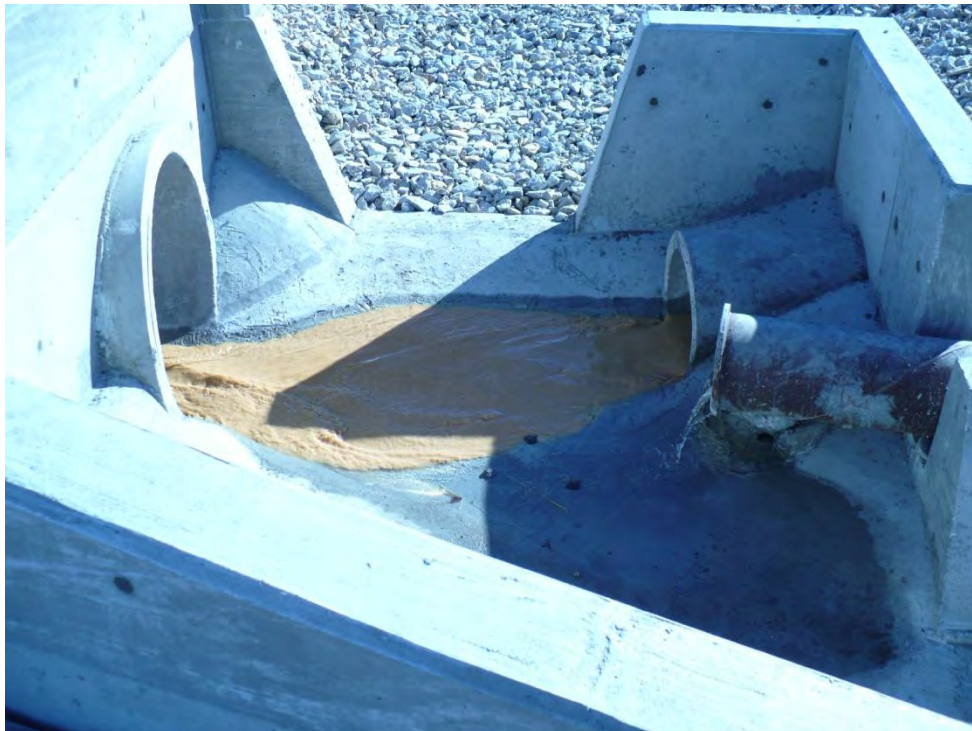
Photo 14: Inlet pipe to the Bottom Ash Pond.

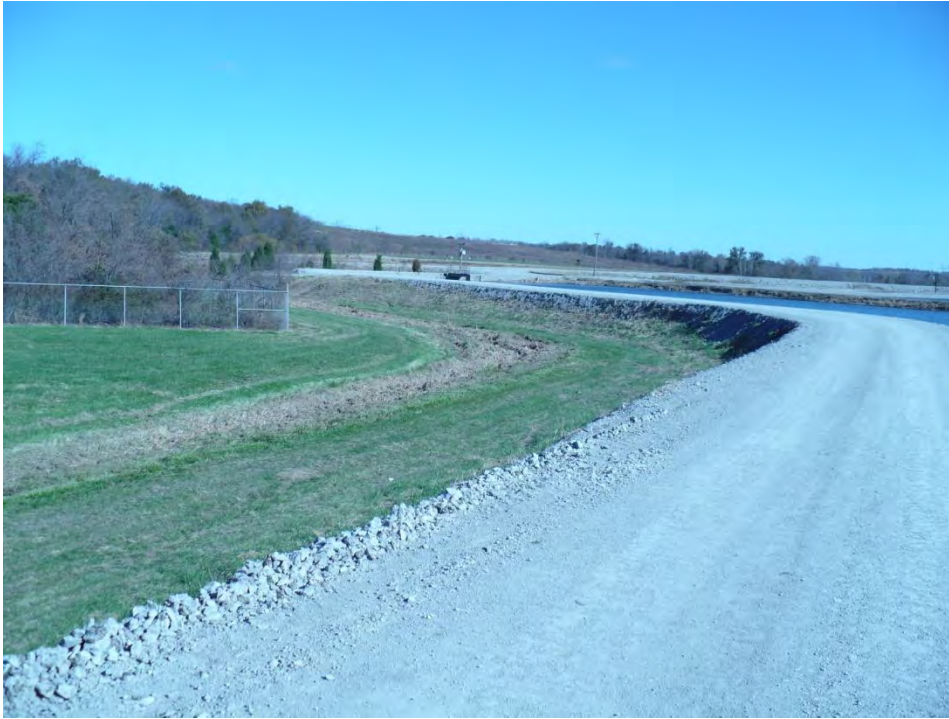
Photo 15: Looking north at the west dike of the Bottom Ash Pond.

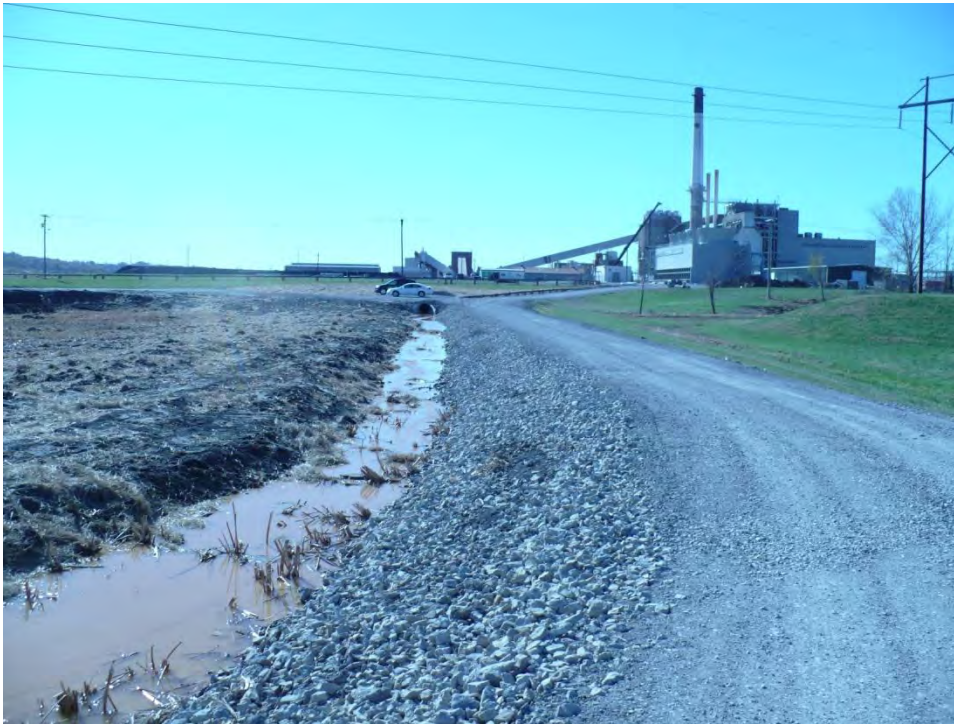
Photo 16: Looking south at the channel from the Bottom Ash Pond discharge into the pond.
