Specific Site Assessment for Blue Valley Power Station North and South Fly Ash Ponds and Bottom Ash Pond

Independence, Missouri

June 2011

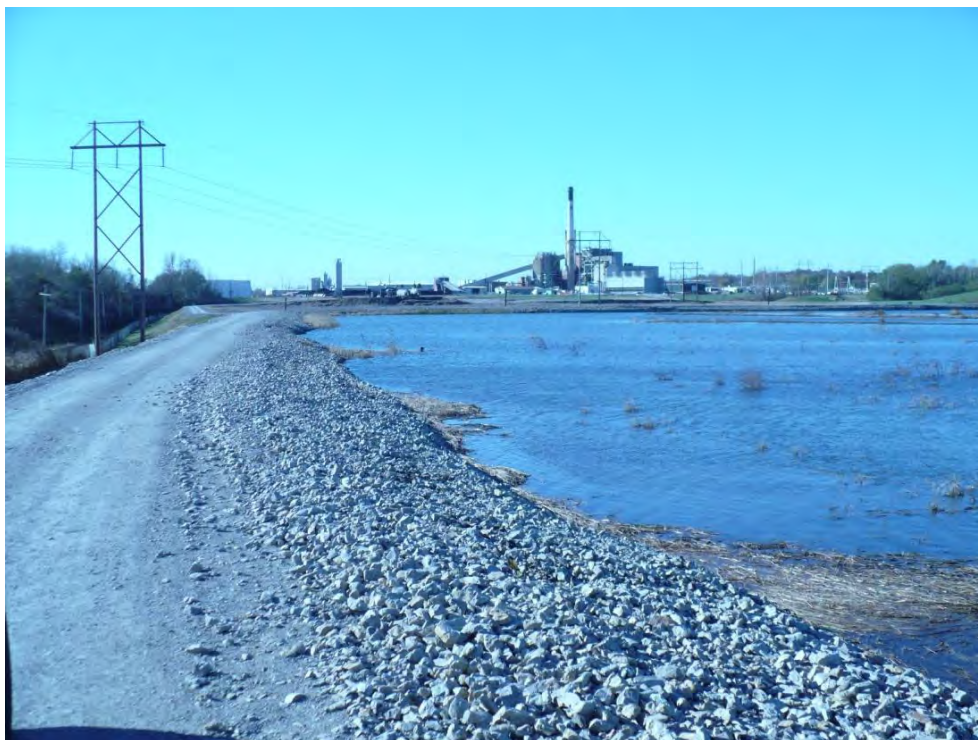
The crest of the dike at the North Fly Ash Pond appeared to be in good condition (see Photo 1). No signs of cracking, settlement, movement, erosion or deterioration were observed during the assessment. The crest appears to be well-drained and no standing water was observed. The dike crest surface is generally composed of gravel road base material that traverses the length of the dike for vehicle access.

Photo 1: Looking south along the east dike of the North Fly Ash Pond.

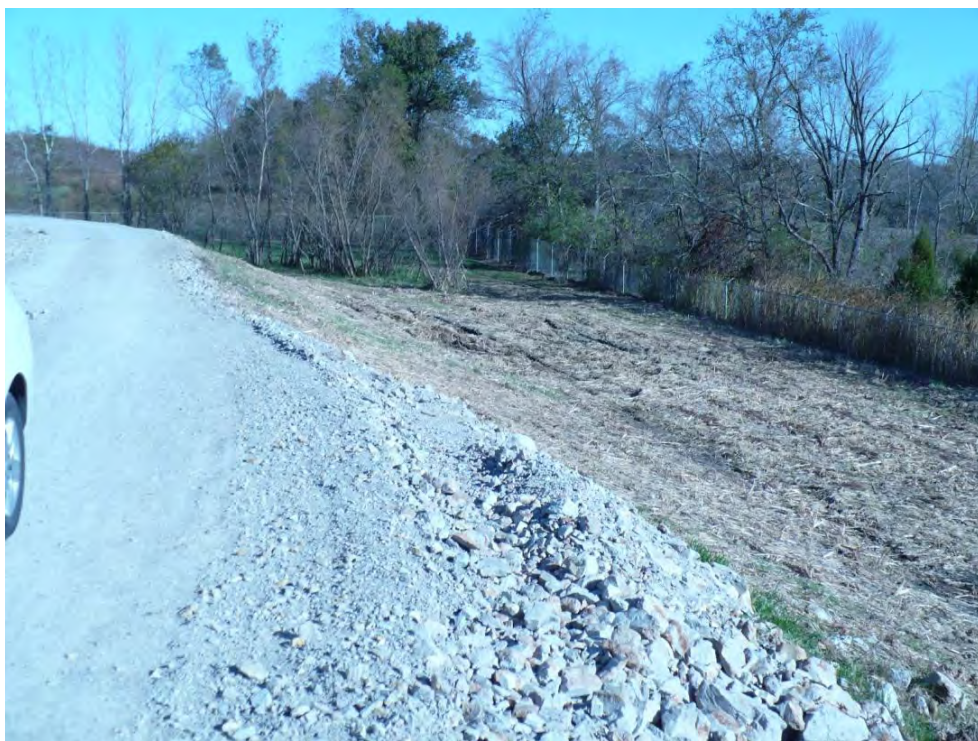
**Photo 2: The north east corner of the North Fly Ash Pond dike.
Note possible seepage occurring at dike toe.**

The dams and outlet works facilities associated with the impoundments at the Blue Valley Power Station were generally found to be in satisfactory condition. No visual signs of instability, erosion, or movement were observed. However, there are wet areas within a storm water drainage ditch that runs along the toe of the east dike of the North Fly Ash Pond. The wet areas may be due to standing water within the drainage ditch, however they could also be seepage from the toe of the dike. Further evaluation should be conducted to determine the source of water in the wet areas.

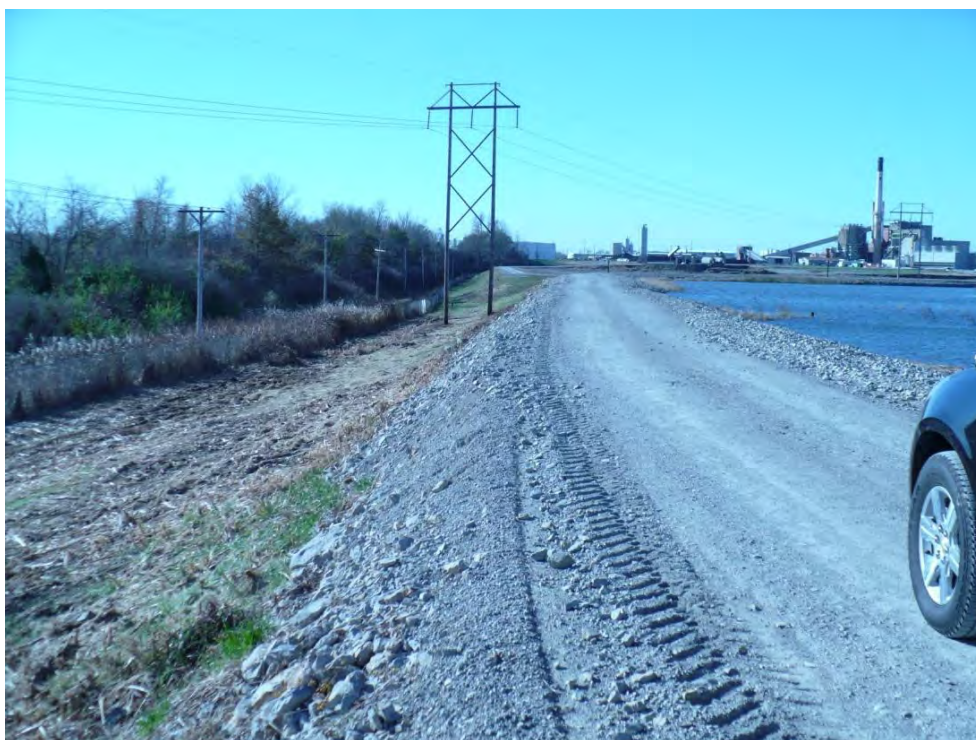
Photo 3: Looking south along the east dike of the North Fly Ash Pond. Note possible seepage occurring at the dike toe.

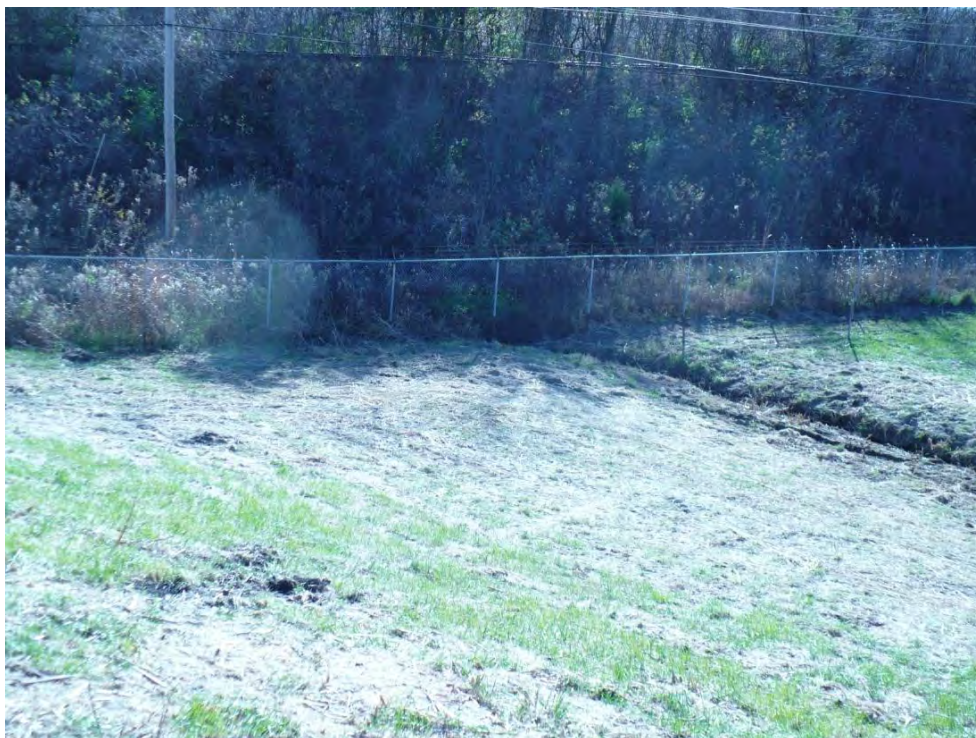
Photo 4: Looking east from the North Ash Pond dike at the abandoned railroad embankment. Site storm water is discharged to a 48-inch-diameter culvert.

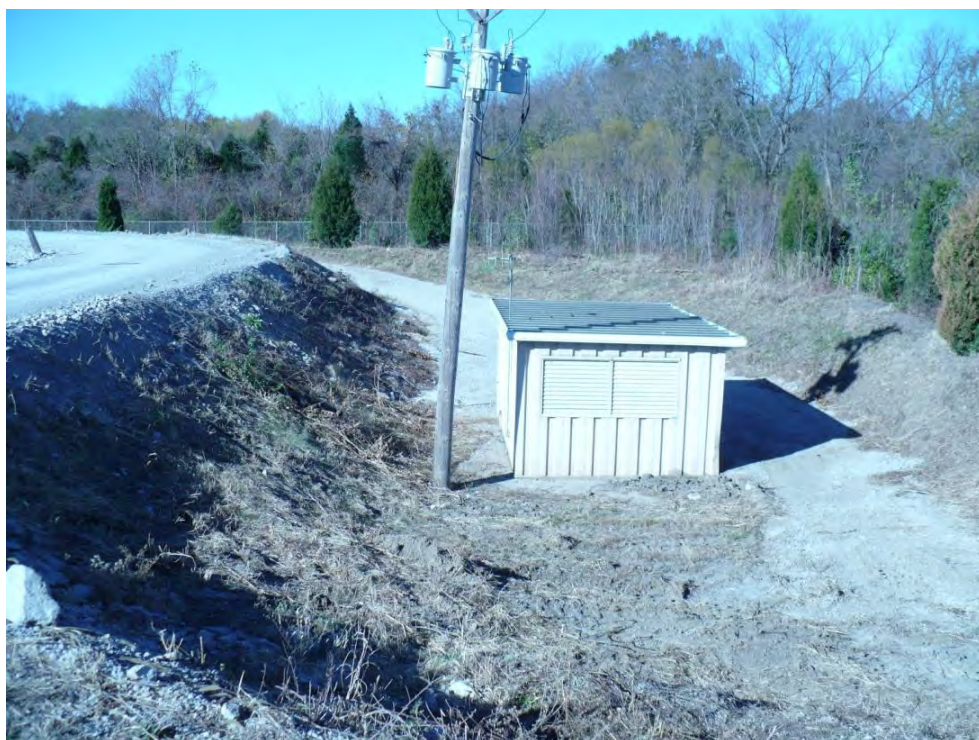
Photo 5: Return water pump house at north end of the Bottom Ash Pond.

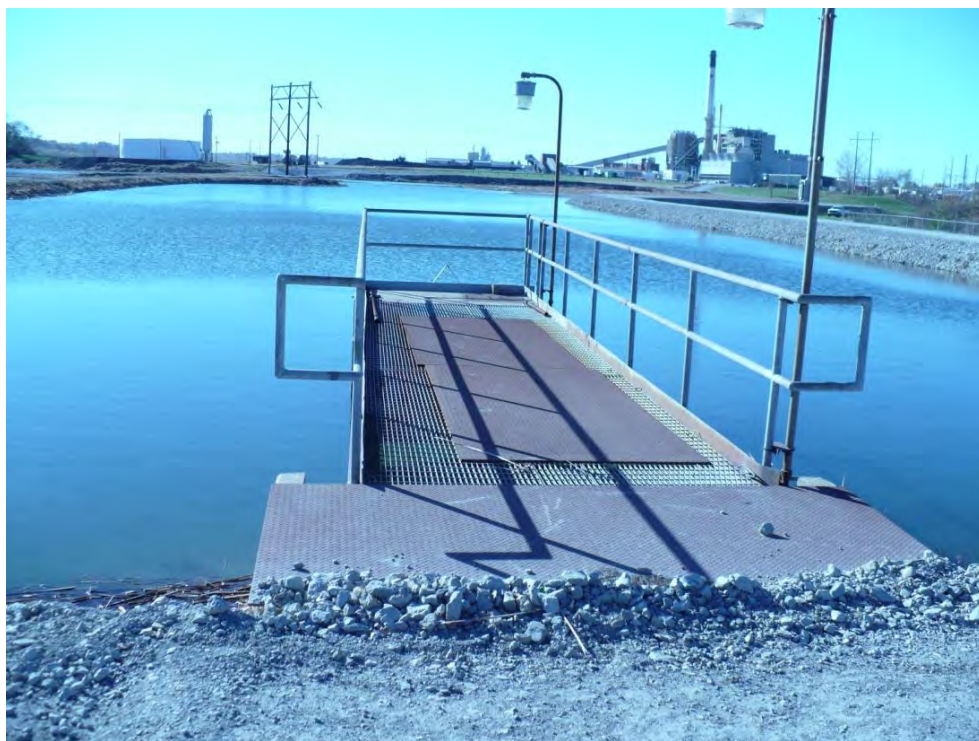
Photo 6: The Bottom Ash Intake Structure at the north end of the Bottom Ash Pond.

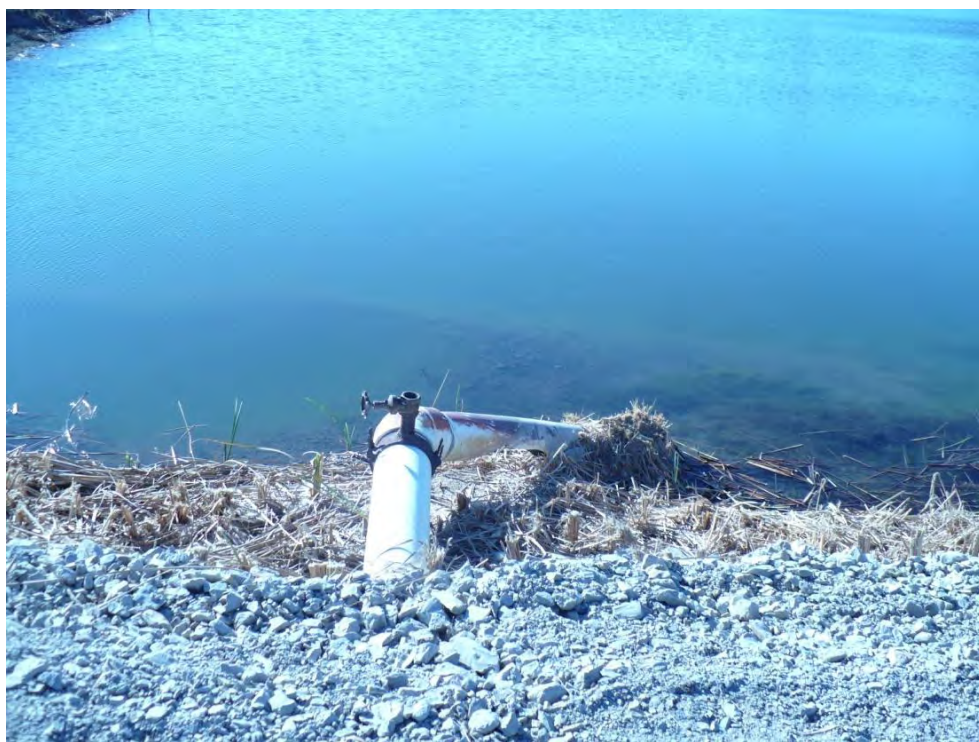
The outlet structure consists of an 8-inch diameter PVC pipe and appears to be in good condition. The invert for the overflow pipe is at elevation 768.0 feet. Currently, there is no active flow through the outlet structure.

Photo 7: The overflow outlet from the North Fly Ash Pond into the Bottom Ash Pond.

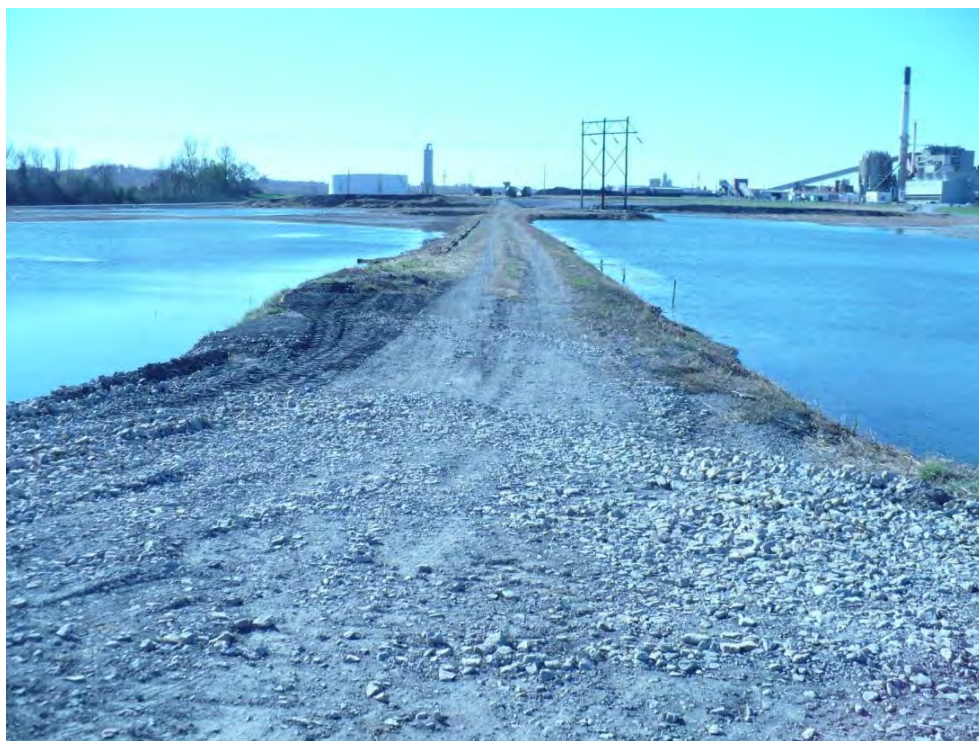
Photo 8: Looking south at the dike that separates the Bottom Ash Pond (right) from the South Fly Ash Pond (left).

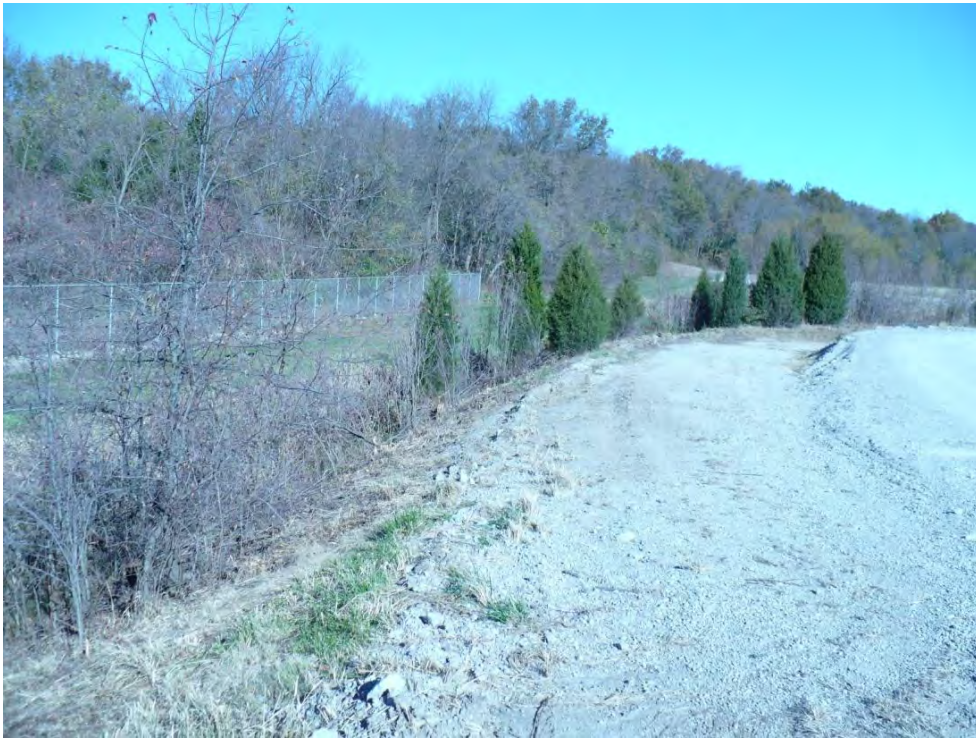
The downstream slopes of the dike at the Bottom Fly Ash Pond have well-established grass growth, which provides some erosion protection. No scarps, sloughs, depressions or other indications of slope instability or signs of erosion were observed during the inspection of the impoundment. A few small trees were noted to be growing on the slope of the pump house access road (see Photo 9). At this time, these trees do not present a concern, however consideration should be given to their removal.

Photo 9: Trees on slope of pump house access road slope at the northwest corner of the Bottom Ash Pond

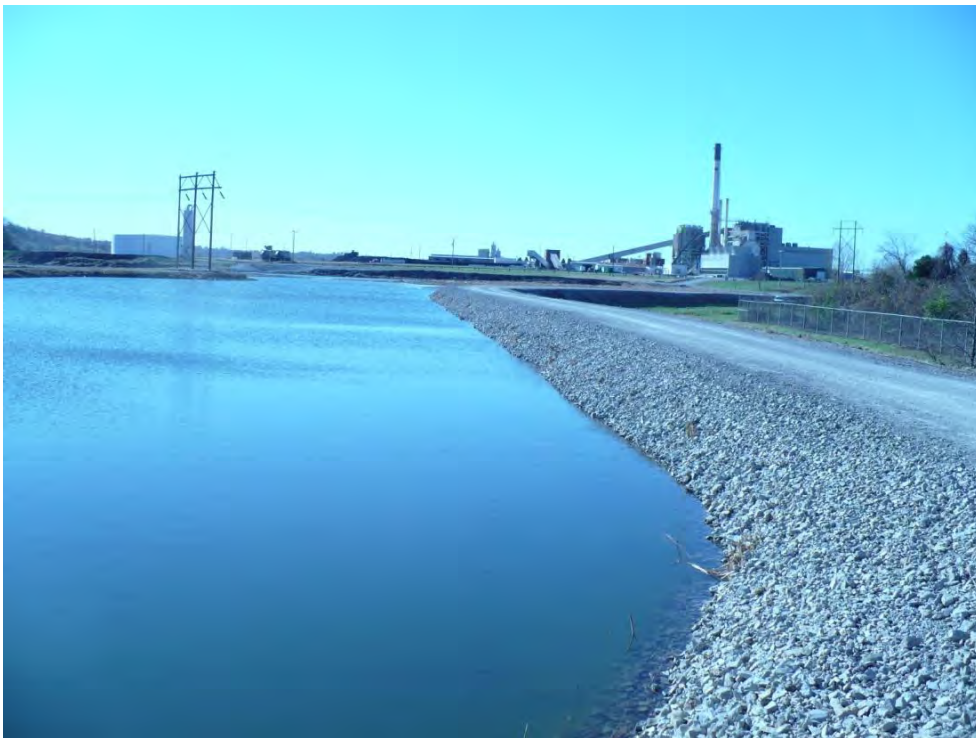
The crest of the dike at the Bottom Ash Pond appeared to be in good condition (see Photos 10 and 15). No signs of cracking, settlement, movement, erosion or deterioration were observed during the assessment. The crest appears to be well-drained and no standing water was observed. The dike crest surface is generally composed of gravel road base material that traverses the length of the dike for vehicle access.

Photo 10: Looking south at the Bottom Ash Pond west dike. Taken from the northwest corner of the Bottom Ash Pond.

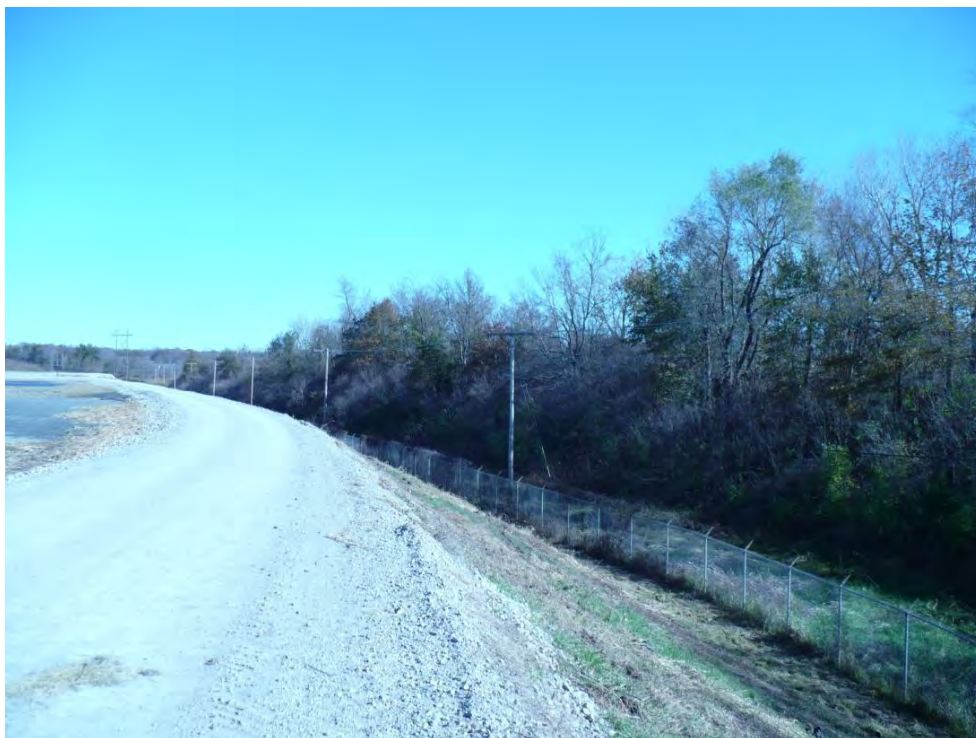
The downstream slopes of the dike at the South Fly Ash Pond have well-established grass growth, which provides some erosion protection (see Photo 11). No scarps, sloughs, depressions or other indications of slope instability or signs of erosion were observed during the inspection of the impoundment.

Photo 11: Looking north at the east dike of the South Fly Ash Pond.

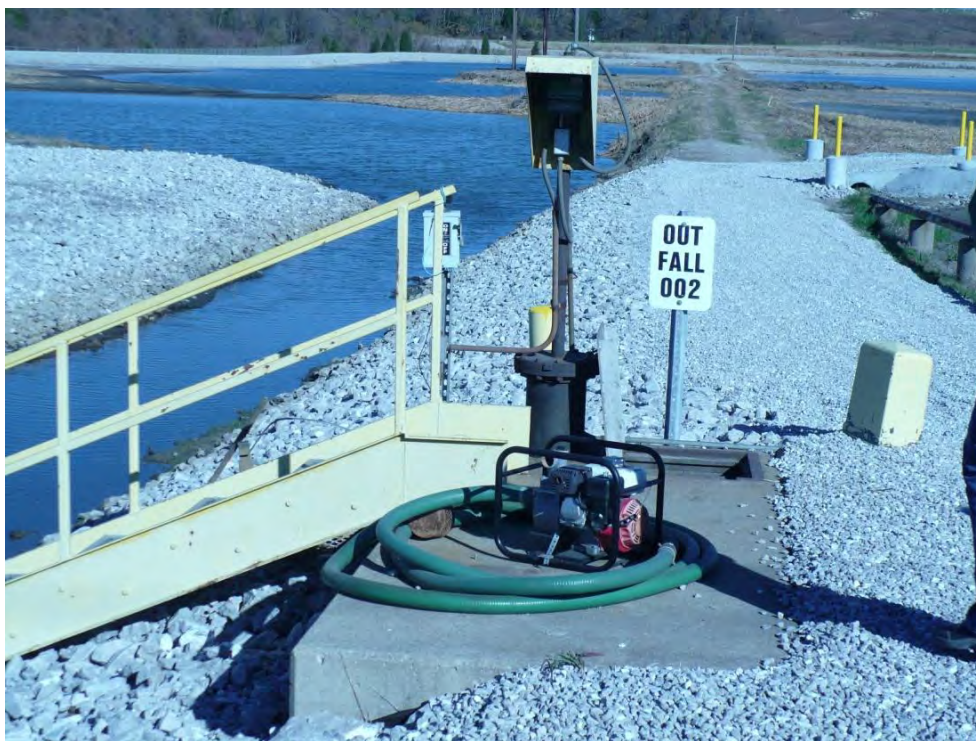
The outlet structure appears to be in good working condition and consists of a 12-inch diameter steel welded pipe discharging into a 12-foot long by 4-foot wide concrete vault that empties into the sanitary sewer system. There was a small amount of debris at the trash rack, but did not restrict flow into the outlet. The channel from the pond to the outlet was riprap and free flowing.

Photo 12: Outfall 002 and associated channel which is the outlet from the Bottom Ash Pond into the sanitary sewer system.

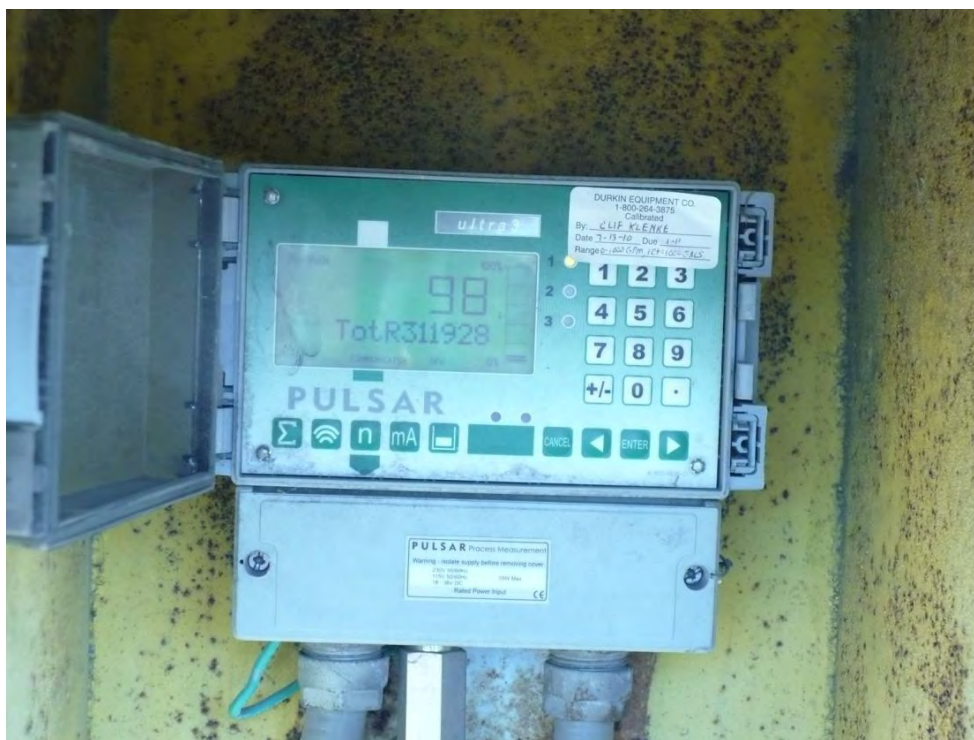
Photo 13: The flowmeter to monitor the discharge from the Bottom Ash Pond into the sanitary sewer system.

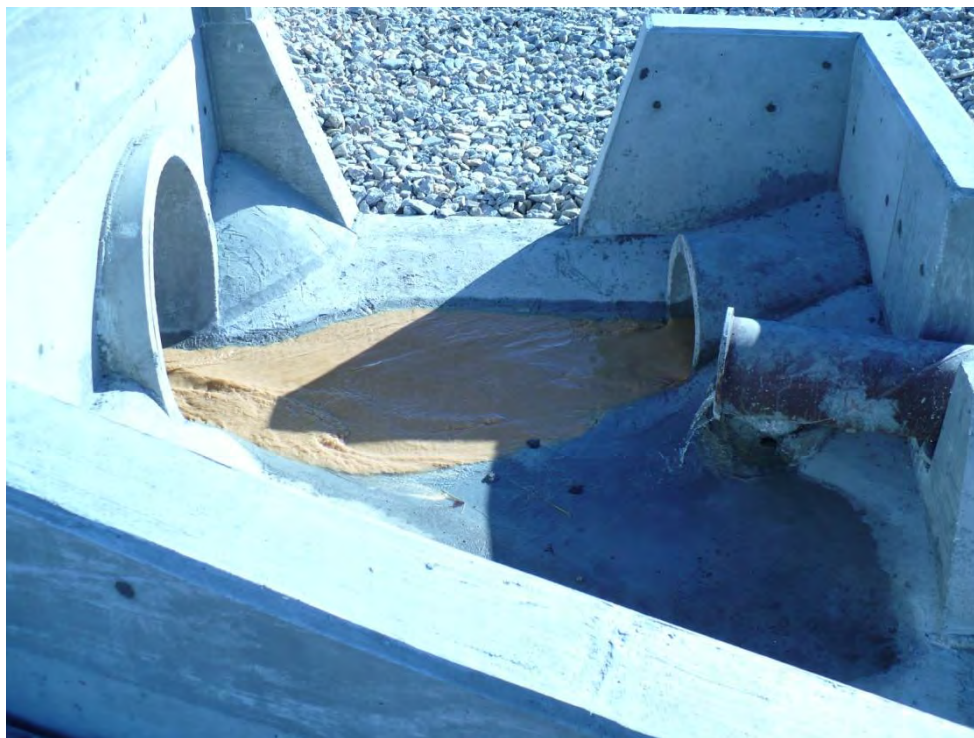
Photo 14: Inlet pipe to the Bottom Ash Pond.

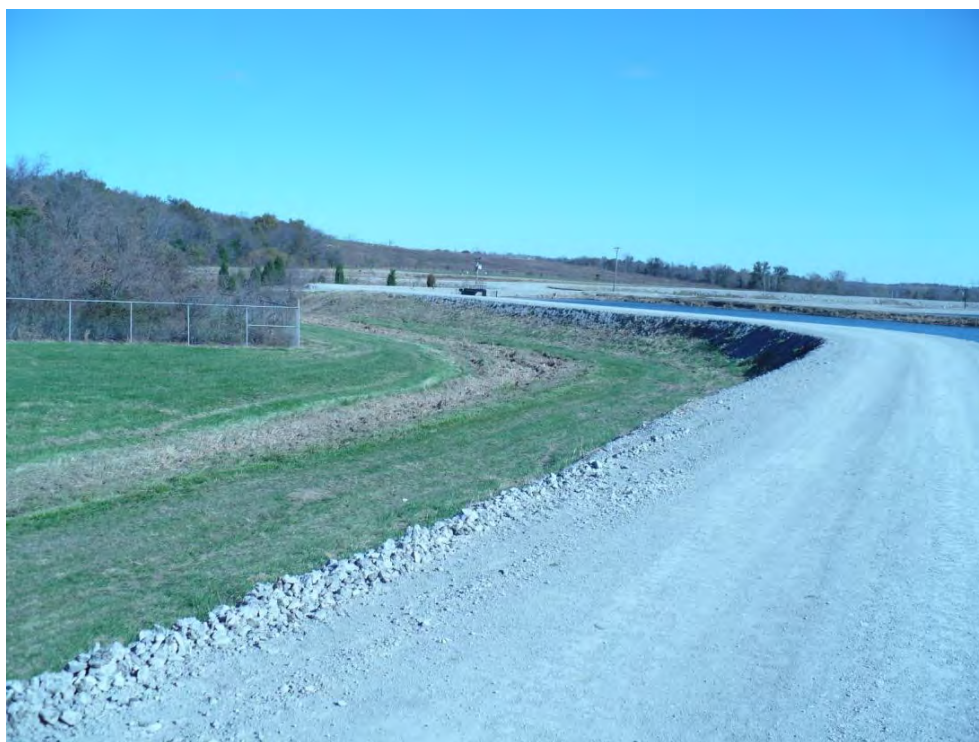
Photo 15: Looking north at the west dike of the Bottom Ash Pond.

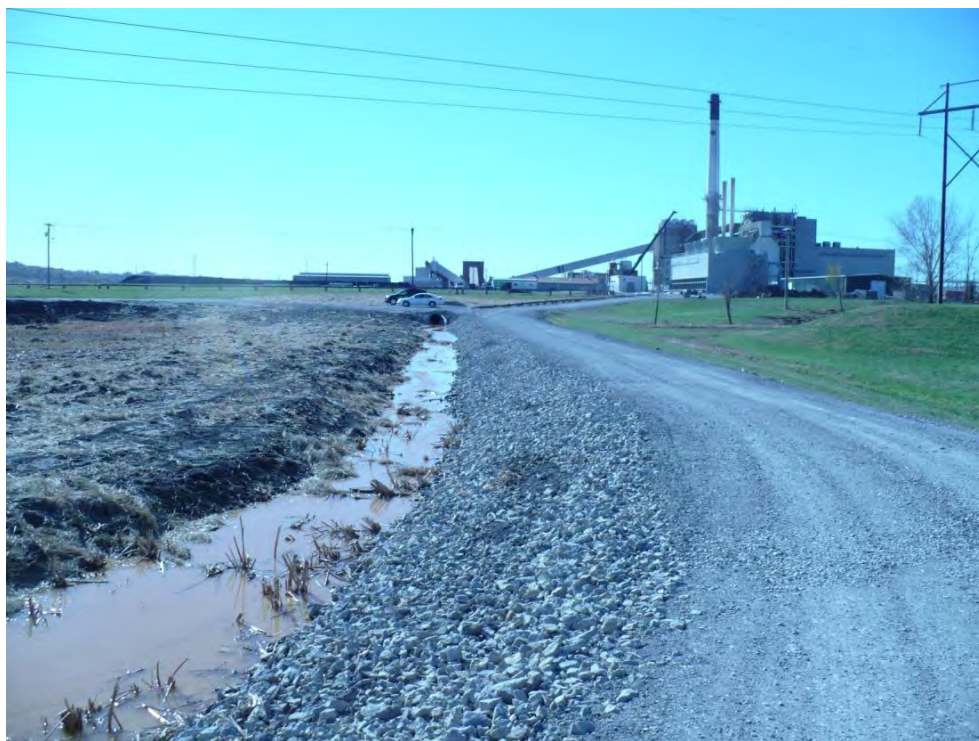
Photo 16: Looking south at the channel from the Bottom Ash Pond discharge into the pond.
