# **Assessment of Dam Safety of Coal Combustion Surface Impoundments**

**Indianapolis Power & Light Company**

**Eagle Valley Generating Station**

**June 4, 2010**

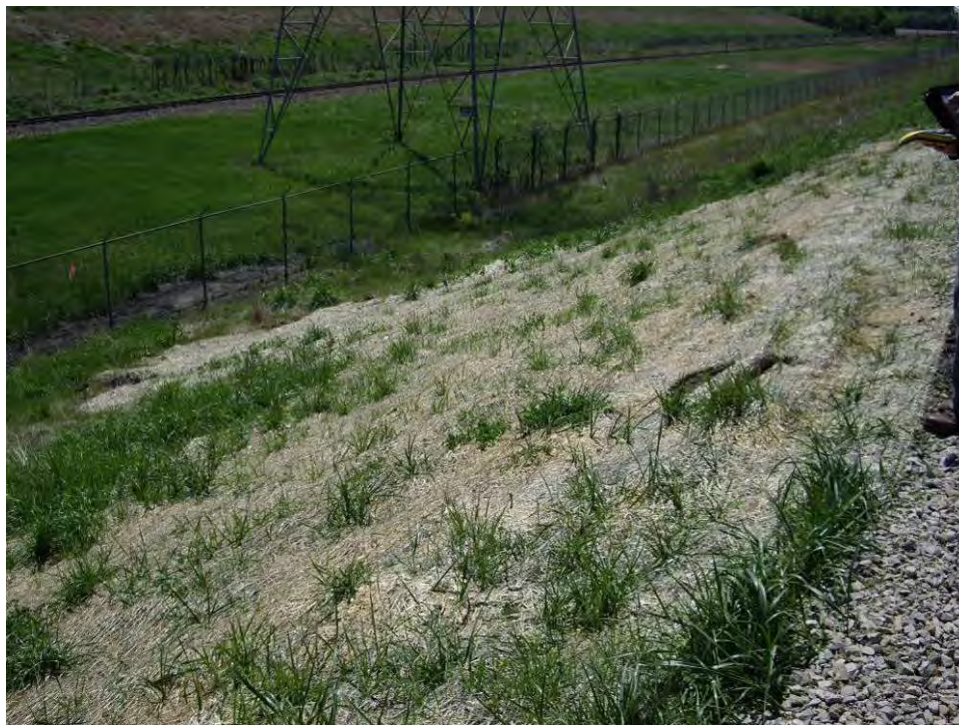
One erosion repair on the northeast corner of the east embankment was observed (Photos 1, 3, and 4). The repair consists of an erosion control blanket. The erosion control blanket did not appear to be installed consistent with typical manufacturer's recommendations. Stakes did not appear to be installed properly, and the blankets were not overlapped or keyed into an anchor trench in the slope. Approximately 1- to 3-inch gaps were observed below the blanket. Another erosion rill was observed on the west embankment (Photo 26). Some crushed stone was placed near the crest of the embankment in an effort to reduce further erosion.

3. Pond A - East embankment exterior slope. Erosion control blanket installed near northeast corner looking southeast. Note: Blanket appears to be improperly staked, there are 1- to 3-inch gaps beneath the blanket, and there is no apparent anchor trench or roll overlap.

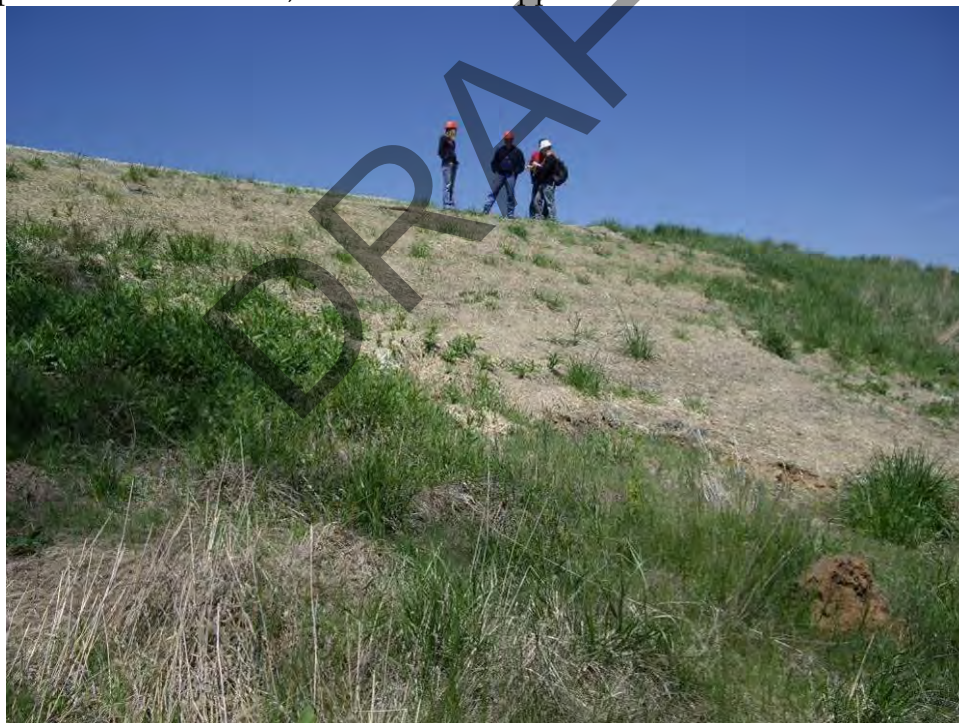
4. Pond A - East embankment exterior slope. Erosion control blanket installed near northeast corner looking northwest.

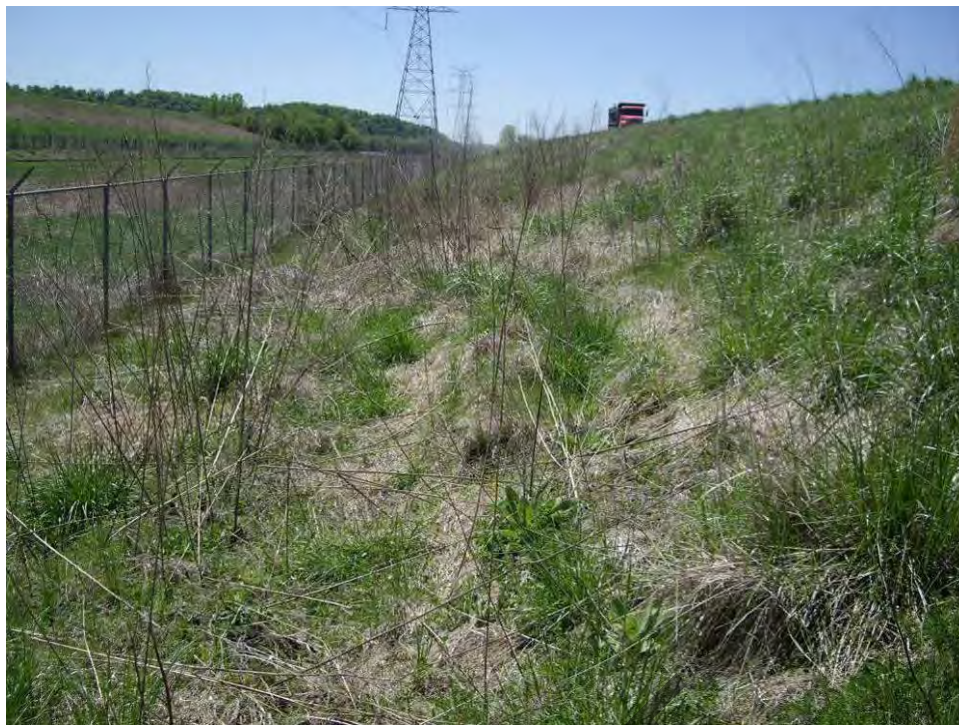
There were two low spots at the toe of the east embankment (Photo 5). At the low spots, there was also some minor sloughing. IPL stated these were low areas where a tractor had previously gotten stuck during mowing operations. A surface depression was also observed near the crest of the eastern embankment (Photo 7).

5. Pond A - East exterior slope looking south. Low spot and minor slough at toe of slope.. Possible tractor rutting.

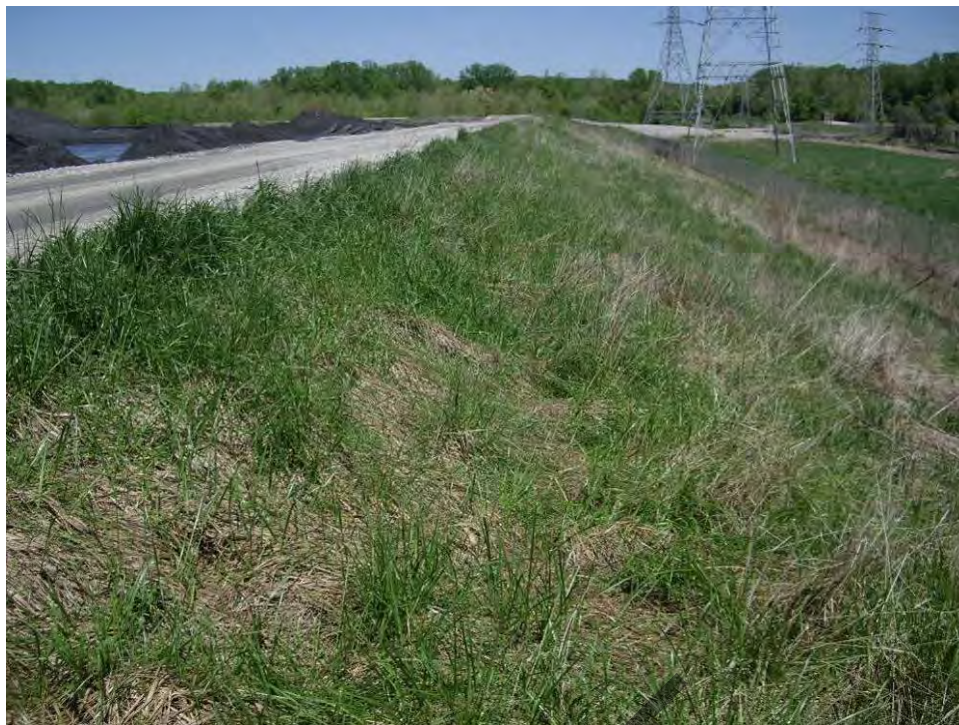
7. Pond A - depression near crest of east embankment, looking north.

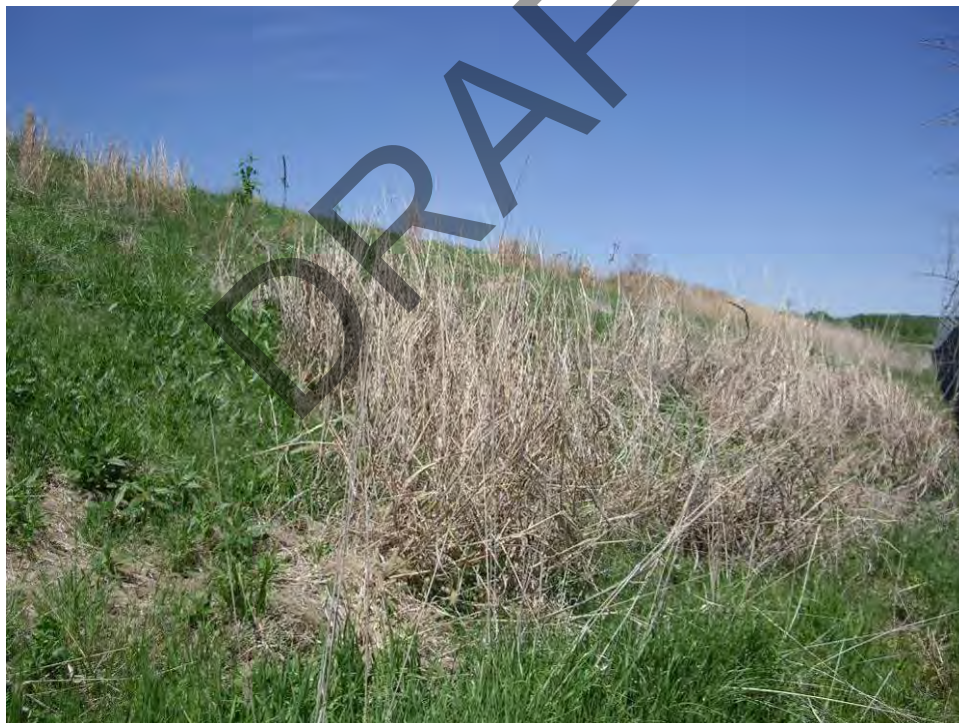
A possible former seep area was observed at the toe of the east embankment (Photo 12). A possible former seep was also observed in a soft spongy area along the toe of the south embankment (Photo 21). No active seepage was observed during the site visit. However, active seepage in these areas has been noted in previous inspection reports.

12. Pond A looking north - Possible former seep location at toe of east embankment.,.

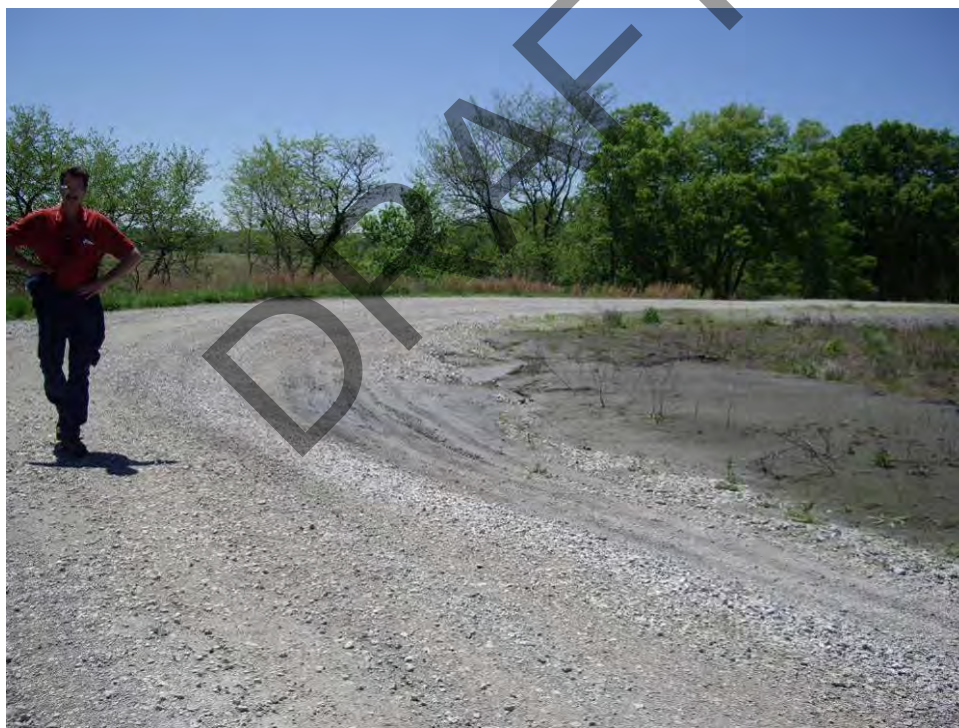
14. Pond A - Depression in crest from truck traffic, looking south.

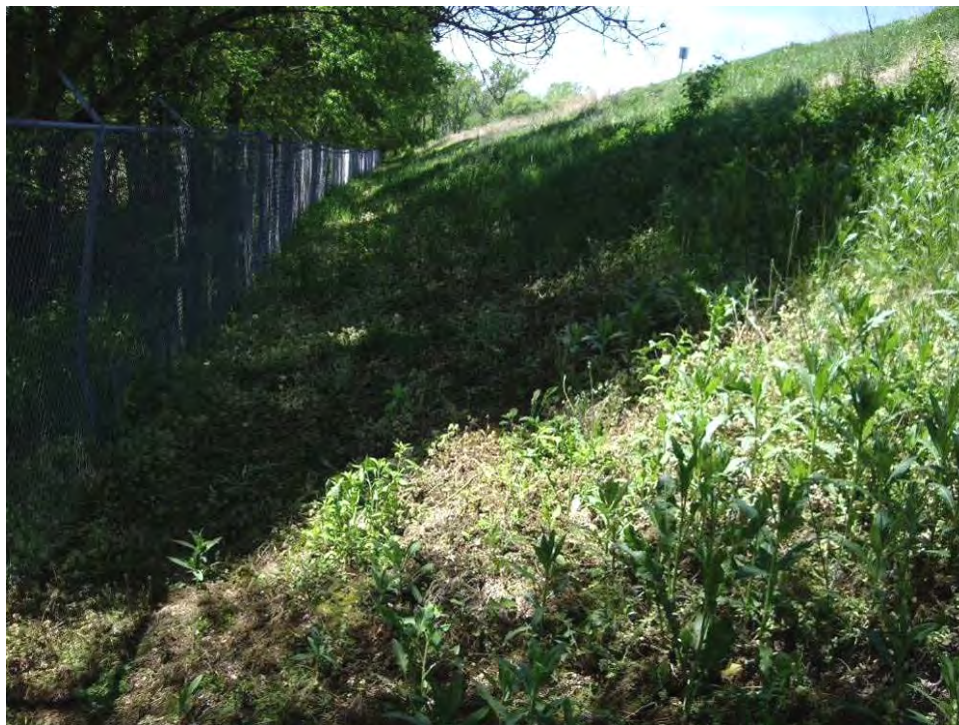
21. Pond A - Soft spongy area at toe of south embankment under tree canopy (possible former active seepage area).

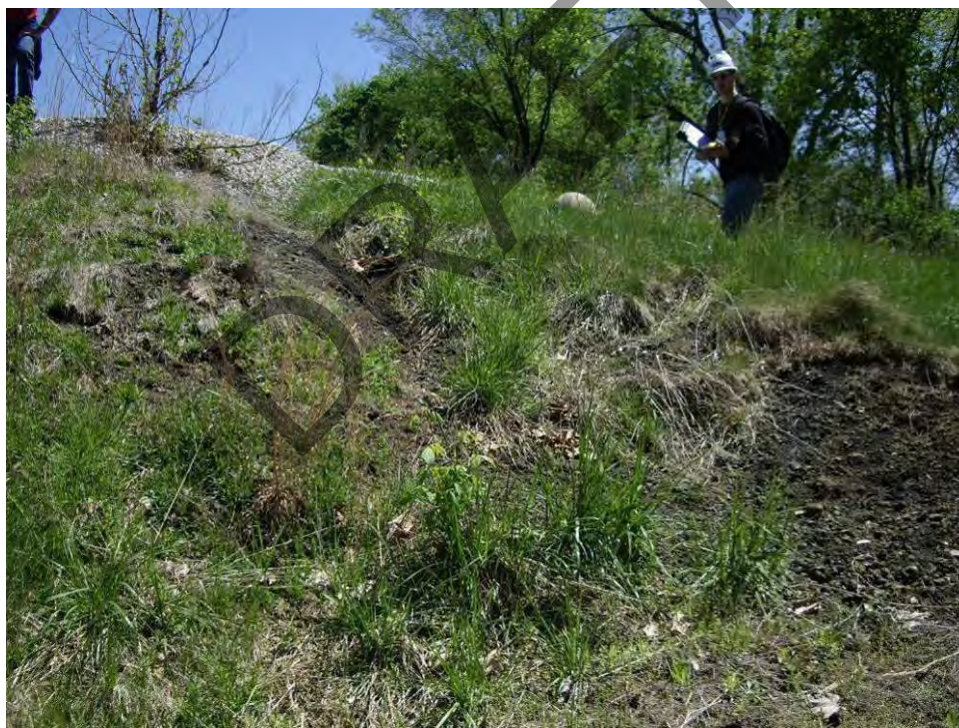
26. Pond A – Erosion rill on west embankment exterior slope, looking east.

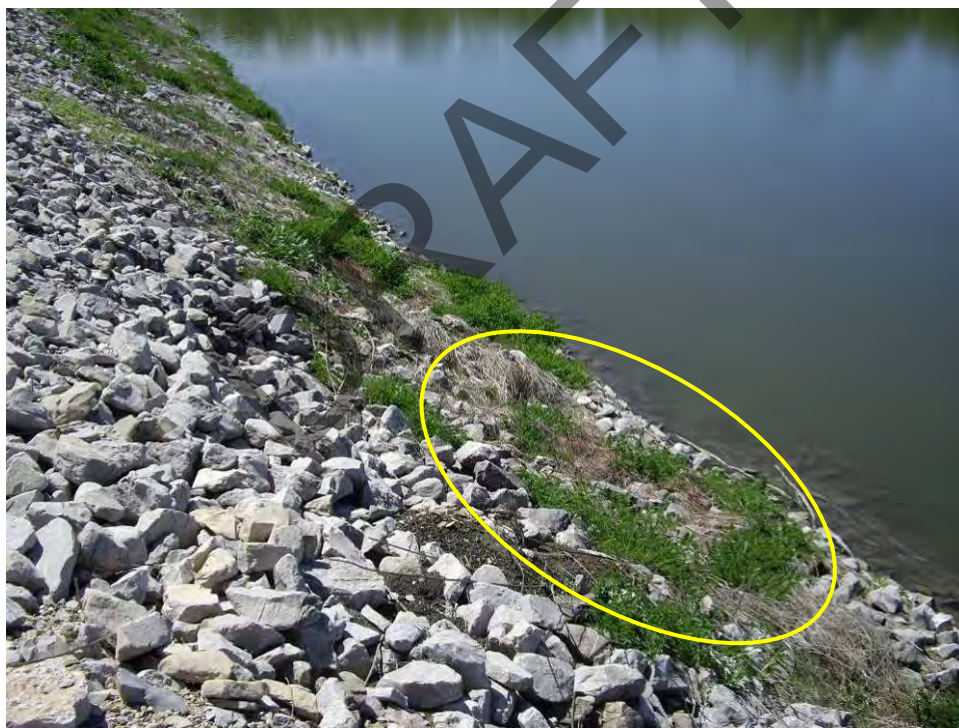
32. Depression in north slope of Pond A/B divider embankment.

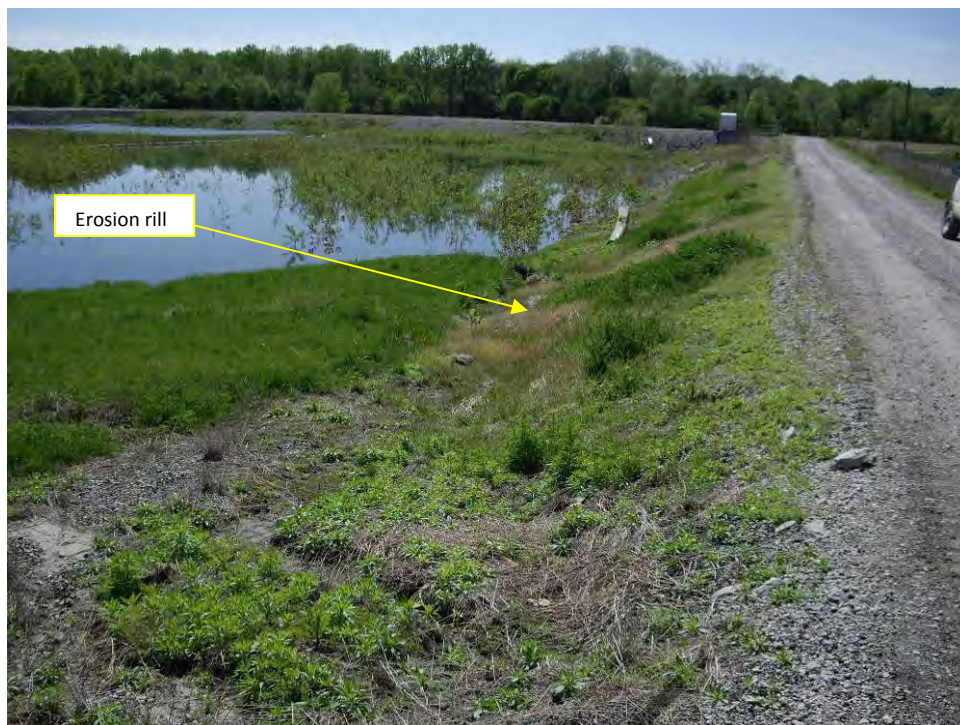
The interior slope of the Pond C embankments appeared to be generally in fair condition (Photos 47, 49, 51, and 54). The interior slopes were approximately 2H:1V. Most of the north embankment has no erosion protection or armor. There is some riprap on the north embankment near the northeast corner and at the outlet structure. On the north embankment in the northeast corner there is an erosion rill developing

47. Pond C – North embankment interior slope and crest, looking west. Note erosion rill on interior slope.

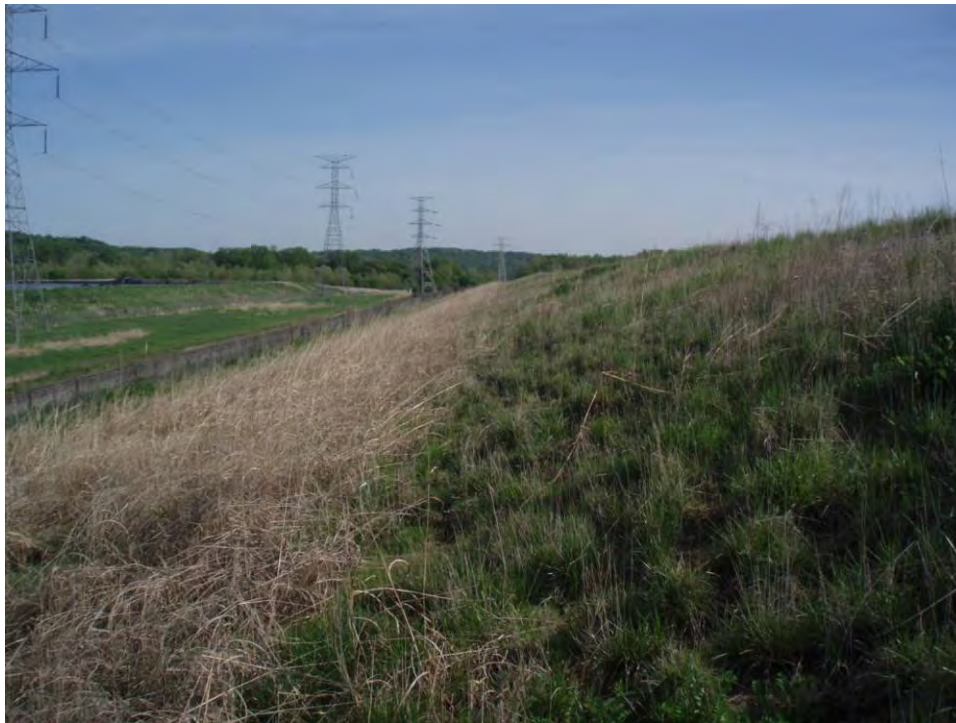
89. Pond D - West embankment exterior slope, looking north. Note bands of vegetation from the vertical expansions. Bare spots observed on upper third.

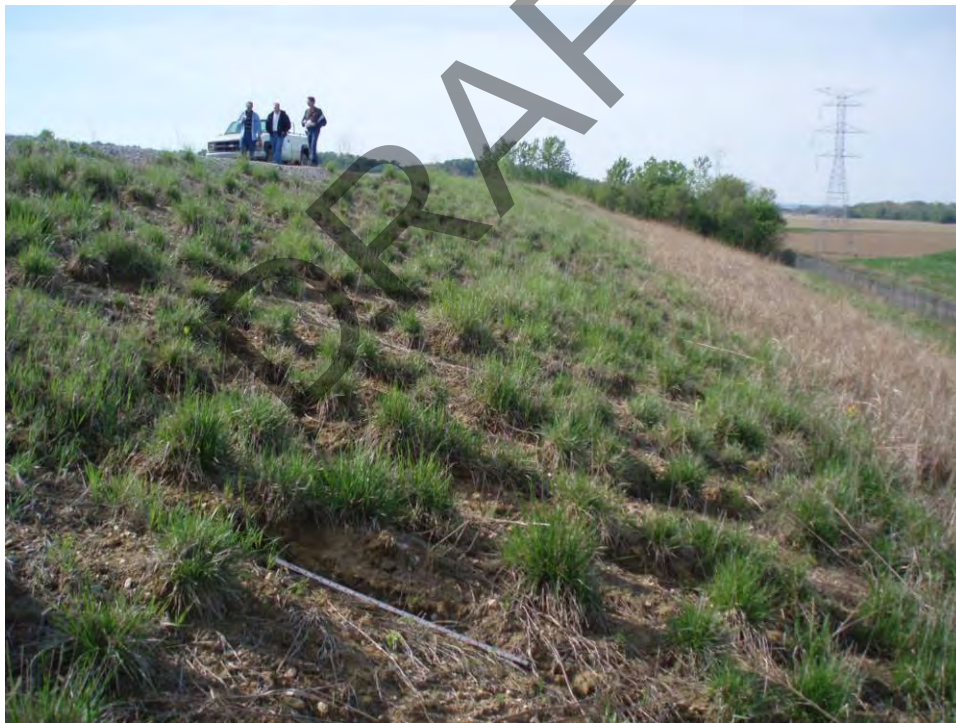
90. Pond D - Typical bare spots on upper third of west embankment exterior slope, looking south.

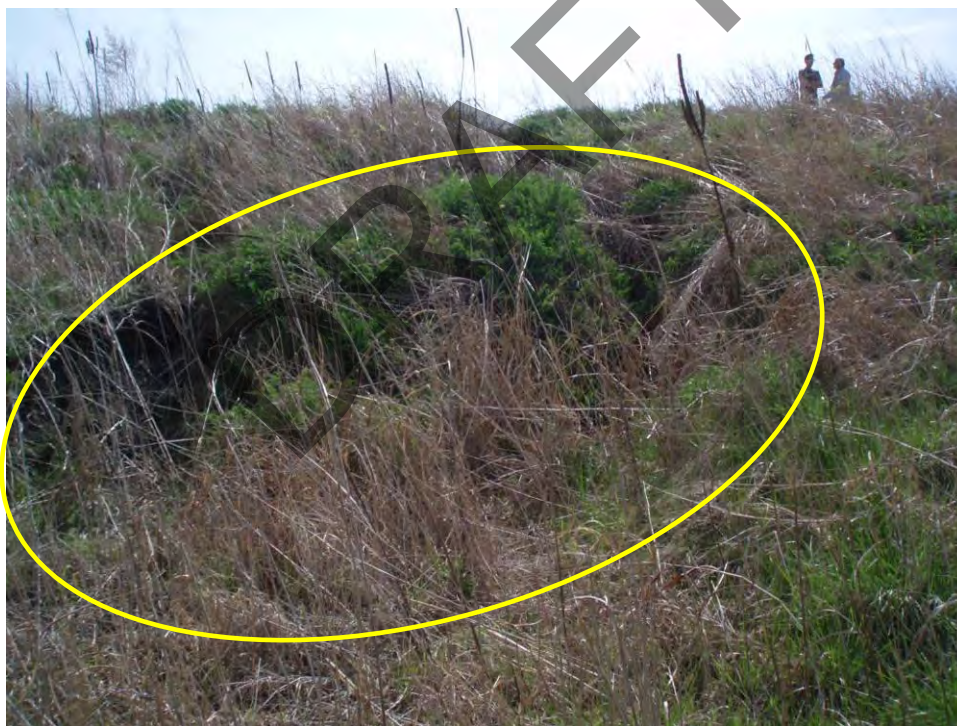
106. Pond E - 16'Wx4'Dx17'L erosion gulley at toe of west embankment exterior slope from previous failure event. Note erosion is scheduled to be repaired.

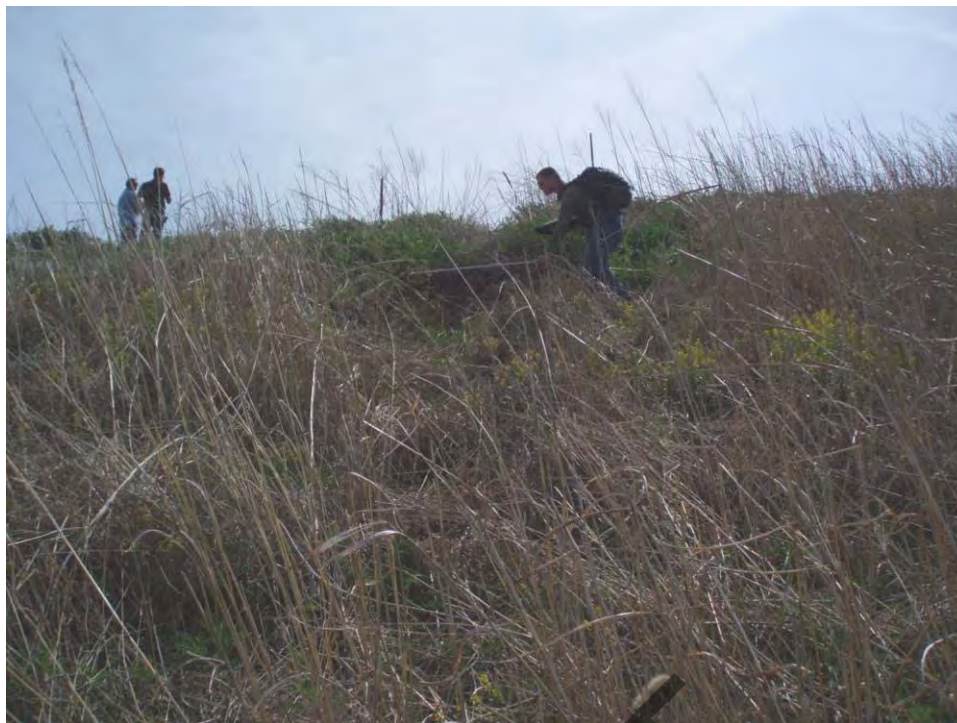
107. Pond E - 8'Wx4.5'Dx15'L erosion gulley at crest of west embankment exterior slope from previous failure event. Note erosion is scheduled to be repaired.

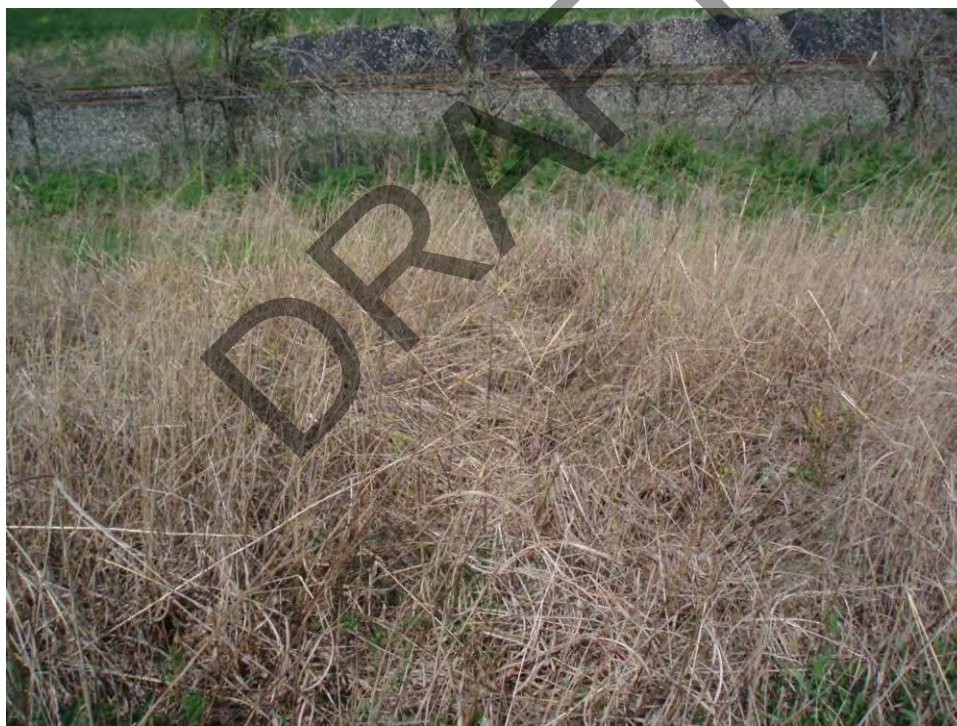
112. Pond E - 8'Wx3'Dx25'L erosion gulley at mid-slope of west embankment exterior slope from previous failure event. Note erosion is scheduled to be repaired.

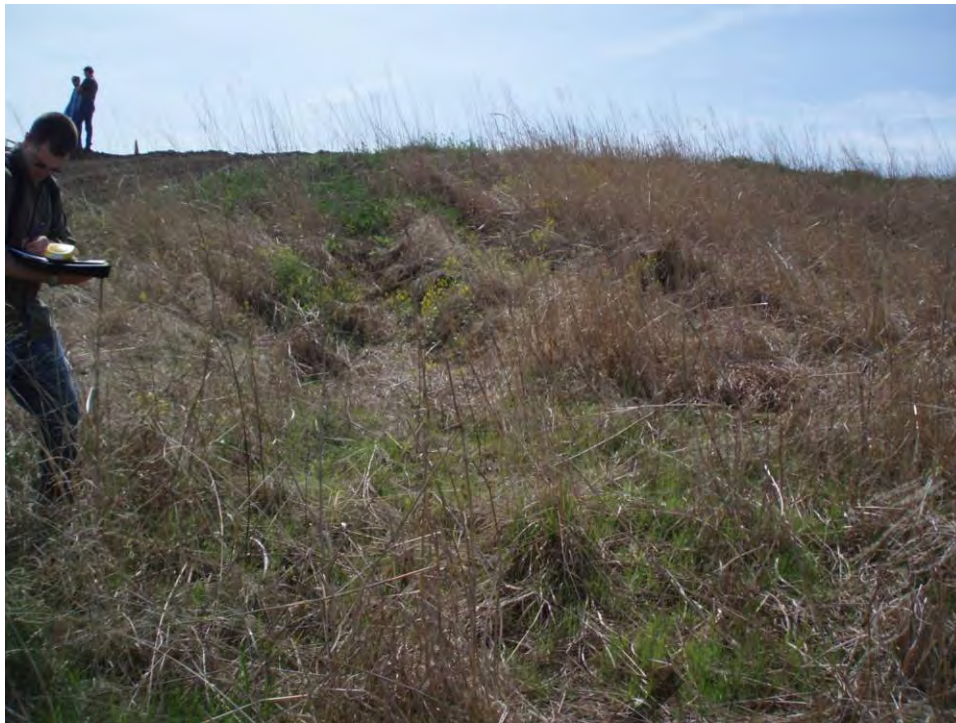
113. Pond E - two approximately 4'Wx3'Dx20'L erosion gulleys at mid-slope of west embankment exterior slope from previous failure event. Note erosion is scheduled to be repaired.

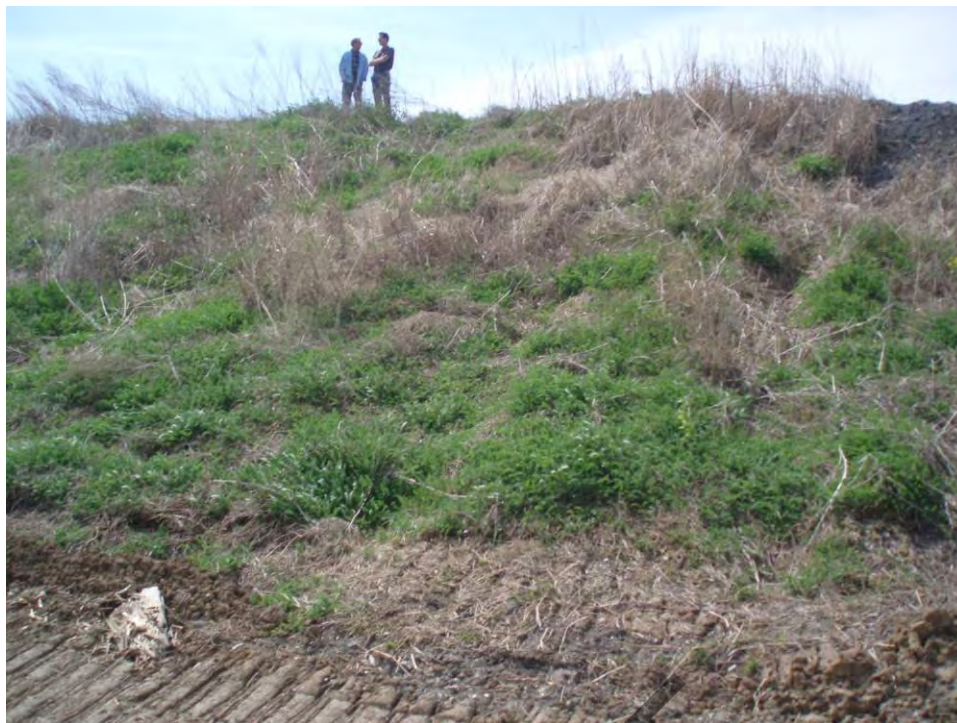
119. Pond E - erosion feature on north embankment exterior slope from previous failure event.

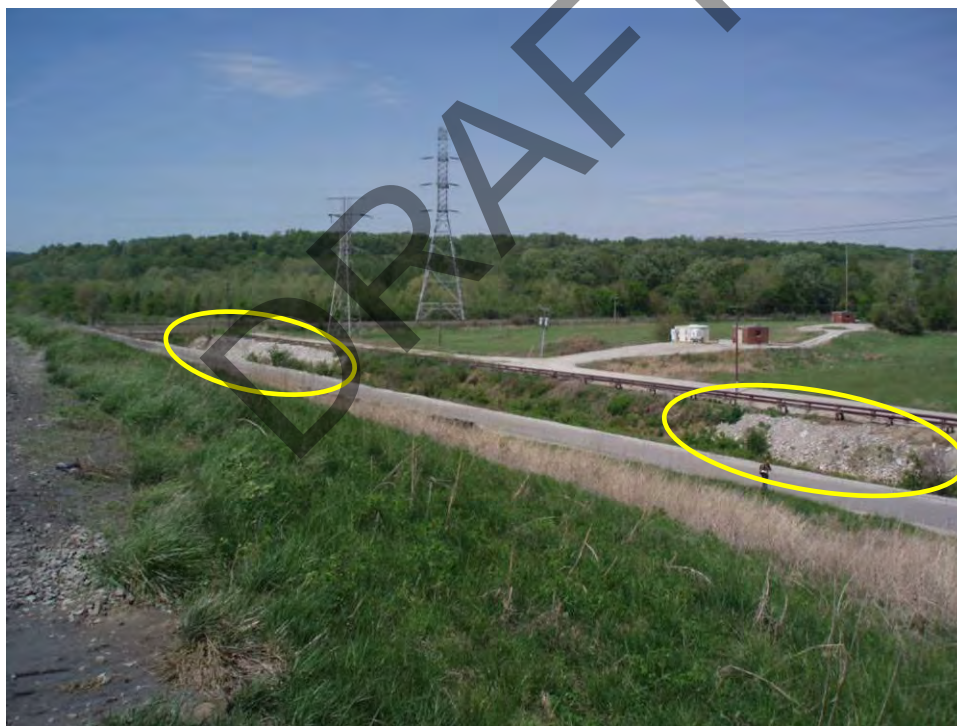
136. Overview of downstream area north of Pond D and Pond E. Note repair of erosion areas which resulted from breach.
