# **Assessment of Dam Safety of Coal Combustion Surface Impoundments**

**Indianapolis Power & Light Company**

**Eagle Valley Generating Station**

**November 15, 2010**

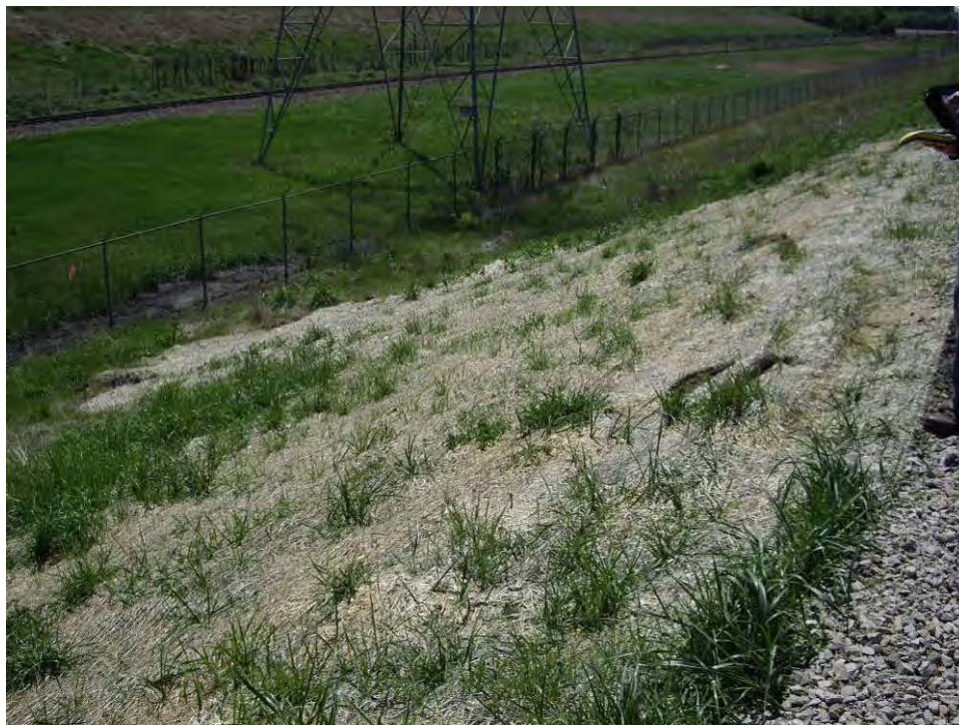
One repair on the northeast corner of the east embankment was observed (Photos 1, 3, and 4). IPL indicated that the repair was needed due to an ash sluice line leak located in the northeast corner of Pond A. The repair consists of an erosion control blanket. The erosion control blanket did not appear to be installed consistent with typical manufacturer's recommendations. Stakes did not appear to be installed properly, and the blankets were not overlapped or keyed into an anchor trench in the slope. Approximately 1- to 3-inch gaps were observed below the blanket.

3. Pond A - East embankment exterior slope. Erosion control blanket installed near northeast corner looking southeast. Note: Blanket appears to be improperly staked, there are 1- to 3-inch gaps beneath the blanket, and there is no apparent anchor trench or roll overlap.

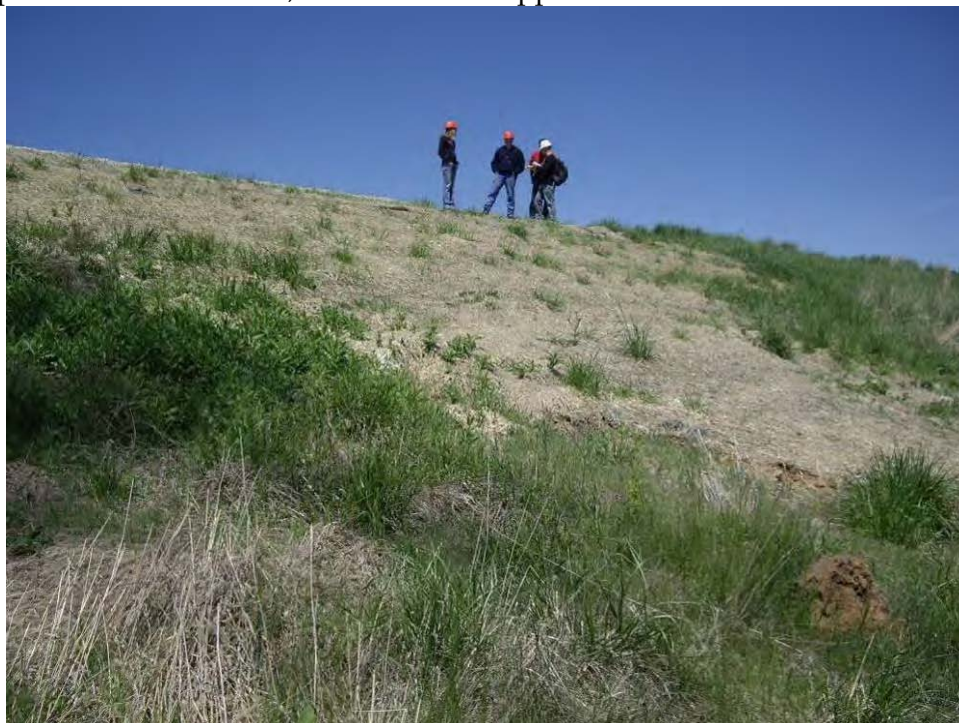
4. Pond A - East embankment exterior slope. Erosion control blanket installed near northeast corner looking northwest.

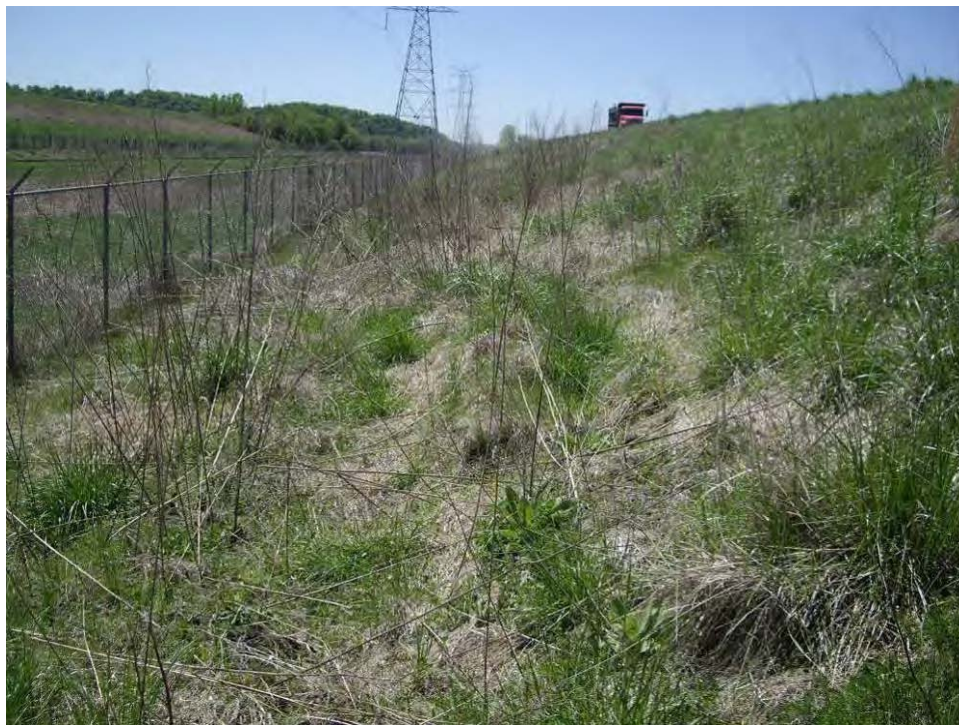
There were two low spots at the toe of the east embankment (Photo 5). At the low spots, there was also some minor sloughing. IPL stated these were low areas where a tractor had previously gotten stuck during mowing operations. A surface depression was also observed near the crest of the eastern embankment (Photo 7).

5. Pond A - East exterior slope looking south. Low spot and minor slough at toe of slope.. Possible tractor rutting.

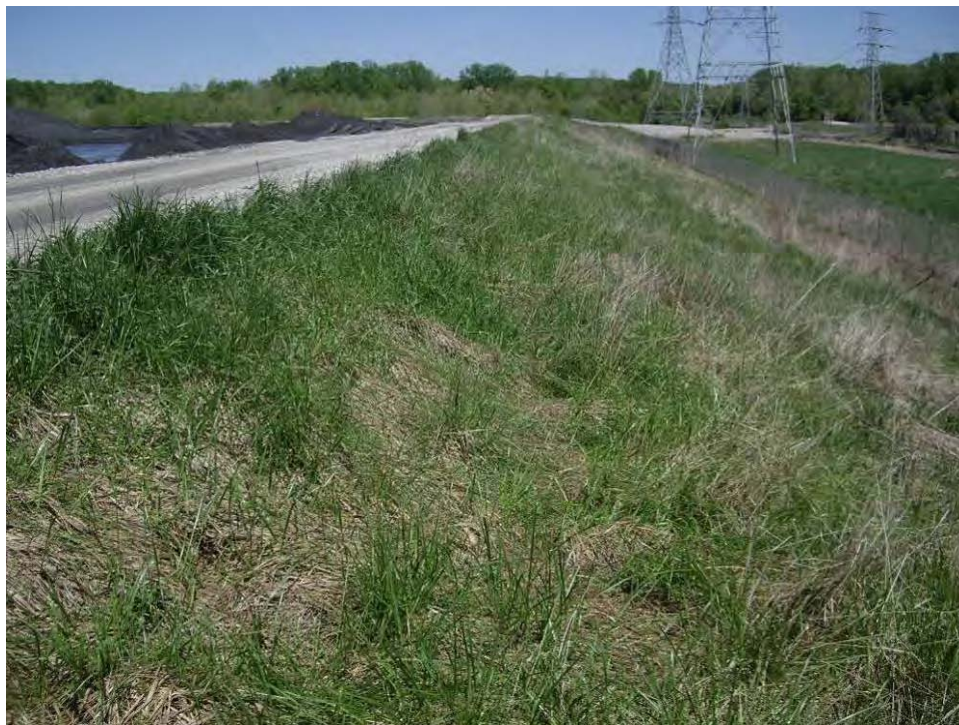
7. Pond A - depression near crest of east embankment, looking north.

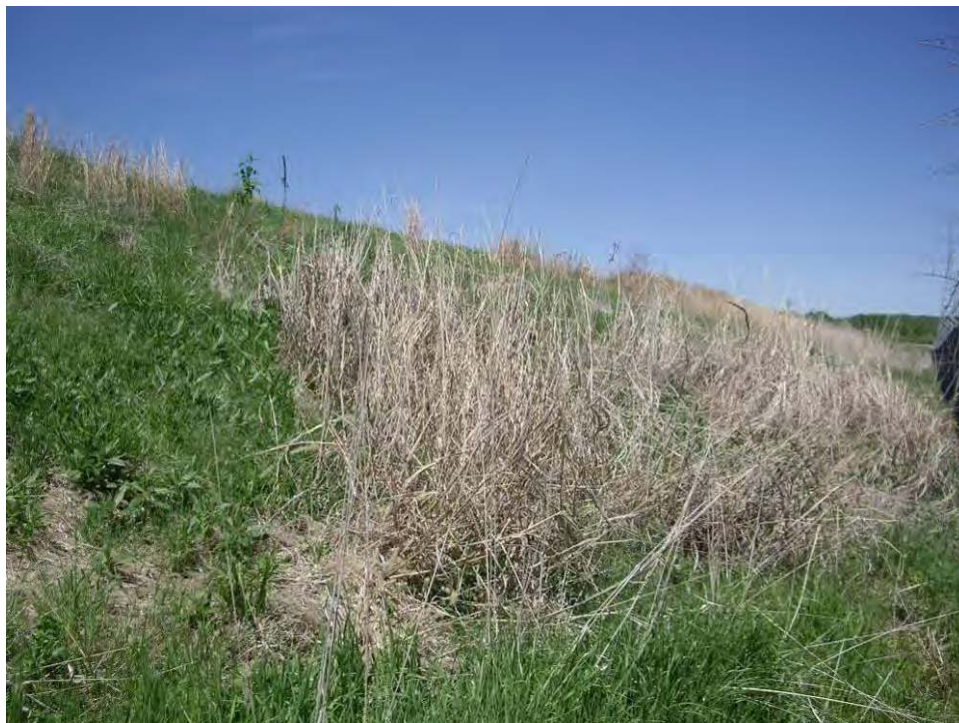
A possible former seep area was observed at the toe of the east embankment (Photo 12). IPL indicated that the conditions observed in this area were the result of an ash sluice line leak. A possible former seep was also observed in a soft spongy area along the toe of the south embankment (Photo 21). No active seepage was observed during the site visit. However, active seepage in these areas has been noted in previous inspection reports.

12. Pond A looking north - Possible former seep location at toe of east embankment.,.

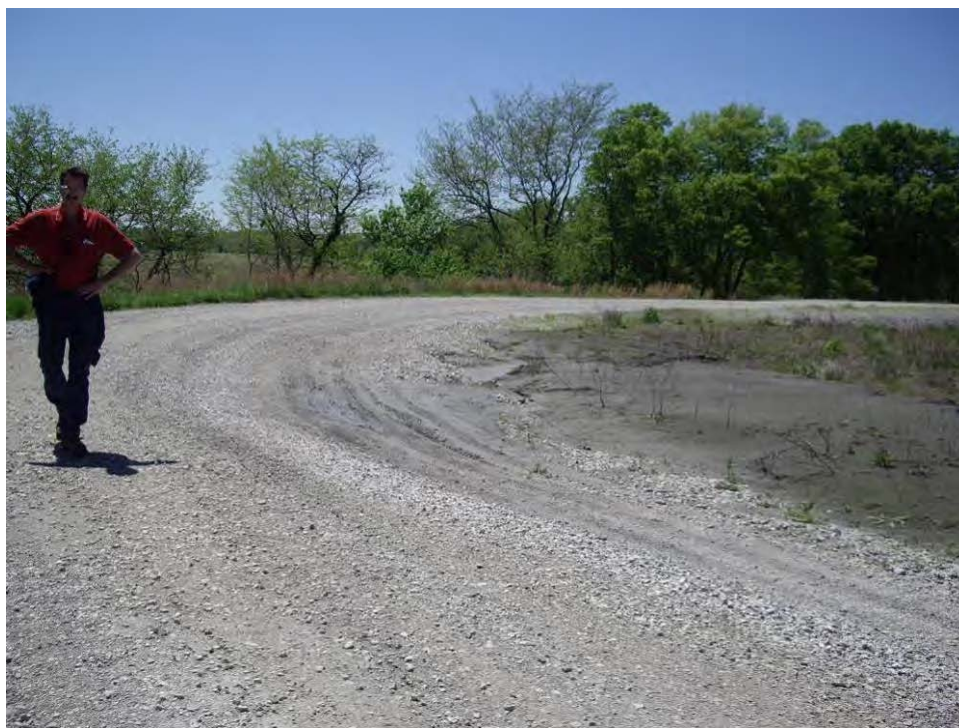
14. Pond A - Depression in crest from truck traffic, looking south.

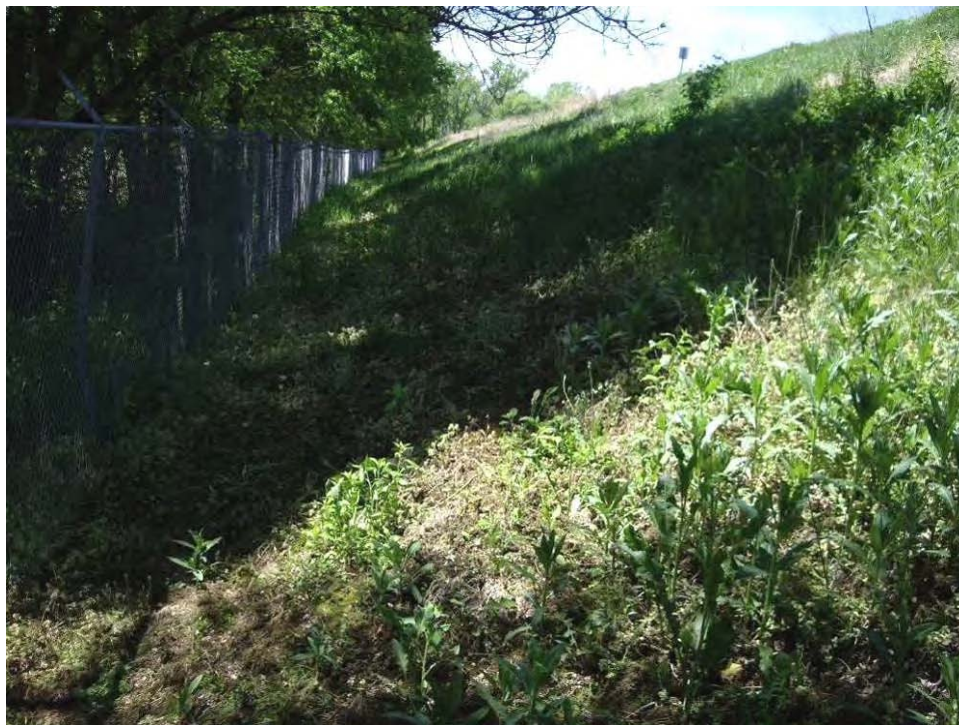
21. Pond A - Soft spongy area at toe of south embankment under tree canopy (possible former active seepage area).

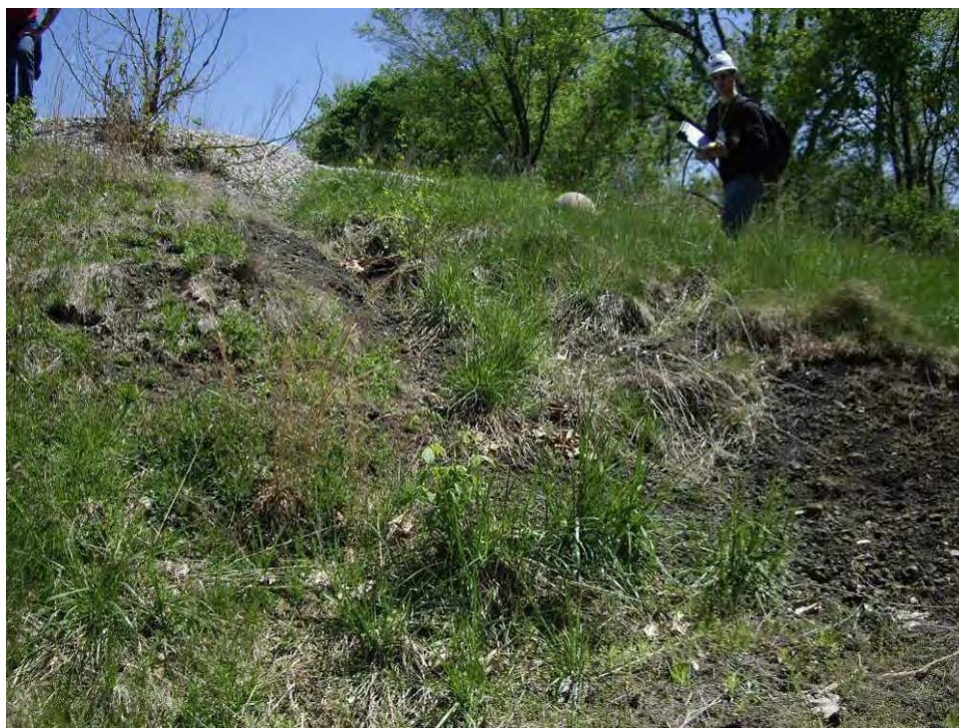
26. Pond A – Erosion rill on west embankment exterior slope, looking east.

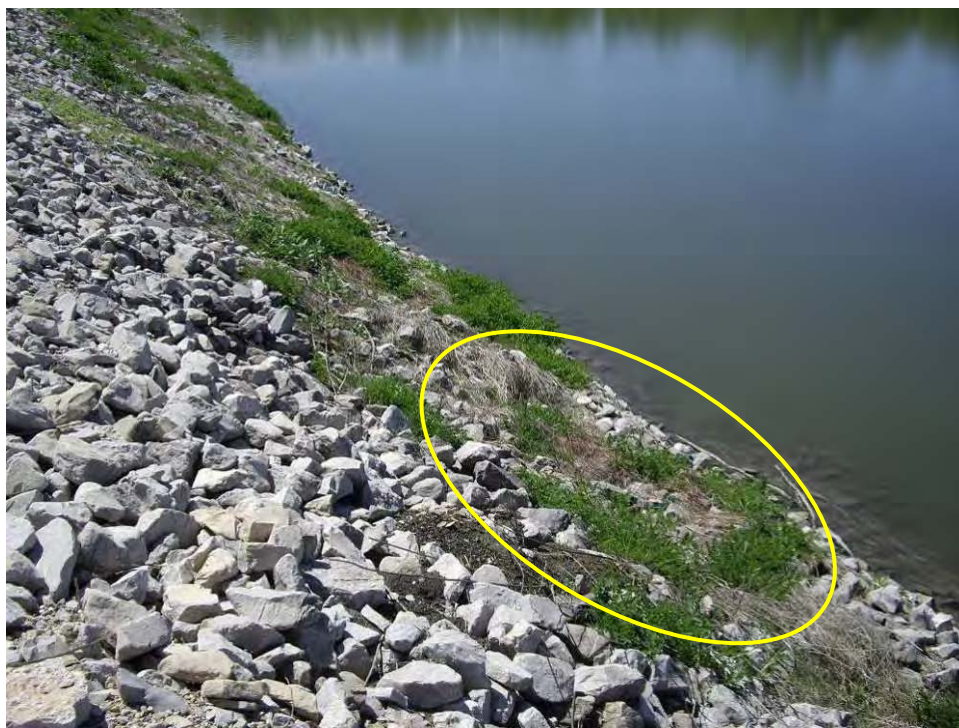
32. Depression in north slope of Pond A/B divider embankment.

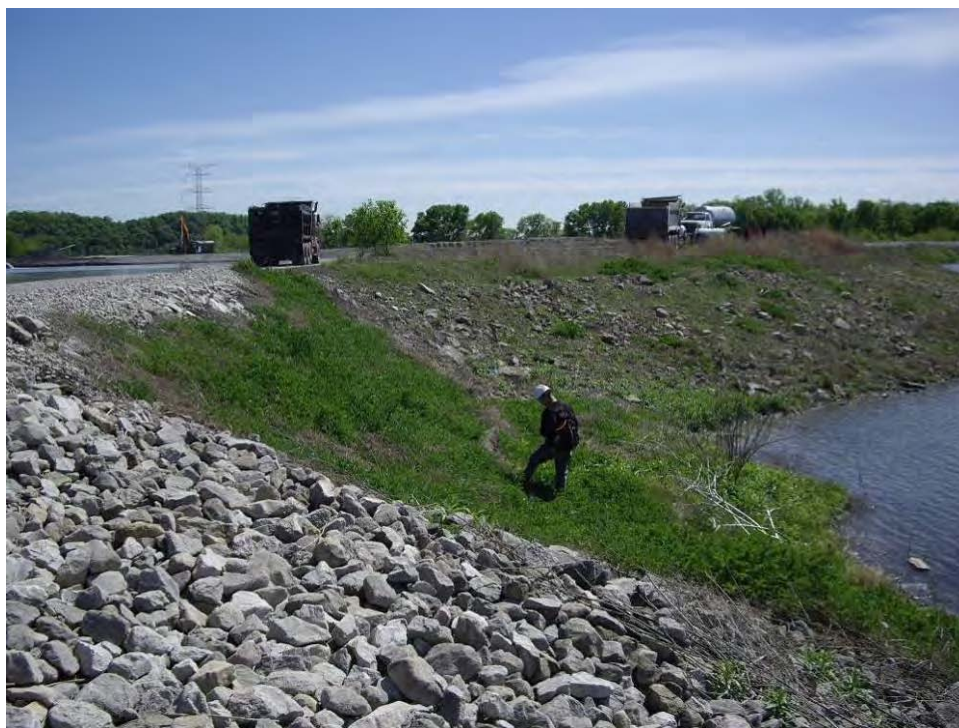
The exterior slopes on the divider embankments A/B and A/C were generally protected with riprap or crushed stone armor. Some areas were not armored and were covered with vegetative protection. Some erosion features, surface depressions, and minor sloughing were observed on the slope (Photos 32, 35, 36, 37, and 38). Some of the larger surface erosion areas appeared to have been recently filled with riprap or

stone (Photos 38, 40, 41, and 42). IPL indicated that the erosion was the result of heavy rainfall in the summer of 2008 and was repaired in June 2008. There was also some brush and small trees growing at the toe of the divider embankment in Pond C (Photo 42).

38. Northwest slope of divider embankment A/B, looking south.

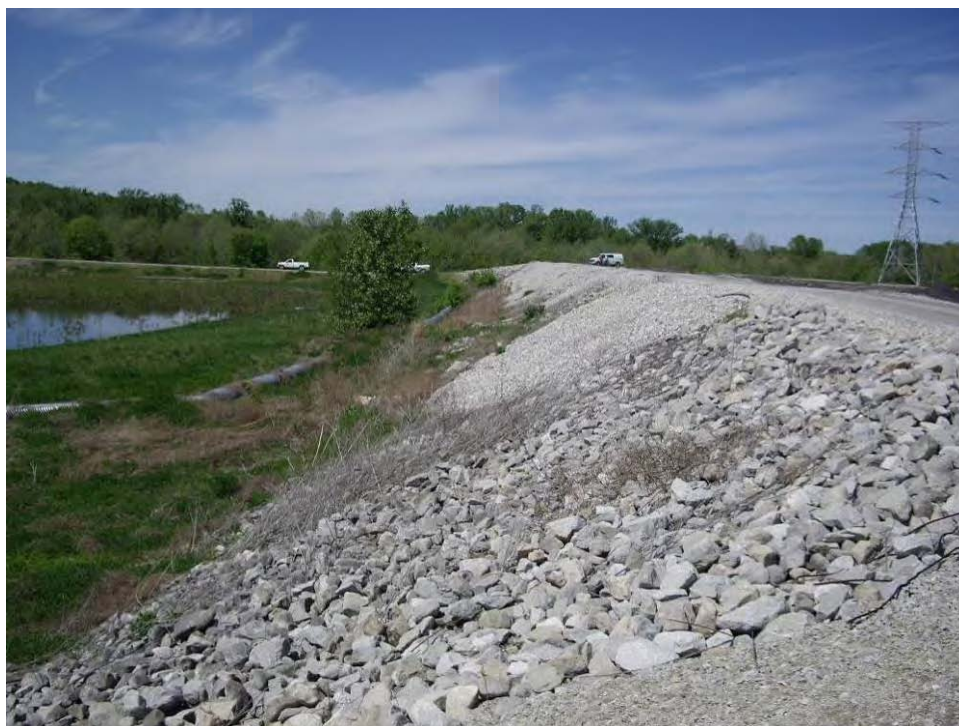
40. West slope of divider embankment A/C from Pond B, looking north.

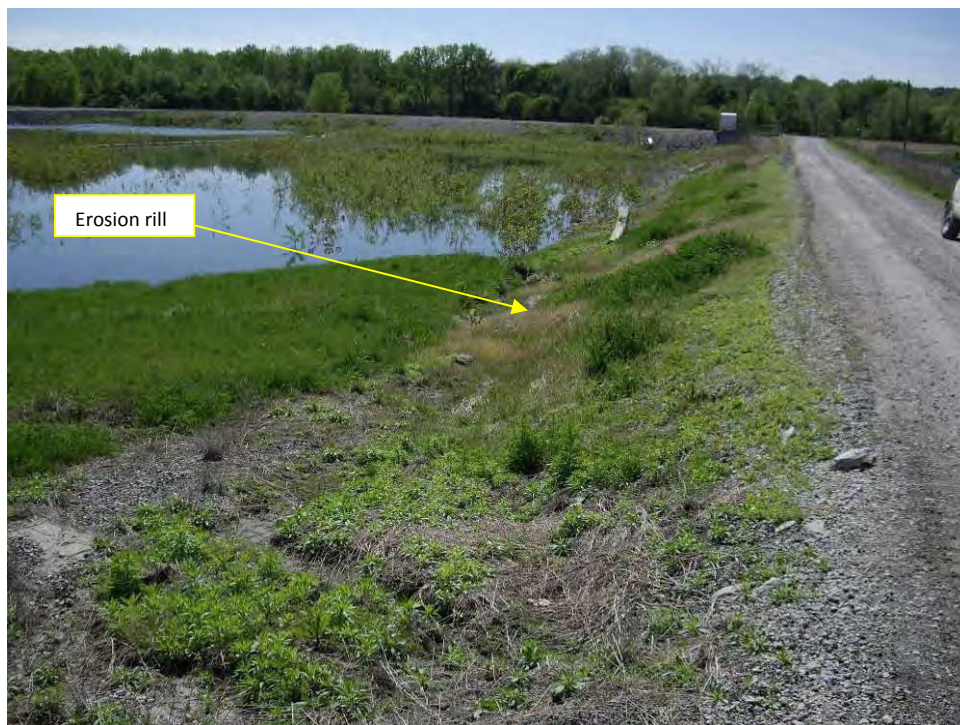
47. Pond C – North embankment interior slope and crest, looking west. Note erosion rill on interior slope.

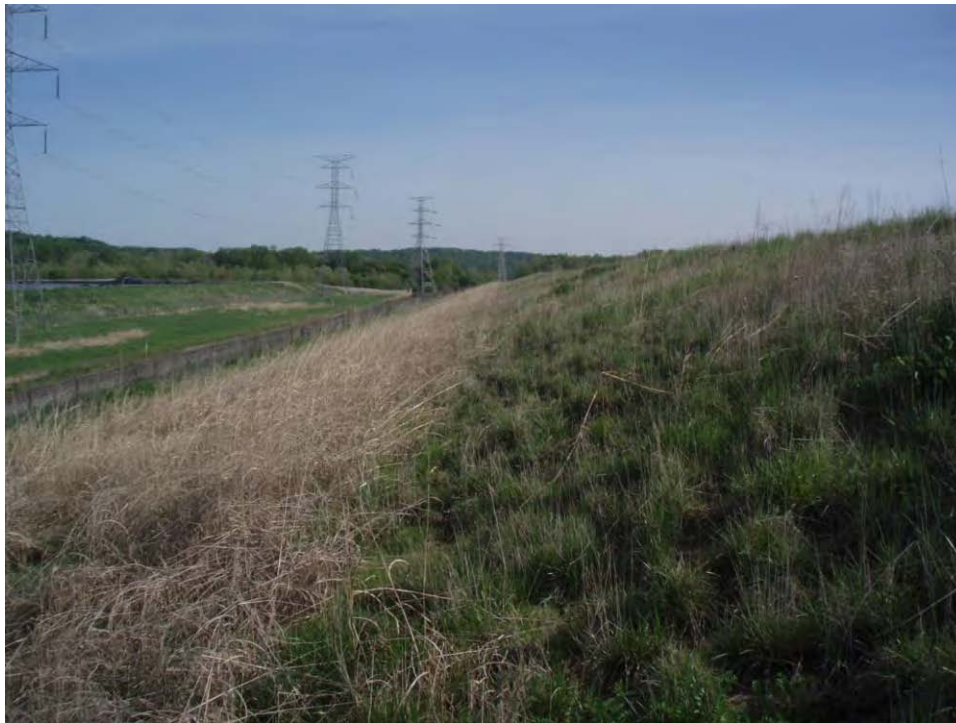
89. Pond D - West embankment exterior slope, looking north. Note bands of vegetation from the vertical expansions. Bare spots observed on upper third.

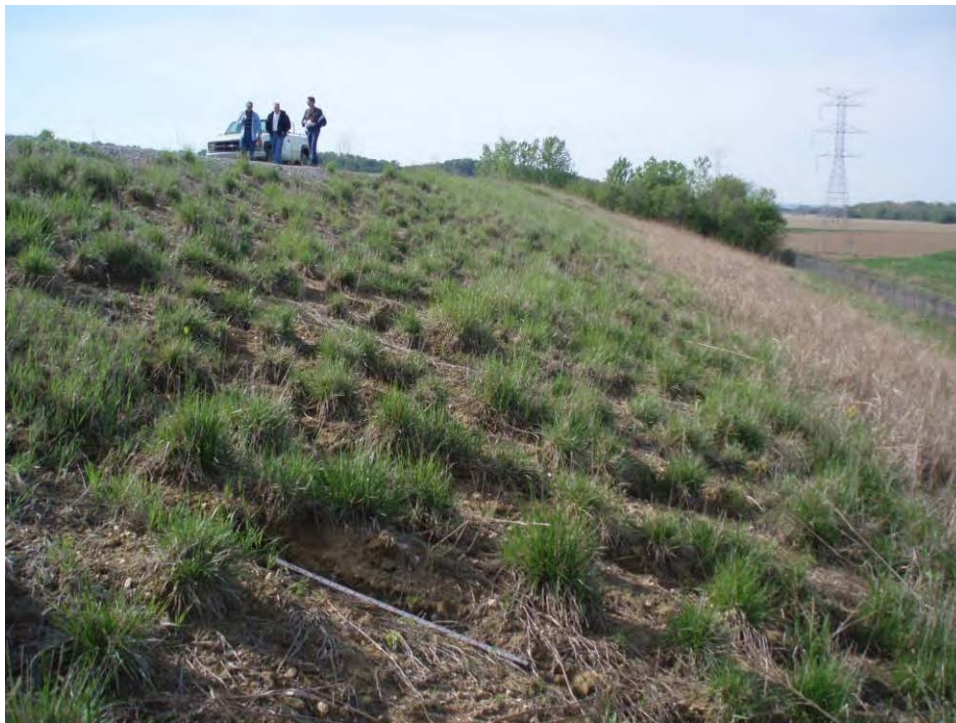
90. Pond D - Typical bare spots on upper third of west embankment exterior slope, looking south.

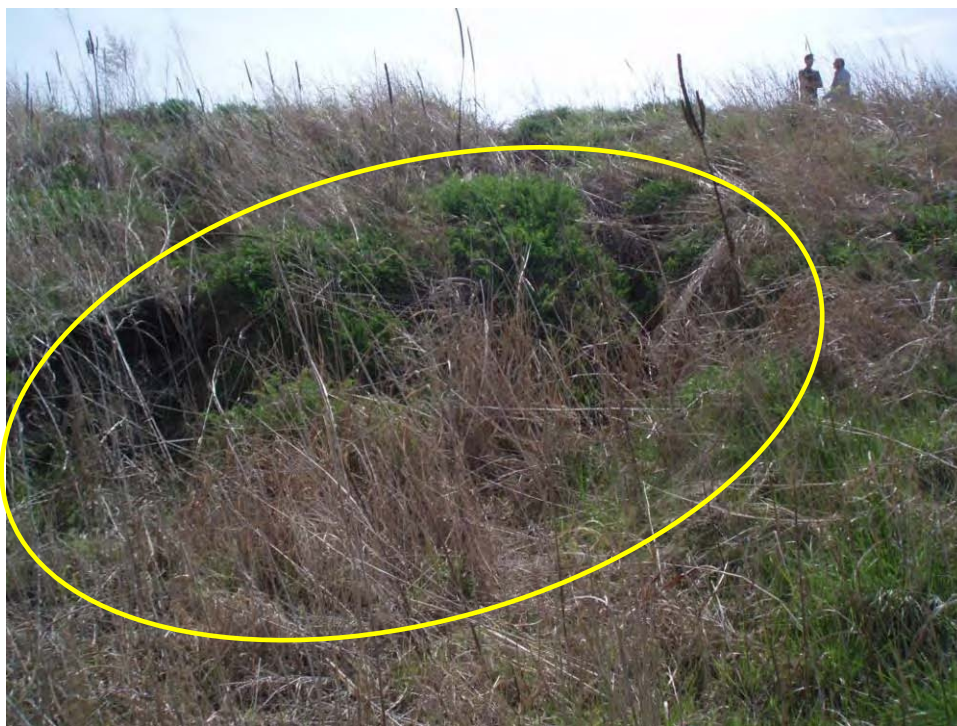
106. Pond E - 16'Wx4'Dx17'L erosion gulley at toe of west embankment exterior slope from previous failure event. Note erosion is scheduled to be repaired.

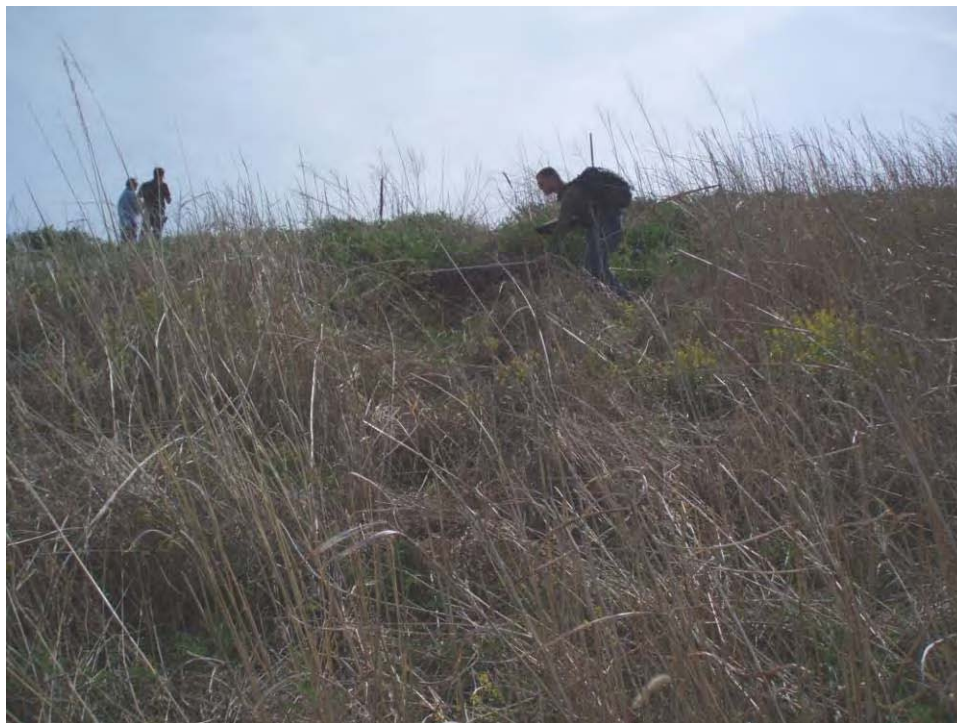
107. Pond E - 8'Wx4.5'Dx15'L erosion gulley at crest of west embankment exterior slope from previous failure event. Note erosion is scheduled to be repaired.

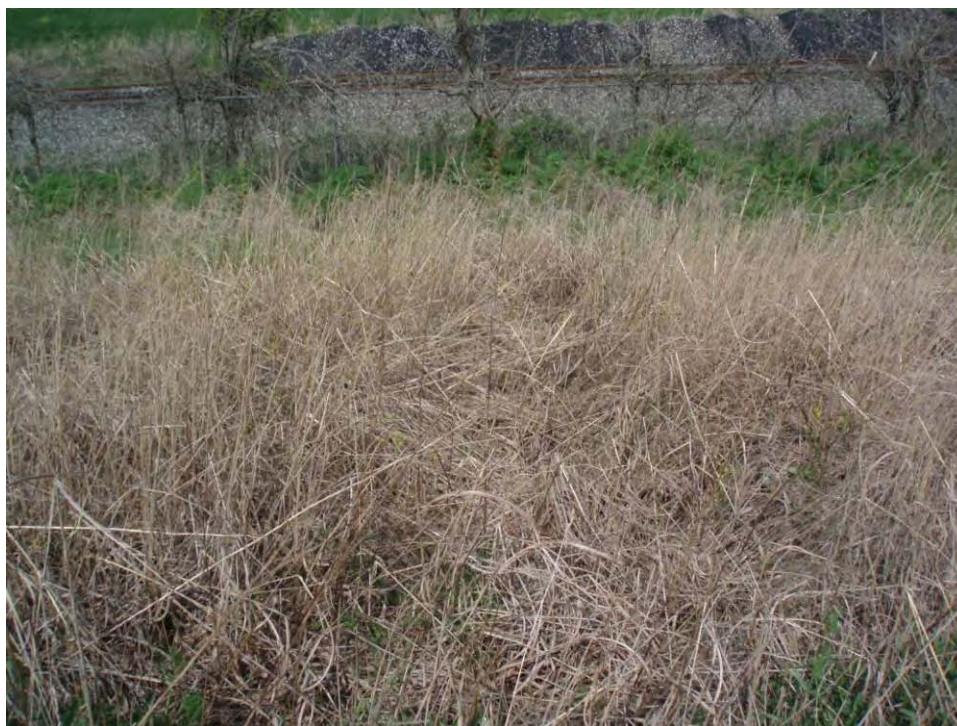
112. Pond E - 8'Wx3'Dx25'L erosion gulley at mid-slope of west embankment exterior slope from previous failure event. Note erosion is scheduled to be repaired.

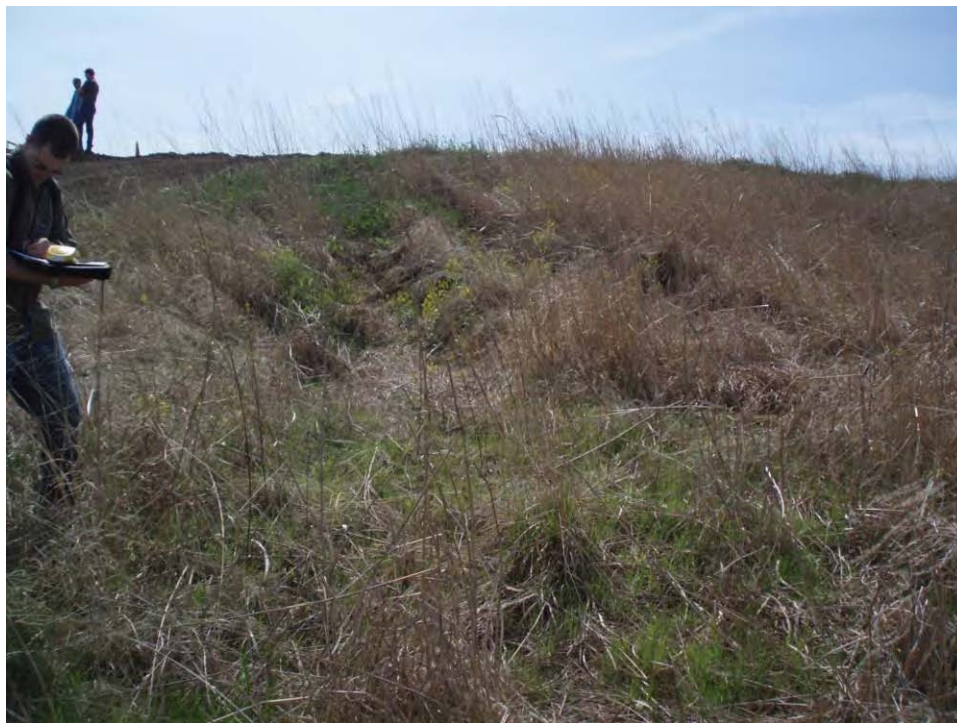
113. Pond E – two approximately 4'Wx3'Dx20'L erosion gulleys at mid-slope of west embankment exterior slope from previous failure event. Note erosion is scheduled to be repaired.

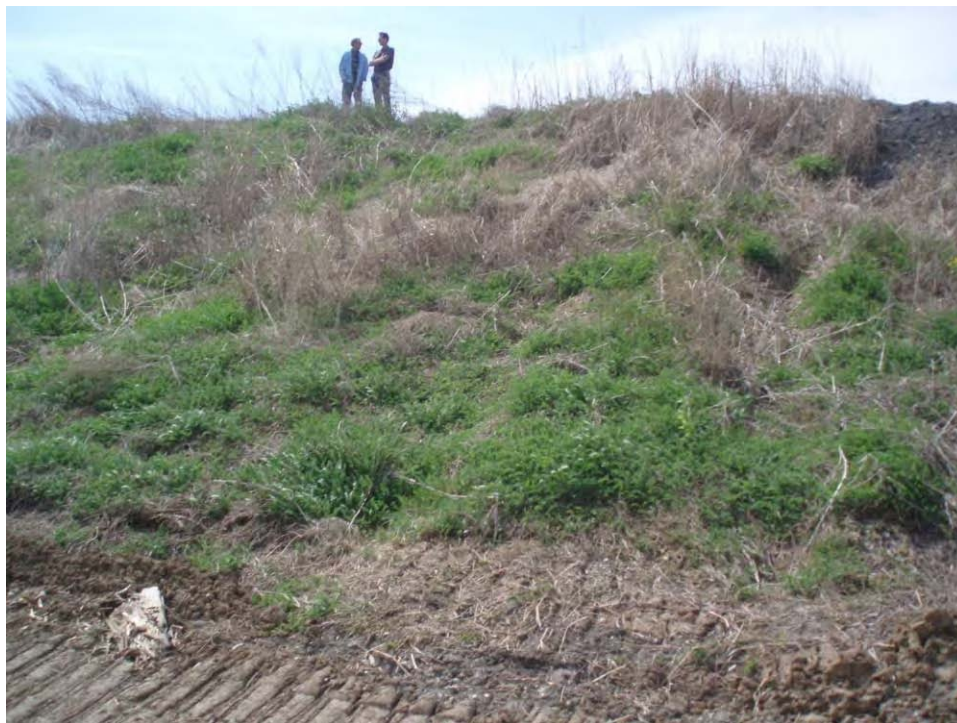
119. Pond E - erosion feature on north embankment exterior slope from previous failure event.

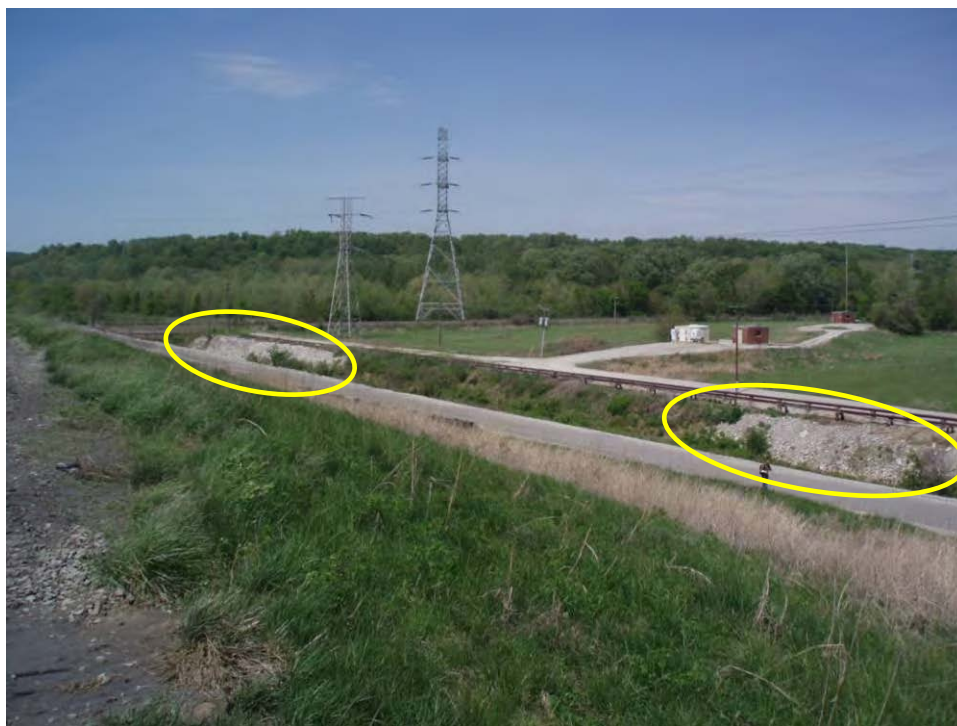
136. Overview of downstream area north of Pond D and Pond E. Note repair of erosion areas which resulted from breach.
