# **Assessment of Dam Safety of Coal Combustion Surface Impoundments**

**Indianapolis Power & Light Company**

**Petersburg Generating Station**

**November 15, 2010**

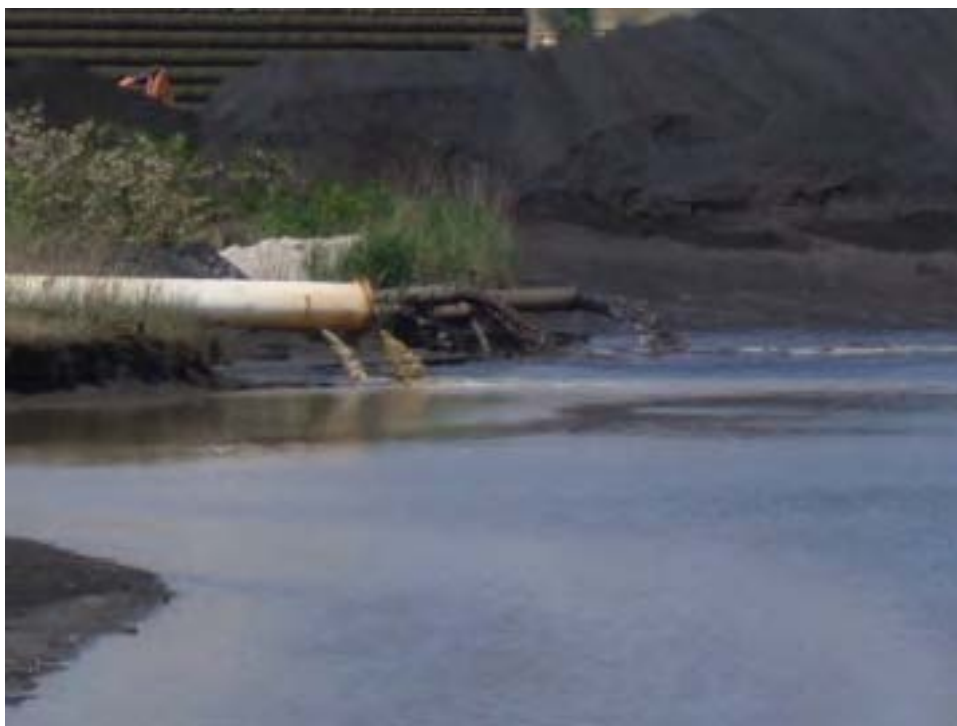
two (2) 36-inch-diameter and five (5) 10-inch-diameter ductile iron (DI) pipes sluice CCW into the impoundment (Photos 7 and 8). A rim ditch (Photos 5, 6, and 7) excavated adjacent to the south and east interior slope diverts flow, increasing the settling time of materials in the impoundment. Along the west embankment one (1) 12-inch-diameter DI and two (2) 8-inch-diameter stainless steel (SS) pipes sluice other liquids into the impoundment (Photo 20). At a headwall located at the western abutment of the divider embankment between Pond A and Pond A – Discharge, two (2) 24-inch-diameter reinforced concrete pipes (RCPs) and one (1) 4-inch-diameter DI pipes sluice other wastes into Pond A (Photo 36). Pond A is connected to Pond A – Discharge through two (2) 36-inch-diameter CMPs (Photo 45). Pond A – Discharge is used as a secondary settling basin prior to water being discharged at the outlet structure or being diverted into the recycling pump station. The outlet structure consists of a box structure with stoplogs and a 24-inch-diameter RCP with an invert elevation of El. 415.9.

During the site visit, four sets of sluice pipes were observed. The CCW sluice pipes on the south embankment appeared to be in fair condition (Photo 8). The two sets of active sluice pipes on the west embankment (Photo 20) and at the west embankment headwall also appeared to be in fair condition (Photo 36). A fourth set of inactive or abandoned pipes appeared to be in poor condition (Photo 30, 33, and 35). The IPL staff did not know the origin or purpose of these pipes. The excavator operator placed ash over the 24-inch-diameter RCP at the fourth set of pipes.

8. Close up of two (2) 36-inch-diameter and five (5) 10-inch-diameter DI sluice pipes.

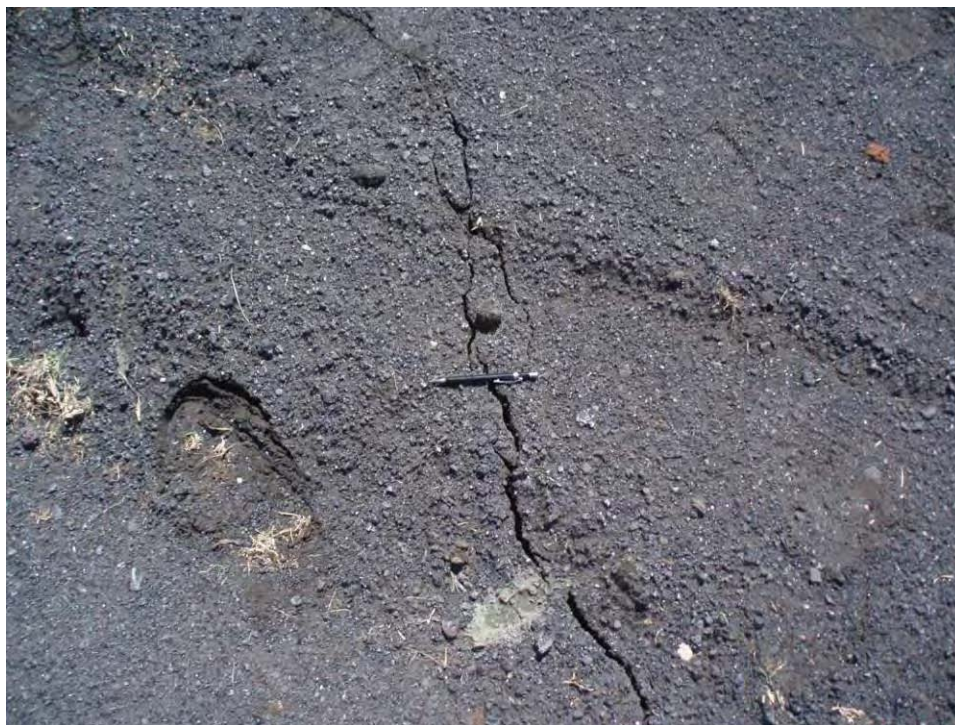
18. Pond A - Surface cracks in recently placed ash material on south embankment crest.

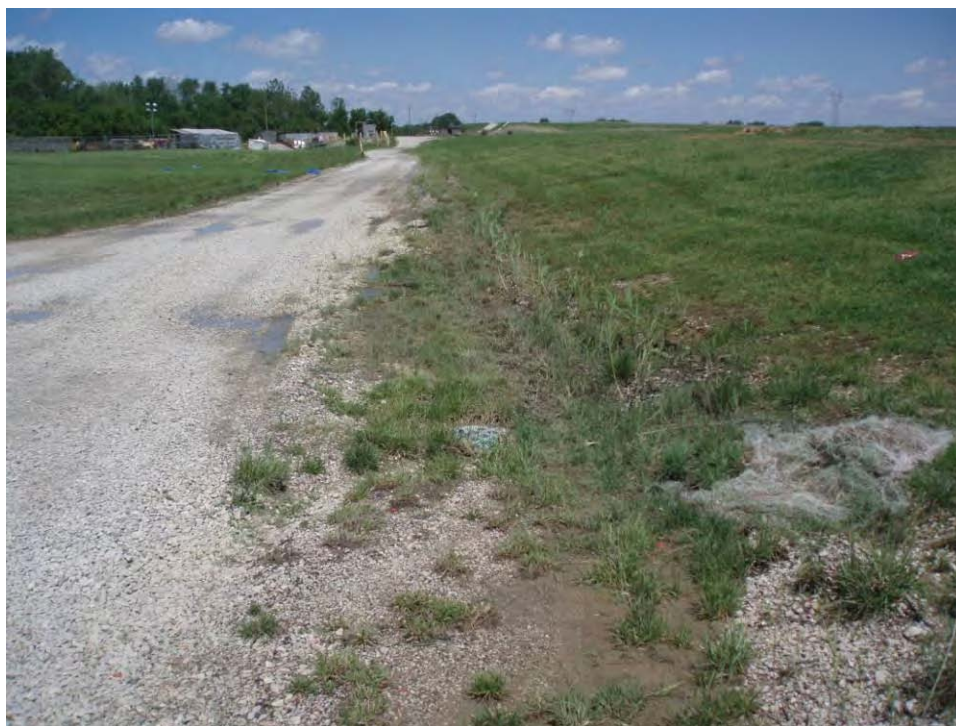
24. Drainage ditch at toe of Pond A west embankment. Note ditch has sparse vegetation.

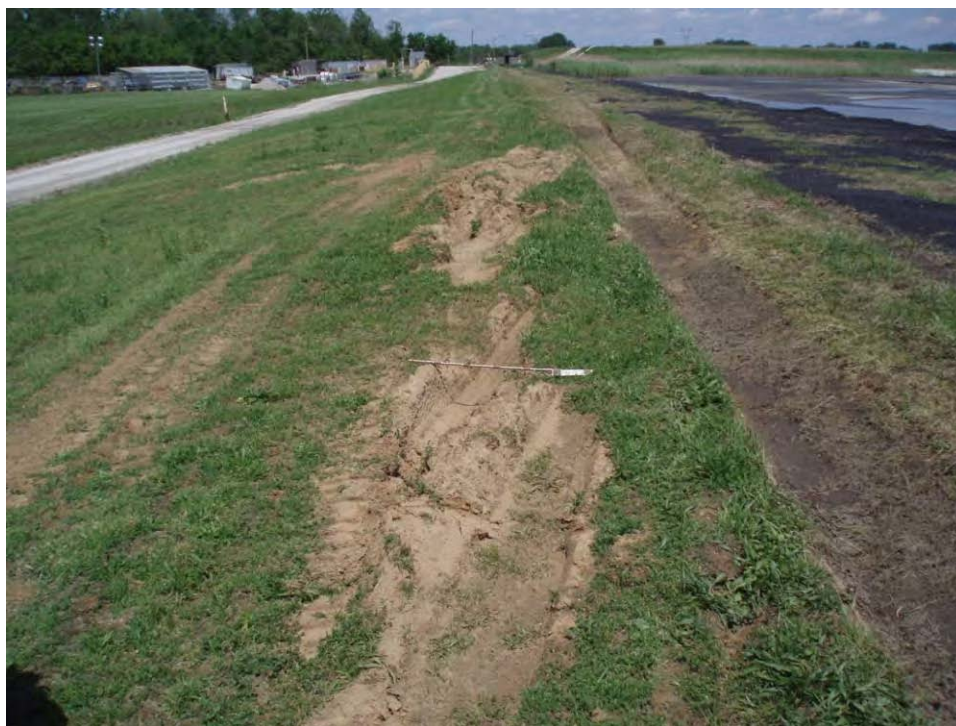
The crest of Pond A generally appeared to be in fair condition (Photos 1, 3, 4, 9, 10, 11, 12, 14, 49, 62, and 64). The crest was approximately 20 feet wide. The crest is surfaced with a compacted gravel access road on the north and east embankments. The crest on the south and west embankments were generally covered with grass approximately 6 to 12 inches tall. The crest around the sluice pipes on the south embankment was covered with ash (Photos 12 and 14). An access ramp excavated into the crest near the sluice pipes on the south embankment was observed (Photo 10 and 12). Track marks from an excavator were observed on the crest of the west embankment (Photos 26, 27, and 29).

26. Pond A - West embankment exterior slope, looking north at large tractor ruts and excavator tracks.

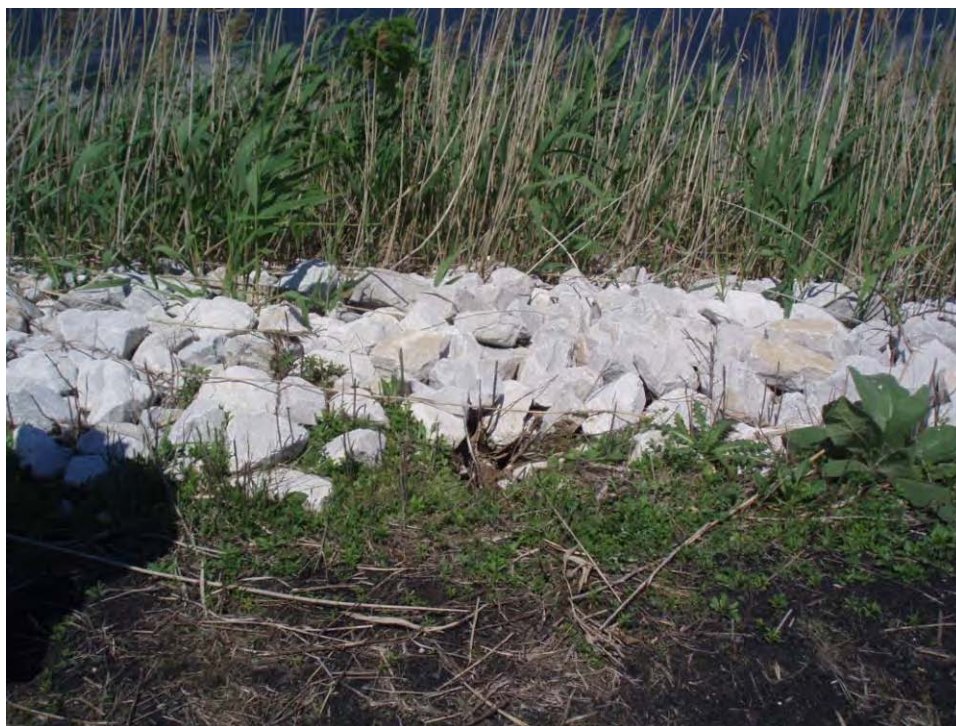
Some surficial erosion under the riprap on the north slope of the divider embankment was observed (Photo 40).

40. Surficial erosion under riprap on north slope of divider embankment between Pond A and Pond A - Discharge.

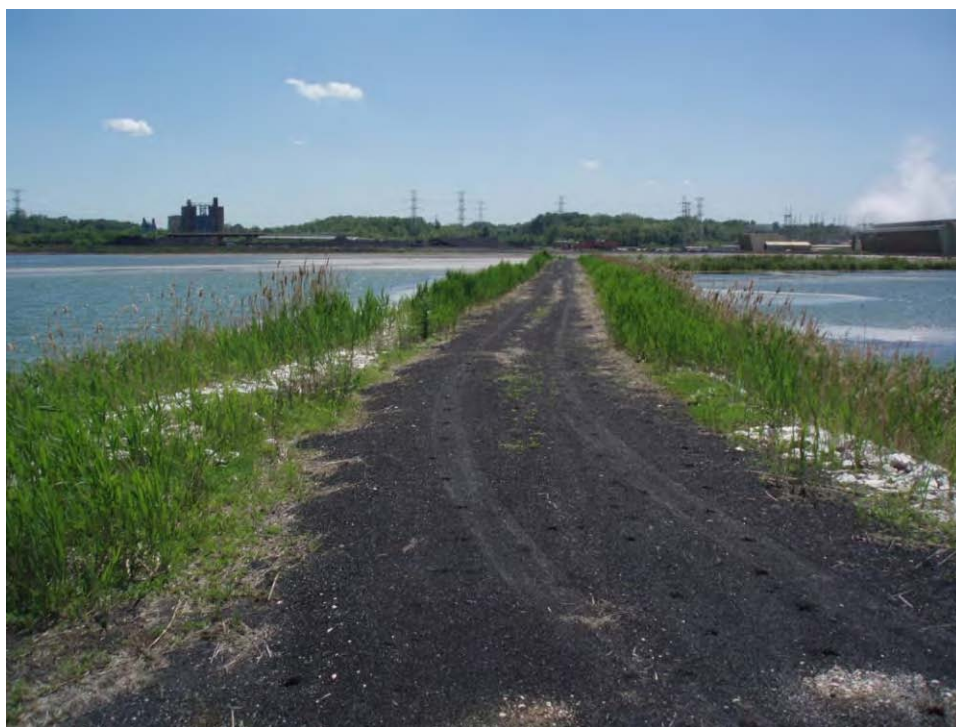
45. Inlet of two (2) 36-inch-diameter CM pipes from Pond A to Pond A - Discharge. Note pipes have T's at inlets and the floating boom to reduce the potential for surface debris from clogging pipes.

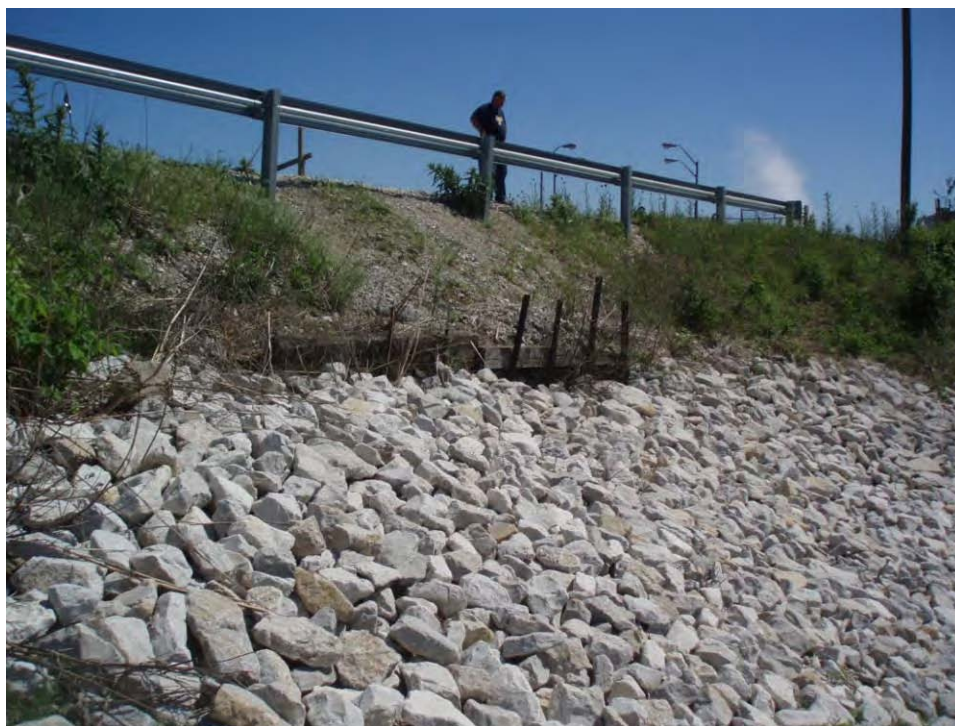
The exterior slopes appear to be in fair condition. The exterior slope on the west embankment was approximately 3H:1V (Photos 70 and 71). The embankment was generally covered with riprap armor to approximately 5 feet below the crest. Some bare spots were observed above the riprap armor. Some metal stakes with 2"x4" lumber were observed above the riprap. The depth of the stakes and lumber, as well as their purpose, is unknown. No erosion or other deficiencies were observed on west embankment during the site visit.

70. Pond A - Discharge, southwest embankment exterior slope looking at steep slope above outfall repaired recently with riprap.

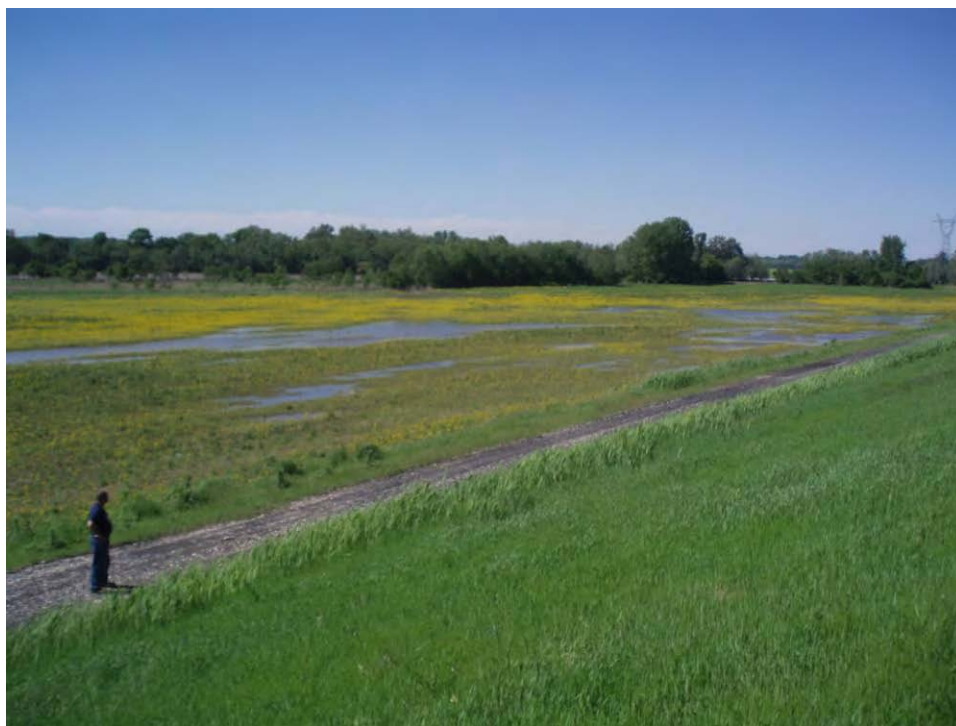
The floodplain at the toe of the west embankment was saturated and flooded from recent storm events (Photos 77, 78, and 84). Possible seepage was observed at the toe of the south embankment and the bench of the west embankment (Photos 63 and 79).

84. Overview of Pond B - West embankment, downstream area, looking northwest. Note field area is flooded from recent storm events.

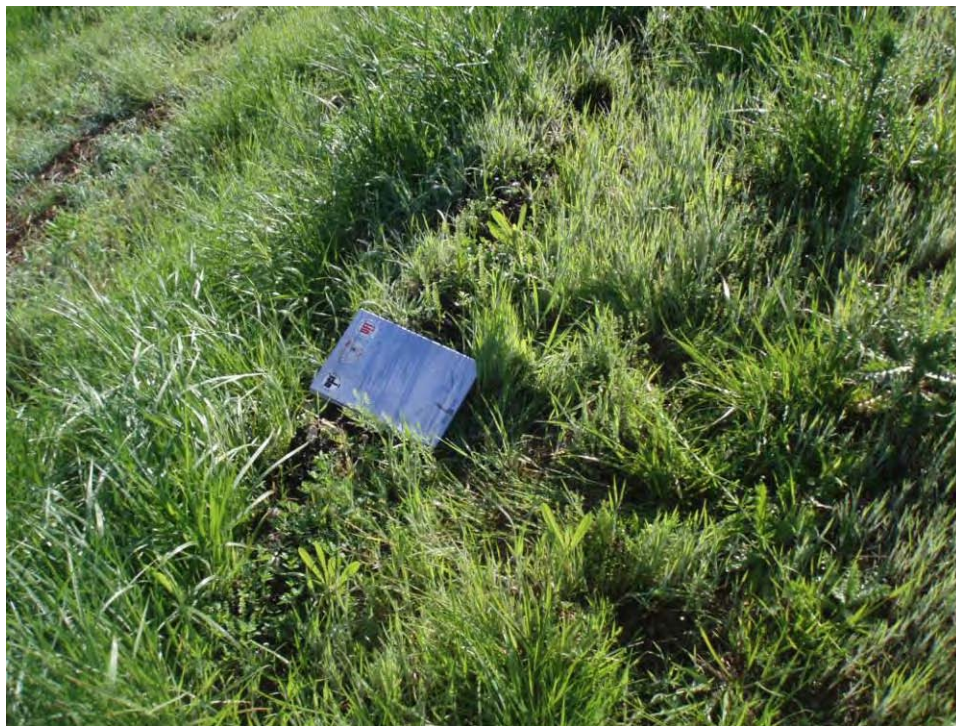
115. Pond C - West embankment lower exterior slope, looking at over-steepened area and tractor rutting at bench.

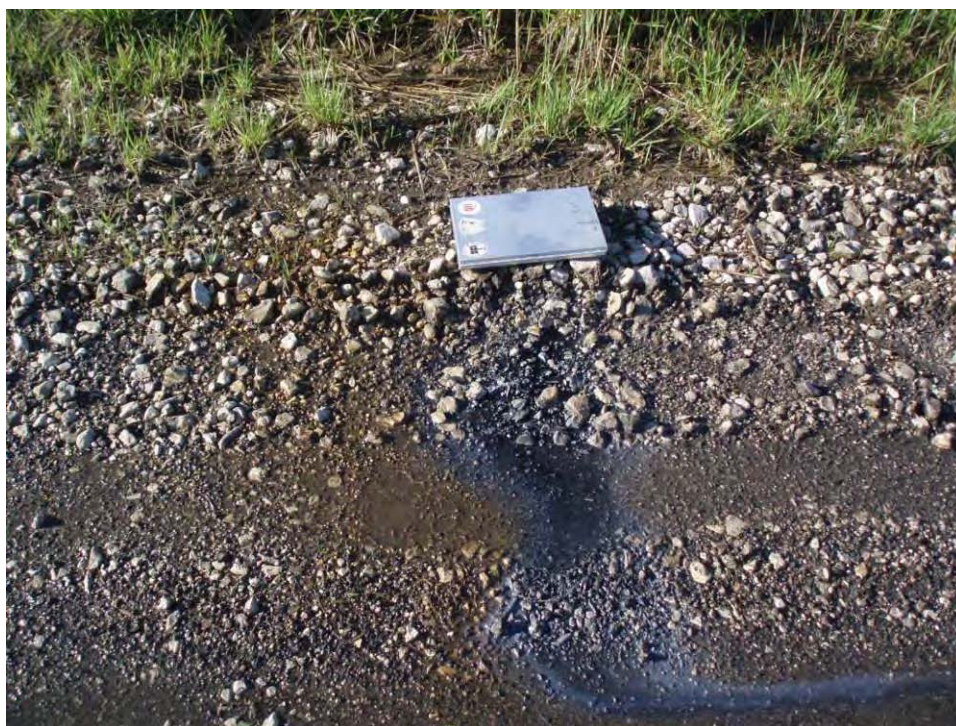
116. Pond C - West embankment bench, looking at active seepage located at toe of upper exterior slope. Note the white and black sheen in the water.

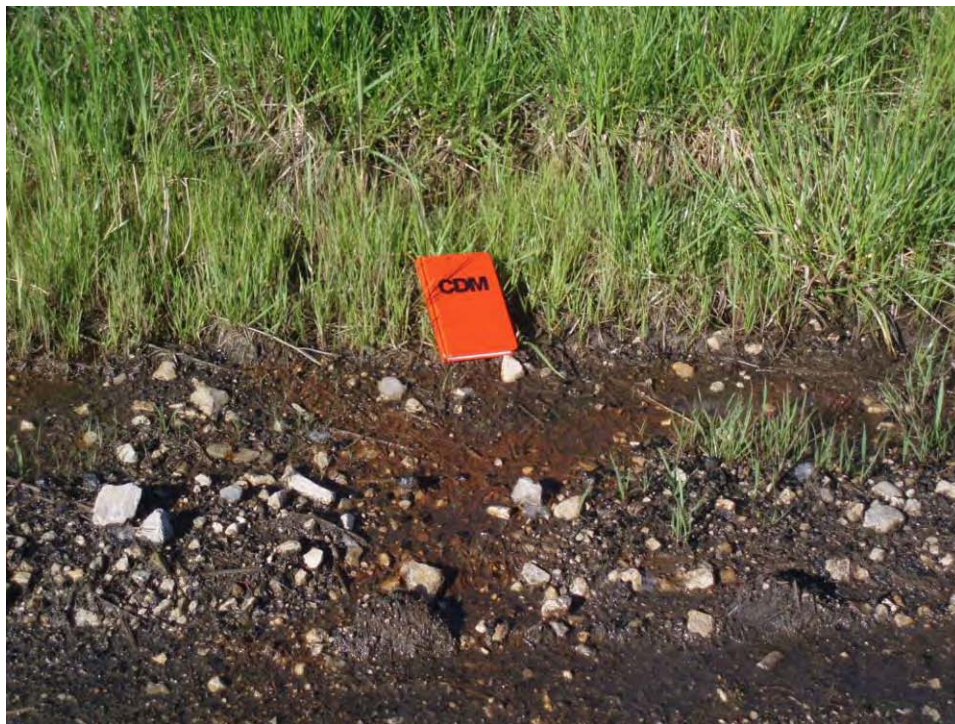
125. Pond C - North embankment bench, looking at active seepage located at toe of upper exterior slope. Note the iron staining in the water

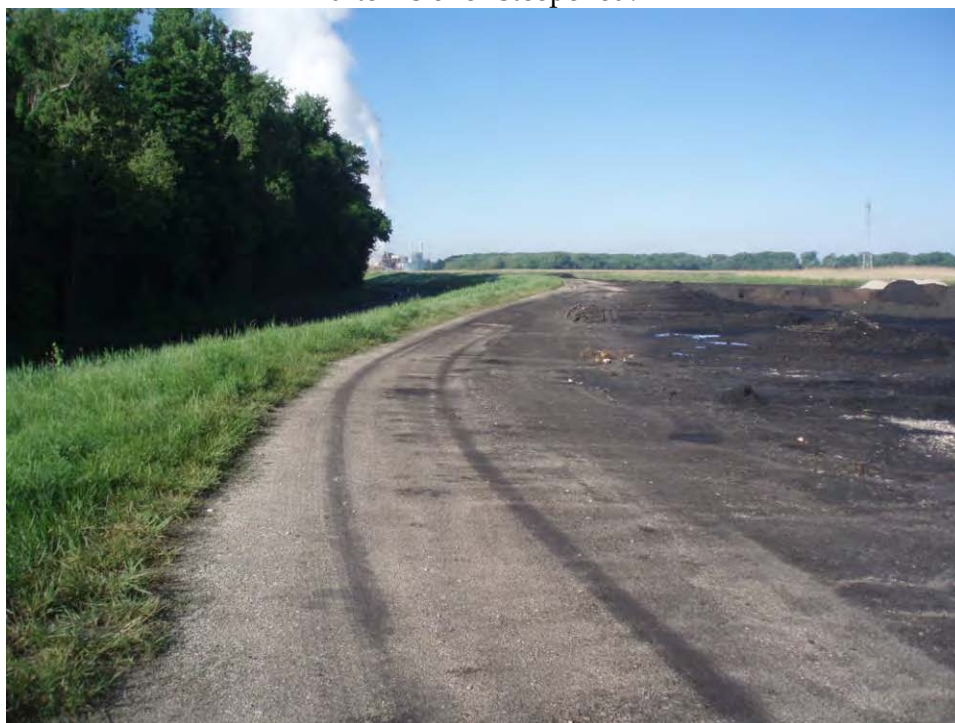
Tractor ruts were observed on the exterior slopes near the crest (Photos 119 and 128) in the very soft, fine-grained, stabilized FGD.

128. Pond C -East embankment crest, looking southwest. Note tire rutting was observed in very soft stabilized FGD near the crest.
