Subject: EPA Comments on “Draft Coal Combustion Residue Impoundment: Round 12 – Dam Assessment Report – JB Sims Power Plant”

The design of the J. B. Sims Unit 3 project includes a two-cell bottom ash pond. The pond dikes were originally constructed with a sandy material and the pond bottom and interior slopes of the dikes were covered with 1 foot of compacted clay to seal the pond and control seepage. When the pond was initially filled with water, piping was noted around the ash water reclaim structure. Repair of the piping problem proved to be less than satisfactory. Subsequently, it was noted that the pond was leaking along the perimeter.

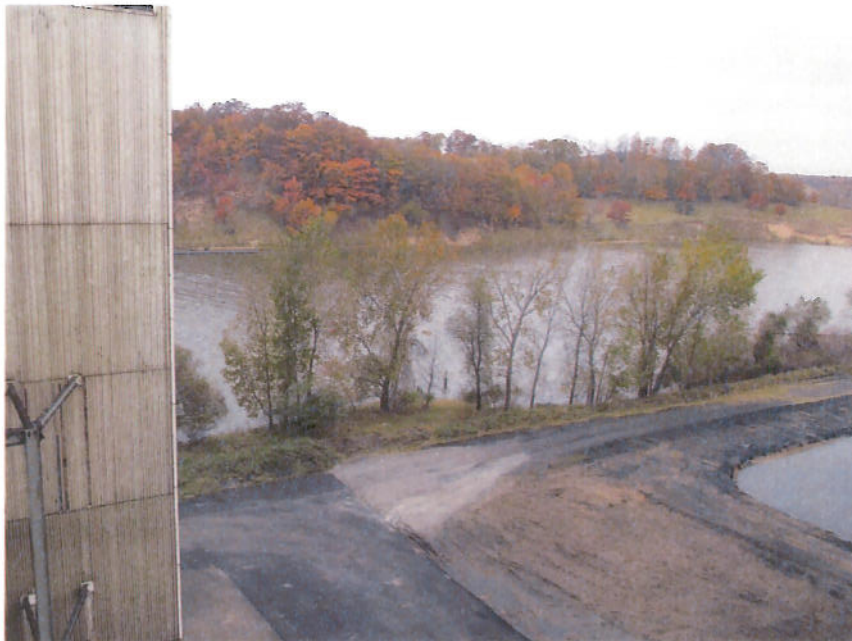
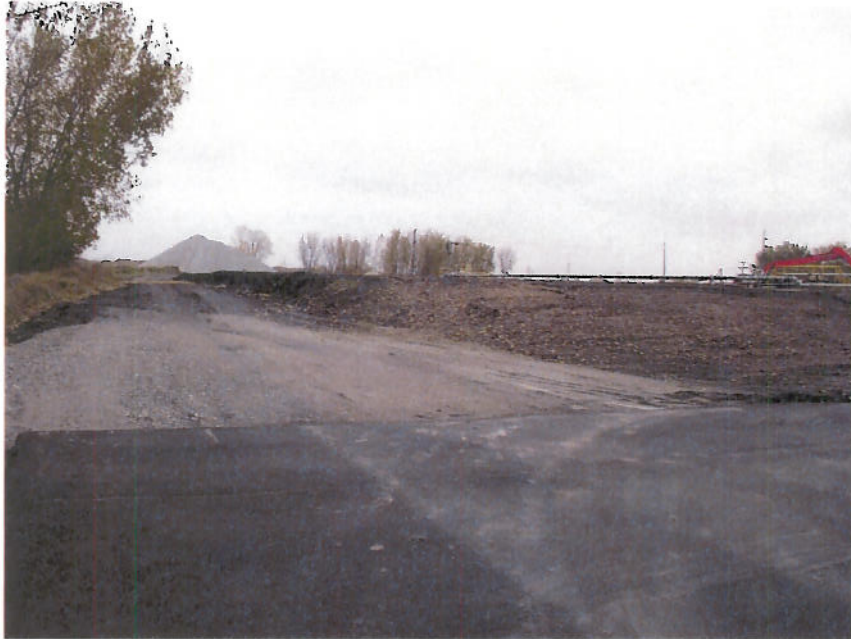
The following pictures were taken on November 1, 2013, one day after receiving 1.07 inches of rain. As evident in the pictures, the upgrading and sloping efforts have considerably improved the ponding of storm water that was previously observed in the middle of the driveway west of the ponds.

The pond area undergoes regular maintenance efforts, and since the site visit the plant has re-sloped and repaved the roadway to the south of the ponds as part of its regular maintenance, in part to redirect storm water. These efforts appear to have been successful. Since the paving modifications, there has been no evidence of storm water ponding in the area in question.

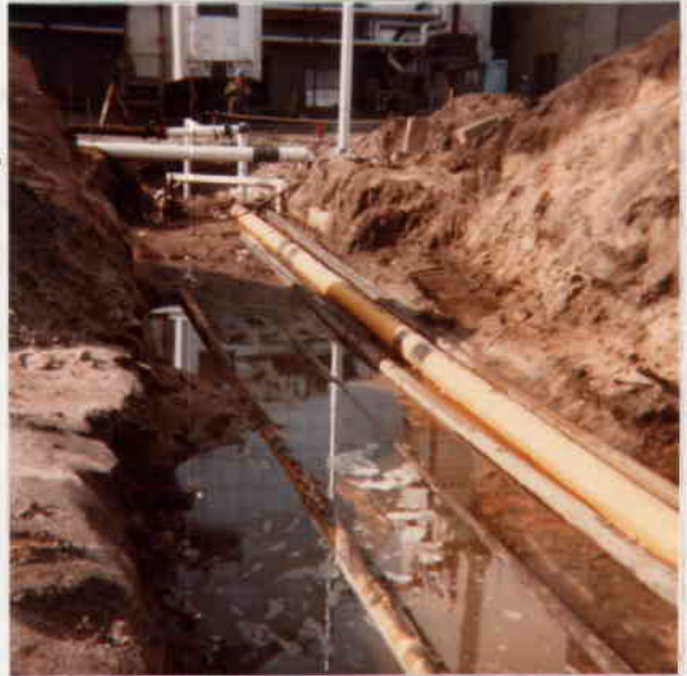
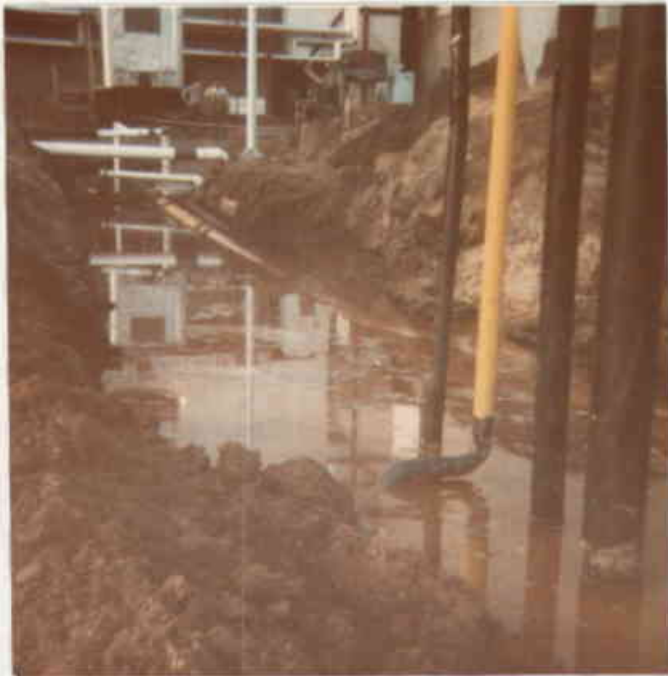
1. Excavation showing existing discharge piping in the south end of interior pond. Temporary piping visible in the background.

2. Existing discharge piping showing approximately 11.5" of differential settlement.

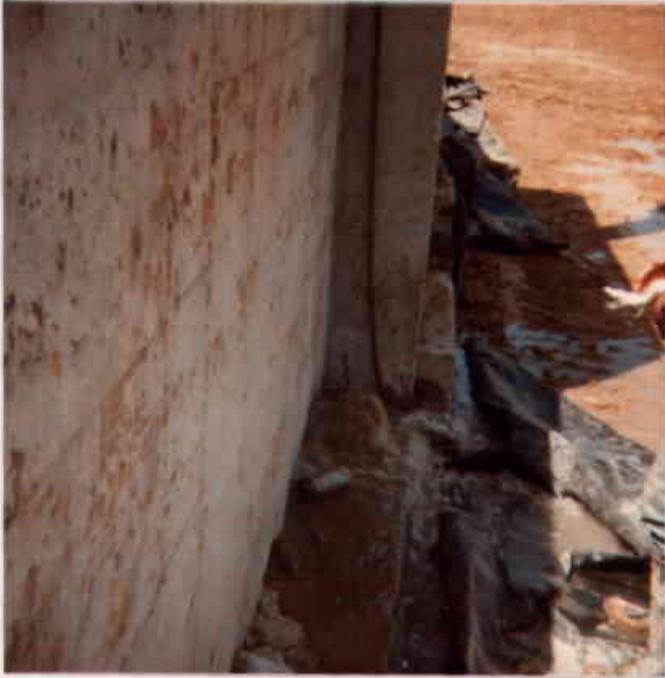
30. Mud forced through three feet of compacted clay from soft subsoil.

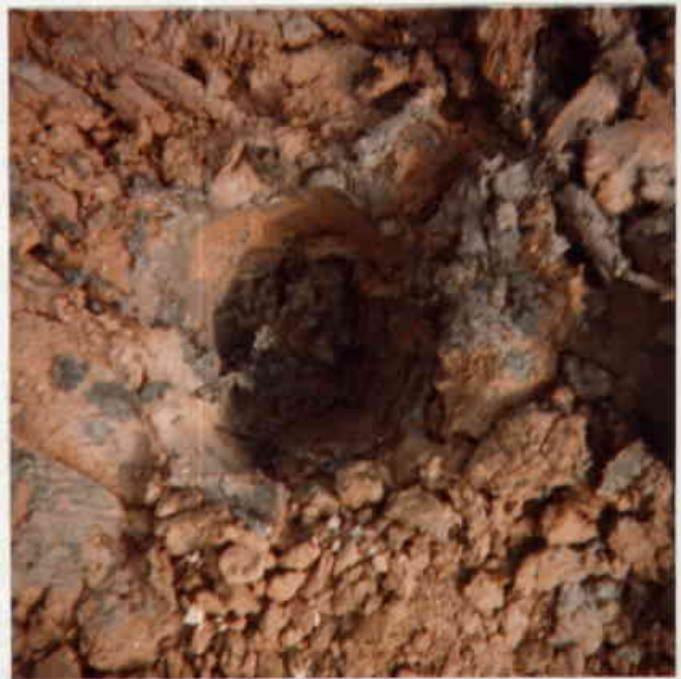
Mud was witnessed pumping through 3 feet of clay. The area was excavated and found to be a localized problem and backfilled.

31. Excavation of mud pumping area revealed that it was a localized problem and the area was backfilled.

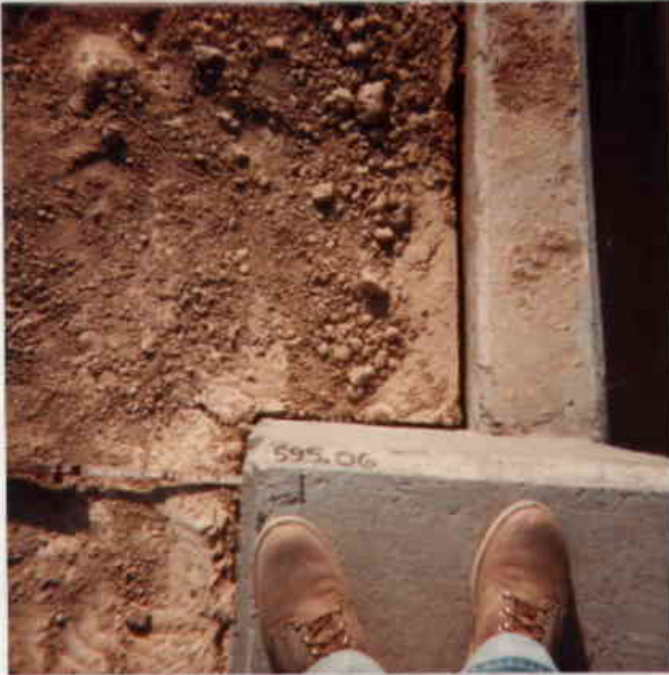
69. Shrinkage between the ash water reclaim structure and the clay dike. Cracks were filled with dry bentonite.

- (1) Backfilled the polyethylene pipes in compacted clay.
- (2) Installed a Hypalon (plastic sheet) seepage cutoff.
- (3) Placed dry bentonite (in the shrinkage cracks) between the ash water reclaim structure wall and the clay dike.
