ASSESSMENT OF DAM SAFETY OF COAL COMBUSTION SURFACE IMPOUNDMENTS – DRAFT REPORT

**City Utilities of
Springfield**

**John Twitty Energy
Center
Springfield, Missouri**

November, 2012
Revision 1, July 2013

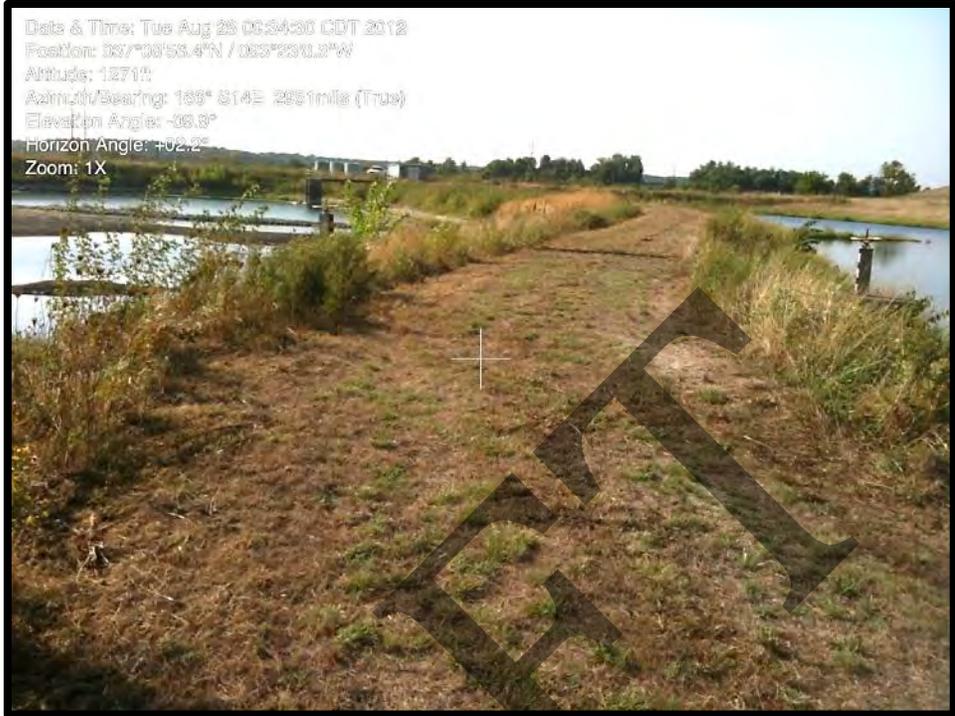
The crest of the embankment of the West Impoundment appeared to be generally in good condition (**Photograph 5.1**). The crest for the south embankment and the common dividing embankment between the East and West Impoundments are approximately 12 feet wide. Most of the embankment crests have crushed-rock visible at the surface to carry maintenance vehicle traffic (**Photograph 5.2**). At a few embankment crest locations, the crushed-rock surfacing appears deteriorated (**Photograph 5.3**). The south embankment crest has grass vegetation up to 12 inches in height, while the crest of the common dividing embankment has trimmed grass with a height up to about 4 inches (**Photograph 5.1**).

The crest of the embankments of the East Impoundment appeared to be generally in good condition (**Photograph 5.1**). The crest for the south embankment and the common dividing embankment are approximately 12 feet wide. Most of the embankment crests have crushed-rock visible at the surface to carry maintenance vehicle traffic (**Photograph 5.2**). At a few embankment crest locations, the crushed-rock surfacing appears deteriorated (**Photograph 5.3**). The south embankment crest has

Photograph 5.1. Crest of Embankment Dividing East and West Impoundments Looking South

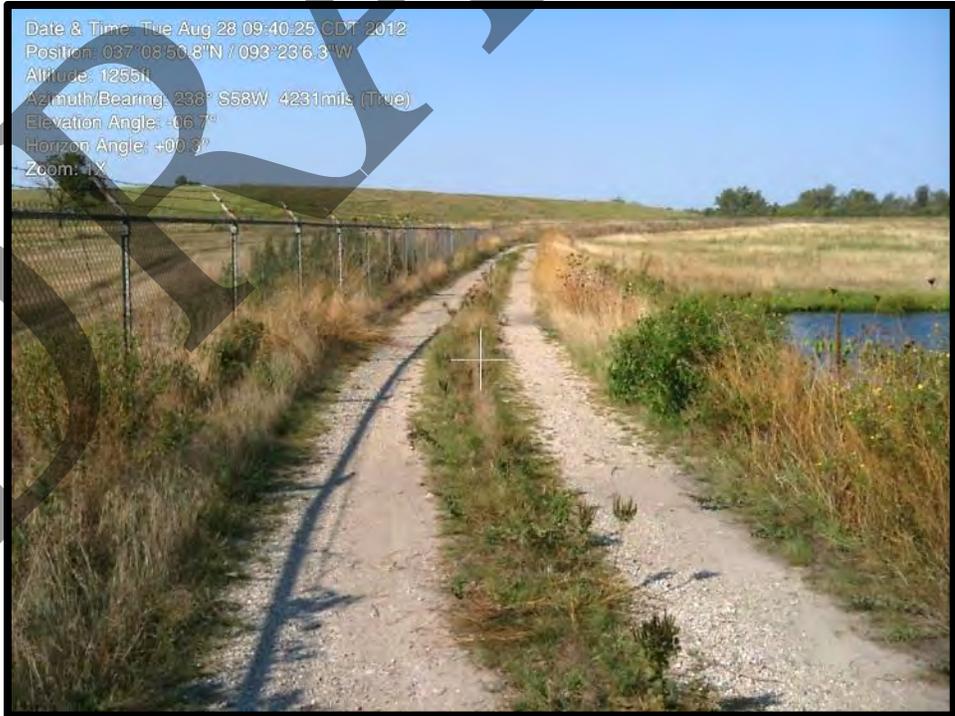
Photograph 5.2. Crest of South Embankment showing West Impoundment Looking West

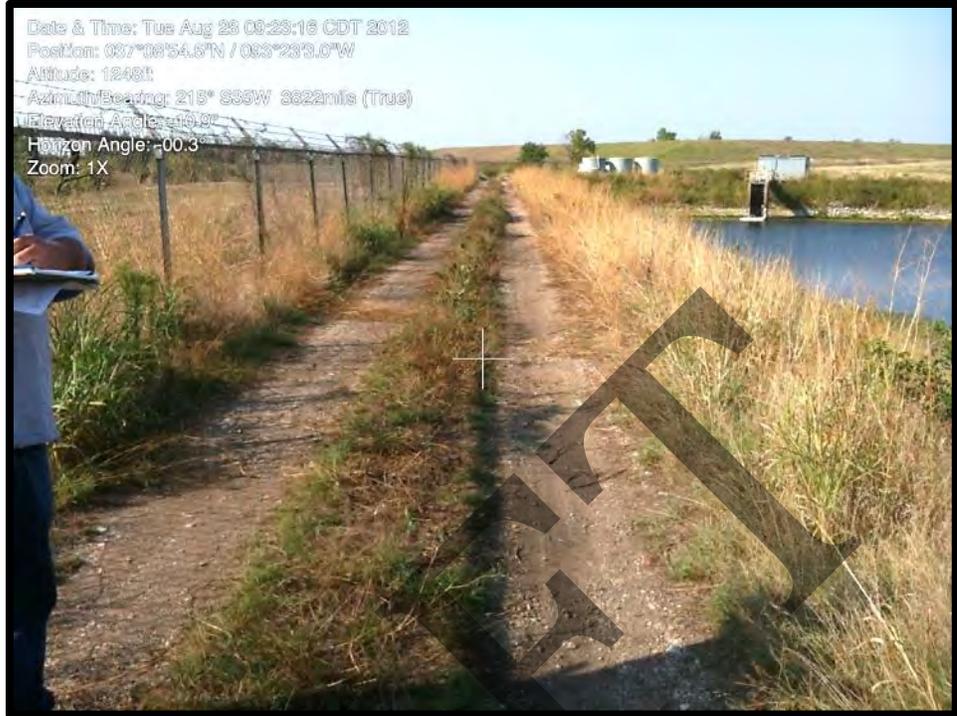
Photograph 5.3. Crest of South Embankment showing East Impoundment Looking West (showing traces of gravel pavement)

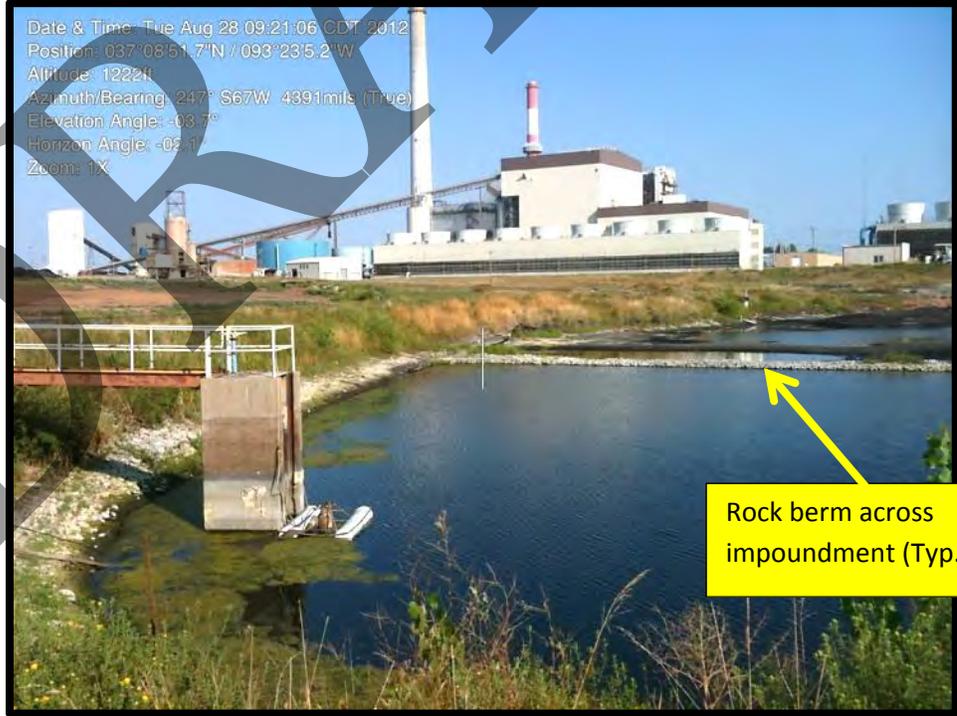
Rock berm across impoundment (Typ.)

Photograph 5.4. Inside Slope of Embankment Dividing East and West Impoundments Showing East Impoundment Looking North

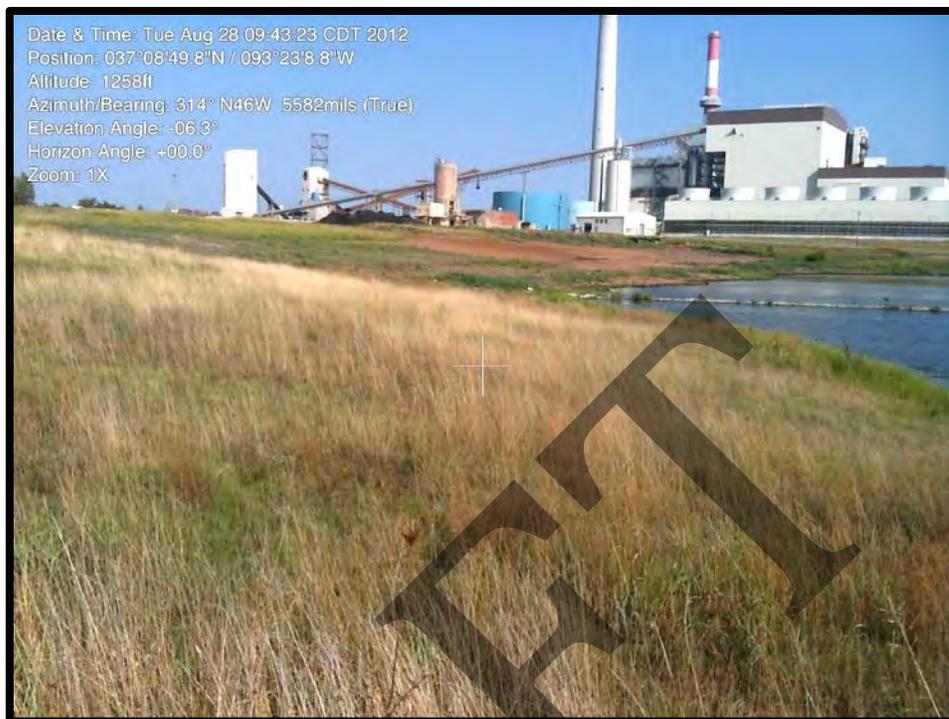
The inside slopes of the impoundments' embankments were in fair condition. Visual observations and field measurements for estimation purposes indicate the inside slope of the south embankment and the common dividing are estimated to be 2H:1V (**Photograph 5.4**). The inside slope of the north embankment and the west embankment generally had slopes on the order of 6H:1V or flatter (**Photograph 5.5**).

The inside slopes of the impoundments' embankments were in fair condition. Visual observations and field measurements for estimation purposes indicate the inside slope of the south embankment and the common dividing are estimated to be 2H:1V (**Photograph 5.4**). The inside slope of the north embankment and the east embankment generally had slopes on the order of 6H:1V or flatter (**Photograph 5.5**).

Photograph 5.5. Inside Slope of West Embankment for West Impoundment Looking North

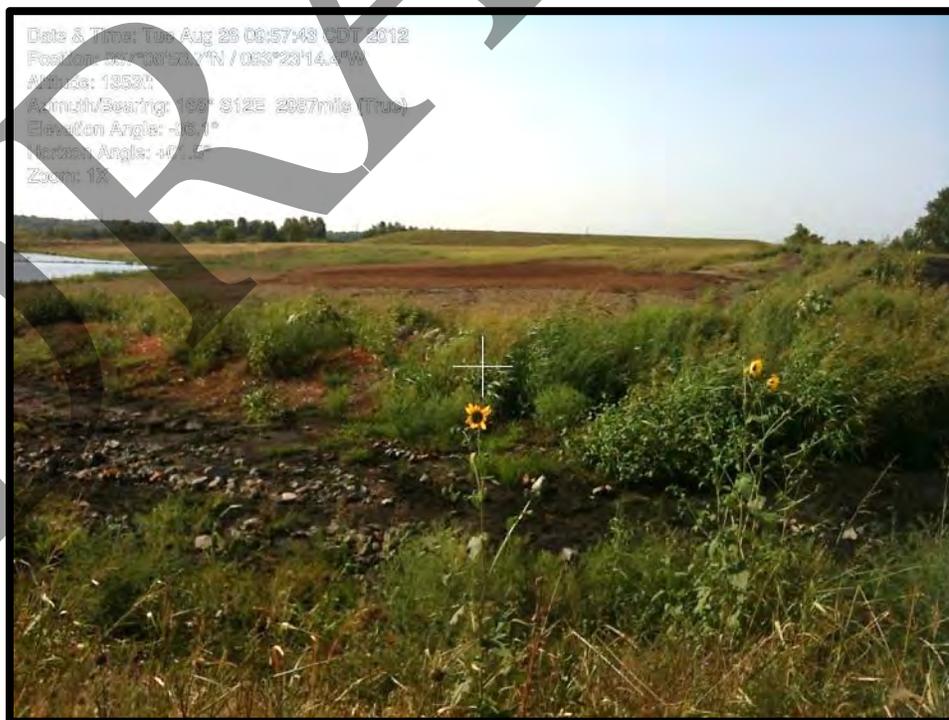
Photograph 5.6. Inside Slope of West Embankment of West Impoundment Looking South

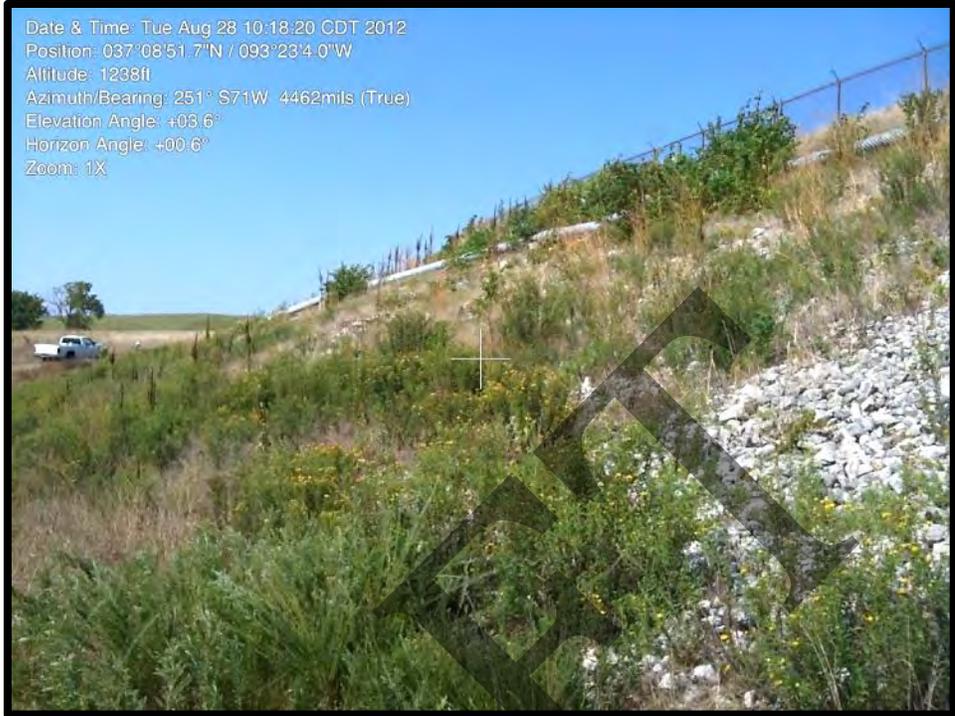
The outside slope of the south embankment appeared to be uniformly graded and generally had a slope of about 2H:1V (**Photograph 5.7**). The outside slope of this embankment is covered with areas of grass and brush up to about 4 feet in height. Unvegetated areas have riprap protection. No evidence of animal burrows, cracks, or erosion was observed on the outside slope of this embankment; there was also no observed evidence of seepage on the ground surface. The grades on the outside slope of the north, and west embankments are relatively flat and generally transition to match the surrounding grade, with no discernible downward outer slope.

The outside slope of the south embankment appeared to be uniformly graded and generally had a slope of about 2H:1V (**Photograph 5.7**). The outside slope of this embankment is covered with areas of grass and brush up to about 4 feet in height. Unvegetated areas have riprap protection. No evidence of animal burrows, cracks, or erosion was observed on the outside slope of this embankment; there was also no observed evidence of seepage on the ground surface. The grades on the outside slope of the north and east embankments are relatively flat and generally transition to match the surrounding grade, with no discernible downward outer slope.

Photograph 5.7. Outside Slope of South Embankment (Dam) of East Impoundment Looking West (Typ.)

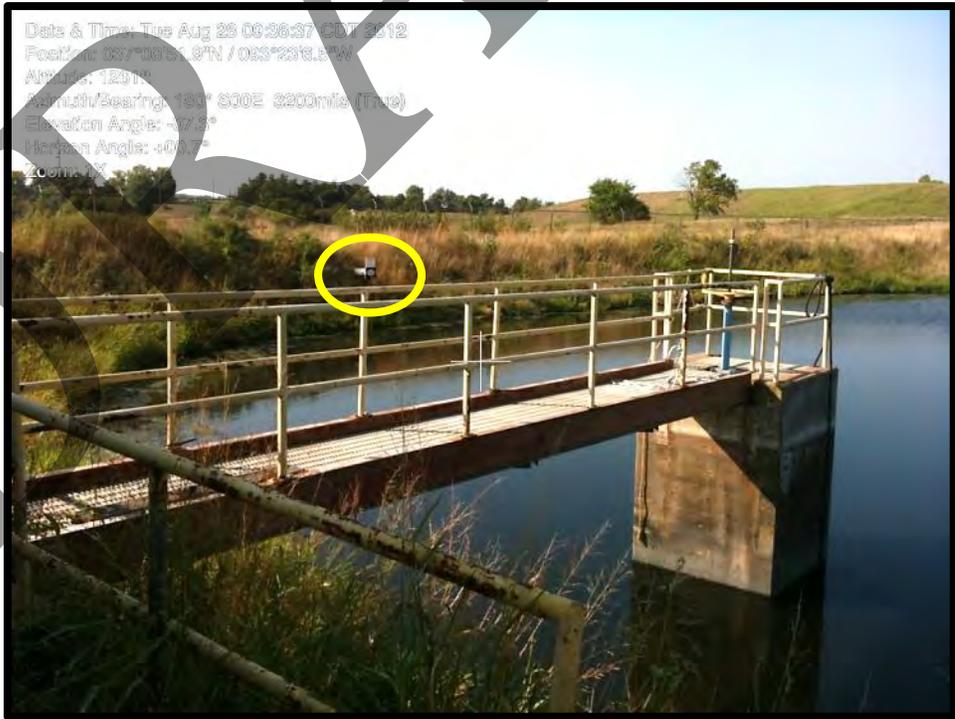
The overflow structure for each impoundment consisted of a 15-inch-diameter corrugated metal pipe that went through the south embankment. These overflow discharge pipes extended south through the embankment to a single outlet weir structure located near the toe of the outside slope. The visible portion of these pipes appeared to be in good condition (**Photograph 5.8**).

Photograph 5.8. 15-in Overflow Pipe for West Impoundment Looking South

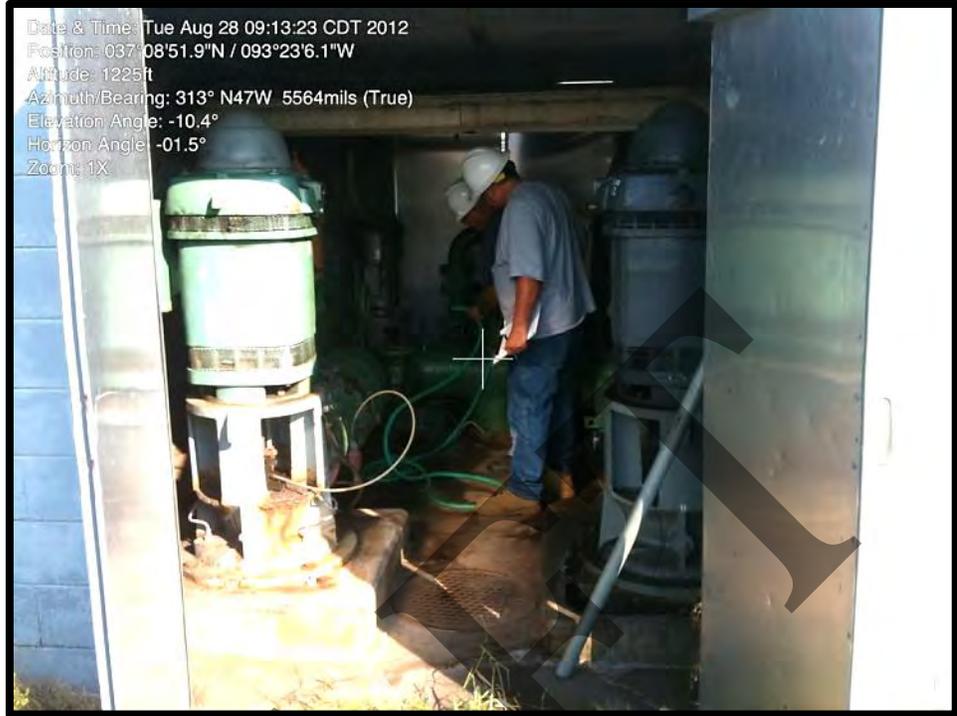
The outlet system consists of a pump station, a weir structure and associated valves and piping. The system appeared to be in good condition, and water was flowing through the weir indicating it is operational (**Photographs 5.9, 5.10, 5.11**). The weir is a concrete structure covered with a steel grate located on the outside slope of the south embankment. According to the plant representatives, the weir structure is used to measure discharge through the outlet.

Photograph 5.9. Pump Station Regulating Outlets for both Impoundments

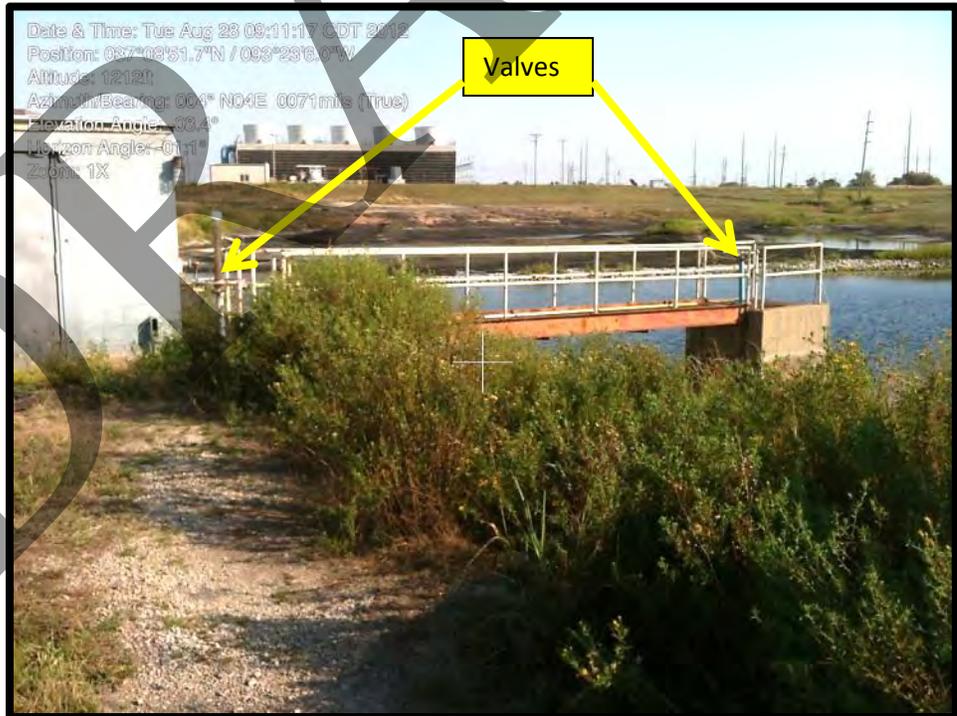
Photograph 5.10. Valves Regulating East Impoundment Outlet Looking North

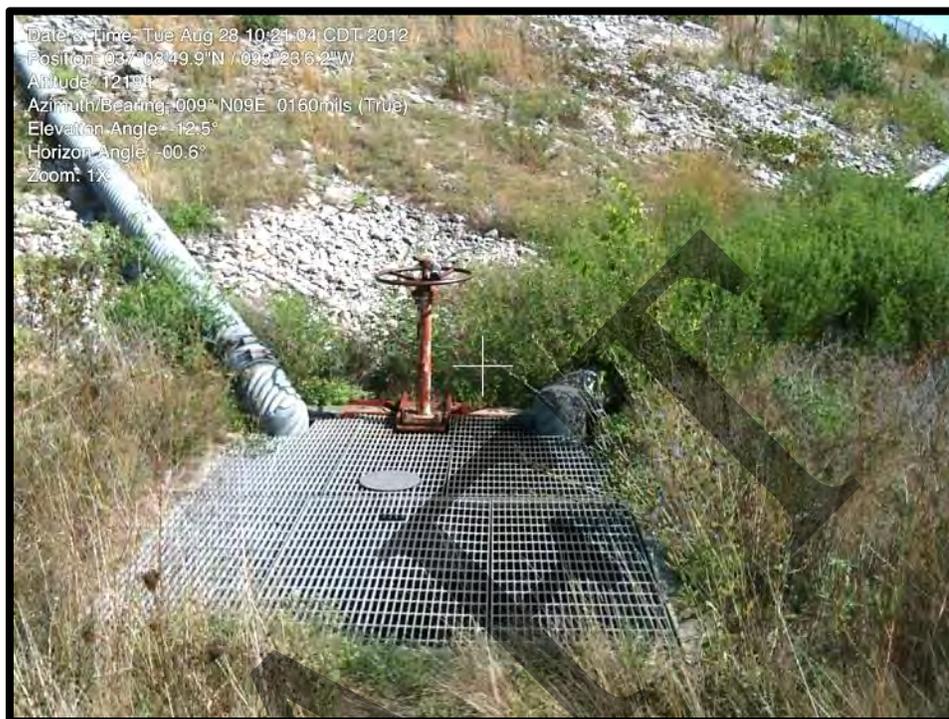
Photograph 5.11. Covered Outlet Weir with Valve for both Impoundments (also showing overflow pipes)
