ASSESSMENT OF DAM SAFETY OF COAL COMBUSTION SURFACE IMPOUNDMENTS – FINAL REPORT

**City Utilities of
Springfield**

**John Twitty Energy
Center
Springfield, Missouri**

May 2014

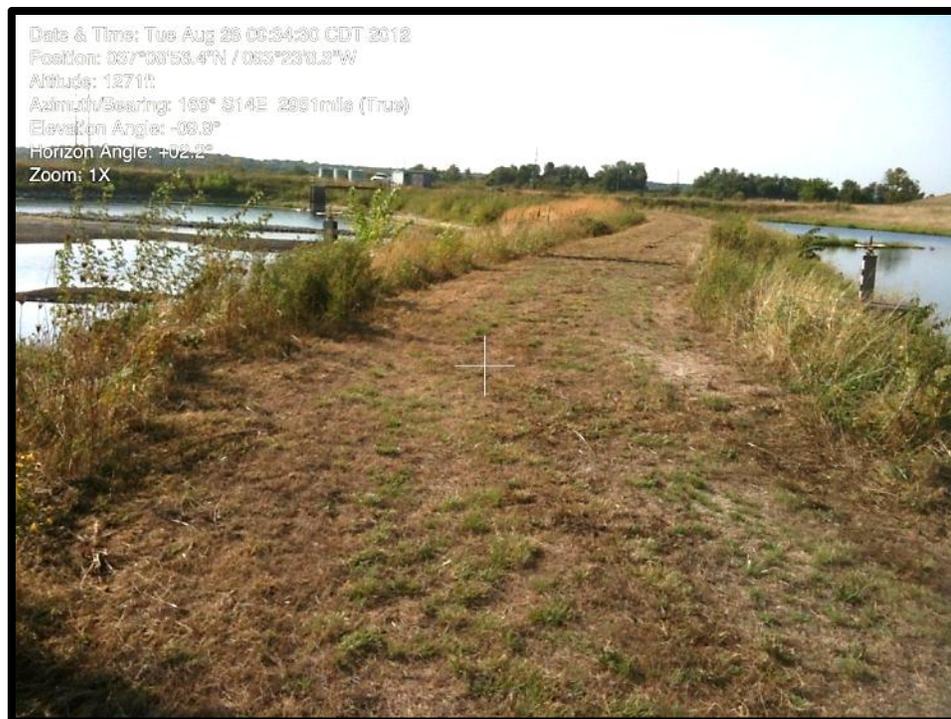
The crest of the embankments of the West Impoundment appeared to be generally in good condition (**Photograph 5.1**). The crest for the south embankment and the common dividing embankment between the East and West Impoundments are approximately 12 feet wide. Most of the embankment crests have crushed-rock visible at the surface to carry maintenance vehicle traffic (**Photograph 5.2**). At a few embankment crest locations, the crushed-rock surfacing appears deteriorated (**Photograph 5.3**). The south embankment crest has grass vegetation up to 12 inches in height, while the crest of the common dividing embankment has trimmed grass with a height up to about 4 inches (**Photograph 5.1**).

Photograph 5.1. Crest of Embankment Dividing East and West Impoundments Looking South

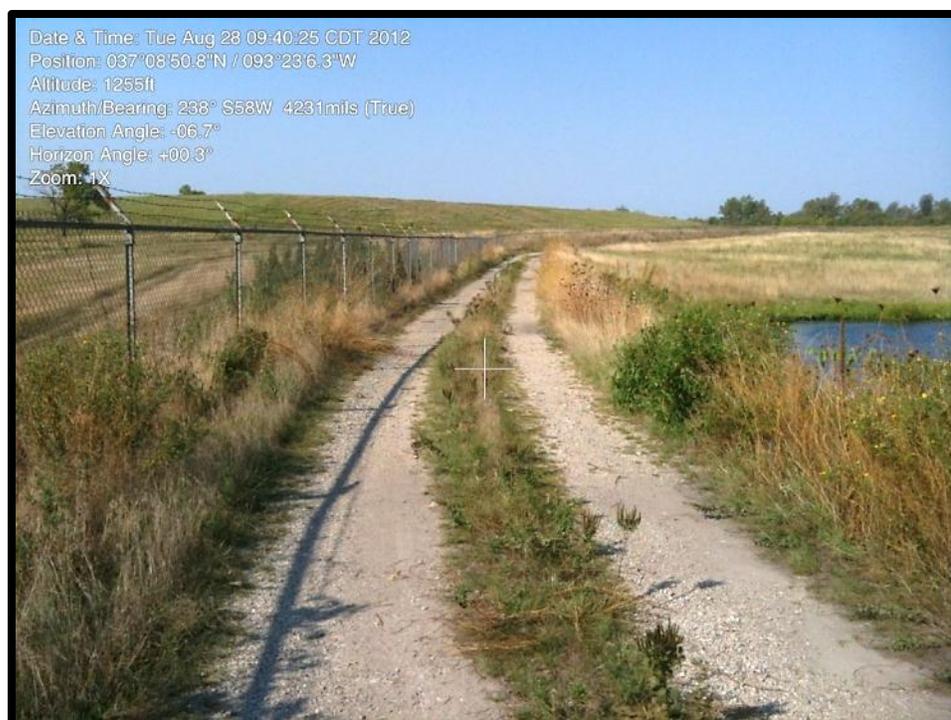
Photograph 5.2. Crest of South Embankment showing West Impoundment Looking West

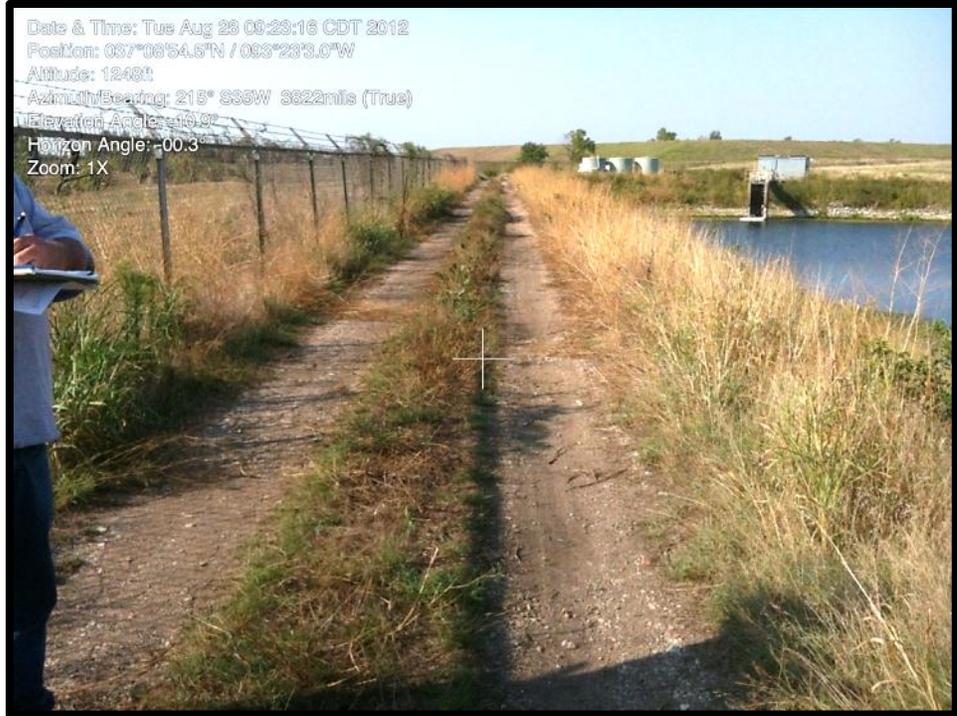
Photograph 5.3. Crest of South Embankment showing East Impoundment Looking West (showing traces of gravel pavement)

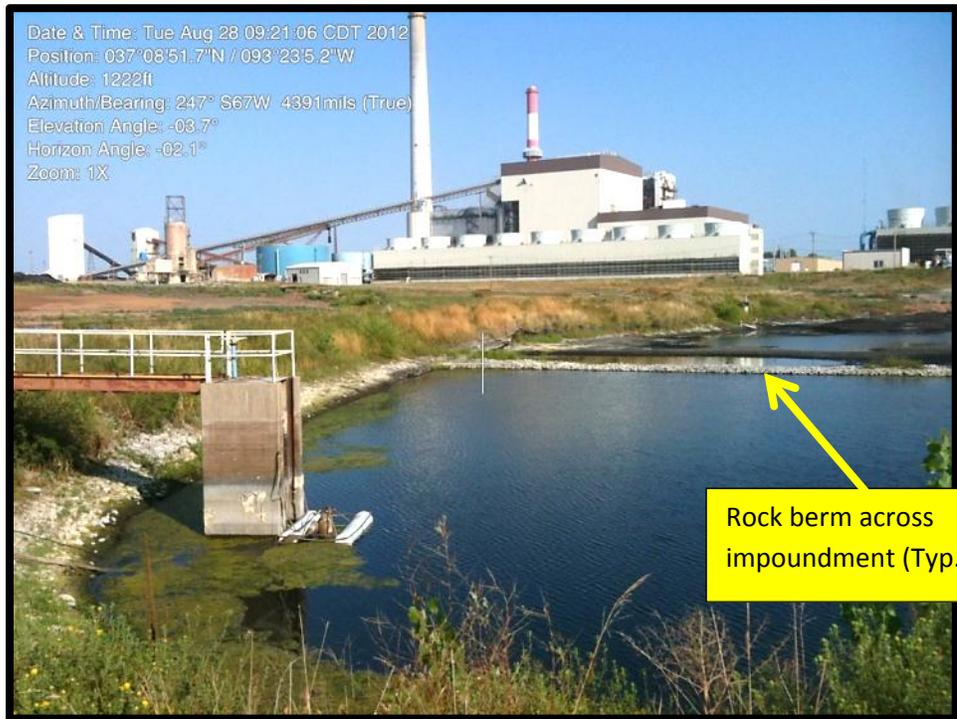
Photograph 5.4. Inside Slope of Embankment Dividing East and West Impoundments Showing East Impoundment Looking North

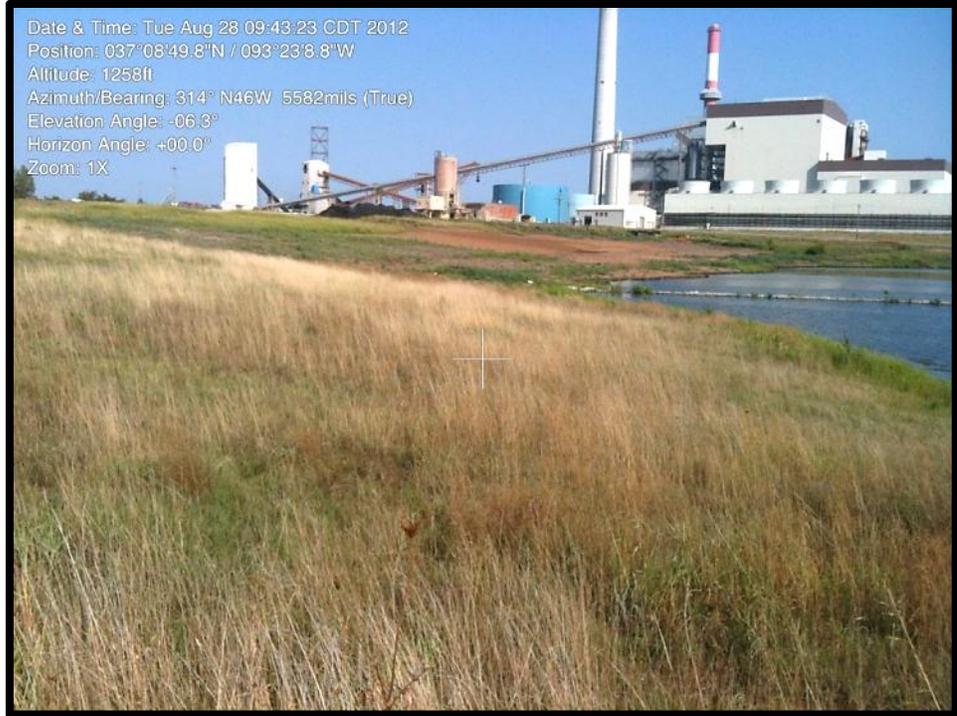
The inside slopes of the impoundment's embankments were in fair condition. Visual observations and field measurements for estimation purposes indicate the inside slope of the south embankment and the common dividing are estimated to be 2H:1V (**Photograph 5.4**). The inside slope of the north embankment and the west embankment generally had slopes on the order of 6H:1V or flatter (**Photograph 5.5**).

Photograph 5.5. Inside Slope of West Embankment for West Impoundment Looking North

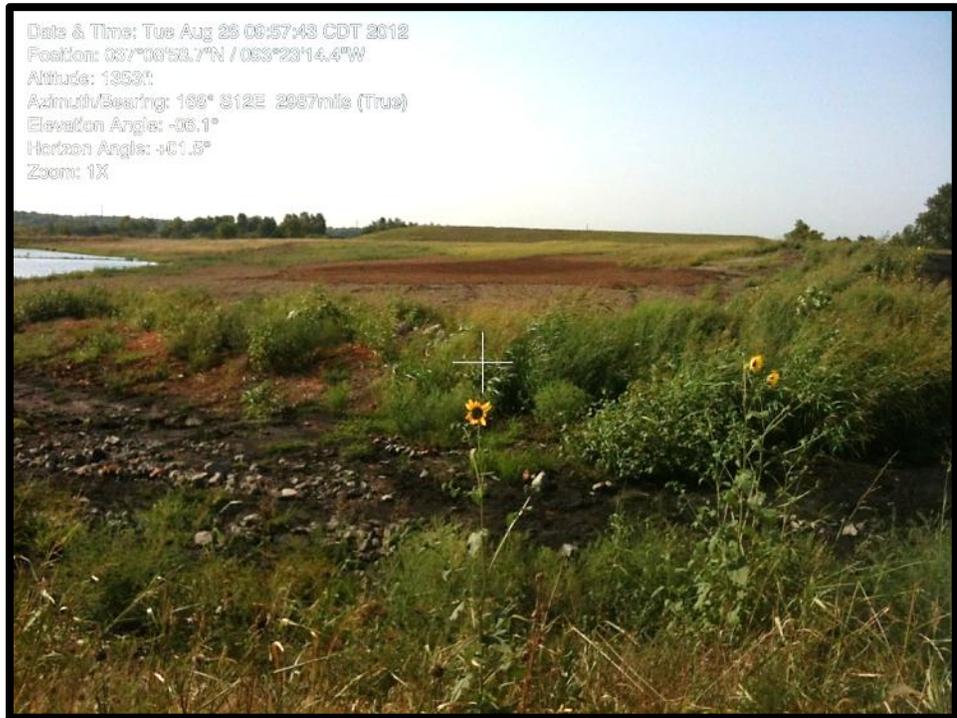
Photograph 5.6. Inside Slope of West Embankment of West Impoundment Looking South

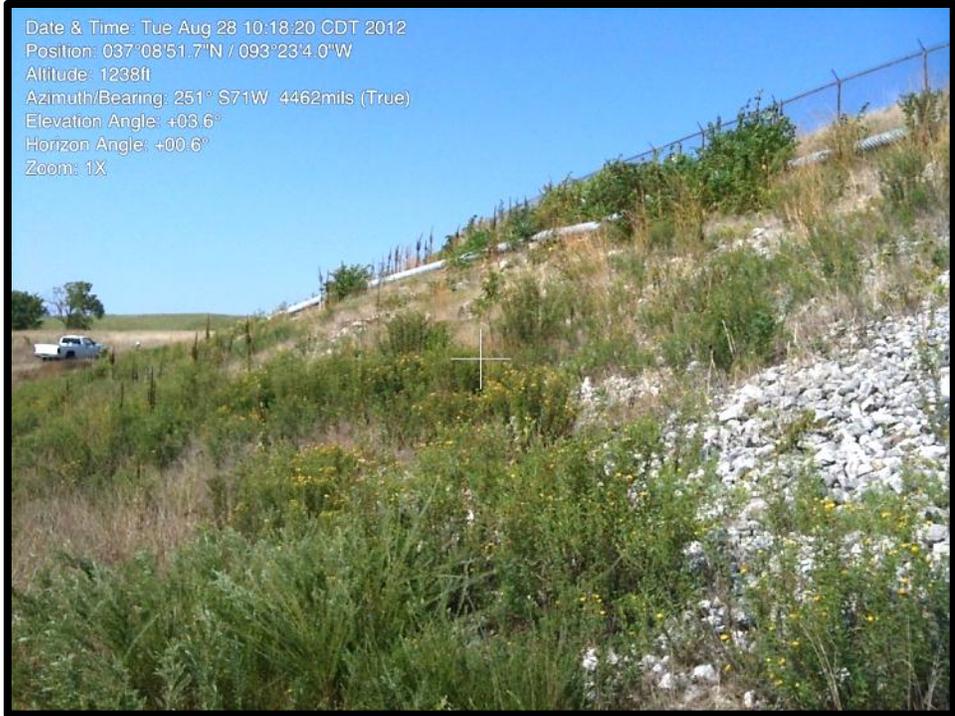
The outside slope of the south embankment appeared to be uniformly graded and generally had a slope of about 2H:1V (**Photograph 5.7**). The outside slope of this embankment is covered with areas of grass and brush up to about 4 feet in height. Unvegetated areas have riprap protection. No evidence of animal burrows, cracks, or erosion was observed on the outside slope of this embankment; there was also no observed evidence of seepage on the ground surface. The grades on the outside slope of the north and west embankments are relatively flat and generally transition to match the surrounding grade, with no discernible downward outer slope.

Photograph 5.7. Outside Slope of South Embankment (Dam) of East Impoundment Looking West (Typ.)

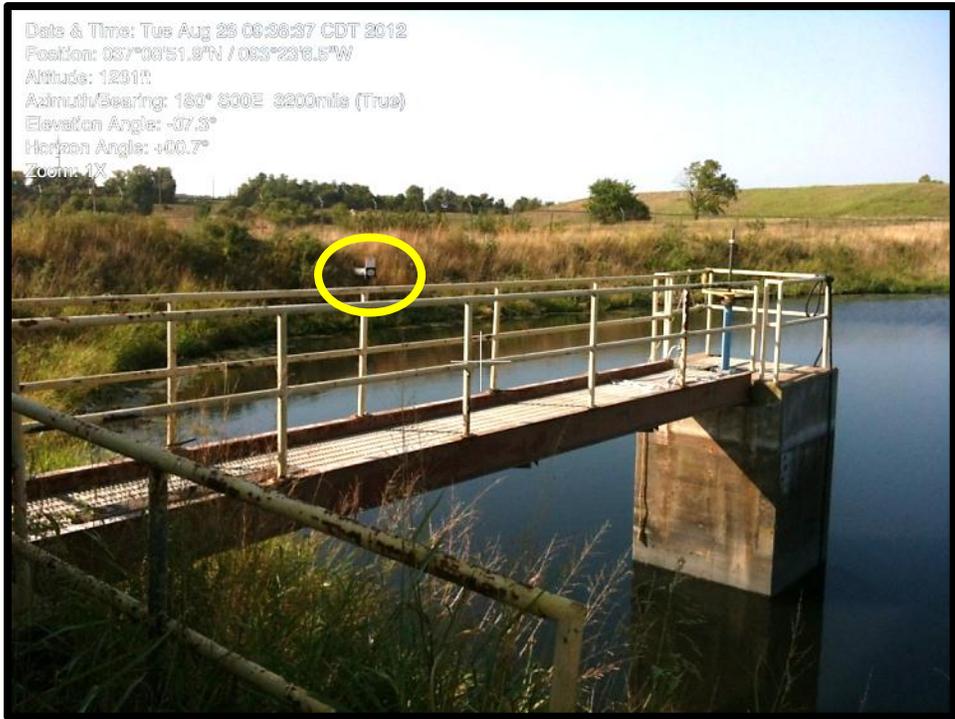
Photograph 5.8. 15-in Overflow Pipe for West Impoundment Looking South

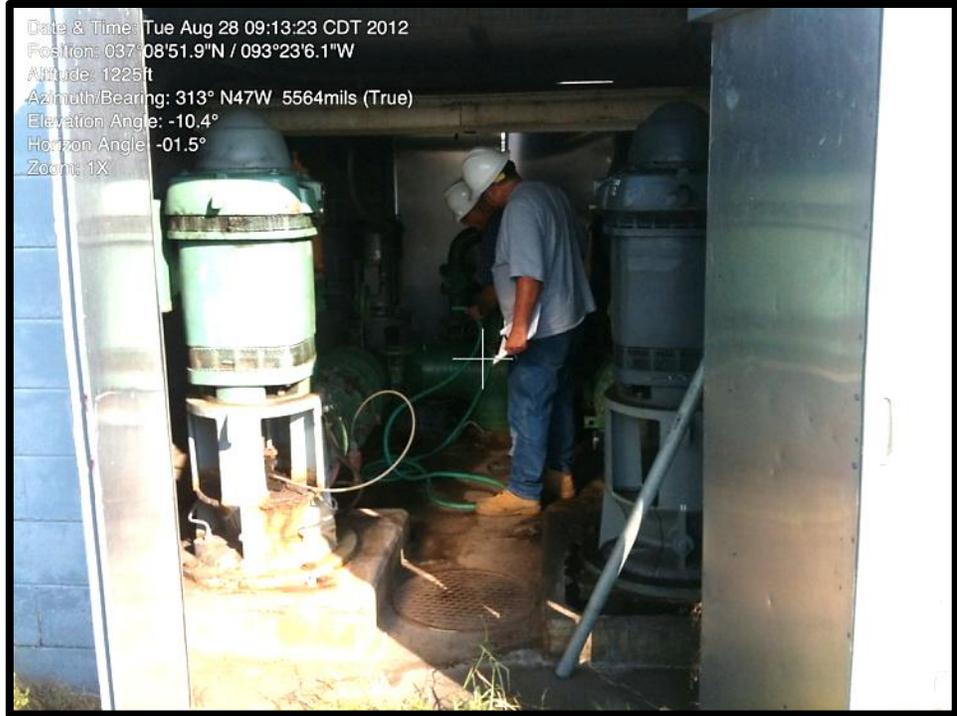
Photograph 5.9. Pump Station Regulating Outlets for both Impoundments

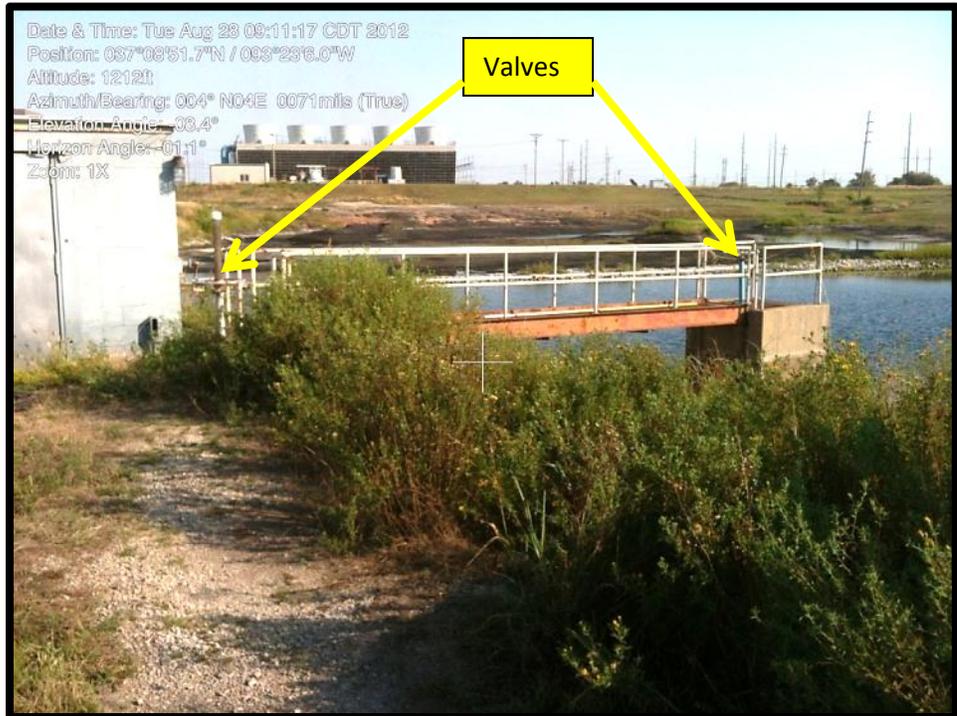
Photograph 5.10. Valves Regulating East Impoundment Outlet Looking North

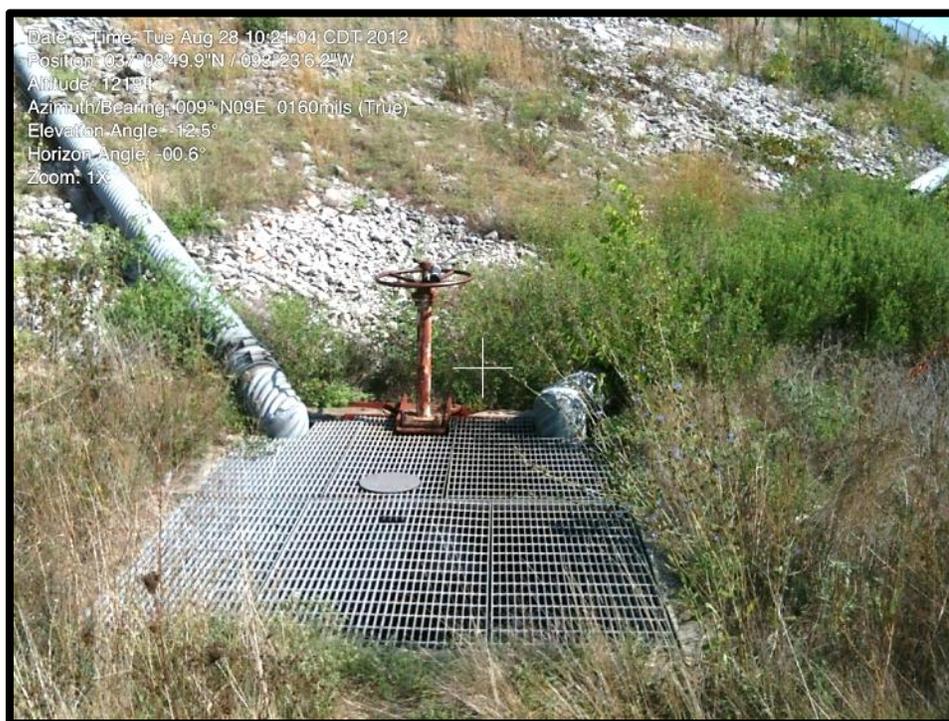
Photograph 5.11. Covered Outlet Weir with Valve for both Impoundments (also showing overflow pipes)
