# DRAFT COAL ASH IMPOUNDMENT SITE ASSESSMENT REPORT

LAKE ROAD GENERATING STATION  
KANSAS CITY POWER & LIGHT  
ST. JOSEPH, MISSOURI

March 2011

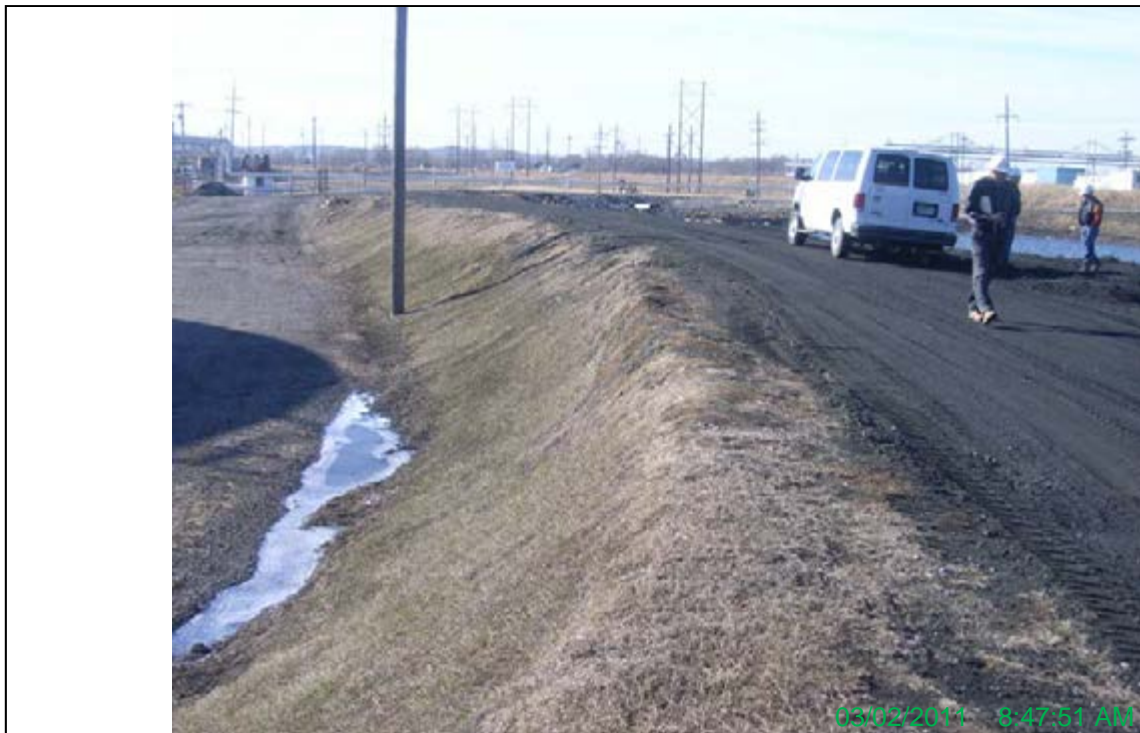
Overall, the crest of the impoundment was in satisfactory condition. Photograph 6 shows the typical condition of the crest. Specific observations include:

Overall, the landside slopes were in fair condition. Photographs 6, 11, 21, and 23 in Appendix B show typical conditions of the landside slopes. Specific observations include:

6-Landside East Embankment of Slag Pool (East Pool) Looking South

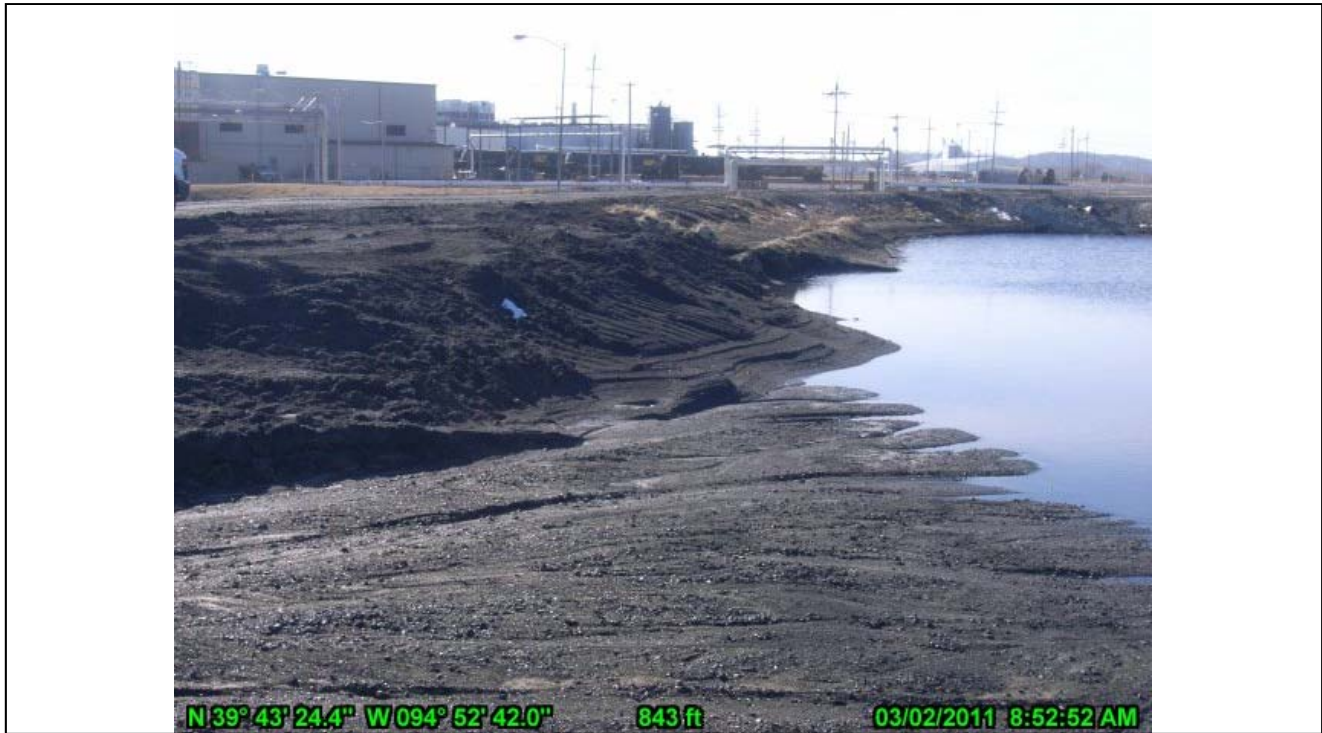
Overall, the waterside slopes were in satisfactory condition. Photographs 8, 10, 22, and 27 in Appendix B show typical conditions of the waterside slopes. Specific observations include:

8-Waterside East Embankment of Slag Pool (East Pool) Looking South

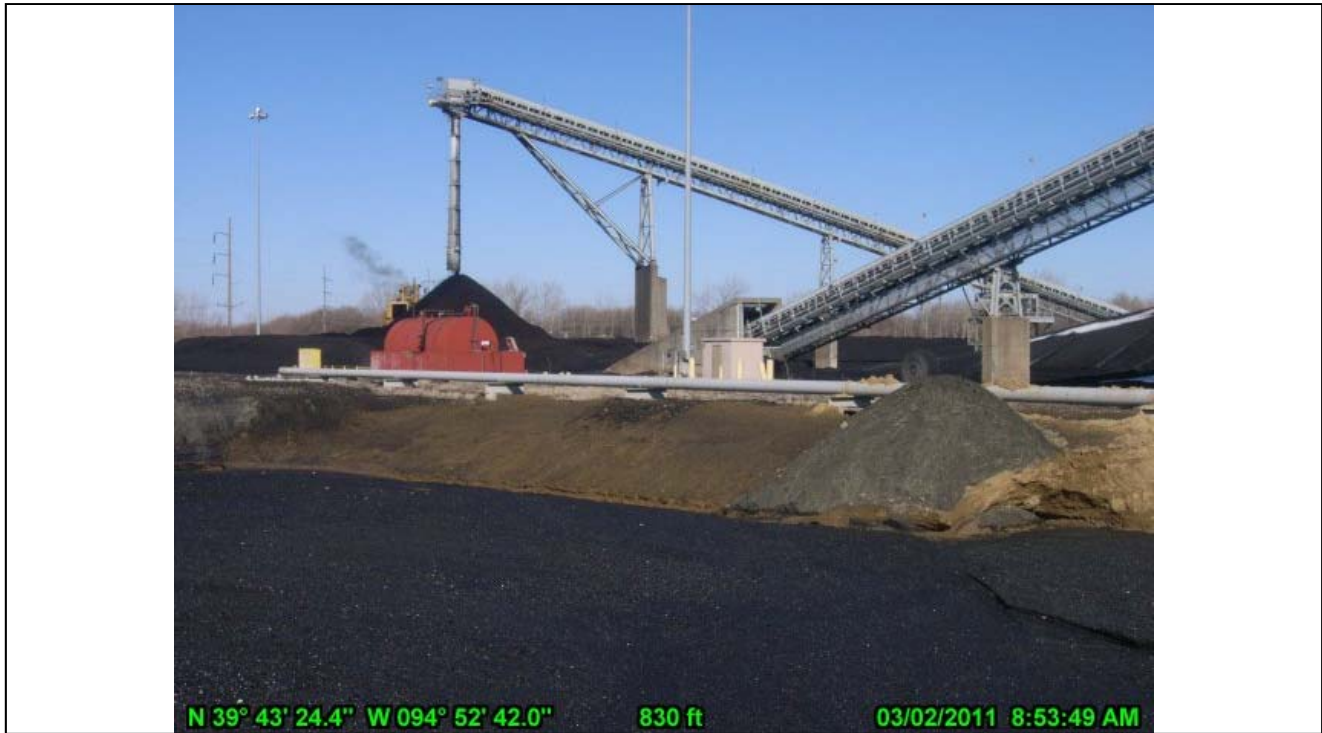
10-Fly Ash Sluice Pipe to Coal Pile Run-off Pool on North Embankment

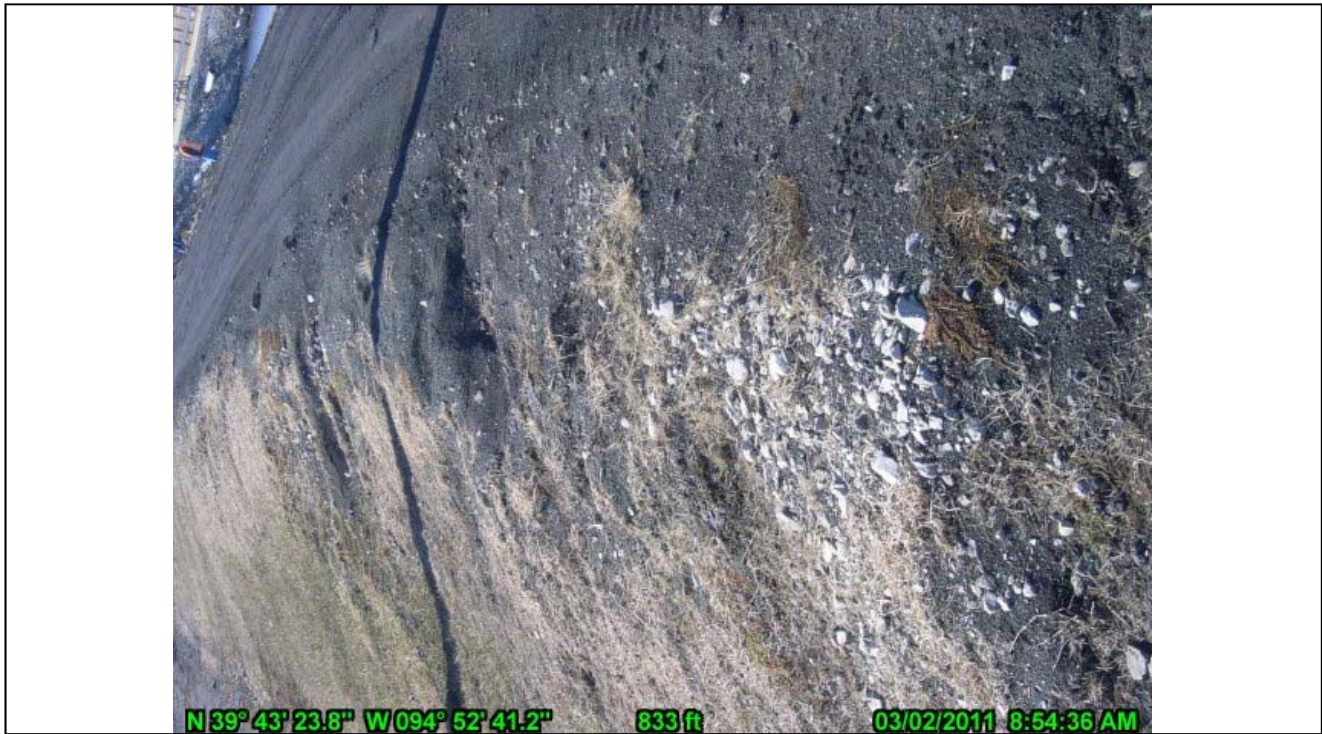
11-Crown and Landside of Slag Pool East Embankment Looking South

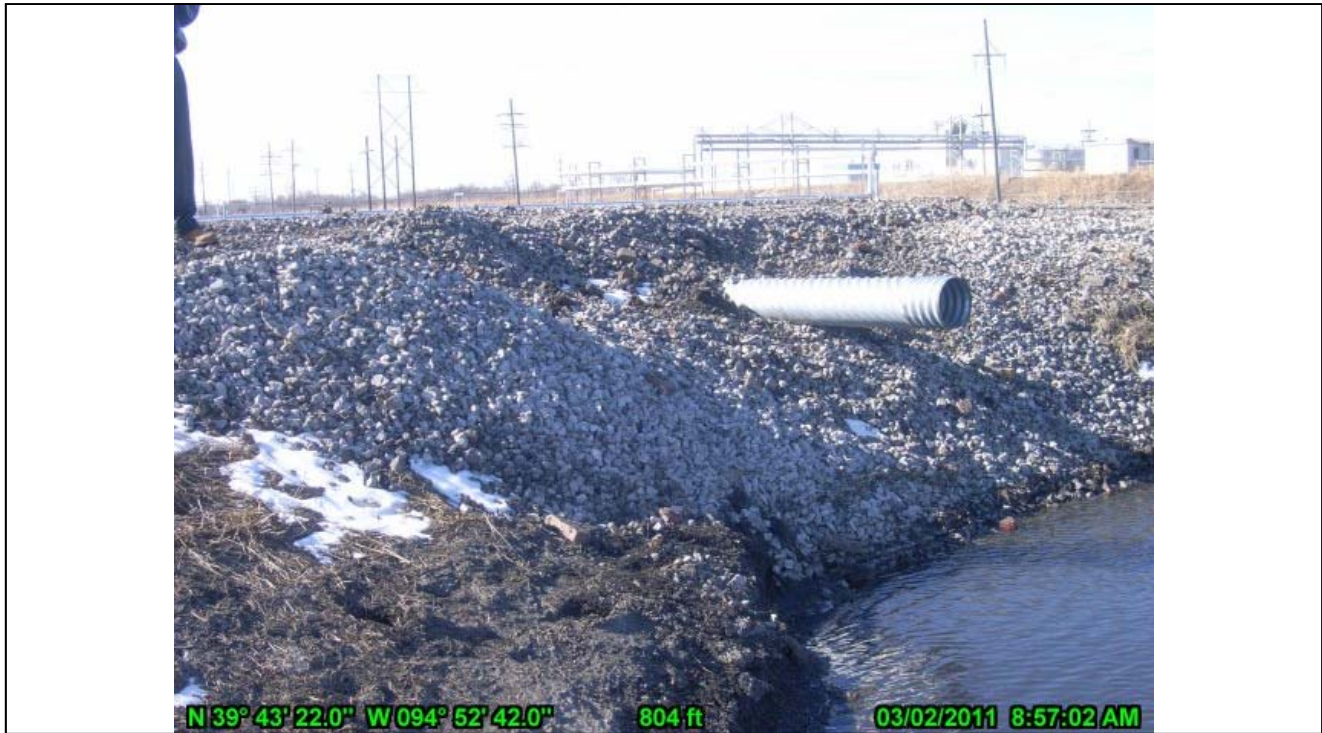
The overflow pipes appeared to be in satisfactory condition with no corrosion at the inlet and outlet; however internal condition of the pipes was not verified. A picture of an overflow pipe is shown in Photograph 12.

12-Stone Filter Outlet and Overflow Pipe at South End of Slag Pool

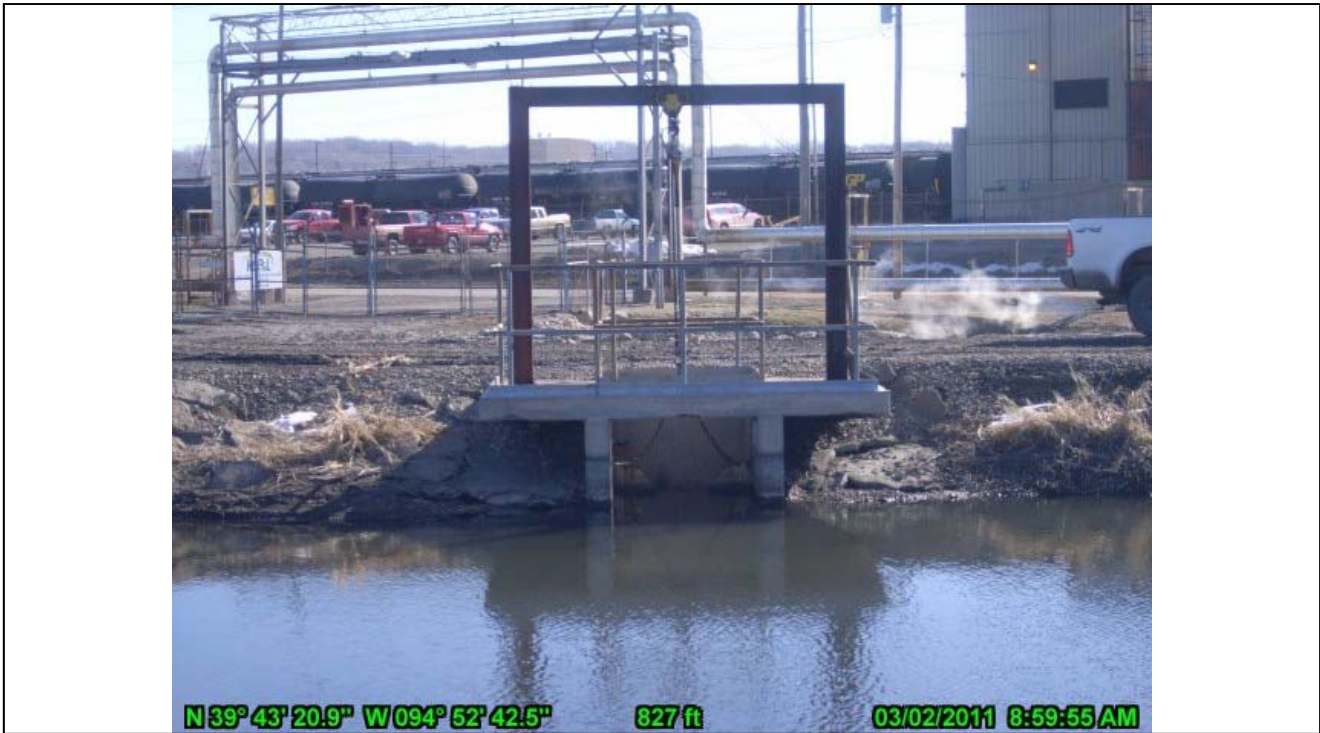
The outlet works was passing flow at the time of inspection and appeared to be in satisfactory condition. The internal condition of the outlet conduit was not inspected and records of internal video inspection were not available.

The decant outlet works appeared to function properly and was passing water. The structure looked plumb and the concrete was in good condition; however the submerged portion of the intake structure and foundation was not visible. The RCP outlet pipe was passing flow and appeared in satisfactory condition with minor deterioration. The internal condition of the outlet conduit was not inspected. The outlet works can be seen in Photograph 14 of Appendix B.

14-Final Settling Basin Decant Outlet Works Intake

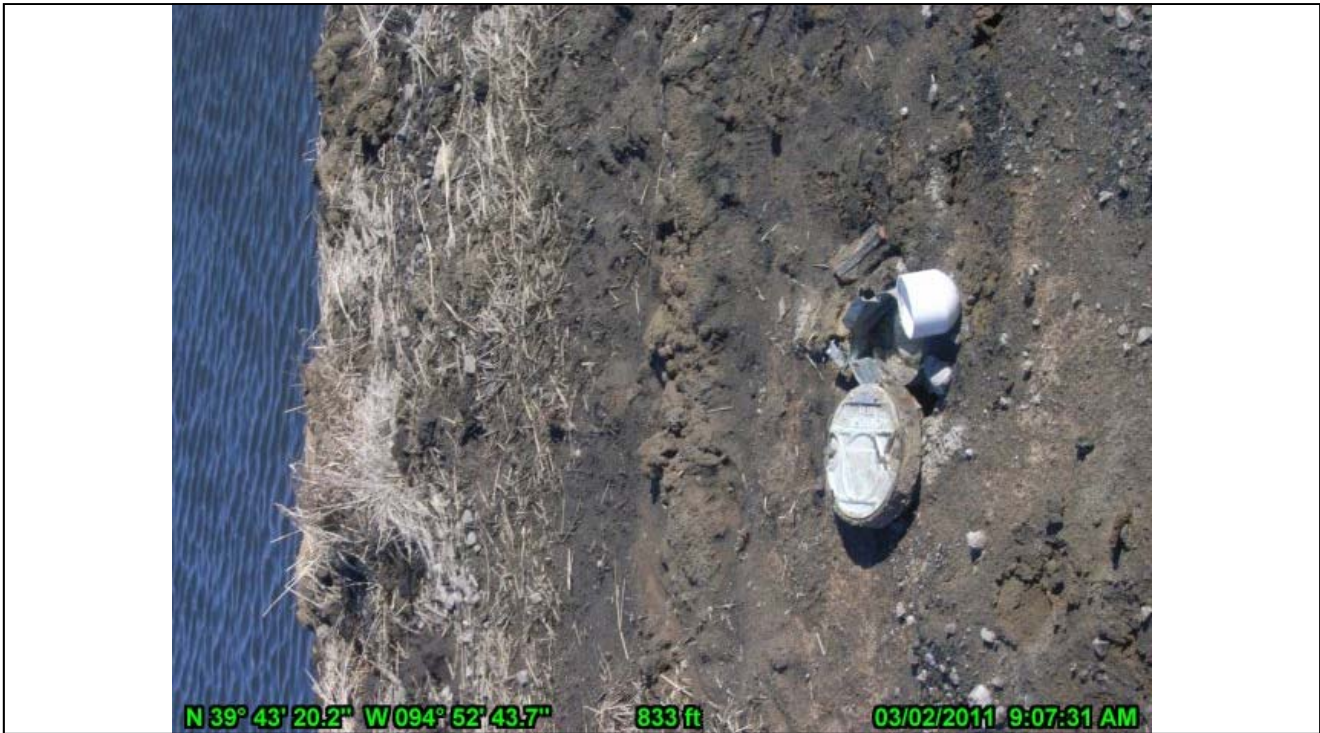
No historical seepage has been reported and none was observed at the time of inspection. Owner documentation shows 15.24 cm of compacted clay was used to line the pond and no toe drains or relief wells are present. URS installed two piezometers on-site in 2011 as part of their Geotechnical Evaluation Report, seepage analysis. They concluded that “infiltration through the embankments is slow and limited and that the embankments are effectively controlling seepage.” KCP&L is not currently taking readings from the instrumentation. A piezometer on the south embankment is shown on Photograph 18.

18-Piezometer on South Embankment of Interim Settling Basin

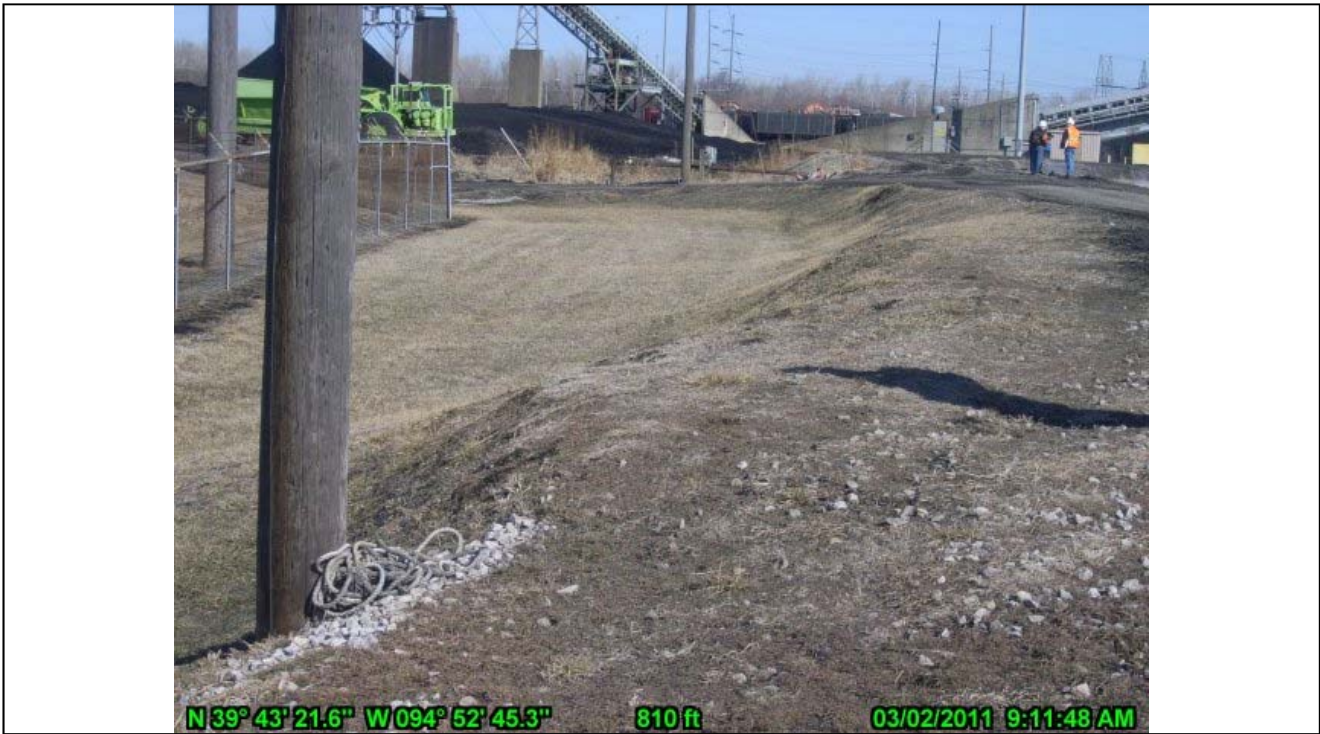
- The west embankment of the Interim Settling Basin showed minor erosion.
- Mowed grass was observed along the west and east embankment of the Ash Pond.
- No large diameter trees or animal burrows were observed in the embankment.

21-Landside of West Embankment Looking North

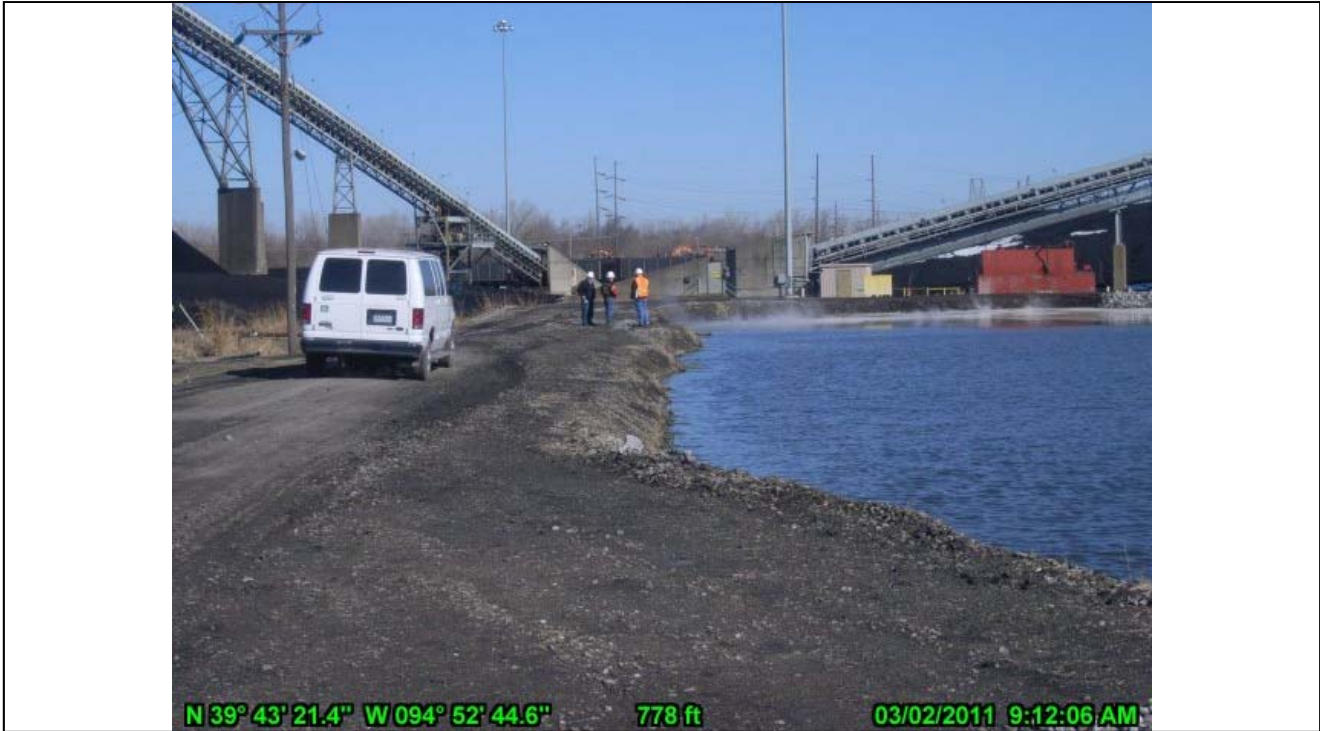
22-Waterside Embankment of Coal Pile Run-off Pool (West Pool)

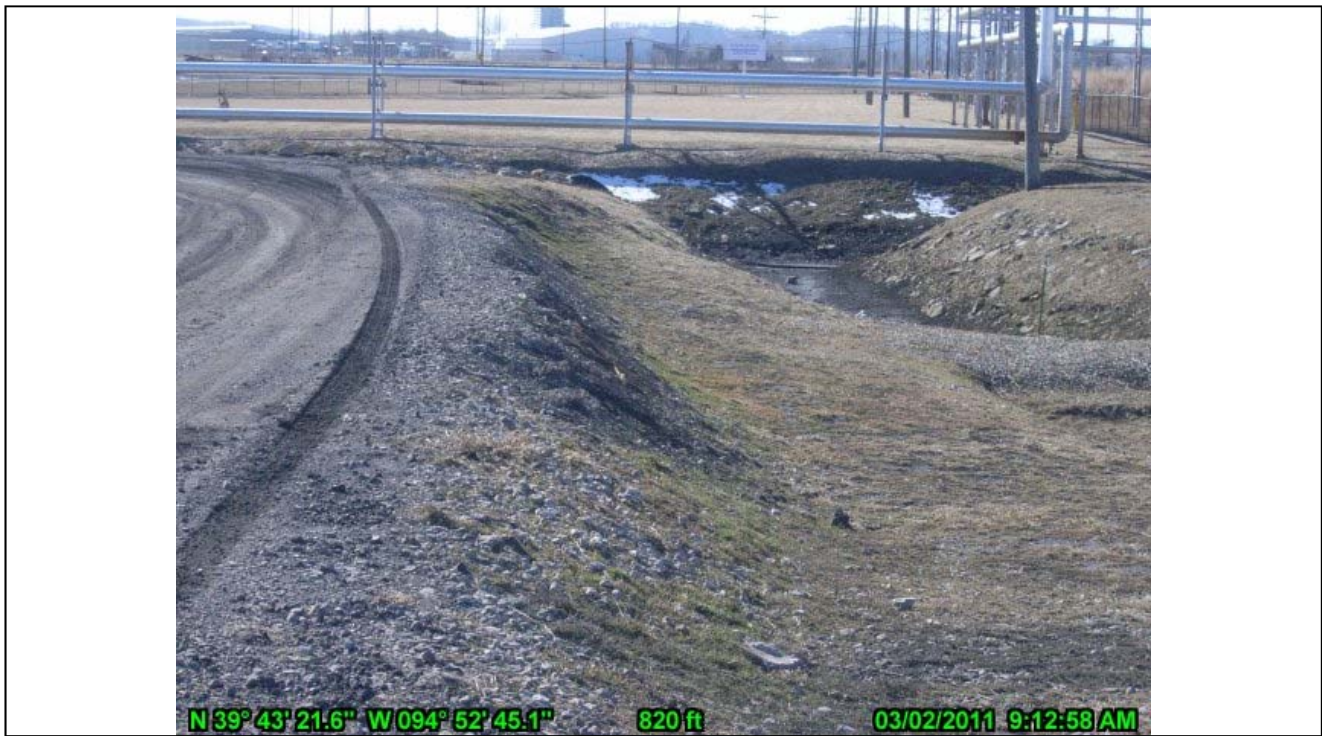
23-Landside Embankment of Interim Settling Basin (West Settling Basin) Looking South

1. Repair erosion on landside embankment west of the Interim Settling Basin.
2. Perform an internal video inspection of the outlet conduit at least once every five year.
3. Update O&M Manual to provide maximum dredging elevation.
4. Continue to update EAP and O&M Manuals.

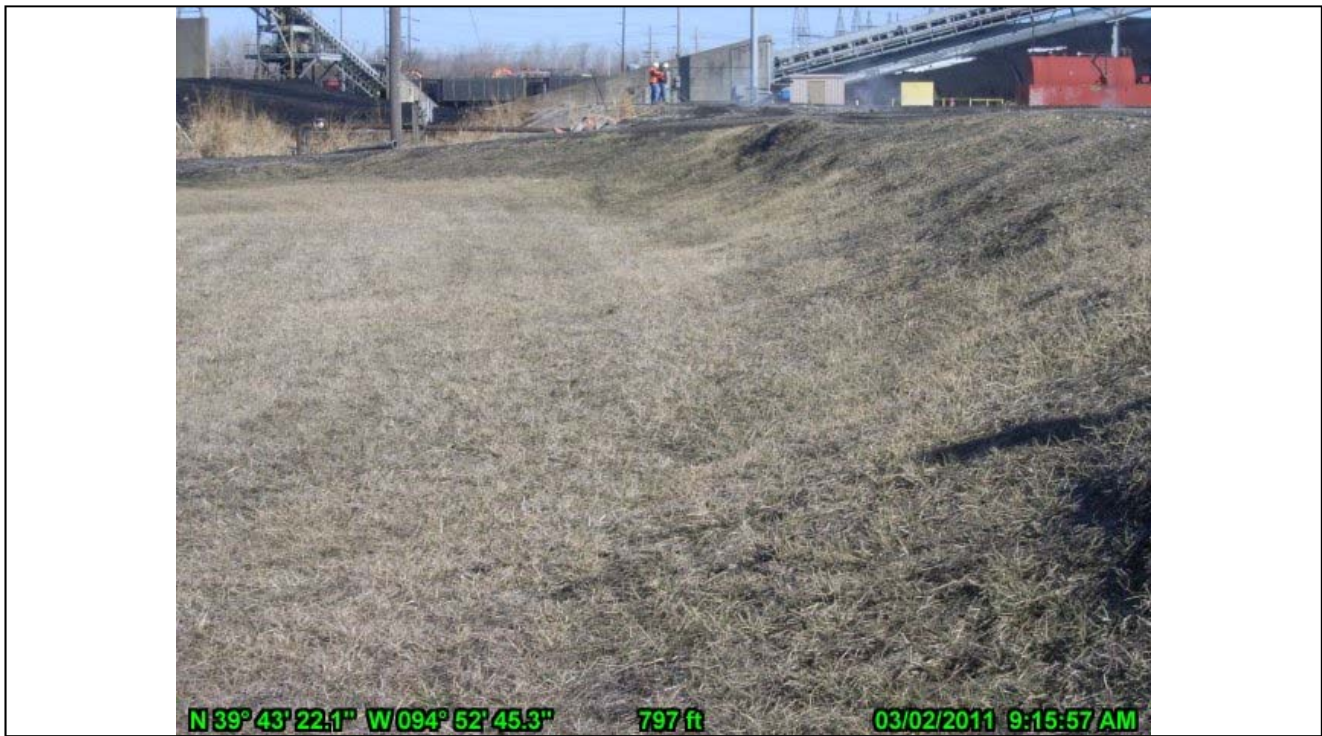
Overall, the landside toe areas were in satisfactory condition. Photographs 6, 24, and 25 in Appendix B show typical conditions of the landside toe. Specific observations include:

- No large trees or hydrophilic vegetation was observed along the embankment toe.
- No ponding water was observed along the embankment toe, with the exception of a coal pile run-off ditch to the northwest and the drainage canal to the south. Both locations appear intended to contain some water.
- Three utility poles were built near the embankment toe.

25-Landside Embankment of Coal Pile Run-off Pool Looking North

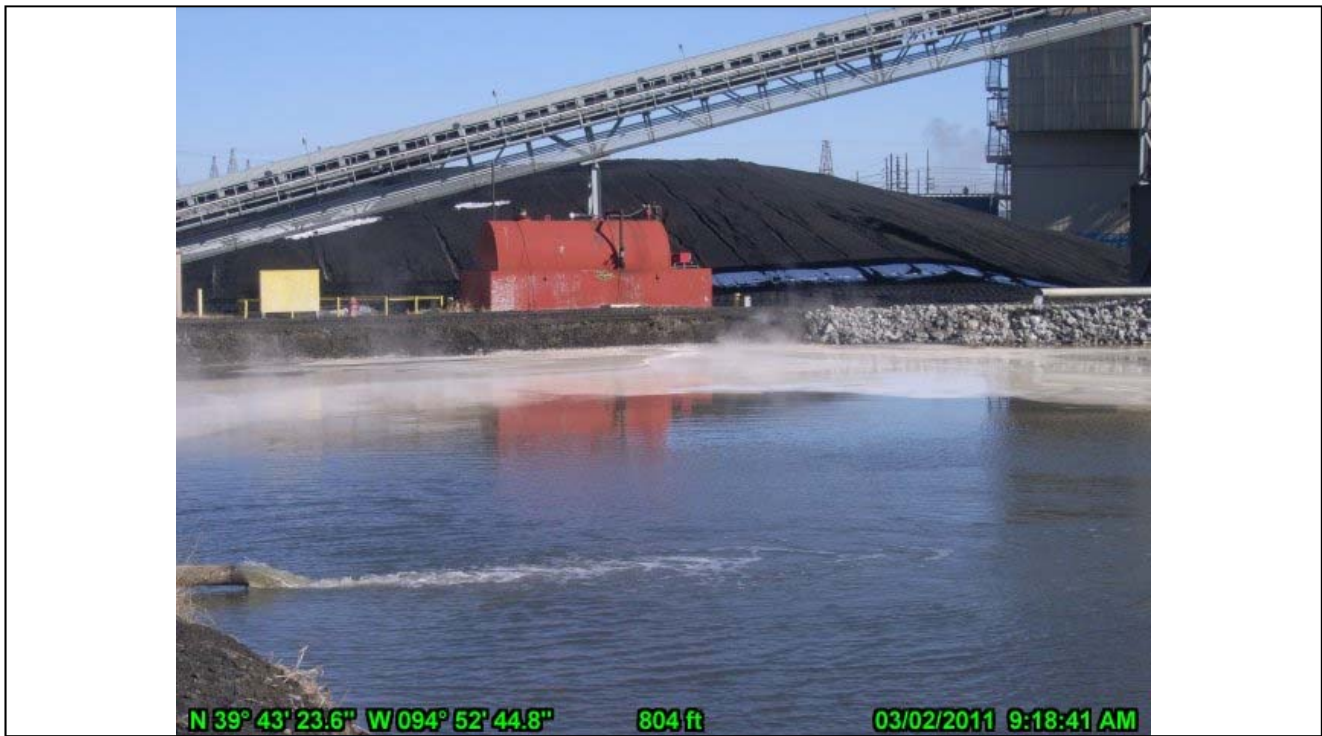
27-Coal Pile Run-off Inlet (foreground) and Fly Ash Inlet (background)
