DRAFT COAL ASH IMPOUNDMENT SITE ASSESSMENT REPORT

MONTROSE GENERATING STATION
KANSAS CITY POWER & LIGHT
MONTROSE, MISSOURI

March 2011

Were assessed on March 1, 2011

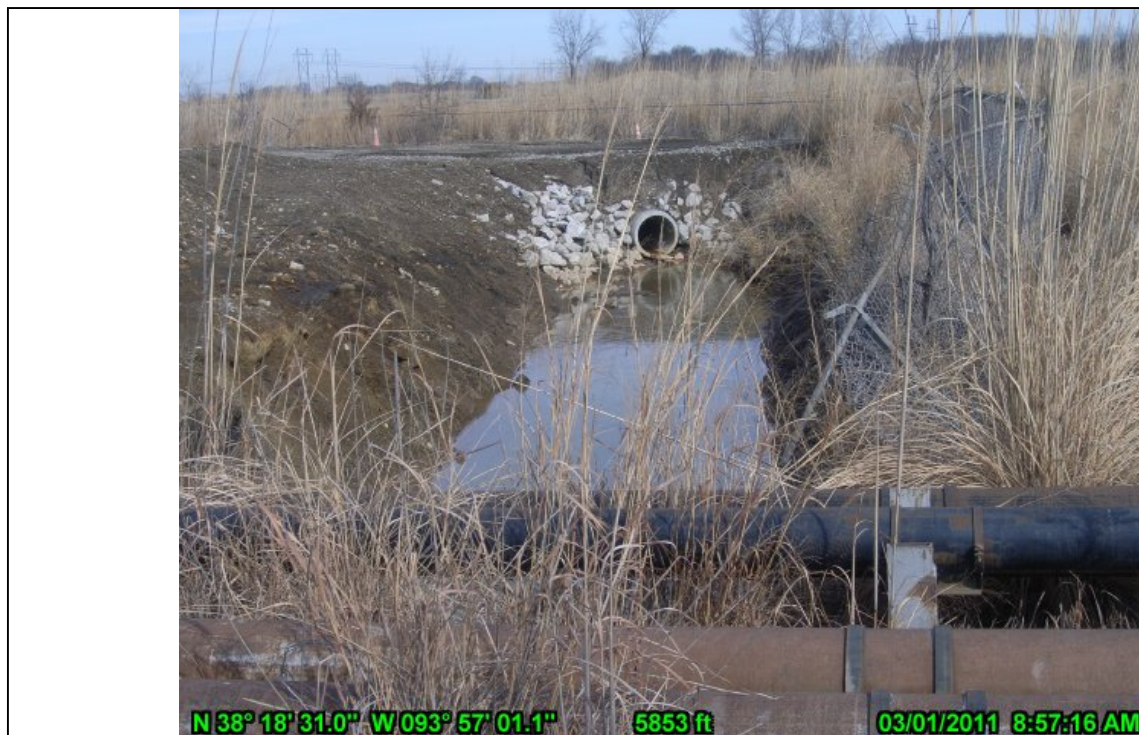
Overall, the incised drainage ditch was in satisfactory condition. The first culvert on the north side was recently replaced and some riprap protection was present (Photographs 8, 41, and 42). The second culvert showed some erosion on the upstream side and a chain-link fence has fallen down (Photograph 43). No vegetation or channel armor was present on the south side of the channel (Photograph 39).

8-Drainage Ditch from North Pond looking North, Upstream

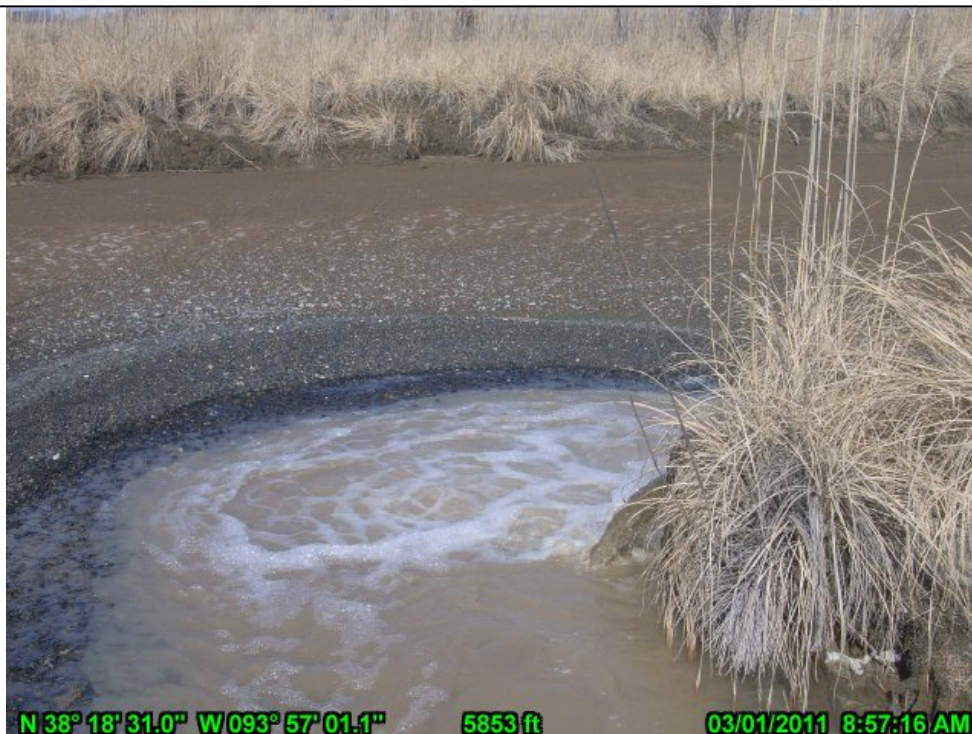
Inflow into the South Ash Pond includes metal pipes on the east side of the impoundment, as well as storm water runoff that flows naturally into the pond. The inlet channel showed some erosion of the bank. The inlet pipe appears to be in satisfactory condition. The Inlet pipe can be seen in Photographs 11 and 12 of Appendix B.

11-North and South Pond Inlet

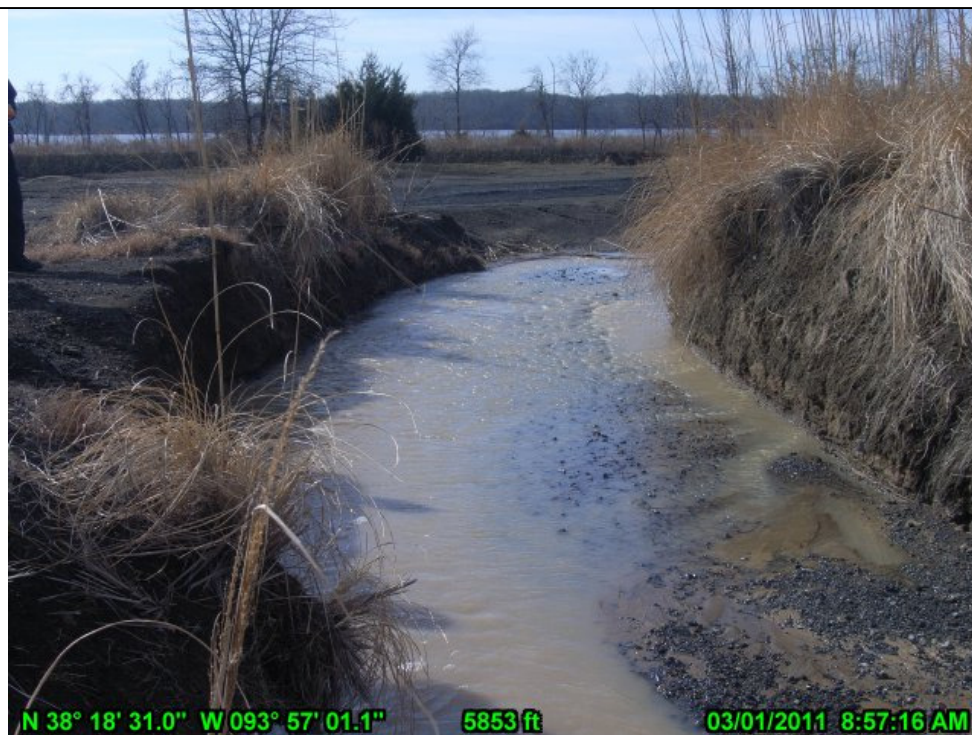
12-North Pond Inlet Channel Looking South

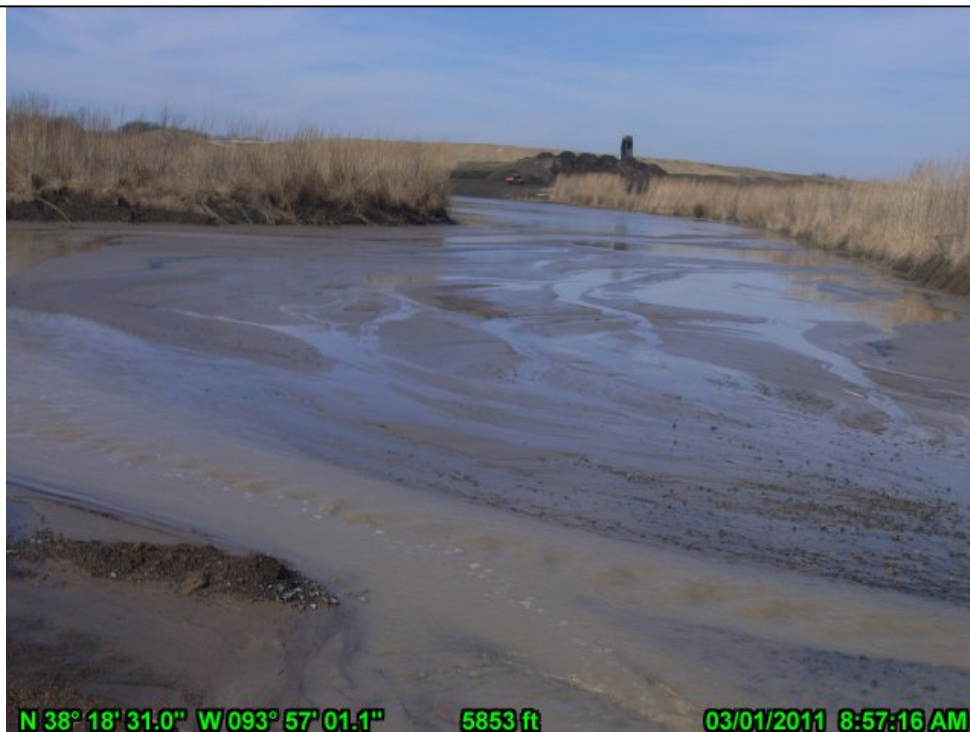
Overall, the incised slope was in satisfactory condition. Photographs 13, 17, 25, and 26 in Appendix B show typical conditions of the incised slope. Specific observations include:

- The incised slope is steep above the water surface, based on visual observations. Inspection occurred while pond was in service so incised embankment slope below the water surface was not observed.
- Tall grass and brush was observed on the incised slope. Vegetation likely improves stability of the slope; however, it obstructed visual inspection of the embankment, inlet, decant, and outlet pipes.
- No large diameter trees or animal burrows were observed in the embankment.

13-East Side of the South Pond Looking West

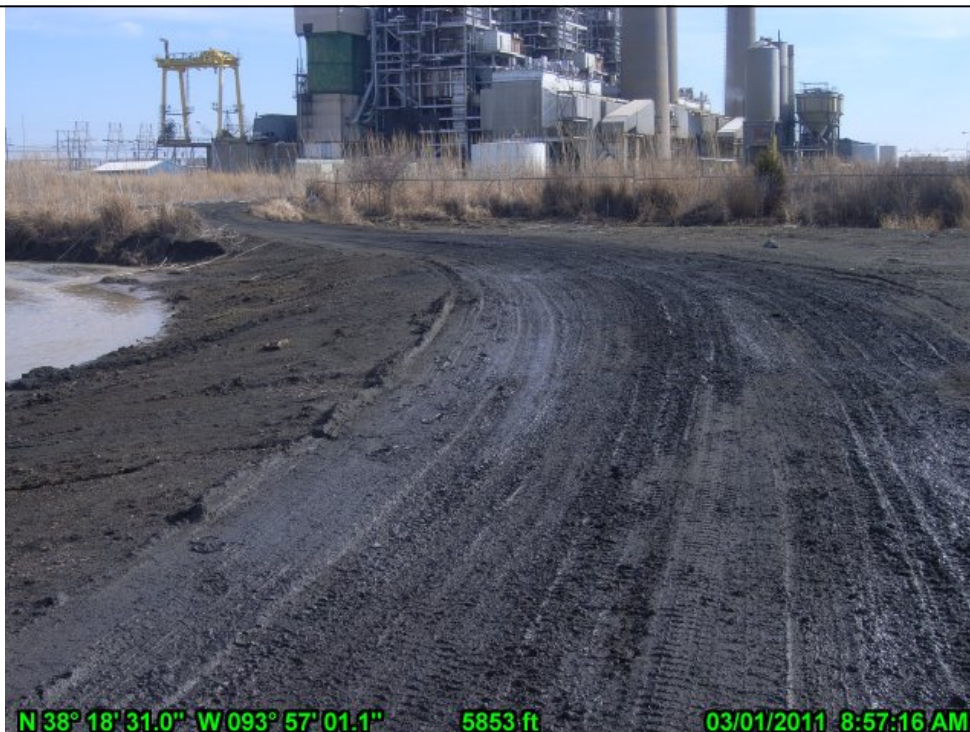
Overall, the crest of the impoundment was in satisfactory condition. Photograph 15 shows the typical condition of the crest. Specific observations include:

- Crest width is variable and usually resembles the natural grade.
- Most of the impoundment crest is a gravel road.
- Almost no grasses were observed on the crest.
- No major depressions or rutting were noted on the impoundment crest.

15-Embankment Adjacent to Inlet Channel Looking Northeast

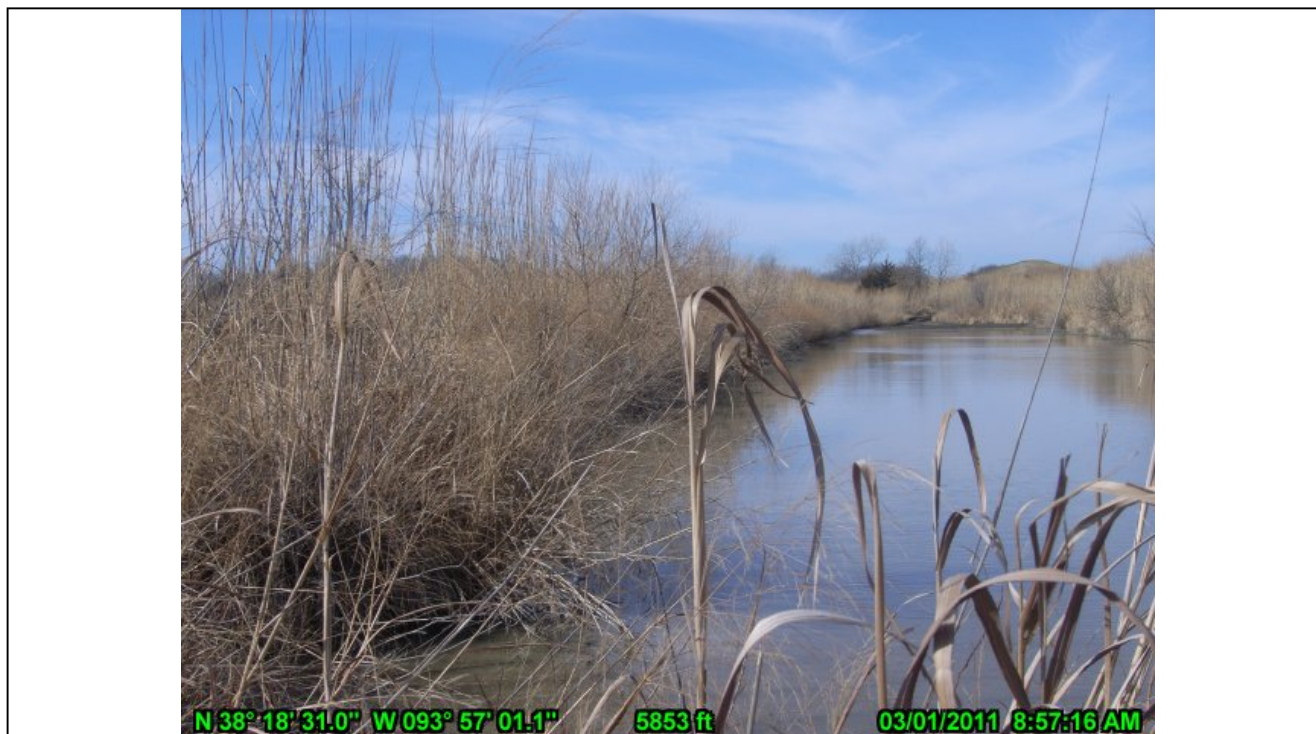
17-Secondary South Pond Looking West

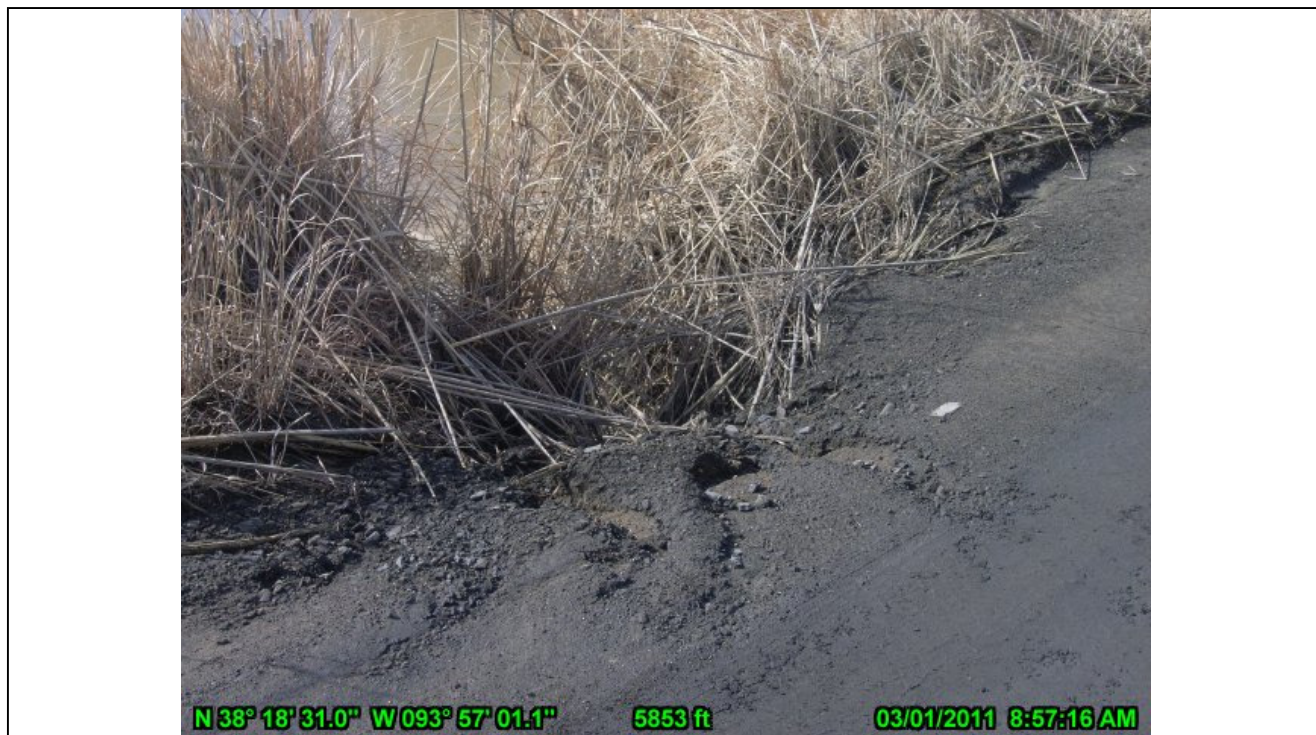
18-Erosion on Land Side of Embankment near Discharge Canal

1. Repair erosion on embankment and drainage ditch.
2. Perform vegetation mitigation around impoundment structures and incised slopes.

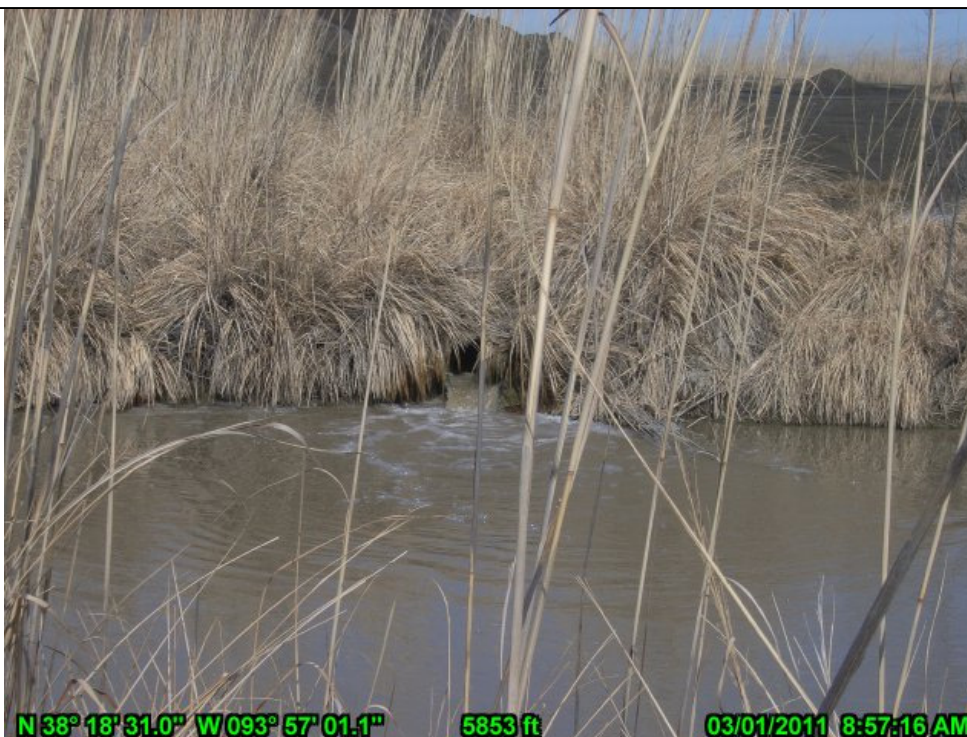
Excessive vegetation was observed around the pipe inlets and outlets. View of the west pipe inlet and outlet was not visible and not inspected. Flow appeared to be passing through both pipes; however internal condition of the pipes was verified. The decant pipes are shown in Photographs 20, and 27 through 30.

The outlet works appeared to function properly and was passing water; however the structure and foundation was submerged and not visible. The steel cover to the outlet works inlet was in good condition and showed minor corrosion. The outlet works can be seen in Photographs 16 and 20 of Appendix B.

20-South Pond Decant Outlet Looking North (West Pipe Not Visible)

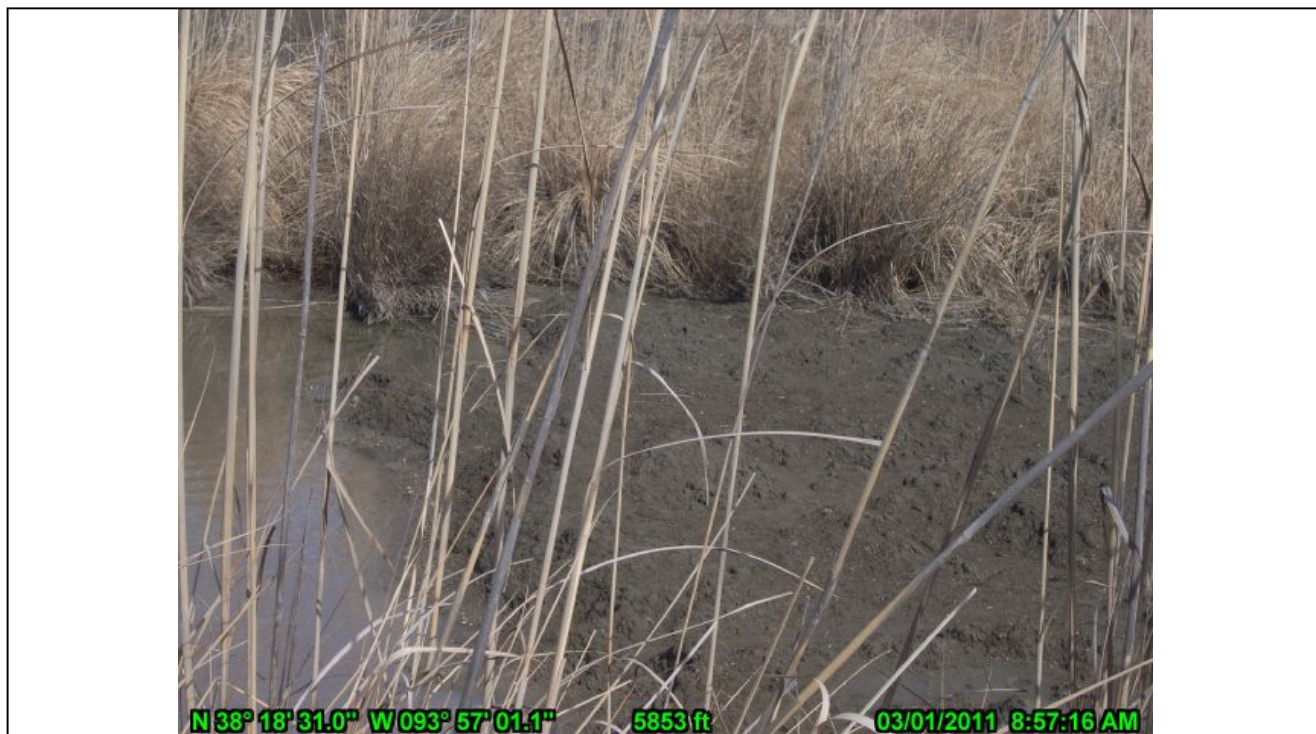
A soil and ash obstruction was observed to impede the flow in the secondary pond after the decant pipes. The debris was about 3-4 inches above the

21-Soil and Ash Obstruction in Secondary South Pond

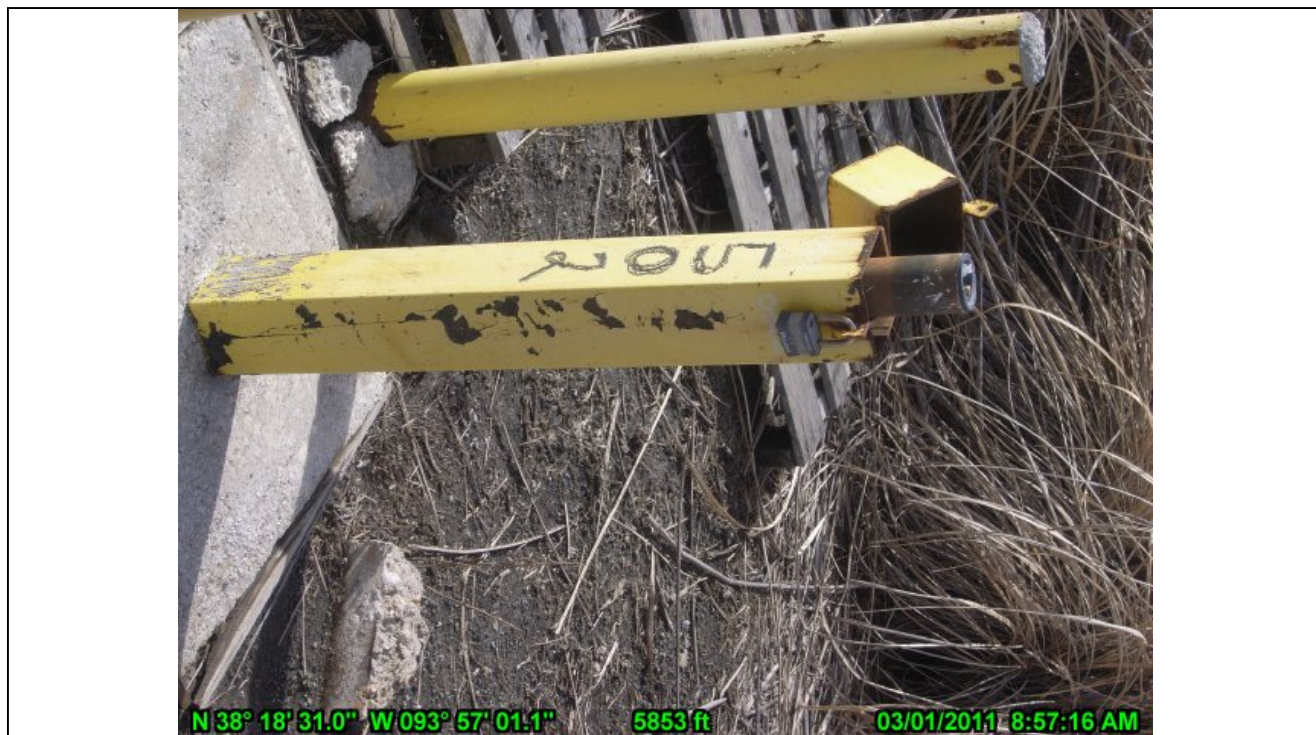
22-Piezometer Not Used for Ash Ponds

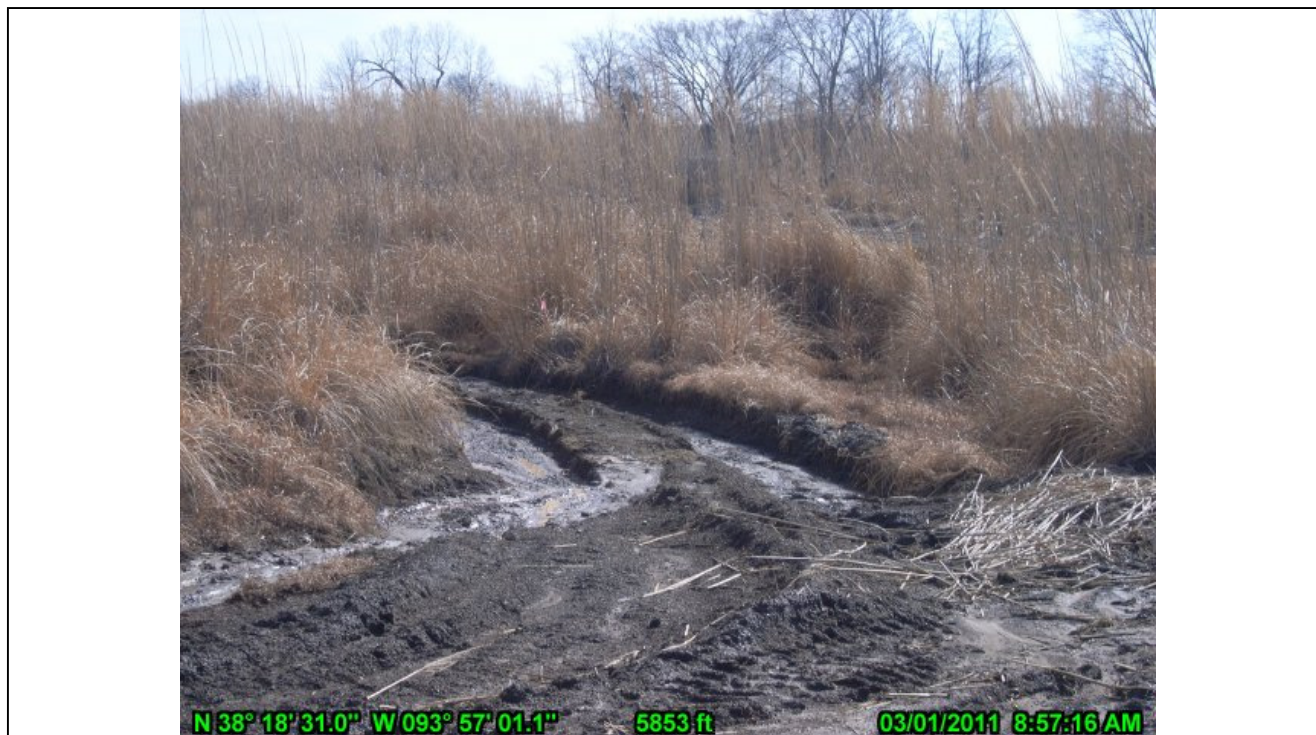
24-Erosion on West End of South Pond Looking East

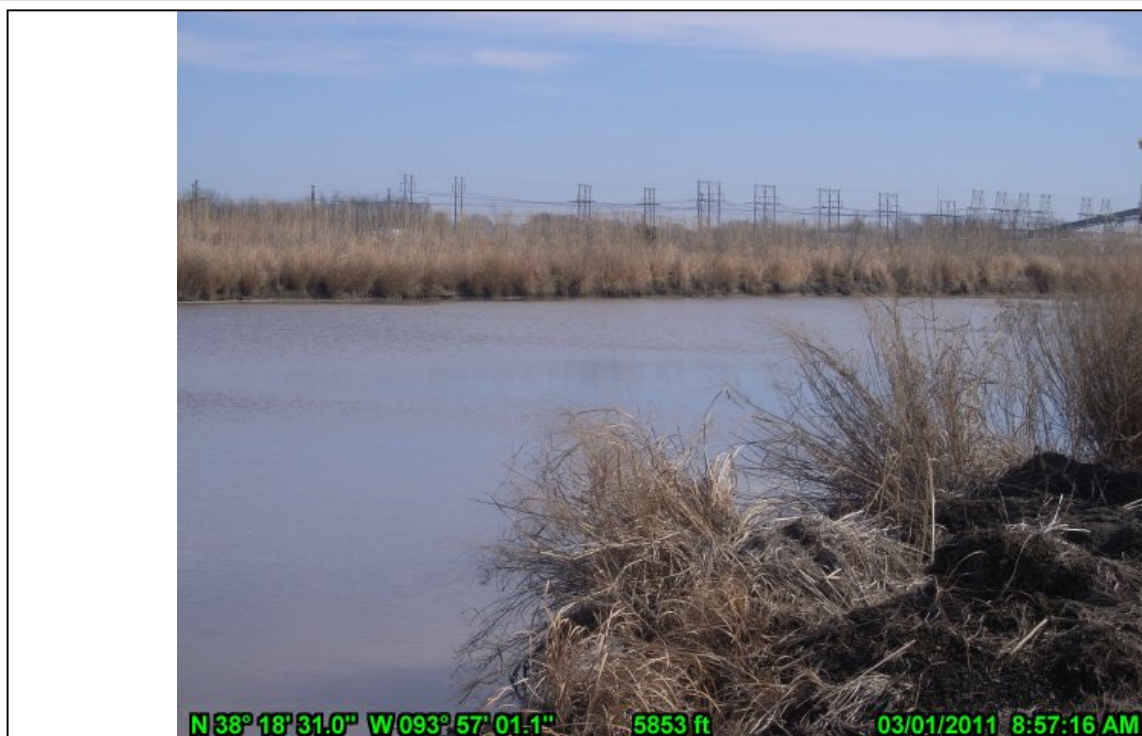
25-Primary South Pond Looking Northeast

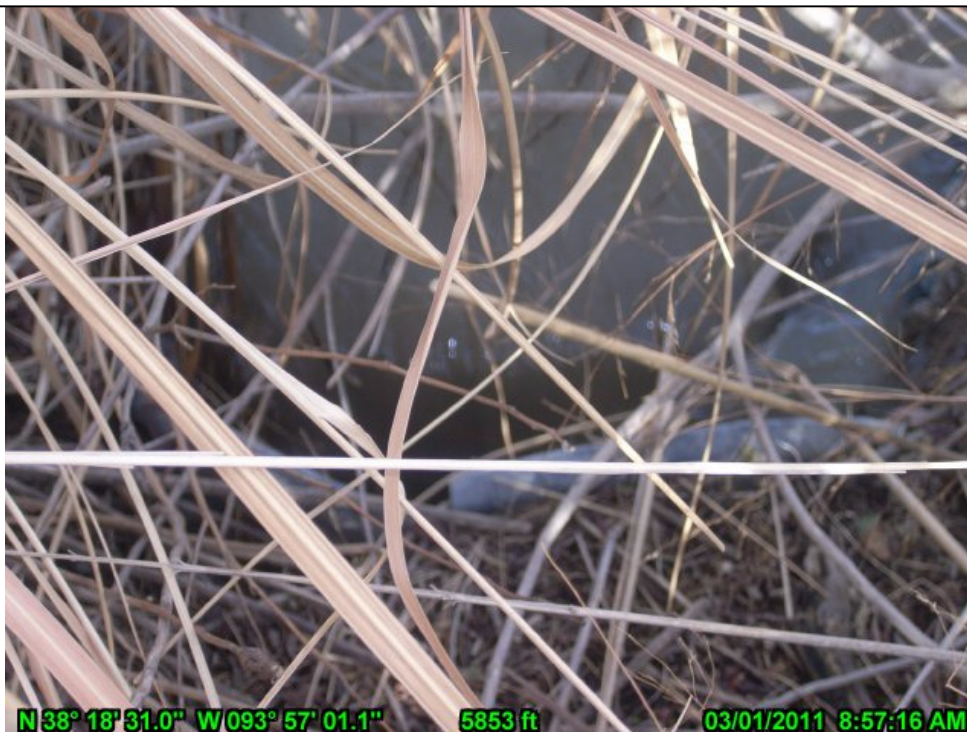
27-Inlet to East Decant Pipe

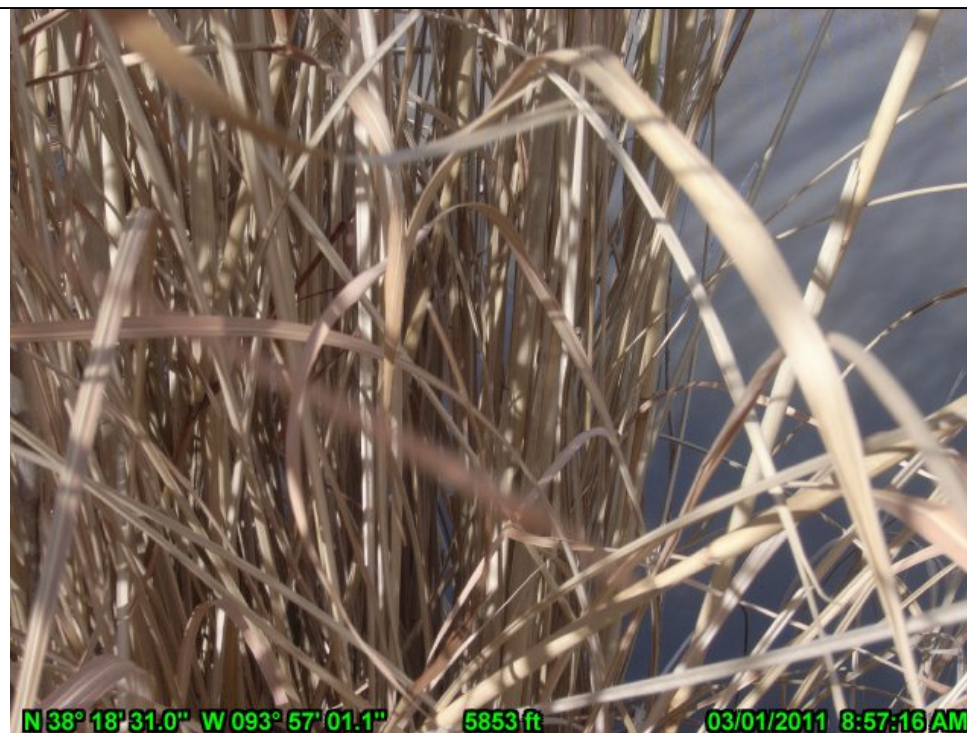
28-Approximate Location of Inlet to West Decant Pipe

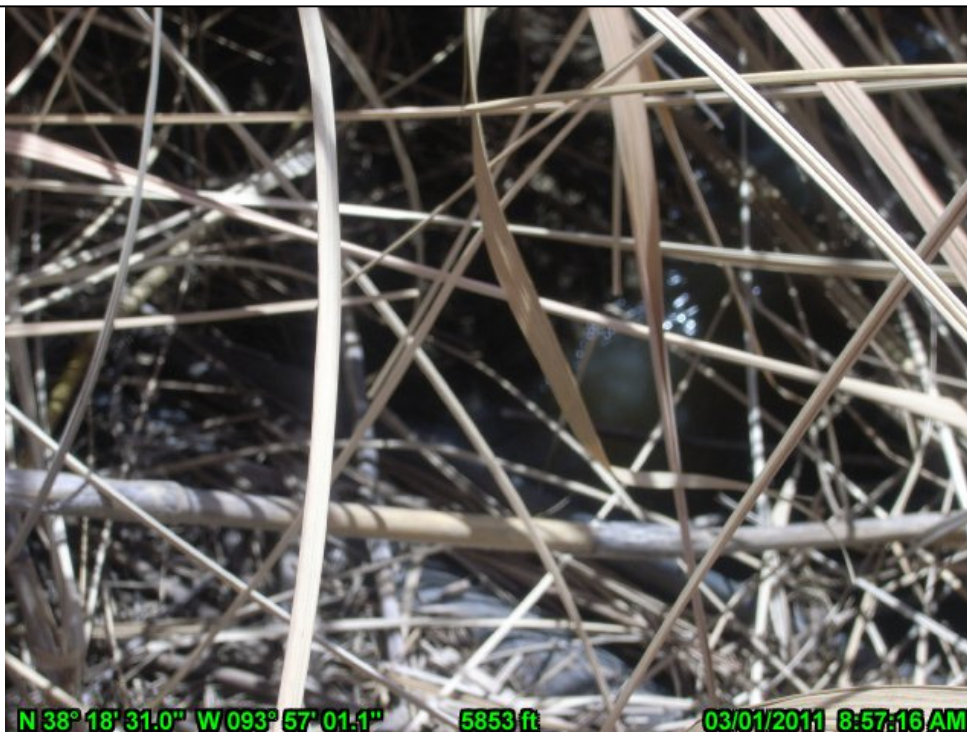
No historical seepage has been reported and none was observed at the time of inspection due to the absence of a landside slope. One Piezometer is located on-site to the South of the South Pond shown in Photographs 29 and 30; however, it is Kleinfelder understanding that this is used to monitor other operations.

29-Outlet to West Decant Pipe

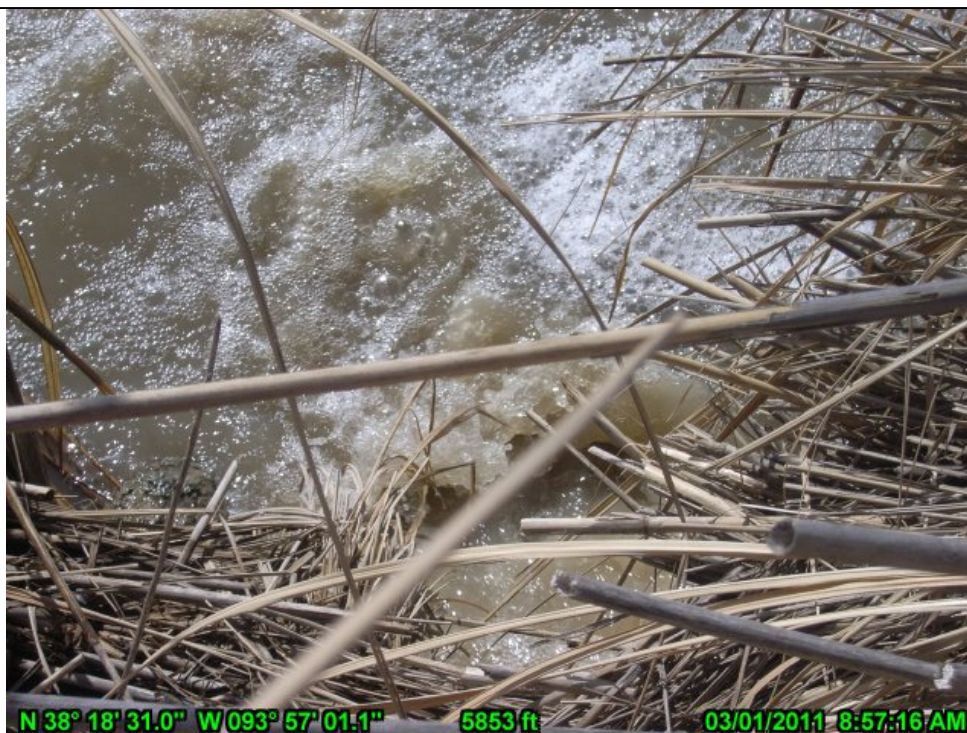
The South Pond has twin 24-inch decant CMPs connecting the primary and secondary settling ponds. Based on external visual inspection, the east pipe appears to be good condition with minor corrosion. Flow can be seen passing through the pipe; however, internal condition could not be verified. The west pipe appears to be passing flow; however, excessive vegetation obstructed visual inspection of the pipe. The 4-foot box outfall structure was in service and submerged at the time of the inspection. Outfall material, foundation, and general condition were not observed.

30-Outlet to East Decant Pipe

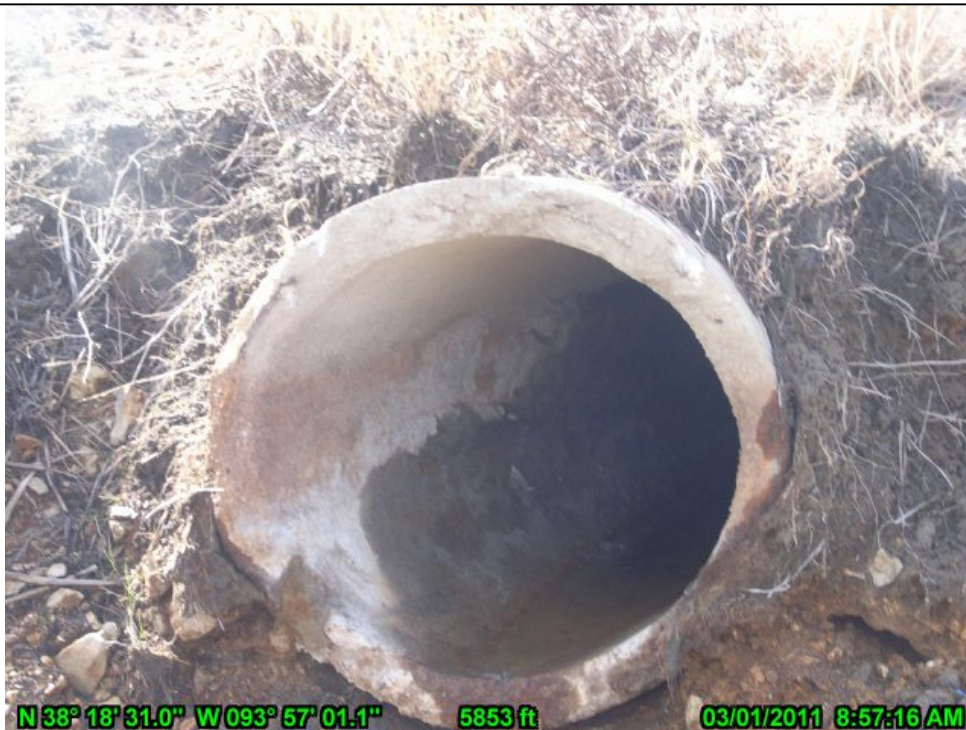
The North Pond has twin 24-inch RCP outfall pipes. Based on external visual inspection the pipes appear to be in fair condition with some concrete deterioration at the ends of each pipe. Flow was not seen passing through the pipes because the North pond was not in service at the time of inspection. The internal condition of the pipes could not be verified.

37-Outlet of North Pond Outfall

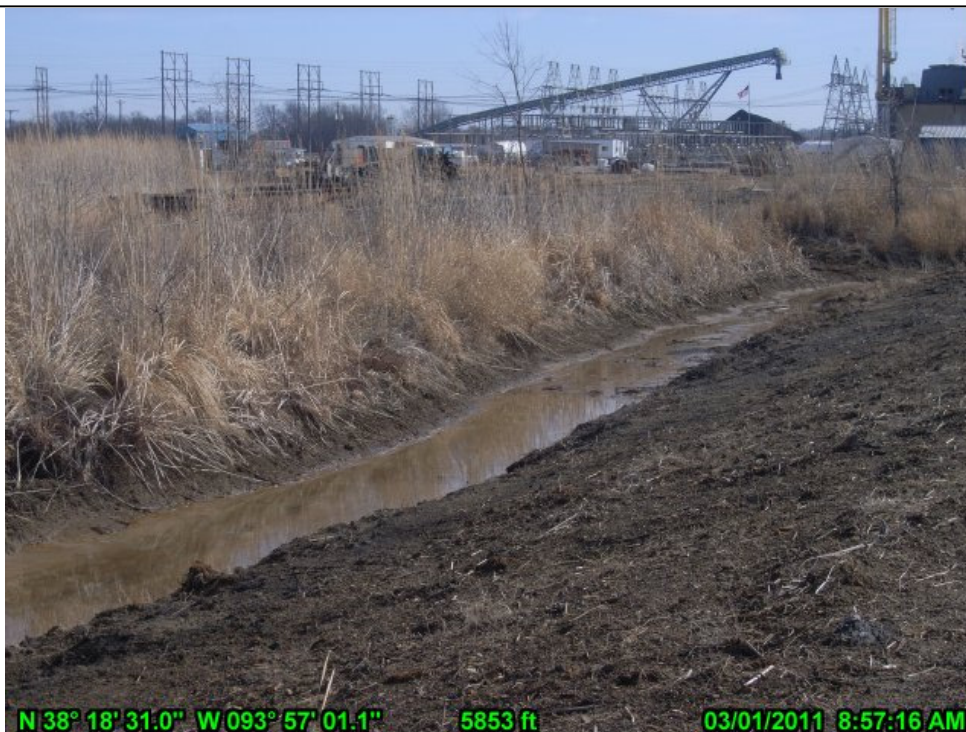
39-North Pond Drainage Ditch Looking Downstream

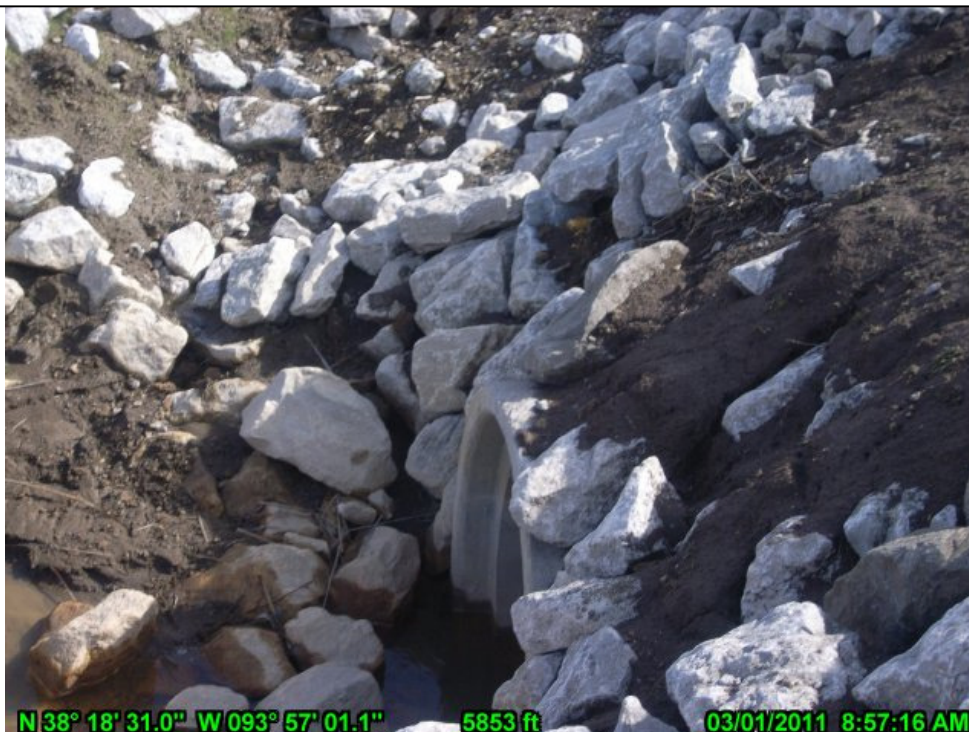
41-First Drainage Ditch Culvert Inlet (Replaced in 2010)

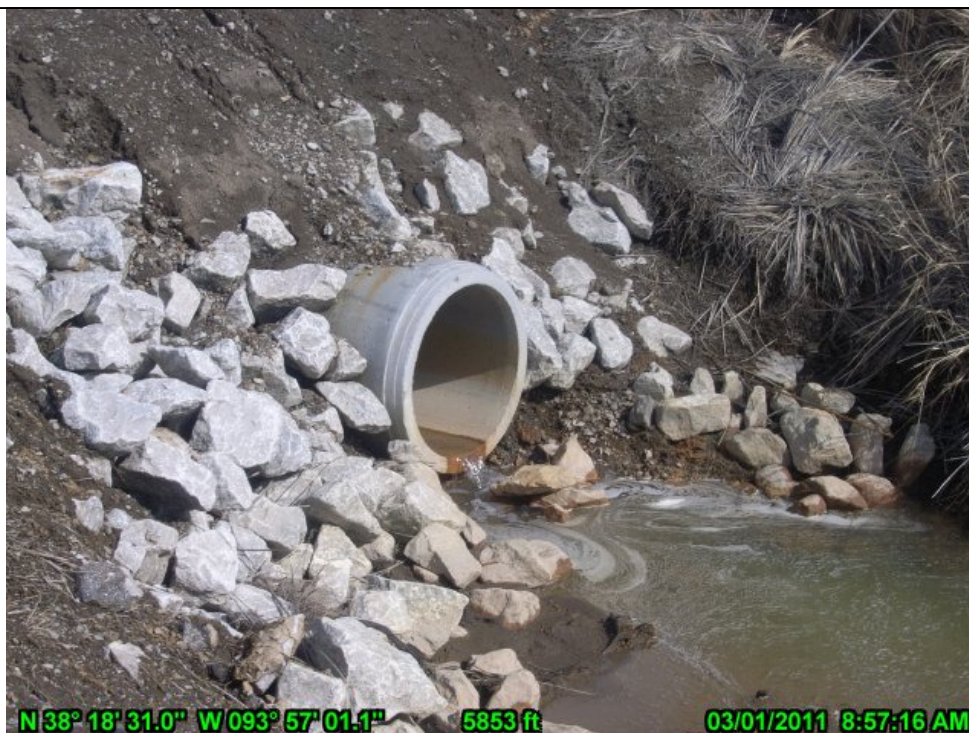
Overall, the incised slope of the impoundment was in satisfactory condition. Photographs 42 and 49 in Appendix B show the typical condition of the upstream slope. Specific observations include:

42-First Drainage Ditch Culvert Outlet (Replaced in 2010)

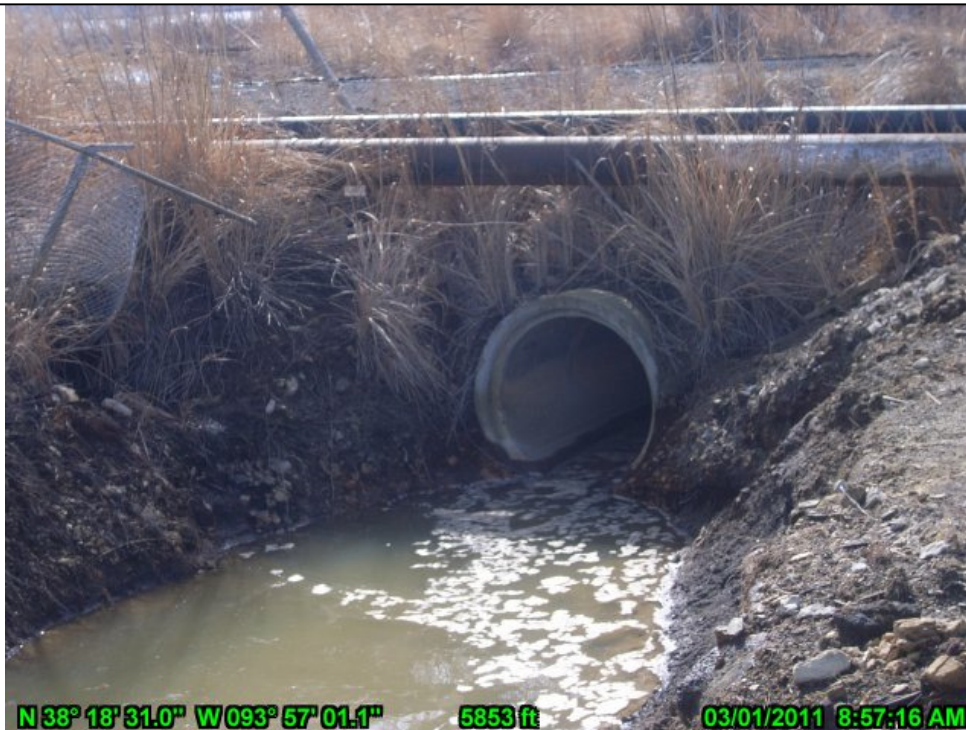
43-Second Drainage Ditch Culvert Inlet
