# COAL ASH IMPOUNDMENT SITE ASSESSMENT FINAL REPORT

MONTROSE GENERATING STATION  
KCP&L Greater Missouri Operations Company  
MONTROSE, MISSOURI

December 2011

**KLEINFELDER PROJECT NUMBER 116664-1**

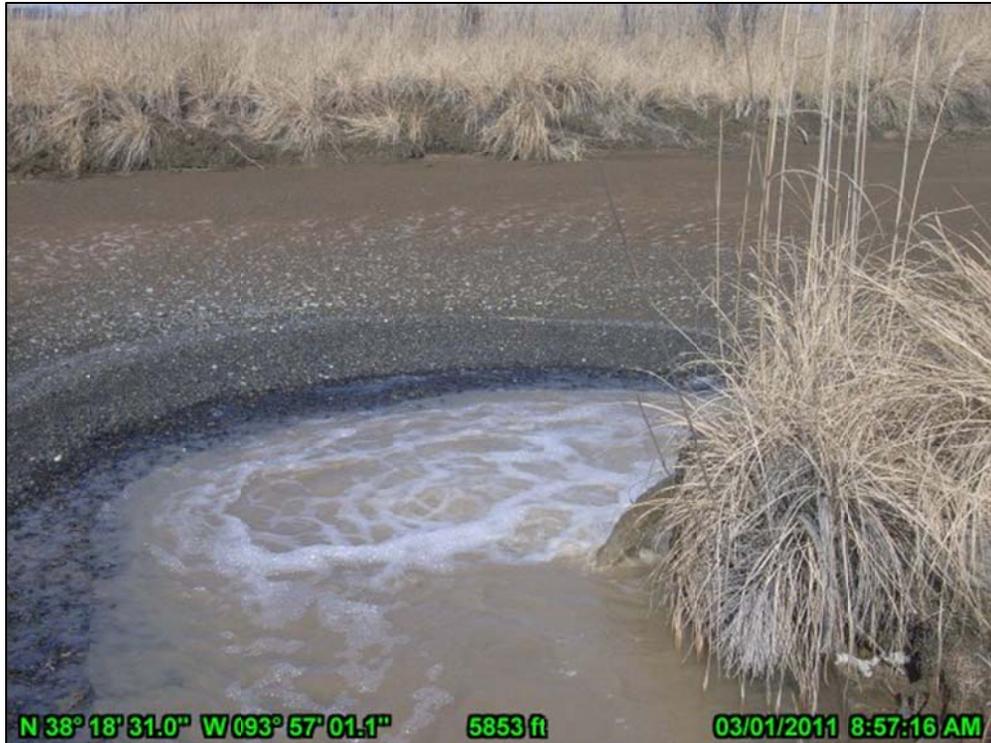
Inflow into the South Ash Pond includes metal pipes on the east side of the impoundment, as well as storm water runoff that flows naturally into the pond. The inlet channel showed some erosion of the bank. The inlet pipe appeared to be in satisfactory condition. The Inlet pipe can be seen in Photographs 3 and 4.

3-Inlet Pipe to North and South Ponds

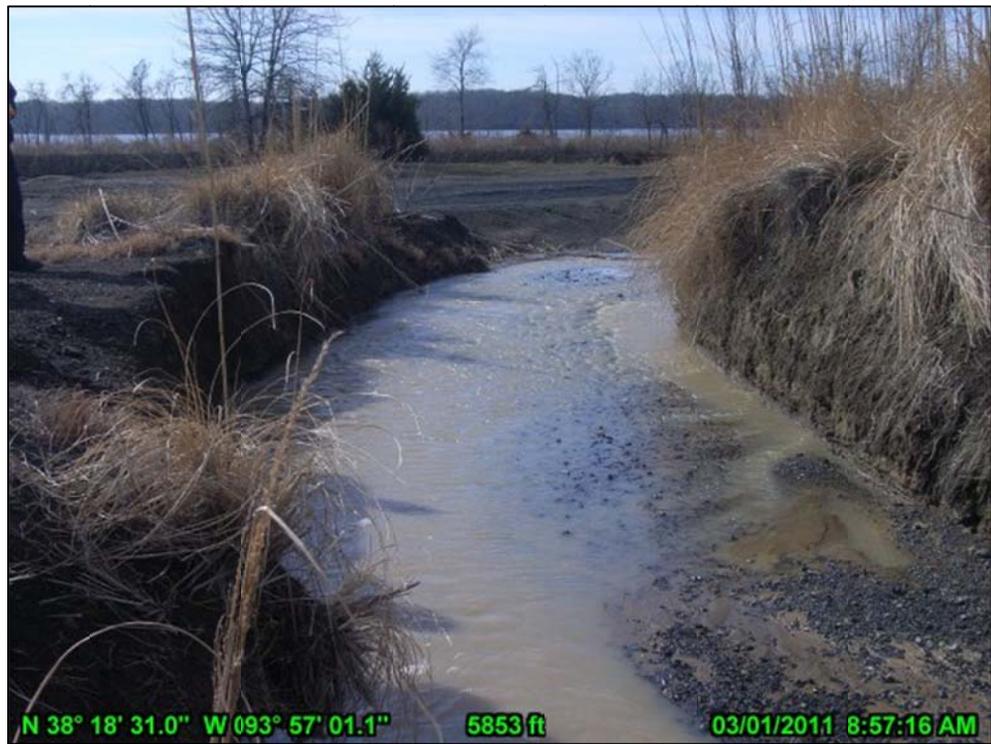
4-South Pond Inlet Channel Looking South

- South Ash Pond inlet where higher velocity flows have eroded the impoundment slope and caused minor caving.
  - Drainage ditch slope near the southern culvert shows some erosion, which likely caused the adjacent chain-link fence to fall over.

2. **Repair erosion on impoundment slope and drainage ditch.** Areas where erosion has occurred should be filled in and re-dressed with appropriate fill to prevent erosion from cutting further into the impoundment slopes. Areas of concern include:

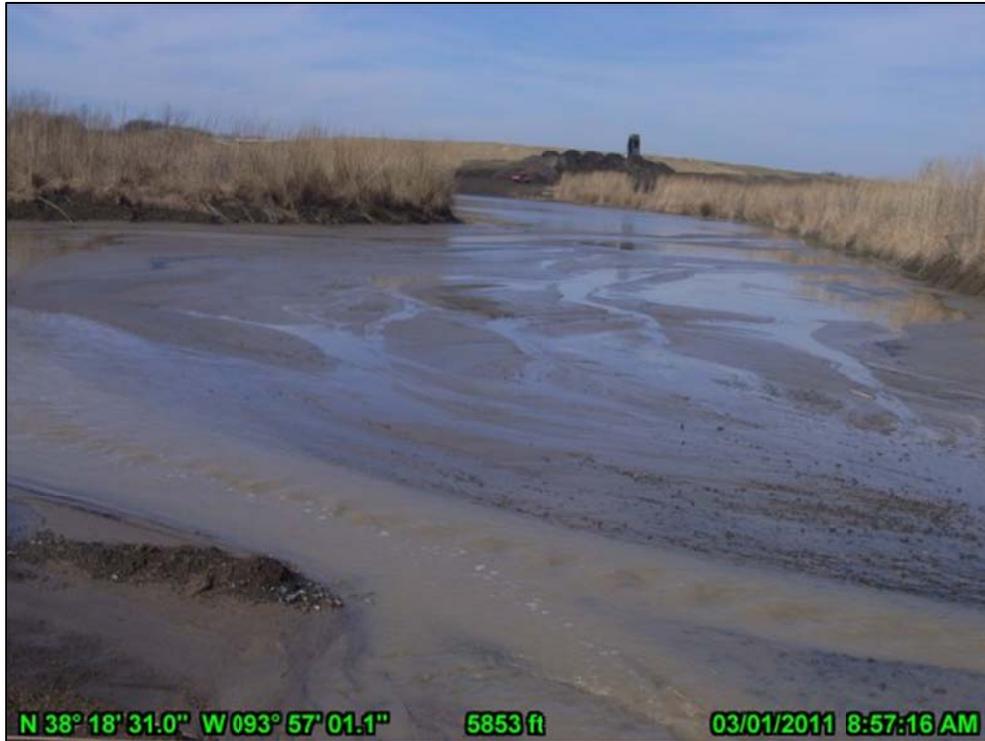
Overall, the incised slope was in satisfactory condition. Photographs 5, and 7 through 10 show typical conditions of the incised slope. Specific observations include:

5-East Side of South Pond Looking West

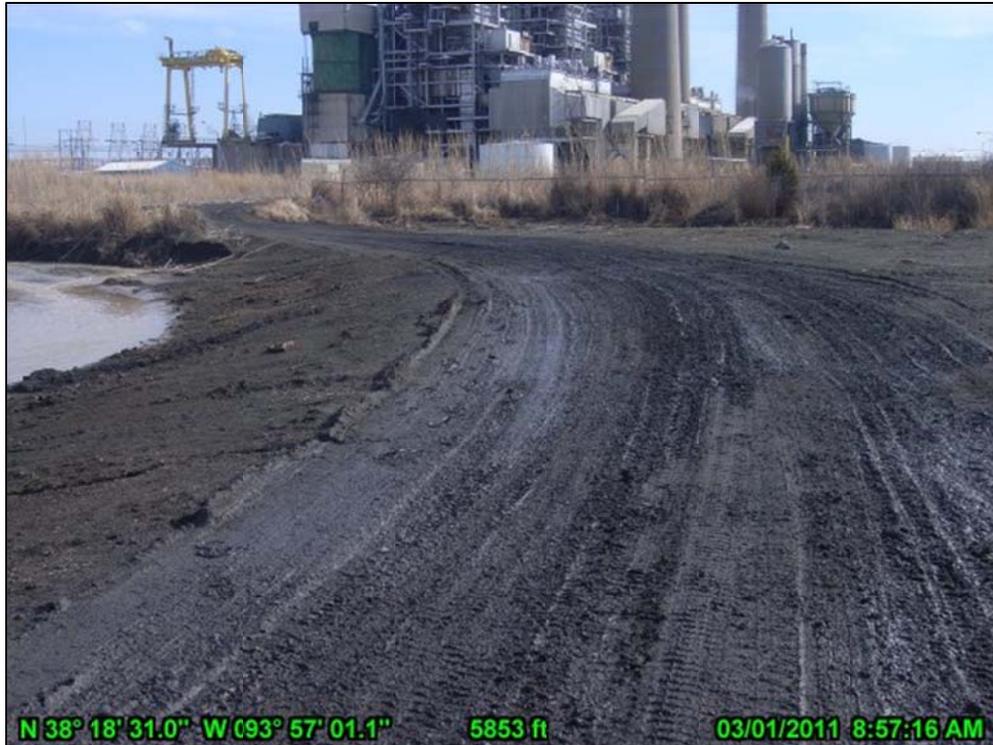
Overall, the crest of the impoundment was in satisfactory condition. Photograph 7 shows the typical condition of the crest. Specific observations include:

7-Embankment Adjacent to Inlet Channel Looking East

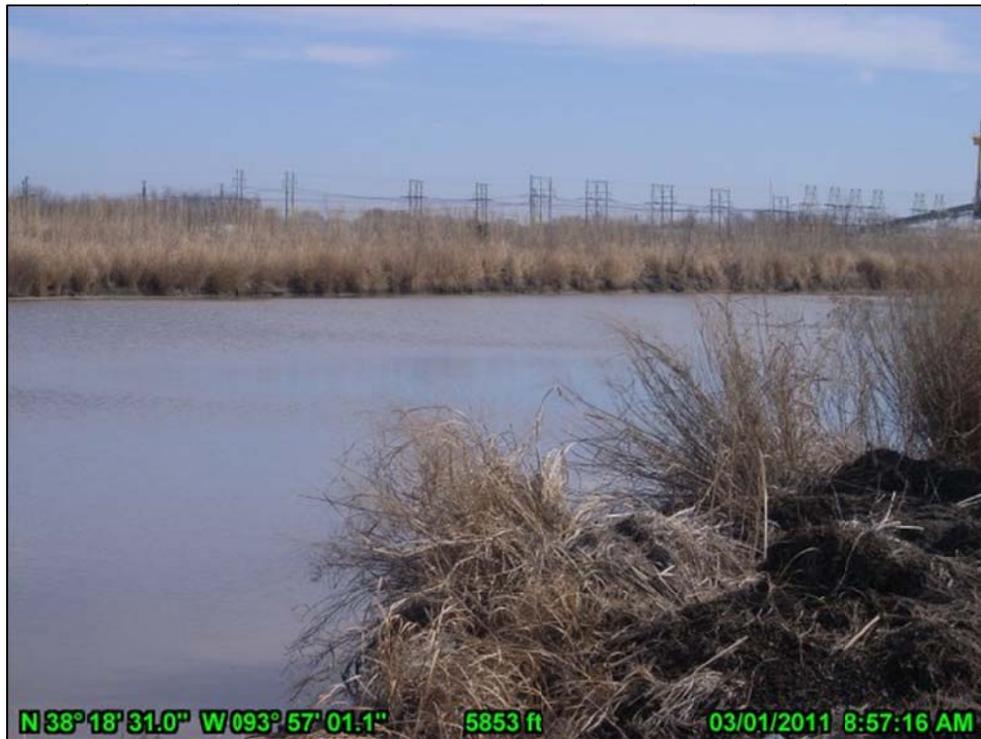
8-Primary South Pond Looking Northeast

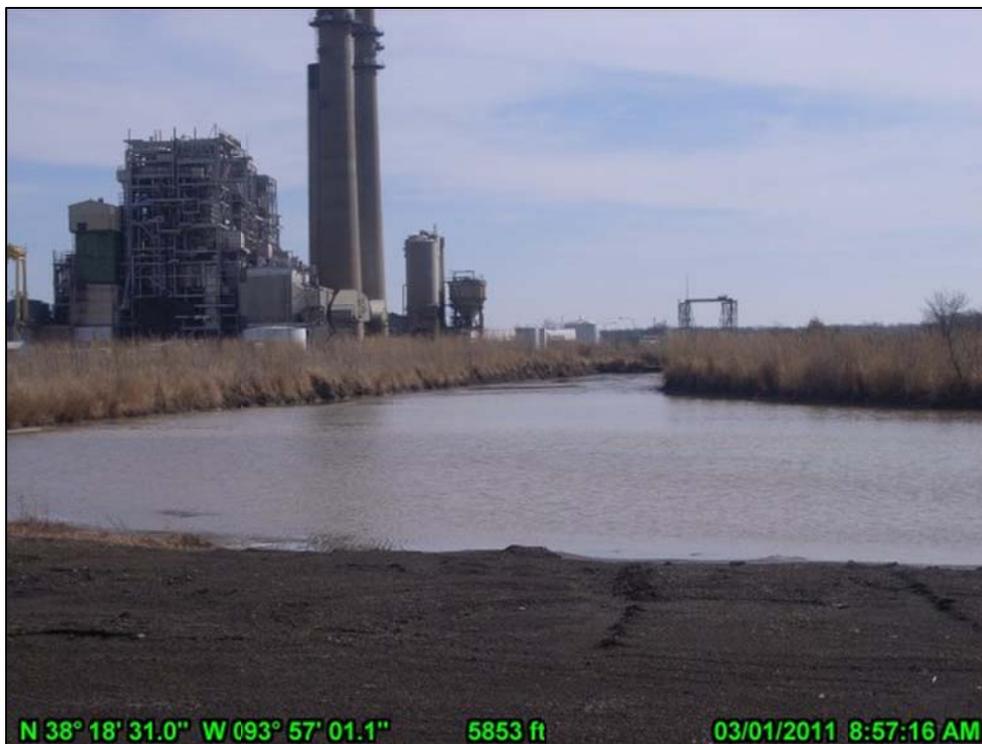
9-Primary South Pond Looking East

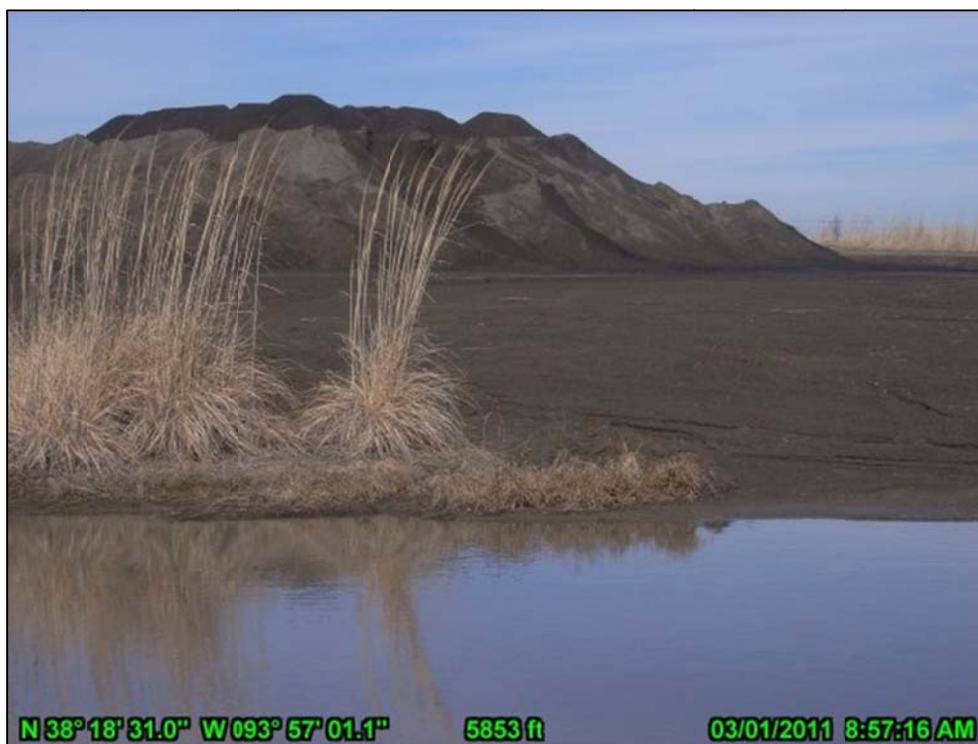
10-Primary South Pond Looking Northwest

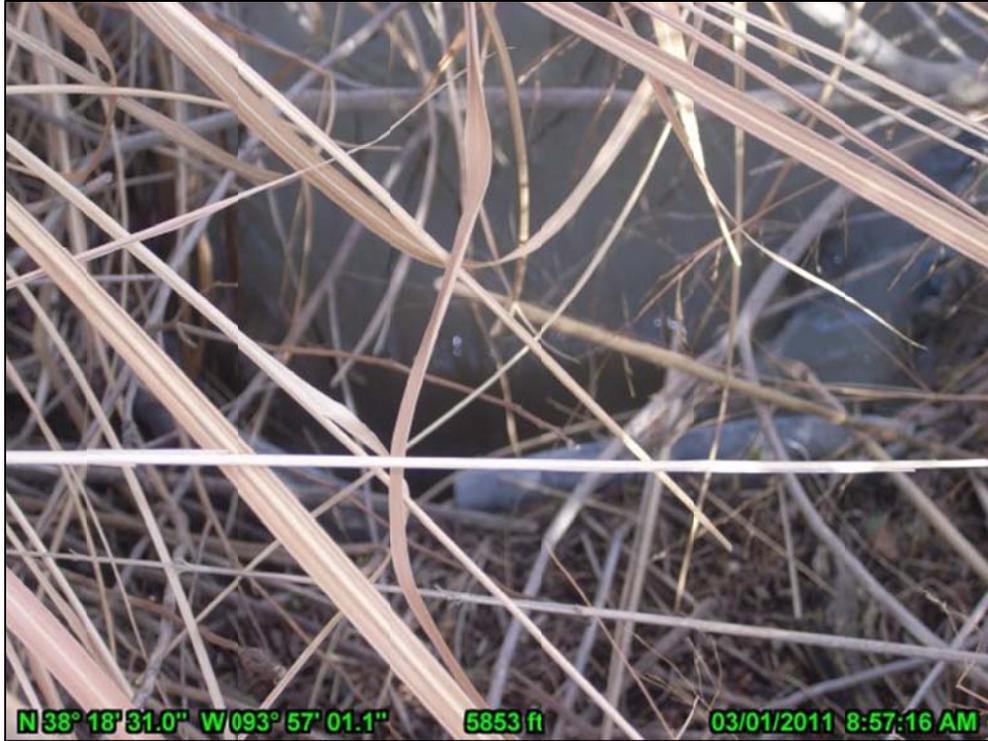
Excessive vegetation was observed around the pipe inlets and outlets. View of the west pipe inlet and outlet was not visible and not inspected. Flow appeared to be passing through both pipes; however internal condition of the pipes was not verified. The decant pipes are shown in Photographs 11 through 14, and 16.

11-Inlet to East Decant Pipe

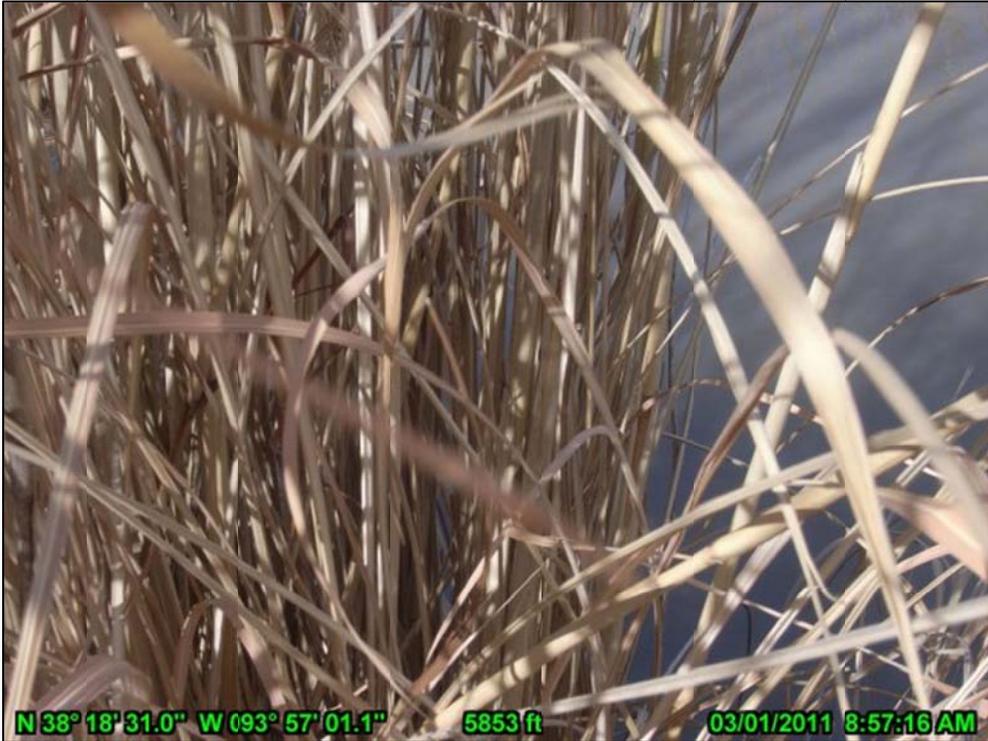
12-Approximate Location of Inlet to West Decant Pipe

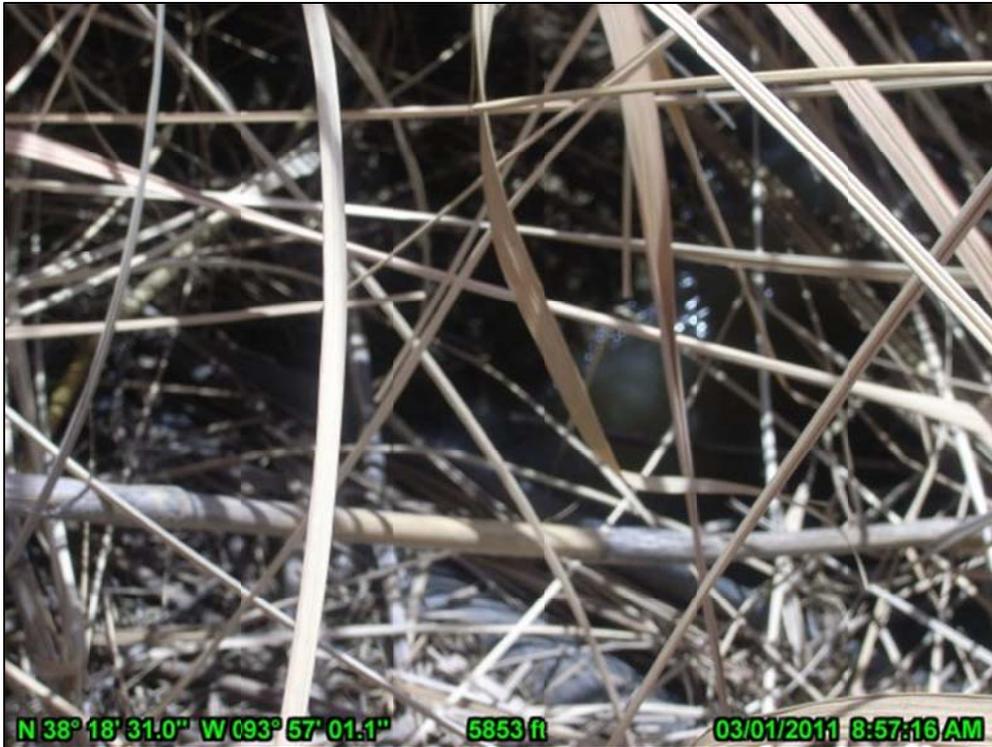
13-Outlet to West Decant Pipe

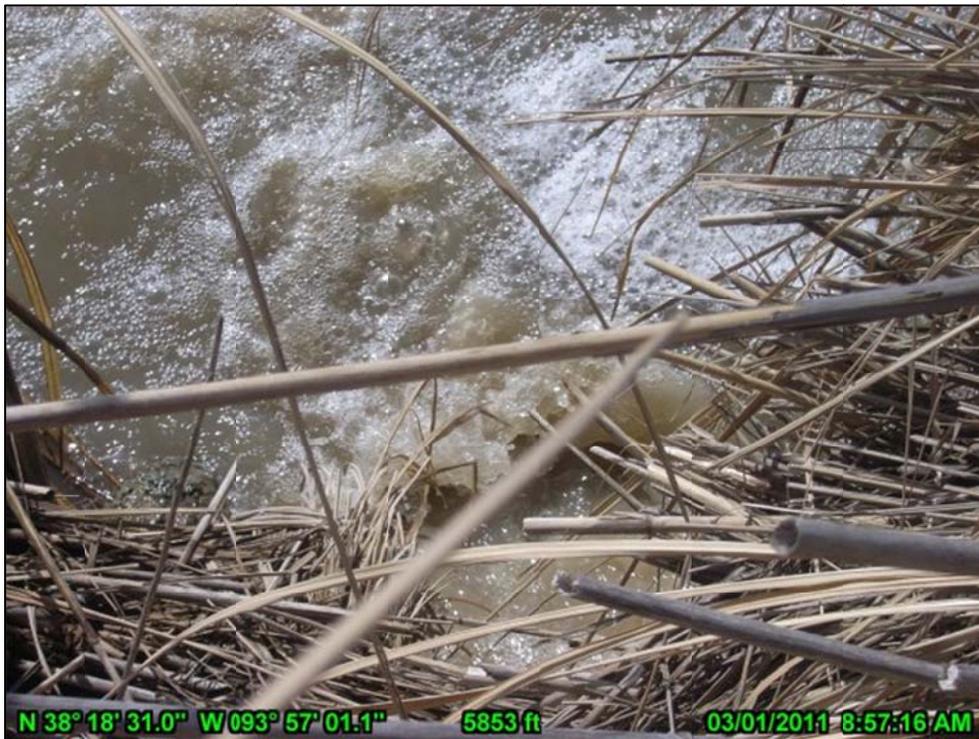
14-Outlet to East Decant Pipe

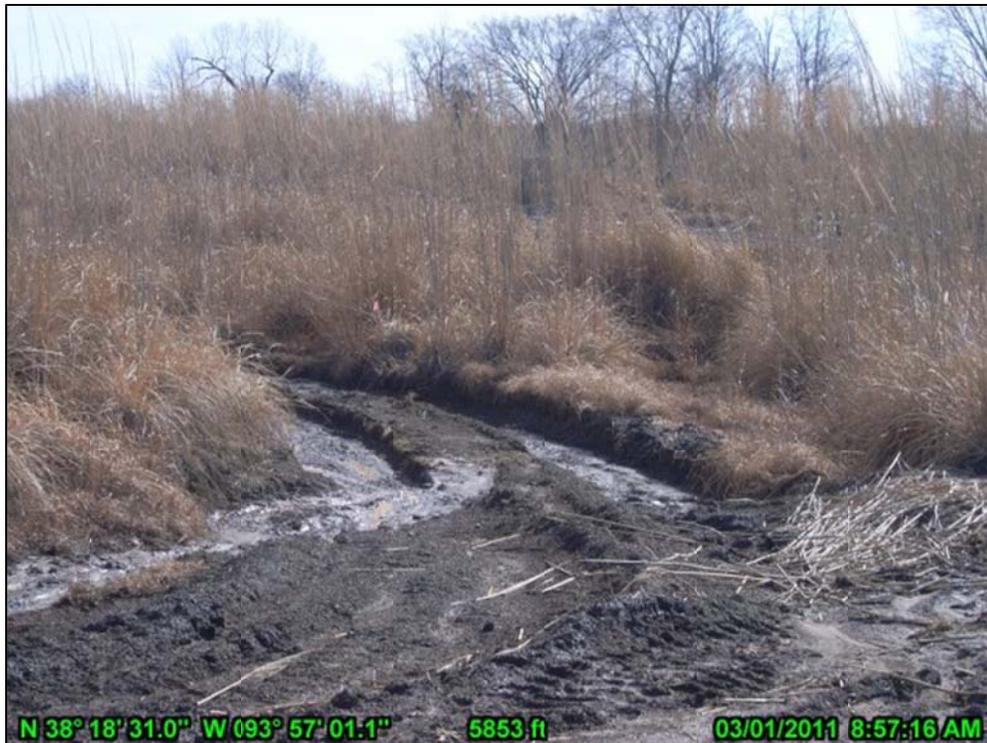
15-Erosion on West End of South Pond Looking South

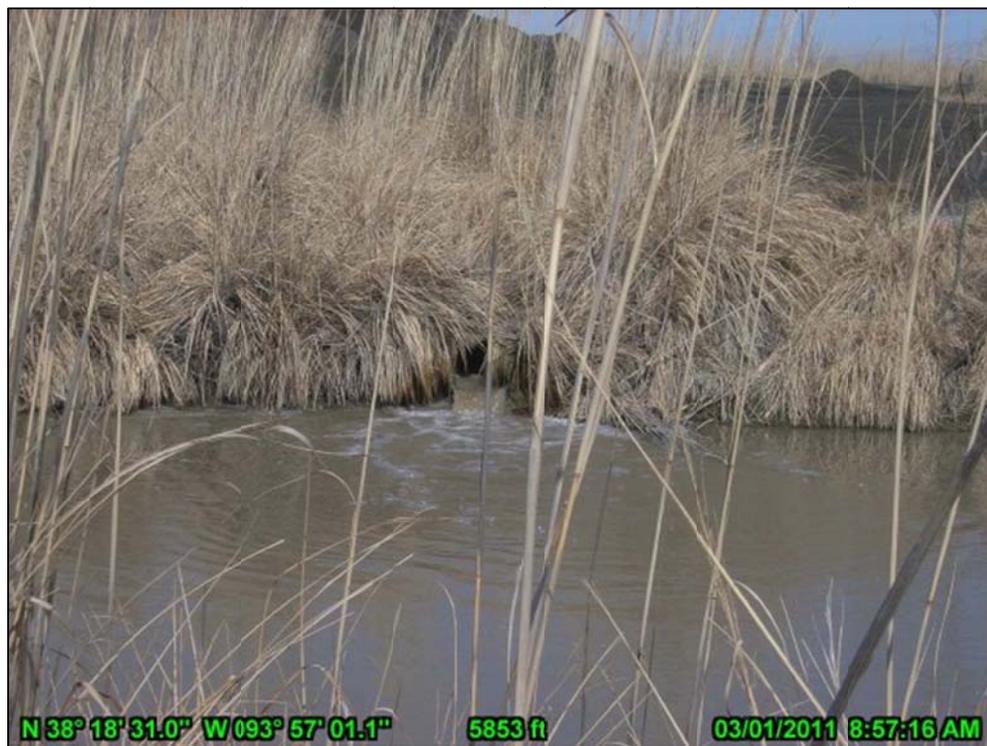
16-South Pond Decant Outlet Looking North (West Pipe Not Visible)

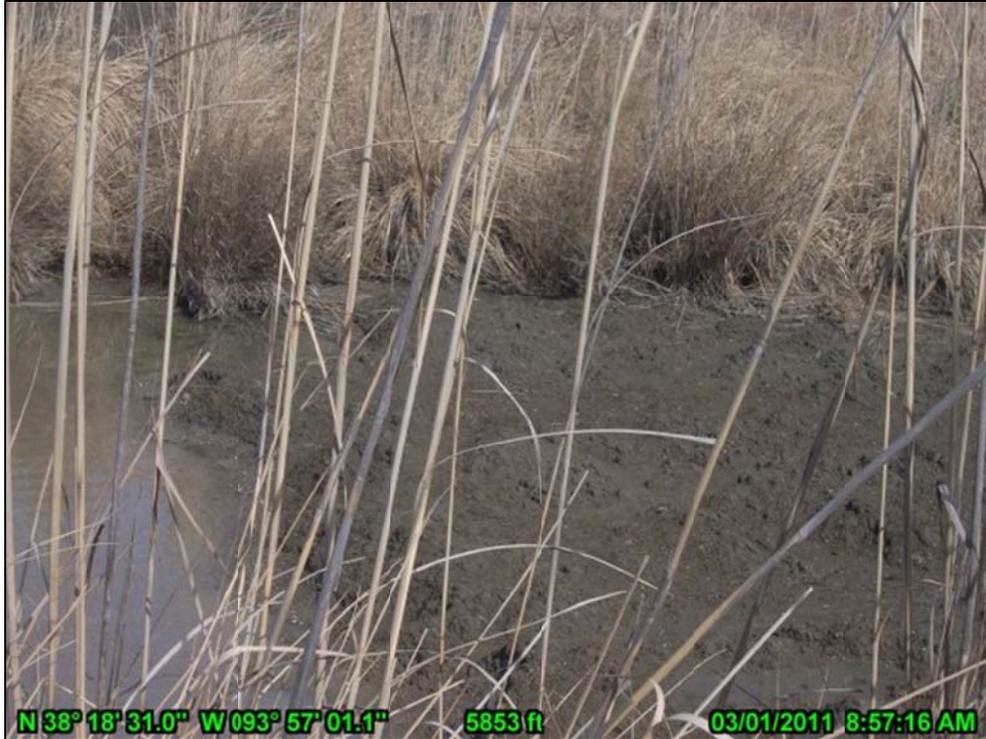
A soil and ash obstruction was observed to impede the flow in the secondary pond after the decant pipes. The debris was about 3-4 inches above the

17-Soil and Ash Obstruction in Secondary South Pond

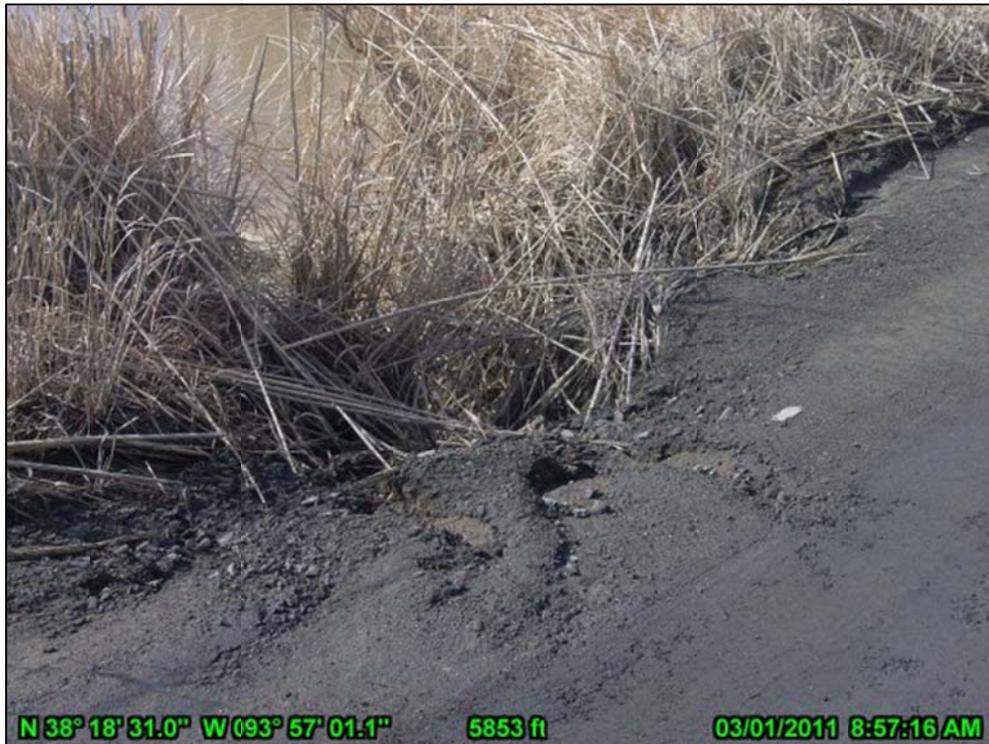
18-Erosion on Land Side of Embankment near Discharge Canal

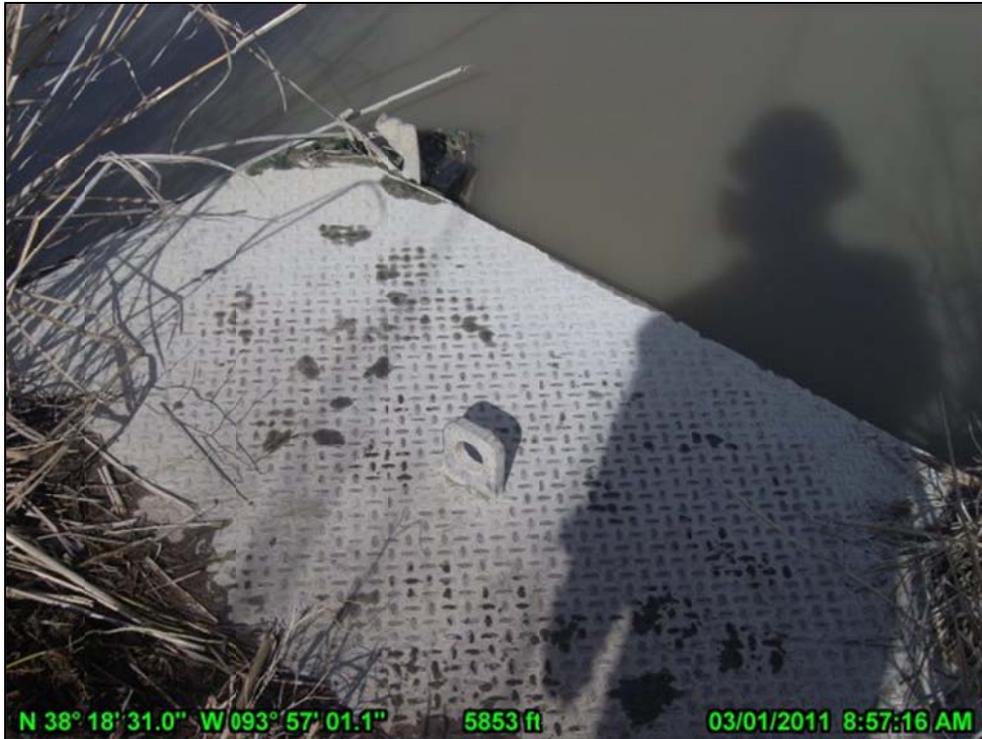
The outlet works appeared to function properly and was passing water; however the structure and foundation was submerged and not visible. The steel cover to the outlet works inlet was in satisfactory condition and showed minor corrosion. The outlet works can be seen in Photographs 19 and 21.

19-South Pond Intake to Outfall

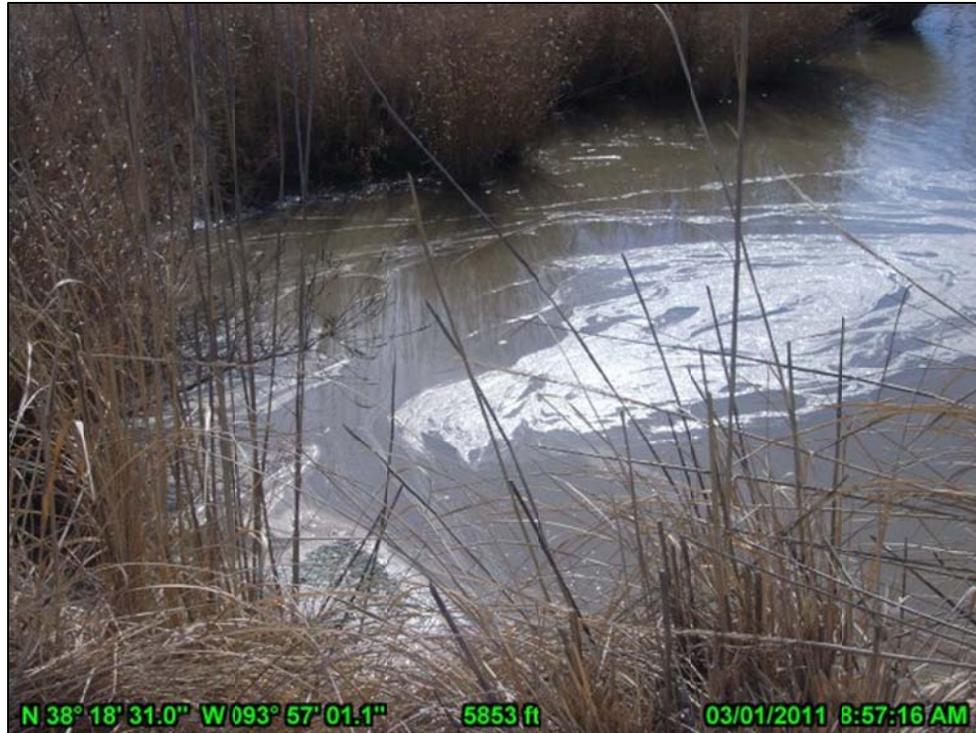
21-Outlet of South Pond Outfall

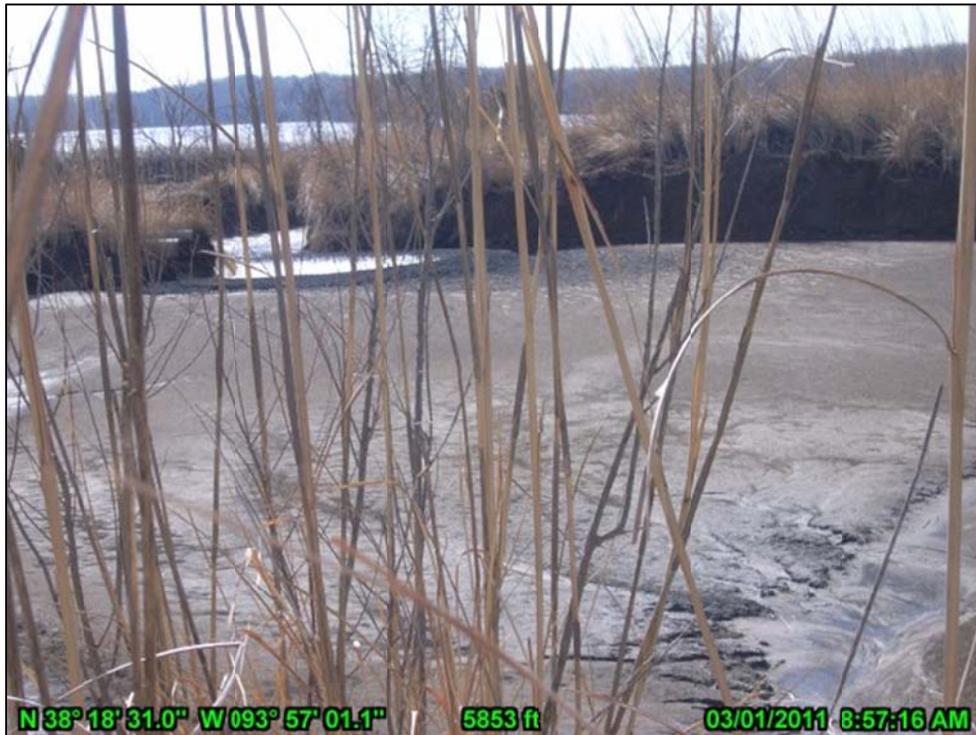
Overall, the incised slope of the impoundment was in satisfactory condition. Photographs 22, 23, and 24 show the typical condition of the incised slope. Specific observations include:

22-Inlet Area of North Pond Looking Southeast

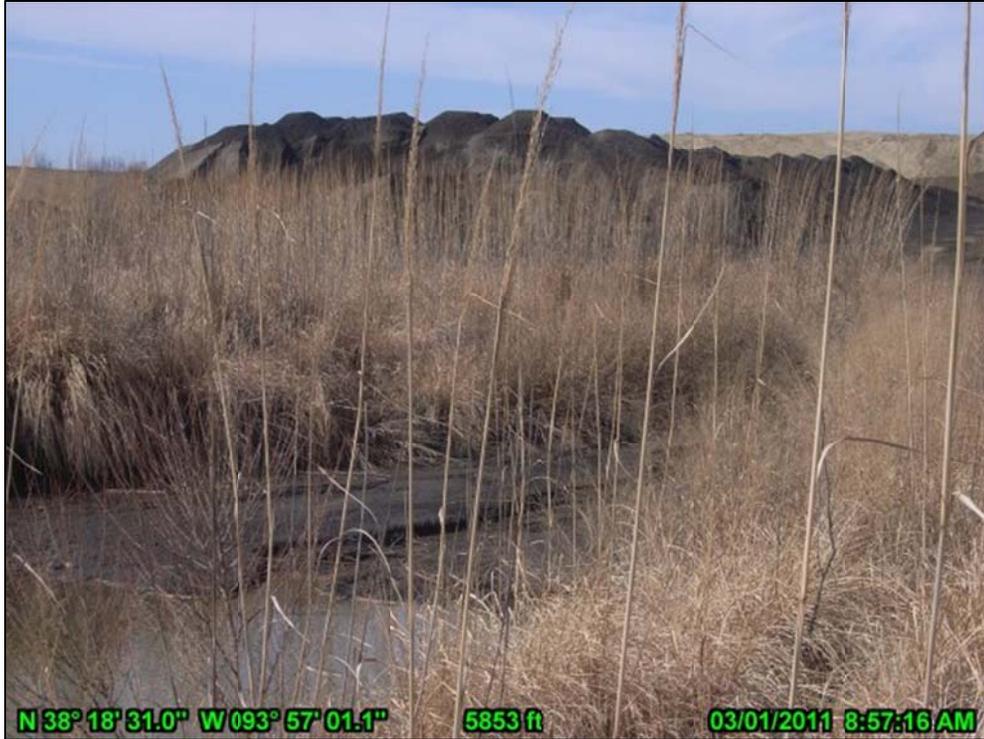
23-Erosion on West Bank of North Pond

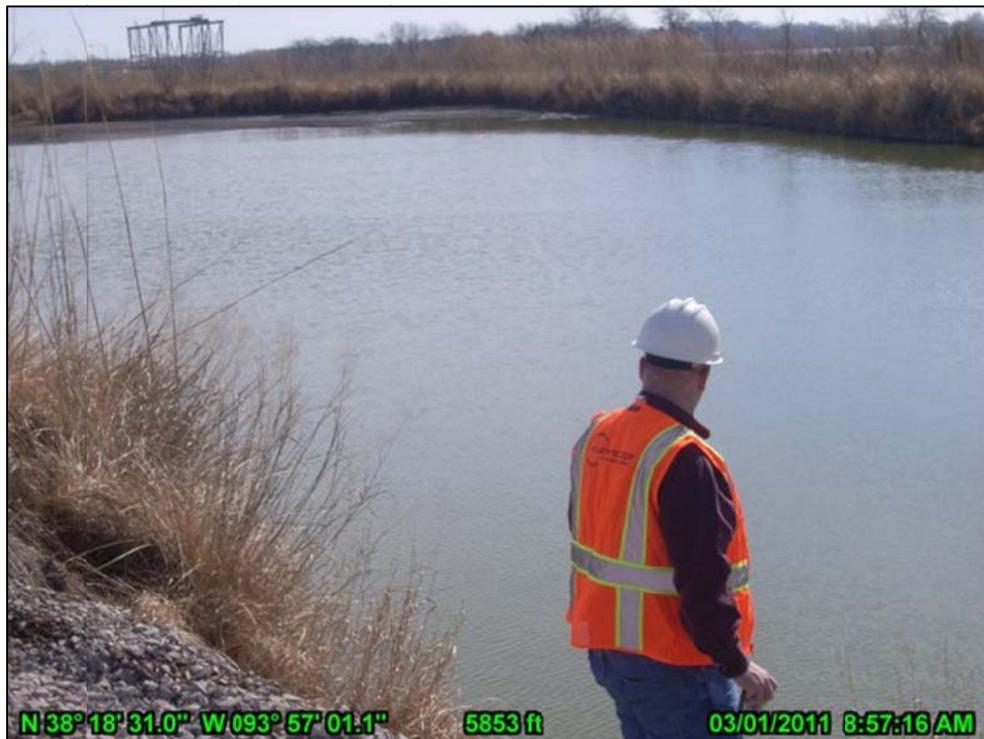
24-North Pond Looking Southeast

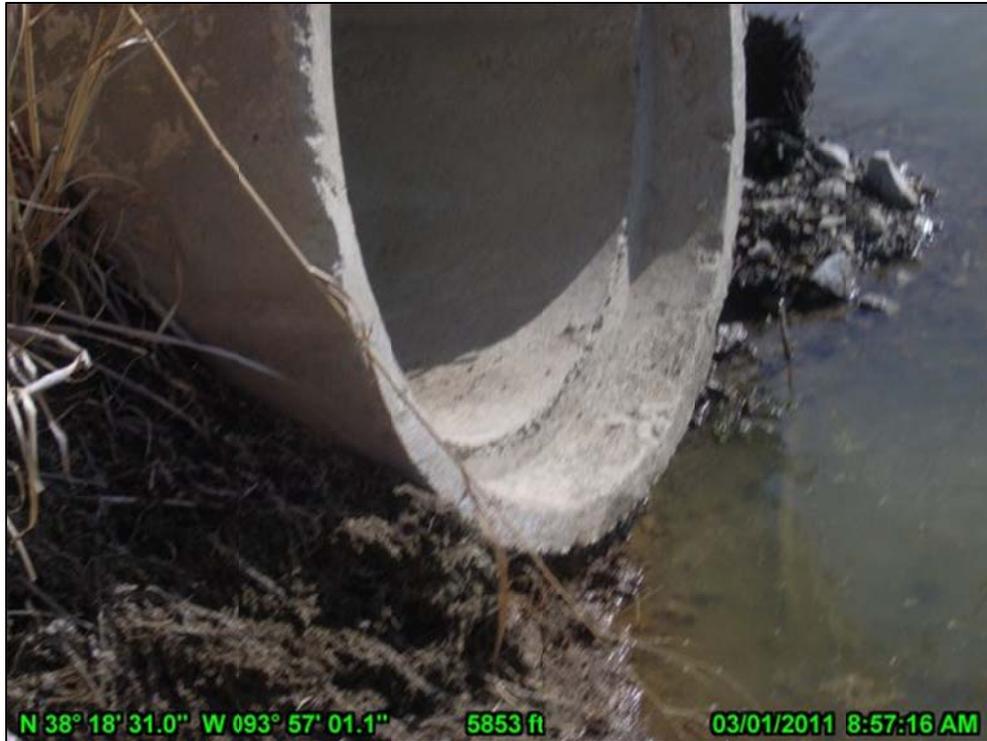
The North Pond has twin 24-inch RCP outfall pipes. Based on external visual inspection the pipes appeared to be in fair condition with some concrete deterioration at the ends of each pipe. Flow was not seen passing through the pipes because the North pond was not in service at the time of inspection. The internal condition of the pipes could not be verified.

25-Inlet to North Pond Outfall

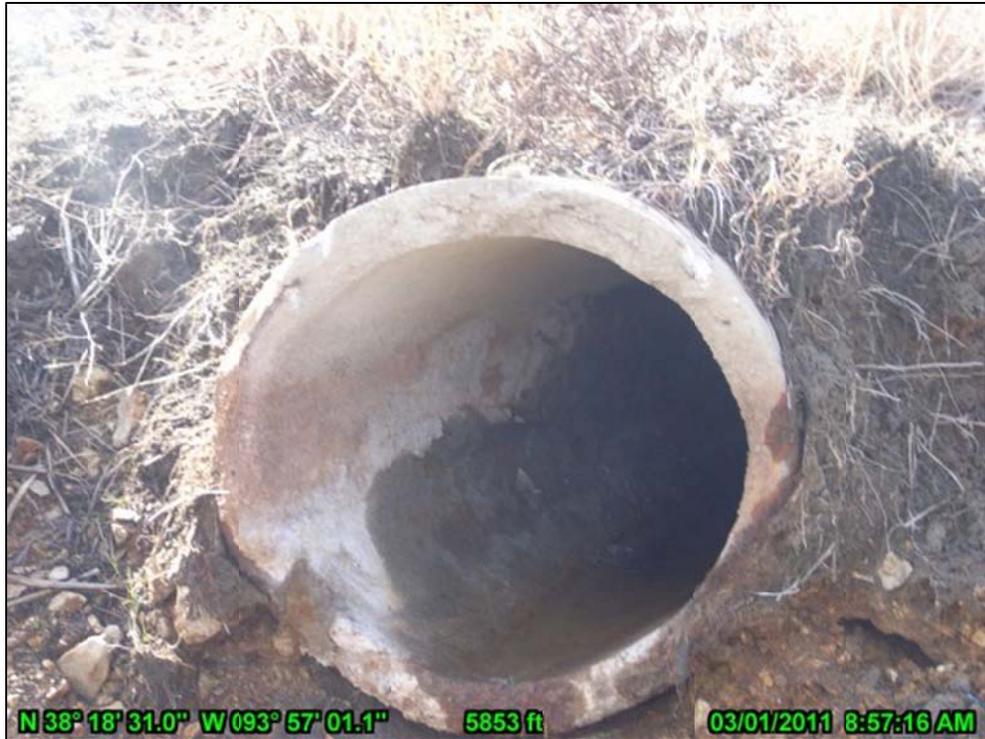
27-Outlet of North Pond Outfall

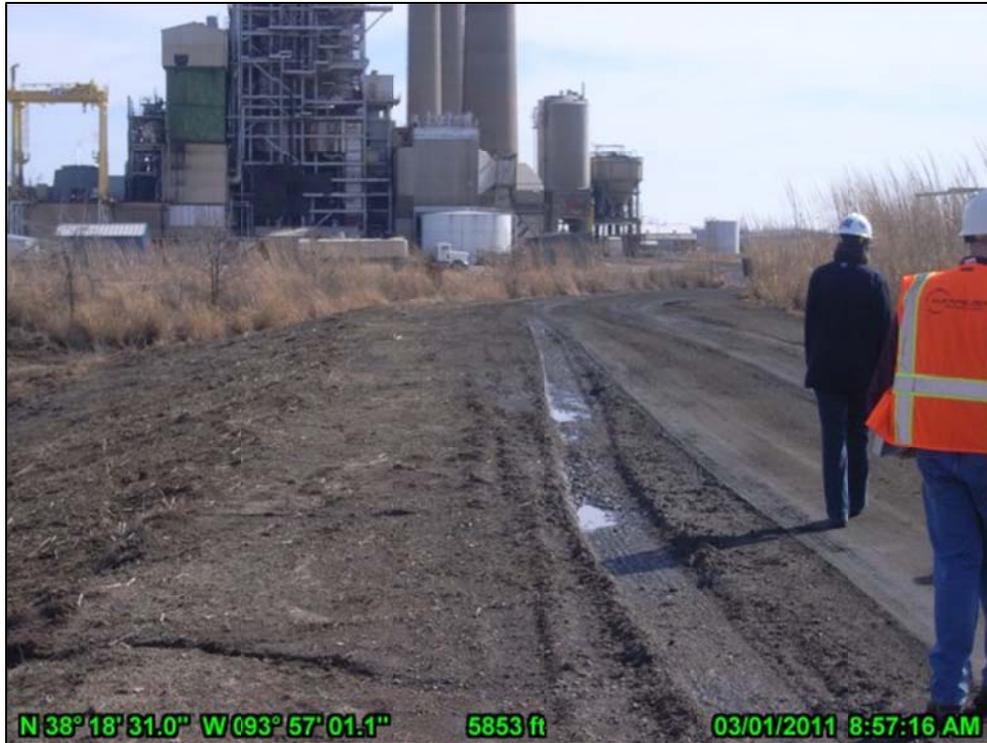
Overall, the crest of the impoundment was in satisfactory condition. Photograph 29 shows the typical condition of the crest. Specific observations include:

29-North Pond North Embankment Looking East

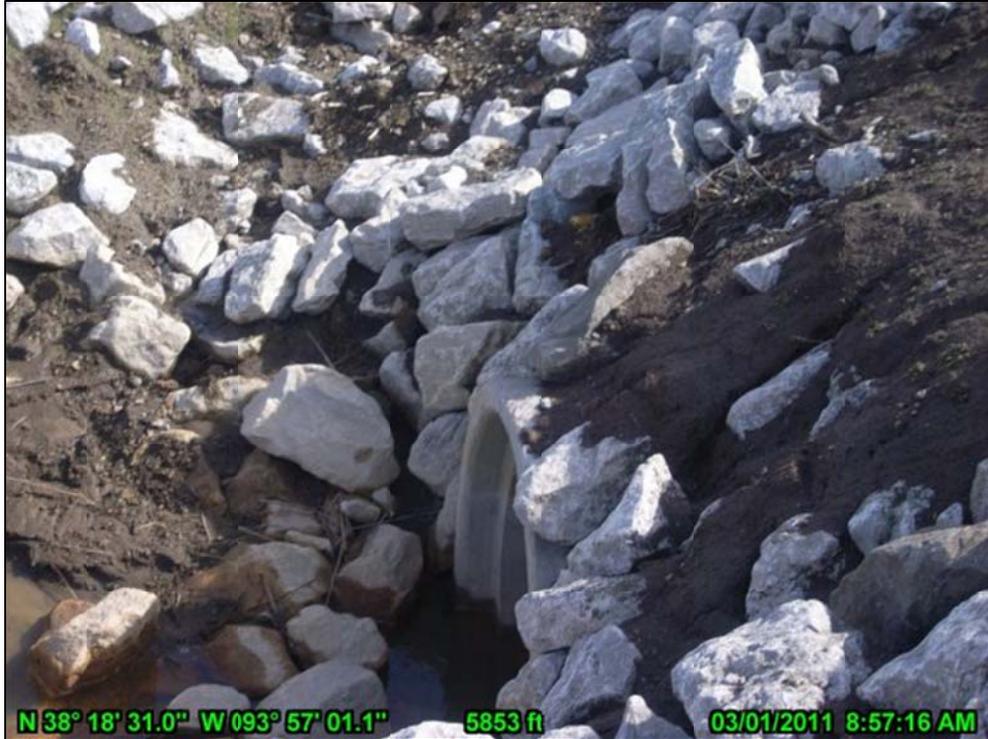
Overall, the incised drainage ditch was in satisfactory condition. The first culvert on the north side was recently replaced and some riprap protection was present (Photographs 31, and 32). The second culvert showed some erosion on the upstream side and a chain-link fence had fallen down (Photographs 33 and 34). No vegetation or channel armor was present on the south side of the channel (Photograph 39).

31-First Drainage Ditch Culvert Inlet (Replaced in 2010)

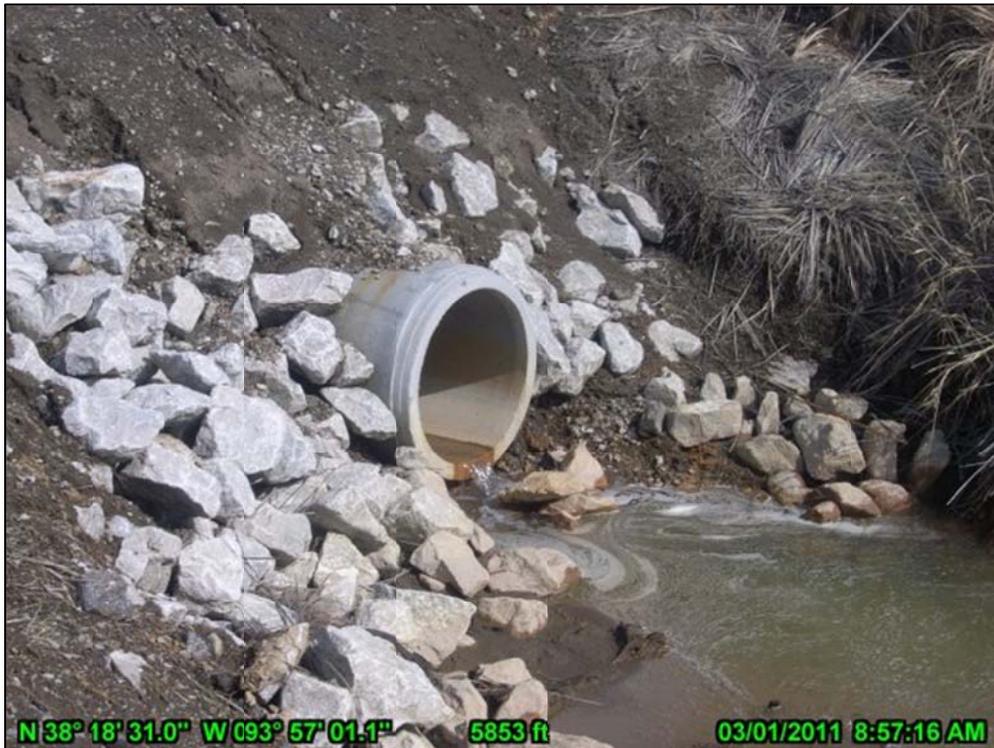
32-First Drainage Ditch Culvert Outlet (Replaced in 2010)

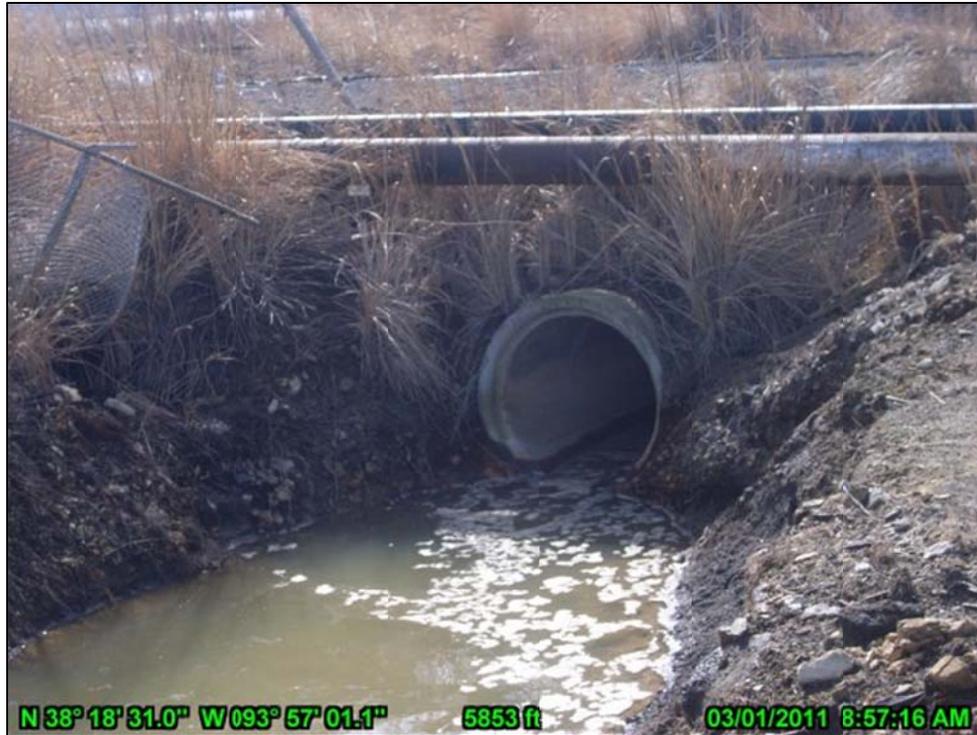
33-Second Drainage Ditch Culvert Inlet

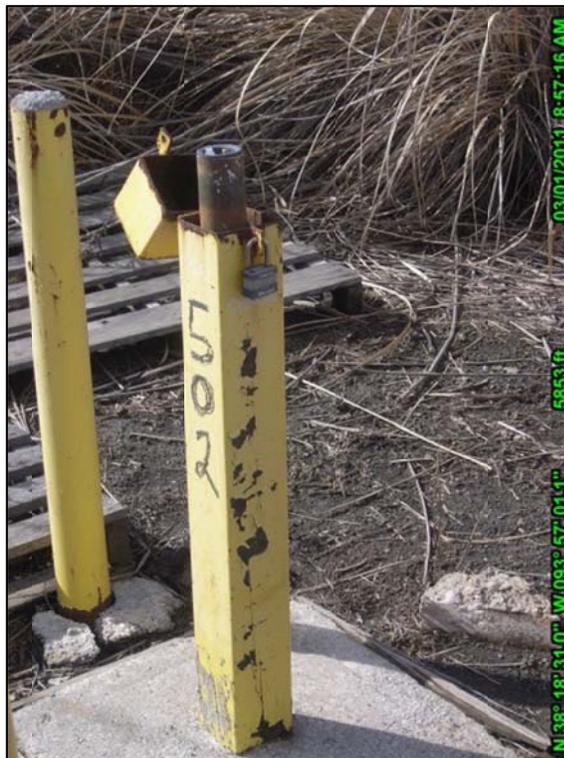
No historical seepage has been reported and none was observed at the time of inspection due to the absence of a landside slope. One Piezometer is located on-site to the South of the South Pond shown in Photographs 29 and 30; however, it is Kleinfelder’s understanding that this is used to monitor other operations.

37-Piezometer Not Used for Ash Ponds

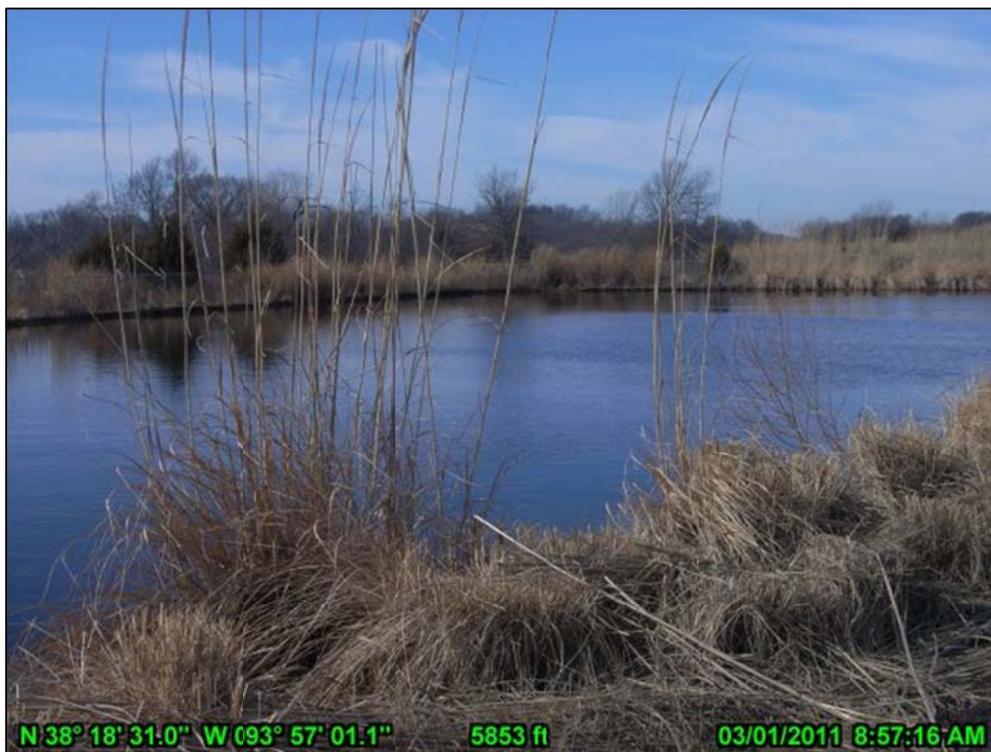
39-Metal Washing Discharge Pond
