Report of Geotechnical Investigation  
Dam Safety Assessment of Coal Combustion  
Surface Impoundments  
Kentucky Utilities, a Subsidiary of E.ON U.S.  
Green River Station, Central City, KY

AMEC Project No. 3-2106-0177-0002

September 2010

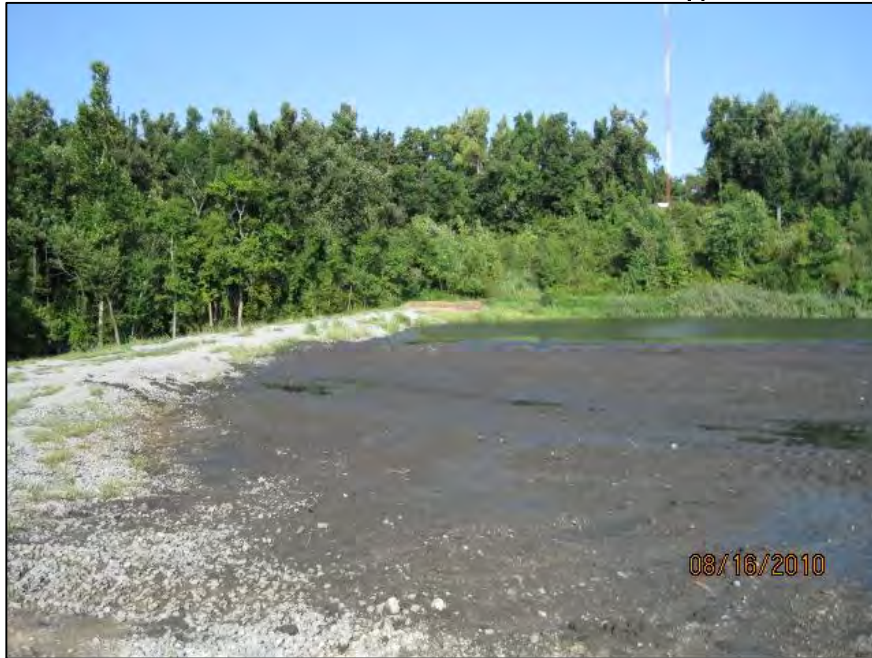
**M-1**

**LOOKING NW AT WEST DIKE - CREST, UPSTREAM SLOPE, POND INTERIOR**

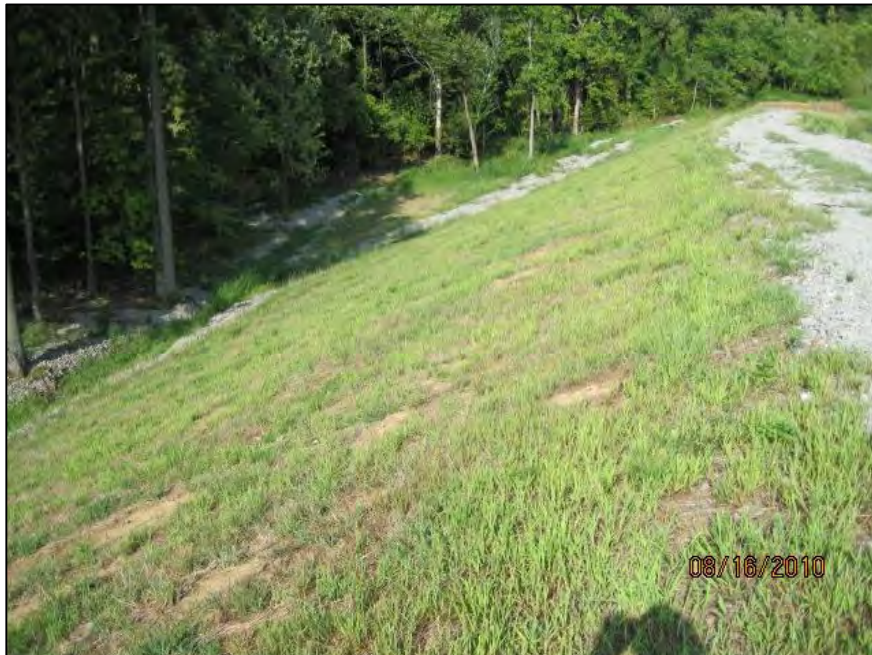
**M-2**

**LOOKING NW AT WEST DIKE - CREST AND DOWNSTREAM SLOPE, SPARSE GRASS COVER**

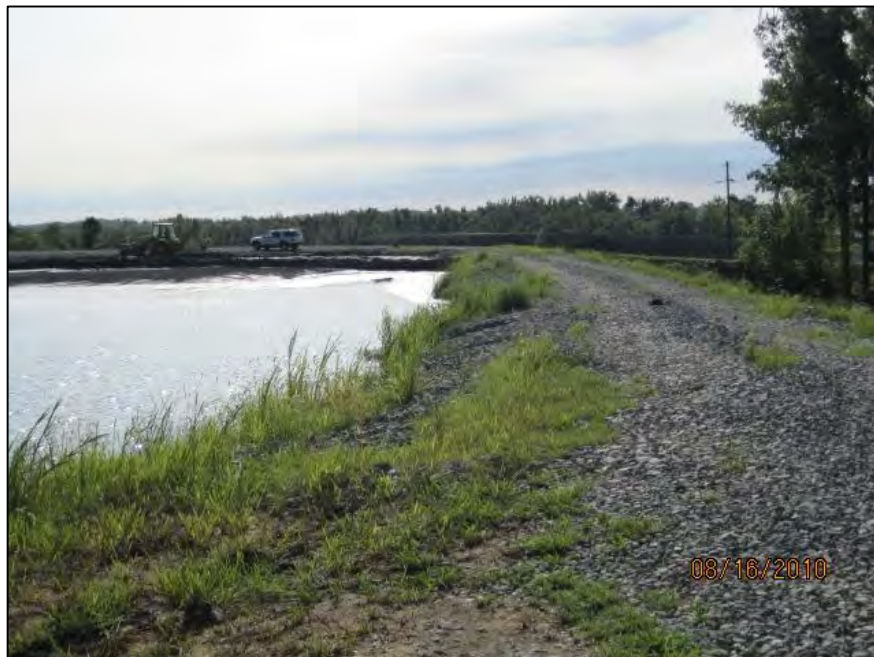
**M-4**

**LOOKING S AT WEST DIKE - CREST AND UPSTREAM SLOPE**

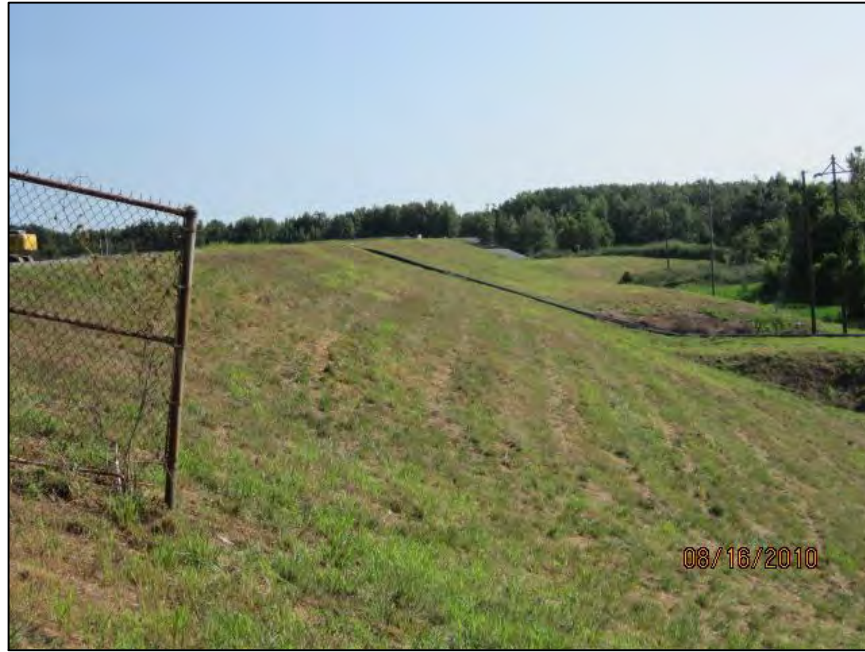
**M-5**

**LOOKING E FROM WEST END OF SOUTH DIKE - DOWNSTREAM SLOPE**

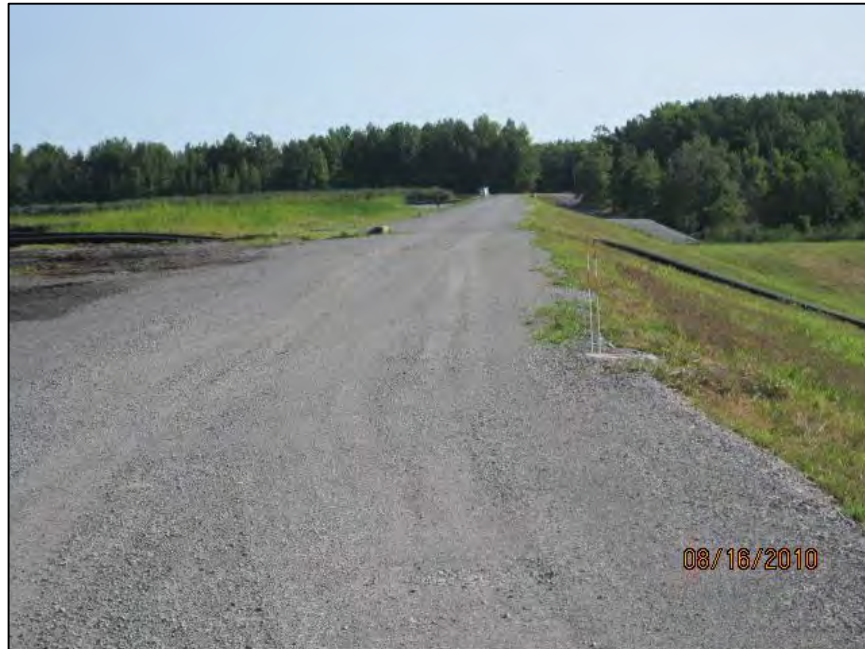
**M-6**

**LOOKING E FROM WEST PORTION OF SOUTH DIKE -  
CREST, NEW PZ-P3A ON SOUTH EDGE OF ROAD**

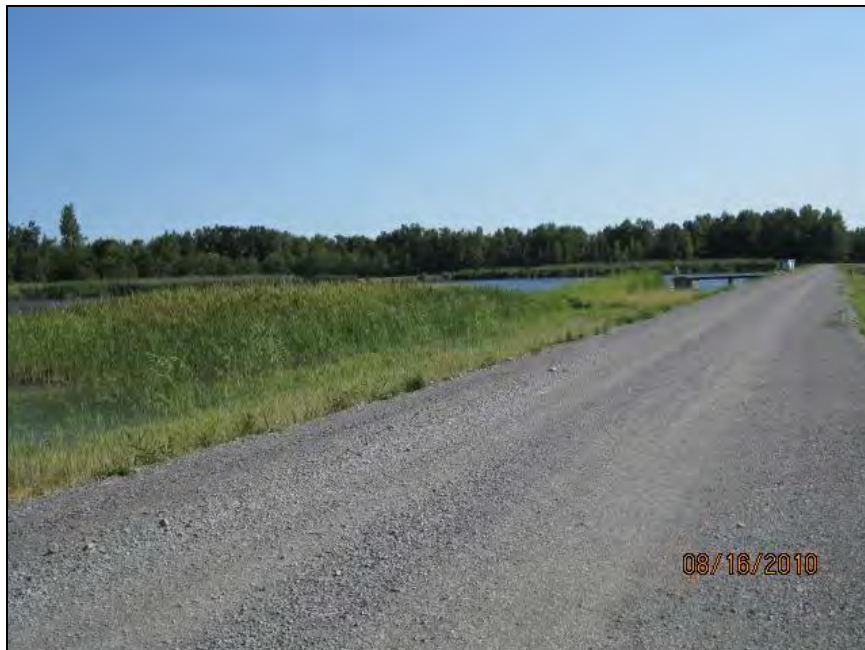
### M-10

LOOKING E FROM SOUTH DIKE - CRUSHED STONE CREST,  
UPPER POND INTERIOR AND OUTLET STRUCTURE

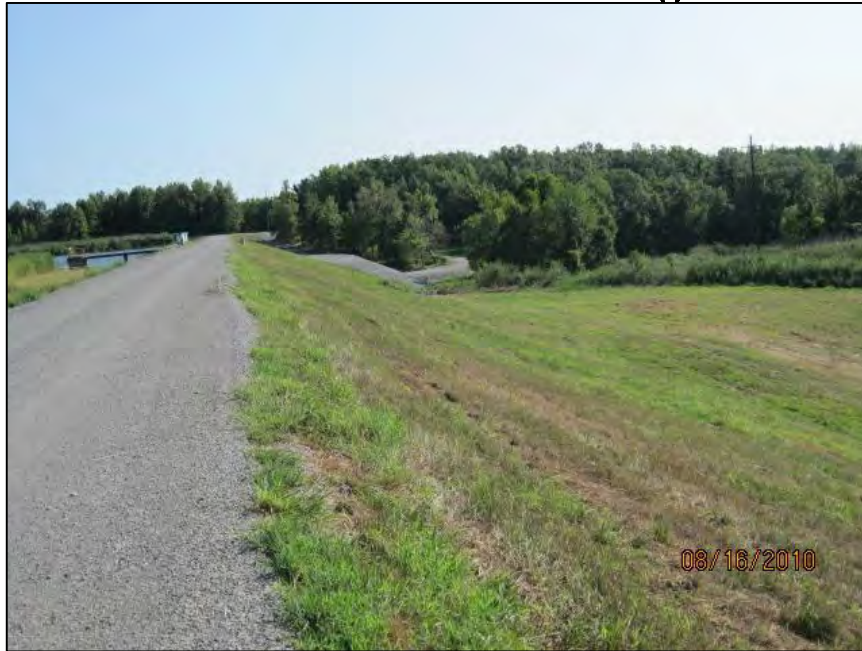
**M-11**

**LOOKING E FROM SOUTH DIKE - DOWNSTREAM SLOPE**

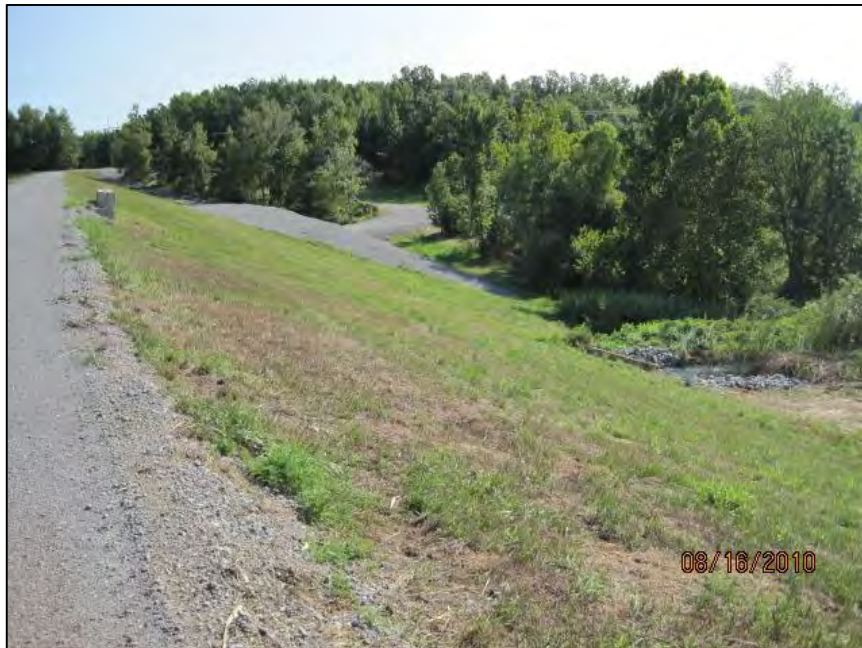
**M-12**

**LOOKING E FROM SOUTH DIKE - AREAS OF SPARSE GRASS COVER, PIPE OUTLET  
OF OUTLET STRUCTURE ON RIGHT, AND EAST BUTTRESS**

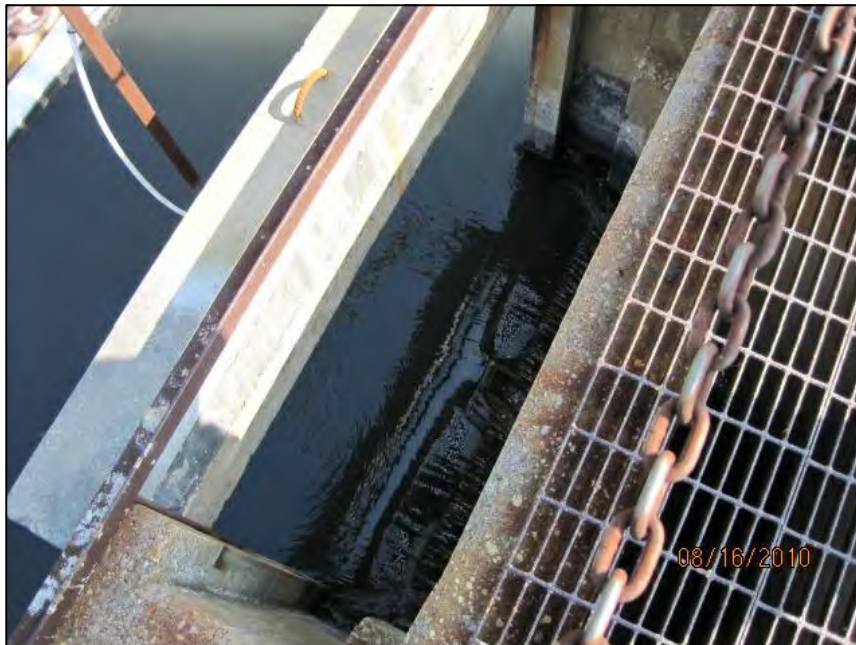
### M-14

LOOKING DOWN INTO INLET OF OUTLET STRUCTURE

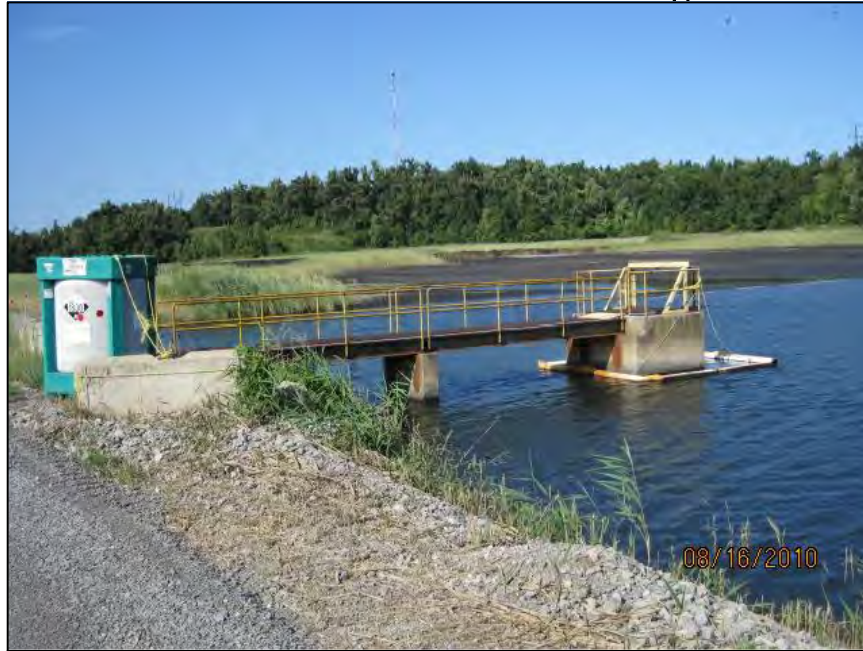
**M-15**

LOOKING NW AT OUTLET STRUCTURE, PERIMETER SKIMMER AND POND INTERIOR  
TO NATURAL HILLSIDE IN BACKGROUND. STACK OF CONCRETE STOP LOGS IN FOREGROUND

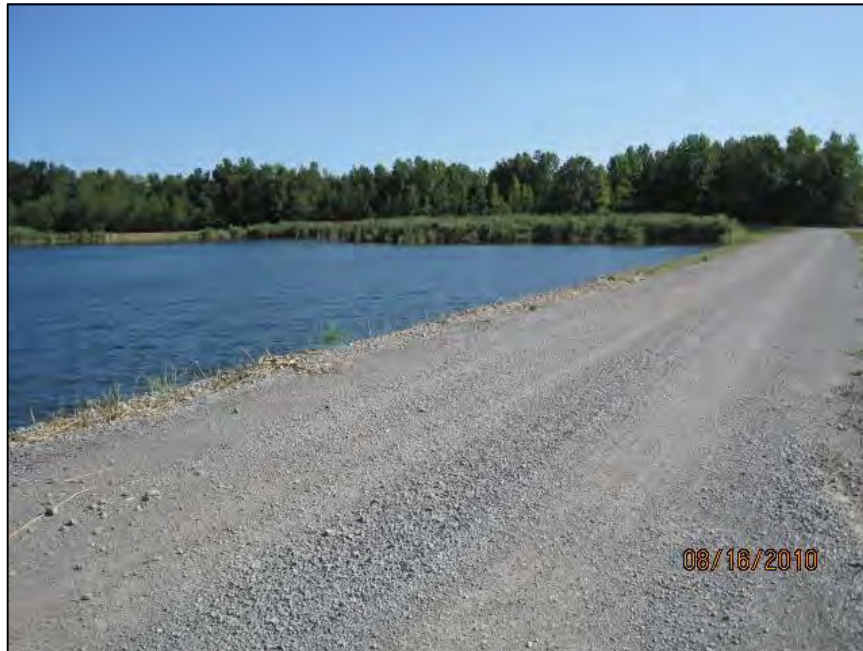
**M-16**

LOOKING NE AT EAST END OF SOUTH DIKE AND  
POND INTERIOR, NATURAL GROUND IN BACKGROUND

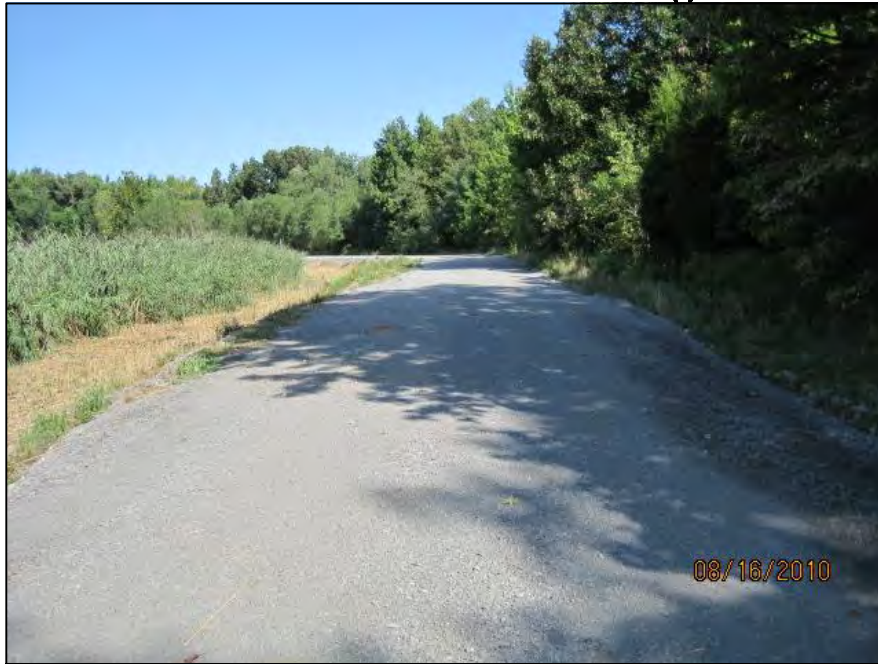
**M-17**

**LOOKING N AT EAST DIKE, PRIMARILY ORIGINAL GROUND ON EAST SIDE**

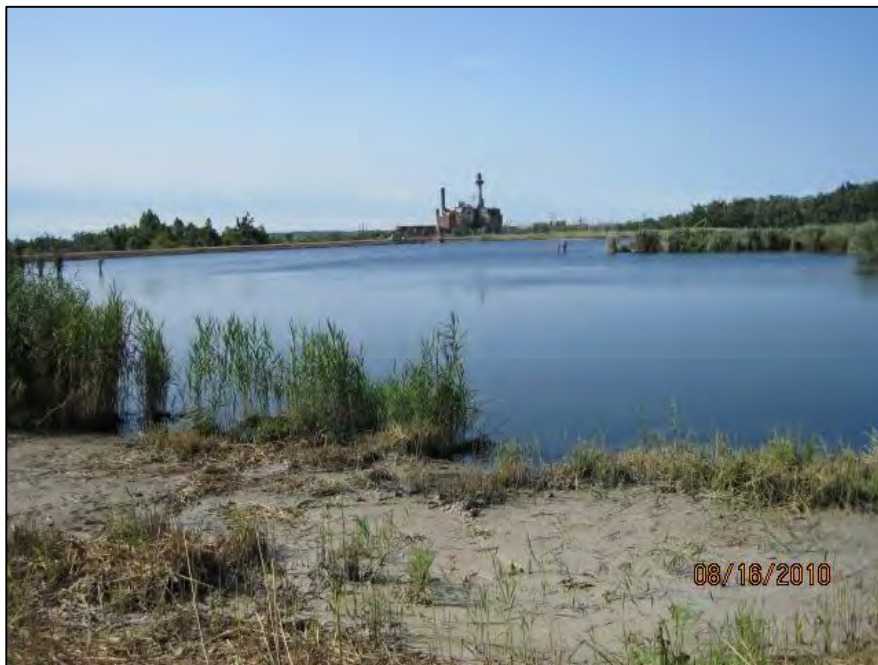
**M-18**

**LOOKING SE FROM EAST DIKE TOWARD PLANT**

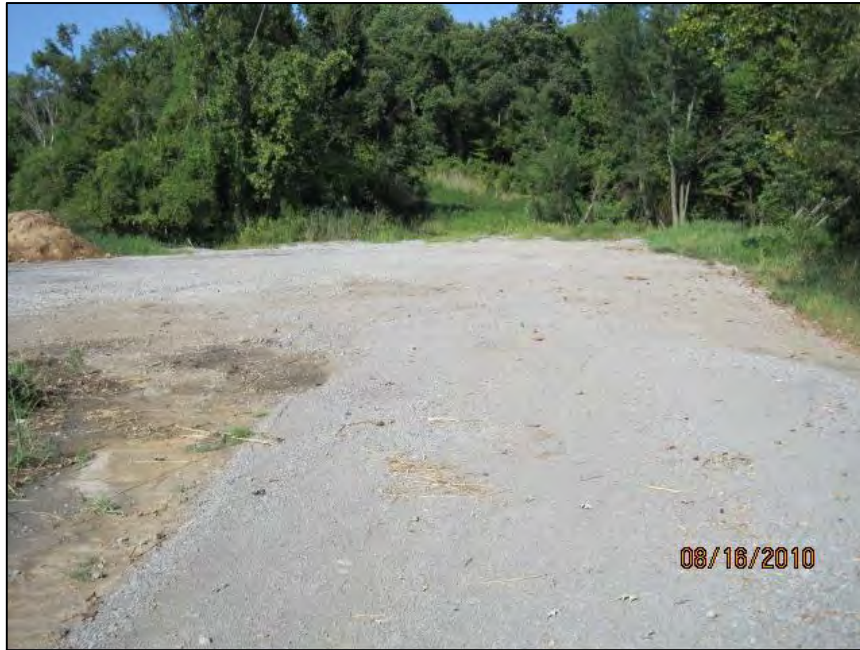
**M-19**

**TIE-IN OF NORTH END OF EAST DIKE TO ORIGINAL GROUND**

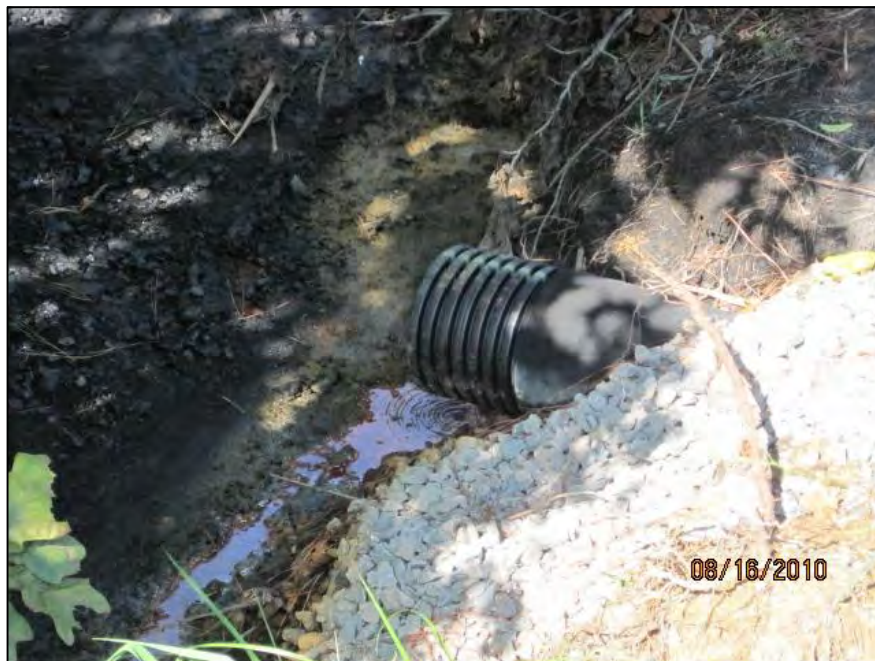
### M-24

TOE DRAIN OUTLET FOR WEST BUTTRESS ON SOUTH DIKE

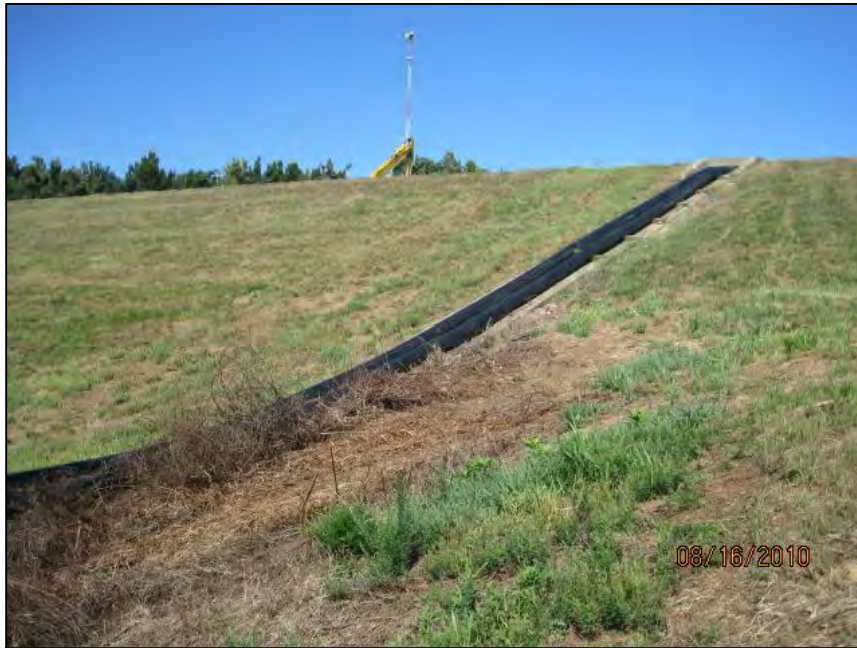
**M-25**  
**LOOKING NW AT SLUICE PIPES ON SOUTH DIKE**

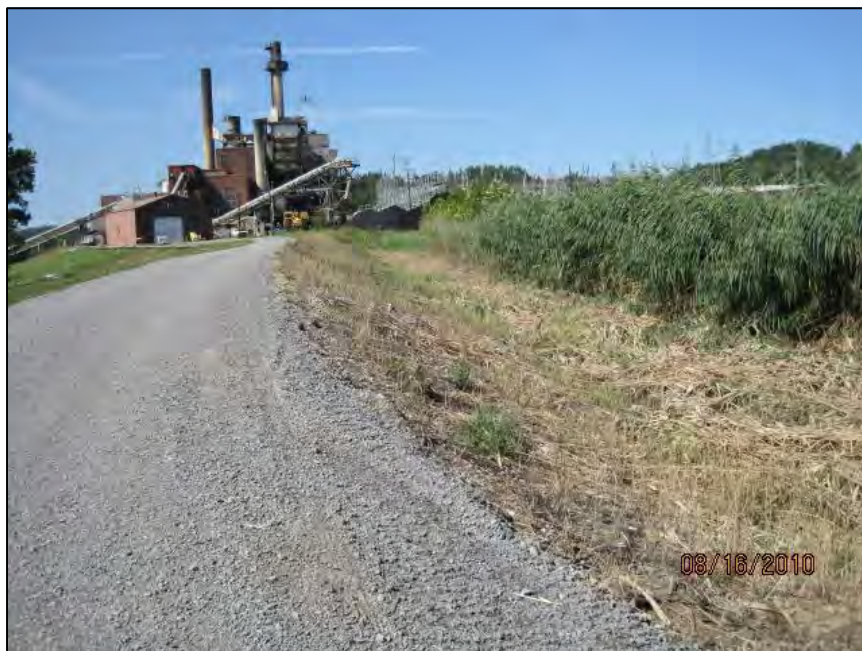
**CR-2**

**LOOKING W AT SOUTH DIKE (ROAD), CREST AND UPSTREAM SLOPE**

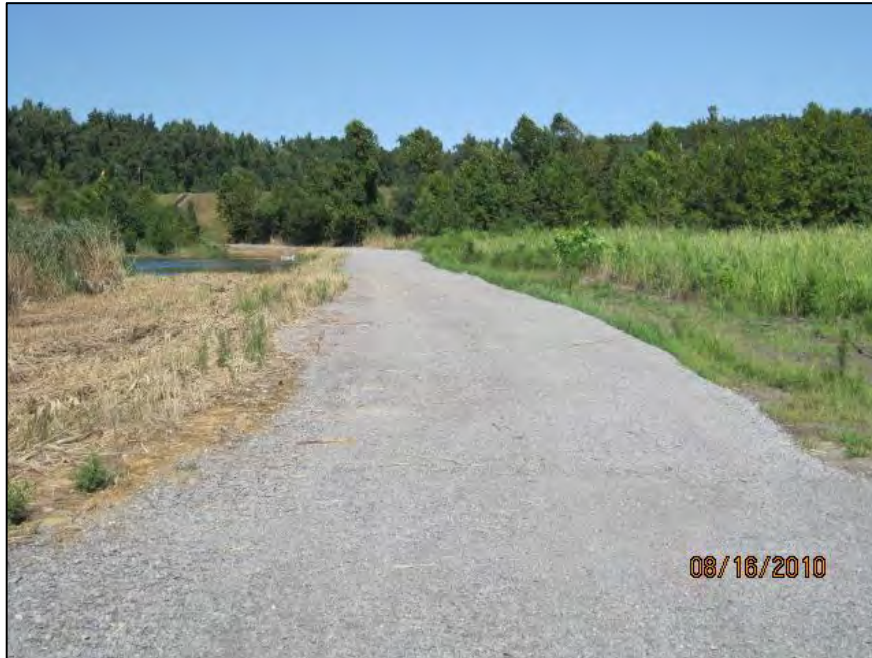
**CR-3**

LOOKING N AT EAST DIKE (COMMON WITH ASH POND 2)

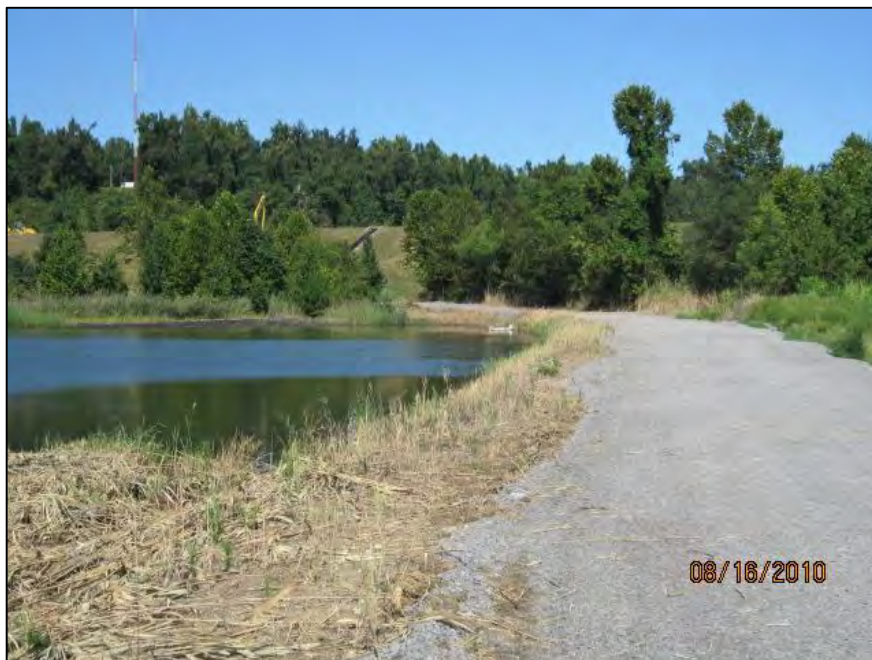
**CR-4**

LOOKING NW ON EAST DIKE, POND INTERIOR AND TIE-IN IN BACKGROUND

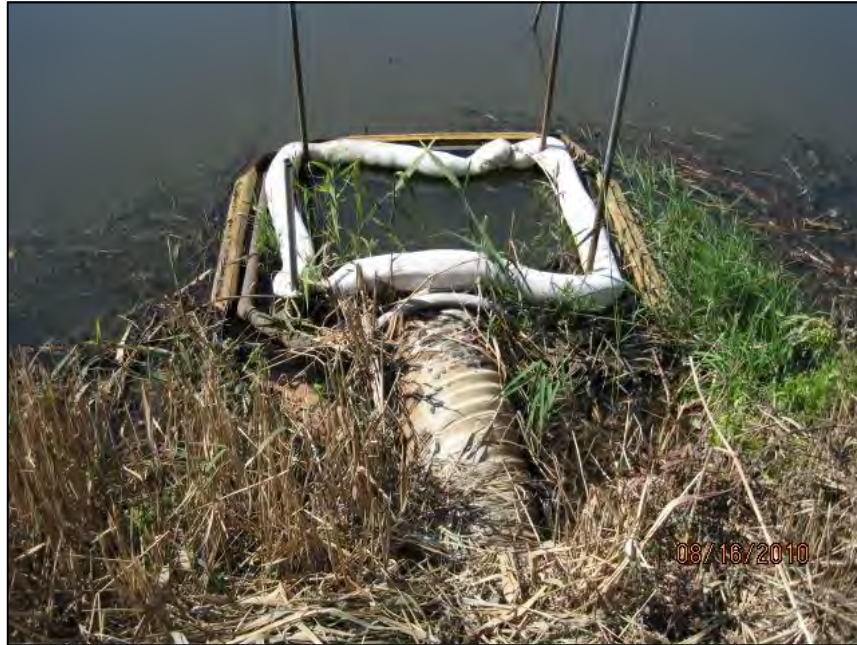
### CR-7

METAL AND BOOM SKIMMER AND CMP PIPE INLET AT NORTH END OF EAST DIKE

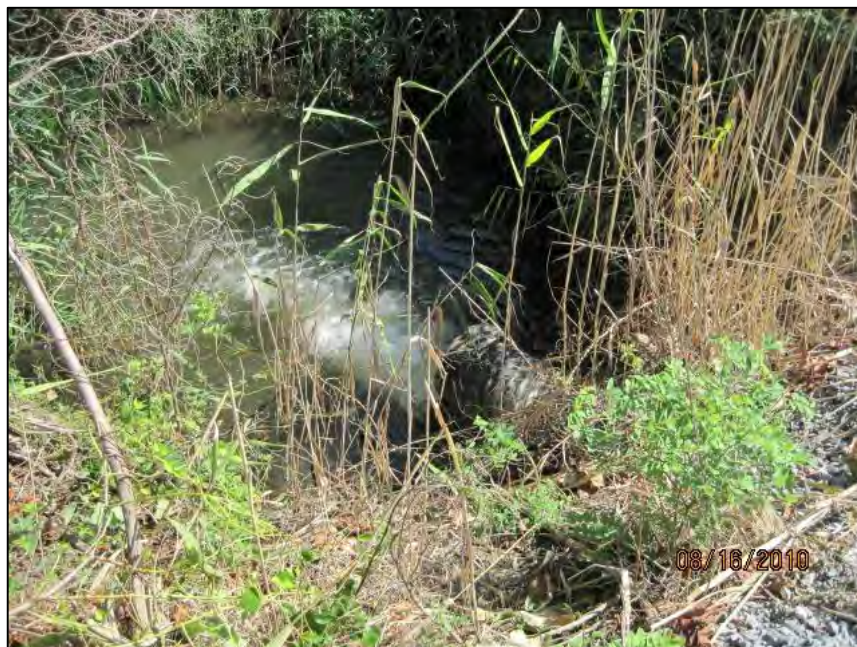
### CR-8

CMP PIPE OUTLET TO ASH POND 2

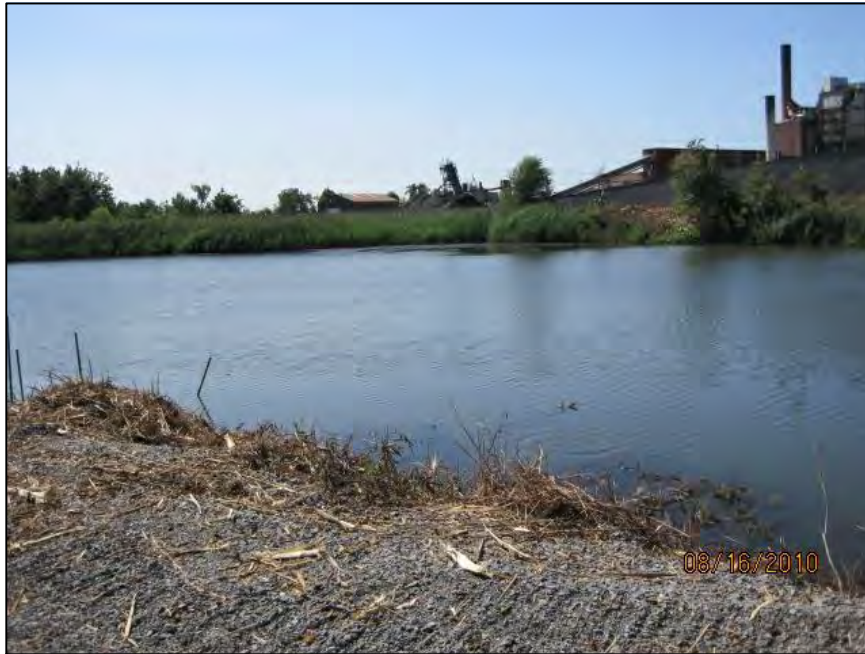
**CR-9**

The Coal Pile Runoff Pond generally has a diked configuration with dikes on the west, south and east embankments and a tie-in to natural ground located to the north. Ash is currently stacked on the south half of the pond and the north half is water (photos CR-3 and CR-9). A freeboard of approximately three feet between the operating water surface and the east dike crest was observed during the site visit (photo CR-4). The crest along the south and east dikes of the pond is covered with crushed stone (photos CR-2, CR-3, and CR-10). The surface of the upstream and downstream embankments was covered with grass (photos CR-1, CR-3, and CR-10). The downstream slope of the south dike (road) was observed to be steep with areas of sparse grass cover (photo CR-1). The west side of the pond is higher ground from the coal pile and includes a separating berm associated with the coal pile (photos CR-5 and CR-9).

**LOOKING SW FROM EAST DIKE AT POND INTERIOR (ABOUT 50% WATER)**

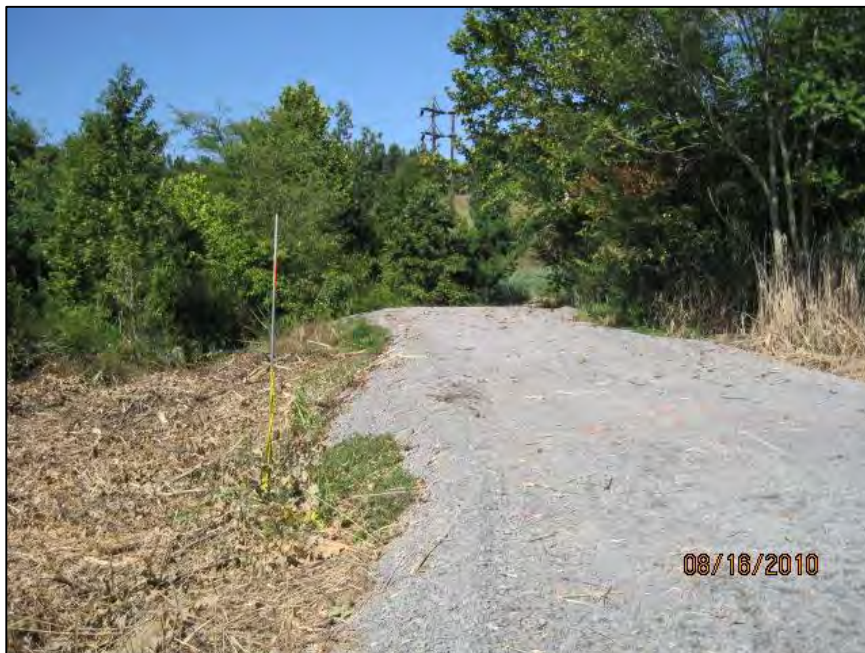
**CR-10**

**LOOKING N FROM EAST DIKE AT TIE-IN**

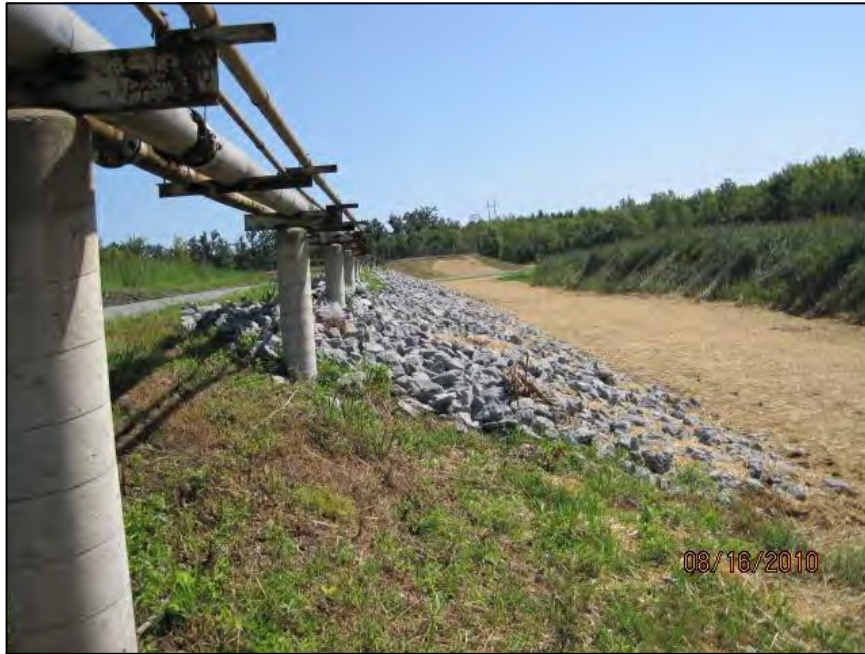
**2-3**

Ash Treatment Basin #2 has a diked configuration with a connection to natural ground located on the north end of the basin. Ash is currently stacked on the southwest end of the pond and the northeast portion, approximately 40% of the total pond area, is water (photos 2-1 and 2-11). A freeboard of approximately 3 feet between the top of water and top of dike was observed during the site visit (photo 2-11). The west dike is common with the Coal Pile Runoff Pond. The crest of the dam was surfaced with crushed stone (photos CR-8, 2-1, and 2-8). Upstream slopes of the dike were covered with grass and/or rock (photo 2-1, 2-2, and 2-8). Except for approximately one-half of the length of the slope on the west end of the south dike, the downstream slopes were covered with rock (photos 2-3, 2-9, and 2-10).

**LOOKING E AT RIP-RAP ON DOWNSTREAM SLOPE OF ROAD (SOUTH DIKE?), STEEP SLOPE**

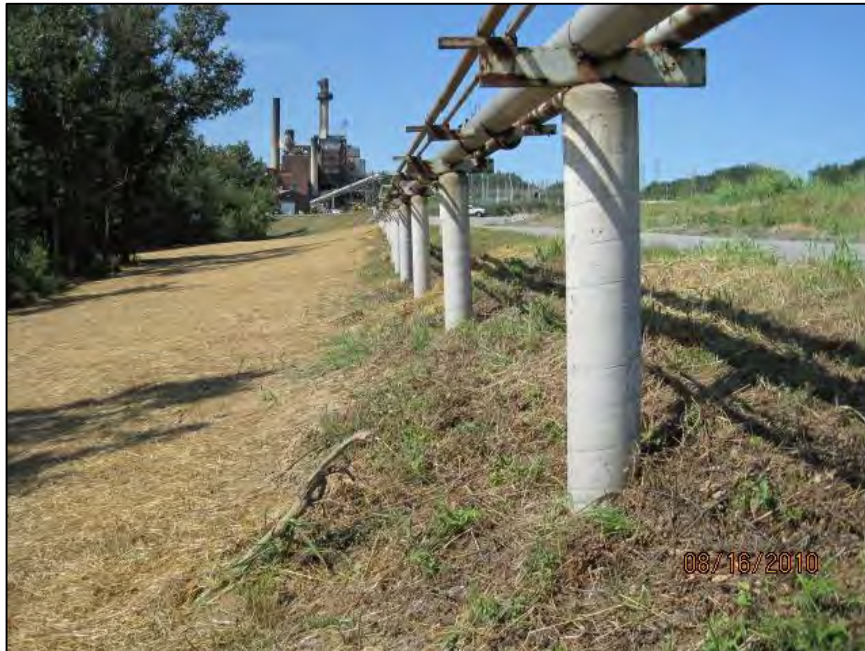
**2-4**

**LOOKING W AT DOWNSTREAM SLOPE OF ROAD (SOUTH DIKE?),  
STEEP SLOPE AND SPARSE GRASS**

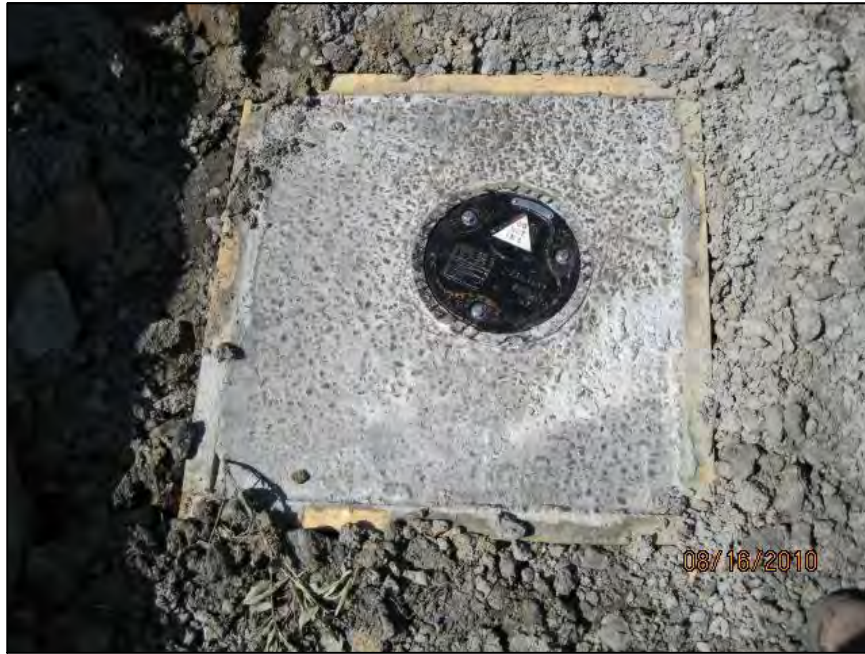
**2-5**  
NEW PZ ON ROAD, SOUTH DIKE

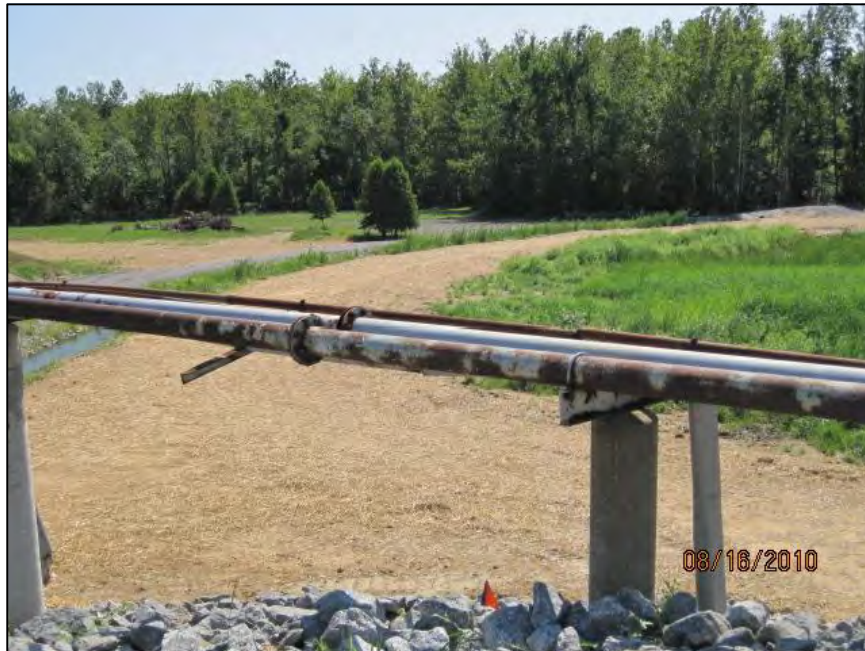
**2-6**  
LOOKING SE FROM SOUTHEAST CORNER OF POND, ELEVATED PIPE LINES TO SCRUBBER POND,  
SITE DISCHARGE DITCH ON LEFT, PORTION OF FORMER ASH POND 3 ON RIGHT

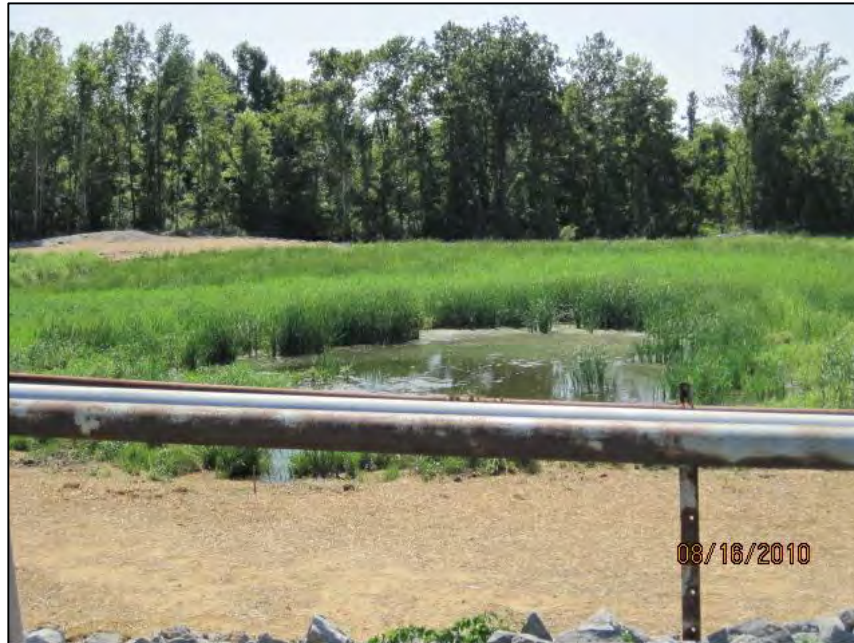
**2-7**

**LOOKING S FROM PHOTO 2-6 AT FORMER ASH POND 3**

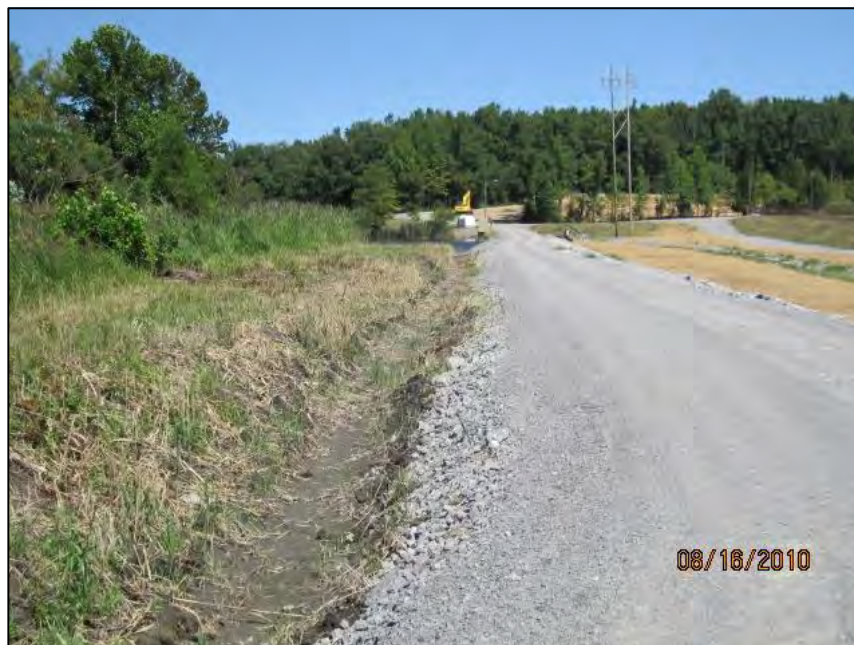
**2-8**

**LOOKING N AT CREST AND UPSTREAM SLOPE OF EAST DIKE**

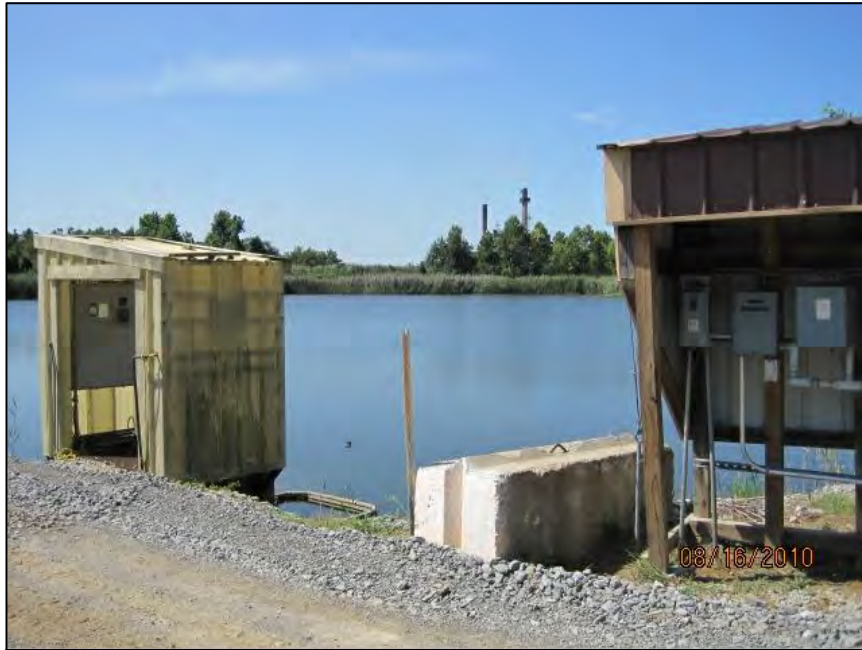
**2-11**

**LOOKING SW FROM NORTHEAST CORNER OF POND AT OUTLET STRUCTURE, CONTROLS AND POND INTERIOR**

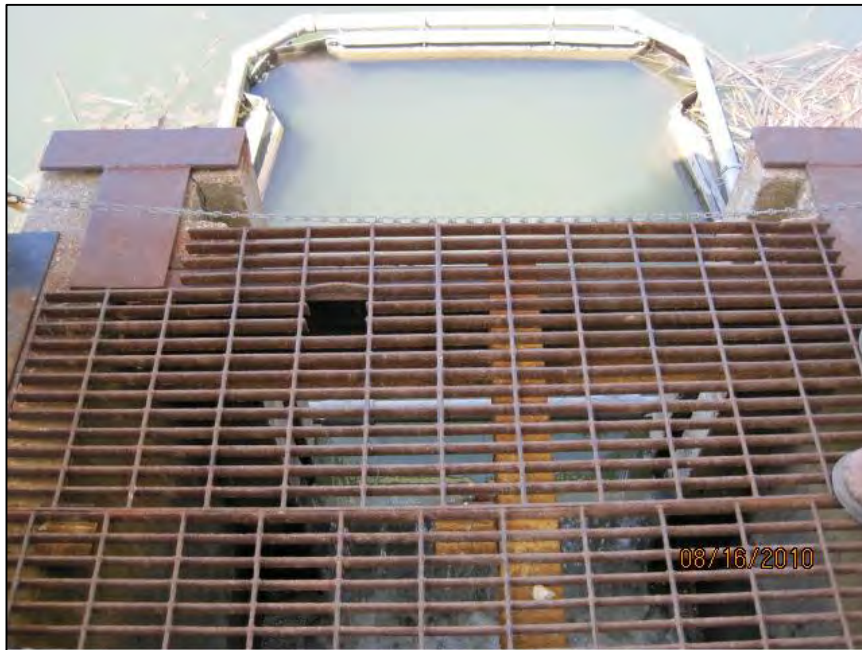
**2-12**

**METAL AND RUBBER SKIMMER AND INTAKE, SILT CLEANED APPROX. EVERY 5 YEARS**

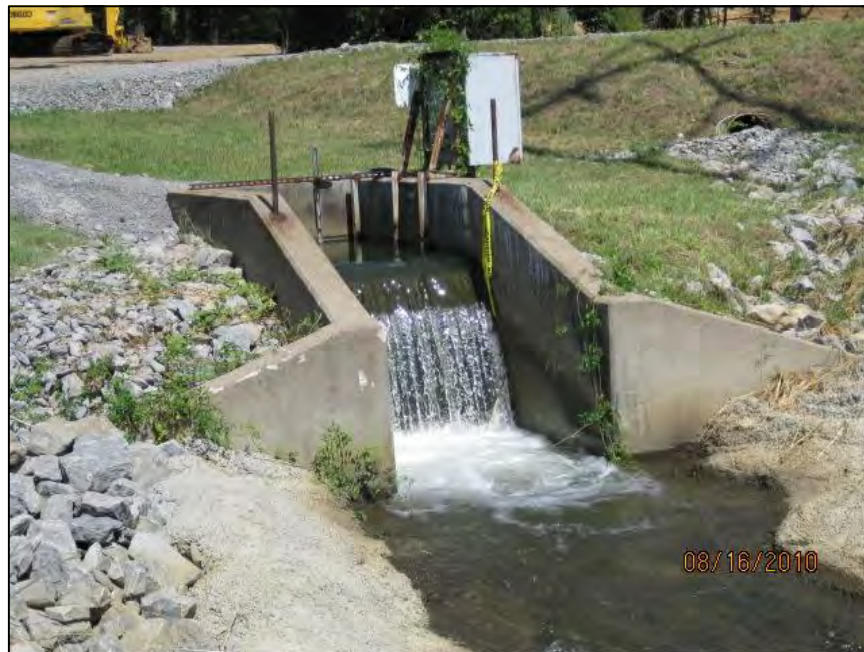
2-14

LOOKING NE AT NPDES OUTFALL 001, OVERFLOW AND GROUTED CHANNEL

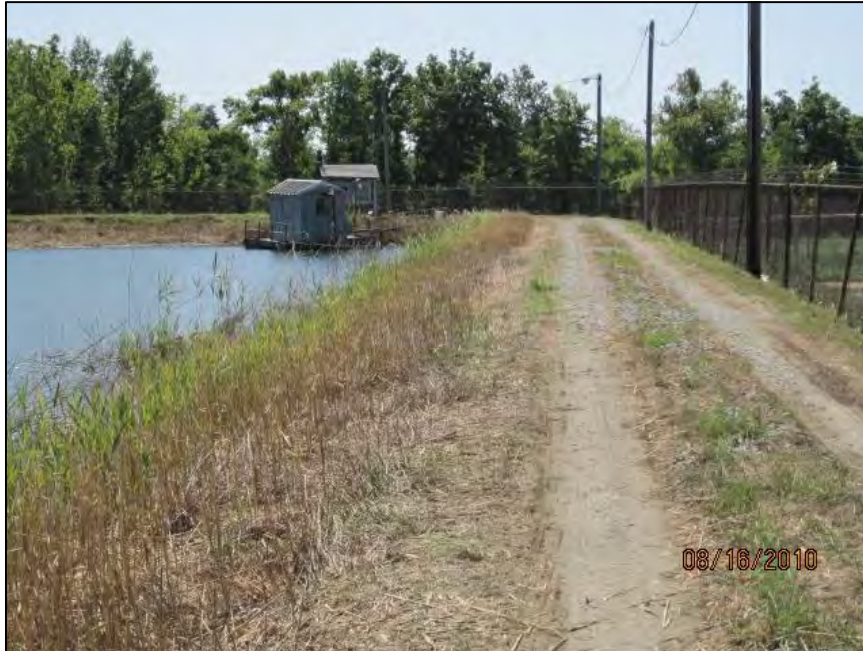
**SP-3**

LOOKING S AT CREST AND UPSTREAM SLOPE OF WEST DIKE, PUMP STATION AT SOUTHWEST CORNER

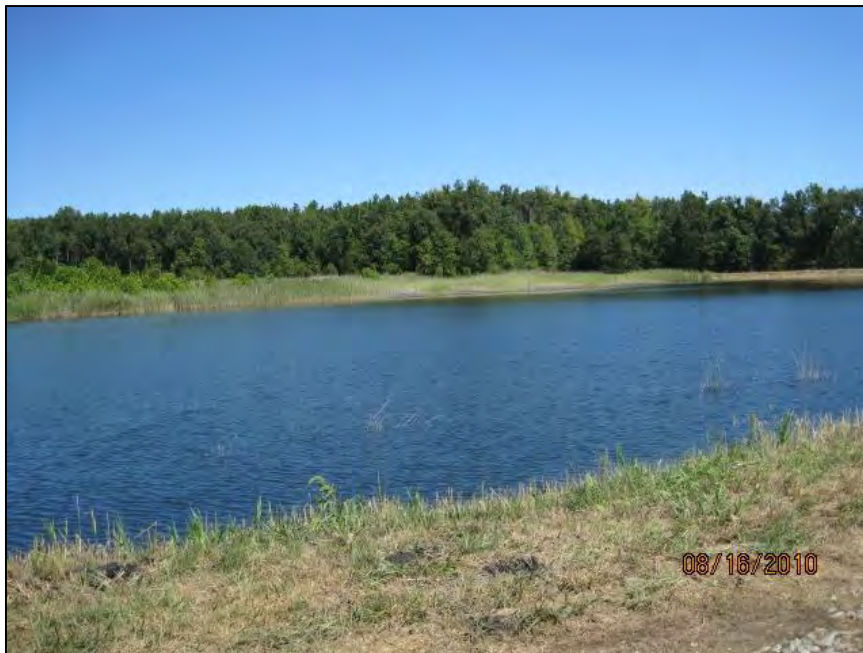
**SP-4**

LOOKING NE FROM SOUTHWEST CORNER AT POND INTERIOR, APPROXIMATELY 50% WATER

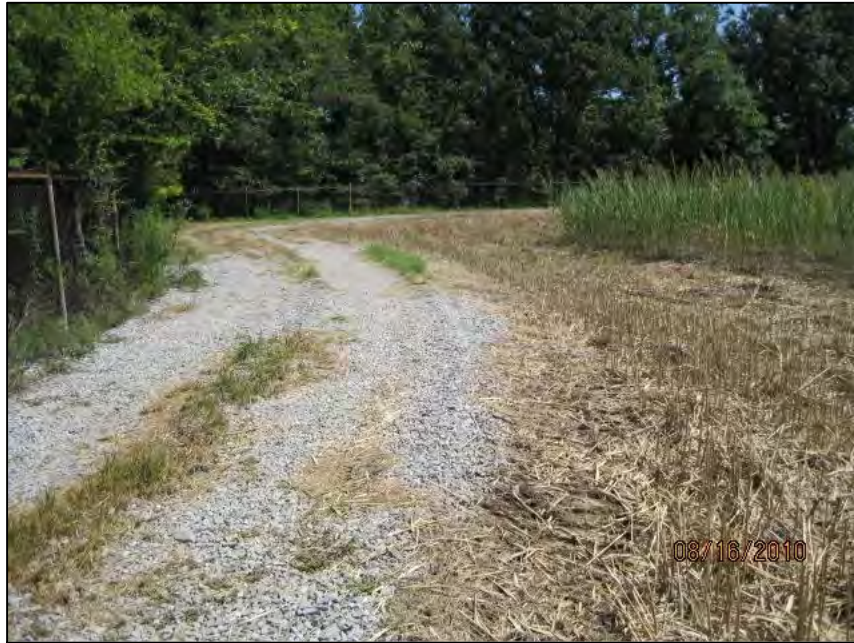
**SP-7**

LOOKING W FROM NORTH DIKE AT NORTHWEST CORNER OF POND, NATURAL GROUND ON DOWNSTREAM SIDE

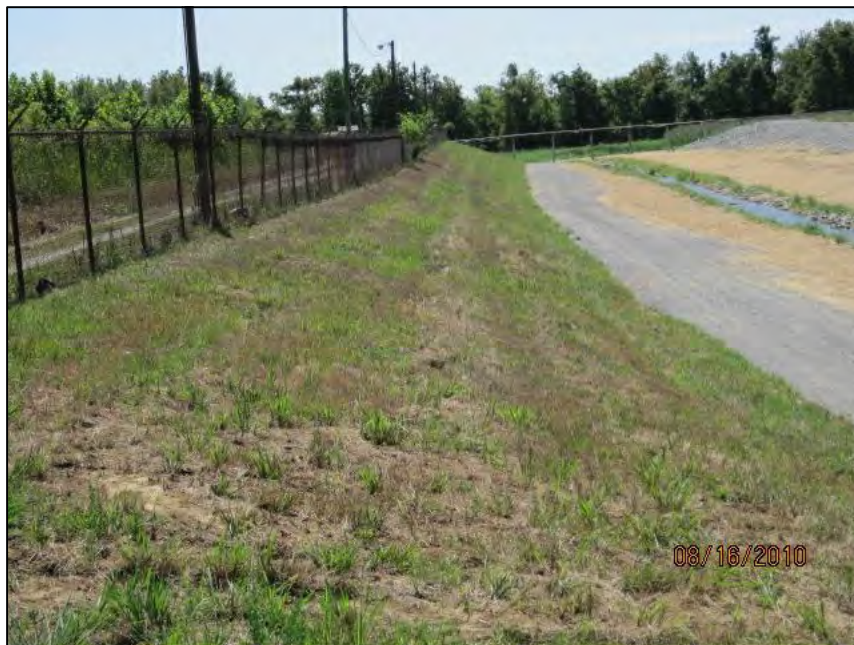
**SP-8**

LOOKING W AT EAST DIKE DOWNSTREAM SLOPE, STEEP AND AREAS WITH SPARSE VEGETATION

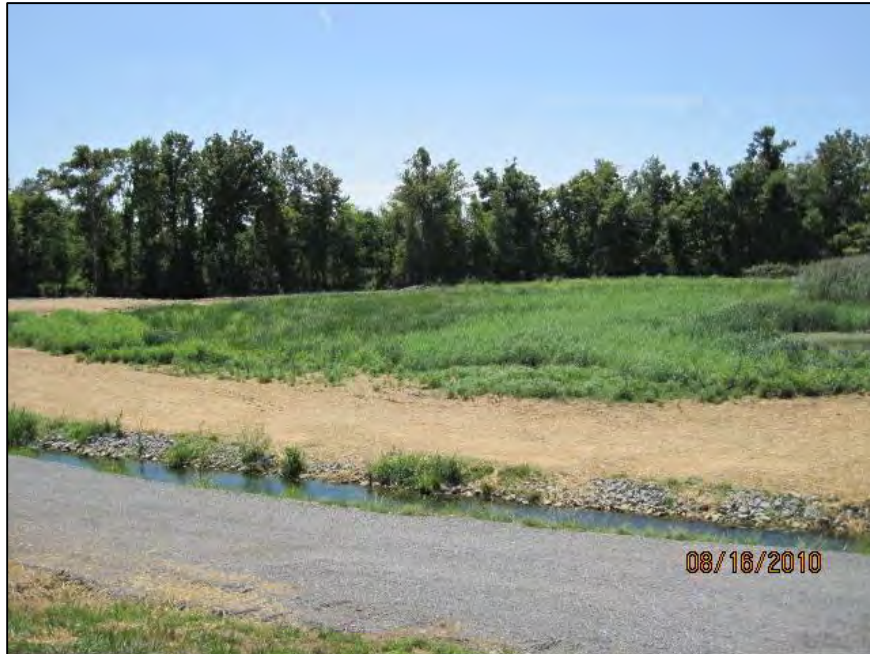
**SP-9**

LOOKING SOUTH FROM NEAR SOUTHEAST CORNER TOWARD FORMER ASH POND 3

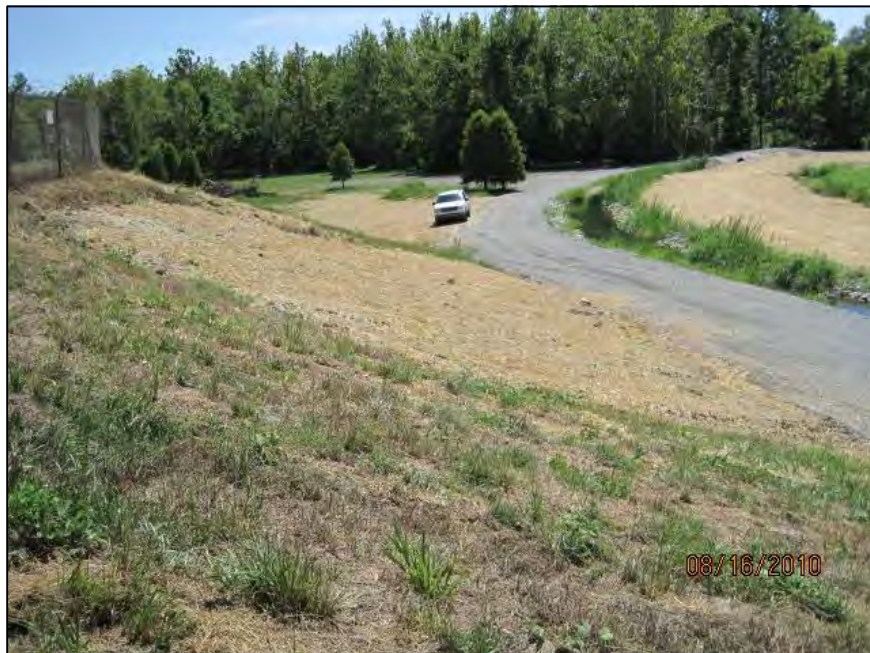
**SP-10**

LOOKING SE AT SOUTHWEST CORNER DOWNSTREAM SLOPE, SHALLOW SURFACE SLIDE REPAIR
