Report of Geotechnical Investigation  
Dam Safety Assessment of Coal Combustion  
Surface Impoundments  
Kentucky Utilities, a Subsidiary of E.ON U.S.  
Green River Station, Central City, KY

AMEC Project No. 3-2106-0177-0002

September 2010

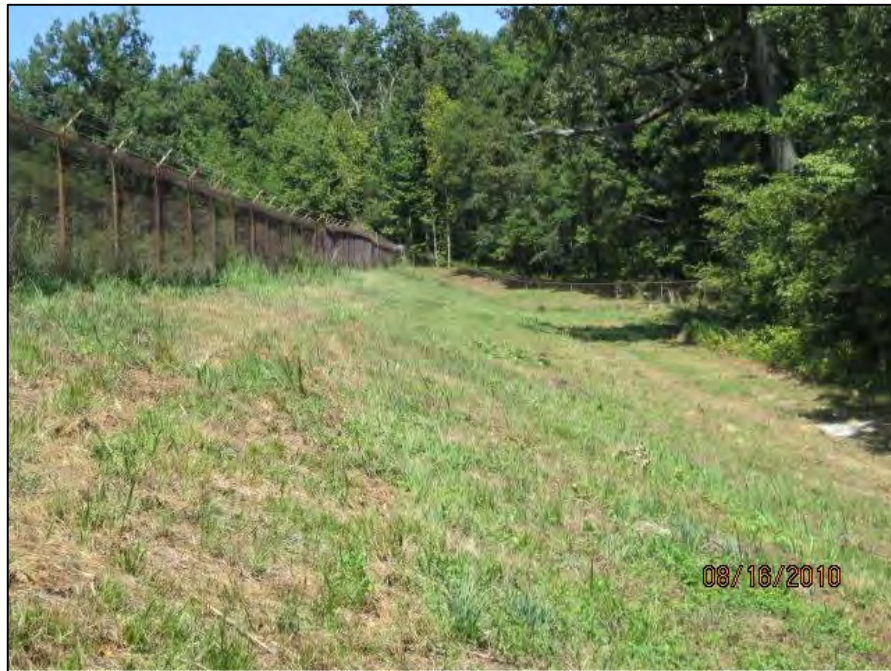
**SP-13**

**LOOKING N AT DOWNSTREAM SLOPE EAST DIKE, STEEP SLOPE, AREAS OF SPARSE GRASS,  
TIE INTO ORIGINAL IN BACKGROUND**

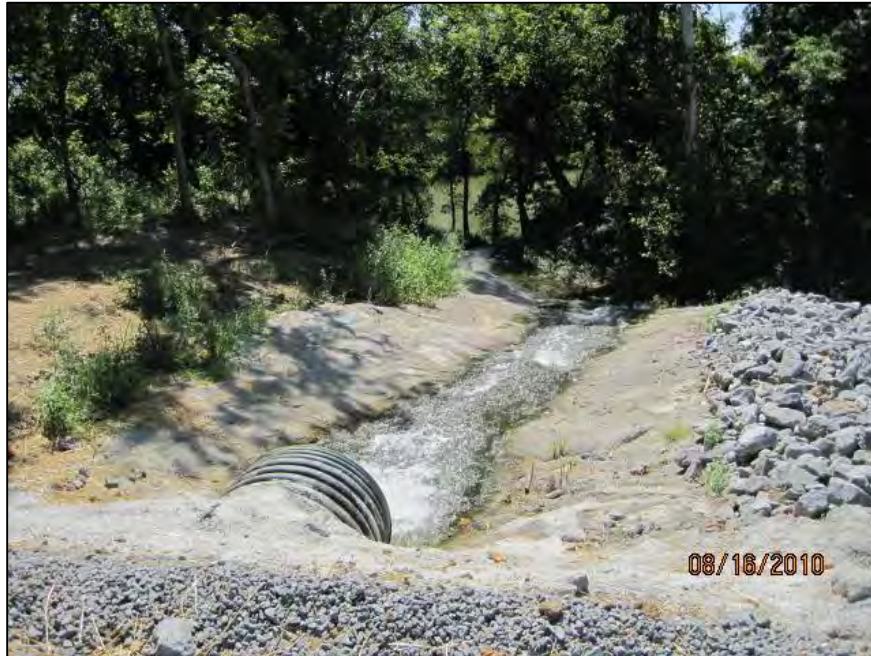
**3-1**

**CULVERT AND OUTLET DITCH TO GREEN RIVER WEST OF ASH POND 3**

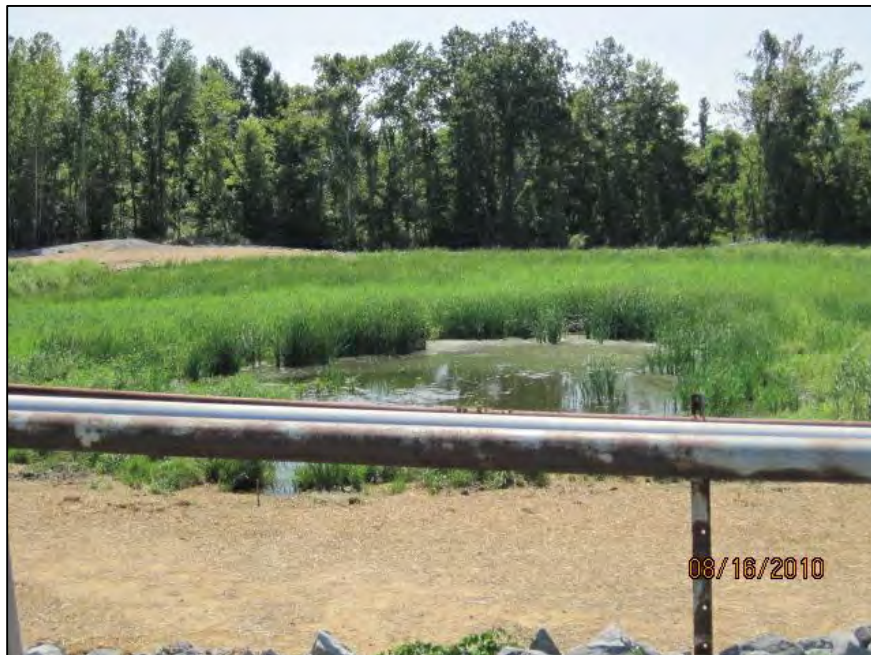
**3-2**

**LOOKING S FROM PHOTO 2-6 AT ASH POND 3**

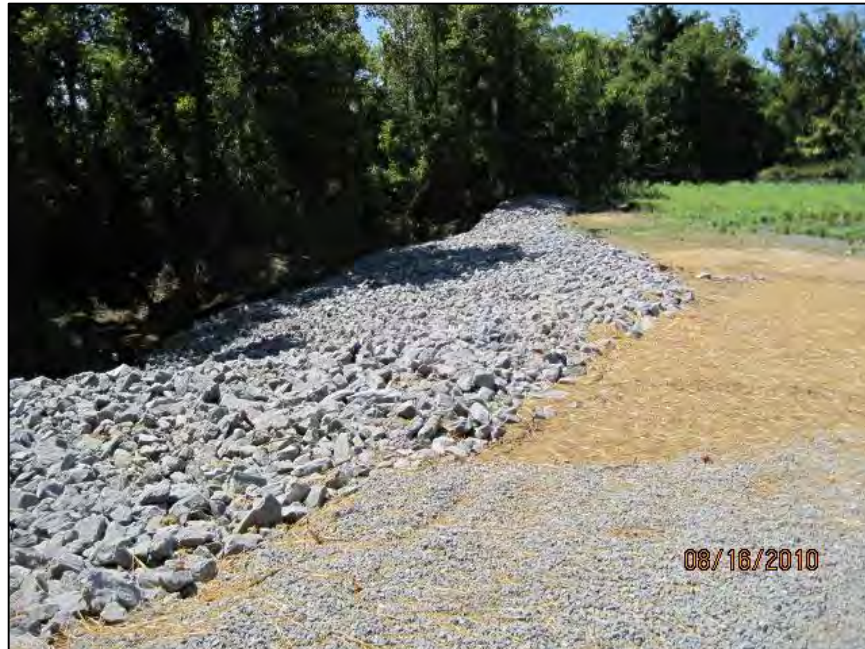
**3-3**

**REGRADED AND RIP-RAP ARMORED SOUTH AND ONLY DIKE OF ASH POND 3**
