Report of  
Dam Safety Assessment of Coal Combustion  
Surface Impoundments

Kentucky Utilities,  
a wholly owned subsidiary of  
LG&E and KU Energy LLC

Green River Station, Central City, KY

AMEC Project No. 3-2106-0177-0002

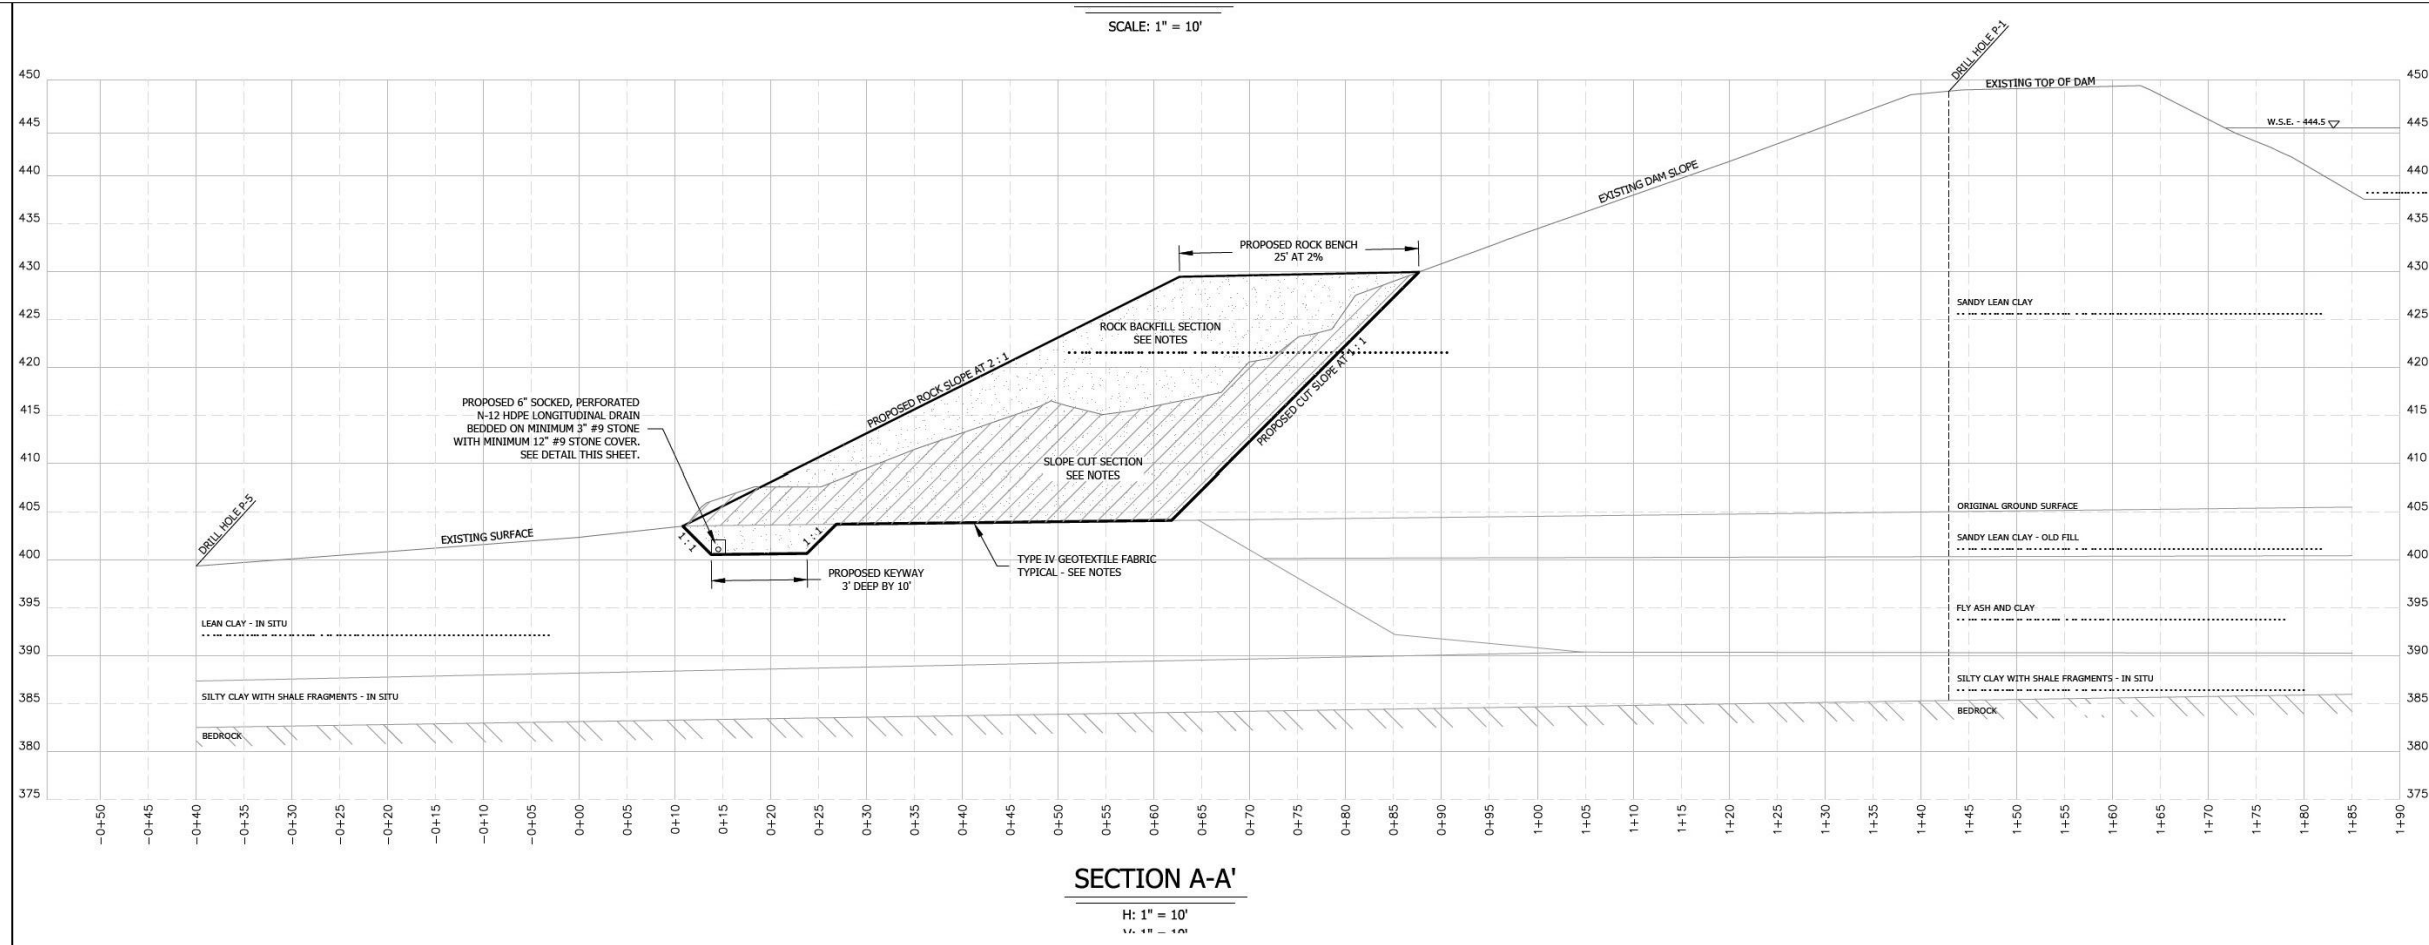
FIGURE No. 9

*Based on the available data, the probable triggering mechanism of the slope failure was excessive moisture originating from a combination of factors including subtle grading at the top of the dam which directs drainage down the slope in this area, and possible focused surface and subsurface drainage along the base of the dam from the northeast due to topographic influence. Rutting and surface scaring that appeared to have occurred during mowing operations, along with*

*poor vegetative cover conditions were also probable causation factors. High moisture conditions appeared to be restricted to a limited area in the outer portion of the dam material near the base and did not extend into the interior of the dam construction material. The lower portions of the fly ash and underlying dark grayish brown silty clay were wet and exhibited N-values of 6 to 8. Moisture may be contributed by these units but they were not part of the existing slump feature.*

The southern slope of the Main Ash Pond was repaired in May and June of 2010 by excavating and removing loose materials and reconstructing the slope with rock. The recommendations were outlined in Associated Engineers report and are summarized below.

PLACE GEOTEXTILE FABRIC, TYPE IV ON EXCAVATED SOIL AREA MEETING THE REQUIREMENTS OF SECTION 843, TYPE IV, OF THE CURRENT EDITION OF KENTUCKY STANDARD SPECIFICATIONS FOR ROAD AND BRIDGE CONSTRUCTION. INSTALL GEOTEXTILE FABRIC ACCORDING TO SECTION 214 OF THE STANDARD SPECIFICATIONS FOR ROAD AND BRIDGE CONSTRUCTION. PREPARE THE SURFACE TO A SMOOTH CONDITION FREE OF OBSTRUCTIONS, DEBRIS, OR SHARP OBJECTS THAT MAY PUNCTURE THE FABRIC. PLACE THE FABRIC SMOOTH AND FREE OF TENSION, STRESS, FOLDS, WRINKLES, OR CREASES. DO NOT OPERATE EQUIPMENT DIRECTLY ON THE FABRIC. OVERLAP STRIPS AT LEAST 18 INCHES. PLACE TRANSVERSE LAPS SO THE UPSLOPE STRIP LAPS OVER THE DOWNSLOPE STRIP. INSTALL FASTENER PINS THROUGH BOTH STRIPS OF OVERLAP FABRIC AT NO LESS THAN 5-FOOT INTERVALS ALONG A LINE THROUGH THE MIDPOINT OF THE OVERLAP, AND AT ANY OTHER LOCATIONS AS NECESSARY TO PREVENT ANY SLIP OF THE FABRIC. PLACE FABRIC WITH THE LONG DIMENSION PARALLEL TO THE LONG DIMENSION OF THE SECTION TO BE COVERED.

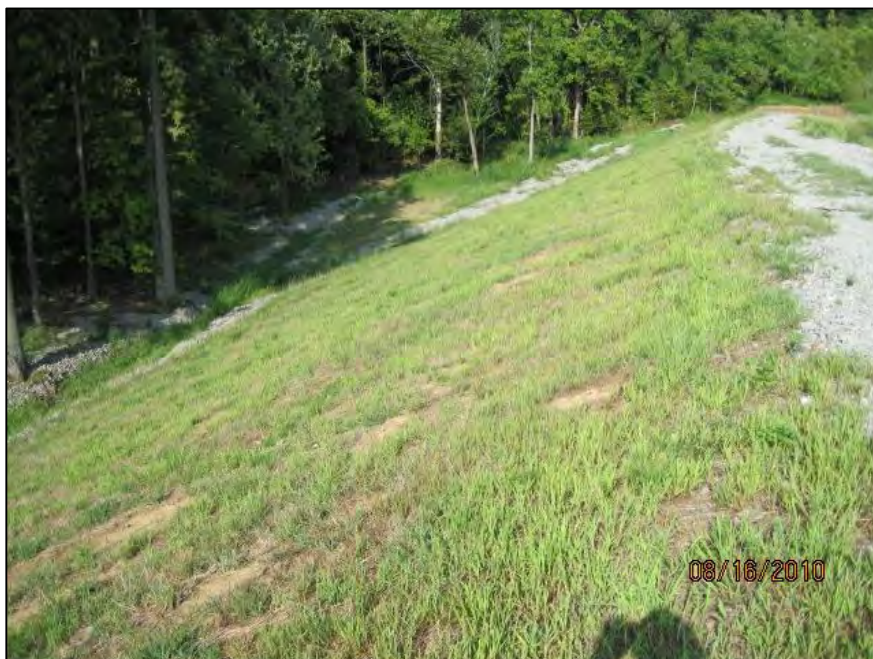
**M-2**

**LOOKING NW AT WEST DIKE - CREST AND DOWNSTREAM SLOPE, SPARSE GRASS COVER**

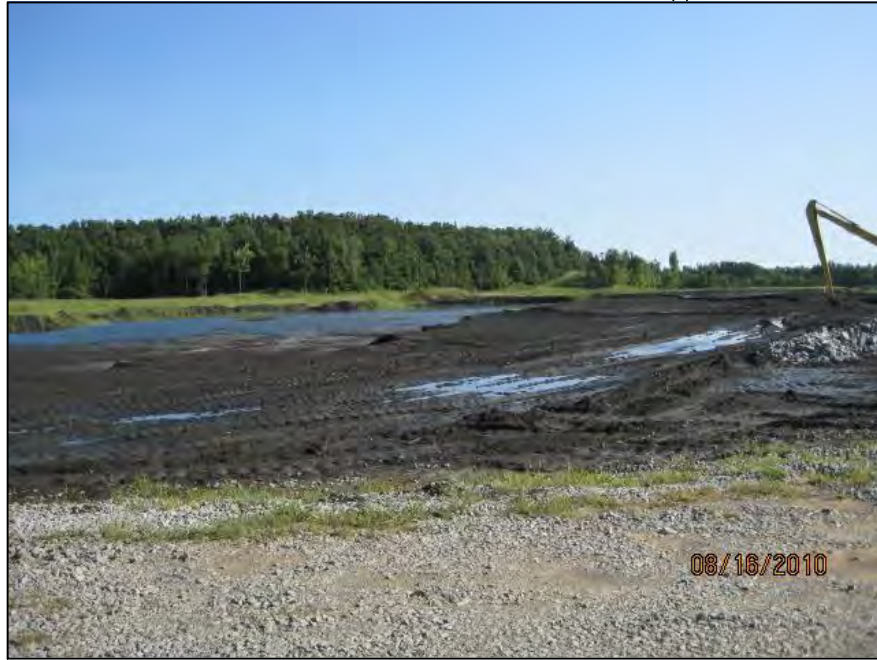
**M-3**

**LOOKING NW FROM WEST END OF SOUTH DIKE -  
ASH STACKED TO NEAR CREST OF SOUTH DIKE**

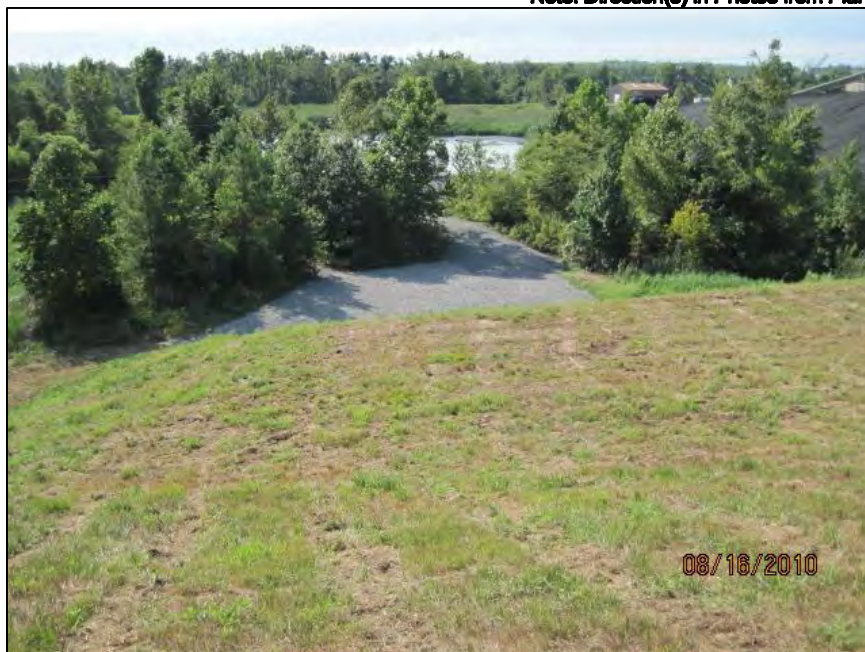
**M-9**

**LOOKING S FROM SOUTH DIKE - AREAS WITH SPARSE GRASS ON DOWNSTREAM CREST, WEST BUTTRESS, AND COAL RUNOFF POND IN BACKGROUND**

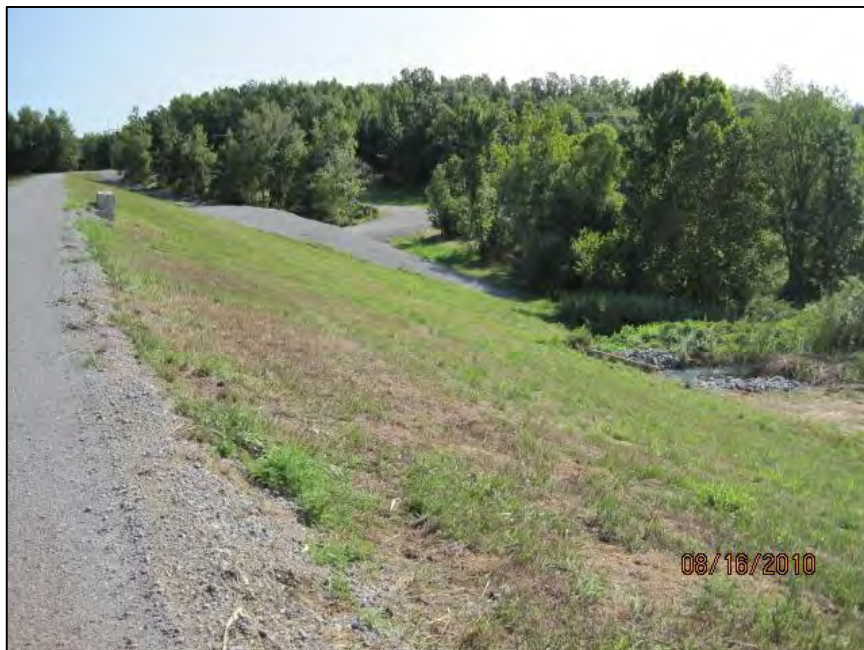
**M-12**

**LOOKING E FROM SOUTH DIKE - AREAS OF SPARSE GRASS COVER, PIPE OUTLET OF OUTLET STRUCTURE ON RIGHT, AND EAST BUTTRESS**

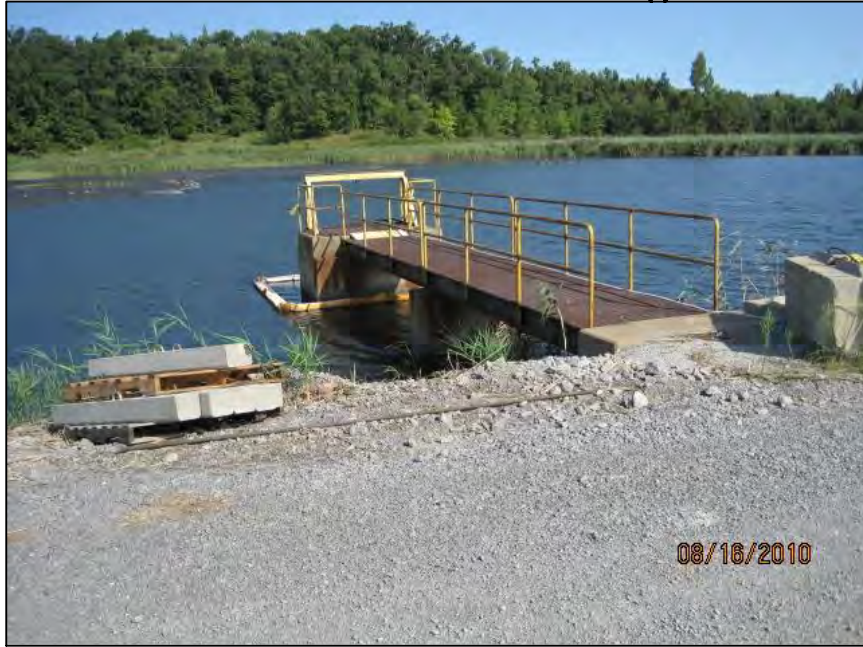
**M-13**

The ash pond has a side-hill configuration; and, a freeboard of approximately 4.5 feet between the top of water and top of dike was observed during the site visit (photo M-13). Original ground above the elevation of the pond is to the north. Dikes are present on the west, south and east sides of the pond. The crest of the dam and upstream slopes of the west and south dikes were primarily surfaced with crushed stone (photos M-1, M-6, M-8, and M-17). The surface of the downstream slopes of the dikes and the upstream slope of the east dike was primarily covered with grass (photos M-2, M-5, and M-17). Sparse grass cover was observed on the downstream slope of the west dike (photo M-2). Ash was observed to be stacked to a height just below the crest of the south dike at the southwest end of the pond (photo M-3). Two above ground pipes for sluicing ash to the pond are located on the west portion of the south dike. The pipes traverse the downstream slope of the south dike then cross the crest through a concrete culvert (photos M-25 and M-8). Two buttresses, reportedly installed due to shallow surface failures, were observed on the downstream slope of the south dike, one on the west (compacted soil construction) and one on the east (rock construction) portions of the dike (photos M-9 and M-12). The buttresses reportedly include drains which are tied to a collector pipe and directed to the toe of the slope. Flowing water was observed from the outlet of the west buttress; however, flowing water was not observed at the east outlet (photos M-24 and M-21). Sparse grass cover and uneven slopes were observed on the mid-section of the downstream slope of the south dike beginning at the west buttress and extending for about 300 feet to the east (photo M-23). A stockpile of sand and gravel was observed at the north end of the east dike (photo M-20). Trees appeared to be growing within the interior at the northeast end of the pond, but they may be growing on fingers of original ground extending into the interior from the north (photo M-20). Old matting and straw was observed on the downstream slope of the west dike. Reportedly, the slope was seeded and matted last fall but weather killed most of the planting. Kentucky Utilities stated they had bid out a contract to reseed the slopes this fall.

**LOOKING NE AT OUTLET STRUCTURE, PERIMETER SKIMMER AND POND INTERIOR TO NATURAL HILLSIDE IN BACKGROUND, STACK OF CONCRETE STOP LOGS IN FOREGROUND**

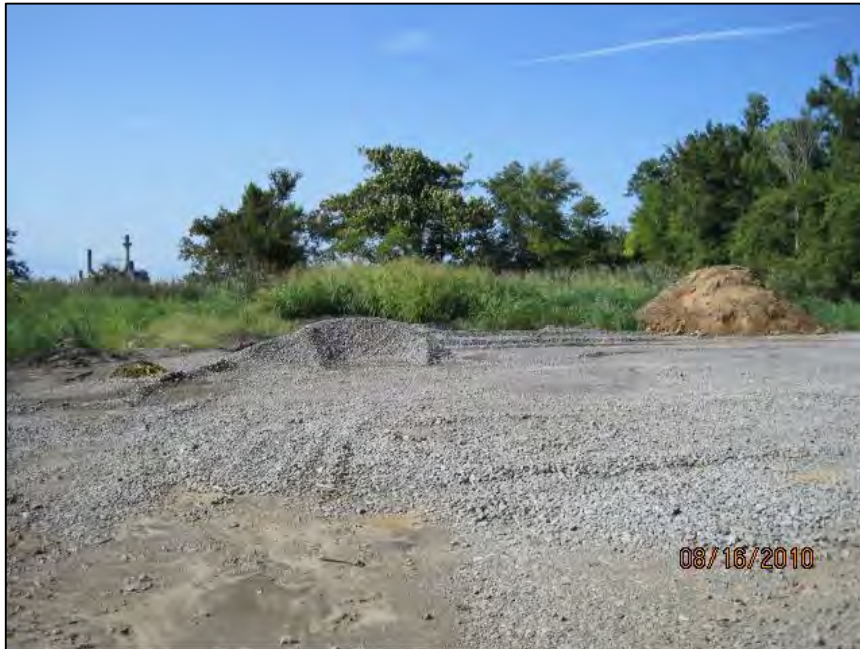
**M-20**

**GRAVEL AND SAND STOCKPILE AT NORTH END OF EAST DIKE. TREES APPEAR TO BE GROWING IN POND INTERIOR.  
TREES COULD BE GROWING ON FINGER OF ORIGINAL HILLSIDE**

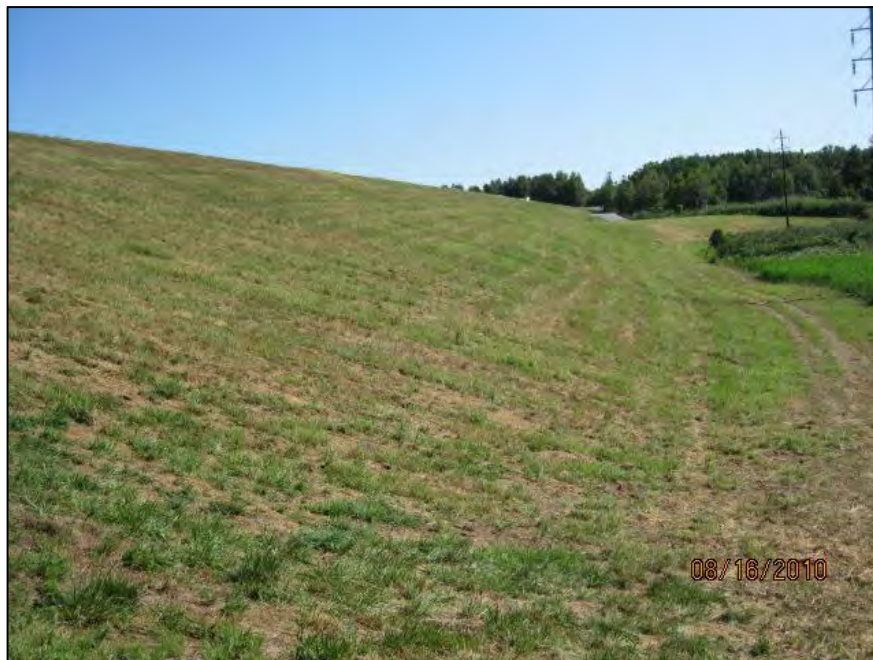
**M-23**

**LOOKING EAST ON SOUTH DIKE, UNEVEN SLOPES AND SPARSE GRASS ON DOWNSTREAM SLOPE FROM WEST BUTTRESS TO ABOUT 300 FEET EAST**

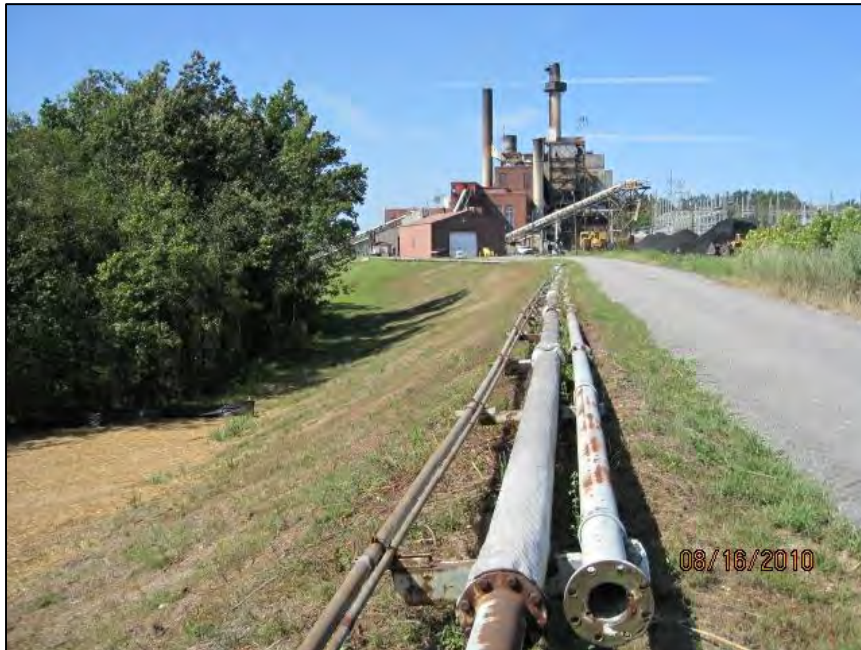
**CR-1**

**LOOKING W AT SOUTH DIKE (ROAD), EROSION, SPARSE GRASS, STEEP SLOPE**

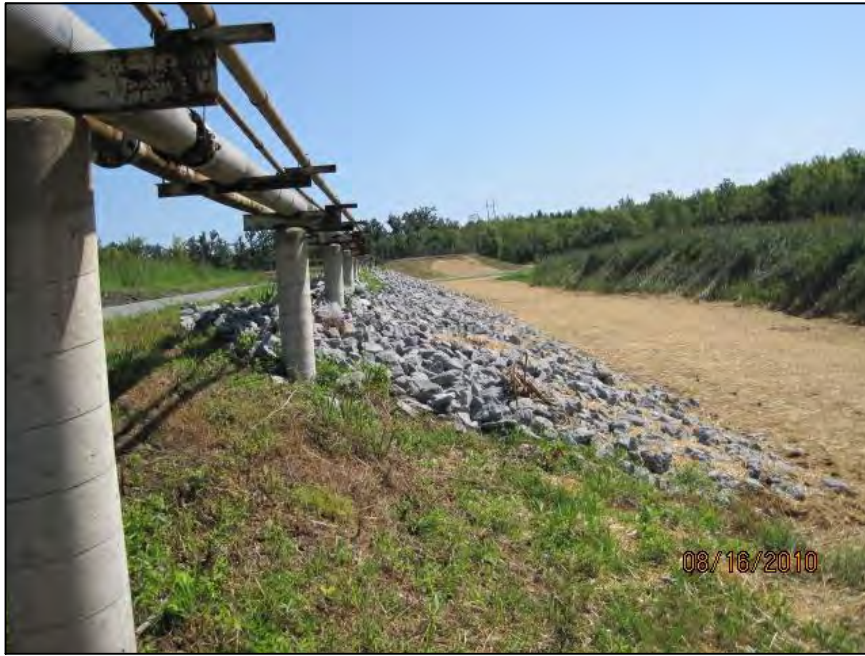
LOOKING E AT RIP-RAP ON DOWNSTREAM SLOPE OF ROAD (SOUTH DIKE?), STEEP SLOPE

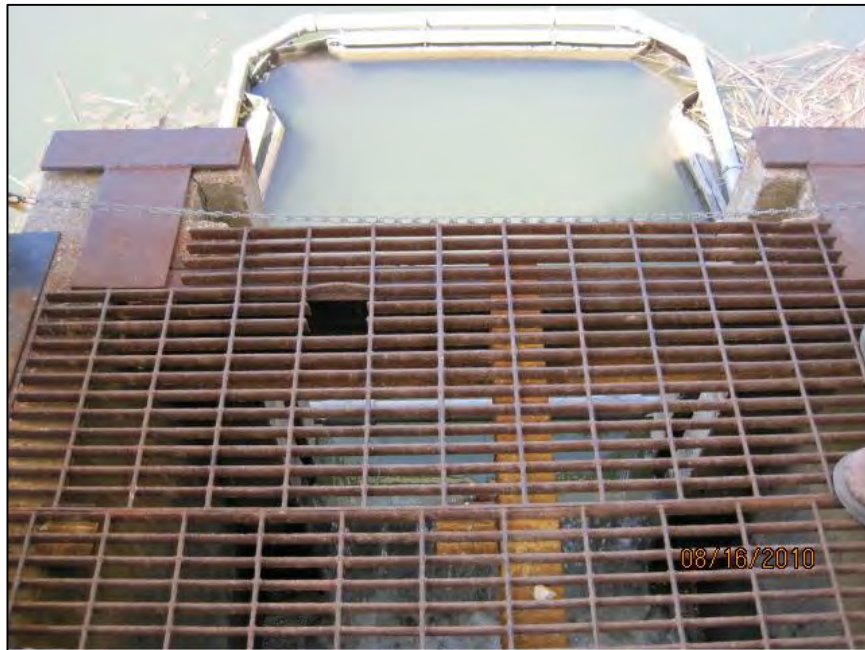
**2-12**

**METAL AND RUBBER SKIMMER AND INTAKE, SILT CLEANED APPROX. EVERY 5 YEARS**

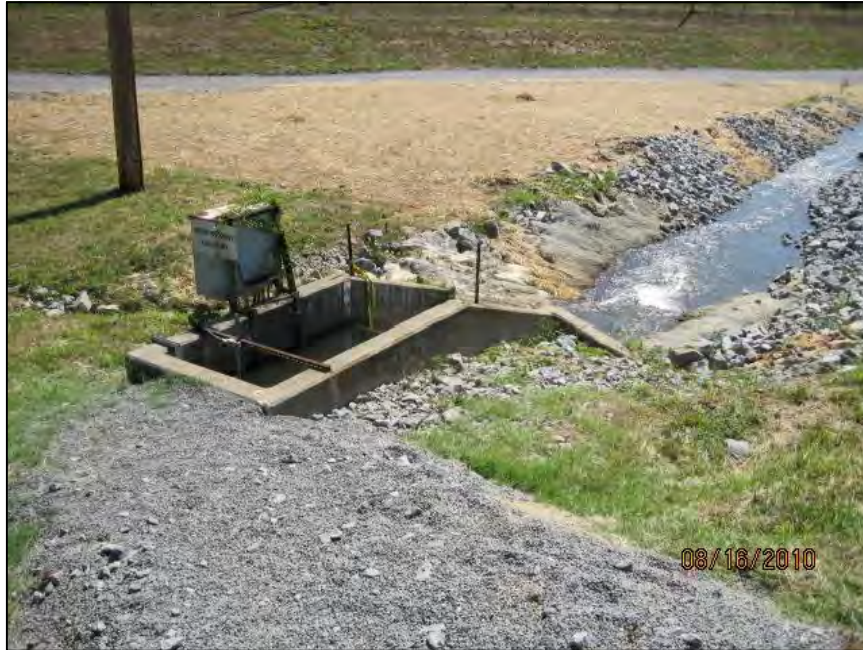
**2-13**

**LOOKING SW AT NPDES OUTFALL 001, BACKGROUND: SPARSE GRASS ON DOWNSTREAM SLOPE OF SCRUBBER POND WEST DIKE**

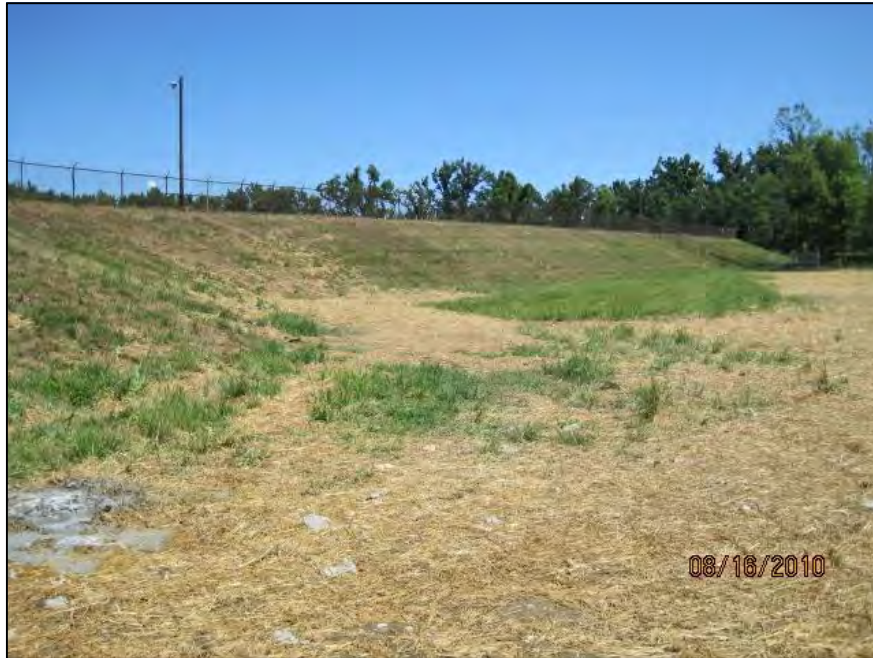
**SP-11**

**LOOKING E AT DOWNSTREAM SLOPE OF SOUTH DIKE, WET AREA BELOW TOE, STEEP SLOPE, SPARSE GRASS**
