Comments on Draft report- E on- Kentucky Utilities- Pineville Generating Station

DRAFT Report of Geotechnical Investigation Dam Safety Assessment of Coal Combustion Surface Impoundments Kentucky Utilities, a Subsidiary of E.ON U.S. Pineville Generating Station, Pineville, Kentucky

Cover pages, cover letter, appendices A and C of 2011 Pond Inspections Visual Site Assessment Report Six Impoundment Facilities

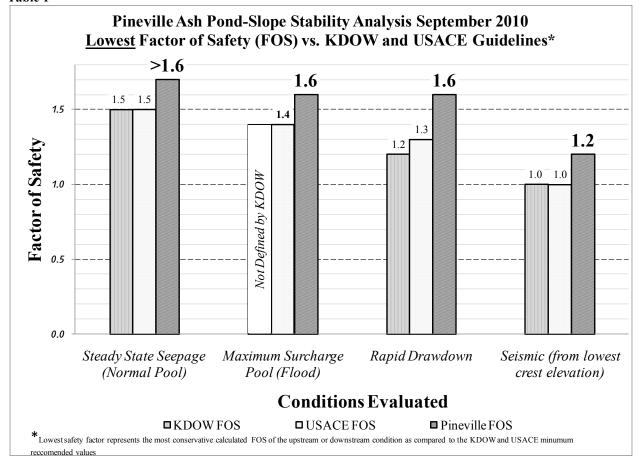
Table 1

KU Notes: A comprehensive geotechnical exploration and slope stability analysis for the Pineville Ash Pond was completed in September, 2010 and is included as attachment 2. The results of the analysis are summarized in Table 1.

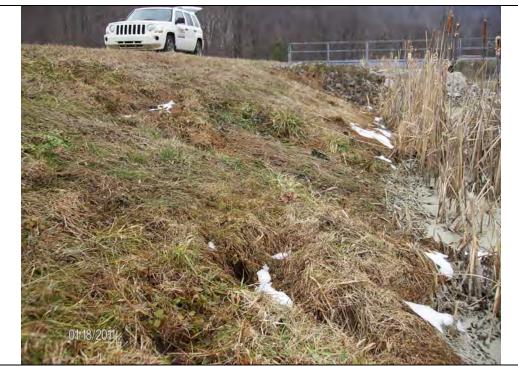
Photo #1: Interior slope, east end of south embankment, various animal burrows observed along slope, looking west

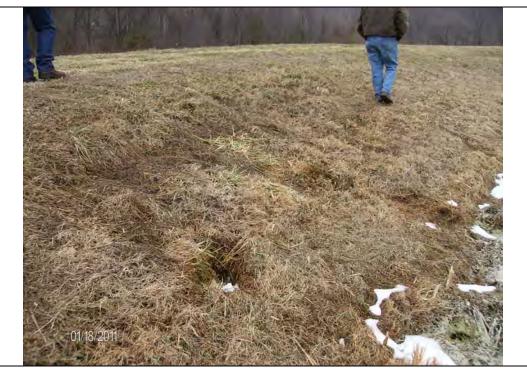
Photo #2: Interior slope, west end of south embankment, various animal burrows observed along slope, looking west

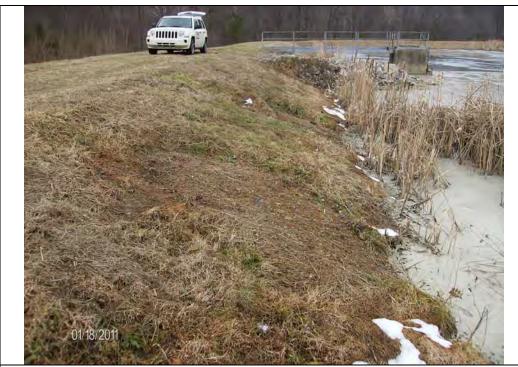
Photo #5: Interior slope, south embankment, sparse vegetation, southeast corner, looking west

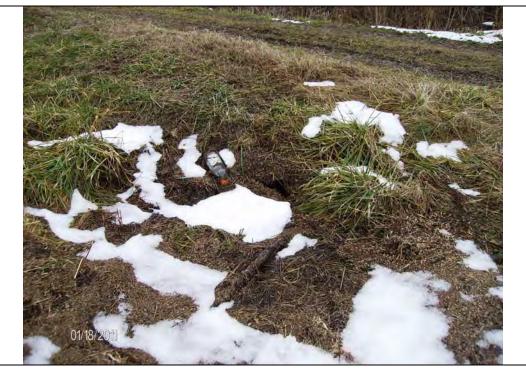
Photo #6: Exterior slope, partially blocked culvert draining ditch below toe at SW corner, looking southeast

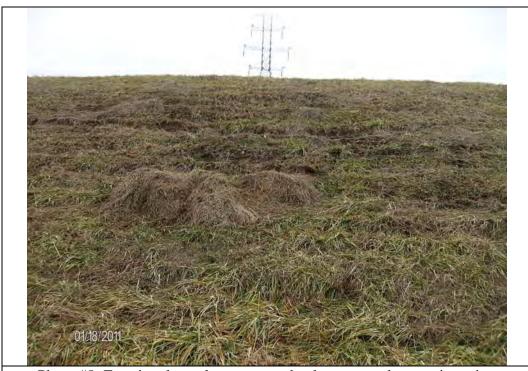
Photo #8: Exterior slope along west embankment, need to repair rutting and re-establish vegetation along slope, looking east

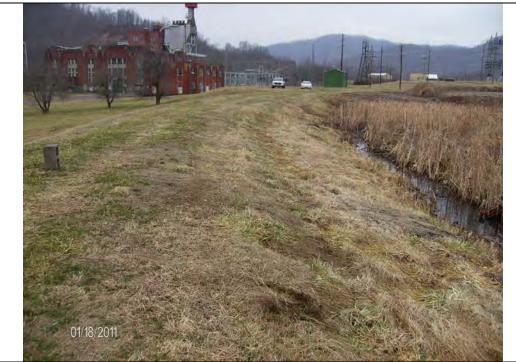
Photo #9: Crest of west embankment, fill low area at upstream side to restore to nominal width, looking north
