Comment on Draft Report – Kentucky Utilities – Tyrone Generating Station

**Re: Kentucky Utilities' Comments for  
*DRAFT Report of Geotechnical Investigation Dam Safety Assessment of Coal Combustion Surface  
Impoundments Kentucky Utilities, a Subsidiary of E.ON U.S. Tyrone Generating Station, Tyrone, Kentucky***

TYRONE ASH POND PHOTOS  
January 7, 2011

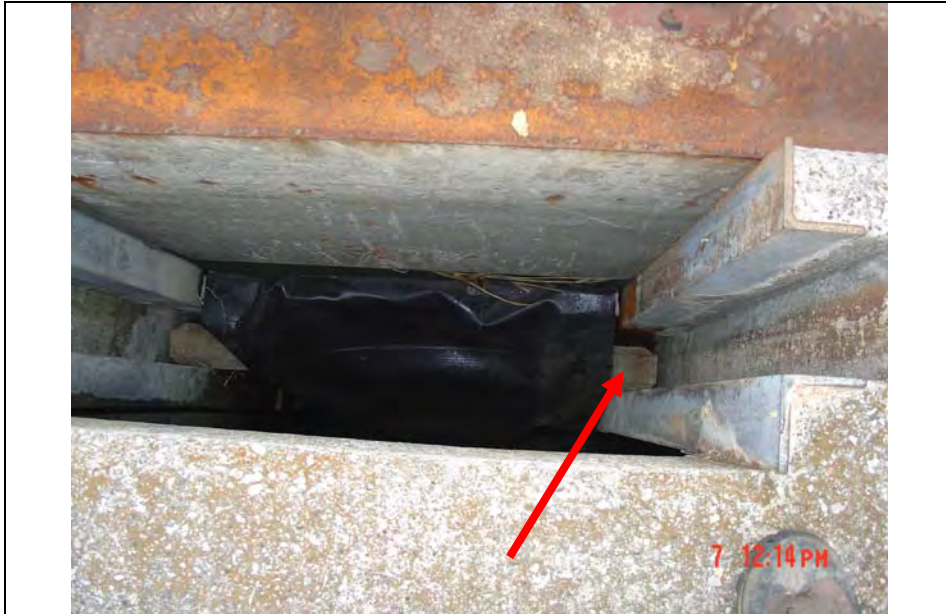
**Photo #1:** Stop logs in main spillway, no maximum placement elevation noted on spillway inlet

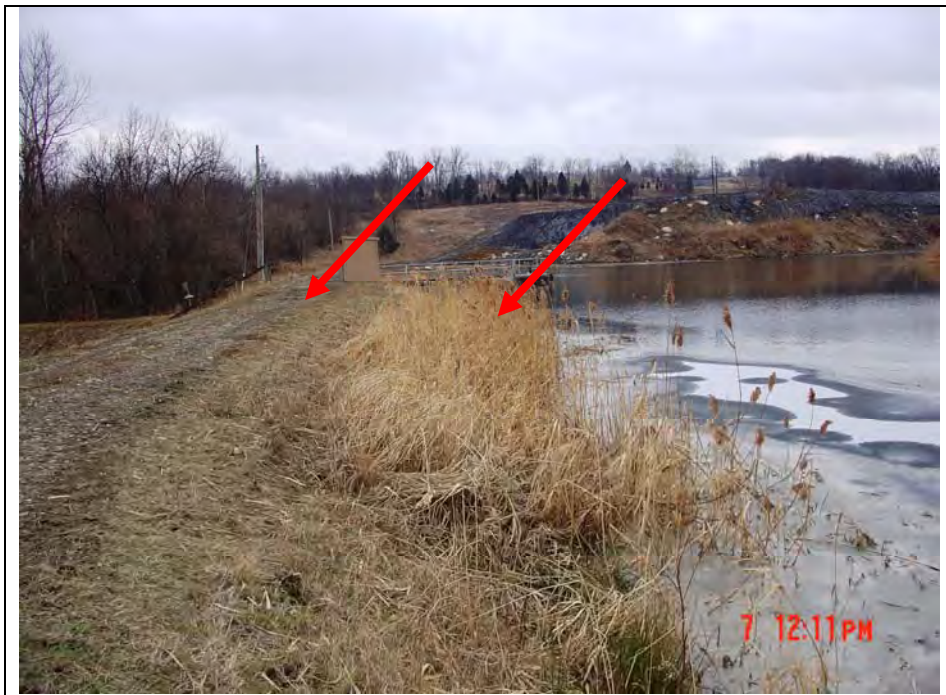
**Photo #2:** Vegetation on north embankment upstream slope, low elevation areas on dam crest, looking south

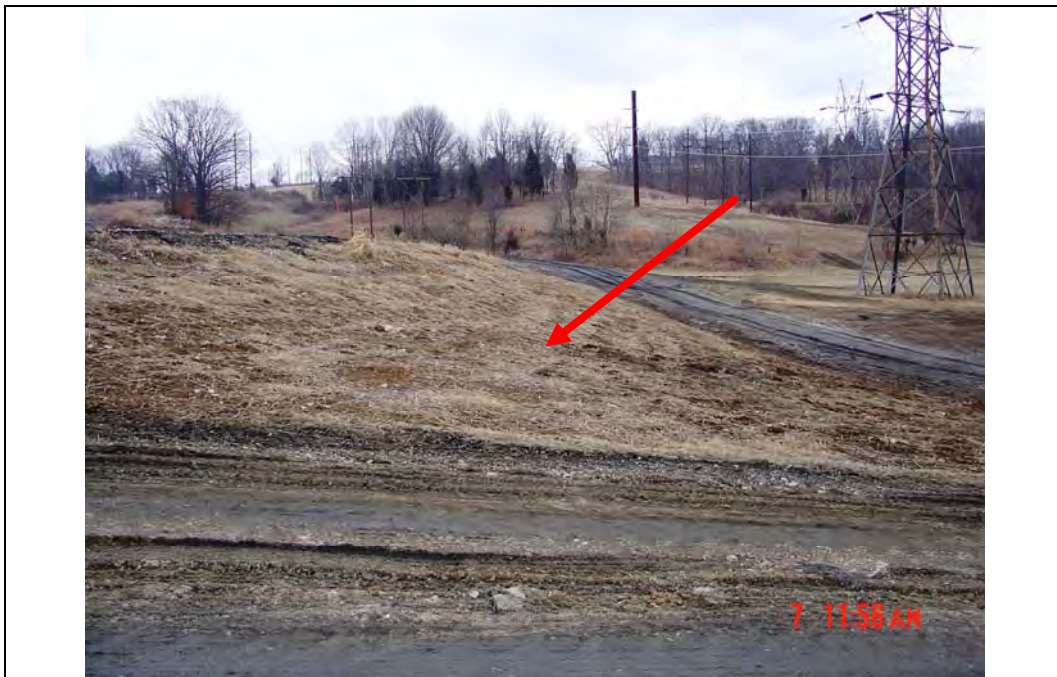
**Photo #6:** South exterior slope at recent repair, area needs vegetation established, looking east

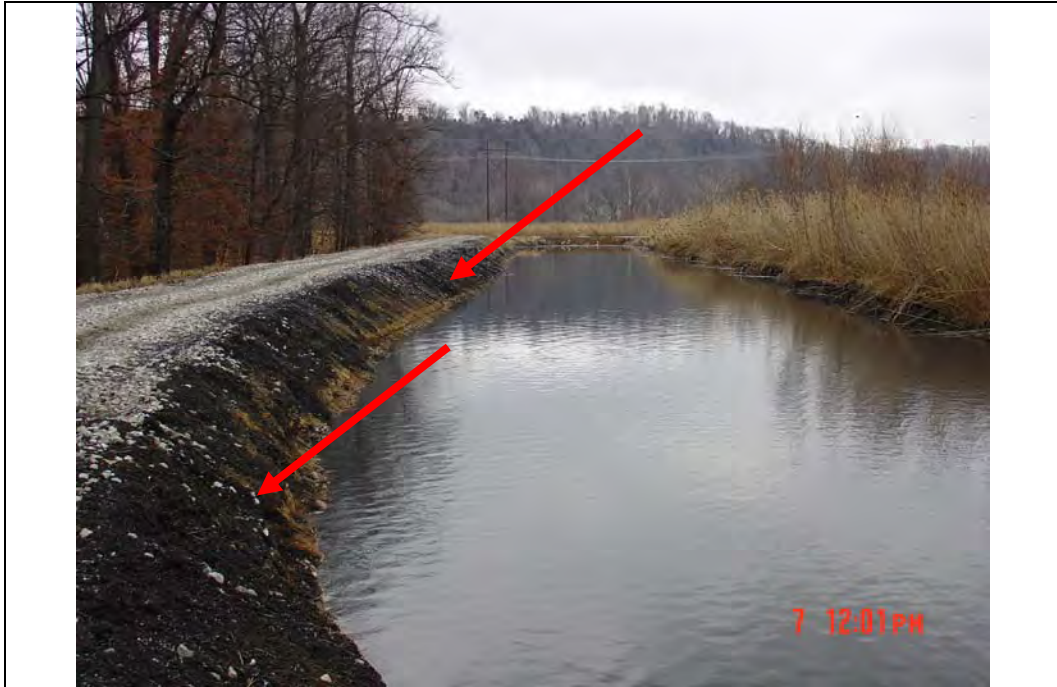
**Photo #7:** Interior slope west embankment, area needs erosion protection, looking north
