US EPA ARCHIVE DOCUMENT

Report of  
Dam Safety Assessment of Coal Combustion  
Surface Impoundments

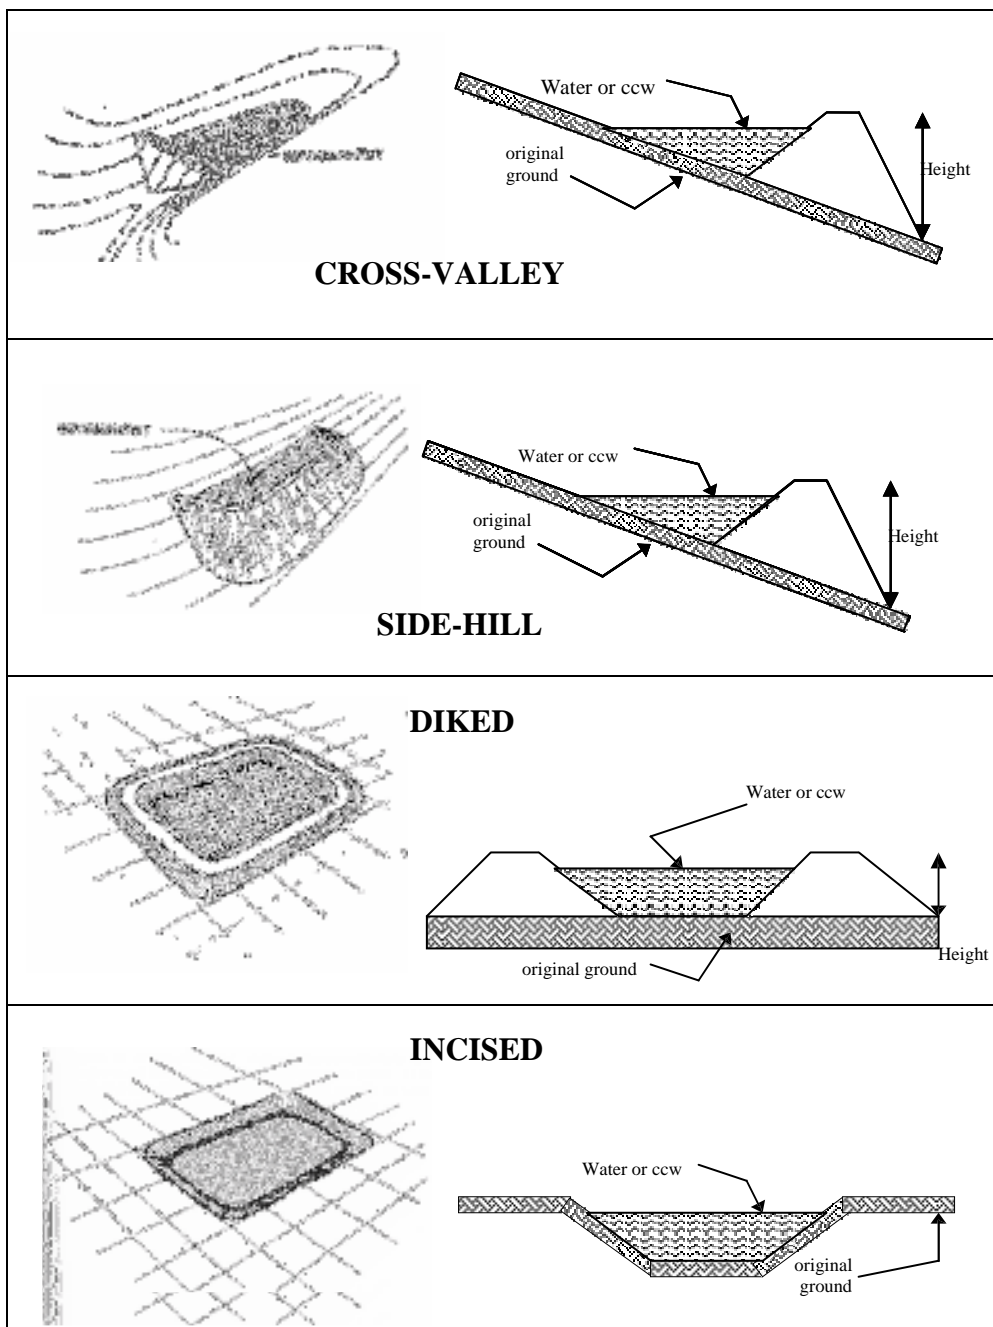
☐ Cross-Valley  
☒ Side-Hill  
☐ Diked  
☐ Incised (form completion optional)  
☐ Combination Incised/Diked
