**DRAFT ROUND 10 DAM ASSESSMENT REPORT  
LANSING BOARD OF WATER & LIGHT  
ERICKSON STATION  
ASH POND**

**APRIL 30, 2012**

Re: Round 10 Dam Assessment - Draft Report  
EPA Contract No. EP10W001313  
Lansing Board of Water & Light – Erickson Station  
Ash Pond  
Lansing, Michigan

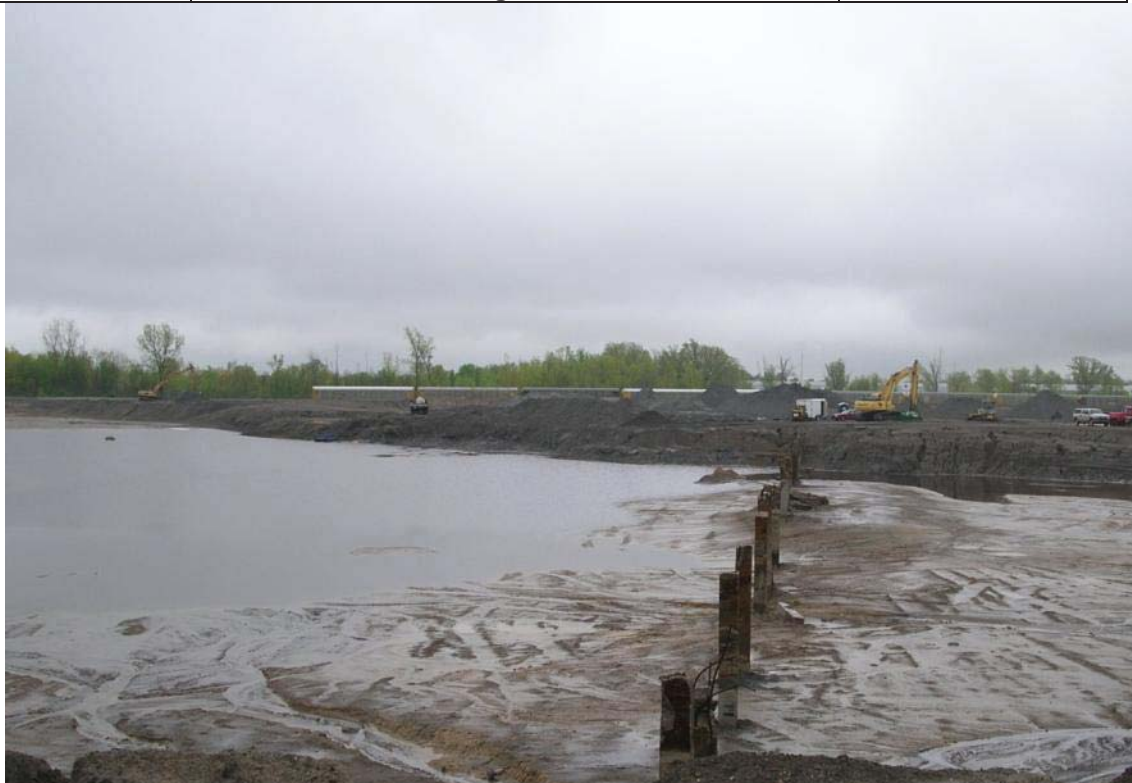
**Photo No.**  
**2**

Crest of embankment.

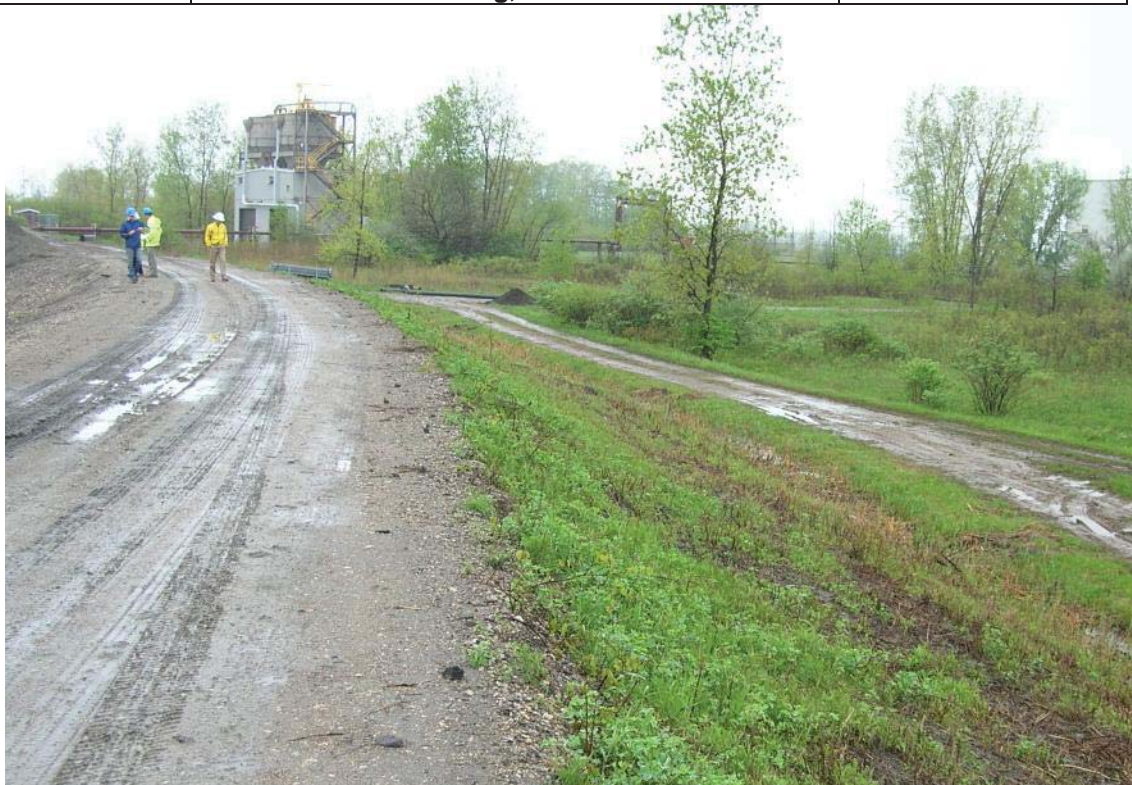
**Photo No.**  
**4**

**Description:**  
Crest and inner slope of  
embankment. Some minor  
erosion channeling was  
present on the inner slope.

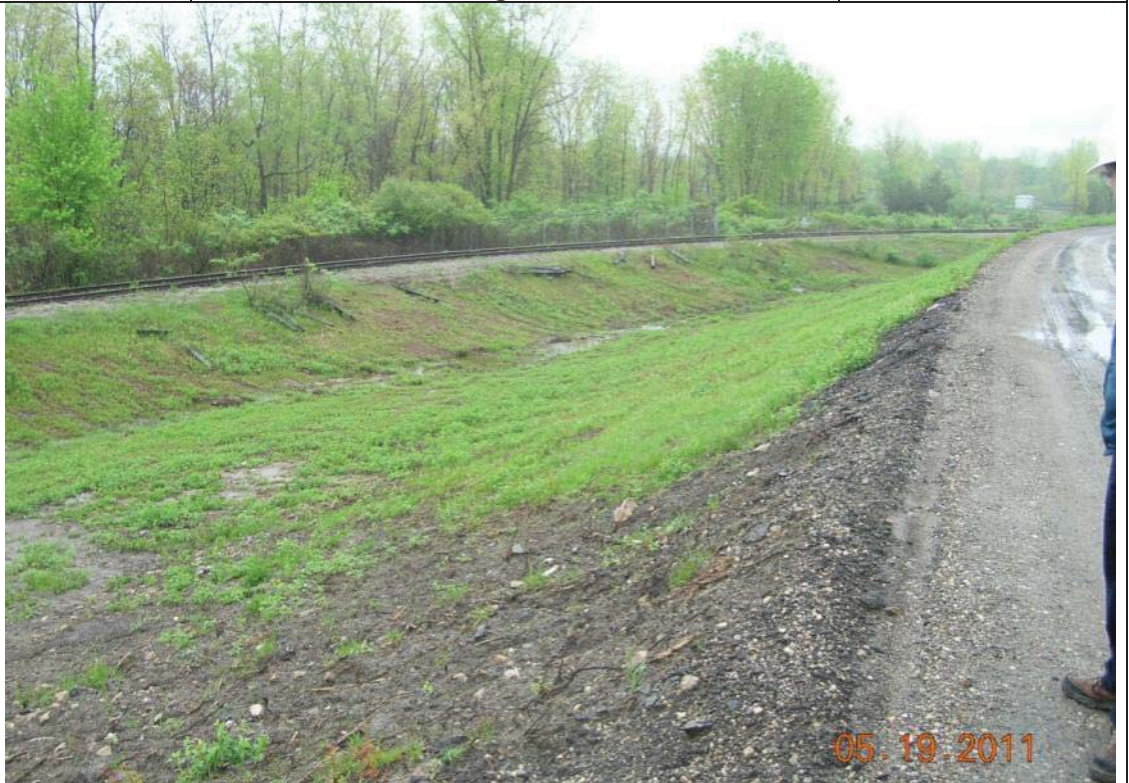
**Photo No.**  
**6**

**Description:**  
Culvert that drains water  
from the toe of the slope to  
Holly Drain.

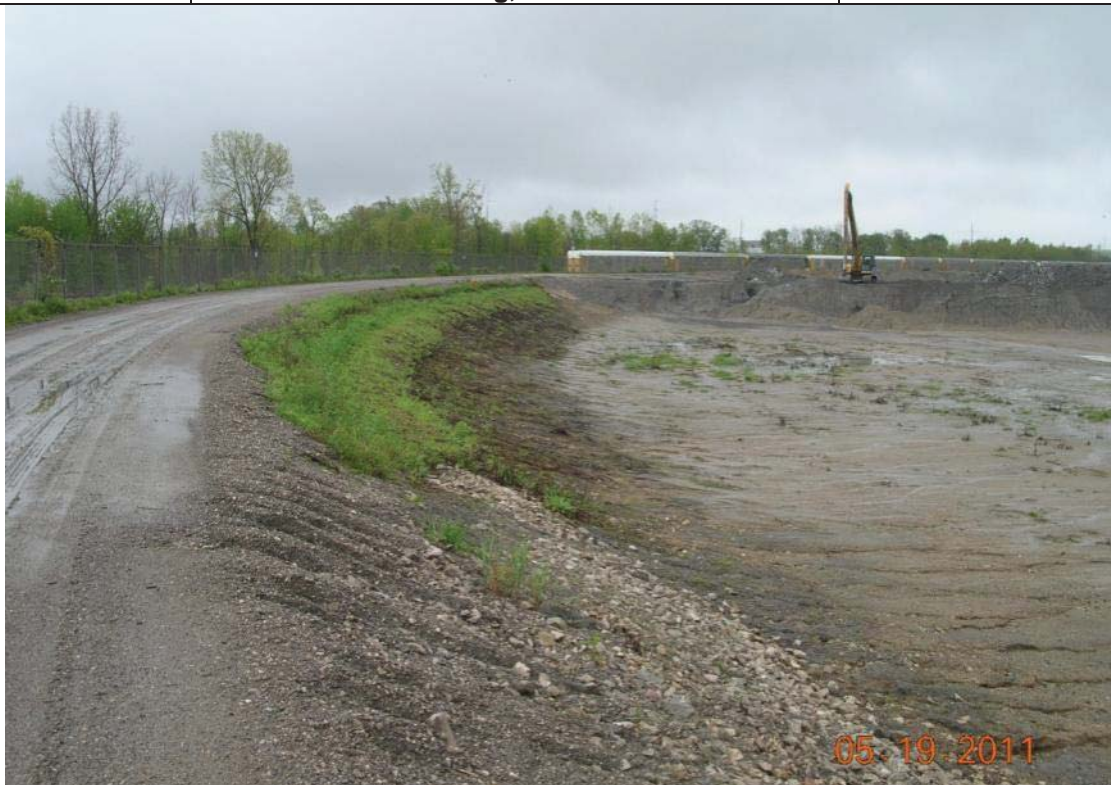
**Photo No.**  
**8**

**Description:**  
Water along the downstream  
toe of the slope.

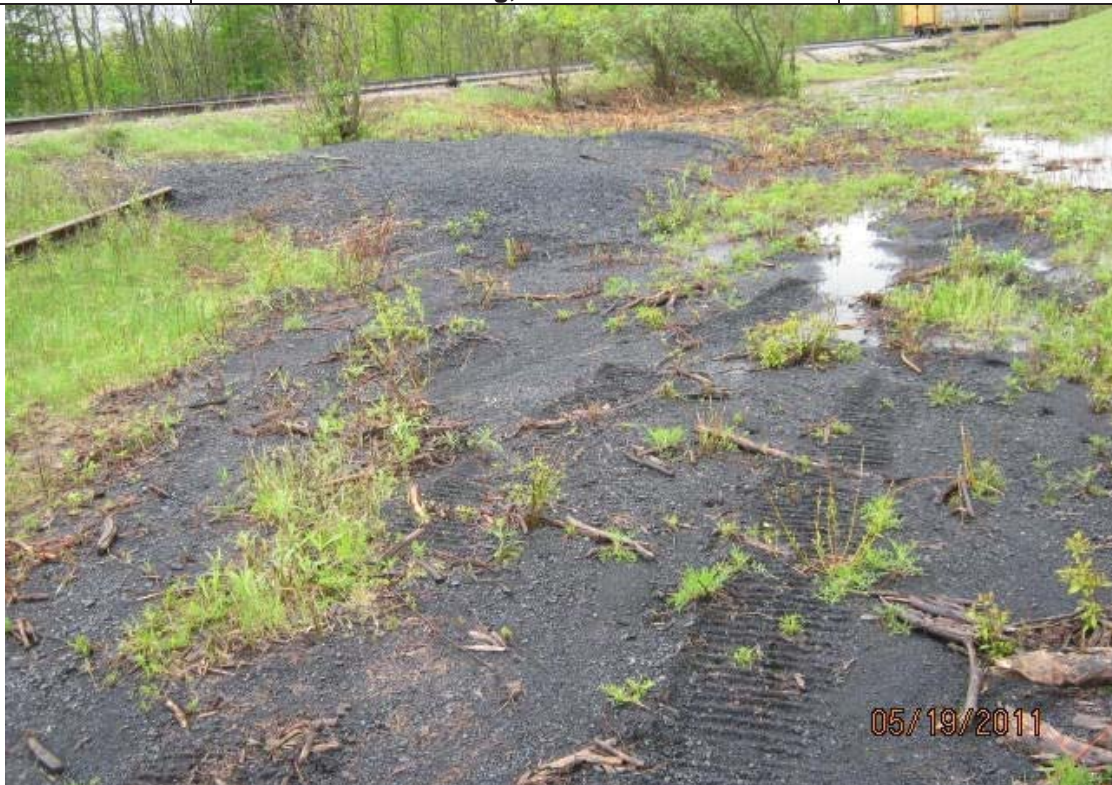
**Photo No.**  
**10**

**Description:**  
Evidence of rip rap along the toe of the slope.

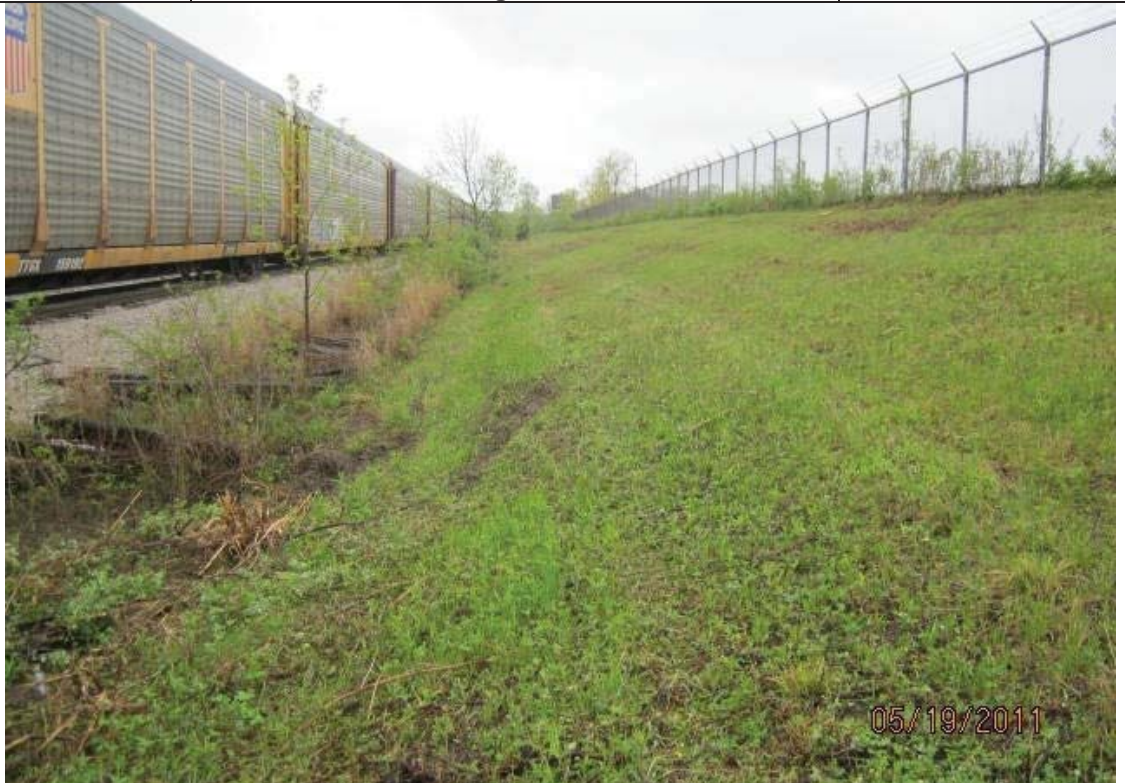
**Photo No.**  
**12**

**Description:**  
Crest and embankment near  
Station 104+00. The  
shallow hole on the right of  
the photo was caused by a  
surveyor attempting to locate  
a surface monument.

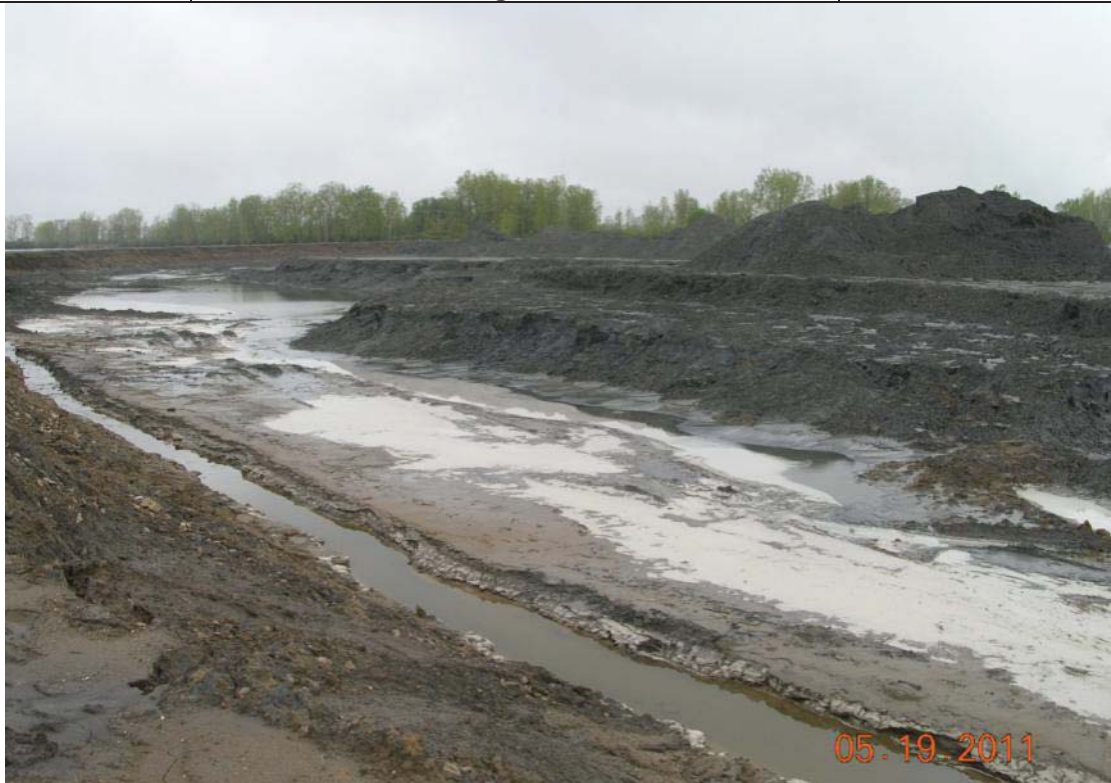
**Photo No.**  
**18**

**Description:**  
Embankment between the  
Ash Pond and Clear Water  
Pond.

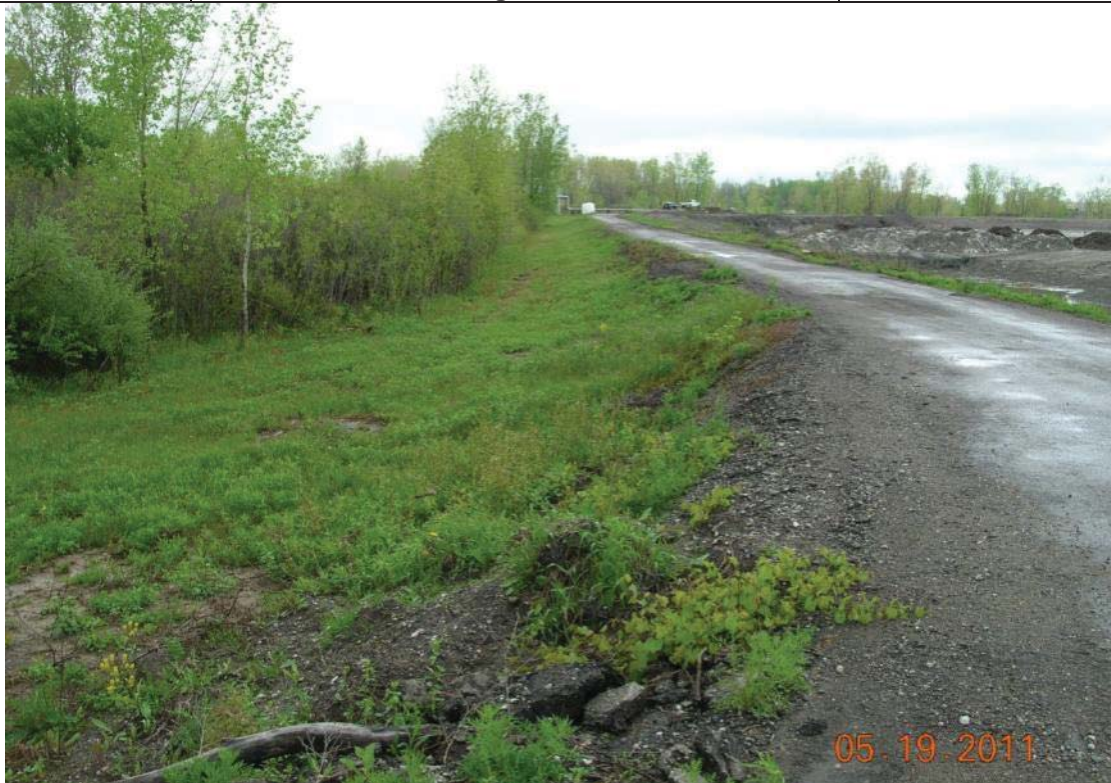
**Photo No.**  
**26**

**Description:**  
Temporary road constructed  
in the Ash Pond to facilitate  
ash removal.

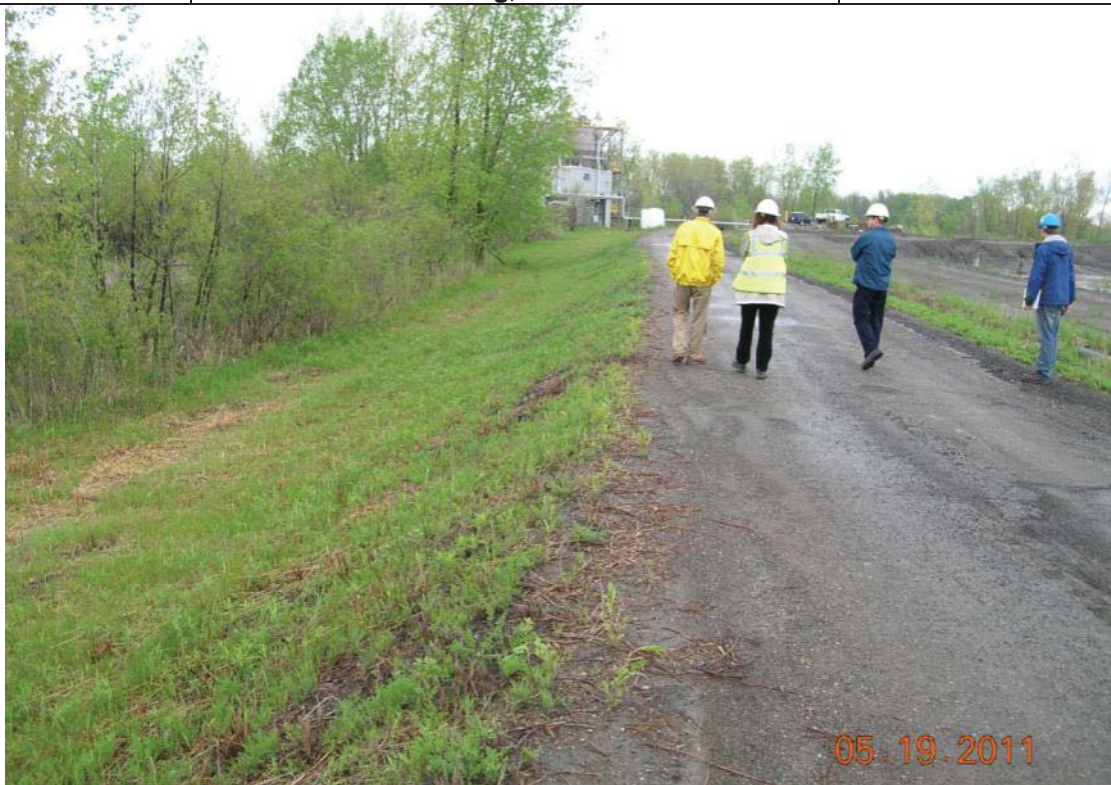
**Photo No.**  
**28**

**Description:**  
Crest of Ash Pond  
embankment and bottom ash  
discharge pipe that is placed  
inside the Ash Pond.

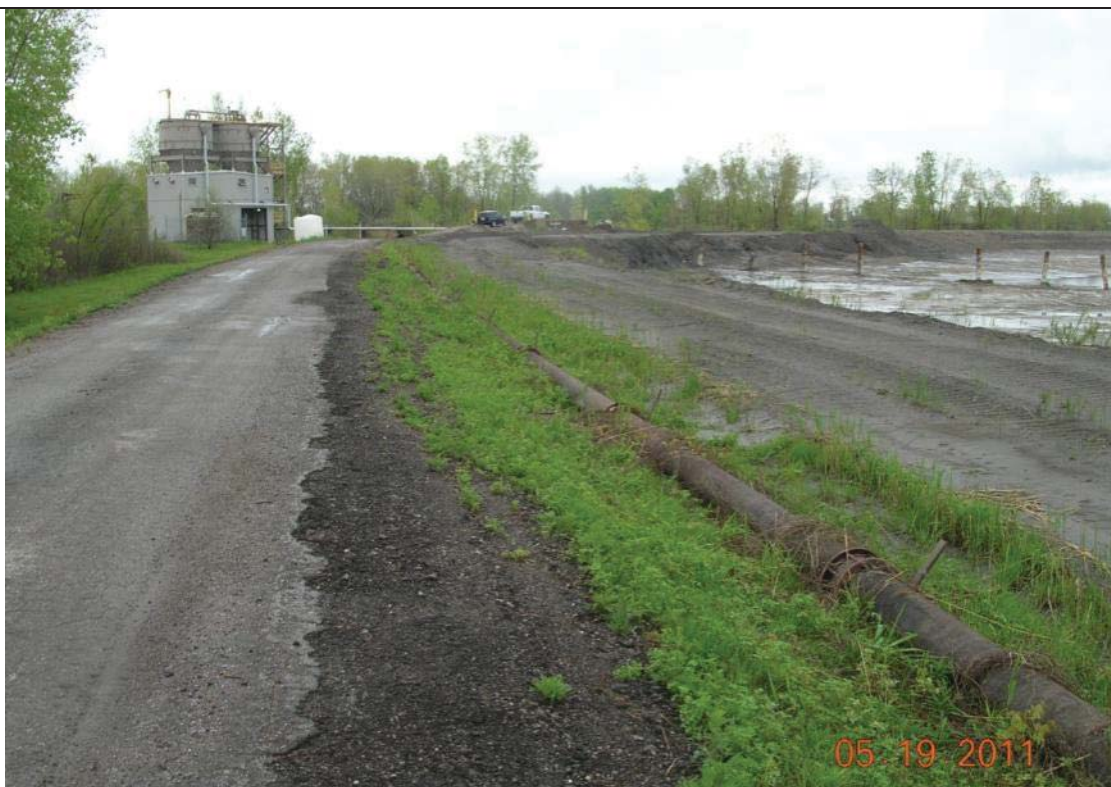
**Description:**  
Apparent leak in the bottom  
ash discharge pipe.

1. Repair the leaking bottom ash discharge pipe; and,
2. Evaluate the necessity of the unknown pipe found on the north side of the Ash Pond and remove the pipe if it is not needed.

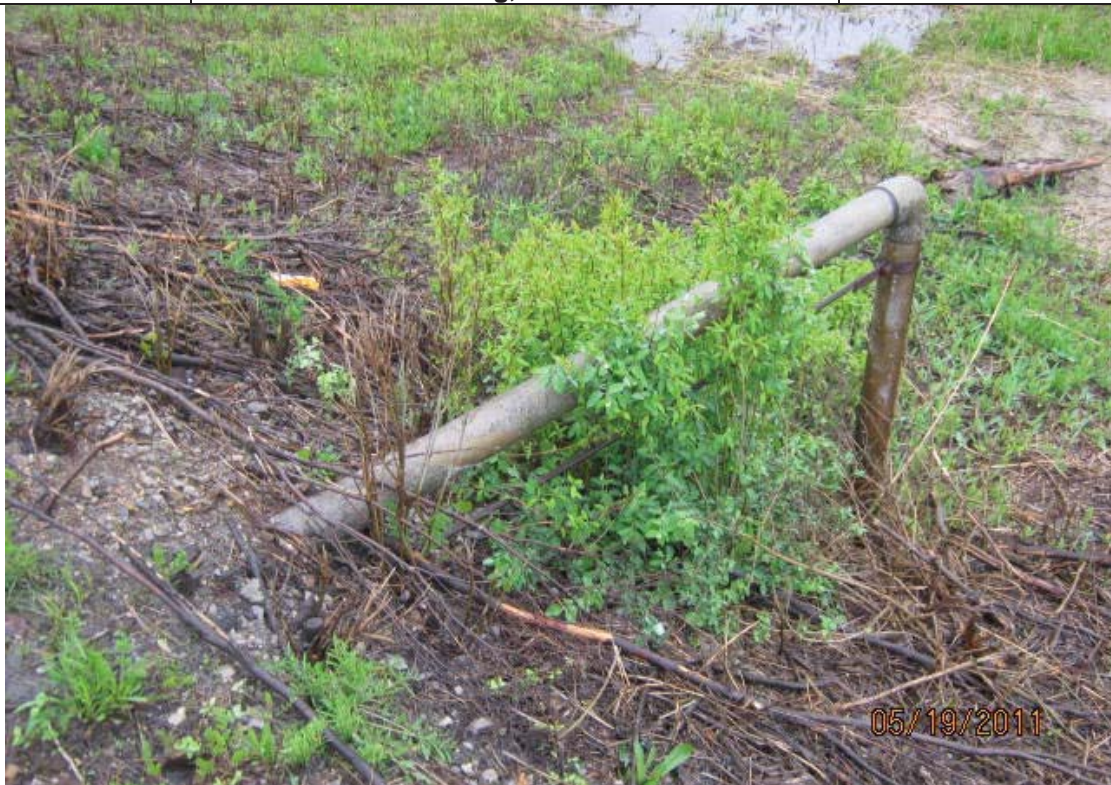
**Photo No.**  
**34**

Discharge from the coal pile runoff pipe into the Ash Pond.

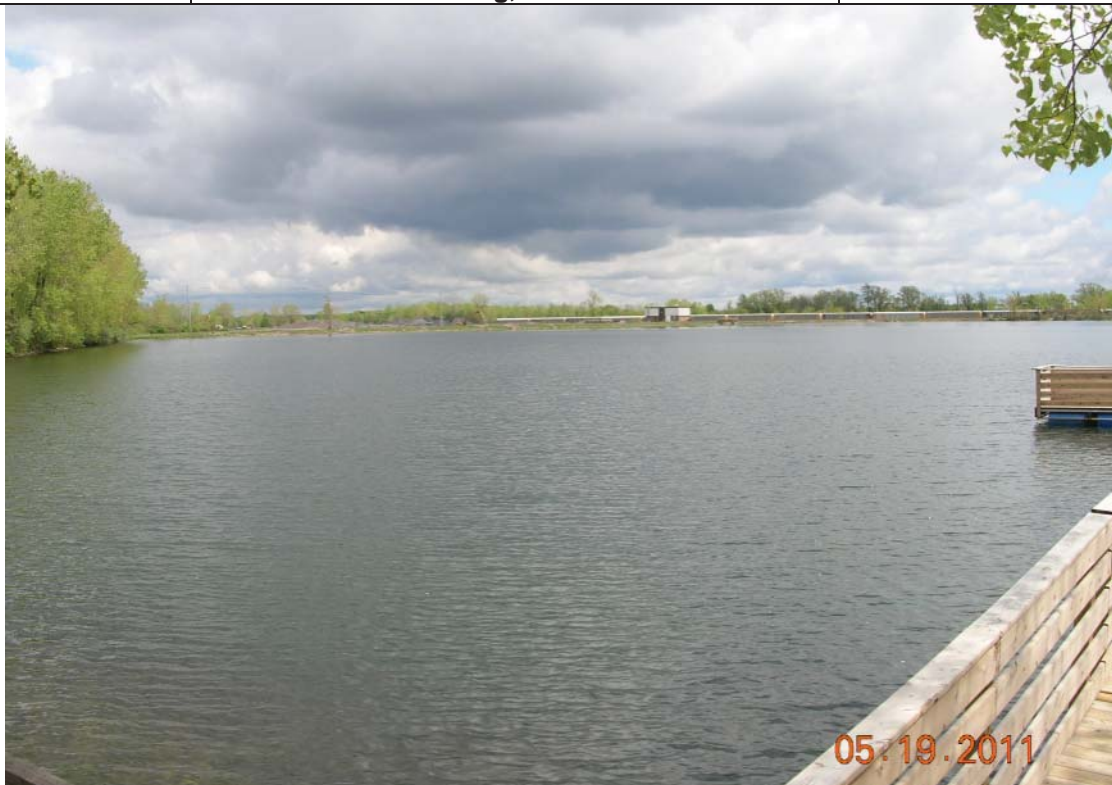
**Photo No.**  
**36**

**Description:**  
Fishing dock on the Water  
Storage Pond.

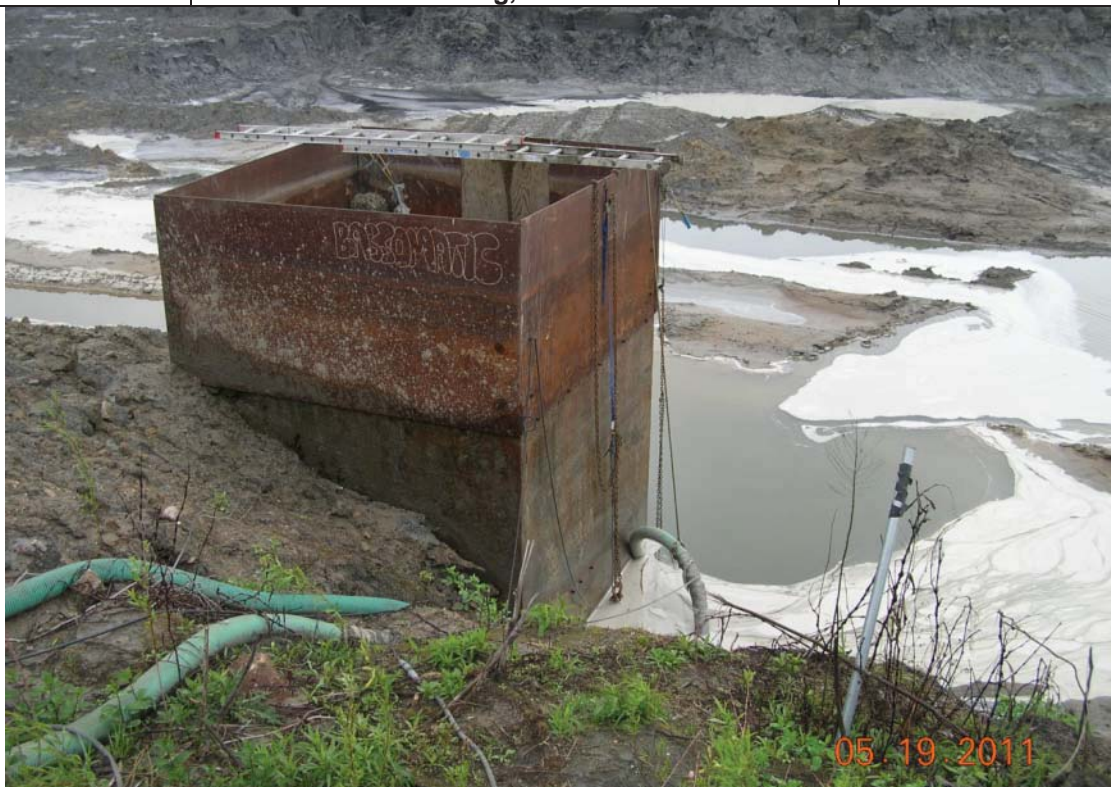
**Photo No.**  
**40**

Stop logs in discharge structure.
