Assessment of Dam Safety of Coal Combustion Surface Impoundments

Sam Seymour - Fayette Power Project Station

Lower Colorado River Authority

Draft Report

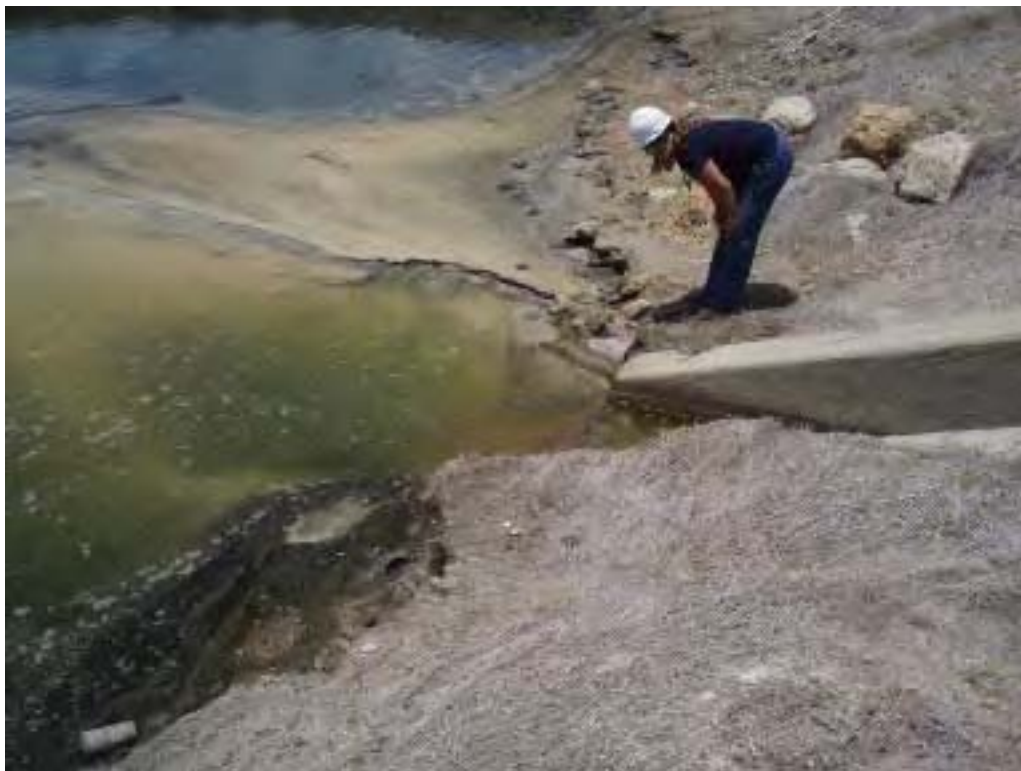
The waste drain trench (Photo 1) on the north embankment that drains into the impoundment was clear of debris and the channel was in good condition. The culvert headwall on the west embankment that discharges into the impoundment appears to

Photo No. 1: Reclaim Pond – Overview of waste drain trench outlet at the north embankment interior slope.

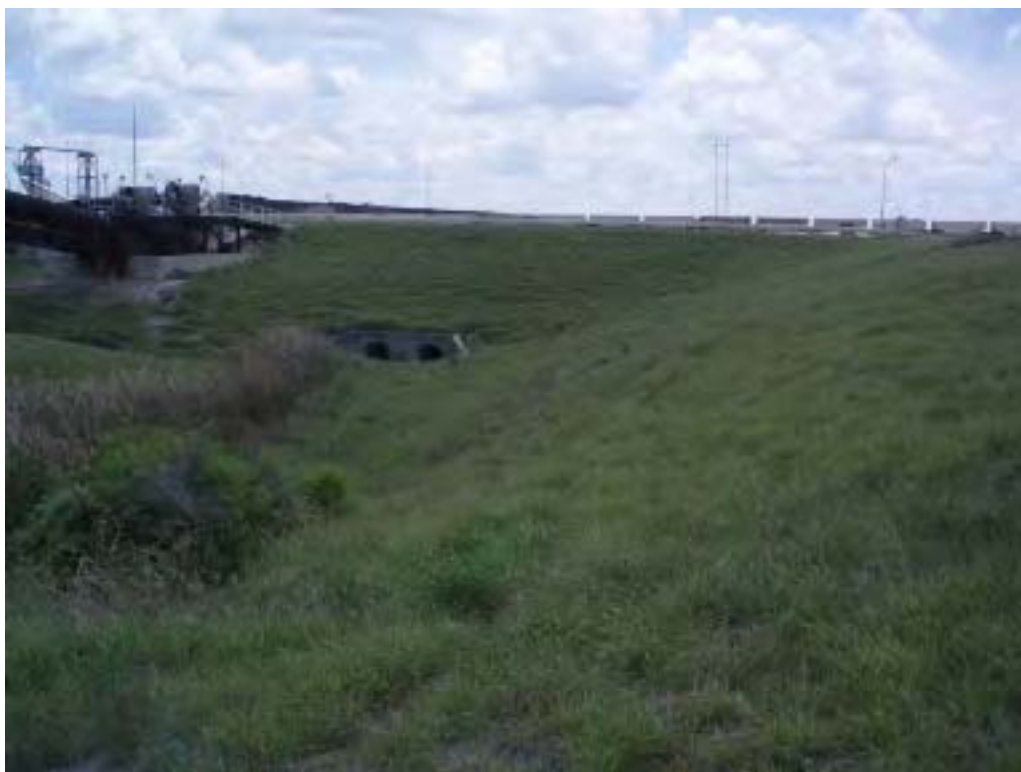
The exterior slope on the north appears to be in fair condition (Photos 2, 27, 34, 37, 38, 39, 40, 41, and 42). The grass on the north embankment ranged from 12 to 36 inches in height. Some minor brush and pricker bushes were observed on the slope. Brush and trees were observed at the toe of the slope in the drainage ditch. Desiccation cracks up to a ½ inch wide and 8 inches deep were observed at various locations on the embankment face.

Photo No. 2: Reclaim Pond – North embankment exterior slope, looking east.

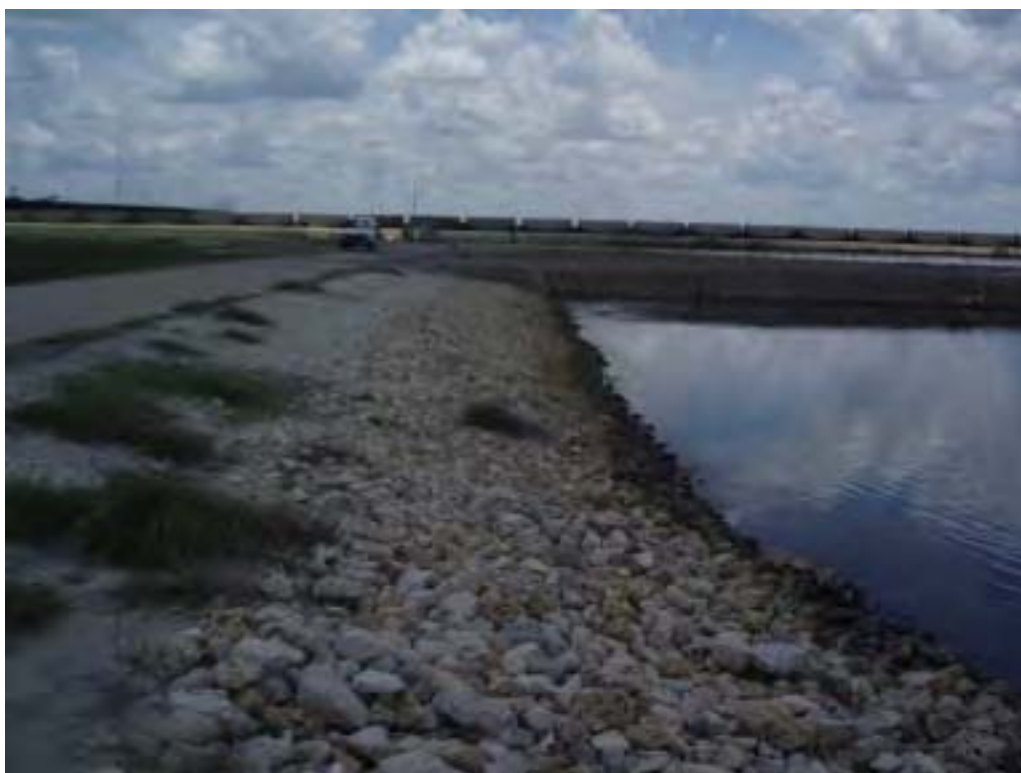
The visible portions of the interior slope generally appeared to be in fair condition (Photos 1, 4, 5, 9, 11, 12, 14, 17, 18, 19, 20, 21, 22, 24, 25, 33, and 36). The interior slope is protected with riprap armor. Some minor brush was growing between the riprap on the east embankment interior slope. On the west and east embankment there were some areas with little or missing riprap and there were areas with sparse vegetation and bare spots near the crest.

Photo No. 4: Reclaim Pond – North embankment interior slope, looking east

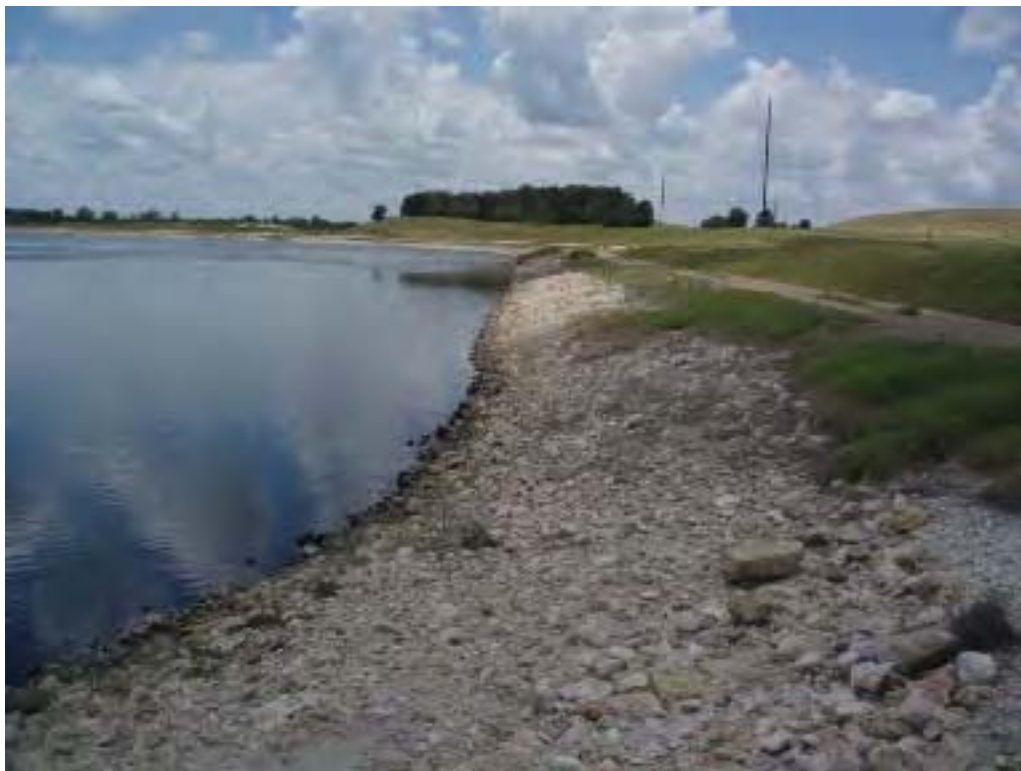
Photo No. 5: Reclaim Pond - West embankment interior slope, looking south.

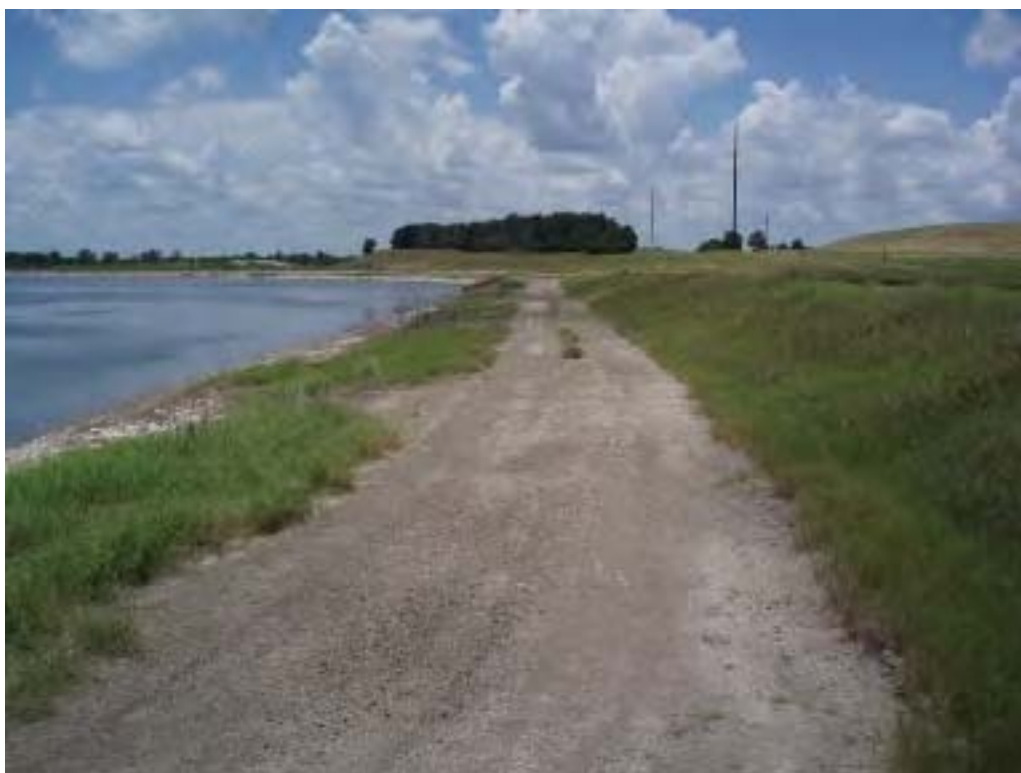
The crest of the Reclaim Pond generally appeared to be in fair condition (Photos 3, 6, 7, 8, 10, 13, 14, 15, 16, 20, 23, 26, 35, 45, and 49). The crest was surfaced with compacted gravel around the perimeter of the impoundment and served as an access road. Some minor rutting was observed on the south and west embankment crest. The railroad spur ballast on the east embankment crest is approximately 2 to 3 feet above the access road. The water level was at approximate El. 366 and there was about four feet of freeboard at the time of the site visit.

Photo No. 6: Reclaim Pond - West embankment crest, looking south.

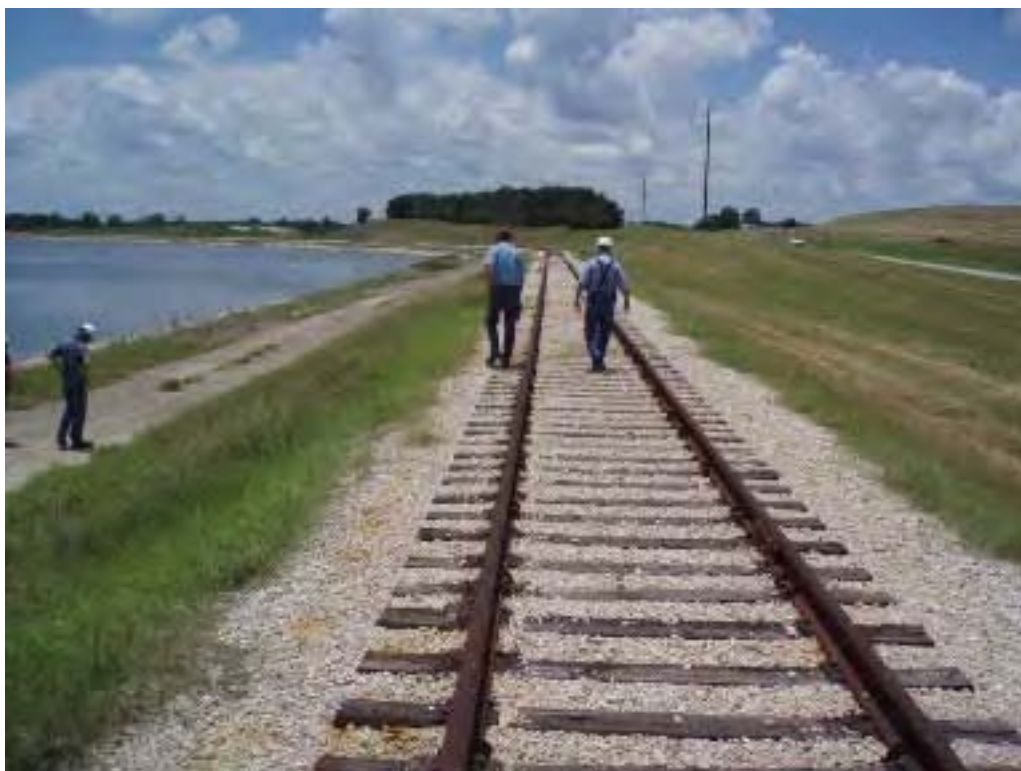
Photo No. 7: Reclaim Pond - Overview of west embankment from railroad spur, looking south.

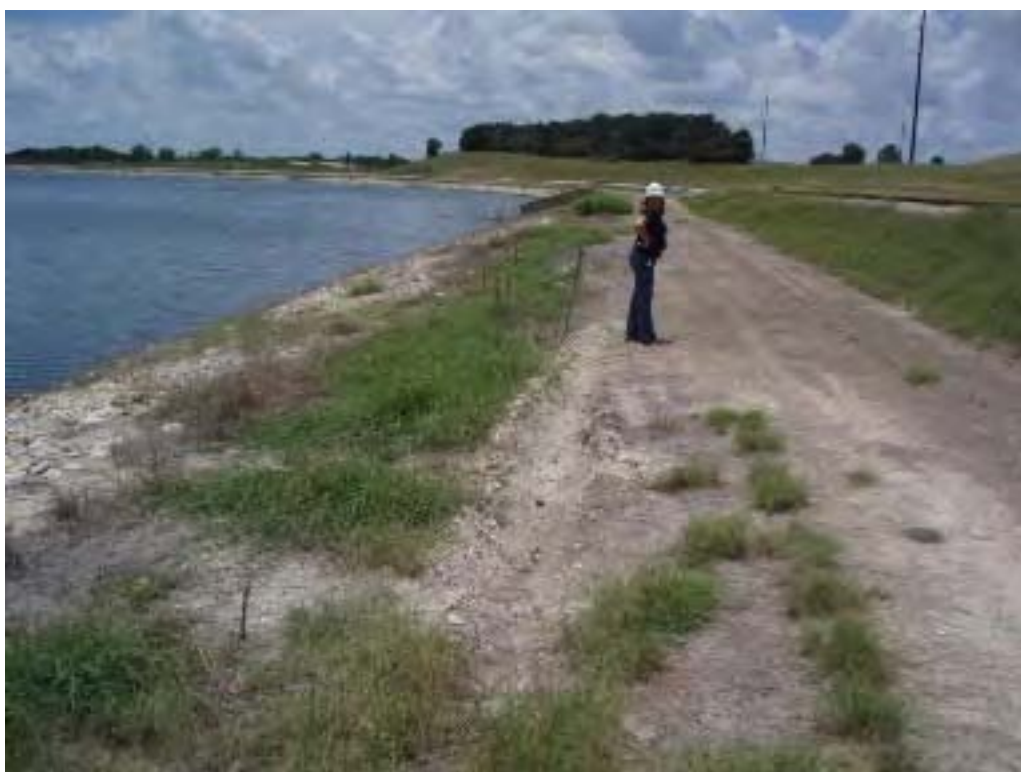
Photo No. 8: Reclaim Pond - West embankment, looking south at typical bare spots and tractor ruts on crest and interior slope.

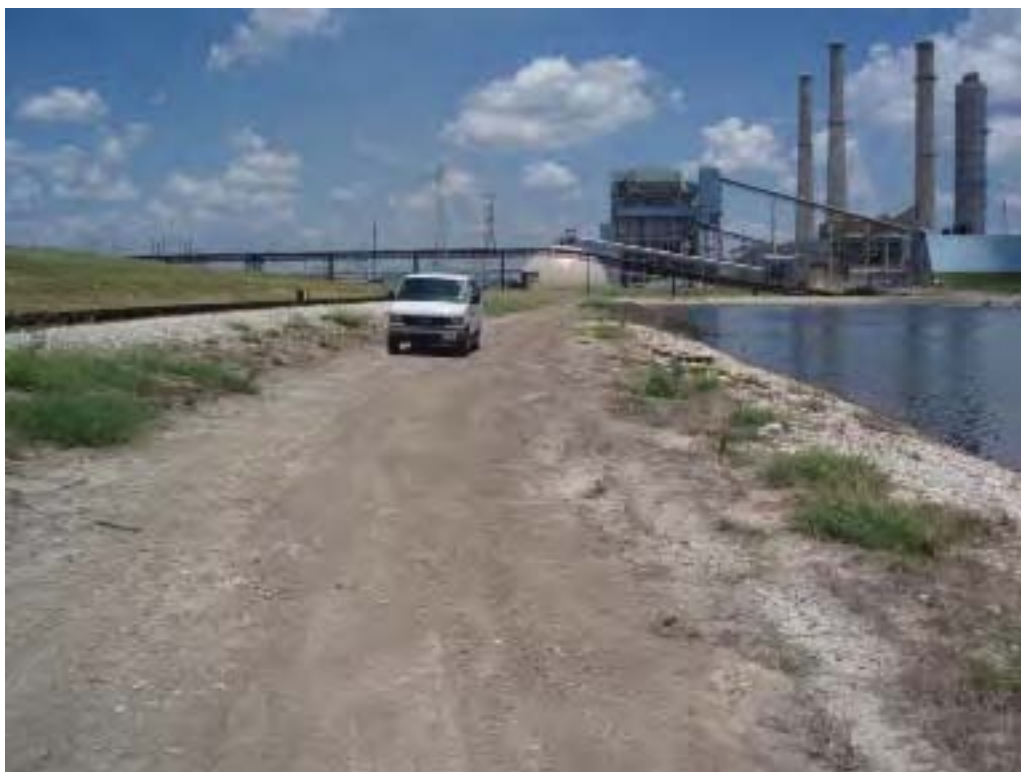
Photo No. 10: Reclaim Pond – West embankment crest, looking north at typical surface erosion and rutting.

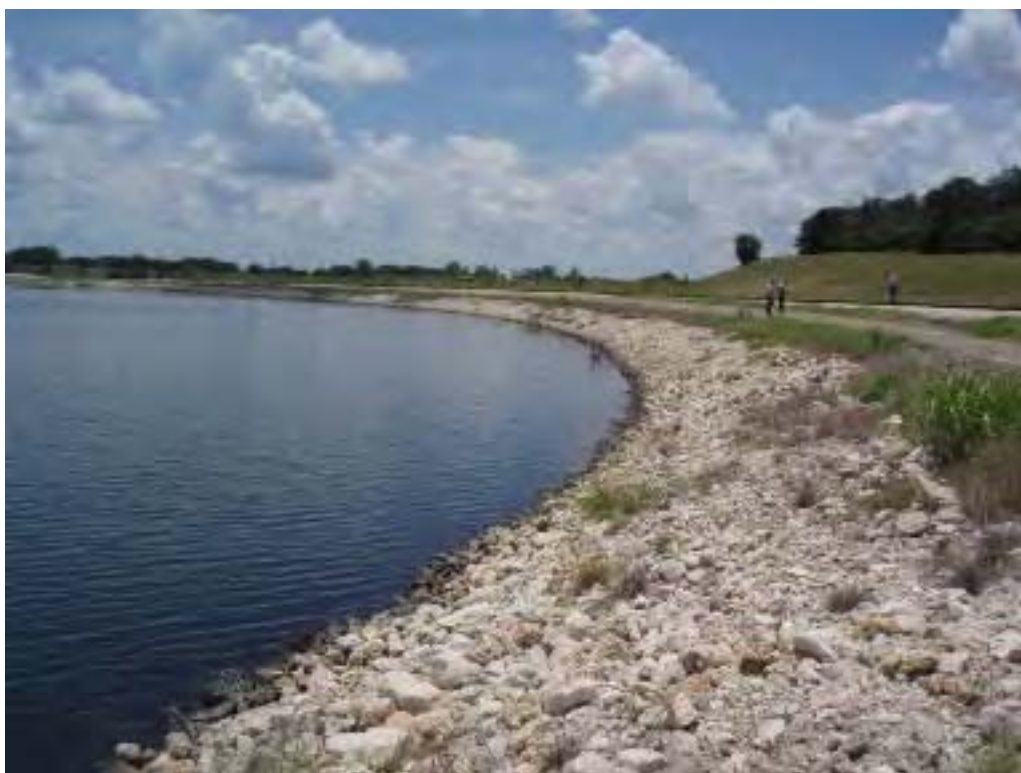
Photo No. 12: Reclaim Pond - South embankment interior slope, looking southeast

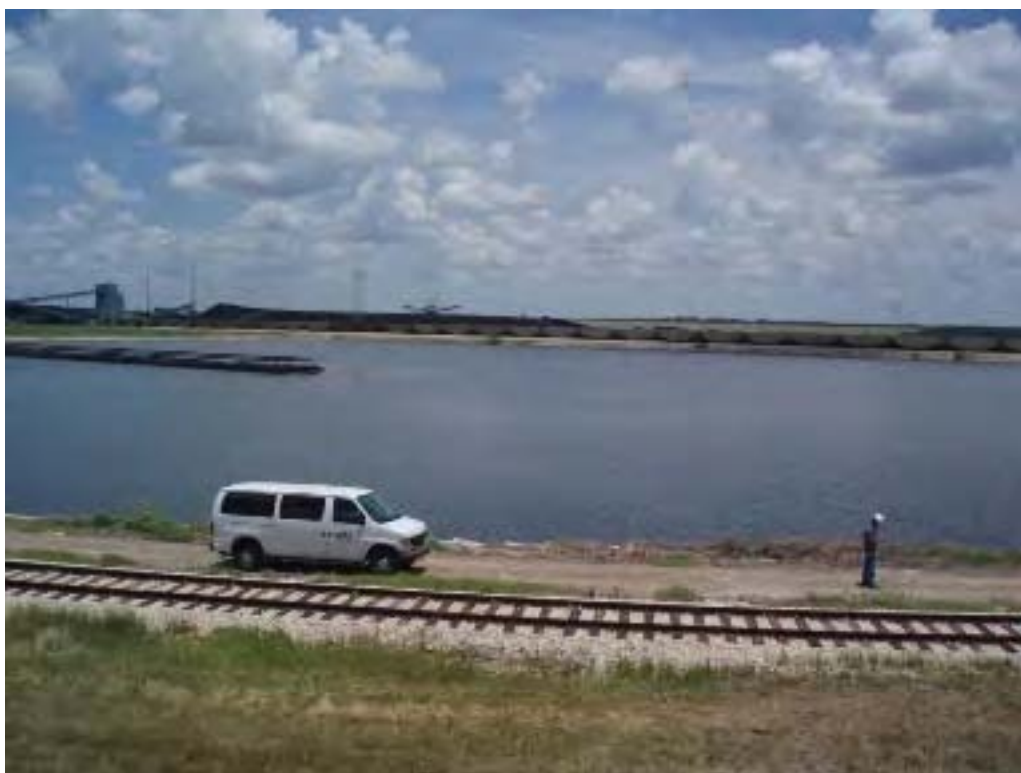
Photo No. 14: Reclaim Pond - Overview of impoundment, looking northeast.

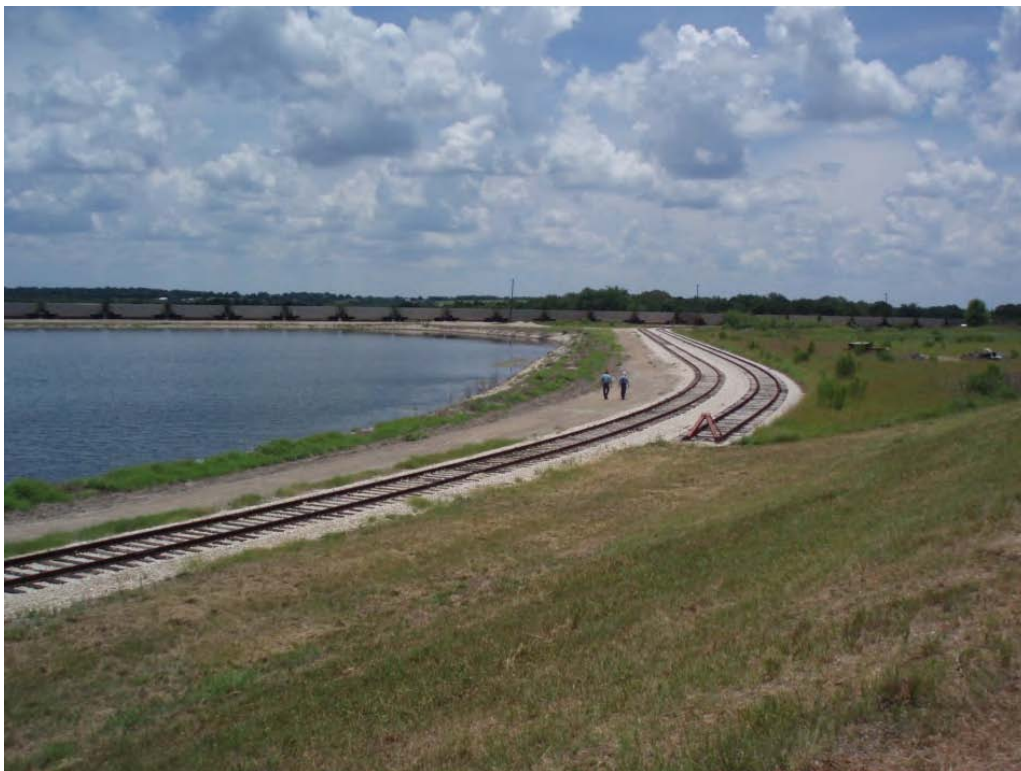
Photo No. 15: Reclaim Pond - Overview of south embankment, looking southeast.

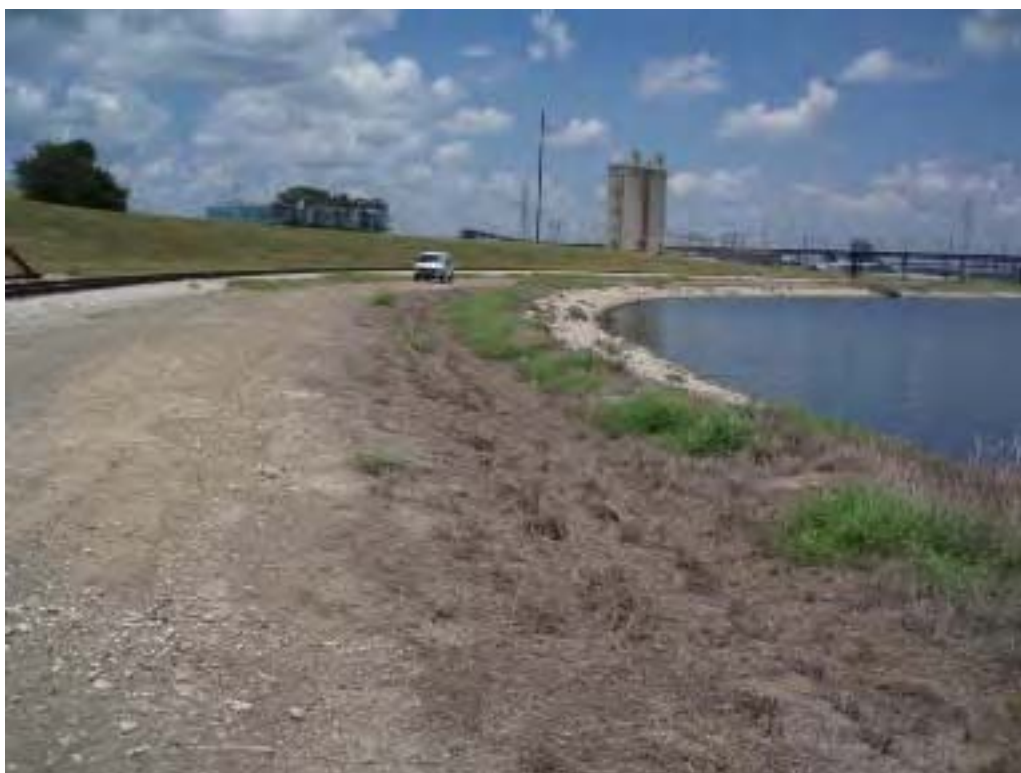
Photo No. 16: Reclaim Pond - South embankment, looking northwest at a low area on the crest

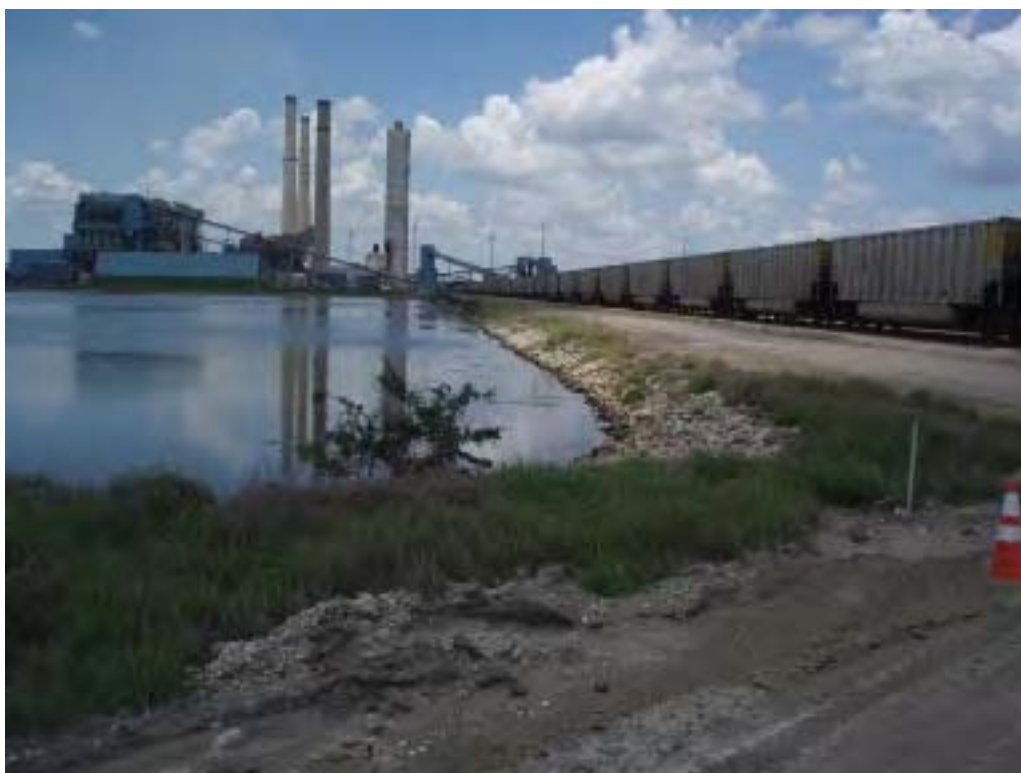
Photo No. 18: Reclaim Pond – East embankment interior slope, looking north. Small woody growth and minor surface erosion noted.

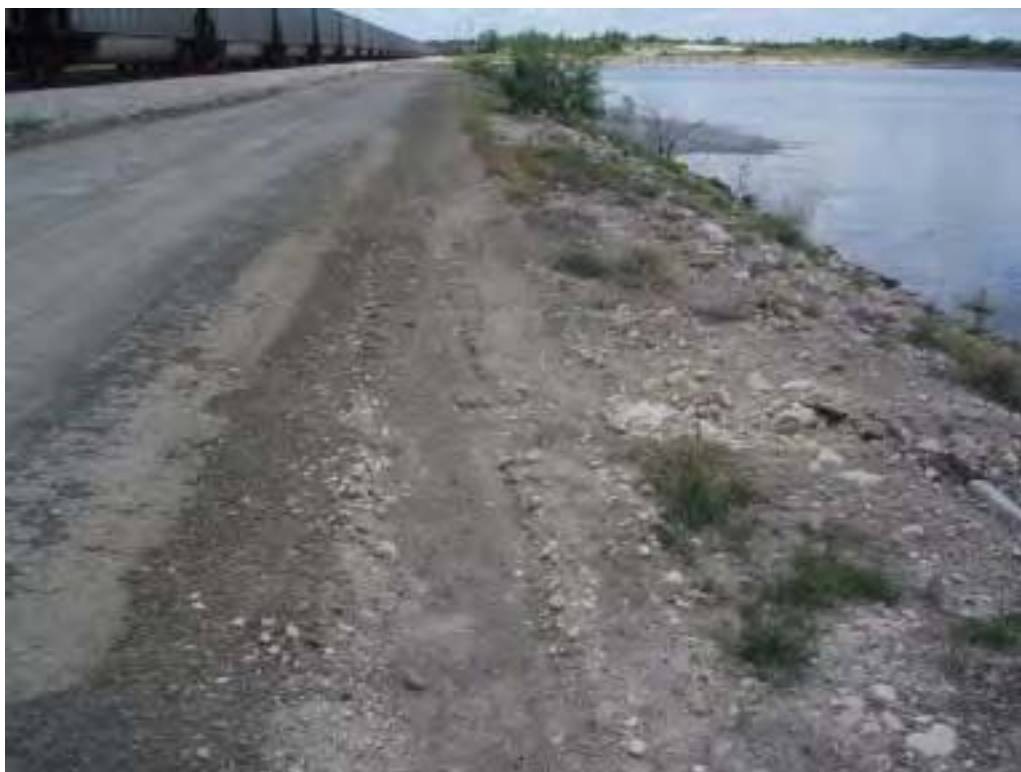
Photo No. 20: Reclaim Pond - East embankment interior slope, looking south at rutting and surface erosion. Note some riprap is missing and displaced.

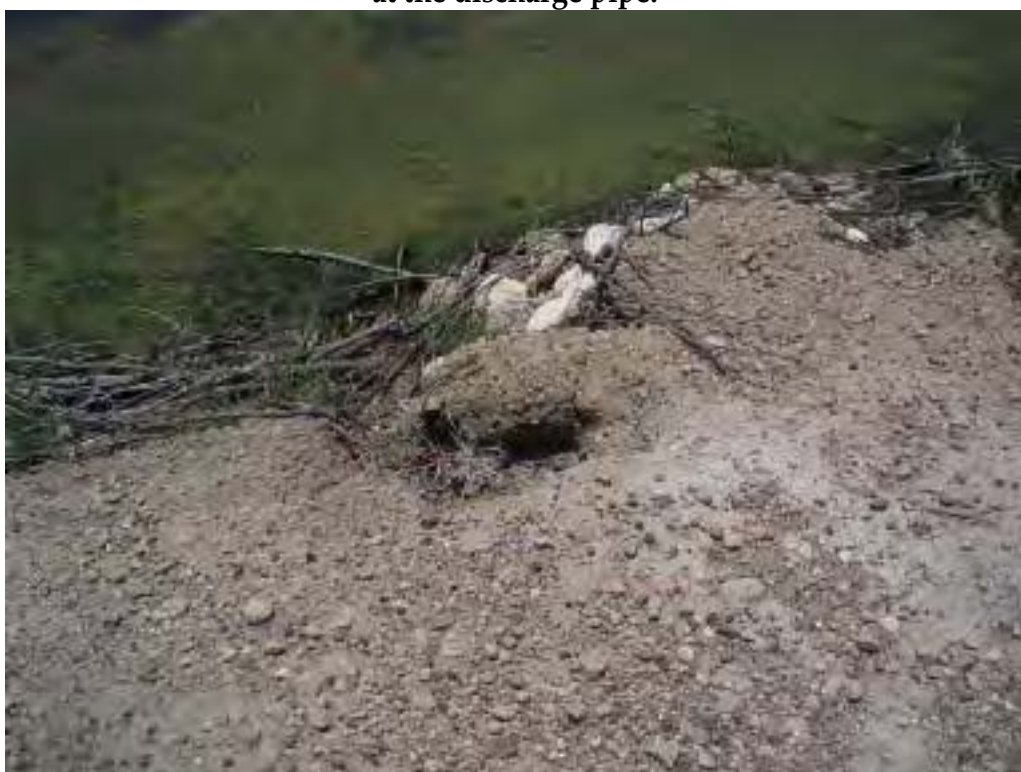
On the east embankment there was one 2.5-foot-wide erosion rill (Photo 22). There was also an area where an abandoned 12-inch-diameter HDPE pipe from the CADP discharged into the Reclaim Pond. This area of the interior slope was eroded and some of the riprap was missing.

Photo No. 22: Reclaim Pond - East embankment interior slope, looking at 2.5'W erosion rill.

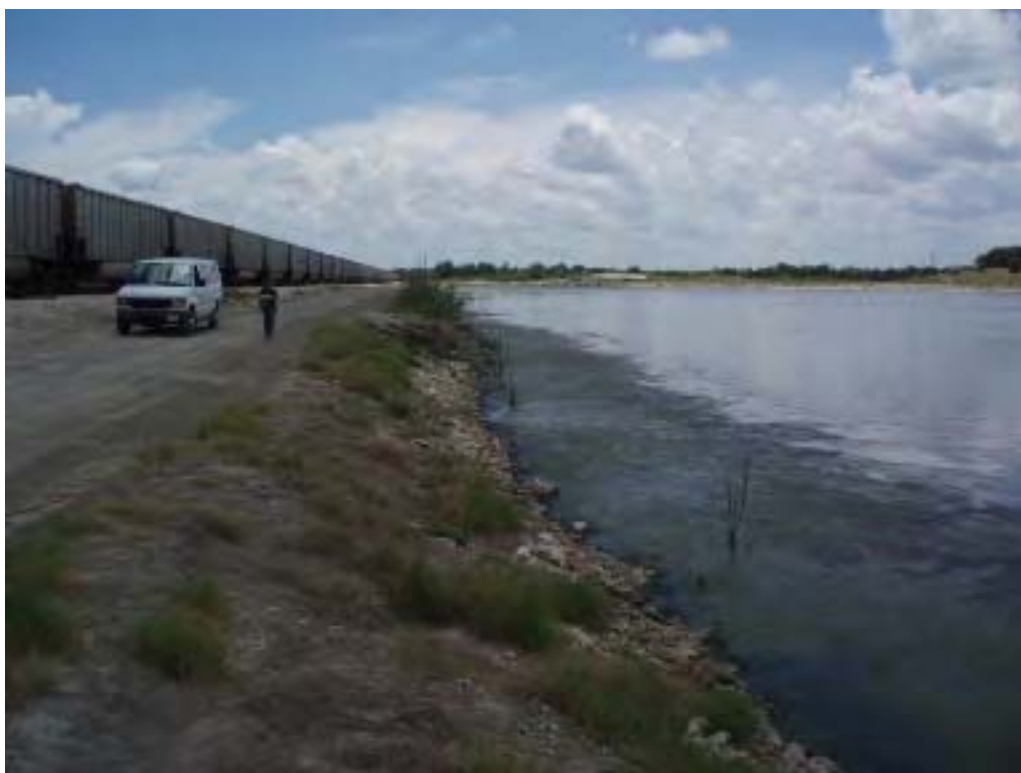
Photo No. 24: Reclaim Pond - East embankment interior slope, looking south. Note occasional mesquite trees growing on interior slope.

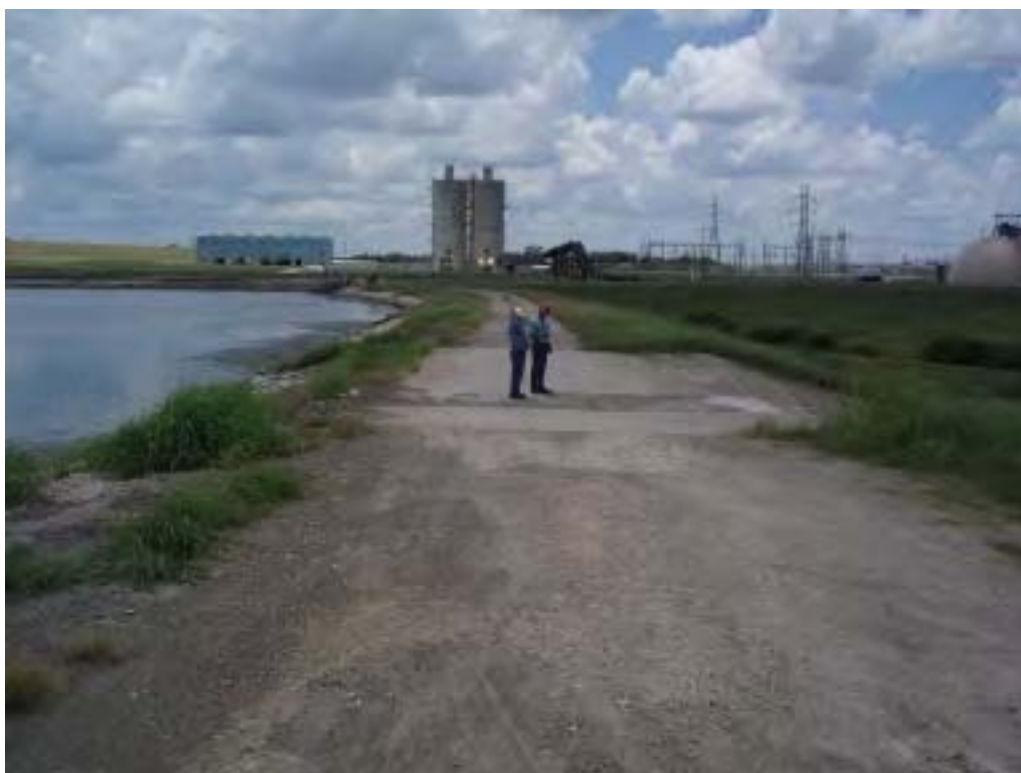
Photo No. 26: Reclaim Pond - North embankment crest, looking west.

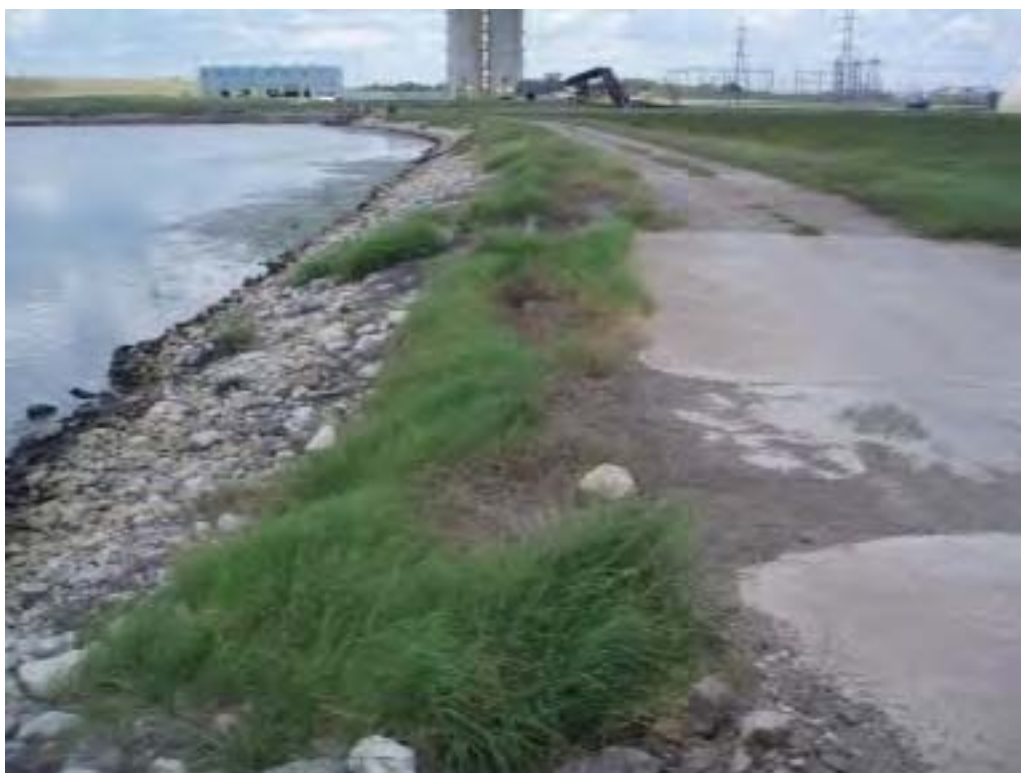
The emergency spillway appeared to be in fair condition (Photos 28, 29, 30, 31, and 41). The concrete lining was in good condition. The spillway discharge channel had some minor grass growing in the channel. The entrance to the spillway channel had excessive vegetation and there was missing riprap. There was also excessive vegetation in the outlet channel.

Photo No. 28: Reclaim Pond - North embankment, looking at emergency spillway channel entrance.

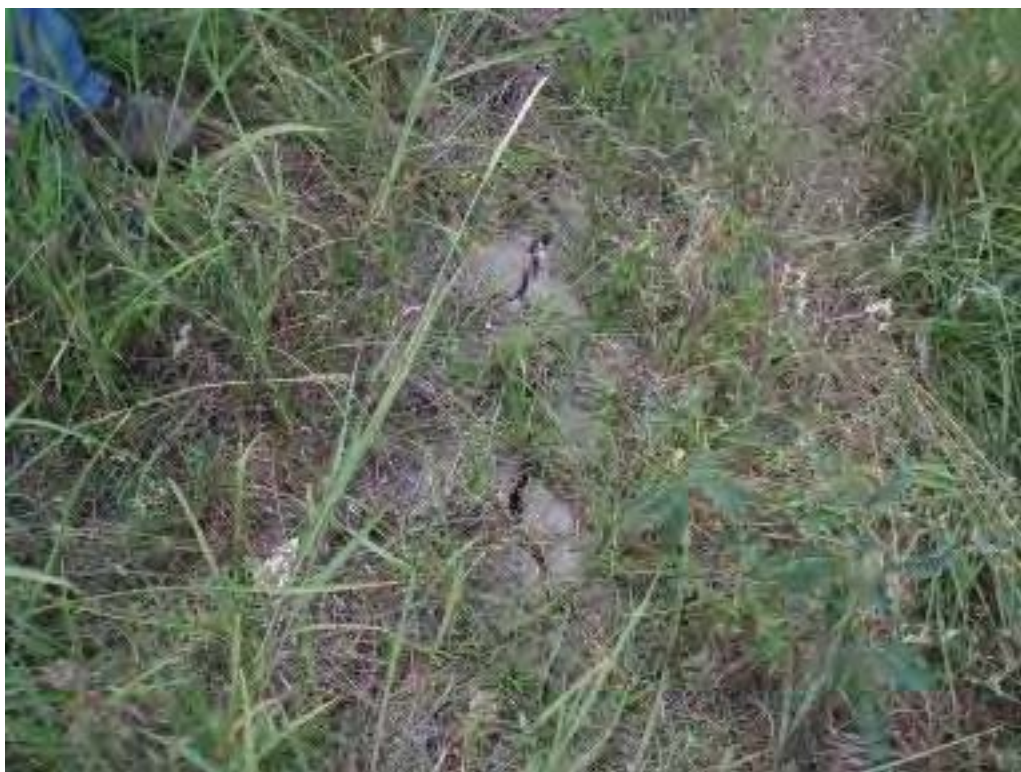
Photo No. 32: Reclaim Pond - North embankment exterior slope, looking at typical desiccation cracks.

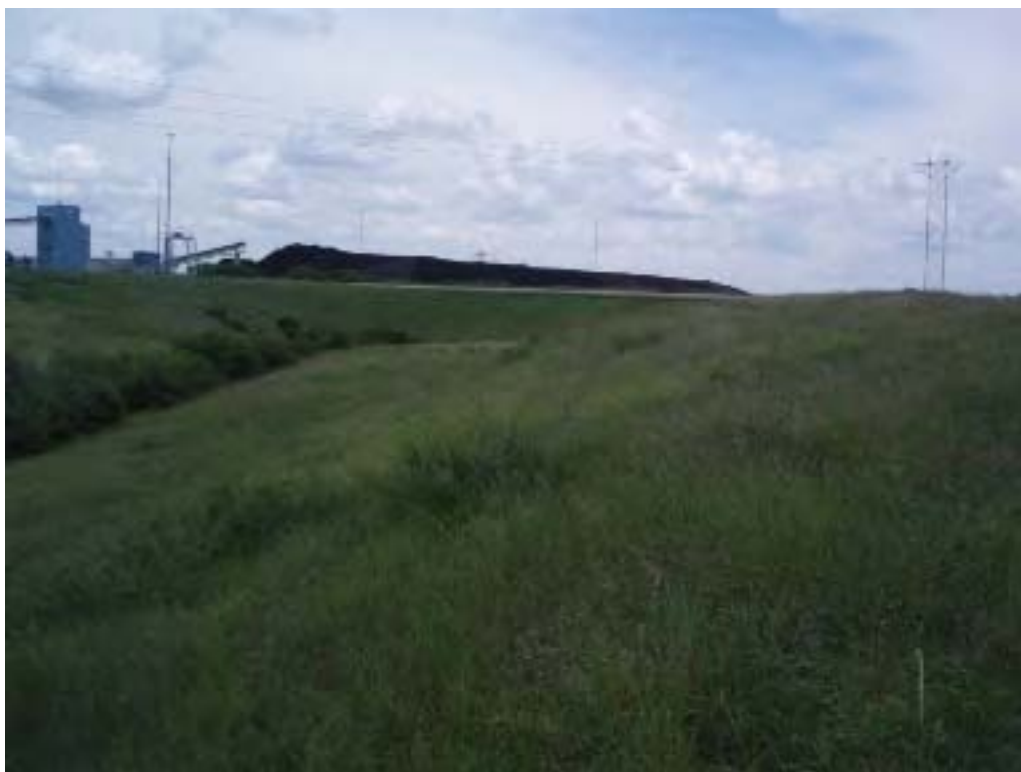
Photo No. 34: Reclaim Pond - North embankment exterior slope, looking east.

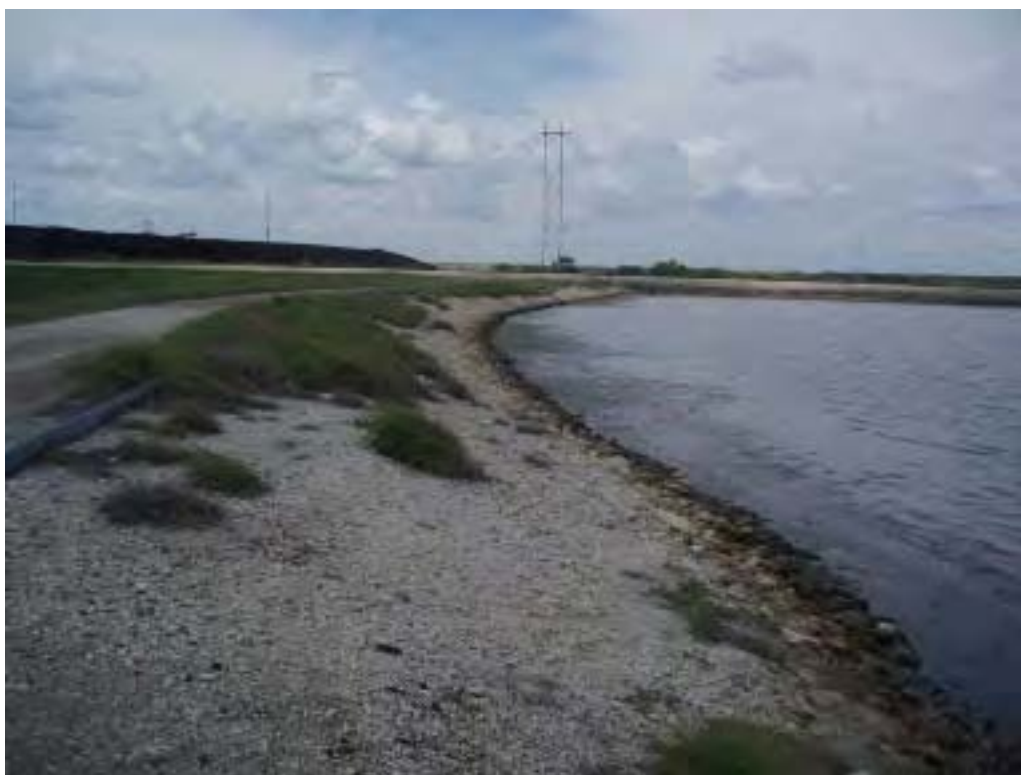
The 6-inch-diameter HDPE pipe from the CADP was in good condition. No water from the CADP was being discharged into the Reclaim Pond during the site visit.

Photo No. 36: Reclaim Pond - North embankment interior Slope, looking east. Note 6-inch-diameter HDPE pipe from the CADP on left side of photo.

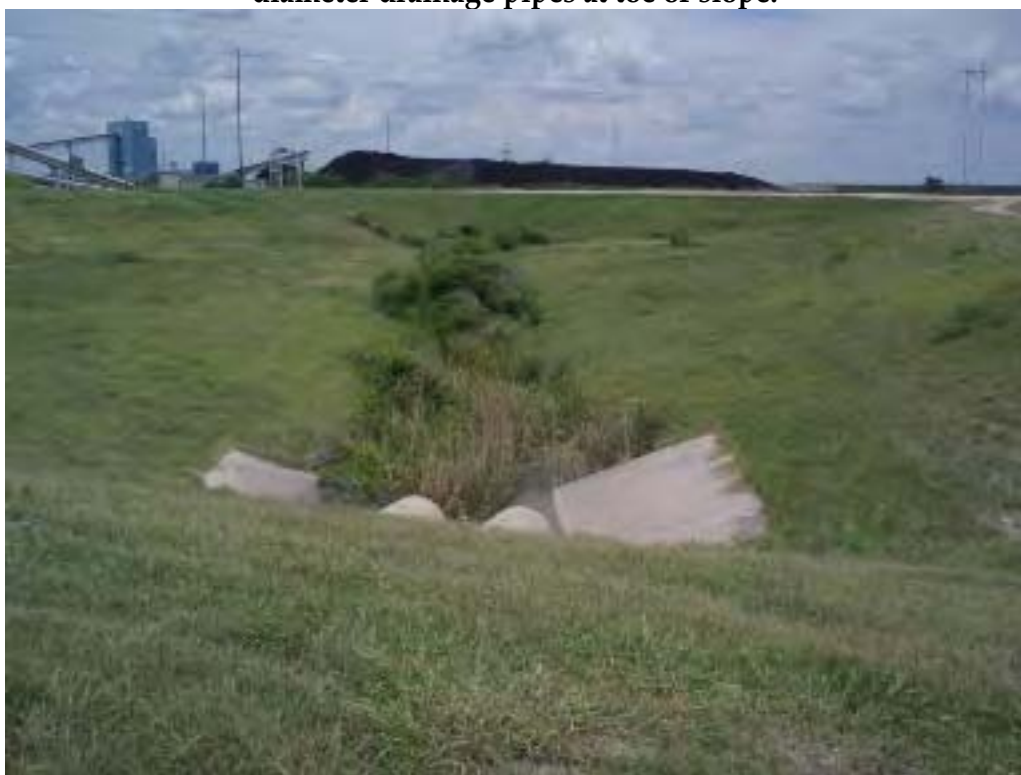
Photo No. 38: Reclaim Pond - Overview of north embankment exterior slope and downstream area, looking east. Note small trees and brush at the bottom of the slope growing in the drainage ditch.

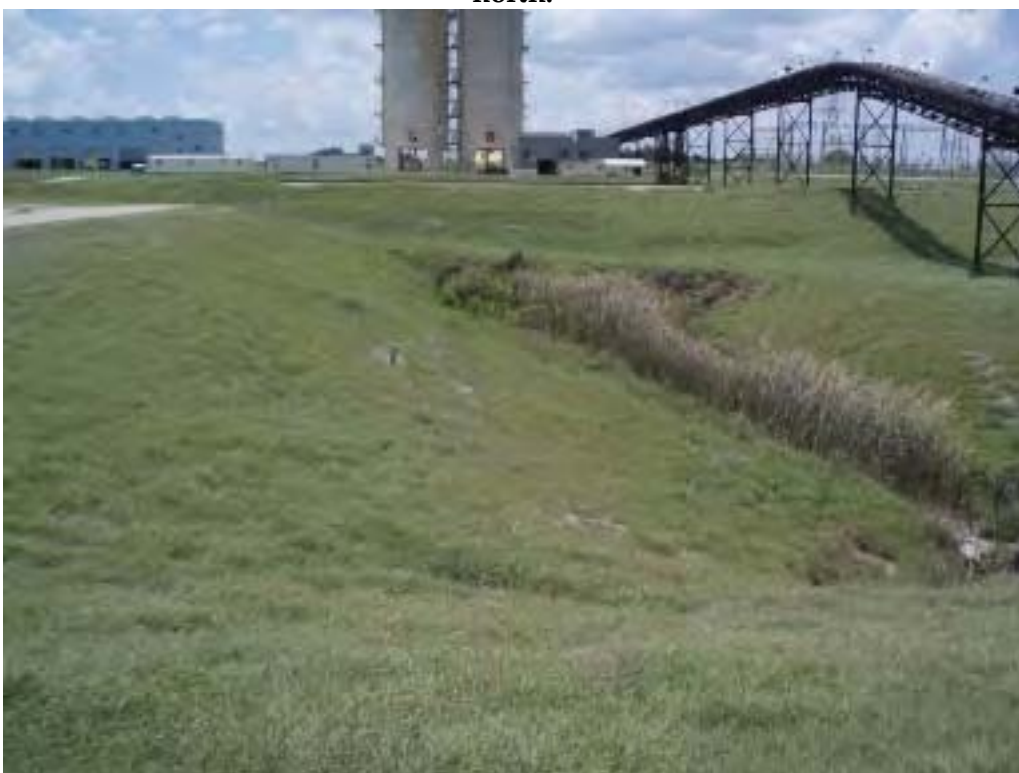
Photo No. 40: Reclaim Pond - Overview of north embankment exterior slope and downstream area, looking west

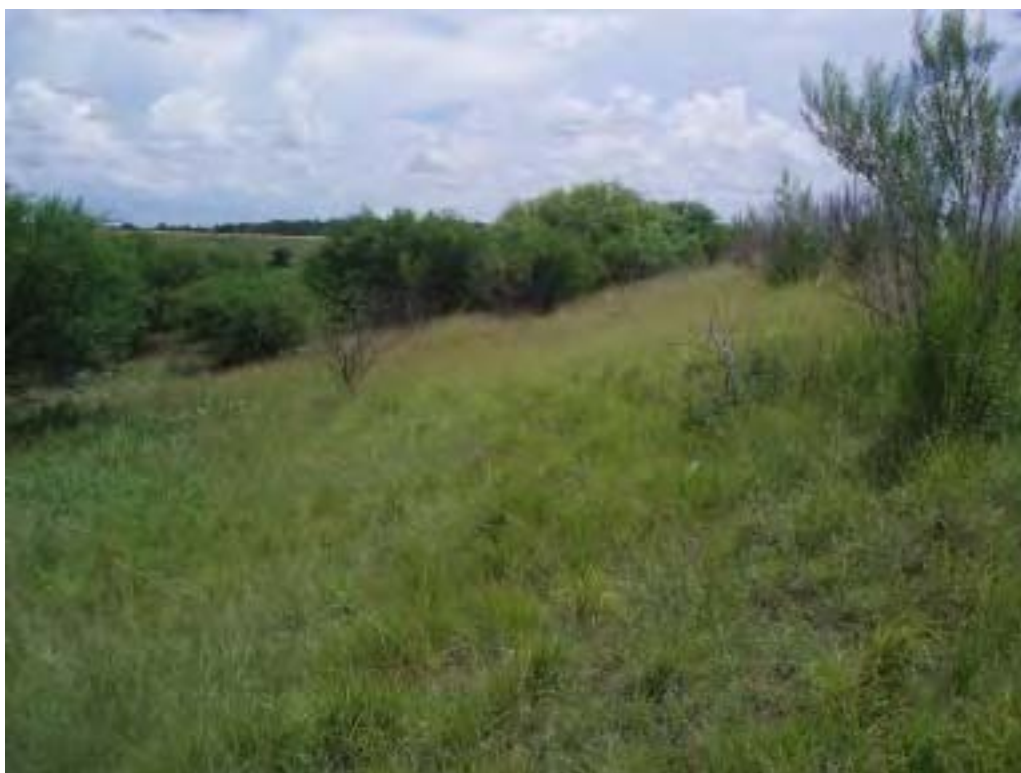
The exterior slope face on the east embankment is generally poor (Photos 43, 44, 46, 47, 48, 50, and 51). The grass on the east embankment ranged from 12 to 36 inches in height. Brush and mesquite trees as large as 30 inches in diameter were observed on the embankment. Desiccation cracks up to a ½ inch wide and 8 inches deep were observed at various locations on the embankment. A flyash surfaced access road was observed on the exterior slope of the embankment (Photos 48 and 50).

Photo No. 44: Reclaim Pond - East embankment exterior slope, looking south.

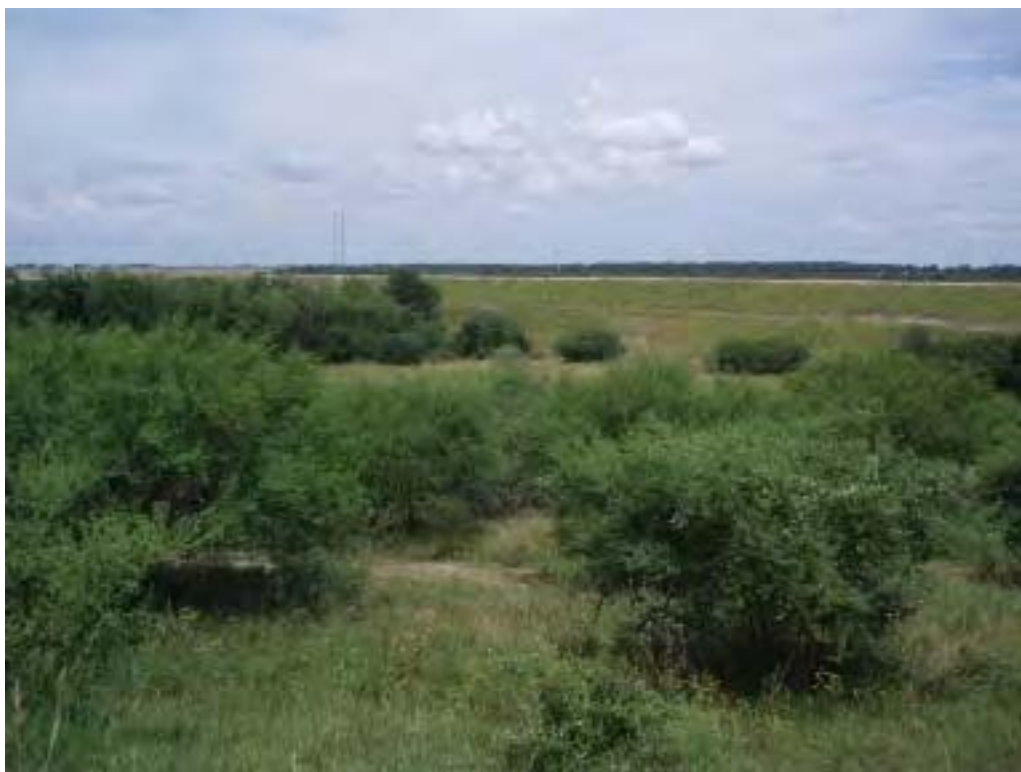
Photo No. 46: Reclaim Pond - East embankment exterior slope, looking east at downstream area. Note railroad embankment in background.

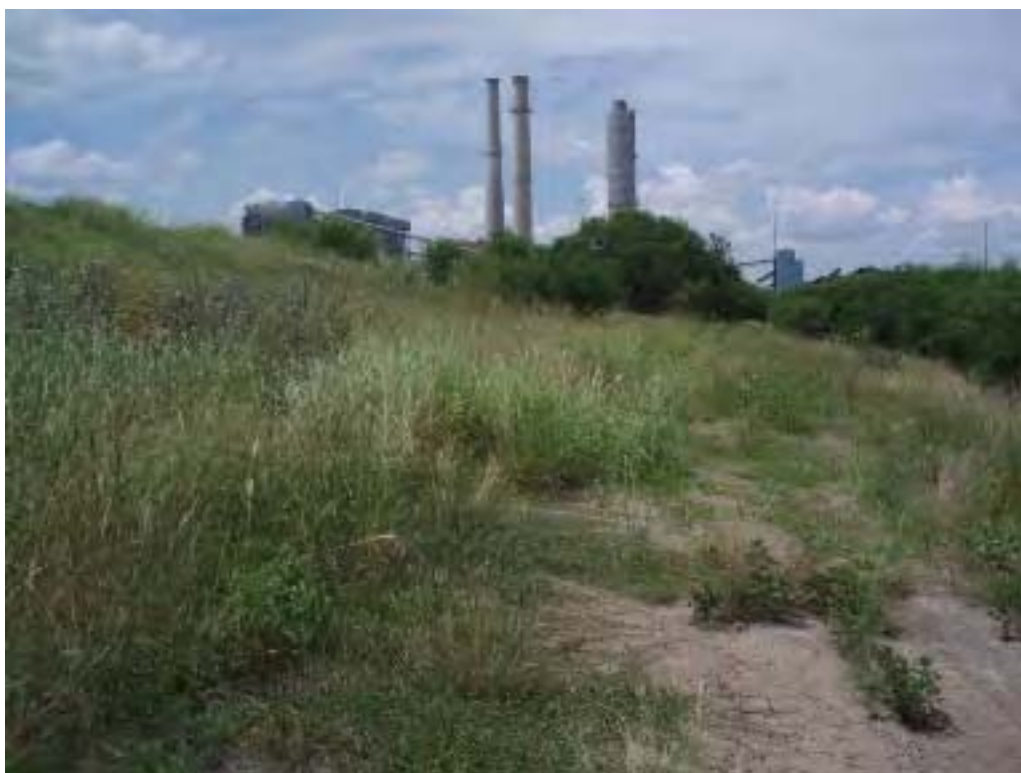
Photo No. 48: Reclaim Pond - East embankment exterior slope, looking north.

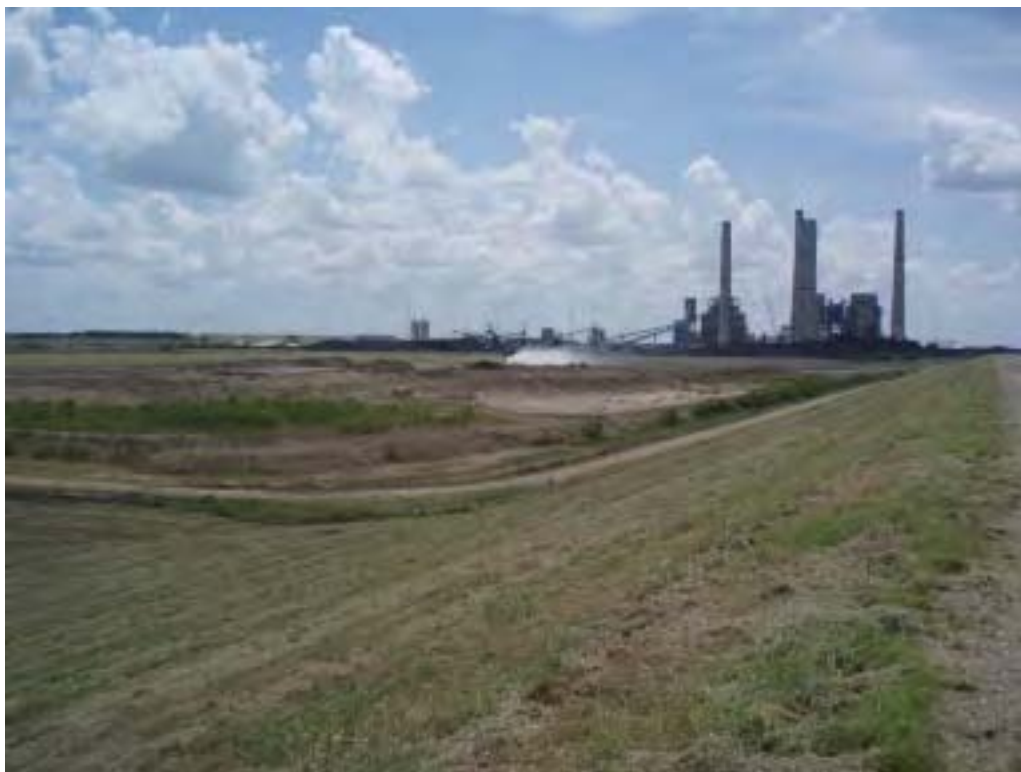
The crest of the CADP appeared to be generally in fair condition (Photos 53, 56, 59, 72, 75, 86, 89, 90, 91, 99, 100, 101, 102, 103, and 104). The crest surface consisted of flyash and was used as an access road. Some minor rutting and depressions were observed on the east and west embankment crest. A tension crack in the previously raised portion of the crest was observed on the north embankment (Photo 99). The chain link fence and posts appeared to holding the raised section of the crest from sloughing. The water level was at about El. 355 and there was approximately 7 feet of freeboard at the time of the site visit.

Photo No. 53: CADP - Overview of active portion of impoundment, looking southwest.
