Assessment of Dam Safety of Coal Combustion Surface Impoundments

Sam Seymour - Fayette Power Project Station

Lower Colorado River Authority

Draft Report

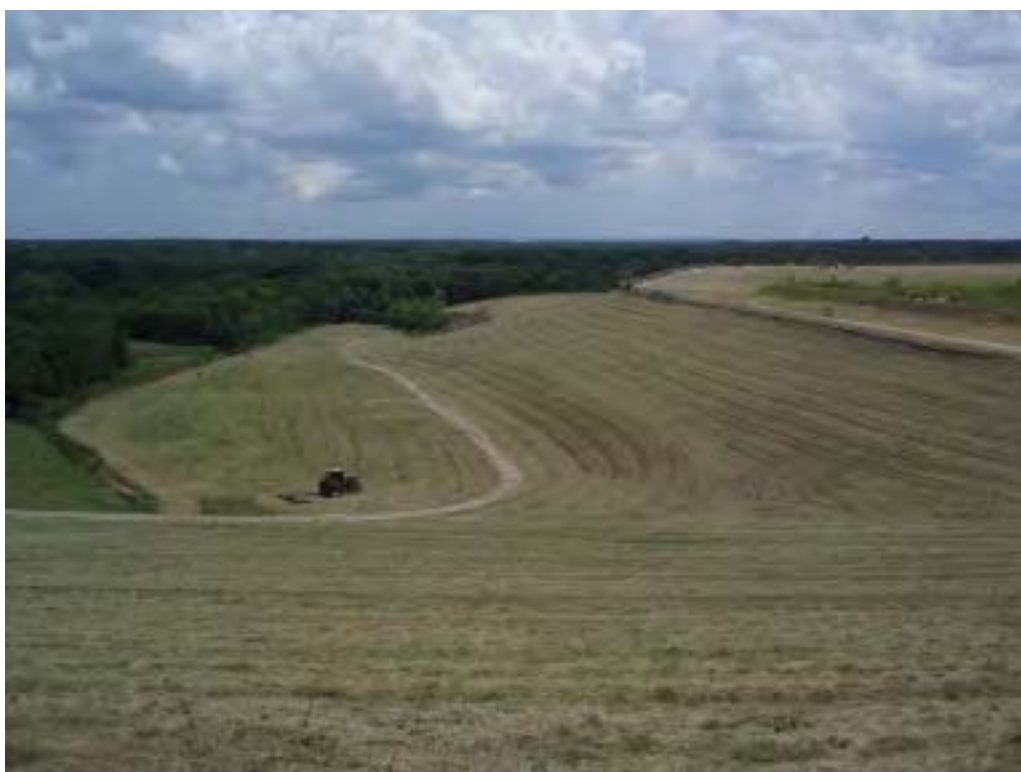
The CADP is incised on the north and west embankments. The south and east exterior slopes appear to be generally in fair condition (Photos 53, 54, 55, 57, 58, 60, 61, 62, 67, 68, 69, 71, 73, 74, 77, 78, and 85). The grass on the embankment was approximately 8 to 12 inches tall and was recently mowed. Trees and brush up to 6 inches in diameter were observed at the toe of the south embankment in the Coal Ash Pile Run-off Pond. There were some bare spots near the middle of the south embankment exterior slope (Photo 81).

Photo No. 54: CADP - Overview of east embankment and downstream area, looking south.

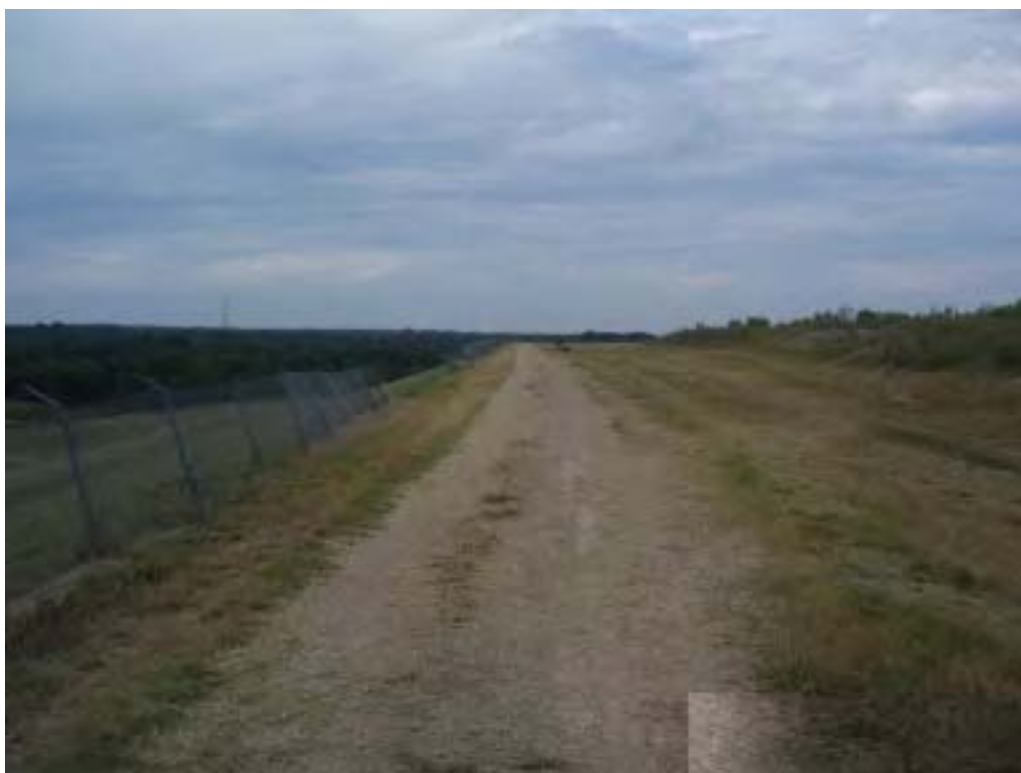
The crest of the CADP appeared to be generally in fair condition (Photos 53, 56, 59, 72, 75, 86, 89, 90, 91, 99, 100, 101, 102, 103, and 104). The crest surface consisted of flyash and was used as an access road. Some minor rutting and depressions were observed on the east and west embankment crest. A tension crack in the previously raised portion of the crest was observed on the north embankment (Photo 99). The chain link fence and posts appeared to holding the raised section of the crest from sloughing. The water level was at about El. 355 and there was approximately 7 feet of freeboard at the time of the site visit.

Photo No. 56: CADP - East embankment crest, looking south. Note the fence has been pushed over from raising the crest 2 feet.

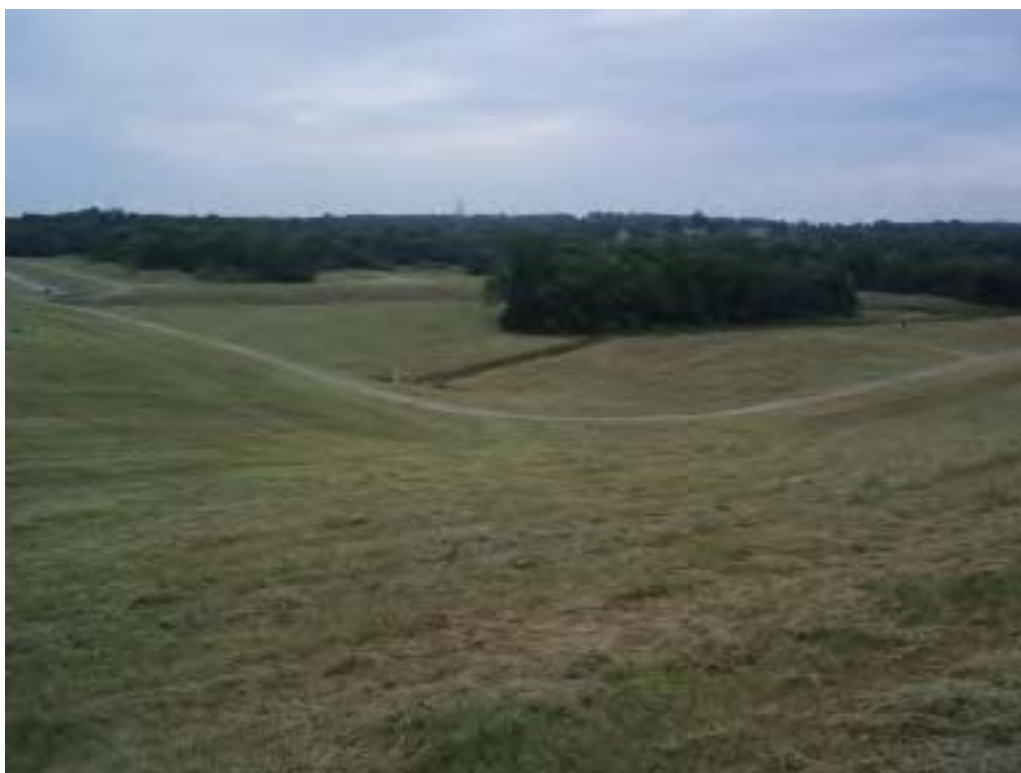
Photo No. 58: CADP - East embankment exterior slope, looking southeast at groin with Cedar Creek Dam.

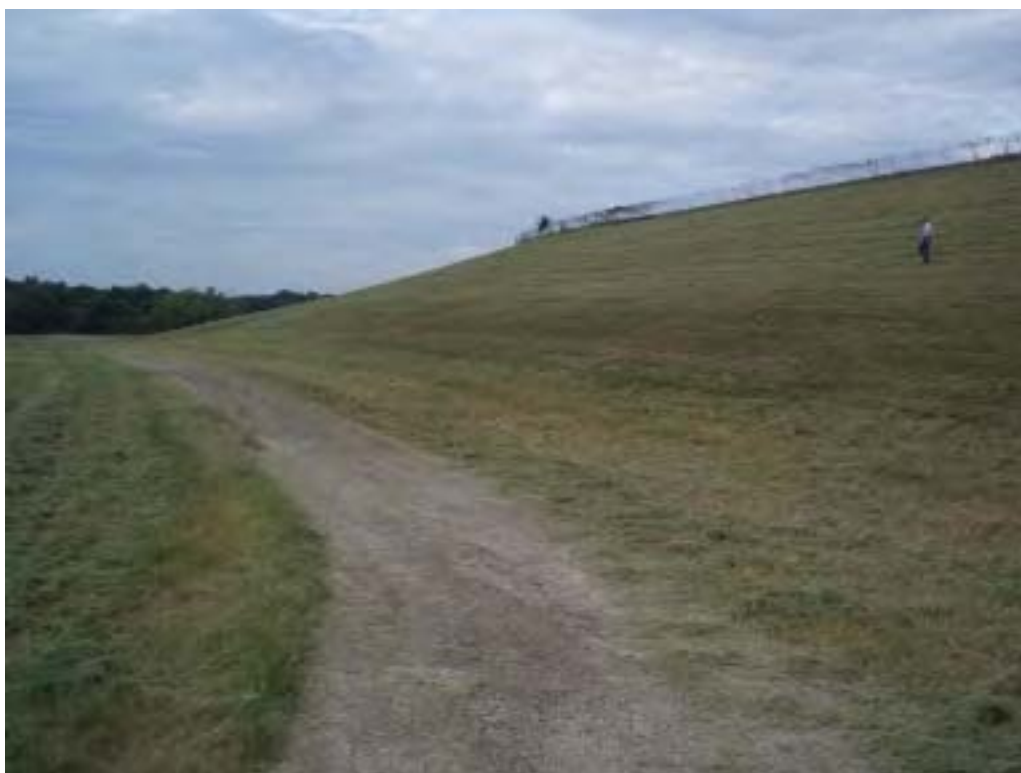
Photo No. 60: CADP - East embankment exterior slope looking southwest.

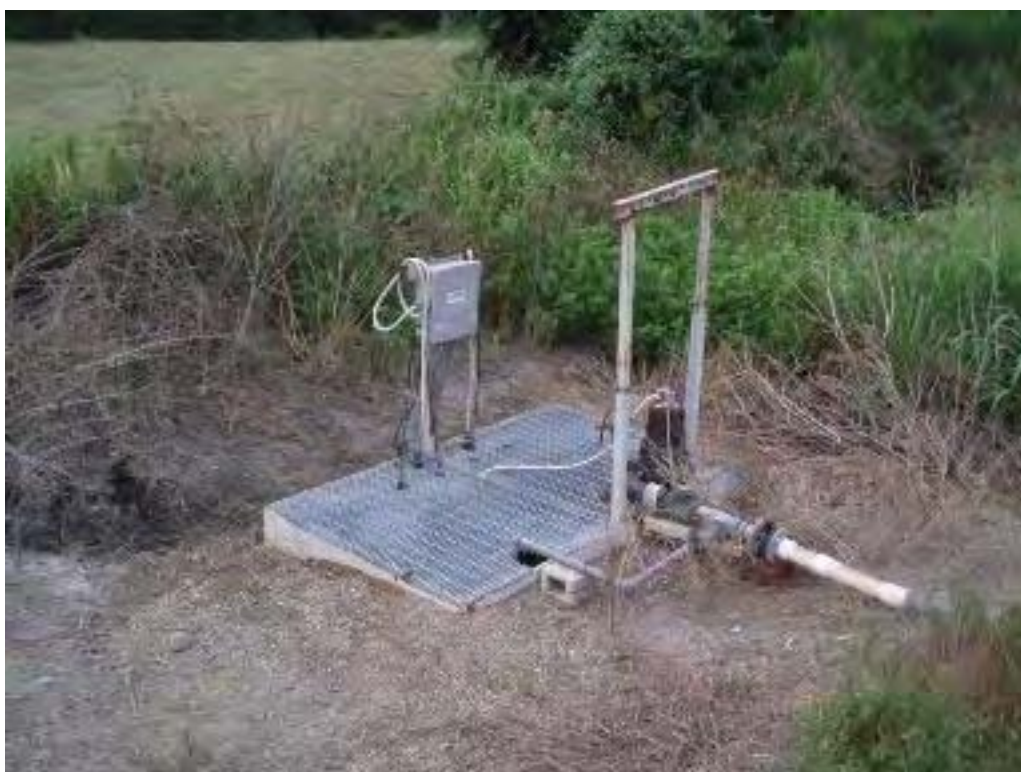
Two of the toe drain outlets from the chimney drain on the east embankment were observed (Photos 64 and 66). One of the toe drain outlets discharges into a seepage collection sump pit. The sump pit pumps water back up into the impoundment.

Seepage was not observed in the sump pit during the site visit. The ground around the other discharge pipe was damp although no significant seepage was observed.

Photo No. 66: CADP - East embankment exterior slope, looking at toe drain seepage collection sump pit. Seepage water from the toe drain is pumped back to the impoundment.

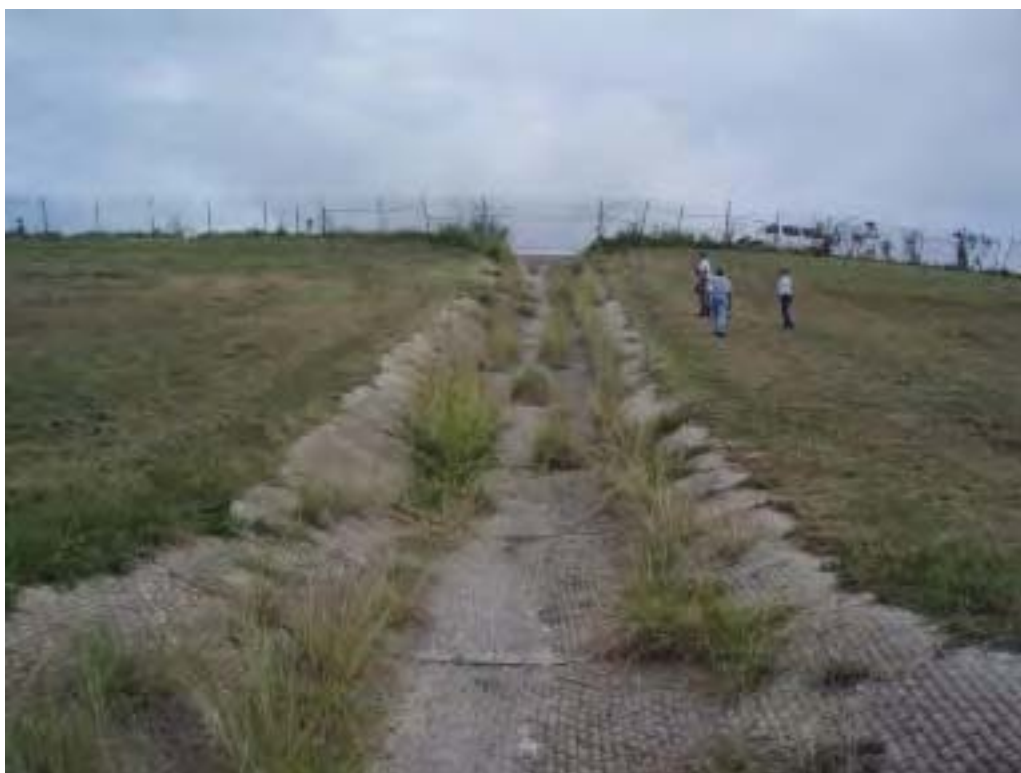
Photo No. 68: CADP - East embankment exterior slope, looking west at stormwater discharge channel from capped portion of the impoundment.

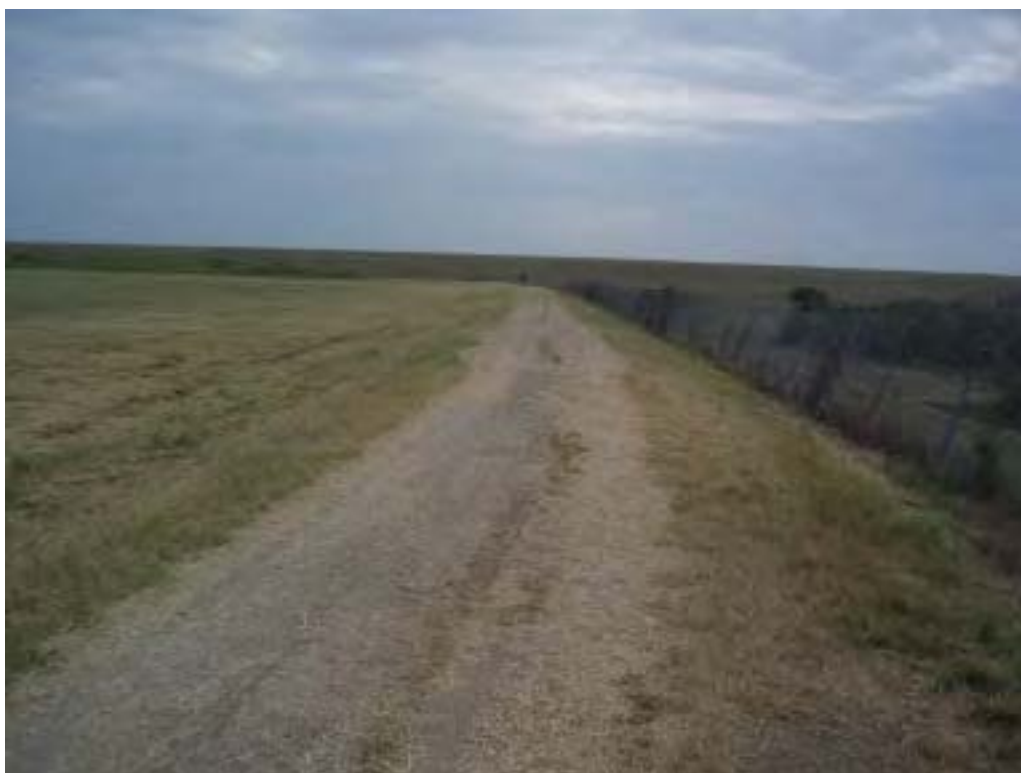
Photo No. 72: CADD - East embankment crest, looking north.

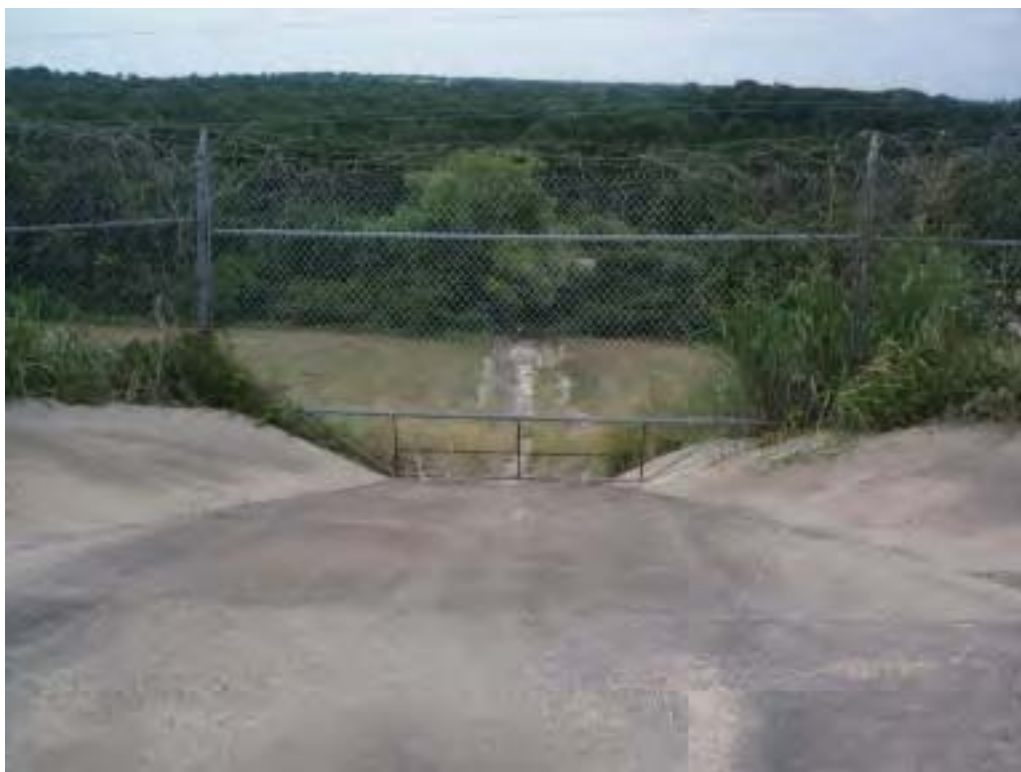
Photo No. 74: CADP - East embankment, looking south at stormwater control section outlet from capped portion of the impoundment.

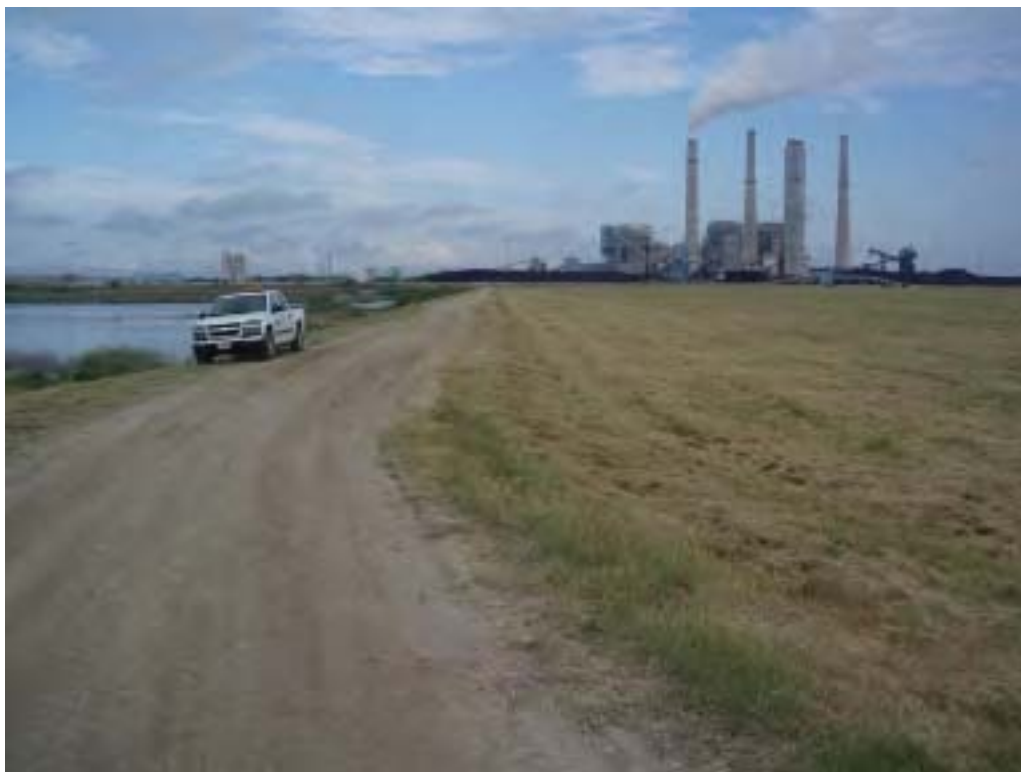
Photo No. 75: CADP - South embankment crest and capped area, looking west.

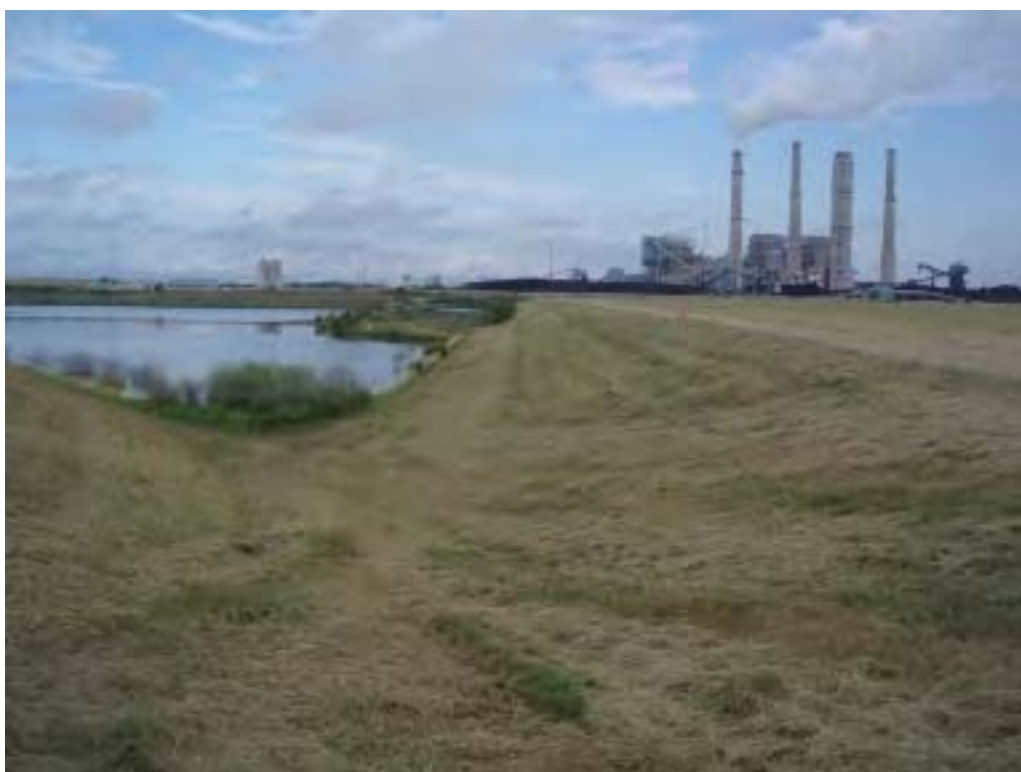
Photo No. 76: CADP - Groin of south embankment exterior slope and Coal Pile Run-off Pond interior slope, looking west. Note water, brush and small trees at toe of slope.

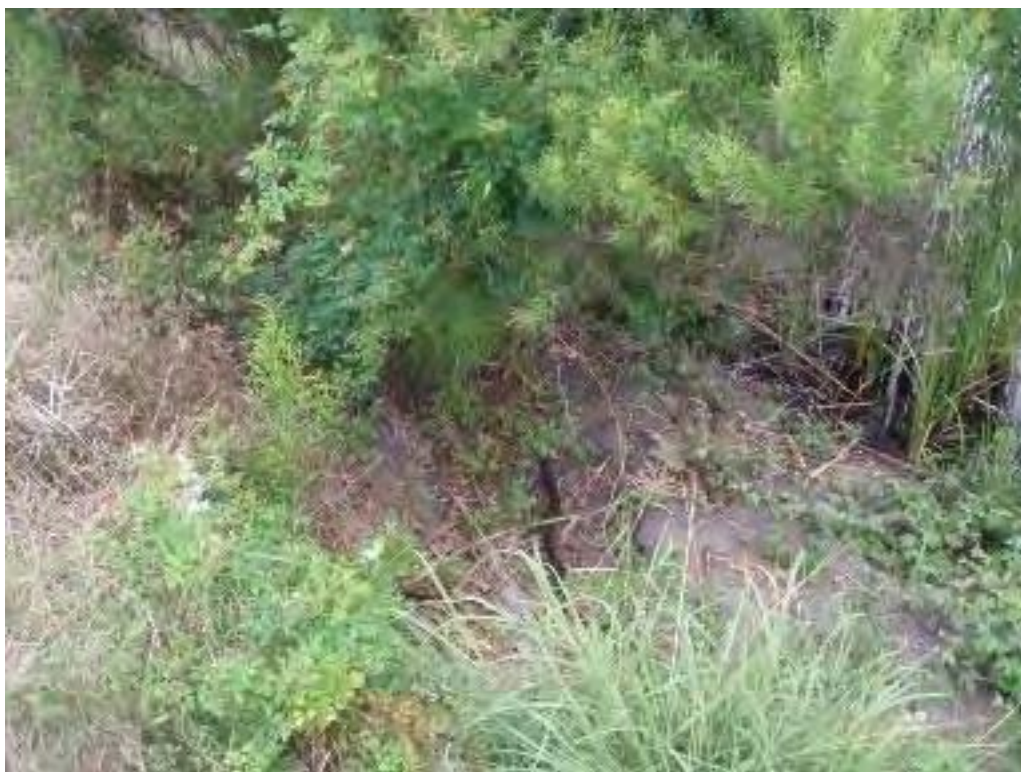
CDM observed 16 rodent holes, reportedly made by armadillo's, on the east embankment exterior slope. The holes ranged in size from 4 to 8 inches in diameter (Photos 63 and 65). There were also multiple surface depressions that were likely rodent holes that collapsed, possibly as a result of mowing operations (Photos 62, 79, 80, and 84).

Photo No. 80: CADP - South embankment exterior slope, looking at 4'Wx5'Lx2'D depression at toe of slope. Possible collapsed rodent burrow.

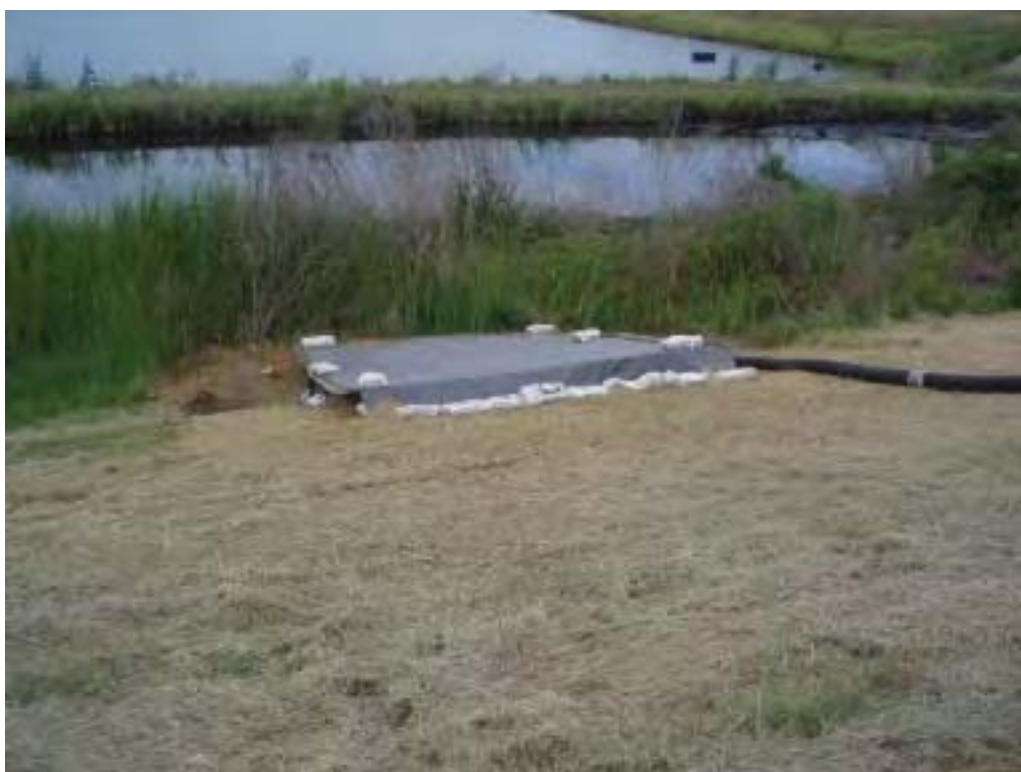
An active seep on the south embankment exterior slope was observed (Photos 82 and 83). LCRA has constructed a containment structure to collect the seepage water. The estimated flow from the seep typically ranges from 8 to 11 gallons per day based on review of information provided by LCRA personnel

Photo No. 82: CADP - South embankment exterior slope, looking at seep containment system.

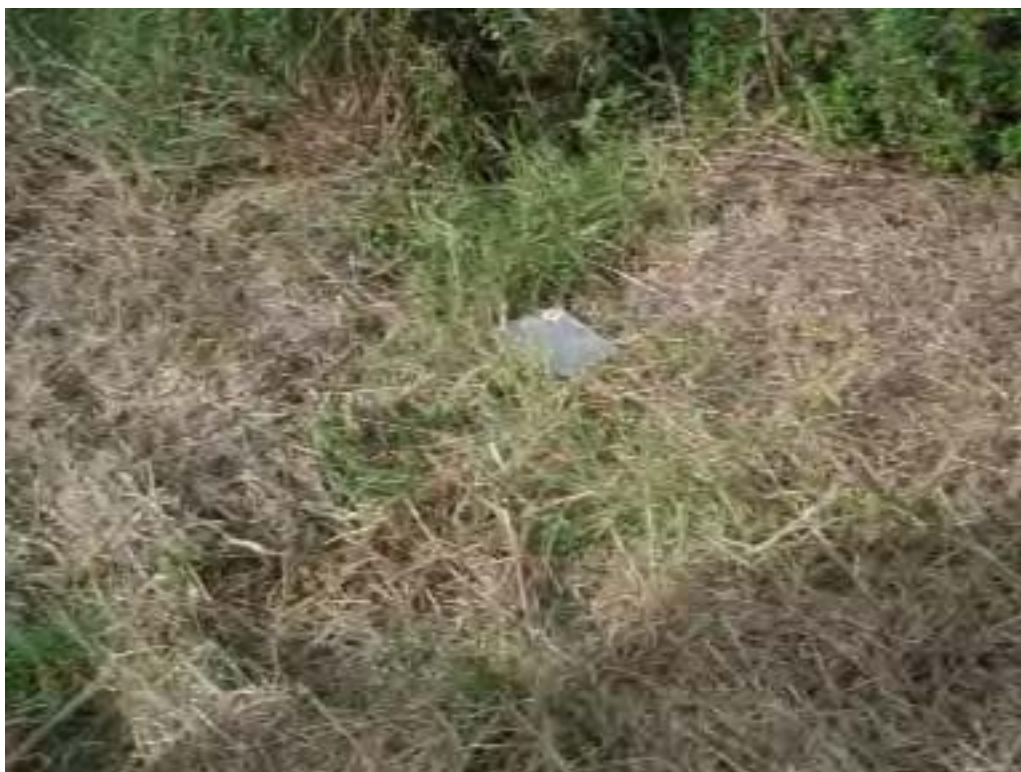
Photo No. 84: CADP - South embankment exterior slope, looking at 2'Wx4'Lx1'D depression at toe of slope. Possible collapsed rodent burrow.

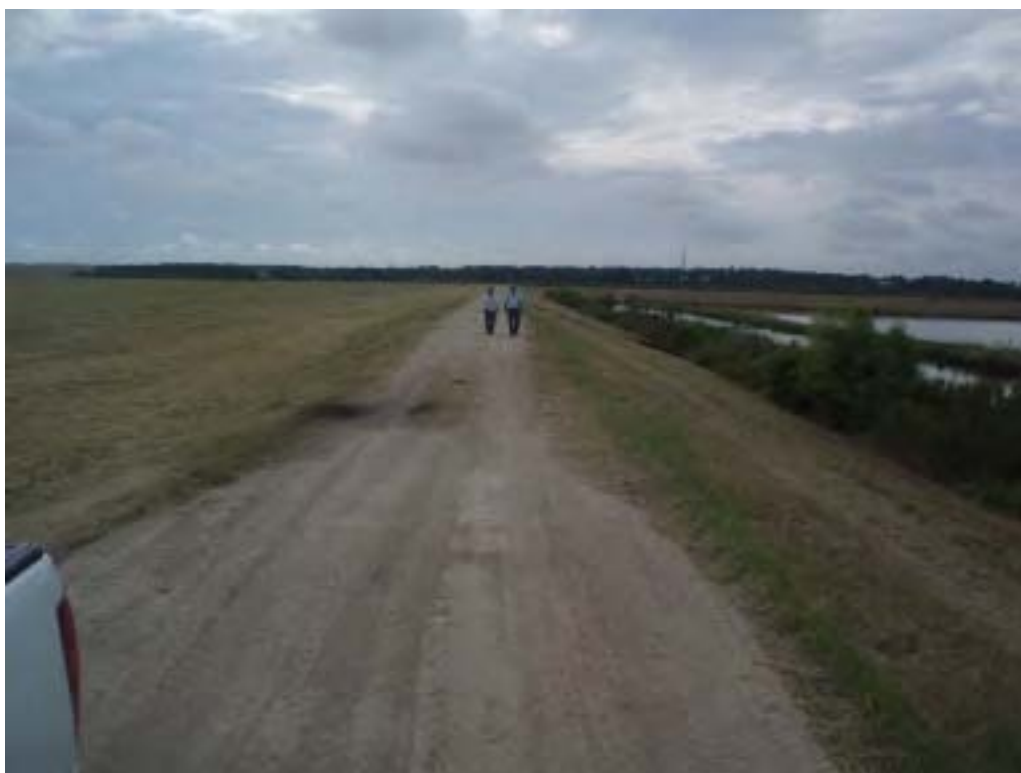
Photo No. 86: CADP - South embankment crest, looking east.

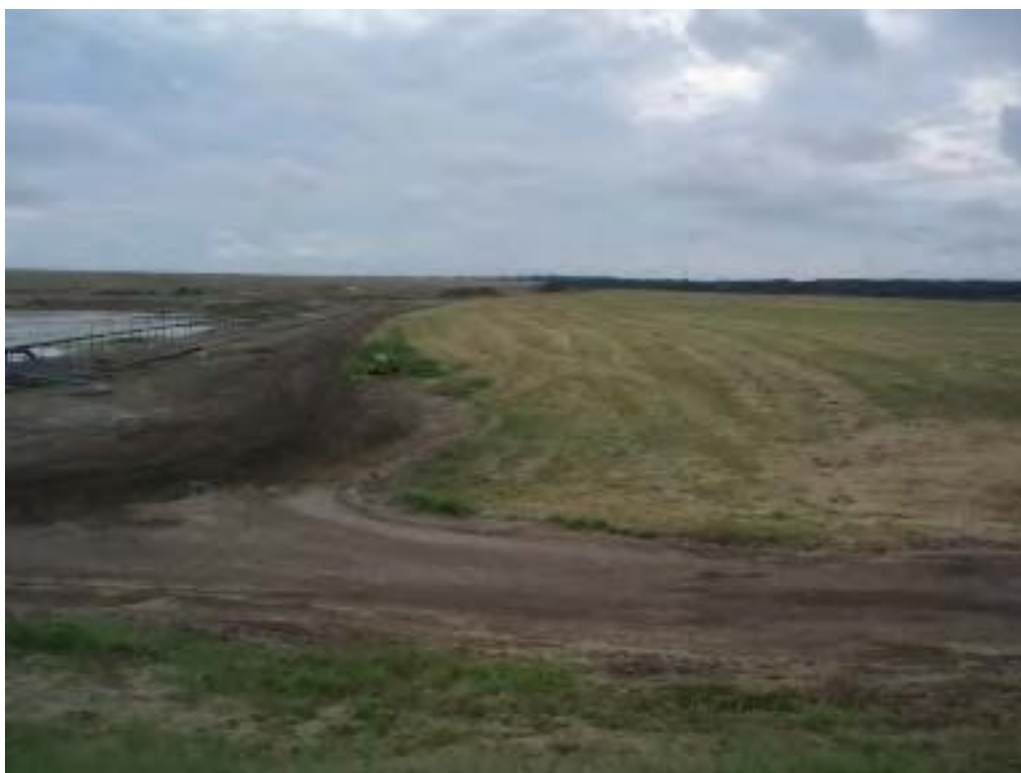
Photo No. 90: CADP - overview of transition between the active and the capped portion of the impoundment, looking east.

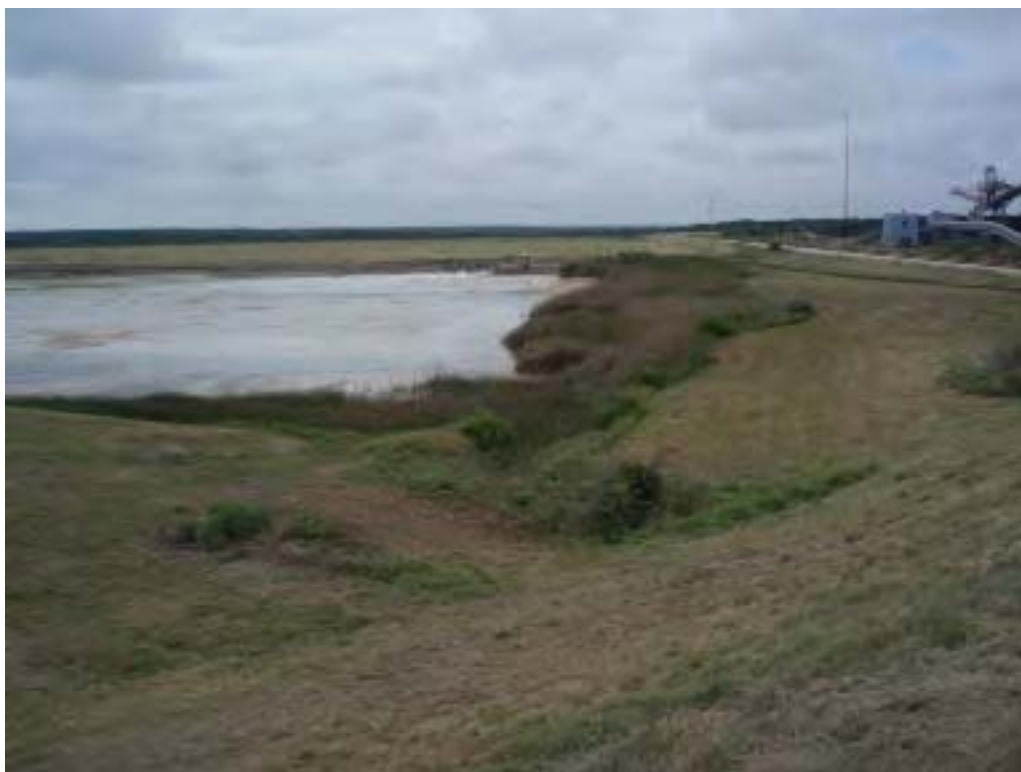
Photo No. 96: CADD – West embankment interior slope, looking south.

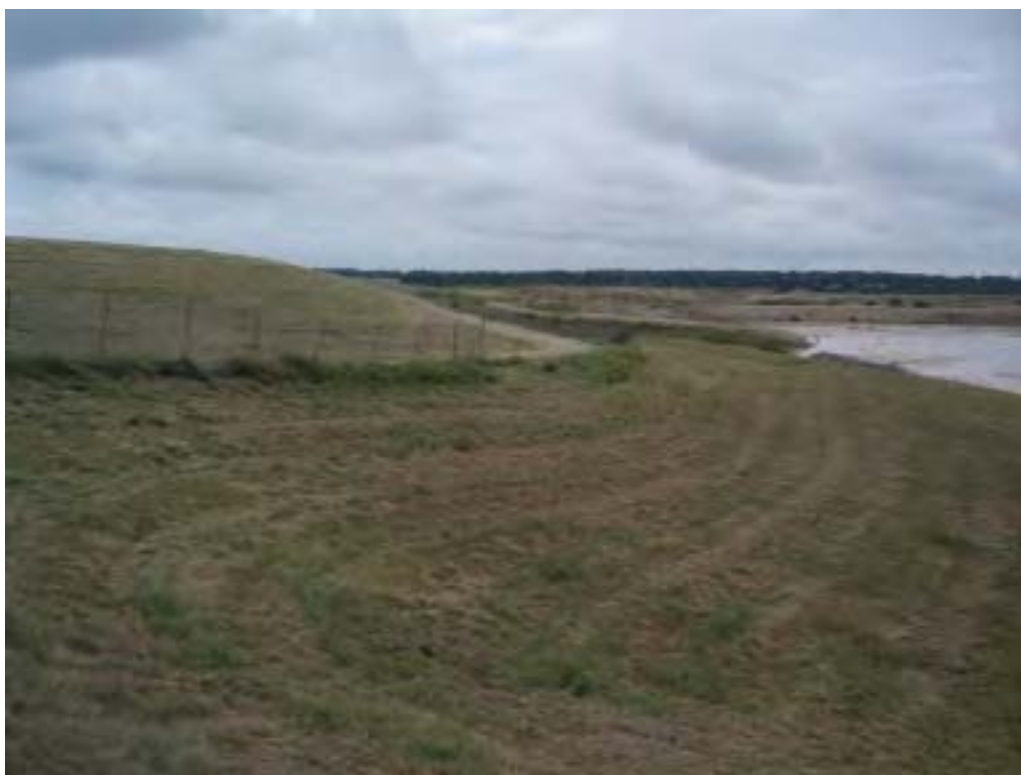
Photo No. 98: CADP - North embankment interior slope, looking east. Note Cedar Creek Dam on left side of photo.

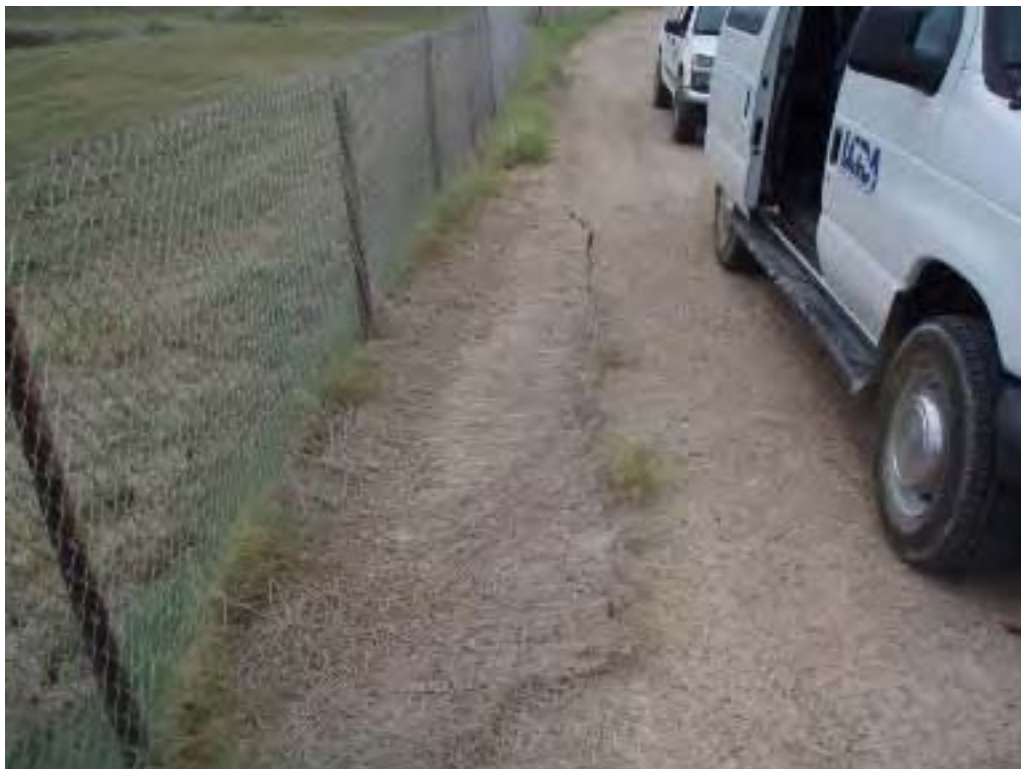
Photo No. 99: CADP - North embankment crest, looking at tension crack in road base fill.

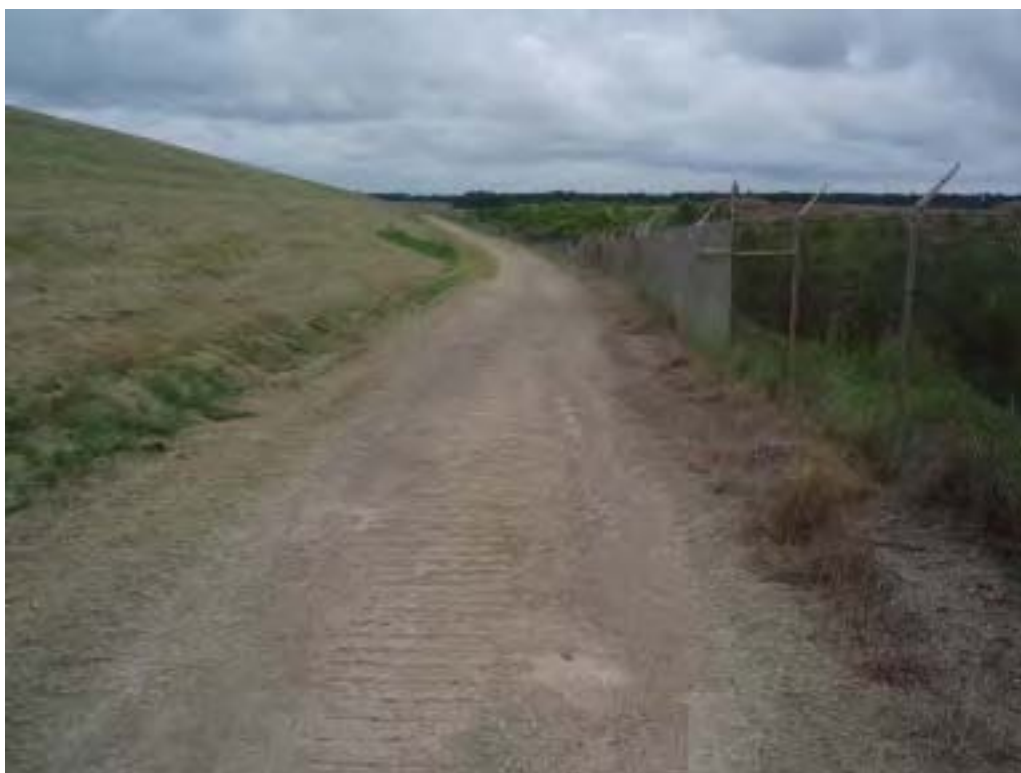
Photo No. 100: CADP - North embankment crest, looking east. Note trees growing inside the fence limits. Trees are in the area of the toe of the Cedar Creek Dam.

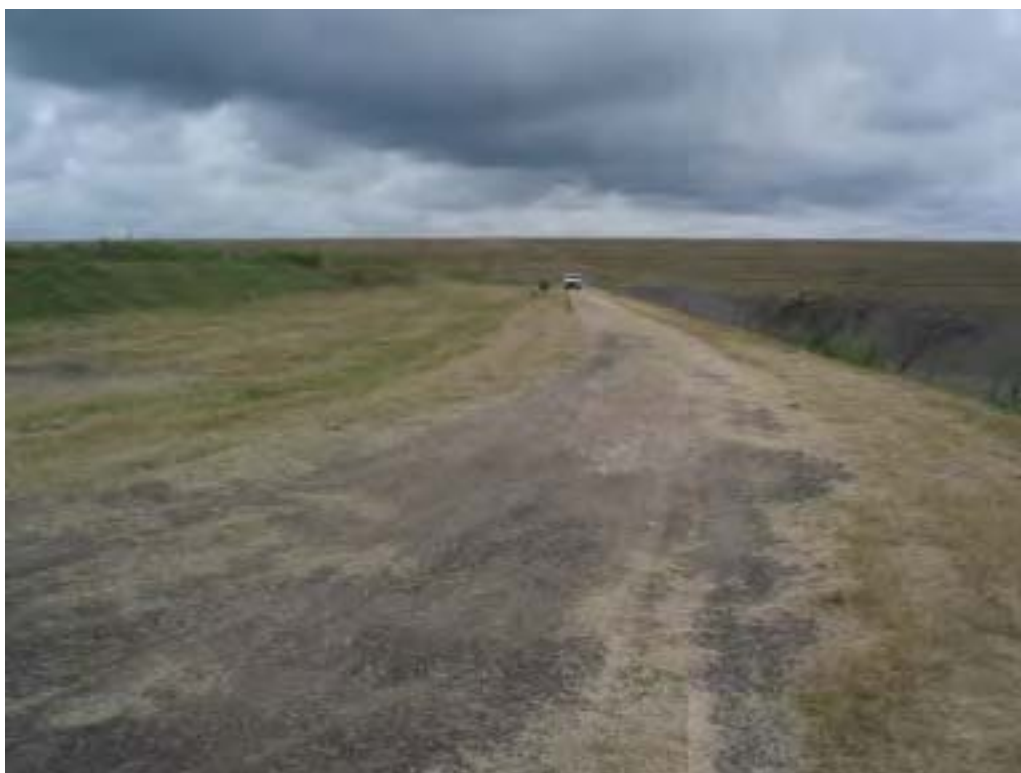
Photo No. 102: CADP - East embankment crest, looking north.

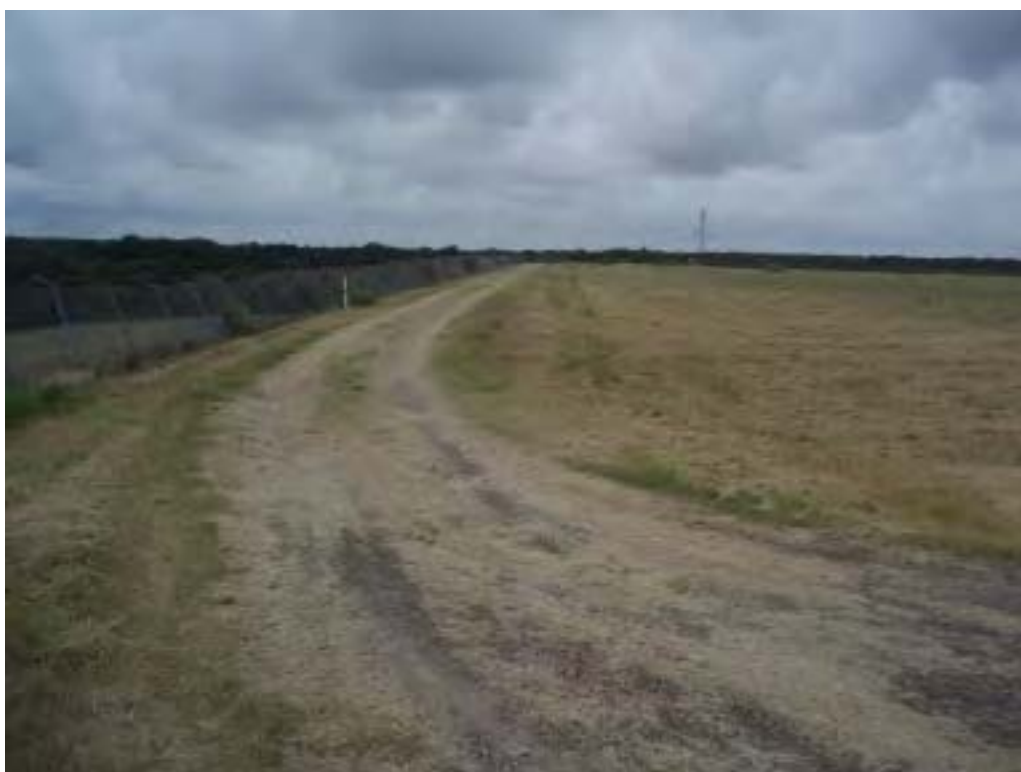
Photo No. 104: CADP - East embankment crest, looking south.
