Assessment of Dam Safety of Coal Combustion Surface Impoundments

Sam Seymour - Fayette Power Project Station

Lower Colorado River Authority

April 18, 2011

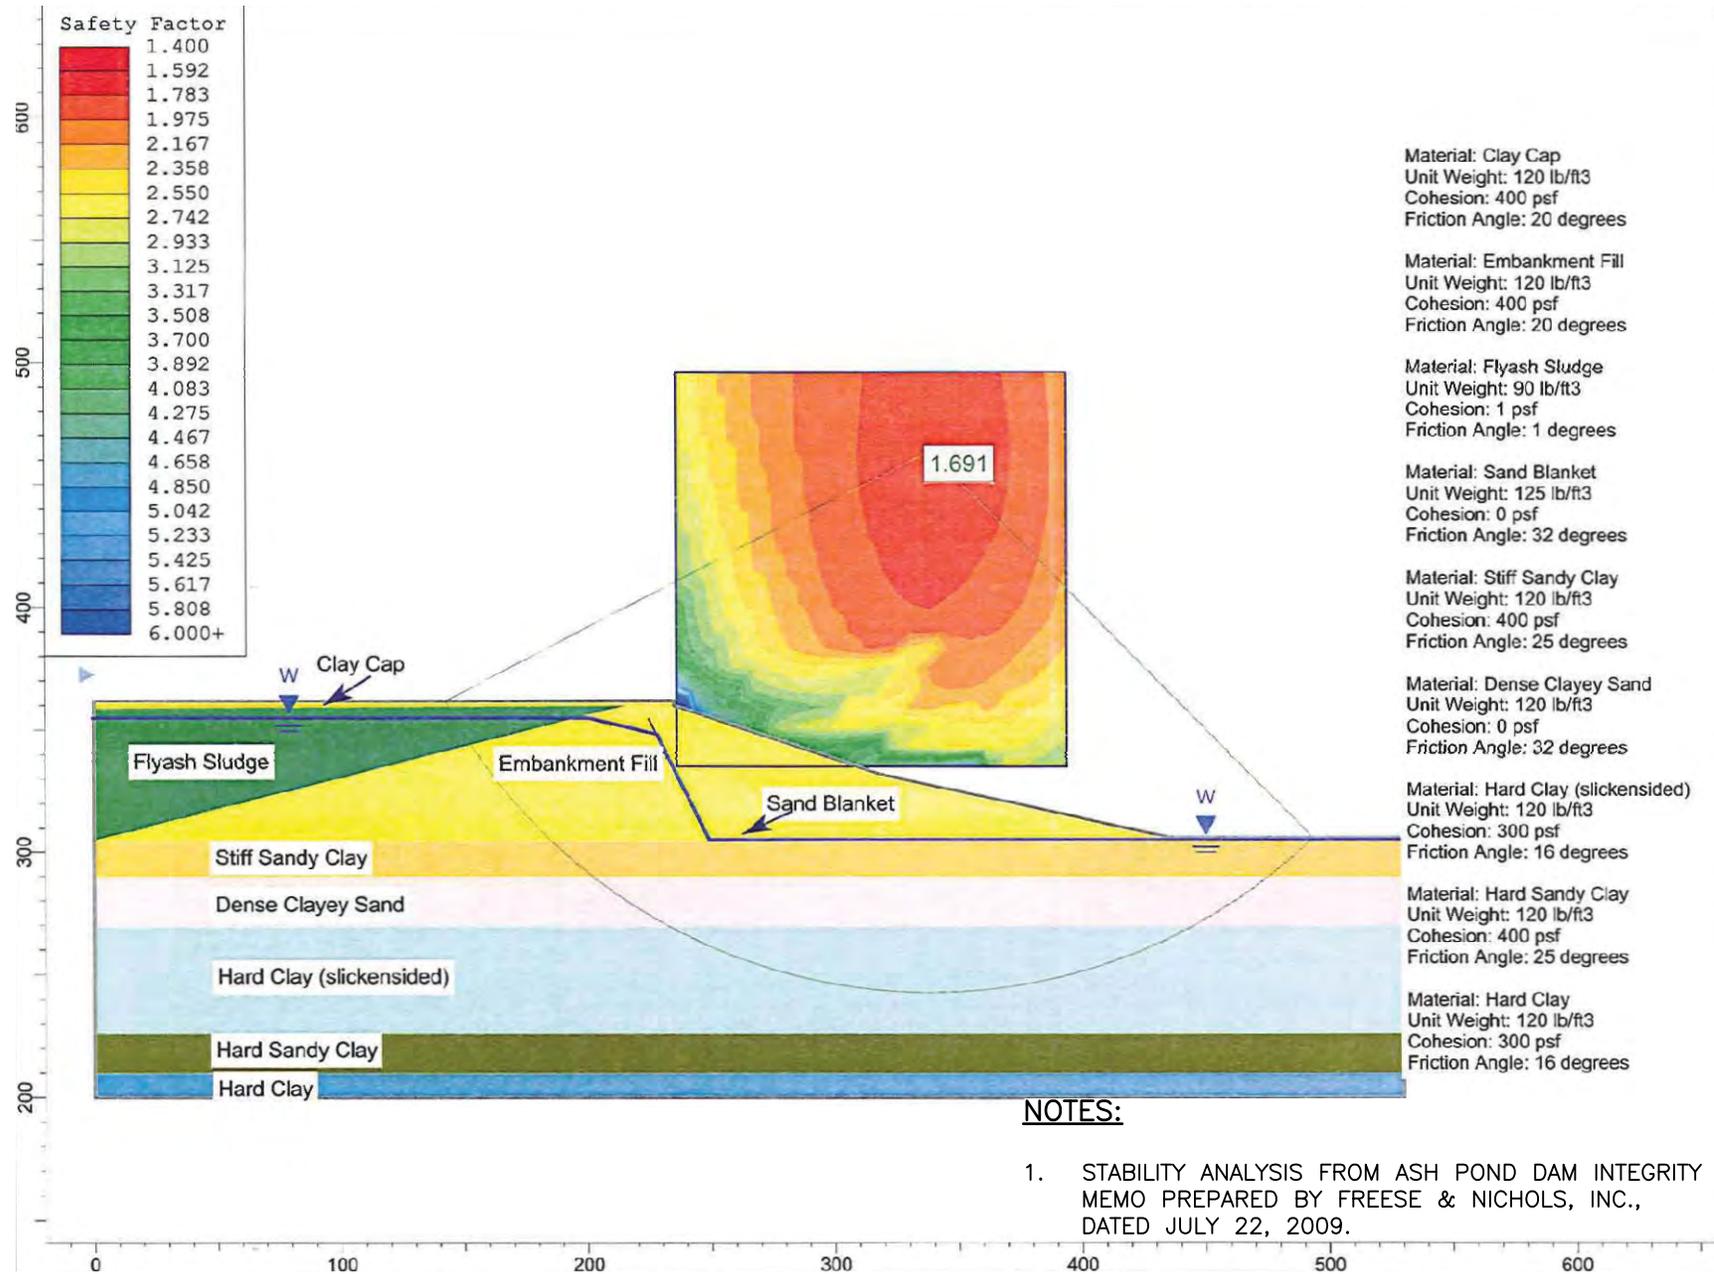
FAYETTE POWER PROJECT
LOWER COLORADO RIVER AUTHORITY
LA GRANGE, TEXAS
**FPP ASH POND DAM SLOPE
STABILITY ANALYSIS SECTION A-A'**
FIGURE 10

Freese and Nichols, Inc. (FNI) in conjunction with Fugro Consultants, Inc. (FCI) prepared a Condition Assessment on the slope stability of the CADP east embankment, dated July 22, 2009. Analyses were performed for long-term steady-state conditions at normal pool level for the active and capped portion of the east embankment. Soil parameters used for the analyses and analysis results are presented on [Figures 10](#) and [11](#). The results on Figure 10 and 11 indicate the factor of safety

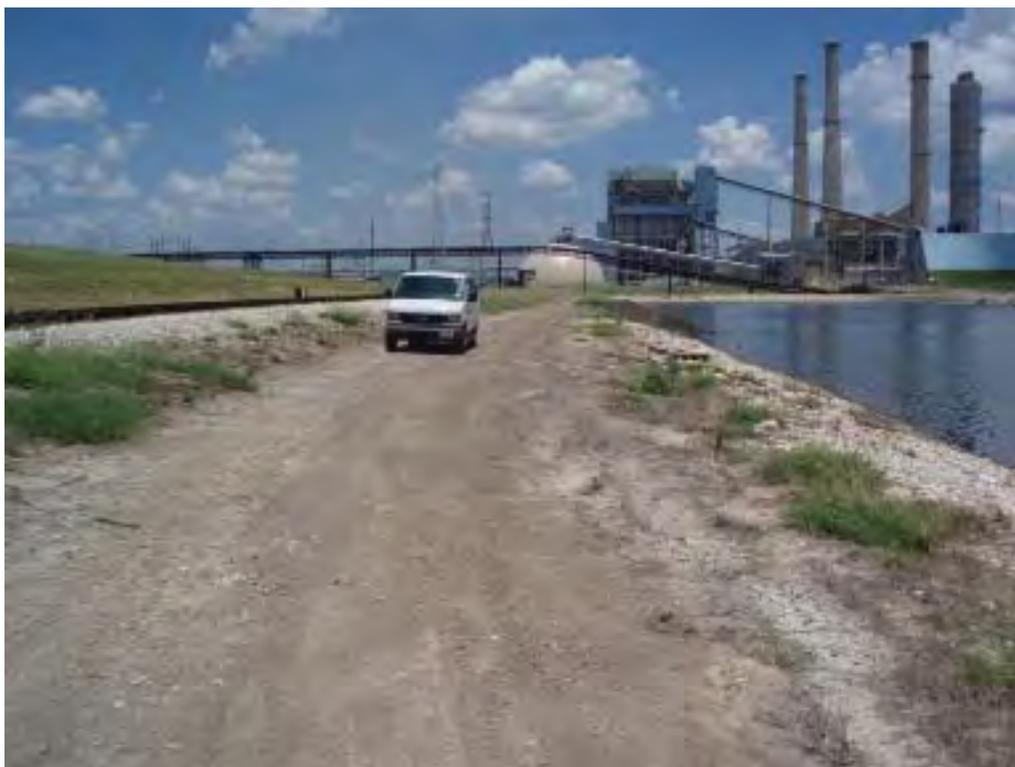
Photo No. 10: Reclaim Pond – West embankment crest, looking north at typical surface erosion and rutting.

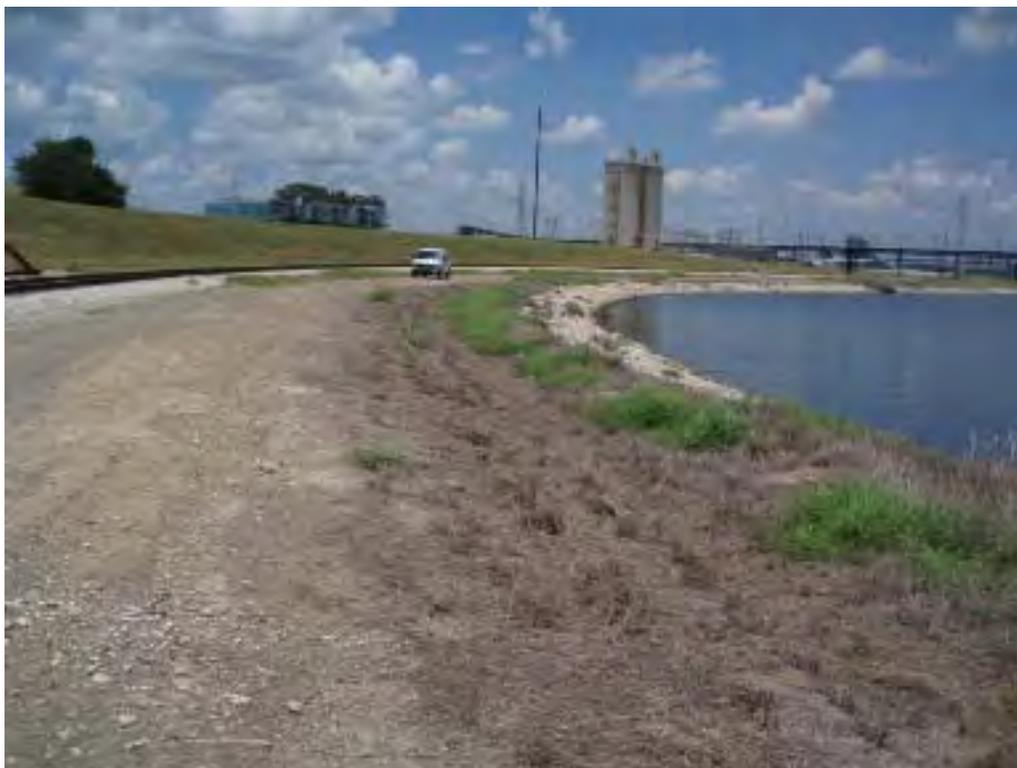
Photo No. 16: Reclaim Pond - South embankment, looking northwest at a low area on the crest

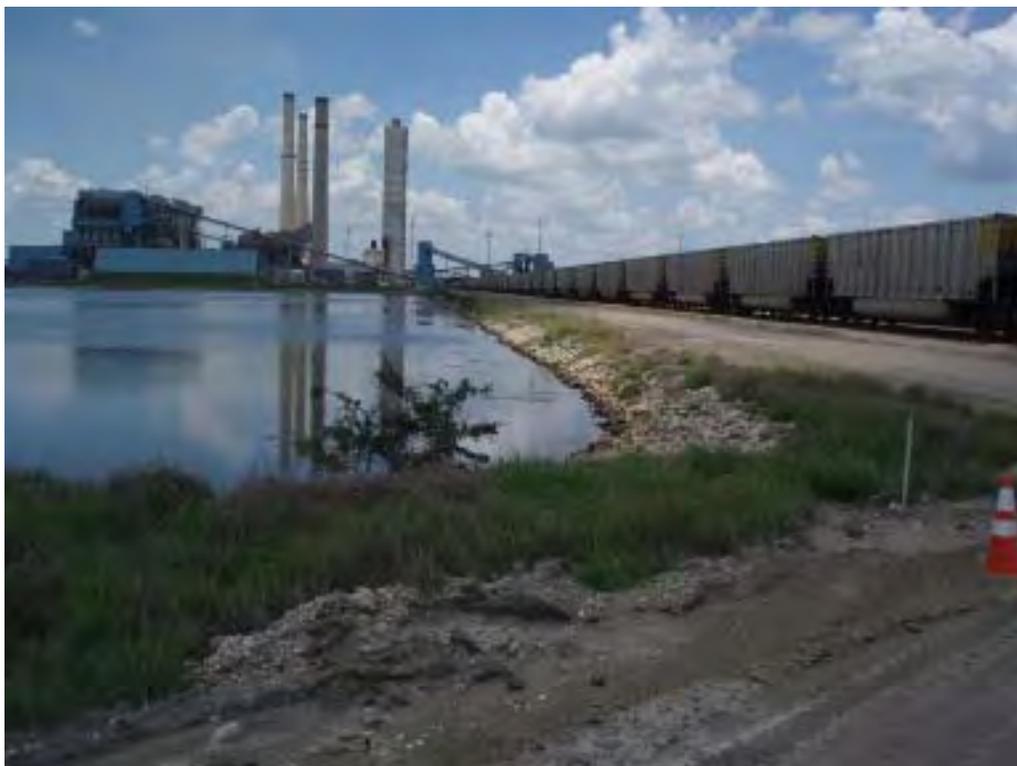
Photo No. 18: Reclaim Pond - East embankment interior slope, looking north. Small woody growth and minor surface erosion noted.

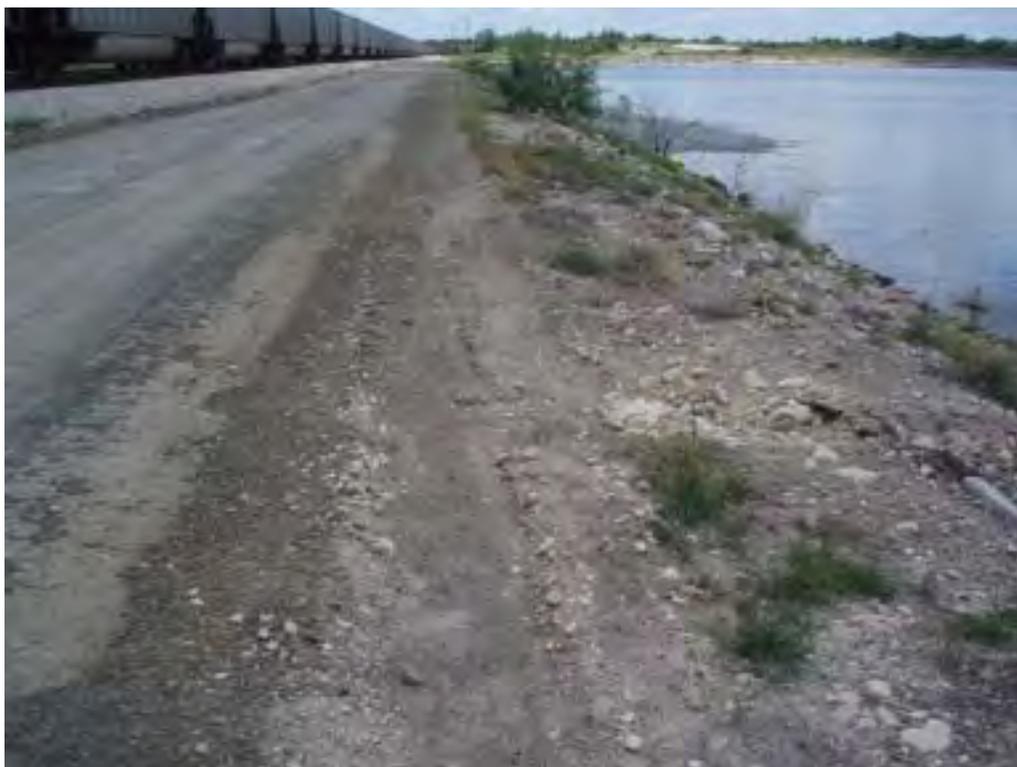
Photo No. 20: Reclaim Pond - East embankment interior slope, looking south at rutting and surface erosion. Note some riprap is missing and displaced.

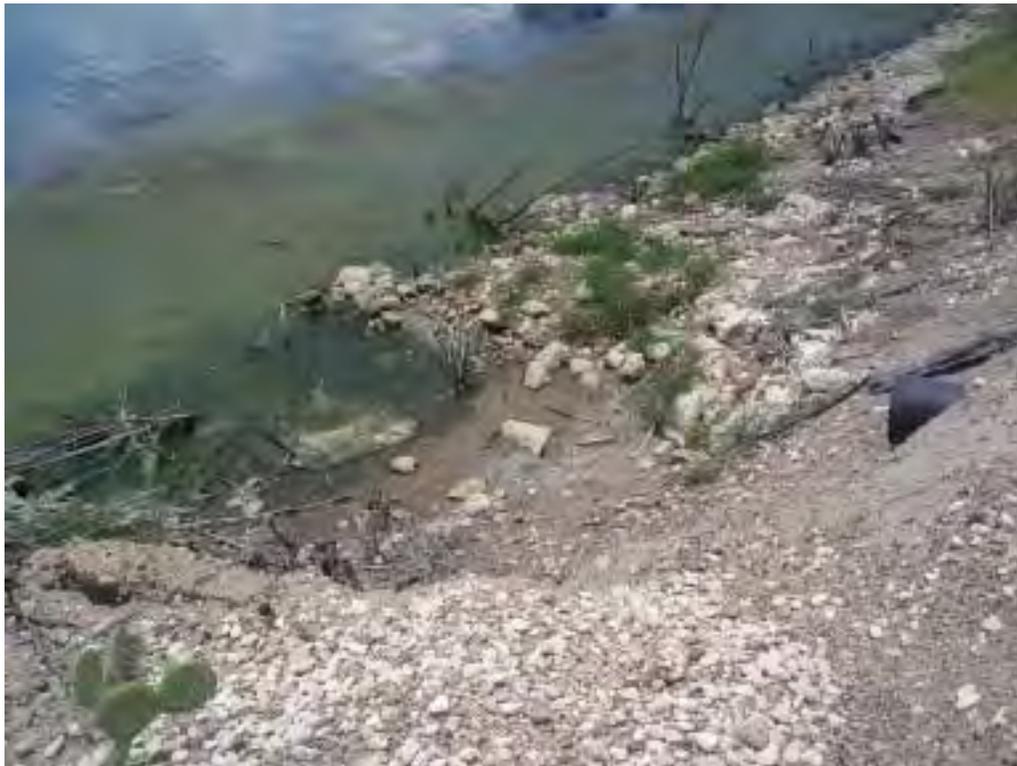
On the east embankment, there was one 2.5-foot-wide erosion rill (Photo 22). There was also an area where an abandoned 12-inch-diameter HDPE pipe from the CADP discharged into the Reclaim Pond. This area of the interior slope was eroded and some of the riprap was missing.

Photo No. 21: Reclaim Pond - East embankment interior slope, looking at abandoned 12-inch-diameter HDPE discharge pipe from the CADP. Note the embankment has been eroded at the discharge pipe.

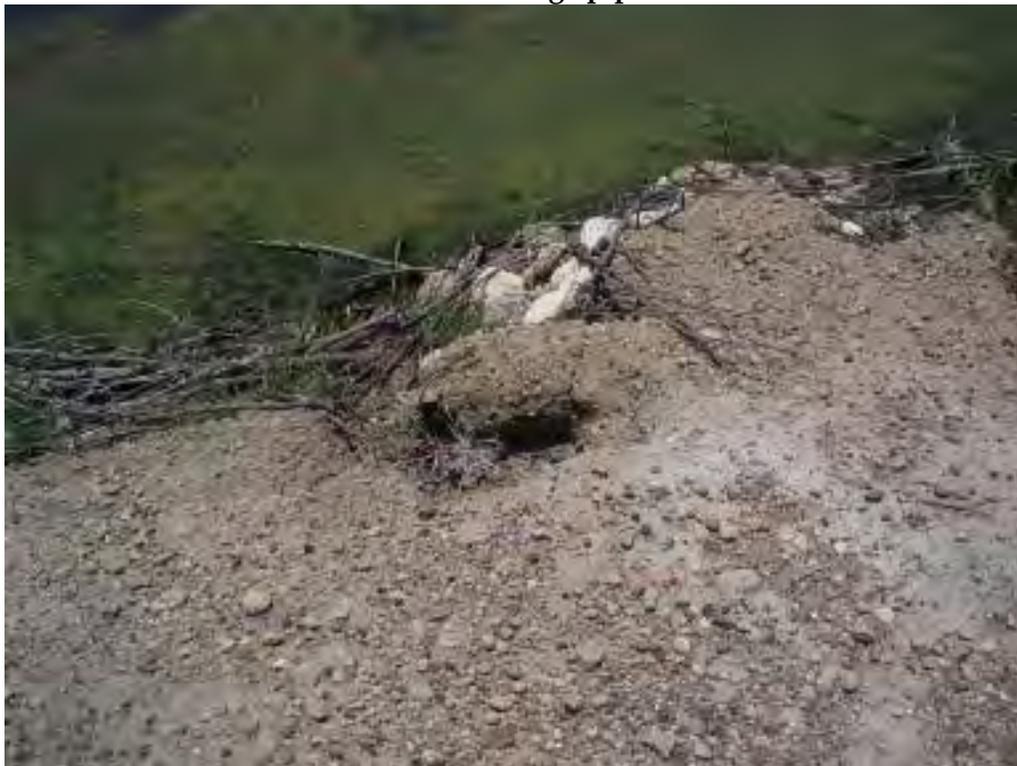
Photo No. 22: Reclaim Pond - East embankment interior slope, looking at 2.5'W erosion rill.

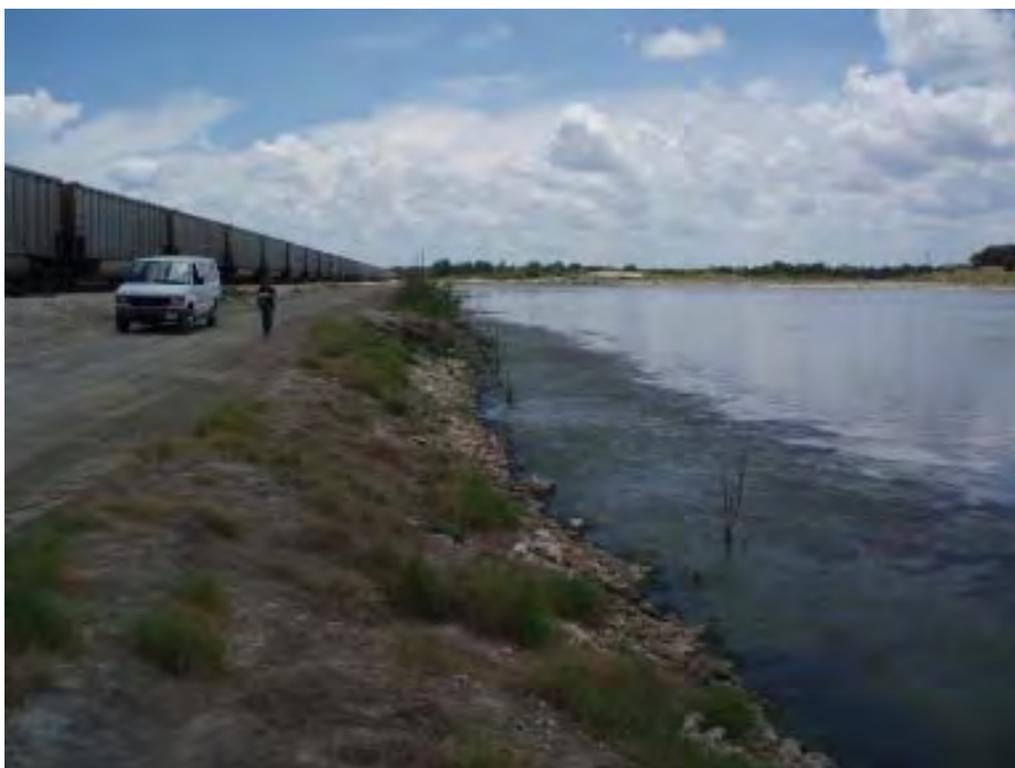
Photo No. 24: Reclaim Pond - East embankment interior slope, looking south. Note occasional mesquite trees growing on interior slope.

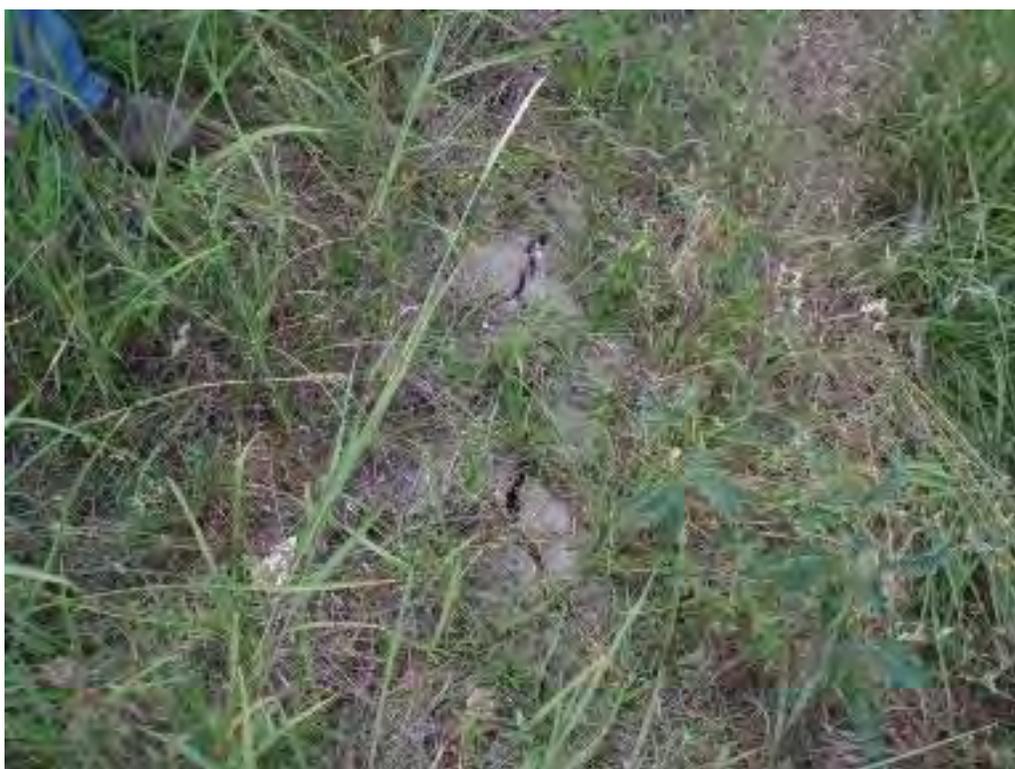
Photo No. 32: Reclaim Pond - North embankment exterior slope, looking at typical desiccation cracks.

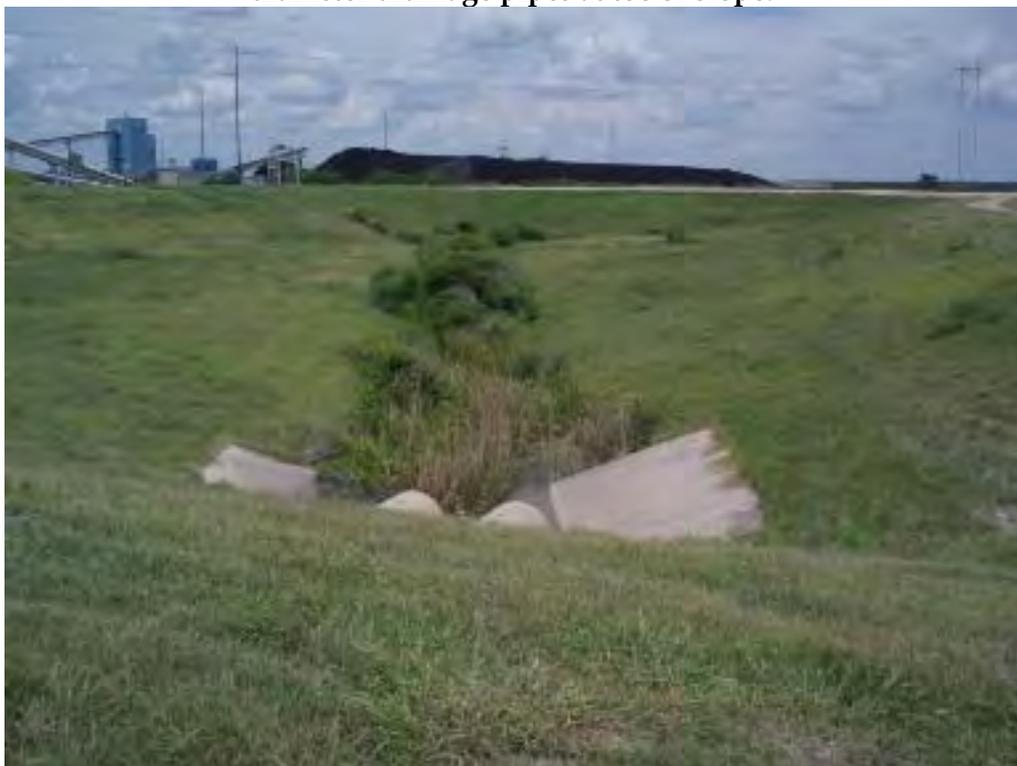
Photo No. 38: Reclaim Pond - Overview of north embankment exterior slope and downstream area, looking east. Note small trees and brush at the bottom of the slope growing in the drainage ditch.

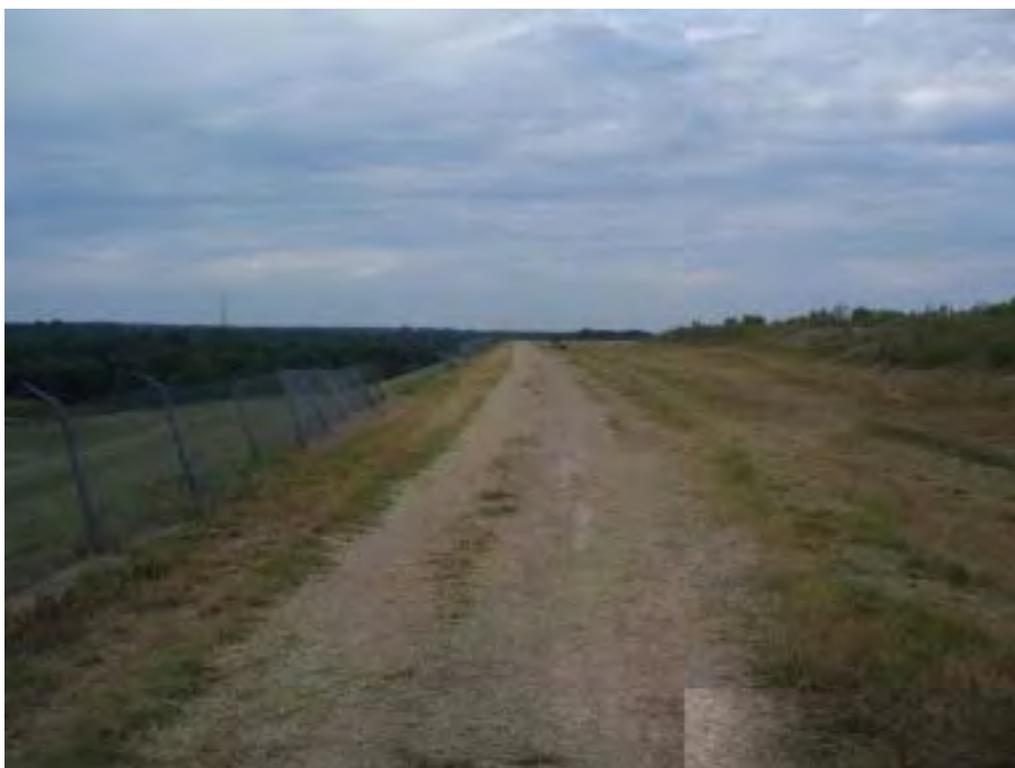
Photo No. 56: CADP - East embankment crest, looking south. Note the fence has been pushed over from raising the crest 2 feet.

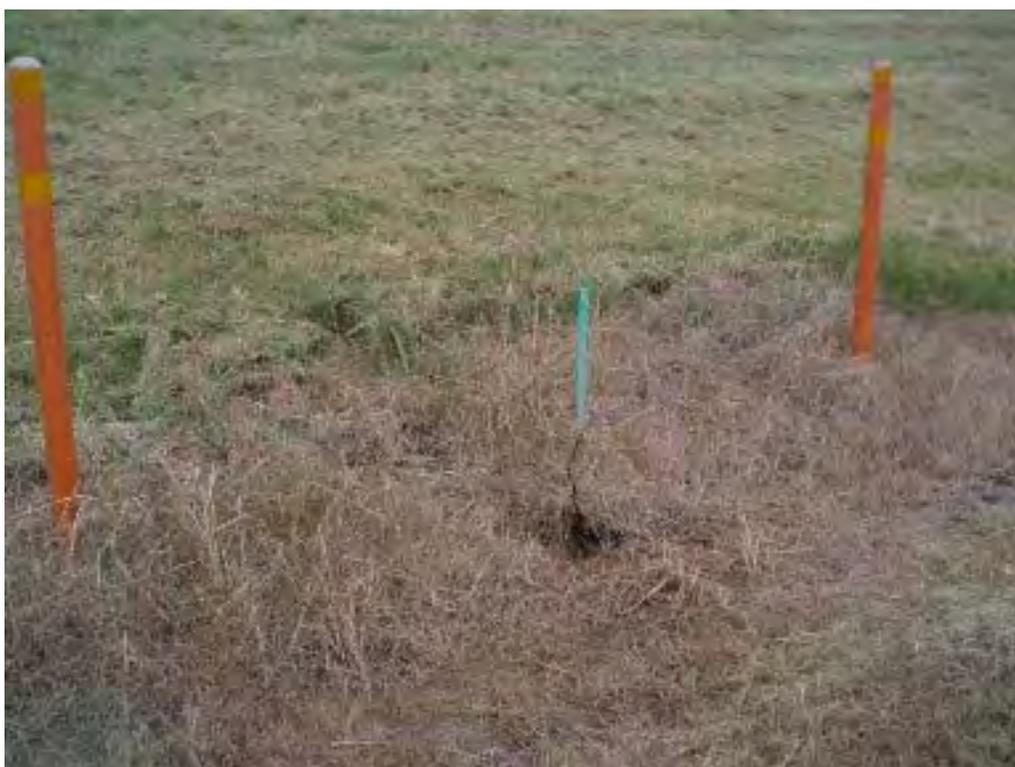
third toe drain (not photographed) that collects drainage from the portion of the chimney drain associated with the Coal Pile Run-off Pond embankment. Both of these toe drains discharge into a seepage collection sump pit, referred to as the Lateral Drain Sump. Water collected in the Lateral Drain Sump is pumped back into the impoundment. Seepage was not observed in the sump pit during the site visit. The ground around the other discharge pipe (Photo No. 64) was damp, although no significant seepage was observed.

Photo No. 64: CADP - East embankment exterior slope, looking at toe drain outlet.

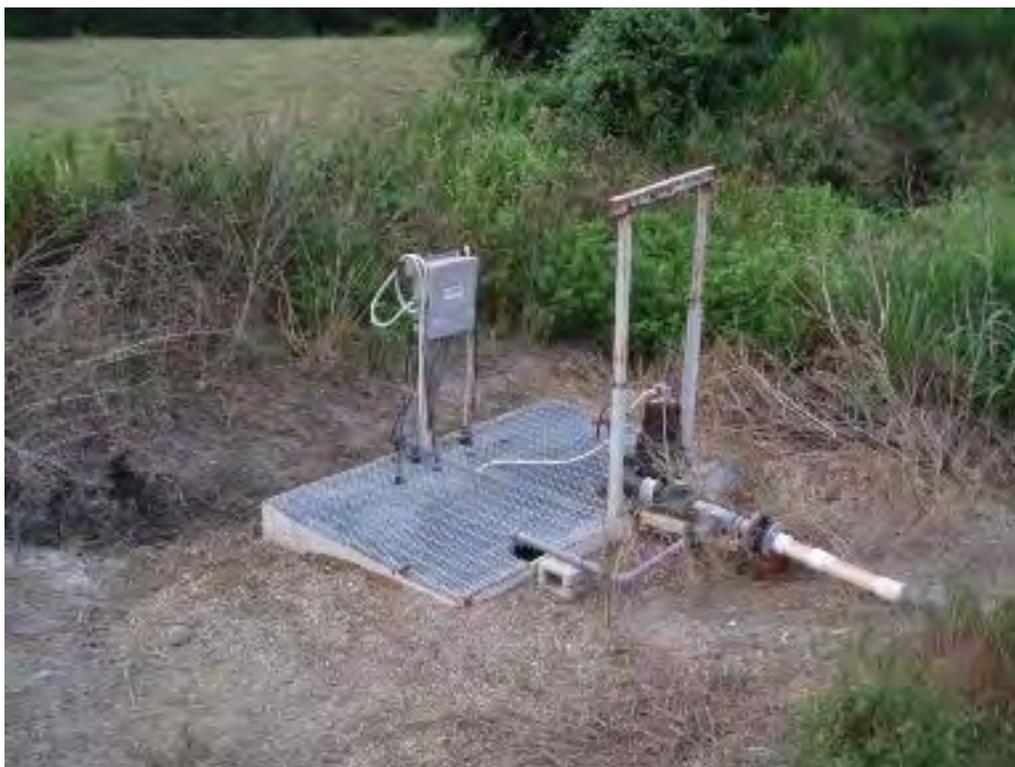
Two of the toe drain outlets from the chimney drain on the east embankment were observed (Photos 64 and 66). The toe drain shown in Photo No. 66 also connects to a

Photo No. 66: CADP - East embankment exterior slope, looking at toe drain seepage collection sump pit. Seepage water from the toe drain is pumped back to the impoundment.

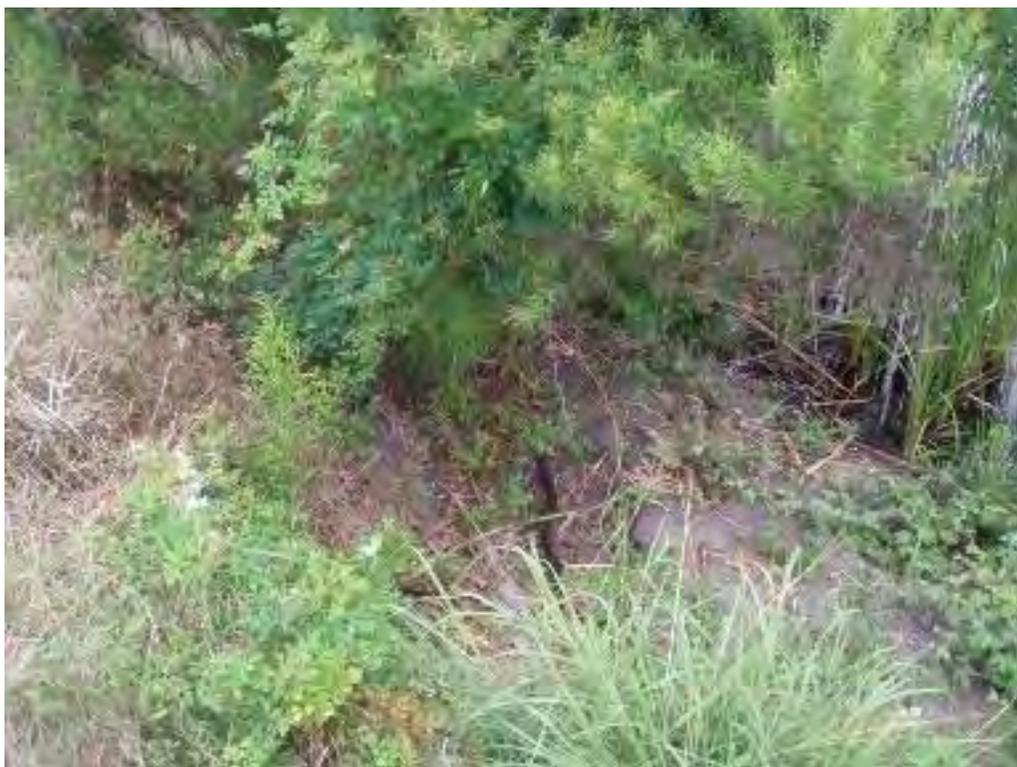
CDM observed 16 rodent holes, reportedly made by armadillos, on the east embankment exterior slope. The holes ranged in size from 4 to 8 inches in diameter (Photos 63 and 65). There were also multiple surface depressions that were likely rodent holes that collapsed, possibly as a result of mowing operations (Photos 62, 79, 80, and 84).

Photo No. 80: CADP - South embankment exterior slope, looking at 4'Wx5'Lx2'D depression at toe of slope. Possible collapsed rodent burrow.

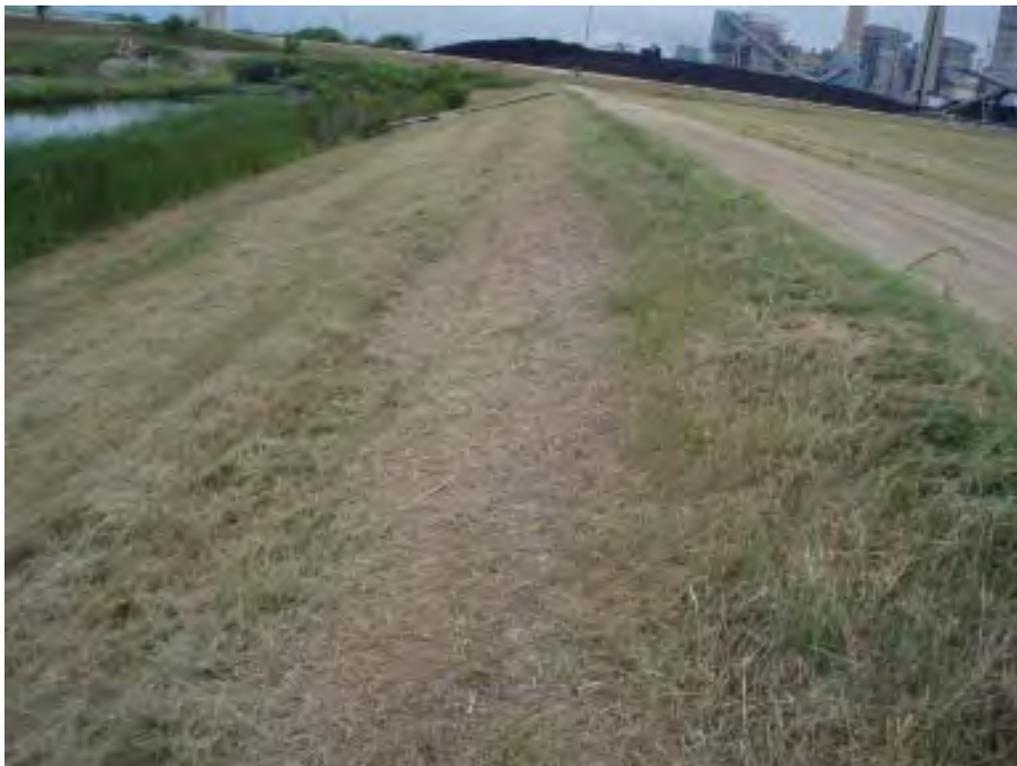
The CADP is incised on the north and west embankments. The south and east exterior slopes appear to be generally in fair condition (Photos 53, 54, 55, 57, 58, 60, 61, 62, 67, 68, 69, 71, 73, 74, 77, 78, and 85). The grass on the embankment was approximately 8 to 12 inches tall and was recently mowed. Trees and brush up to 6 inches in diameter were observed at the toe of the south embankment in the Coal Pile Run-off Pond. There were some bare spots near the middle of the south embankment exterior slope (Photo 81).

Photo No. 81: CADP - South embankment exterior slope, looking west. Note sparse vegetation near crest.

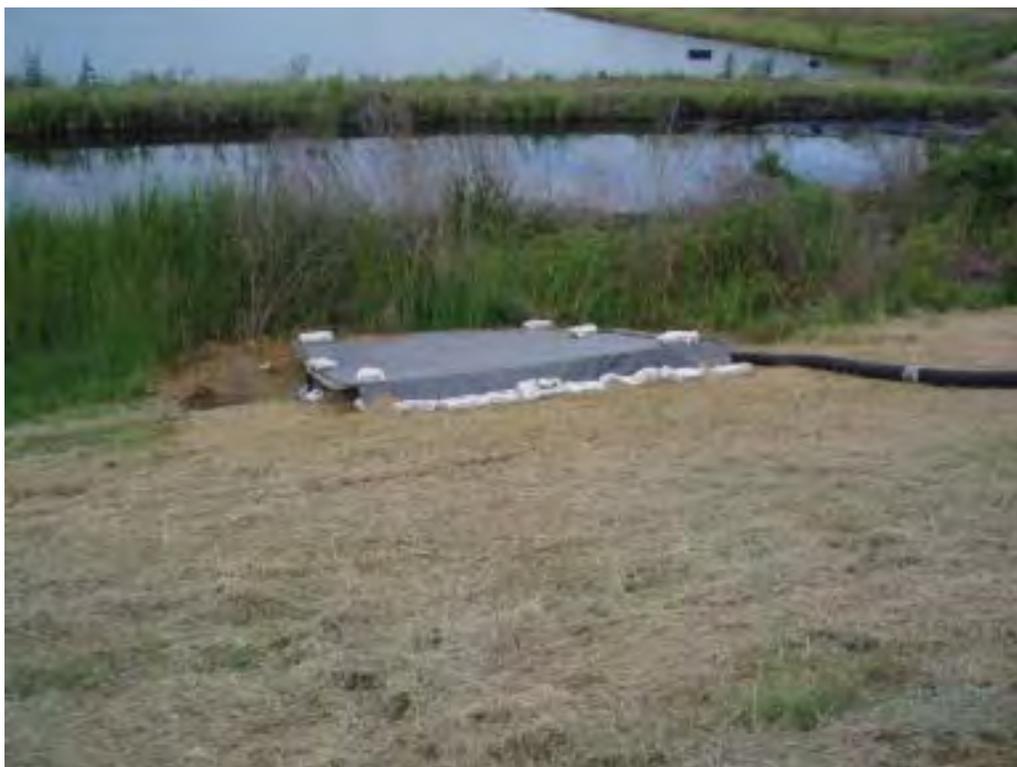
An active seep on the south embankment exterior slope was observed (Photos 82 and 83). LCRA has constructed a containment structure to collect the seepage water. The estimated flow from the seep typically ranges from 8 to 11 gallons per day based on review of information provided by LCRA personnel

Photo No. 82: CADP - South embankment exterior slope, looking at seep containment system.

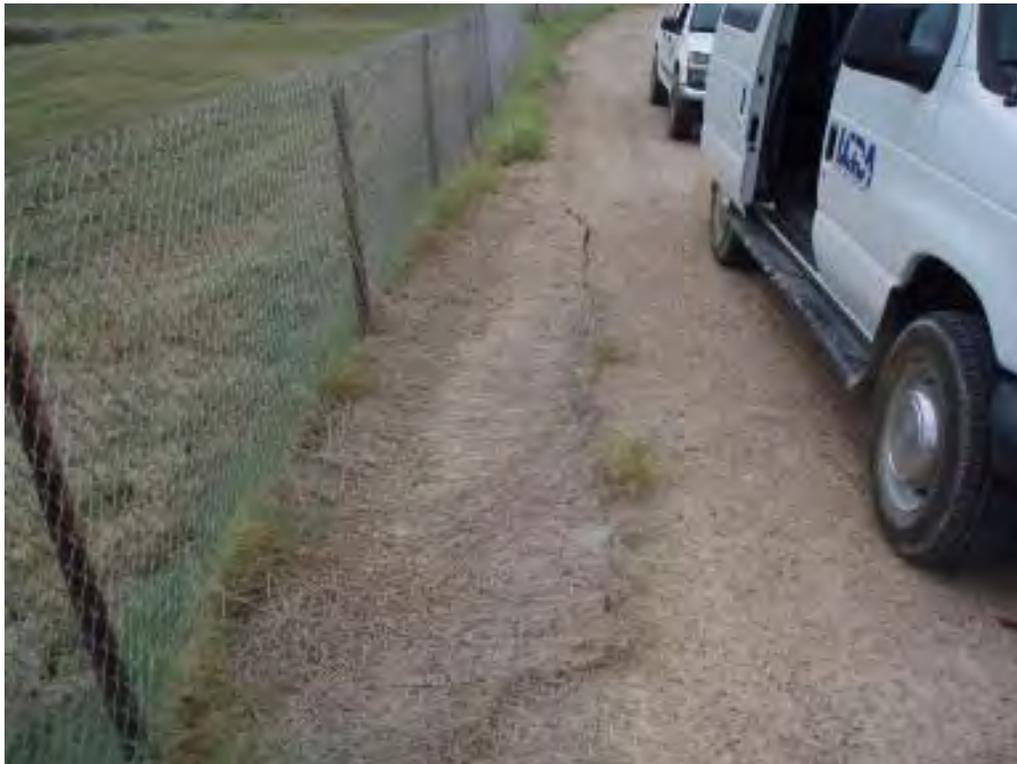
Photo No. 99: CADP - North embankment crest, looking at tension crack in road base fill.

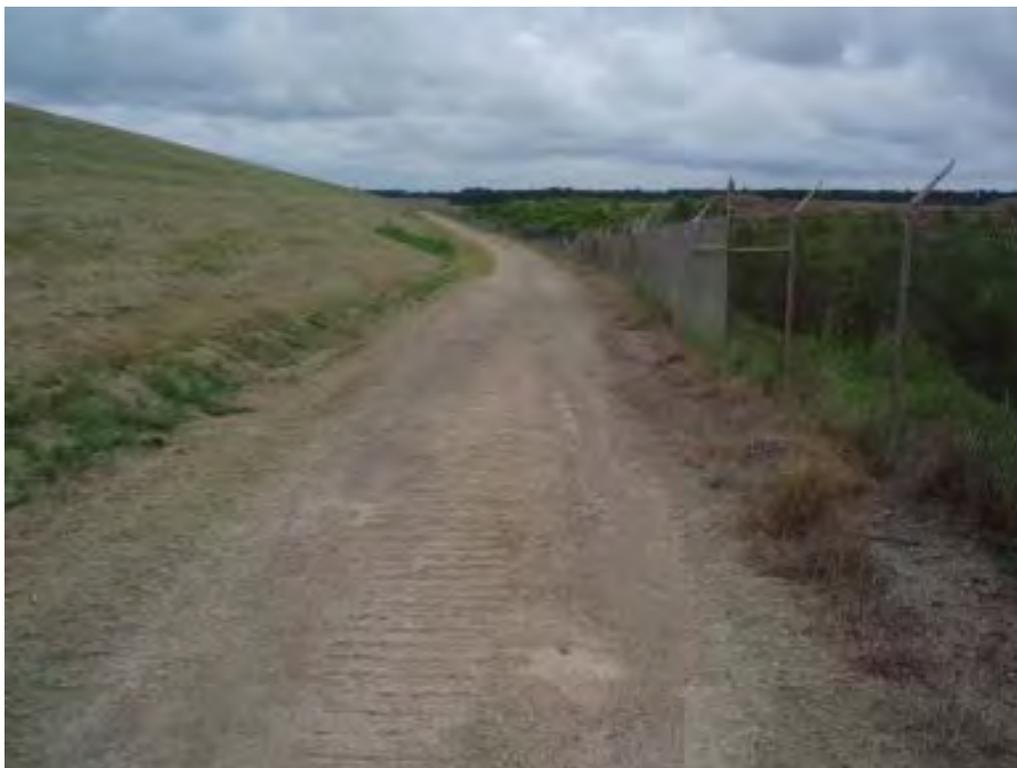
Photo No. 100: CADP - North embankment crest, looking east. Note trees growing inside the fence limits. Trees are in the area of the toe of the Cedar Creek Dam.
