**Bottom Ash Pond – Trimble County  
Station Assessment Report**

**Lockheed Martin  
Contractor for the USEPA**

**September 2009**

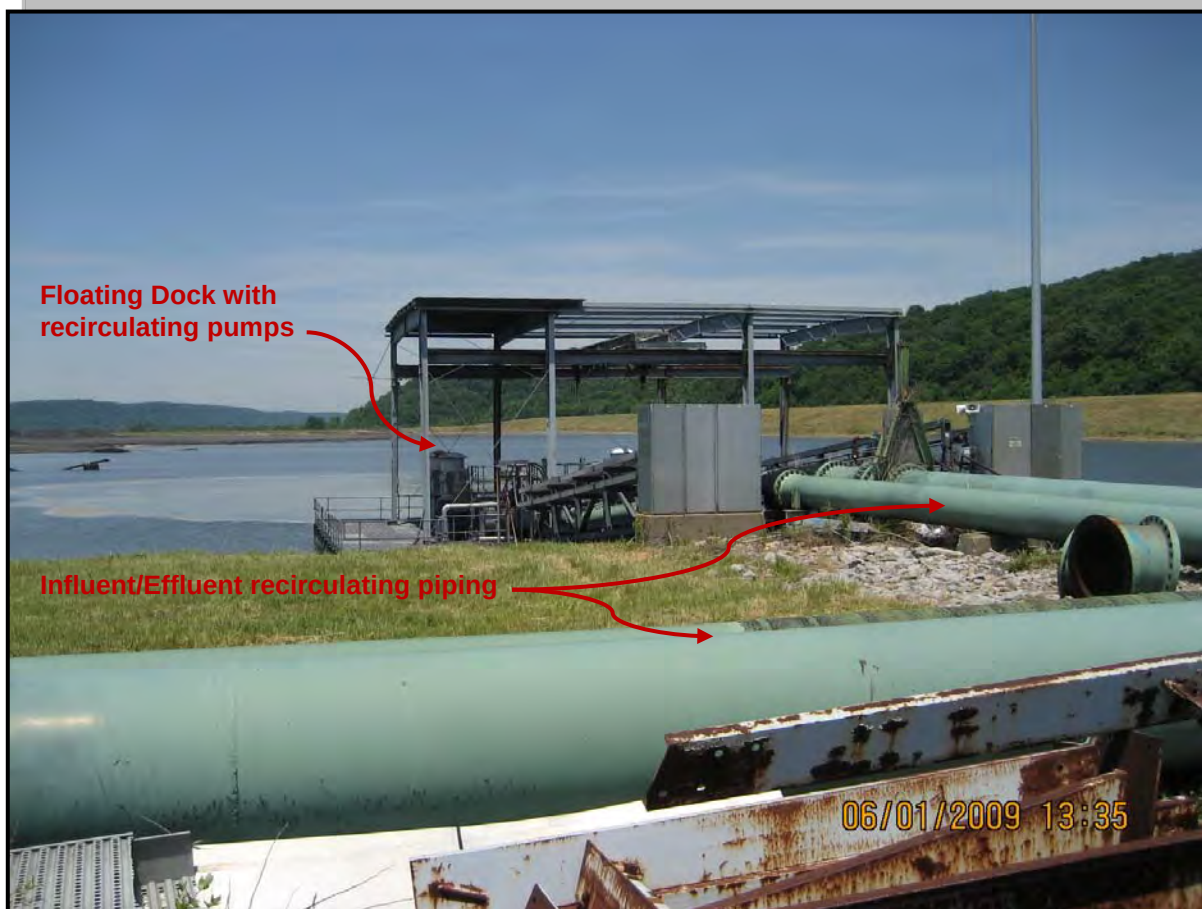
Photo 1 - View of Floating Dock with recirculating pumps and piping along South Dike

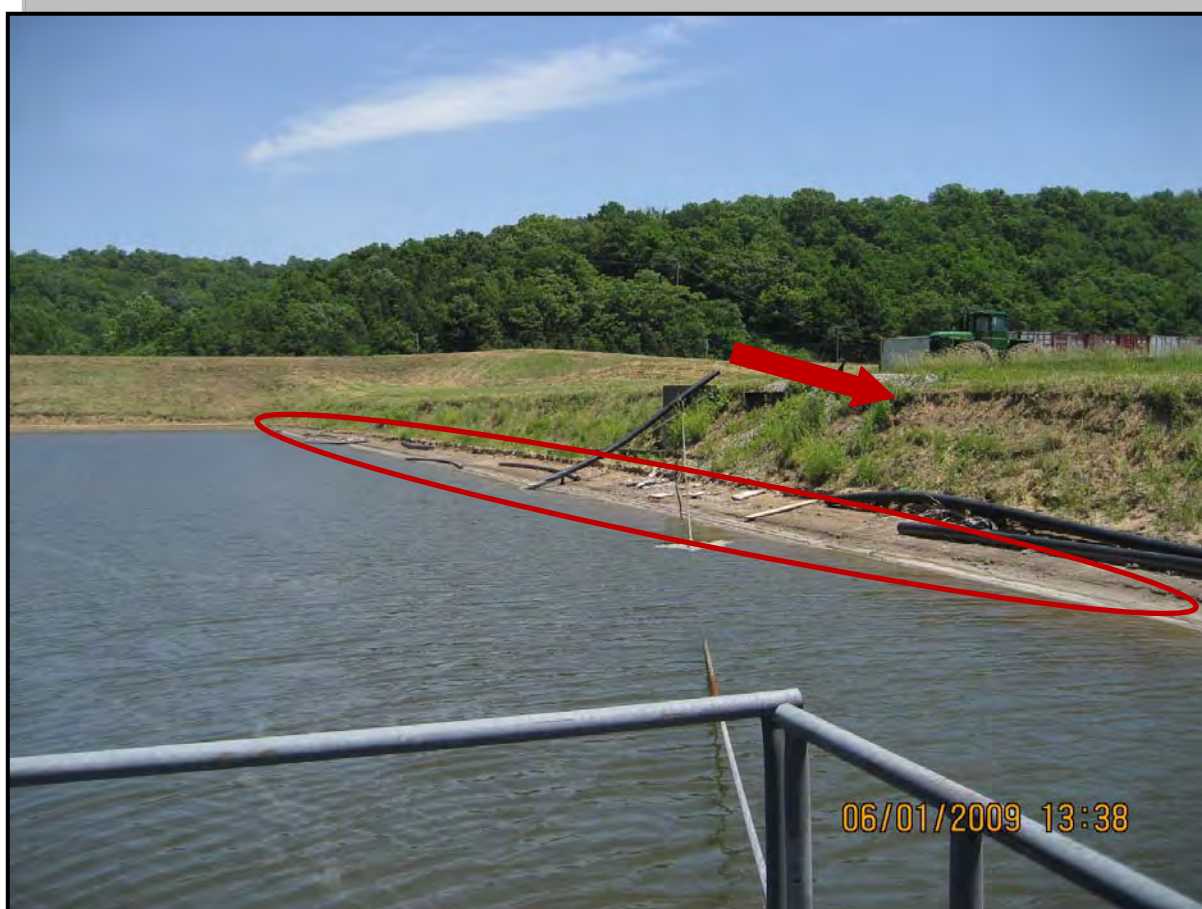
Wave action erosion was observed on the unarmored upstream slopes of both the south and east embankment and was more noticeable with the lower pool elevation. This erosion and some minor gully erosion occurring near the influent/effluent piping were the only deficiencies found on the upstream slope.

Photo 2 – View of South Dike with erosion and sloughing of upstream slope freeboard caused by wave action

1. Upstream slope – repair eroded and sloughed areas near the top of the east and south embankments. Repairs should be completed in accordance with an engineered design. Consider armoring of upper portion of interior eastern and southern slopes to protect against wave action erosion.

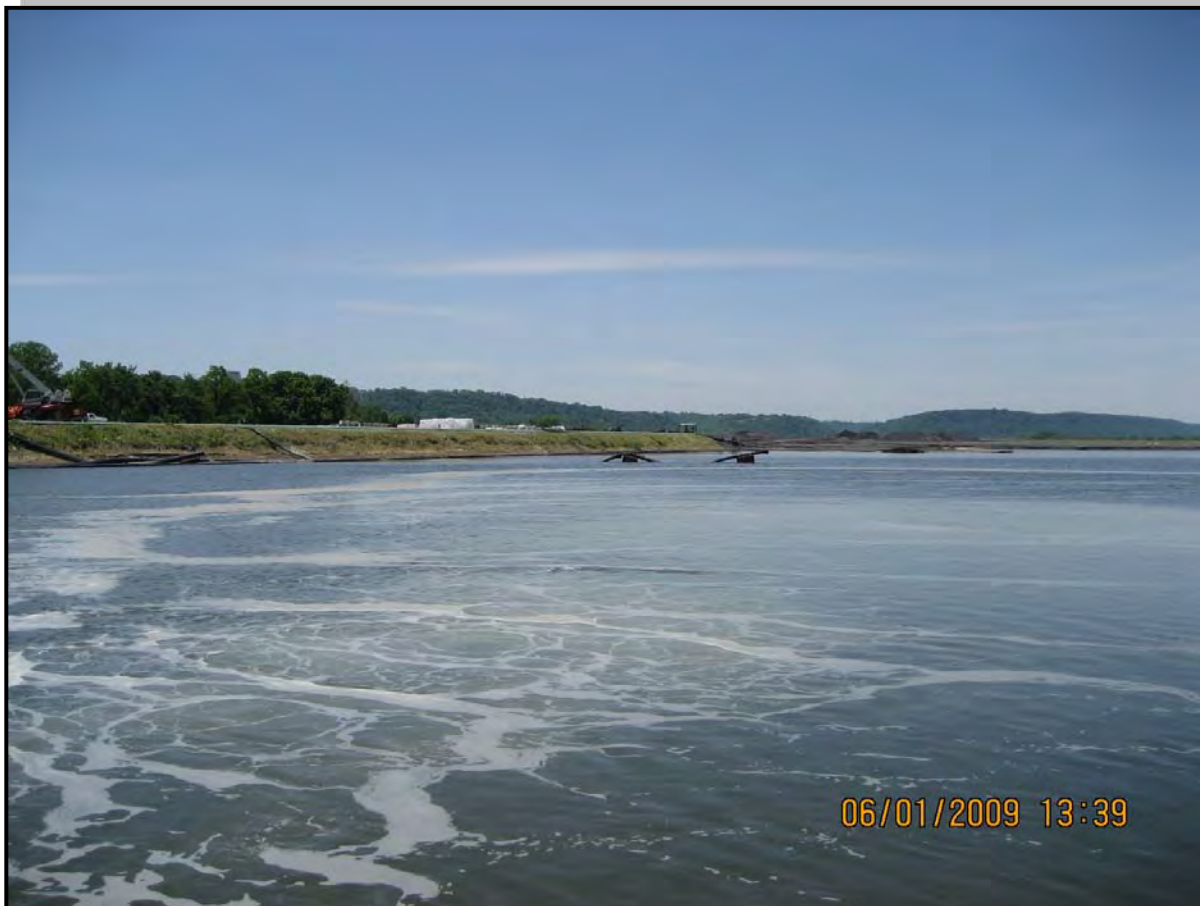
Photo 3 - Typical overview of impoundment viewed from Floating Dock along South Dike

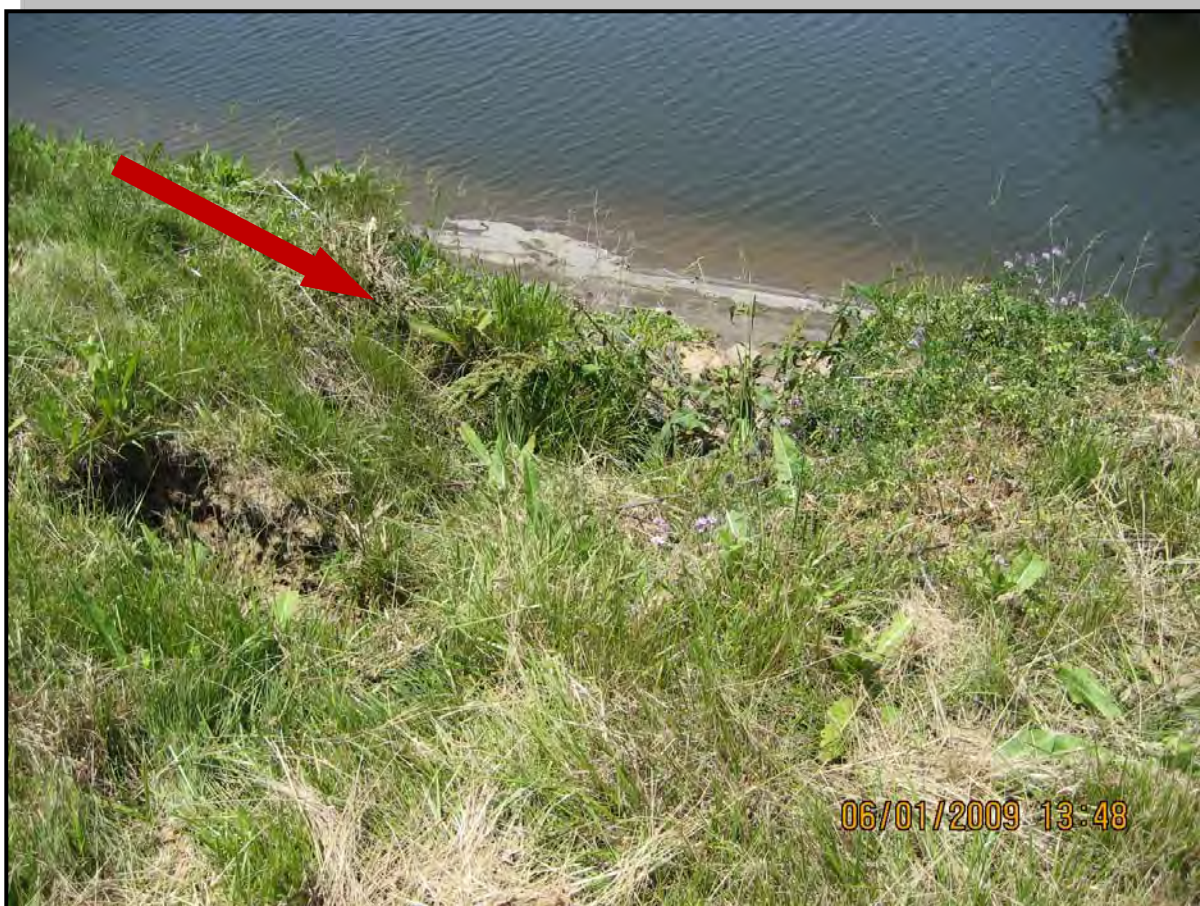
Photo 4 – View of typical erosion gullies in freeboard area along upstream slope near Floating Dock

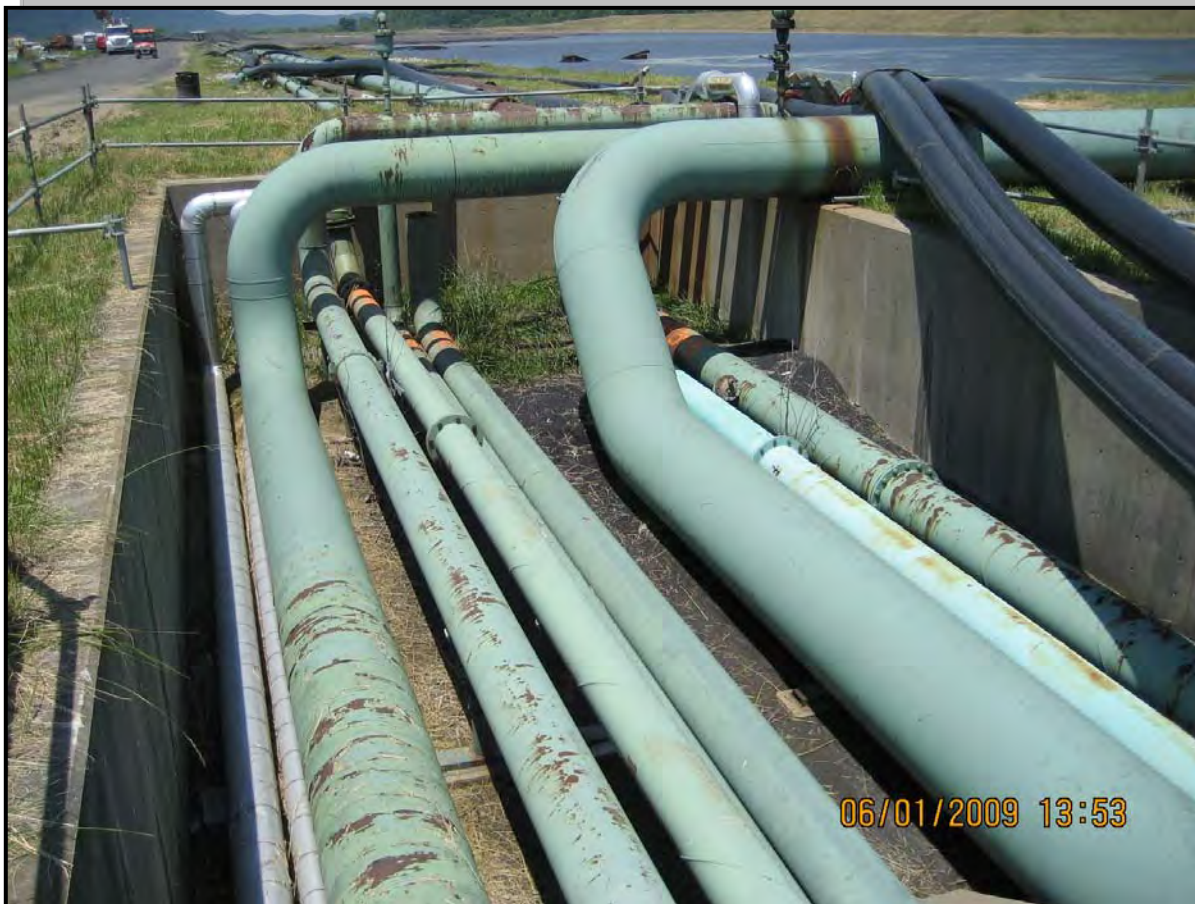
Photo 5 – View of influent/effluent piping and vault along west embankment crest

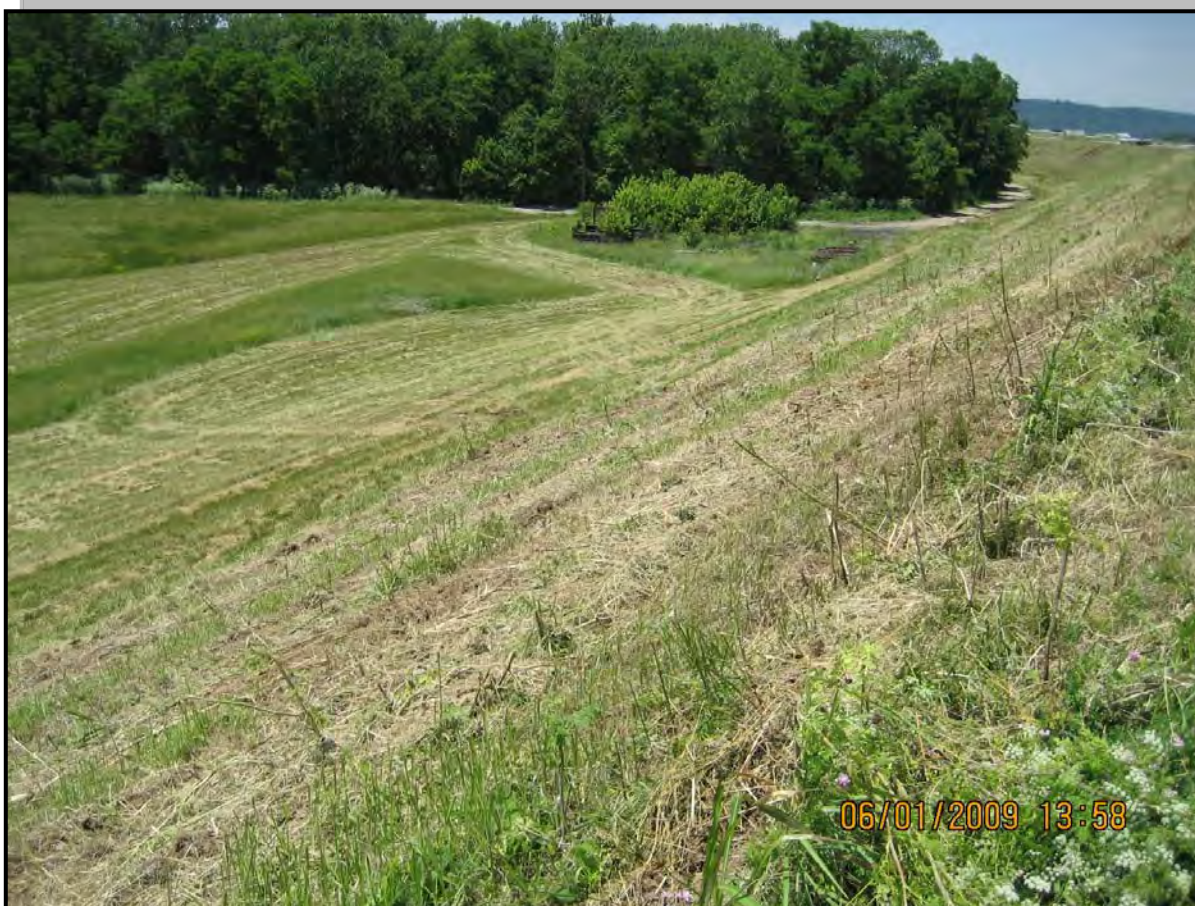
Photo 6 – Overview of downstream slope of the west dike from crest of south dike

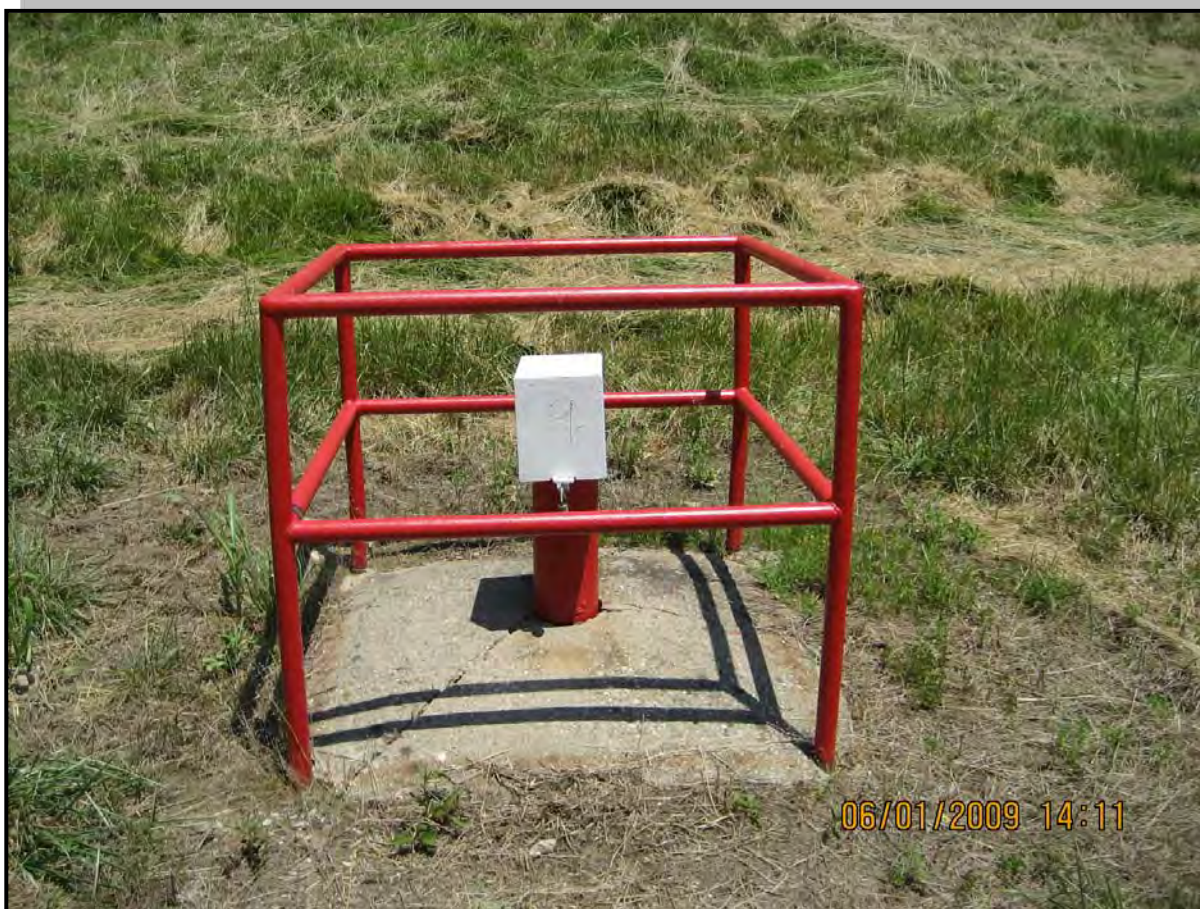
Photo 7 – Typical view of groundwater monitoring well (Not used for seepage or pore pressure monitoring)

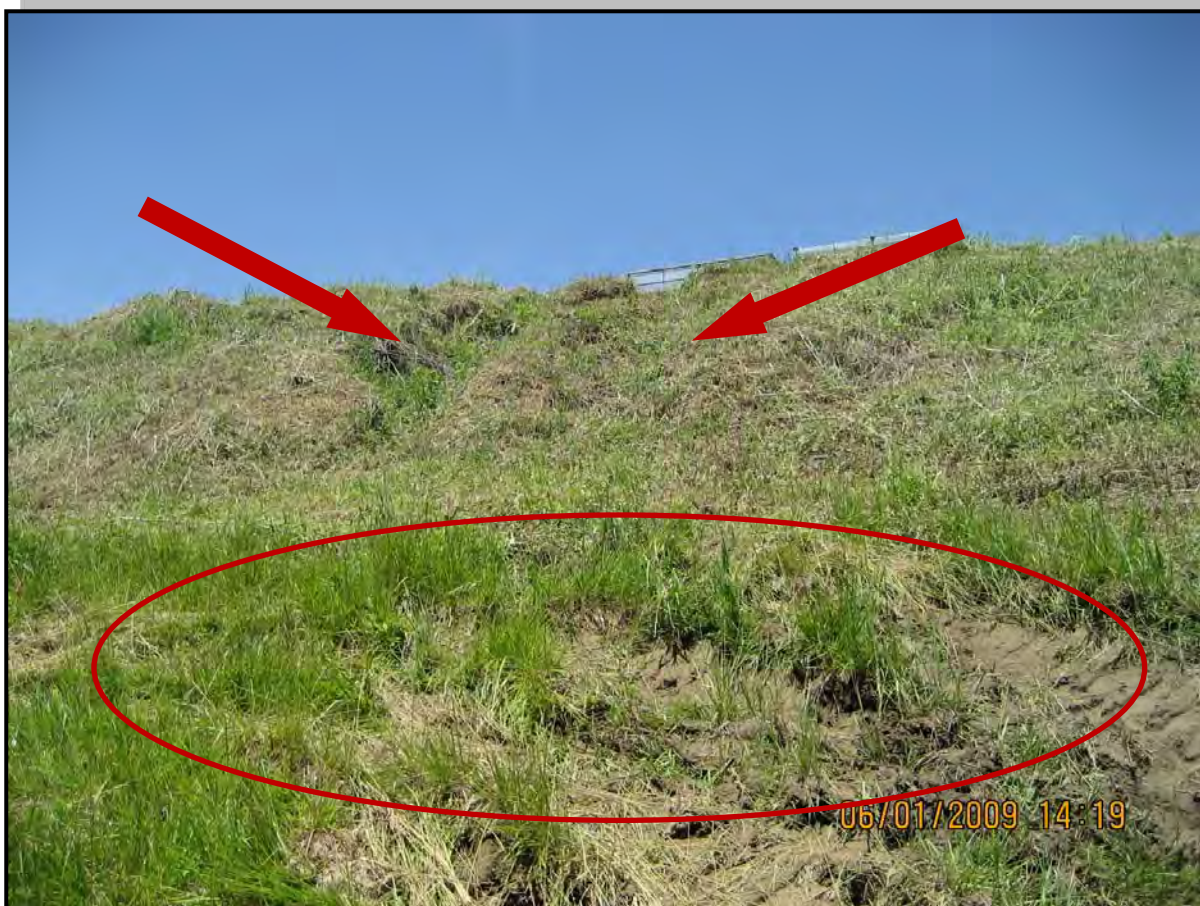
Several erosion gullies were observed on the downstream slopes of the west and north embankments. This erosion appears to be occurring due to concentrated storm water discharge due to rutting of the crest by equipment and irregular grading of the crest toward the downstream slope.

Photo 8 – Typical erosion gullies along western downstream slope near inside curved slope of embankment

3. Downstream slopes – fill erosion gullies on the downstream slopes of the north, east, and west embankments. Repair sloughs, and re-grade irregular areas of slopes to avoid concentrated runoff channels or saturation of portions of slope. Repairs should be performed in accordance with an engineered design. Avoid mowing during wet conditions to reduce rutting by heavy tractor, which may be causing some minor slope sloughing. Place turf reinforcement erosion control matting over repaired areas to reduce the potential for future erosion gullies.

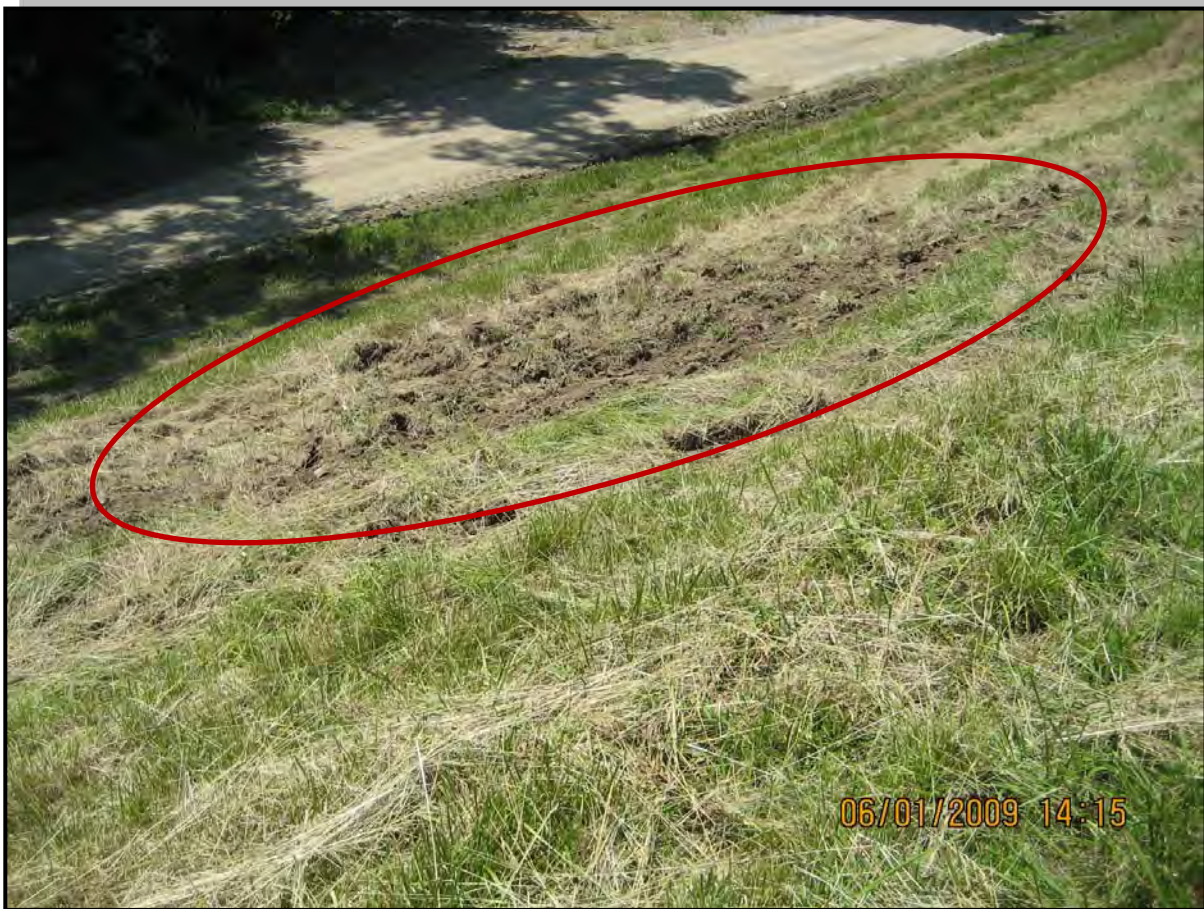
Photo 9 – Typical rutting and slope sloughing due to heavy mowing tractor, western downstream slope

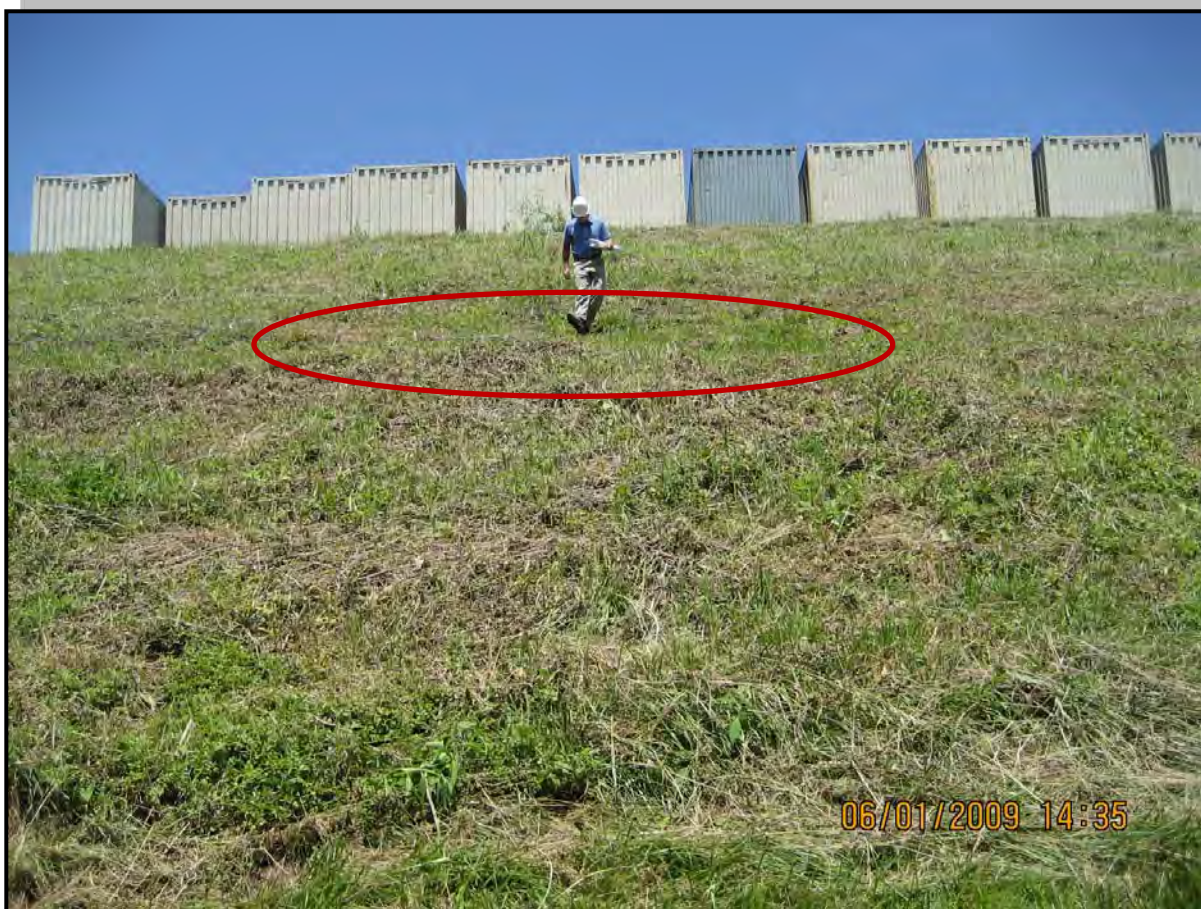
The downstream slope had recently been mowed, which allowed for better observation of the slope. Several shallow sloughs were noticed along the downstream slopes, but it was evident that they were old occurrences due to the vegetative growth around the sloughs. No new sloughs or depressions were found during this inspection.

Photo 10 – Old slough on western downstream slope

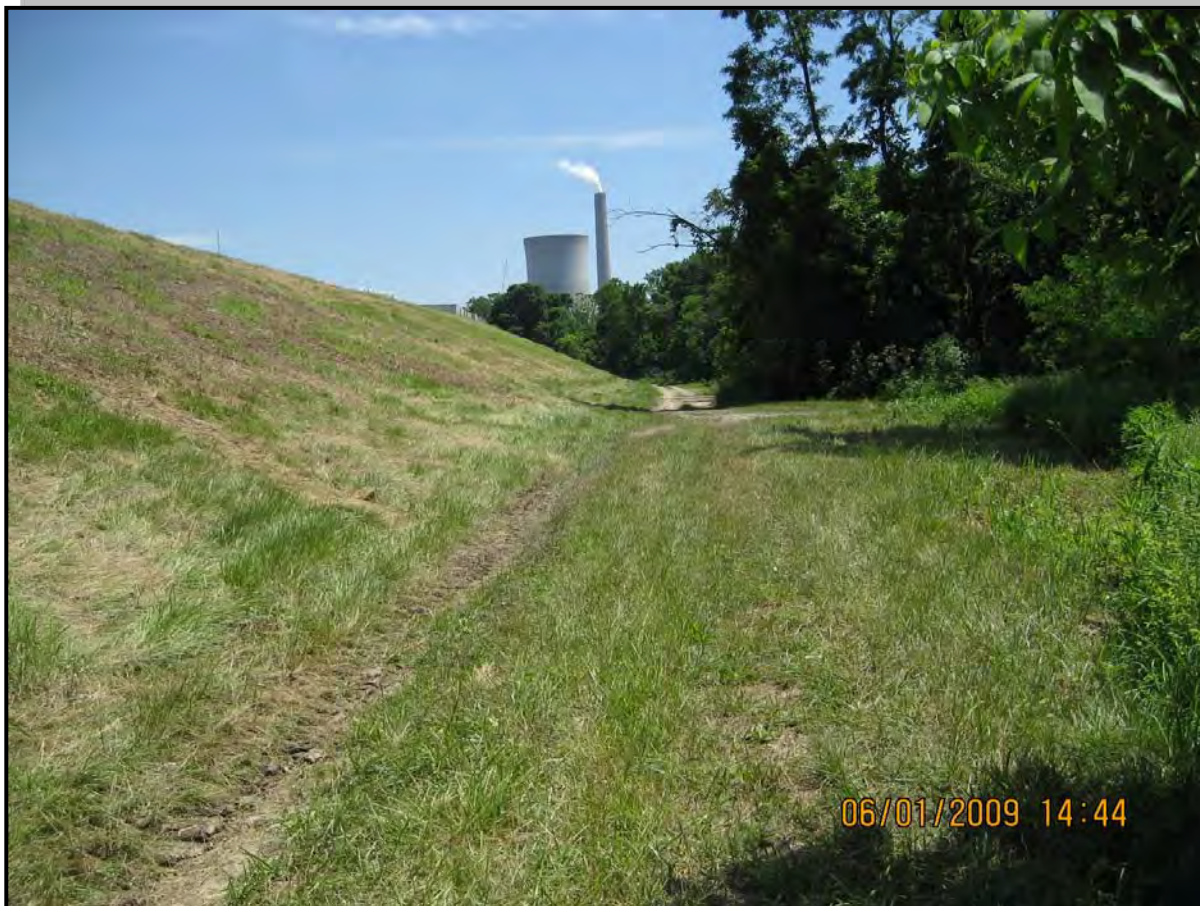
Photo 11 – View along toe of western downstream slope looking south

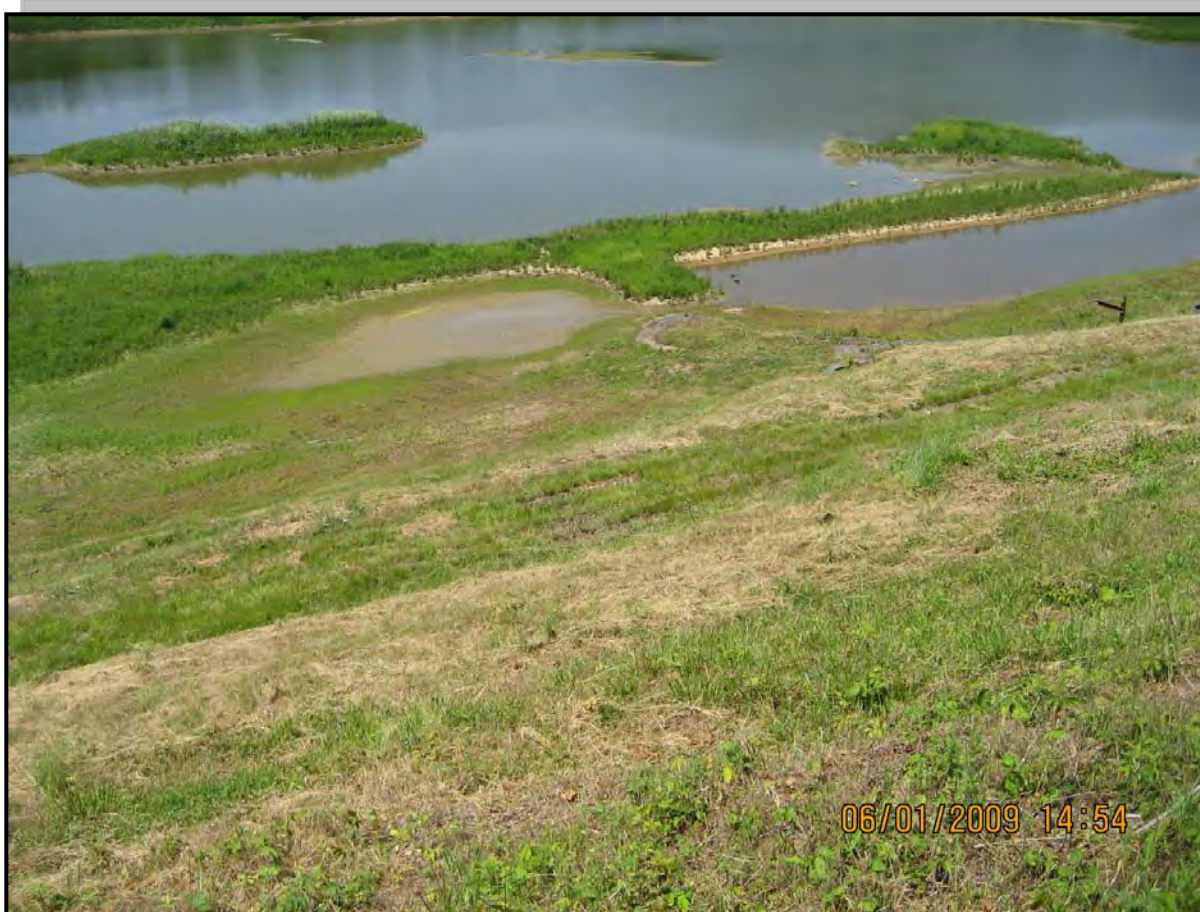
Photo 12 – View of Emergency Fly Ash Pond and northern slope of Bottom Ash Pond

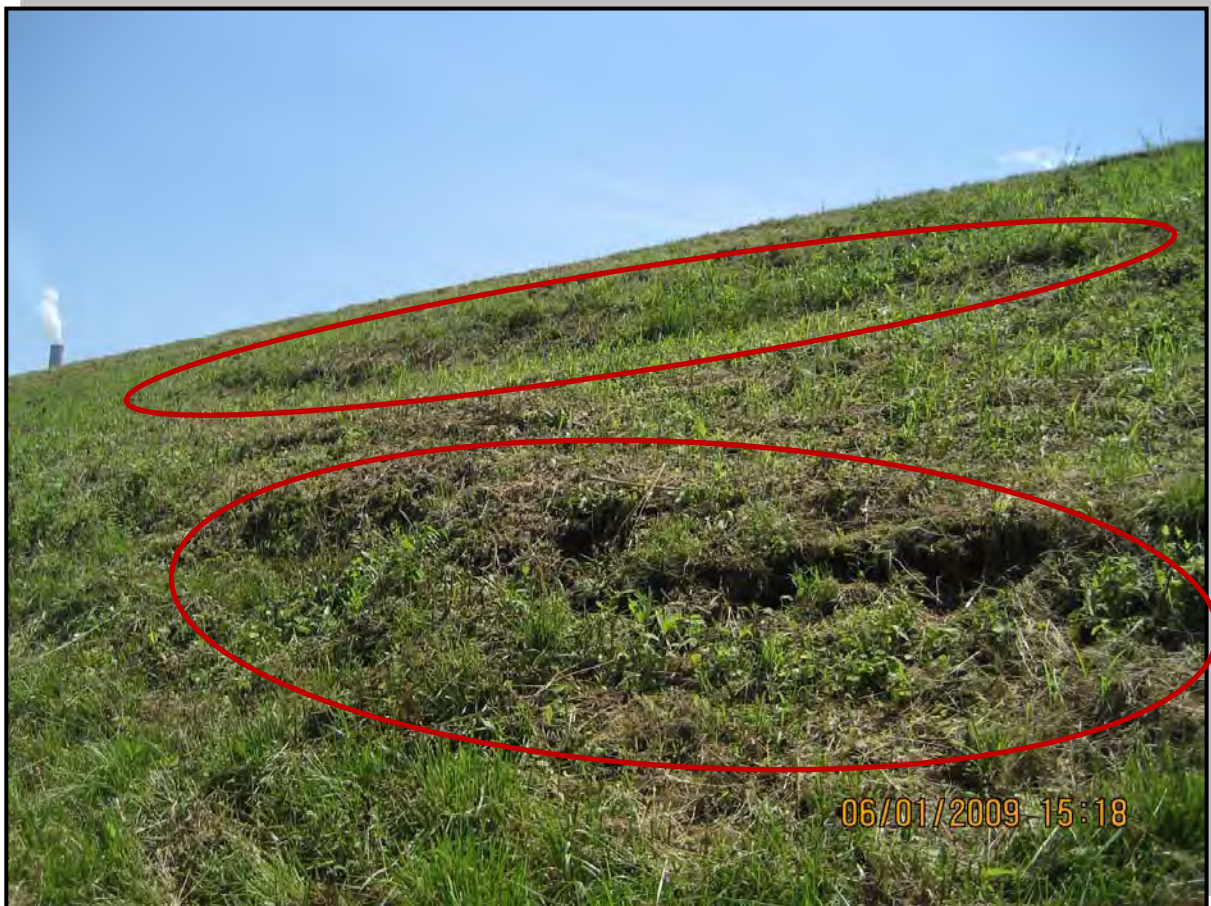
Photo 13 – Old slough on eastern downstream slope

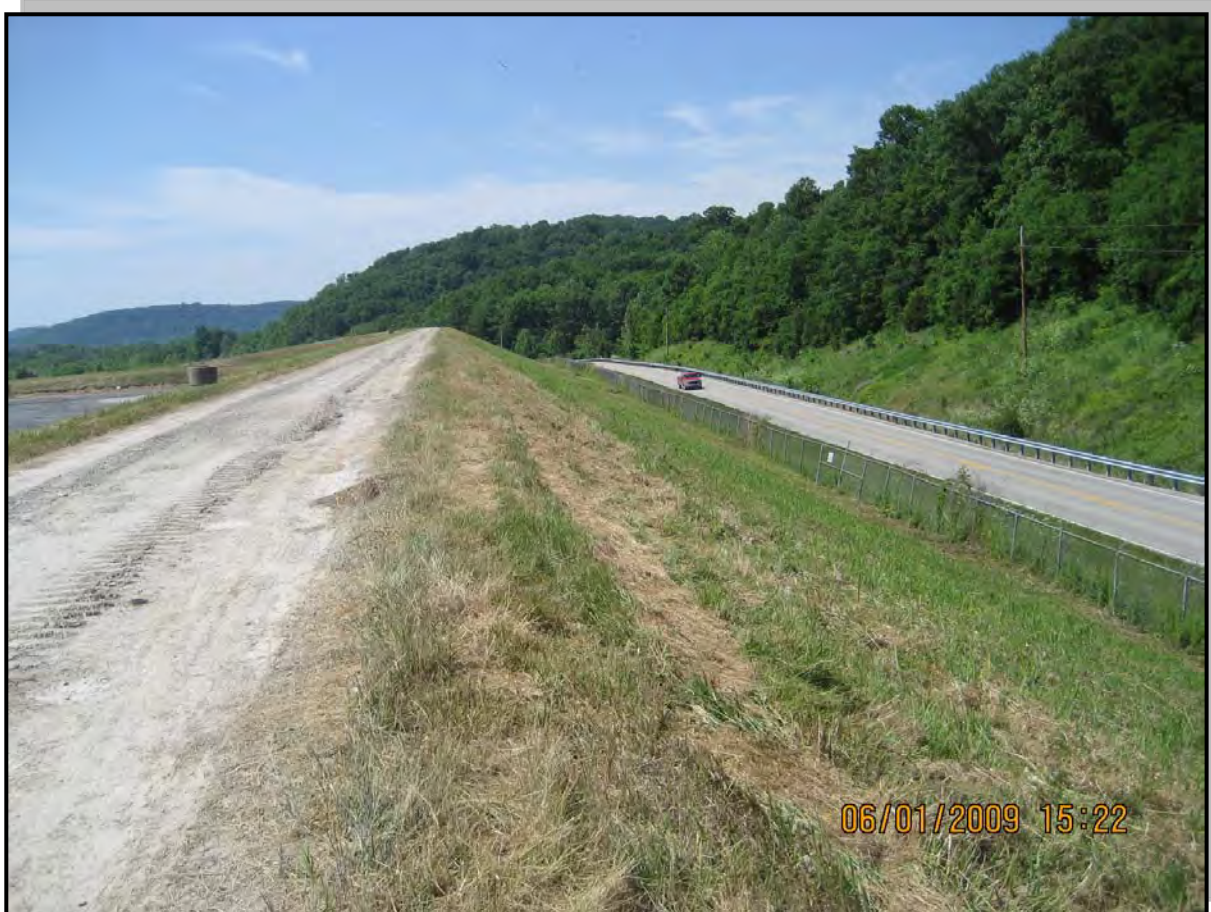
Photo 14 – View along crest and upstream slope of eastern embankment looking north

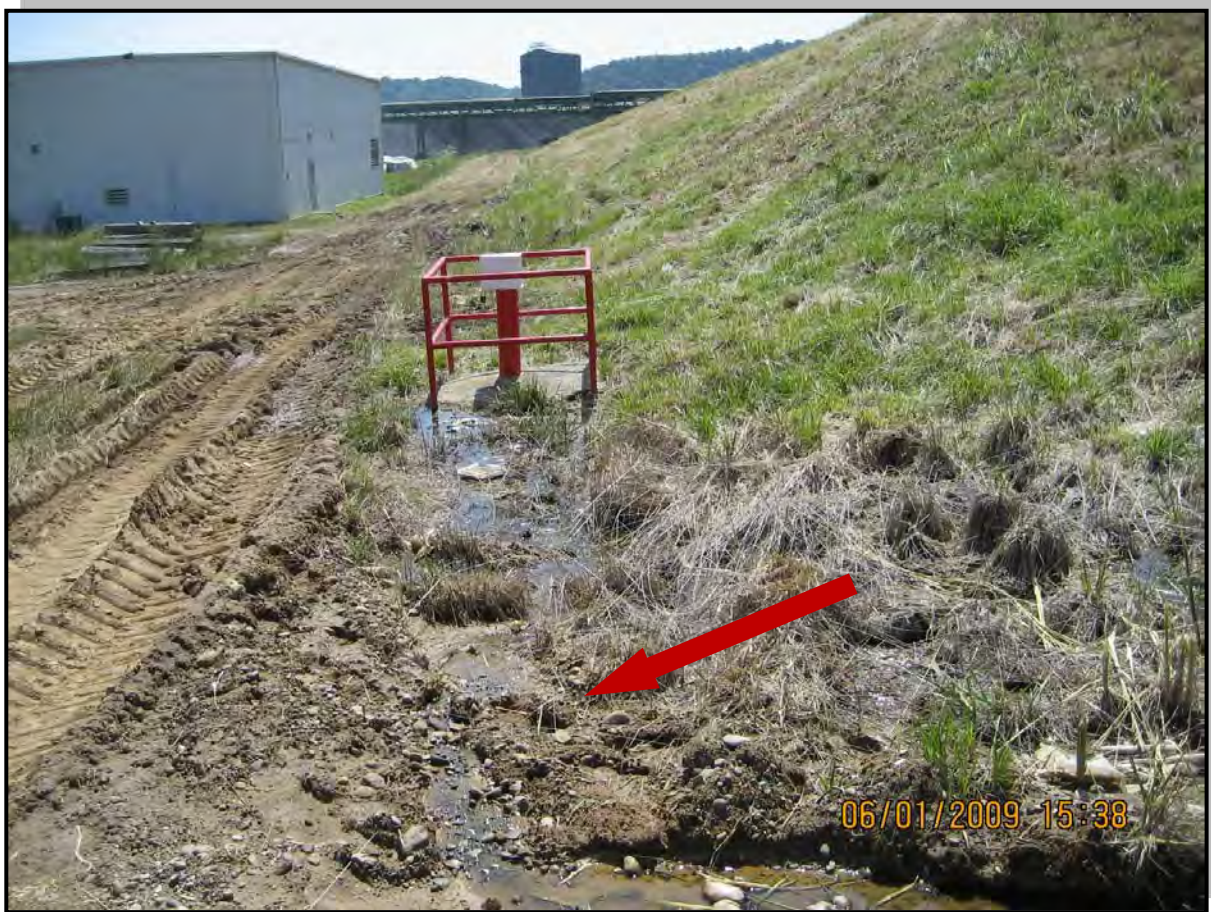
| <u>Inspection Issue #</u> | <u>Comments</u> |
|---|---|
| 21 | Minor seepage estimated at < 1 gallon/min was observed at mid-point of toe of south embankment. Seepage believed to be discharge from gravel blanket drain at toe.<br><br>A few very minor wet areas were observed at isolated areas on downstream slopes. No observed flow from these wet areas.<br><br>Not a safety concern |

Photo 15 – Wet Area or minor seepage at toe of south embankment possibly due to discharge from gravel toe drain (View looking west)

Although the minor seepage/wetness at the downstream toe of the south embankment is believed to be the result of controlled discharge from an engineered toe drain, this seepage area should be monitored for increased seepage volume, transport of fine-grained soils, or other changed conditions that may indicate a potential problem. Installation of a small gravel blanket drain in the area with an outlet channel or pipe would help to alleviate the poor drainage conditions in the area and provide a means to measure seepage flow rate at a convenient discharge point.

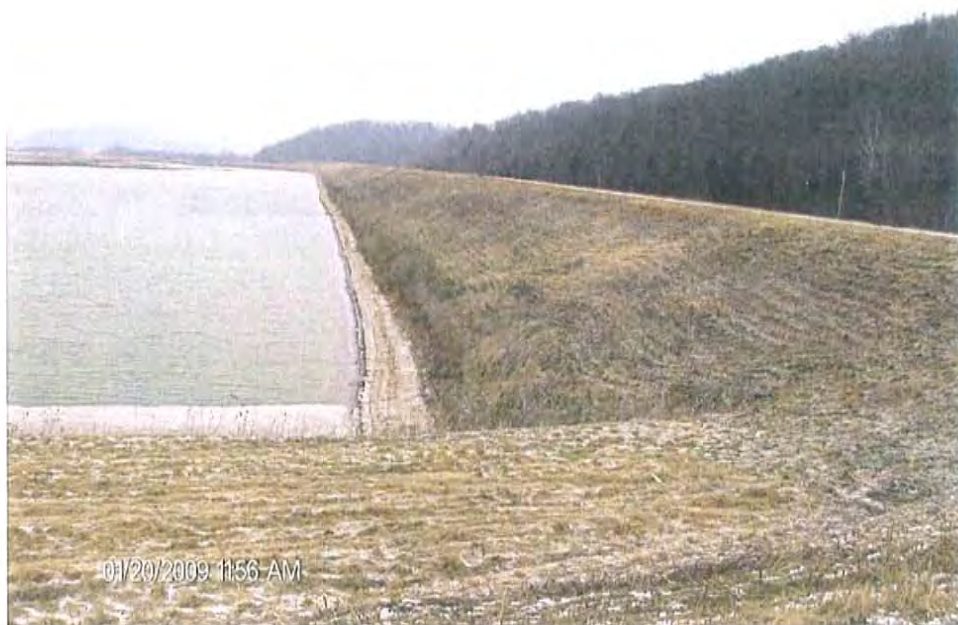
Photo #1: Wave erosion, East embankment, downstream slope, looking North

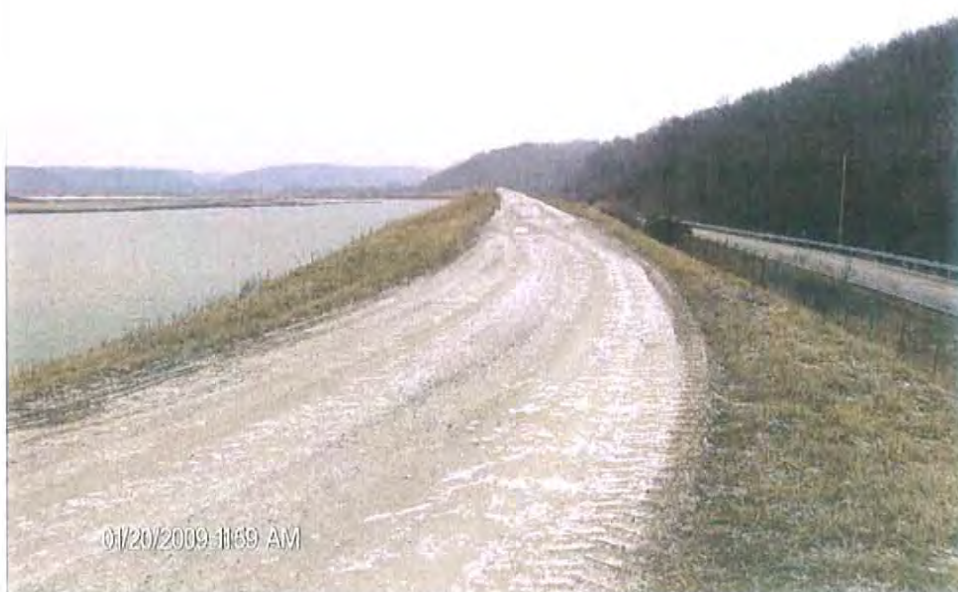
Photo #2: East embankment, crest, looking North

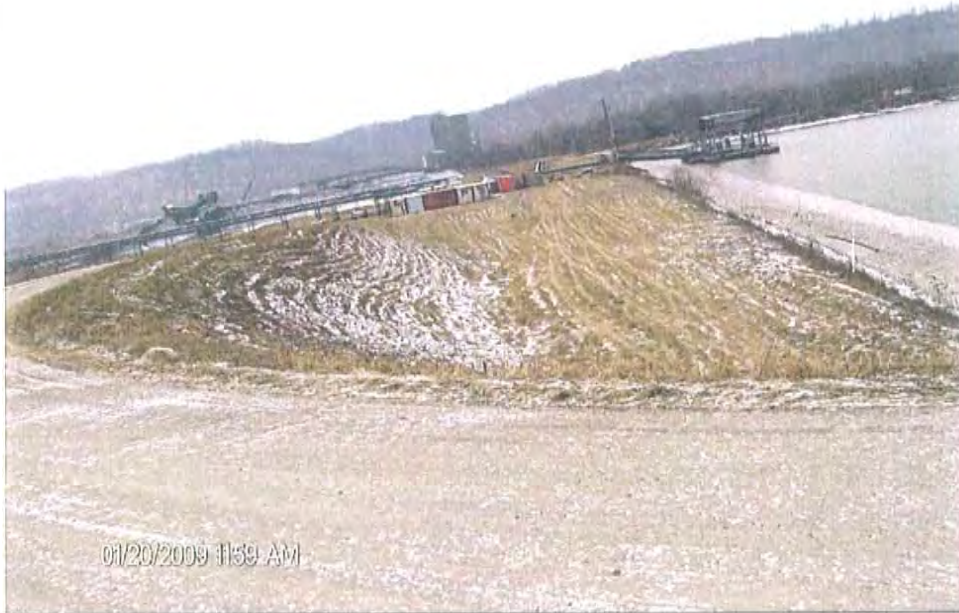
Photo #3: South embankment, upstream slope, looking West

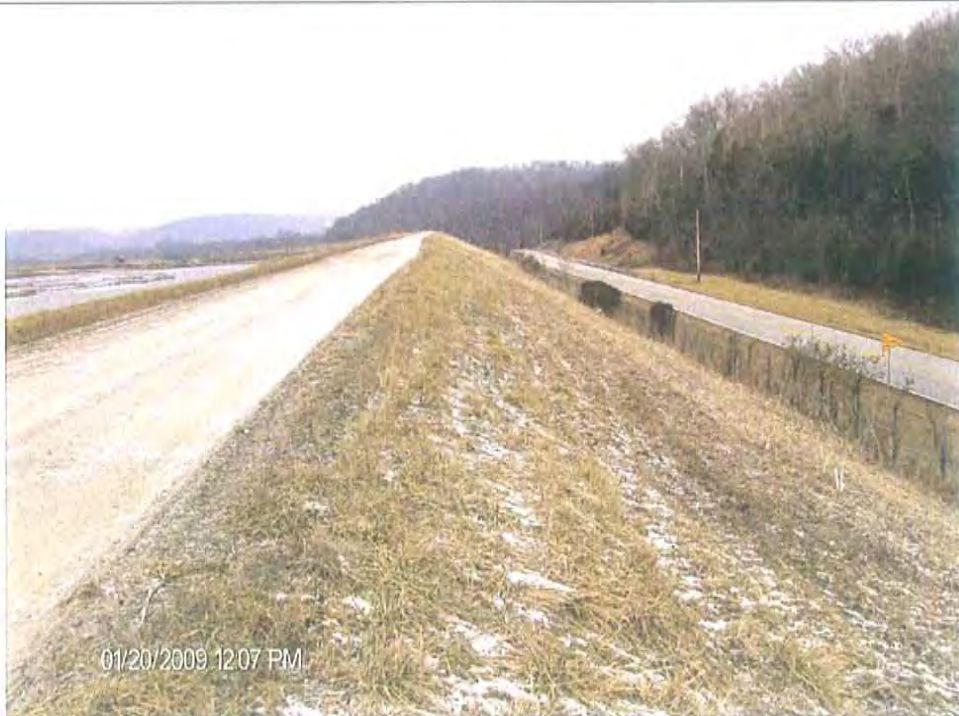
Photo #4: East embankment, crest and downstream slope, looking North

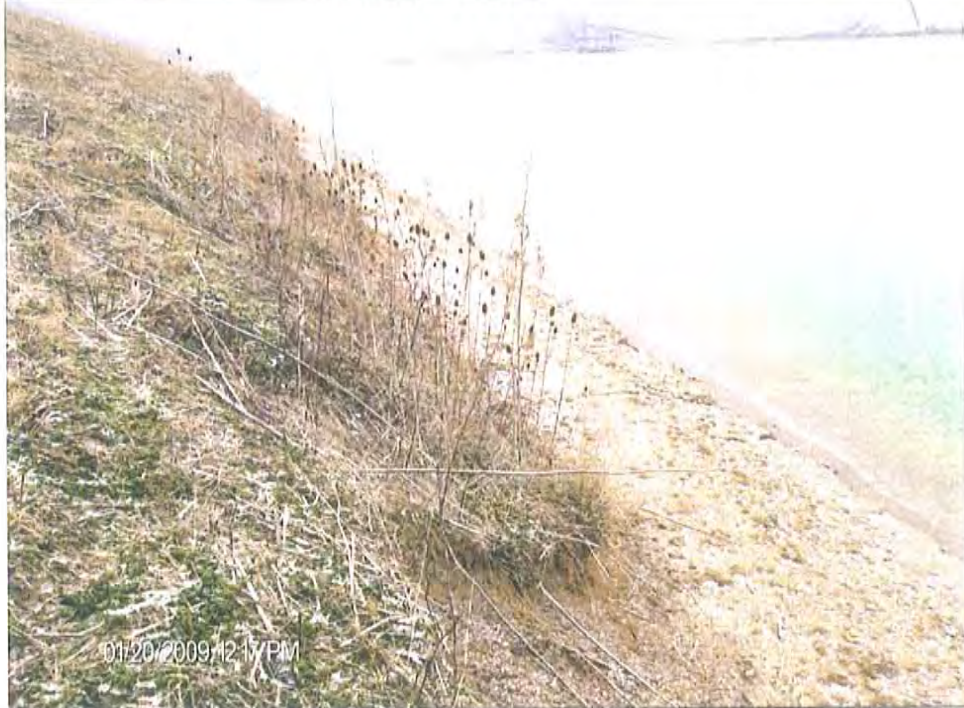
| | Comments: Wave erosion has caused a 4 to 5 foot vertical scarp at waterline (492) on east side of impoundment as well as lateral bench extending out into the pond. No apparent instability of slope above scarp noted. | | |

Photo #5: Wave erosion, steep drop near water surface, East embankment, upstream slope, directly across from bottom ash reclaim, looking South

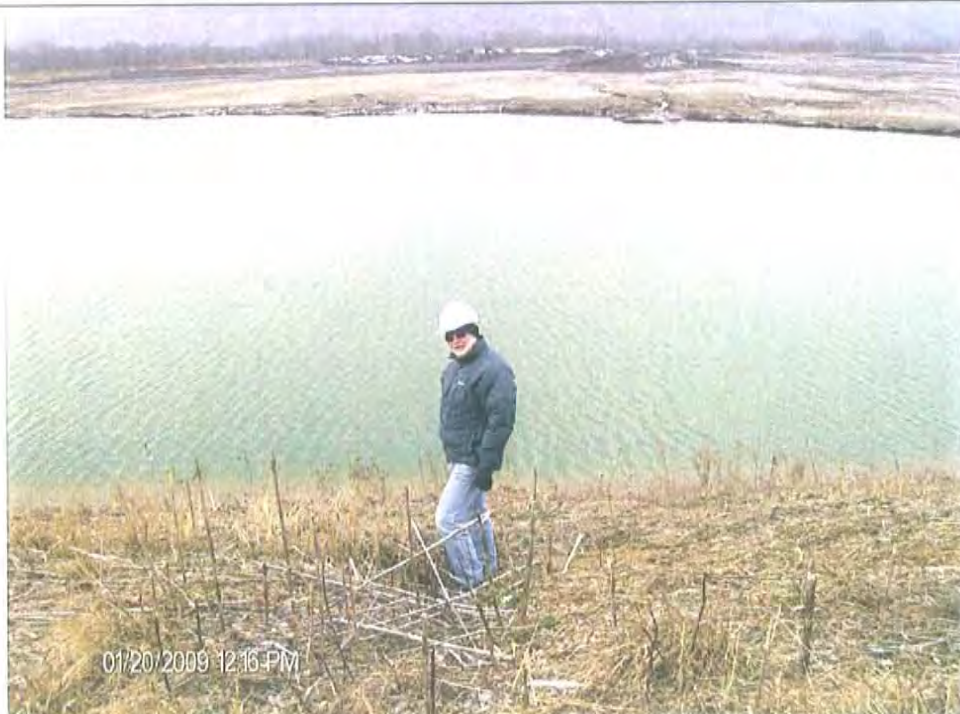
Photo #6: Appears to be filled in gully, East embankment, upstream slope, directly across from bottom ash reclaim, looking West

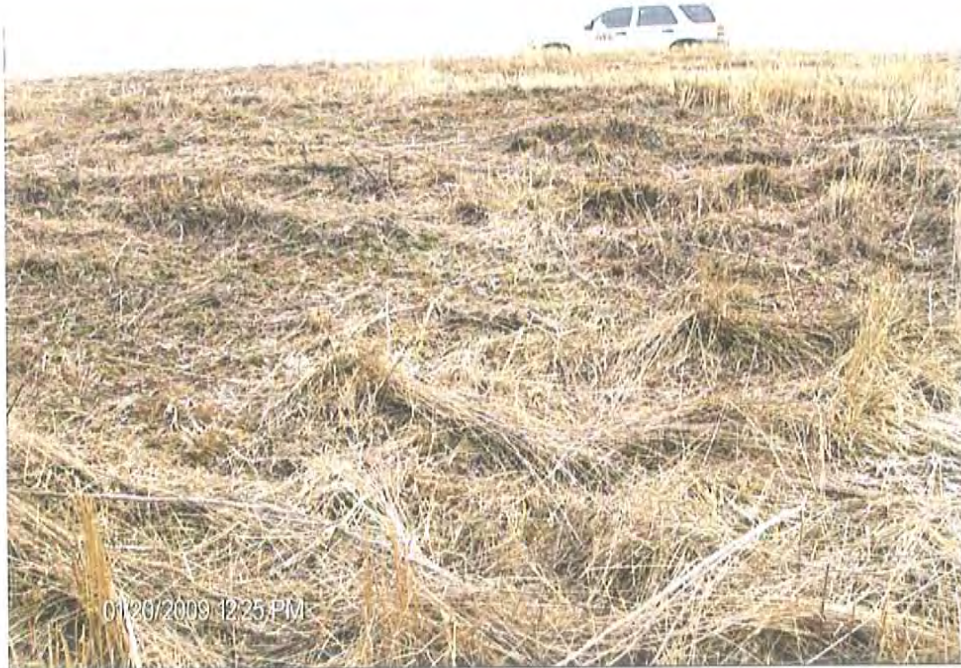
Photo #7: Old slough, East embankment, downstream slope, looking East near NE corner of pond

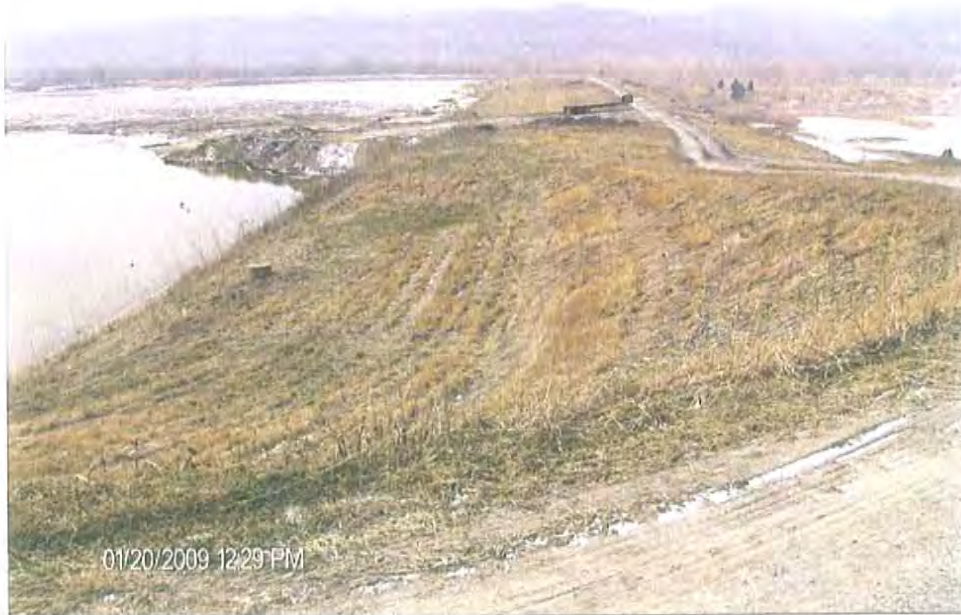
Photo #8: North embankment(shared dike with emergency ash pond), upstream slope, looking West
