**Bottom Ash Pond – Trimble County  
Station Assessment Report**

**Lockheed Martin  
Contractor for the USEPA**

**September 2009**

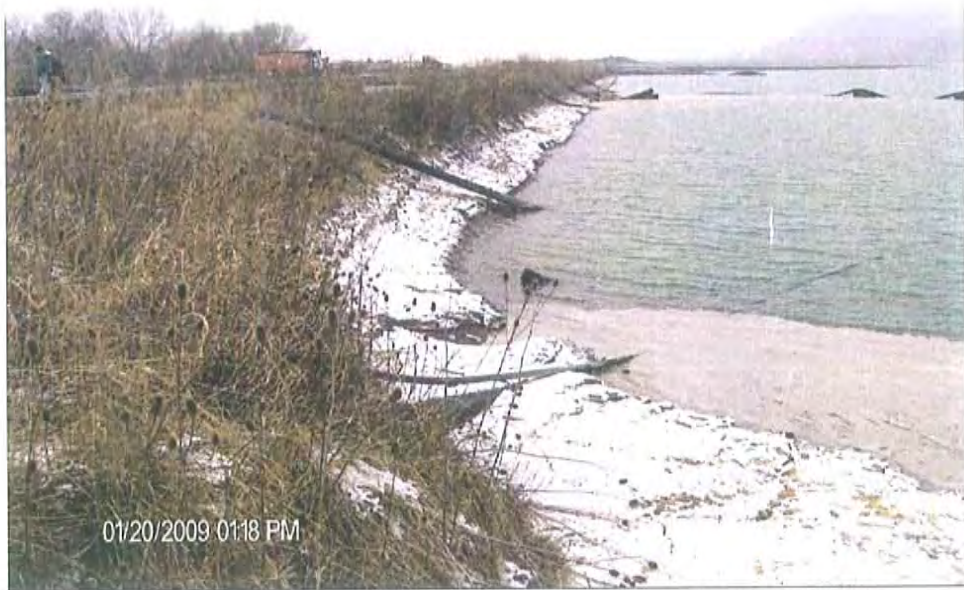
Photo #9: West embankment, upstream slope, looking North

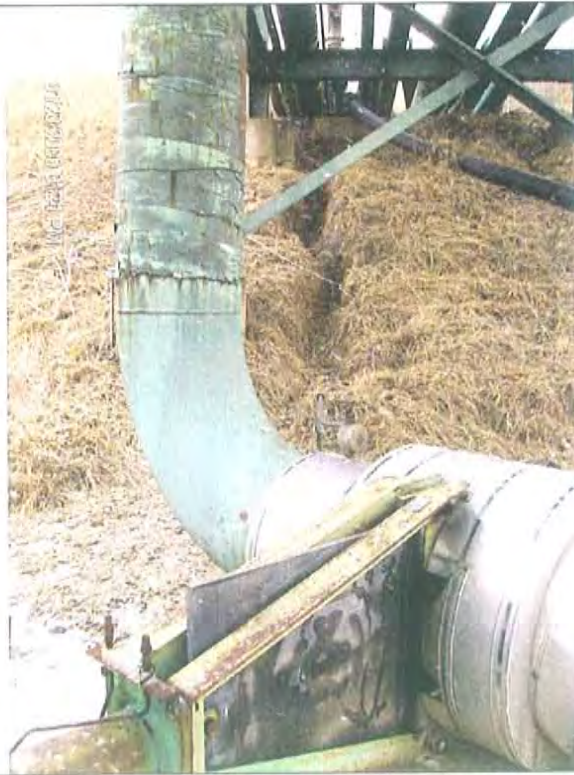
Photo #10: Minor erosion below piping, South embankment downstream slope

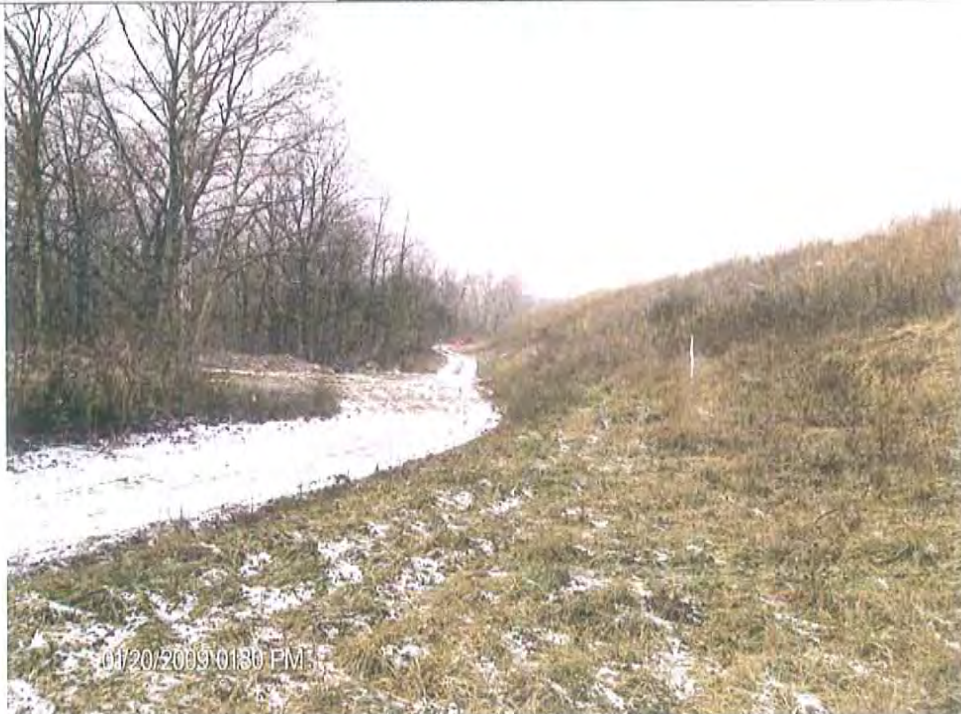
Photo #11: West embankment, downstream slope and toe, looking North

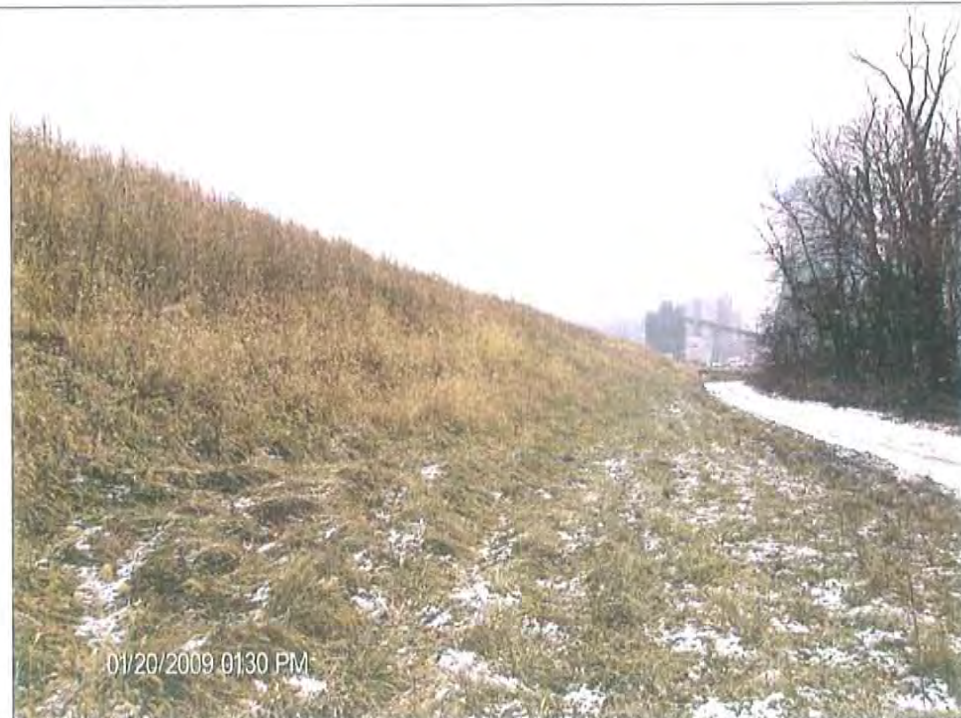
Photo #12: West embankment, downstream slope and toe, looking South

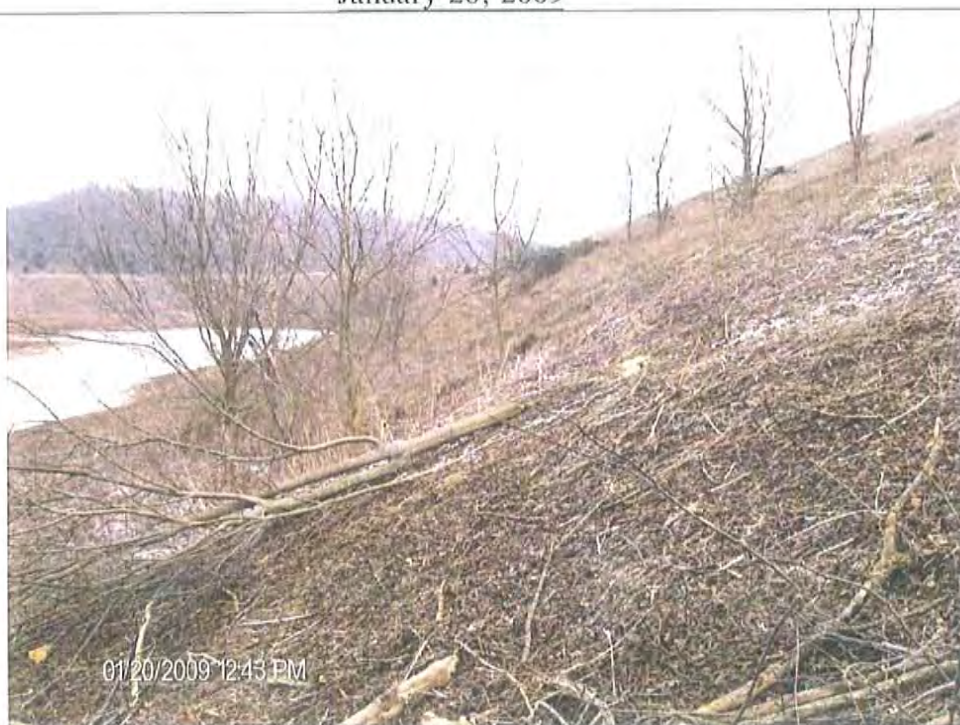
Photo #13: North embankment, shared dike with emergency ash pond, looking East

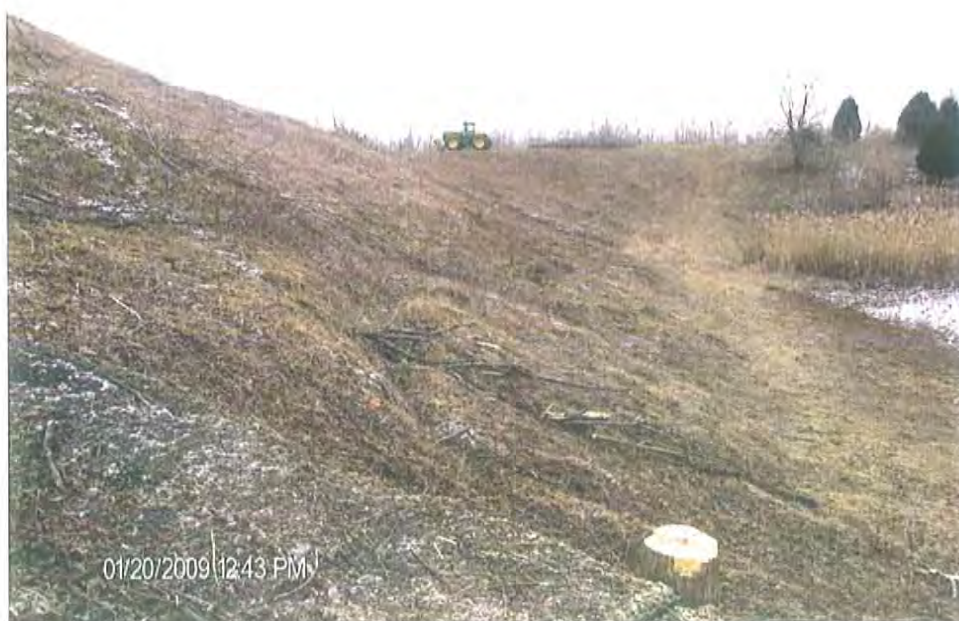
Photo #14: North embankment, shared dike with emergency ash pond, looking West

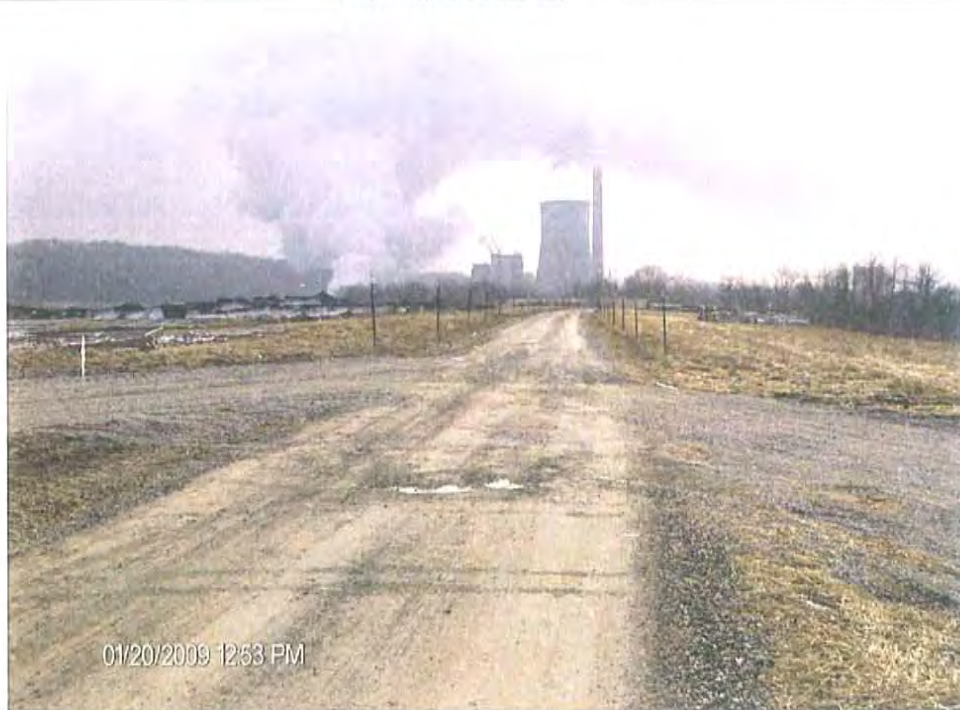
Photo #15: West embankment crest, North end, looking South

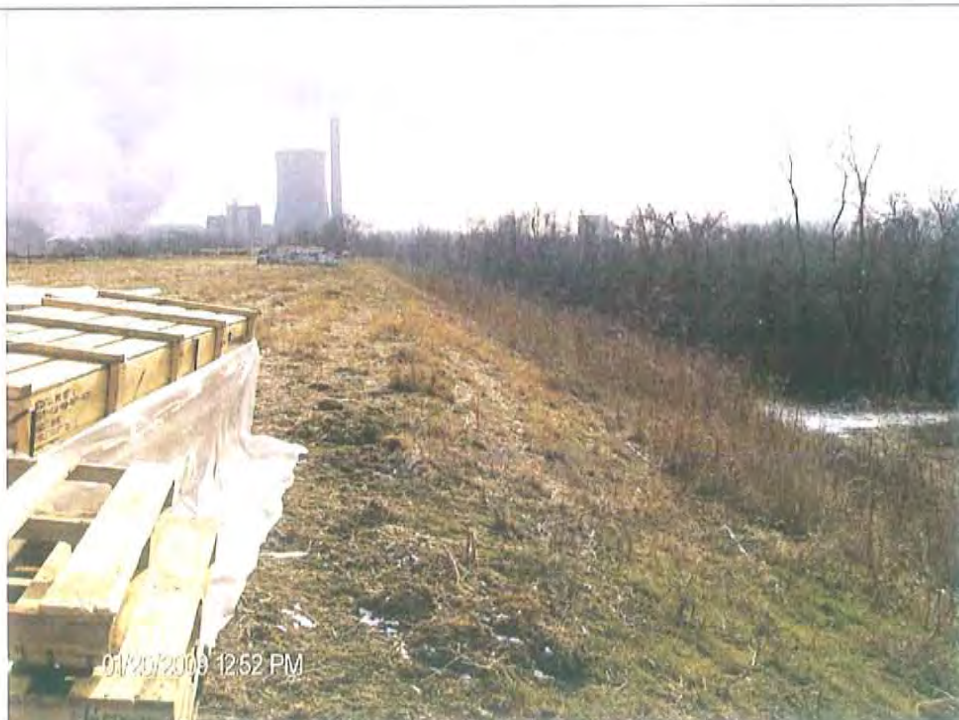
Photo #16: West embankment, crest and downstream slope, north end, looking South
