SUBJECT: EPA Comments on draft revision "Coal Combustion Residue Impoundment Round 12 – Dam Assessment Report: Martin Lake Steam Electric Plant; Fly Ash Dike."

Coal Combustion Residue Impoundment

Round 12 - Dam Assessment Report

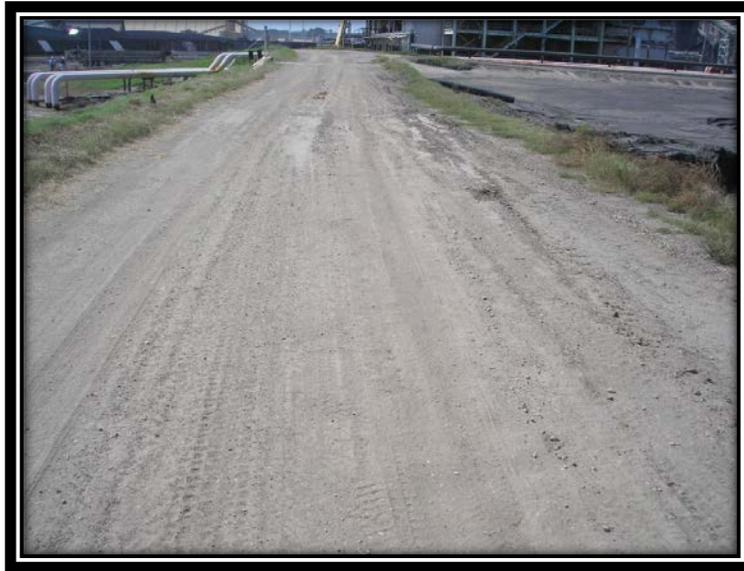
The crest of the embankment had no signs of significant depressions, tension cracks or other indications of settlement or shear failure. Figures 5.2.1-1 through 5.2.3-3 shows the typical crest conditions along the embankments.

Figure 5.2.1-1 Ash Pond West Cell south Dike crest.

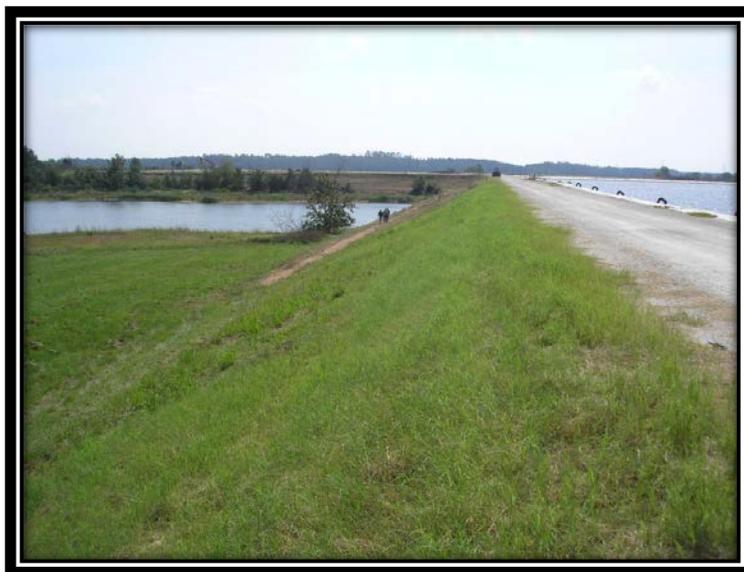
Figure 5.2.1-2 Ash Disposal Pond East cell Dike. ~~Lake Martin~~ is shown to the left of the dike.

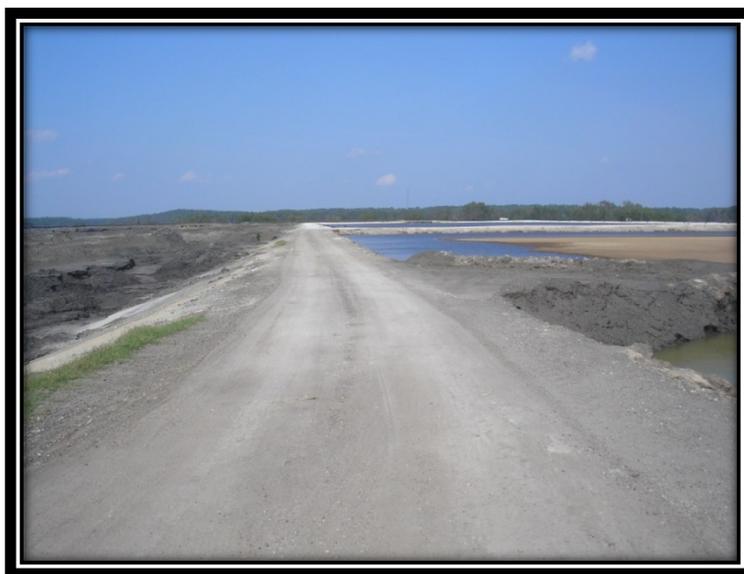
Figure 5.2.1-3 West-East Ash Disposal Pond interior dike.

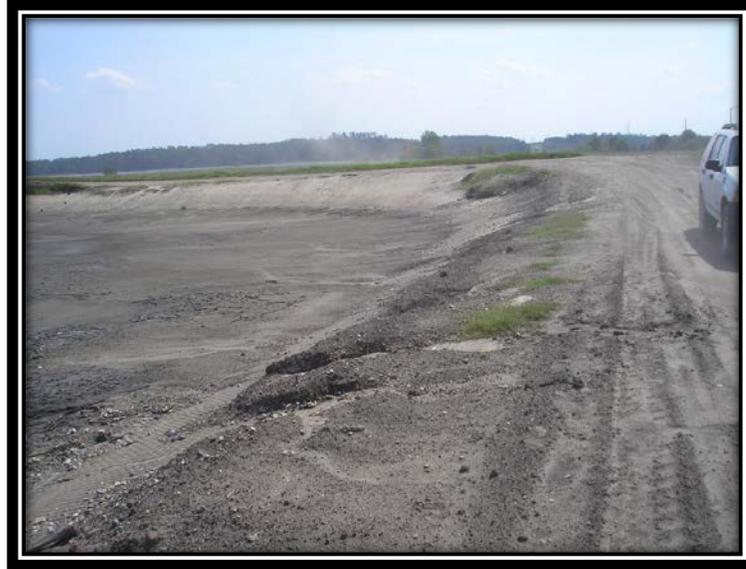
The interior slopes appear stable and maintained. There were no observed scarps, sloughs, bulging, cracks, depressions or other indications of slope instability. Figures 5.2.2-1 and 5.2.2-2 show representative sections of the embankment.

Figure 5.2.2-1 West cell interior slope.

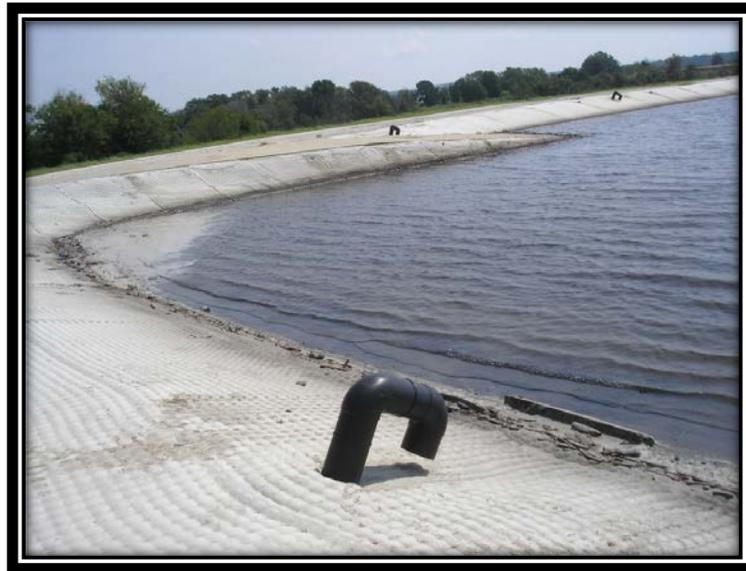
Figure 5.2.2-2 East cell interior slope.

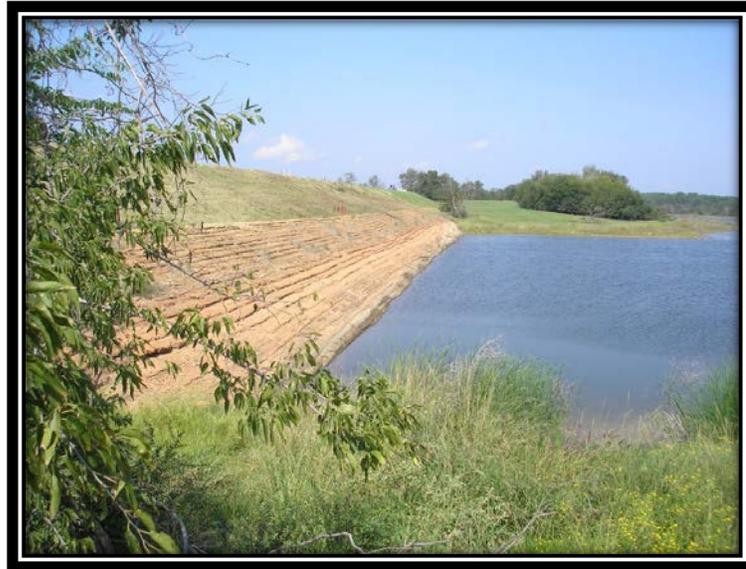
The outside slope of the embankment appeared to have a fairly well maintained cover of grasses/weeds. No scarps, sloughs, bulging, cracks, depressions or other indications of slope instability were observed along the slope. Figures 5.2.3-2 and 5.2.3-3 show representative sections of the embankment. Figure 5.2.3-1 shows the outside slope of Ash Pond East

cell adjacent to Martin Lake. The base of this slope is constructed with soil-cement.

Figure 5.2.3-1 Ash Disposal Pond East cell exterior slope south end. Martin Lake right of the embankment.

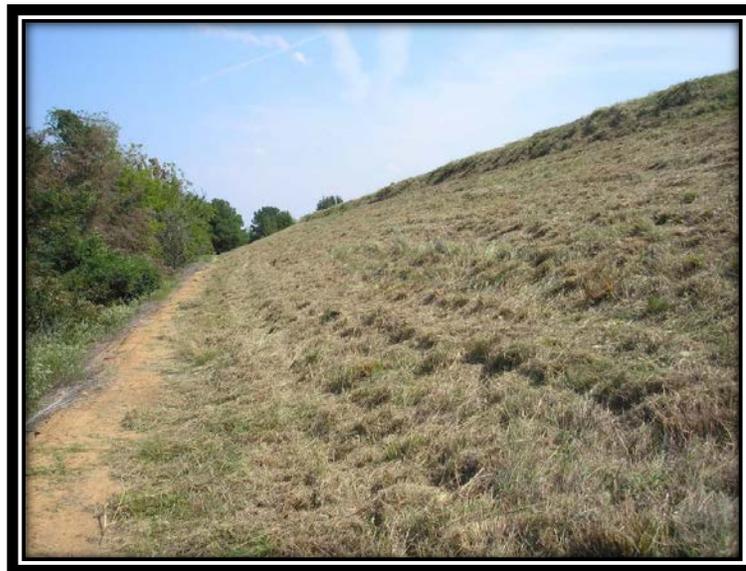
Figure 5.2.3-2 Ash Disposal Pond Emergency Sludge cell north exterior slope.

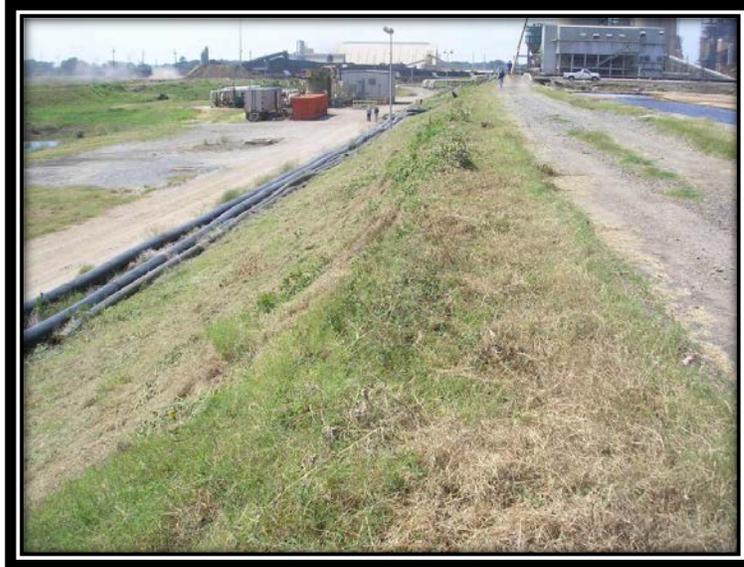
Figure 5.2.3-3 Ash Disposal Pond West cell south dike exterior slope.

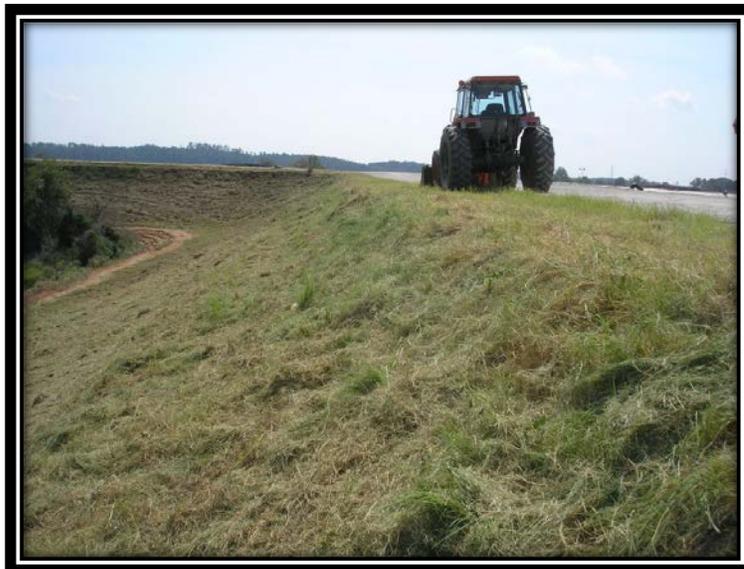
There were no observed scarps, sloughs, bulging, cracks, depressions or other indications of slope instability at dike abutments and groin areas of the Ash Disposal Pond.

Figure 5.2.4-1 Typical exterior groin in the Ash Disposal Pond.

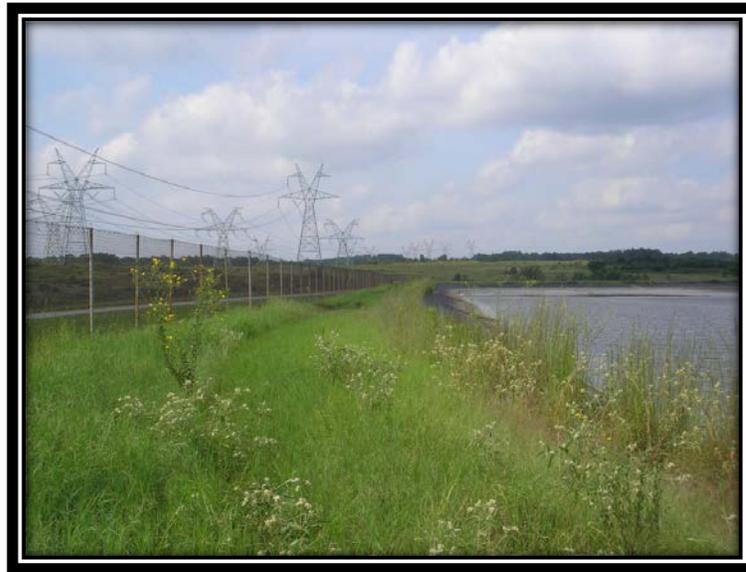
The crest of the embankment had no signs of significant depressions, tension cracks or other indications of settlement or shear failure.

Figure 5.2.1-2 PDP-4 south crest.

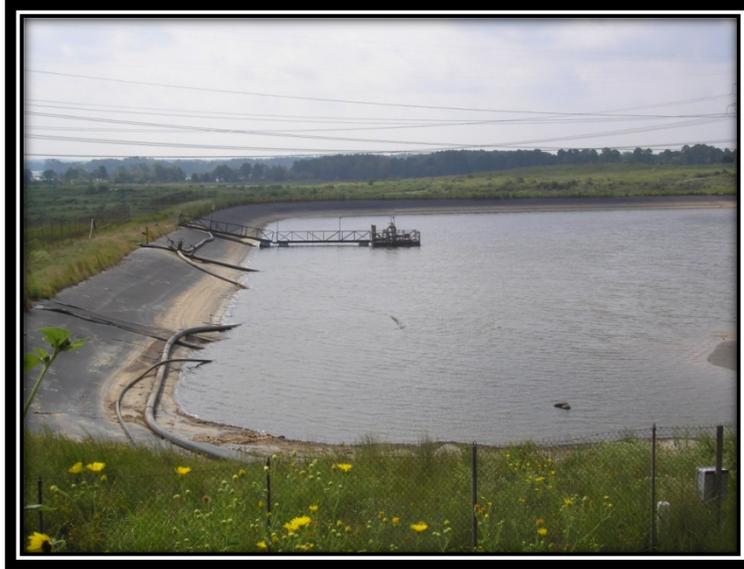
Inside slope of the PDP-4 Pond is lined with a HDPE protective cover over a 3 foot thick compacted clay layer. The slopes appear stable and well maintained. There were no observed scarps, sloughs, bulging, cracks, depressions or other indications of slope instability.

Figure 5.2.2-1 PDP-4 east interior slope.

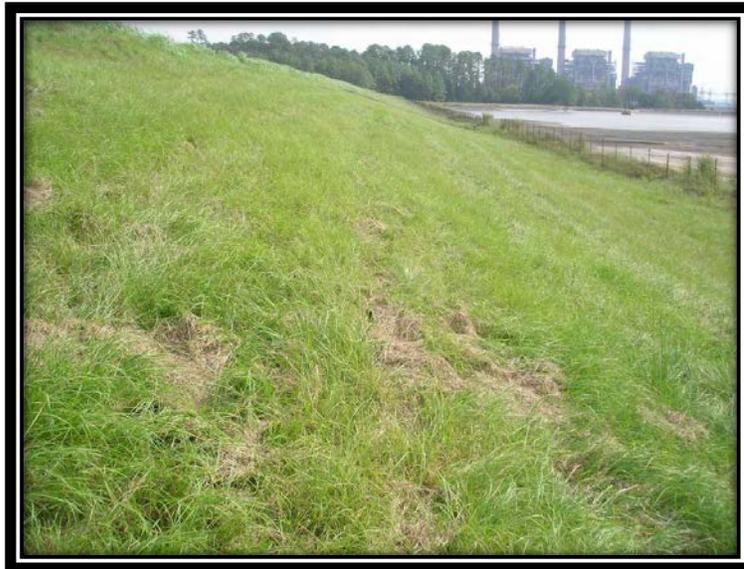
The outside slope of the PDP-4 Pond embankment appeared to have a satisfactorily maintained cover of grasses/weeds. No scarps, sloughs, bulging, cracks, depressions or other indications of slope instability were observed along the slope. Figure 5.3.3-1 shows a section of the PDP-4 Pond outside slope.

Figure 5.3.3-1 Typical exterior slope at PDP-4

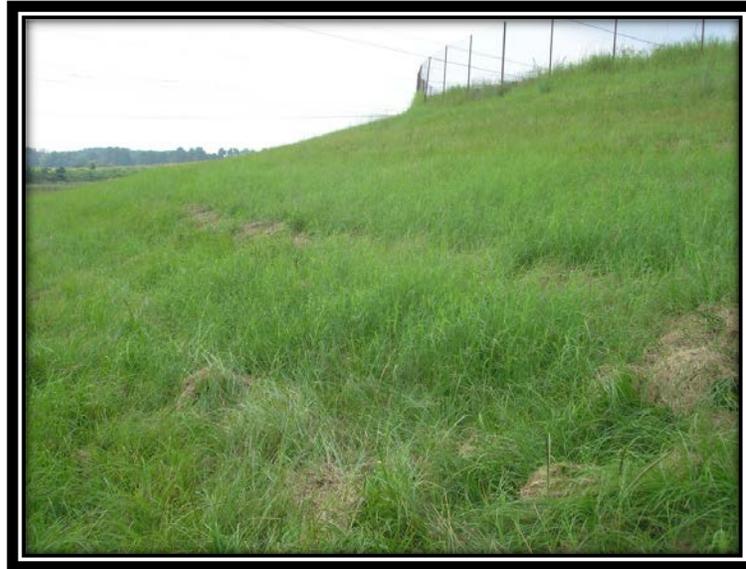
During the field observations burrowing animal (e.g. ~~ground hogs~~) holes were observed in the embankments. The animals should be removed and the holes should be filled.

There were no observed scarps, sloughs, bulging, cracks, depressions or other indications of slope instability at dike abutments and groin areas of the PDP-4 Pond. Evidence of potential animal burrows was observed in isolated locations. Such burrows may weaken the structural integrity of the embankments.

Figure 5.3.4-1 Typical groining area at PDP-4 Pond. Potential rodent burrow lower left quadrant.

- Control all burrowing animals (e.g. ~~ground hogs~~ ^{rodents or armadillos}) and appropriately fill-in burrows in the embankments around the ponds. The burrows were also noted in the two annual inspection reports; see Appendix A – Docs 01 and 04.

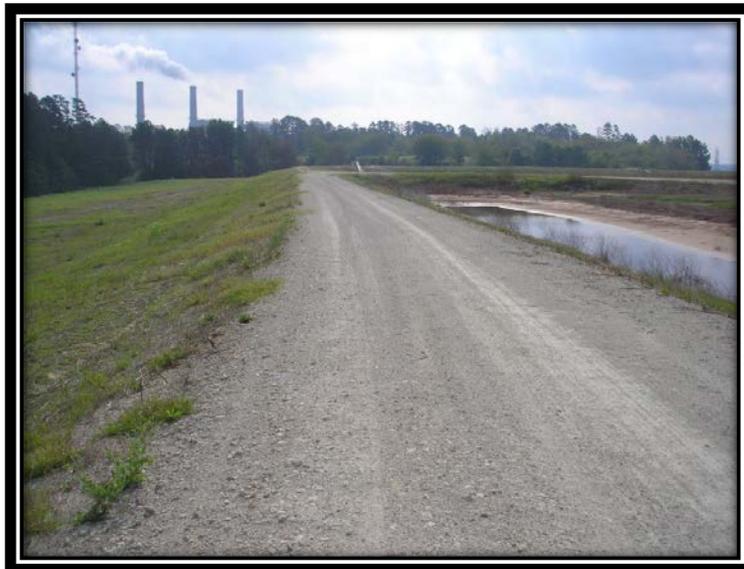
The crest of the embankment had no signs of significant depressions, tension cracks or other indications of settlement or shear failure.

Figure 5.3.1-1 Typical crest around PDP-5 Pond.

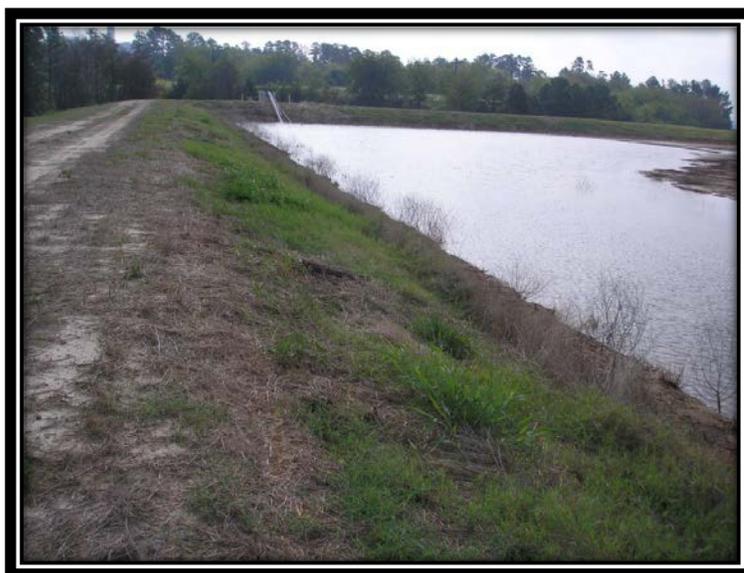
Inside slope of the PDP-5 Pond is lined with a 3-foot thick clay layer. The slopes appear stable and well maintained. There were no observed scarps, sloughs, bulging, cracks, depressions or other indications of slope instability.

Figure 5.2.2-3 PDP-5 north interior slope.

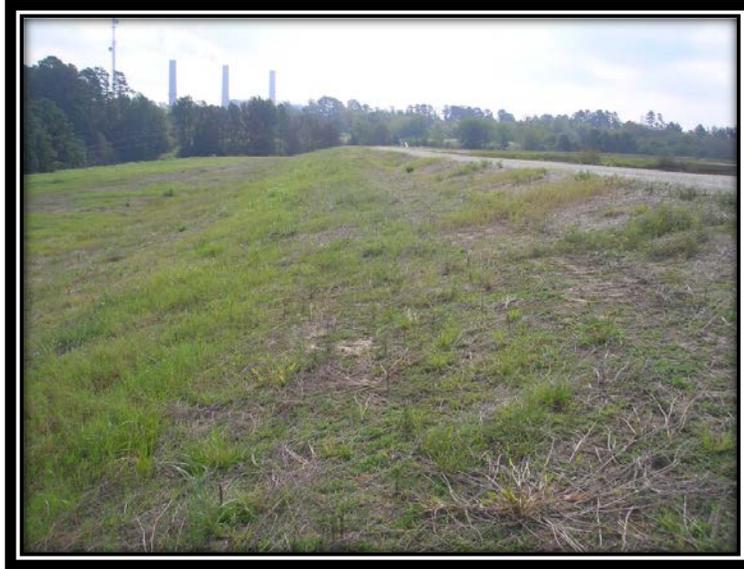
The outside slope of the PDP-5 Pond embankment appeared to have a satisfactorily maintained cover of grasses/weeds. No scarps, sloughs, bulging, cracks, depressions or other indications of slope instability were observed along the slope. Figures 5.4.3-1 shows a section of the PDP-5 Pond outside slope.

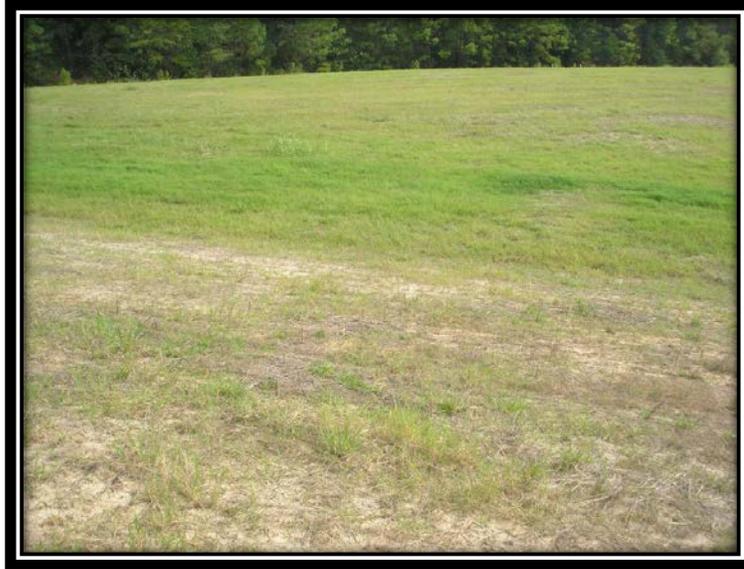
There were no observed scarps, sloughs, bulging, cracks, depressions or other indications of slope instability at dike abutments and groin areas of the PDP-5 Pond. Figure 5.4.4-1 shows the south groin of PDP-5.

Figure 5.4.4-1 South groin of PDP-5.

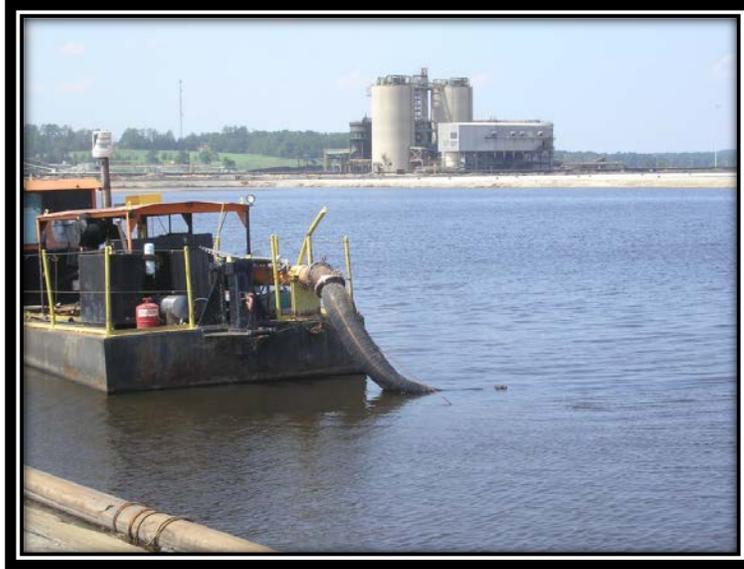
The outlet at all of the impoundments consist of a submersible pump at the east end of the impoundment via a SDR17 High Density Polyethylene Pipe (HDPE) smooth lined 19.5” outside diameter pipe. The water from the Ash Disposal Pond and PDP-4 is pumped to the plant for recycling. Water from PDP-5 Pond is pumped back to PDP-4.

Figure 5.5.2-1 Outlet pump for Ash Disposal Pond.
