**Coal Combustion Residue Impoundment**

**Round 12 - Dam Assessment Report**

*Martin Lake Steam Electric Plant*

**Tatum, Texas**

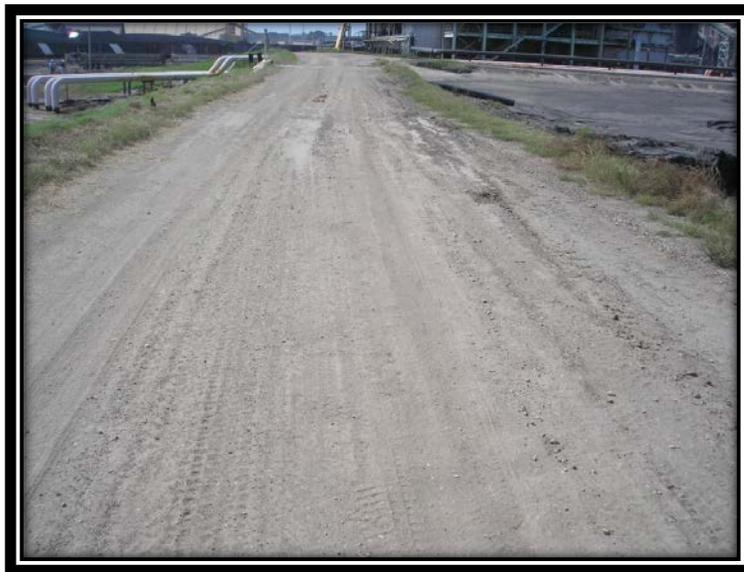
The crest of the embankment had no signs of significant depressions, tension cracks or other indications of settlement or shear failure. Figures 5.2.1-1 through 5.2.3-3 shows the typical crest conditions along the embankments.

Figure 5.2.1-1 Ash Pond West Cell south Dike crest.

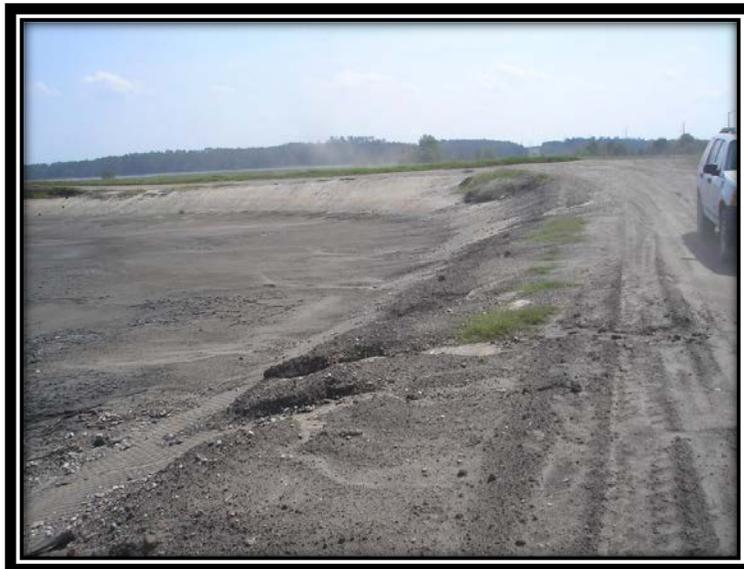
The interior slopes appear stable and maintained. There were no observed scarps, sloughs, bulging, cracks, depressions or other indications of slope instability. Figures 5.2.2-1 and 5.2.2-2 show representative sections of the embankment.

Figure 5.2.2-1 West cell interior slope.

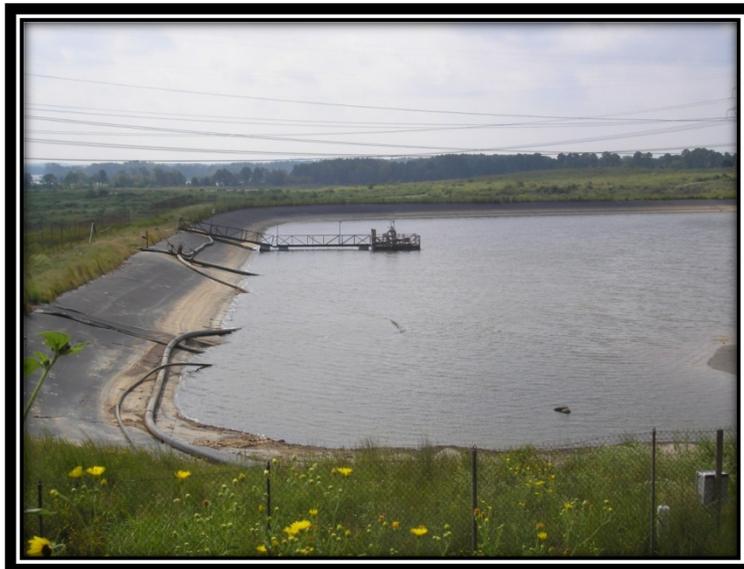
Inside slope of the PDP-4 Pond is lined with a HDPE protective cover over a 3 foot thick compacted clay layer. The slopes appear stable and well maintained. There were no observed scarps, sloughs, bulging, cracks, depressions or other indications of slope instability.

Figure 5.2.2-1 PDP-4 east interior slope.

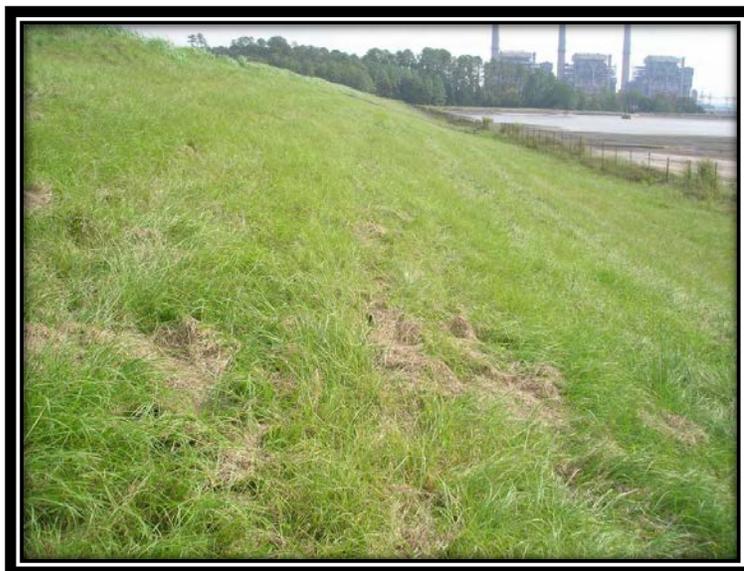
The outside slope of the PDP-4 Pond embankment appeared to have a satisfactorily maintained cover of grasses/weeds. No scarps, sloughs, bulging, cracks, depressions or other indications of slope instability were observed along the slope. Figure 5.3.3-1 shows a section of the PDP-4 Pond outside slope.

Figure 5.3.3-1 Typical exterior slope at PDP-4

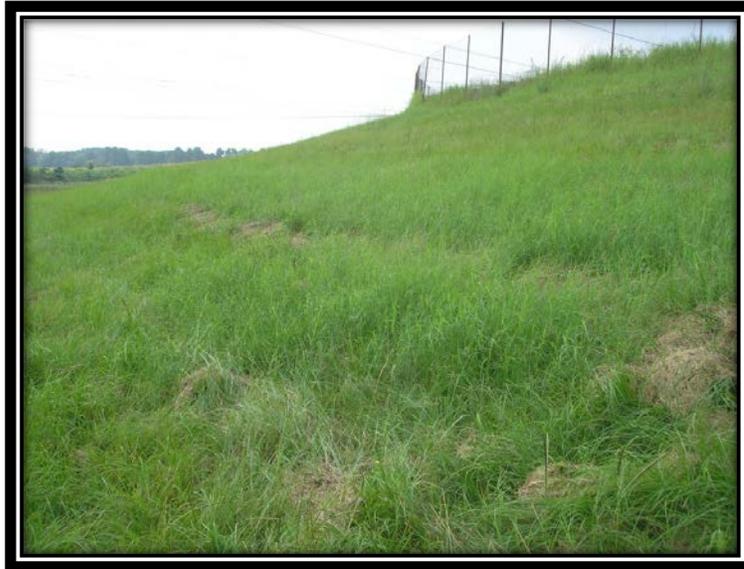
During the field observations burrowing animal (e.g. ground hogs) holes were observed in the embankments. The animals should be removed and the holes should be filled.

There were no observed scarps, sloughs, bulging, cracks, depressions or other indications of slope instability at dike abutments and groin areas of the PDP-4 Pond. Evidence of potential animal burrows was observed in isolated locations. Such burrows may weaken the structural integrity of the embankments.

Figure 5.3.4-1 Typical groining area at PDP-4 Pond. Potential rodent burrow lower left quadrant.

- Control all burrowing animals (e.g. ground hogs) and appropriately fill-in burrows in the embankments around the ponds. The burrows were also noted in the two annual inspection reports; see Appendix A – Docs 01 and 04.

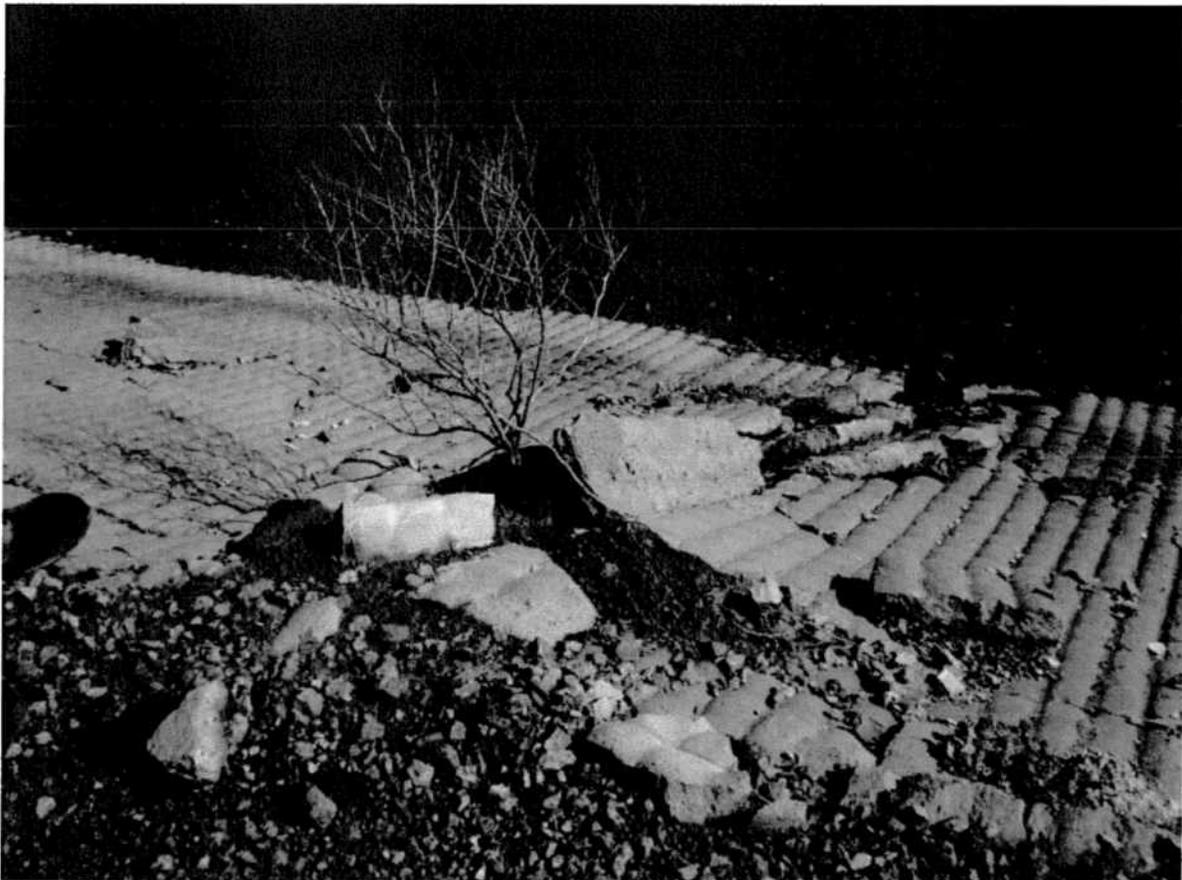
**Figure 7: Revetment Damage and Plant in Liner Vent**

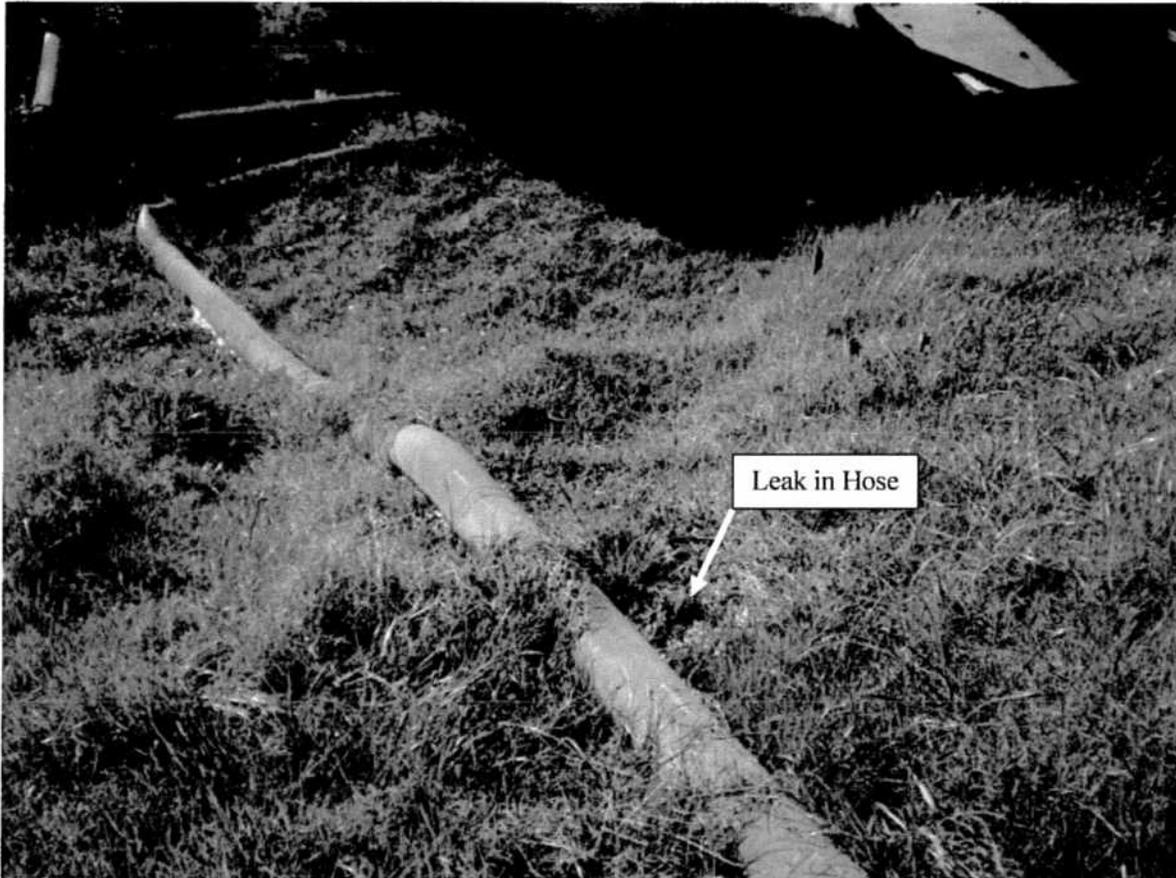
**Figure 10 - Leak in Flexible Hose**

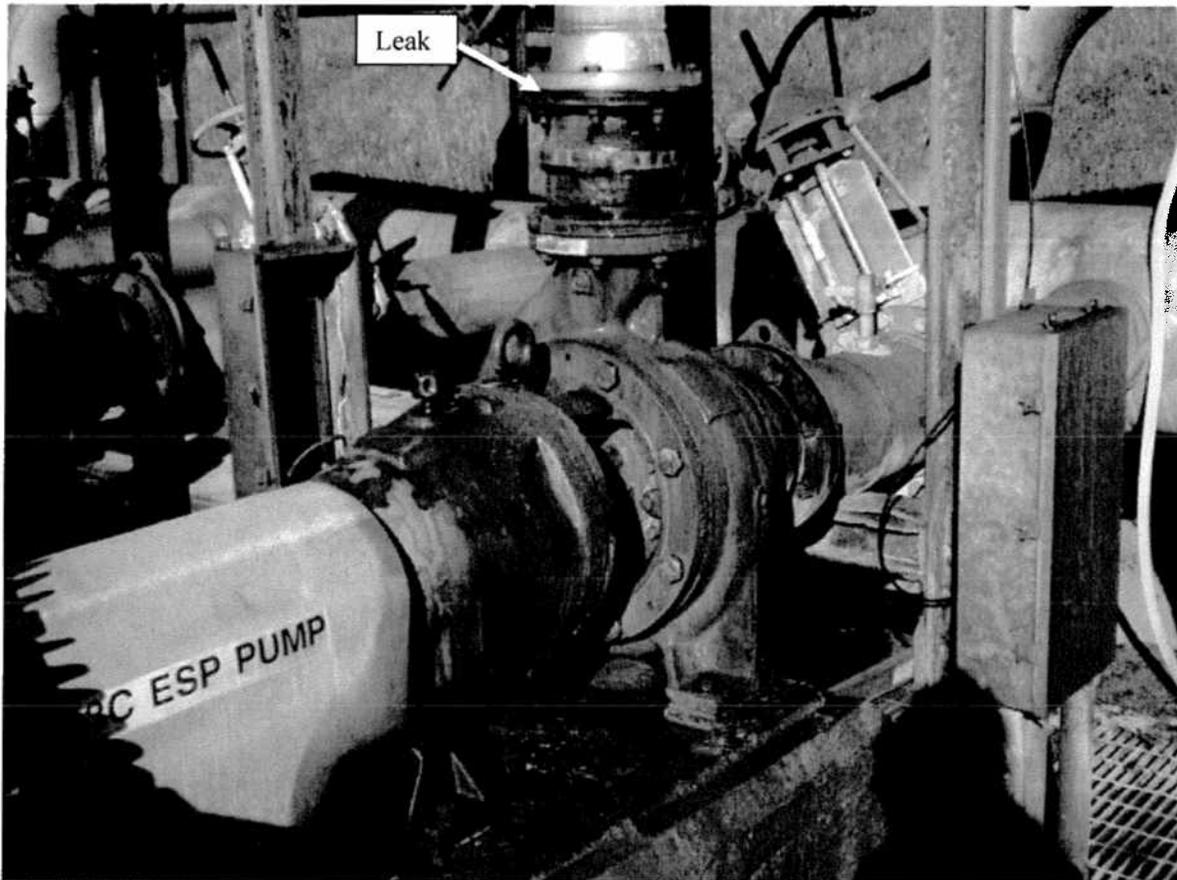
**Figure 11: Leak at 3C ESP Pump**

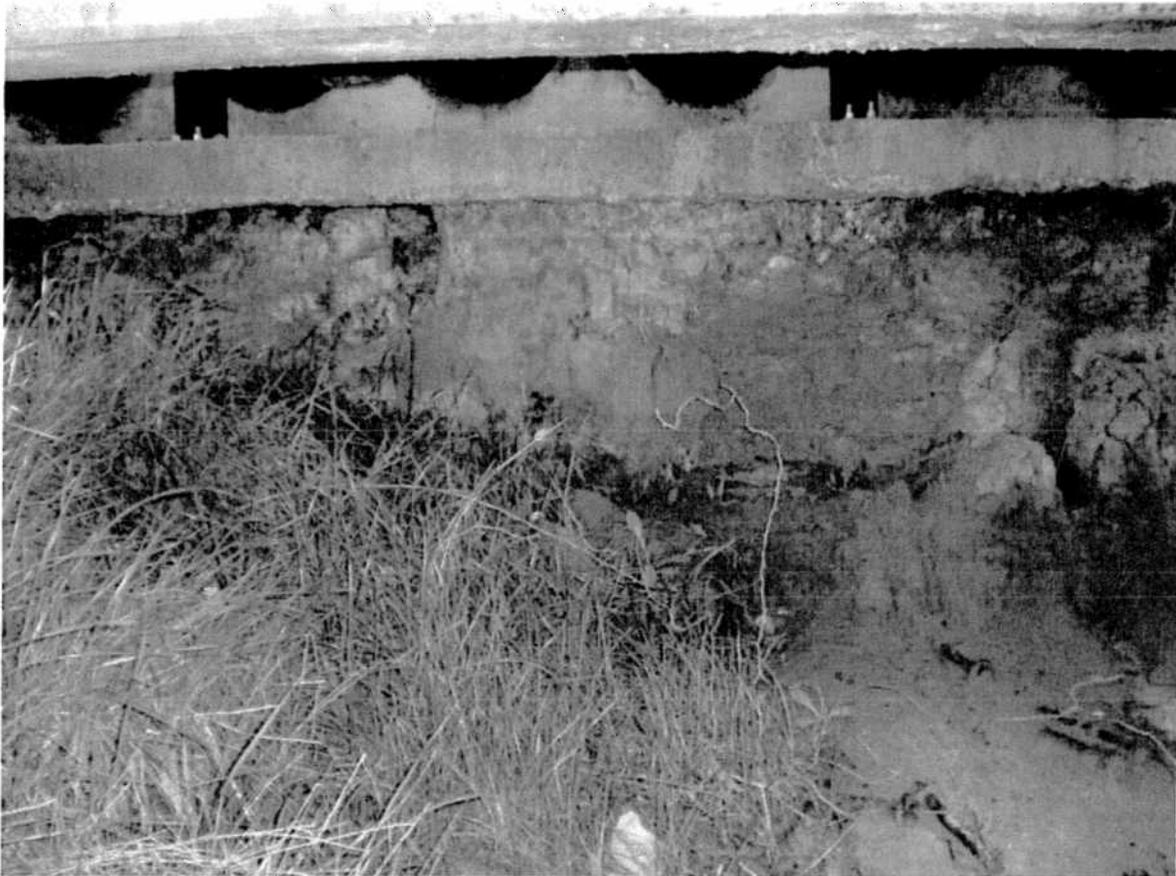
**Figure 21: Erosion Under Pipe Rack**

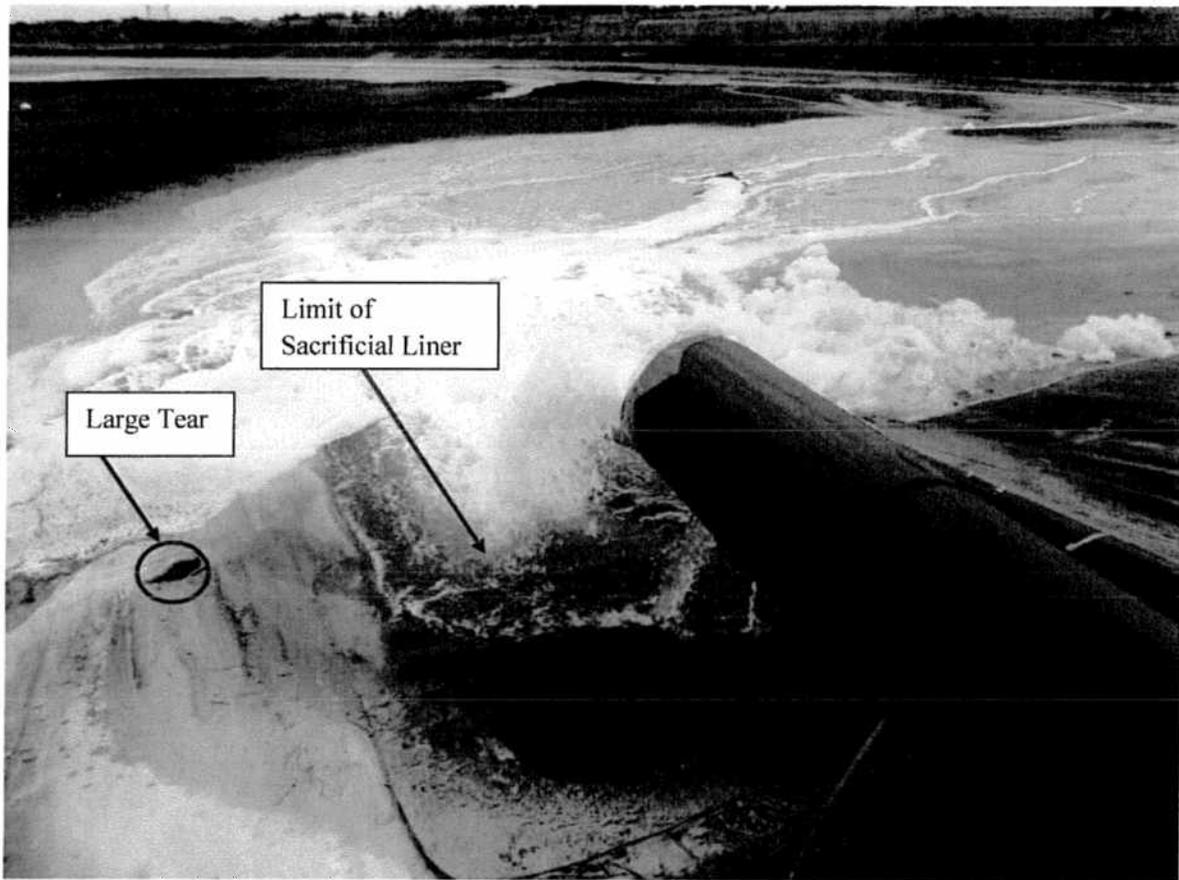
**Figure 62: Tear in Liner and Outfall Exceeds Sacrificial Liner**
