US EPA ARCHIVE DOCUMENT

**Coal Combustion Residue Impoundment
Round 12 - Dam Assessment Report**

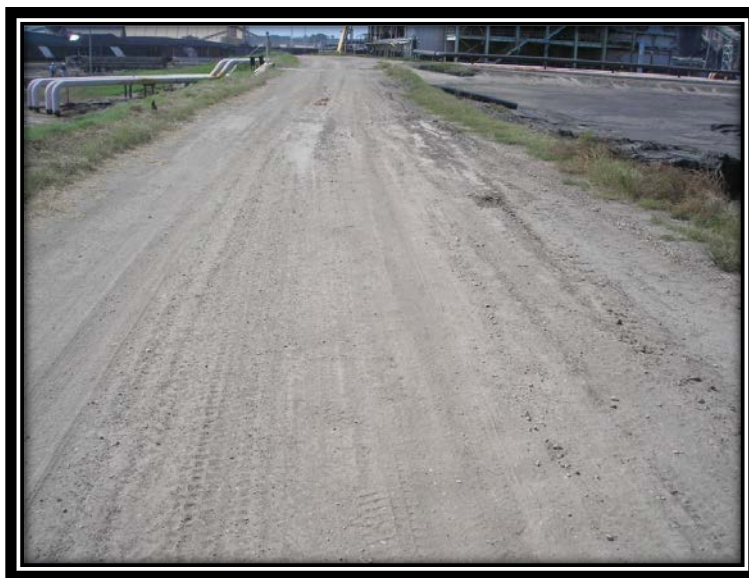
Figure 5.2.1-1 Ash Pond West Cell south Dike crest.

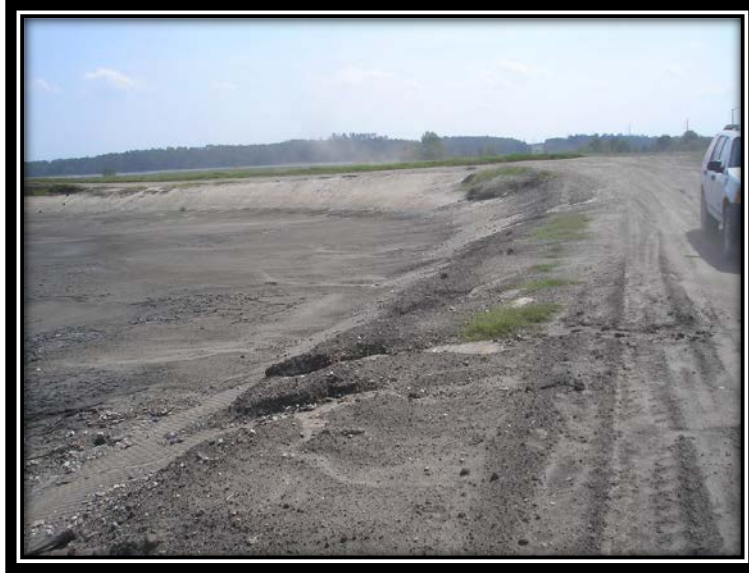
Figure 5.2.2-1 West cell interior slope.

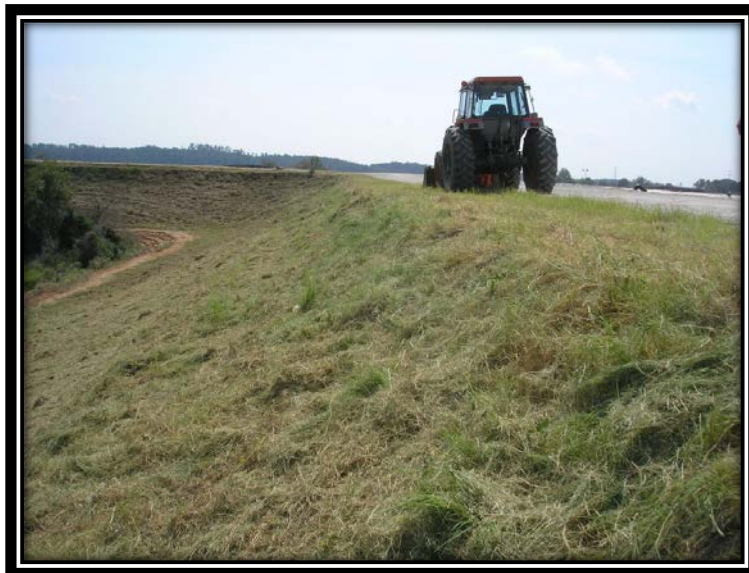
Figure 5.2.4-1 Typical exterior groin in the Ash Disposal Pond.

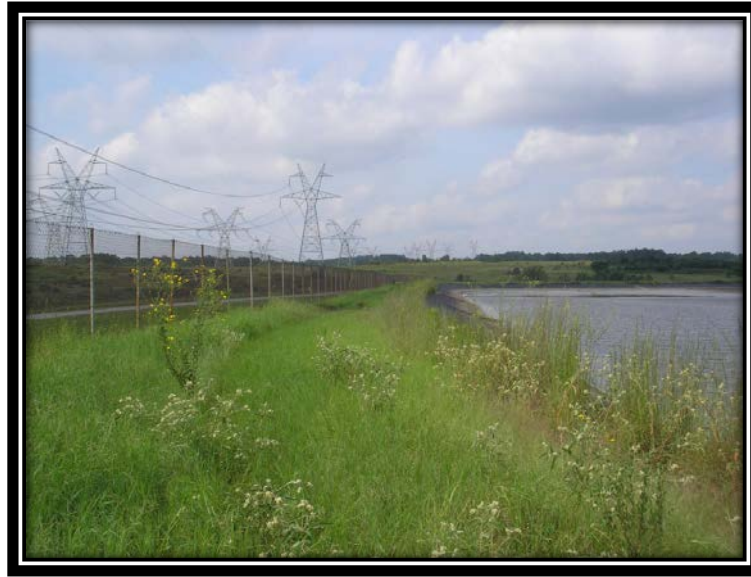
Figure 5.2.1-2 PDP-4 south crest.

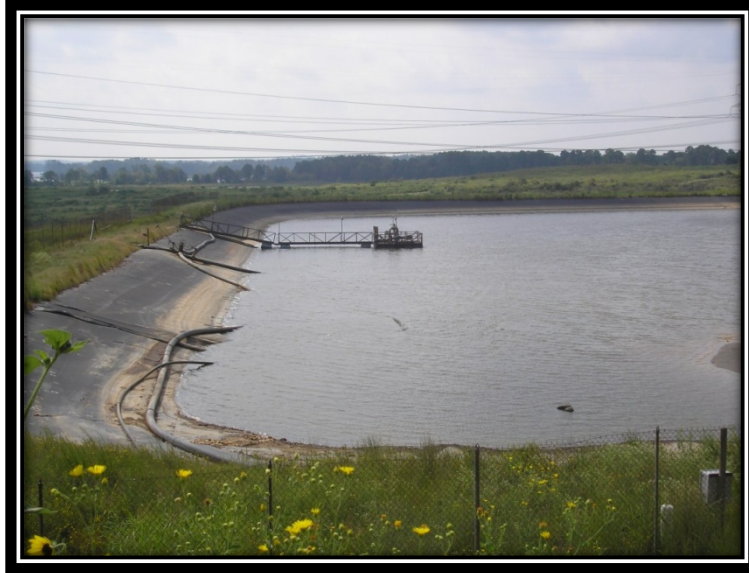
Figure 5.2.2-1 PDP-4 east interior slope.

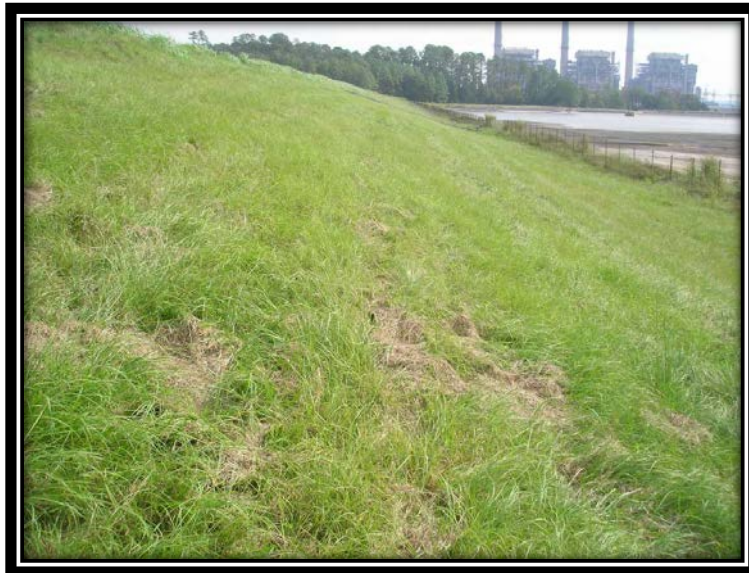
Figure 5.3.3-1 Typical exterior slope at PDP-4

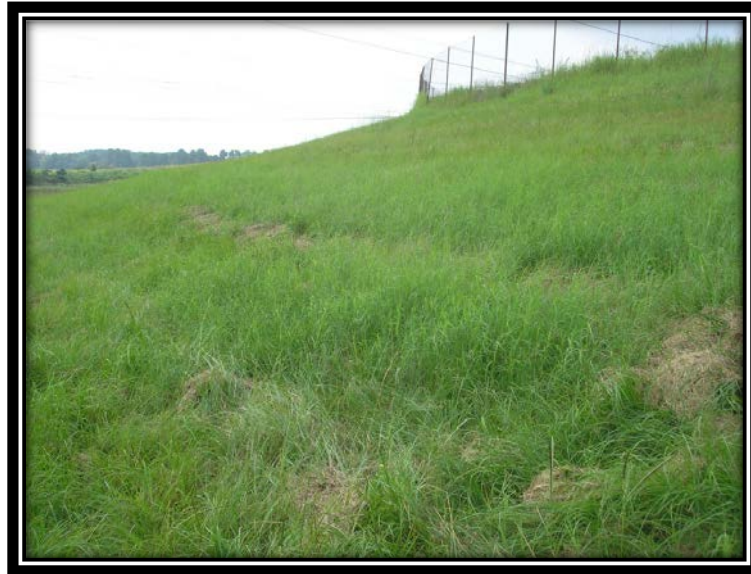
Figure 5.3.4-1 Typical groining area at PDP-4 Pond. Potential rodent burrow lower left quadrant.

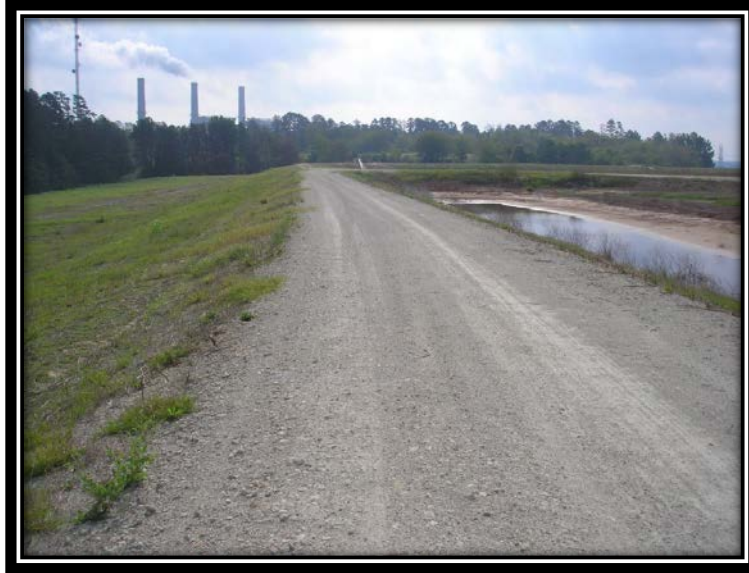
Figure 5.3.1-1 Typical crest around PDP-5 Pond.

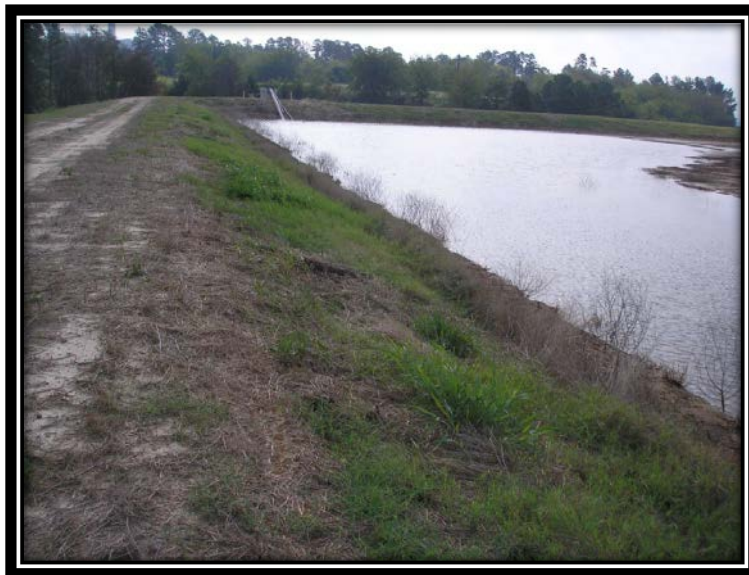
Figure 5.2.2-3 PDP-5 north interior slope.

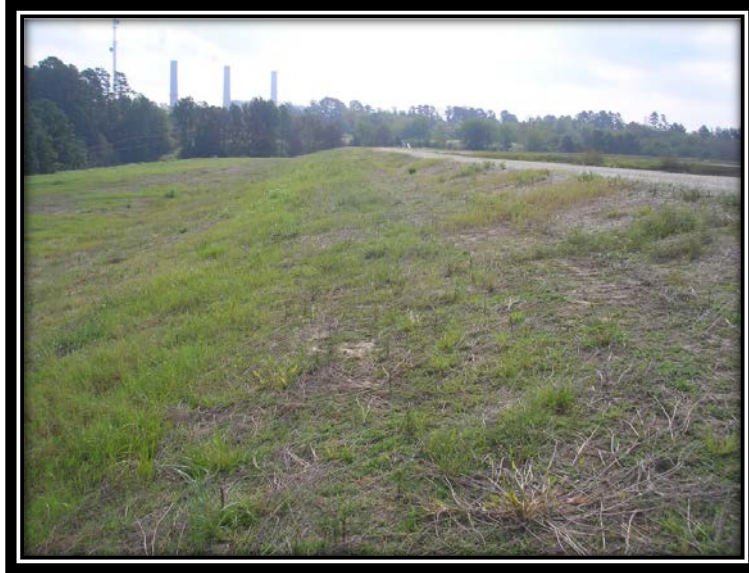
5.4.4 Abutments and Groin Areas

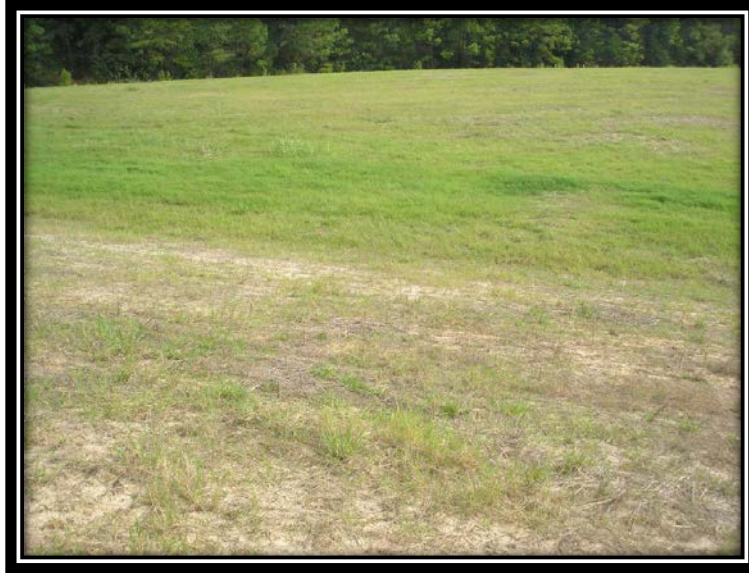
Figure 5.4.4-1 South groin of PDP-5.

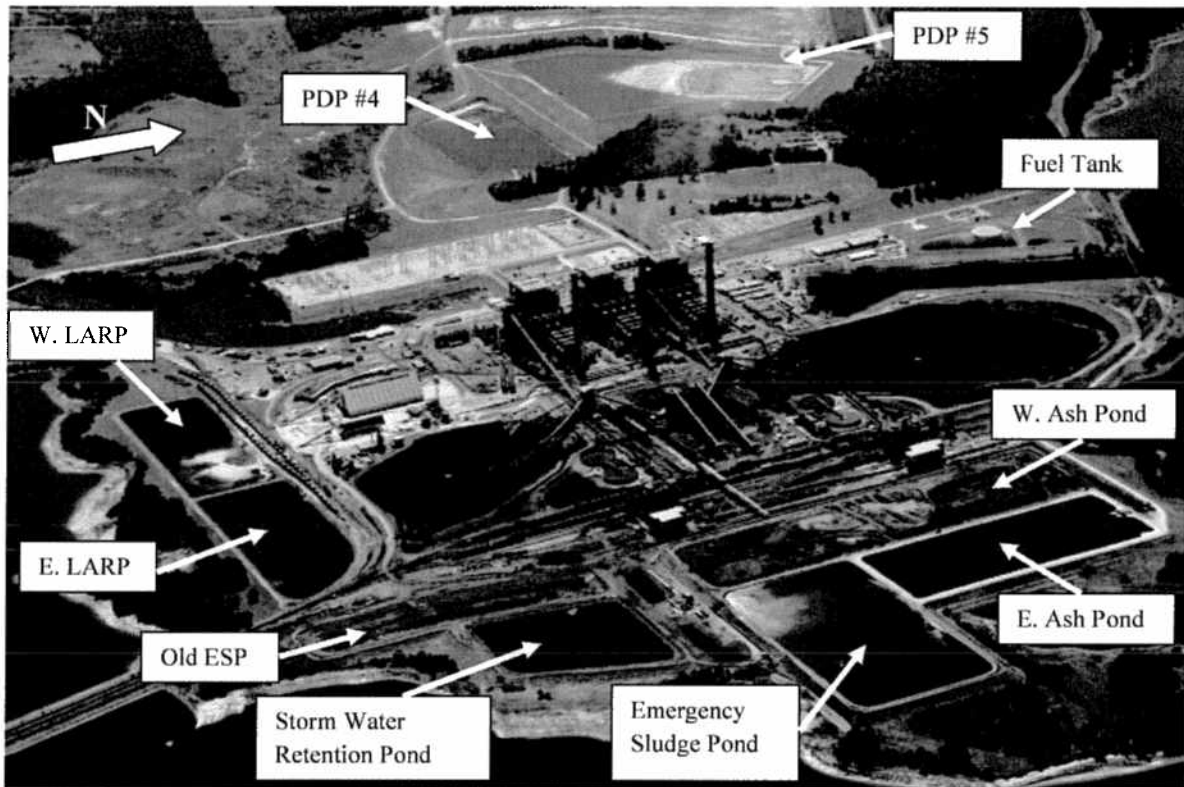
Figure 1: Martin Lake Critical Impoundments

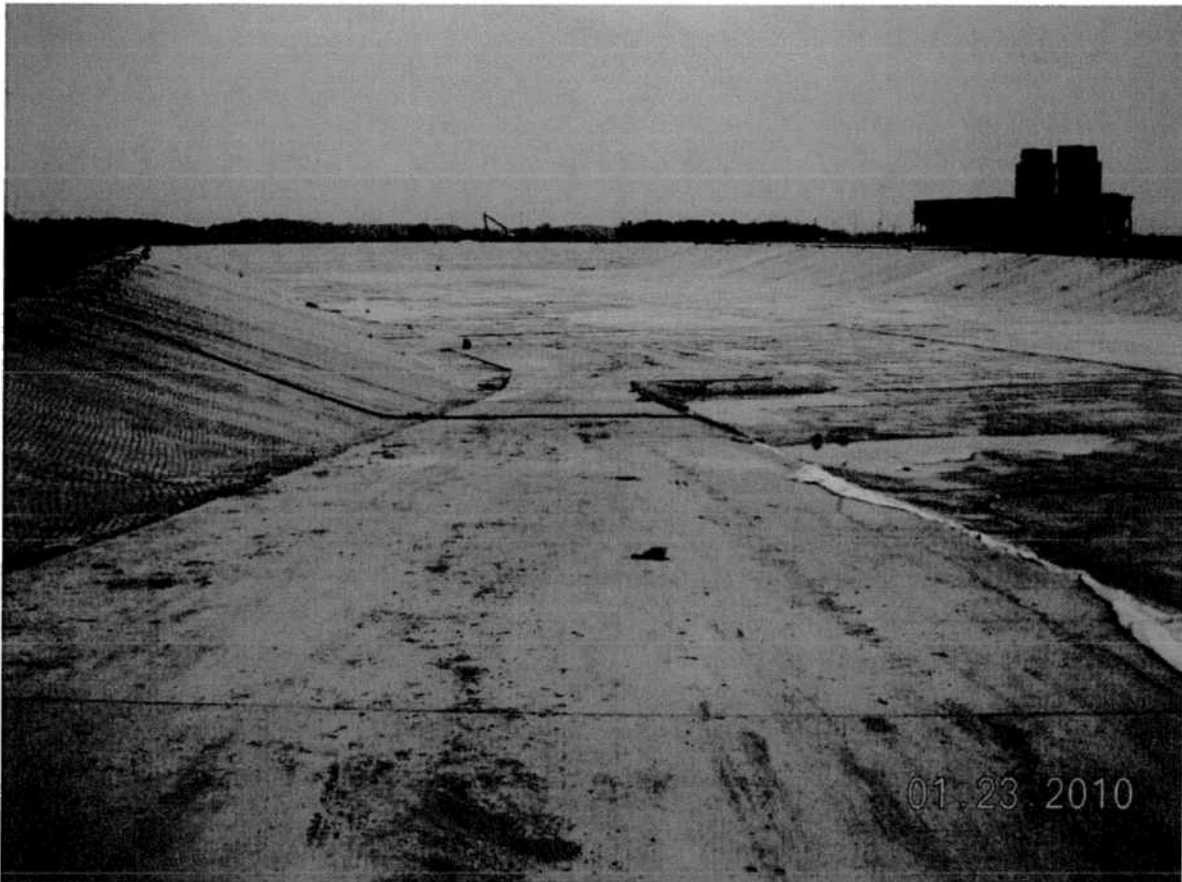
Figure 2: East Bottom Ash Pond (Note this picture was taken during construction before becoming operational and not during the inspection)

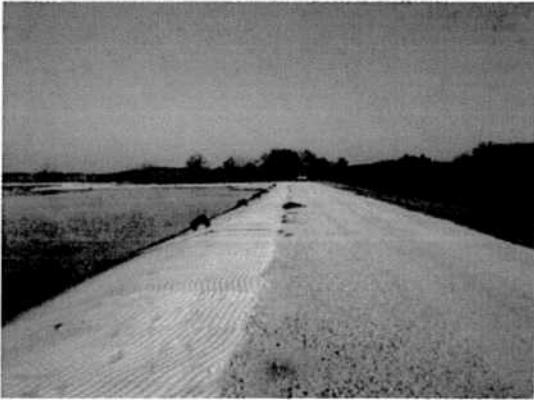
Figure 3: Upstream Slope of Berm and Crest

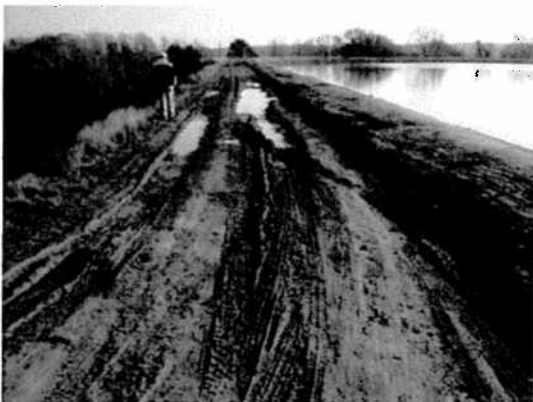
Figure 5: Crest Rutting North Side

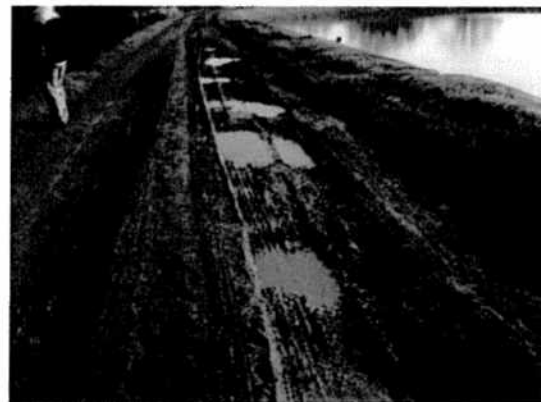
Figure 6: Crest Rutting North Side

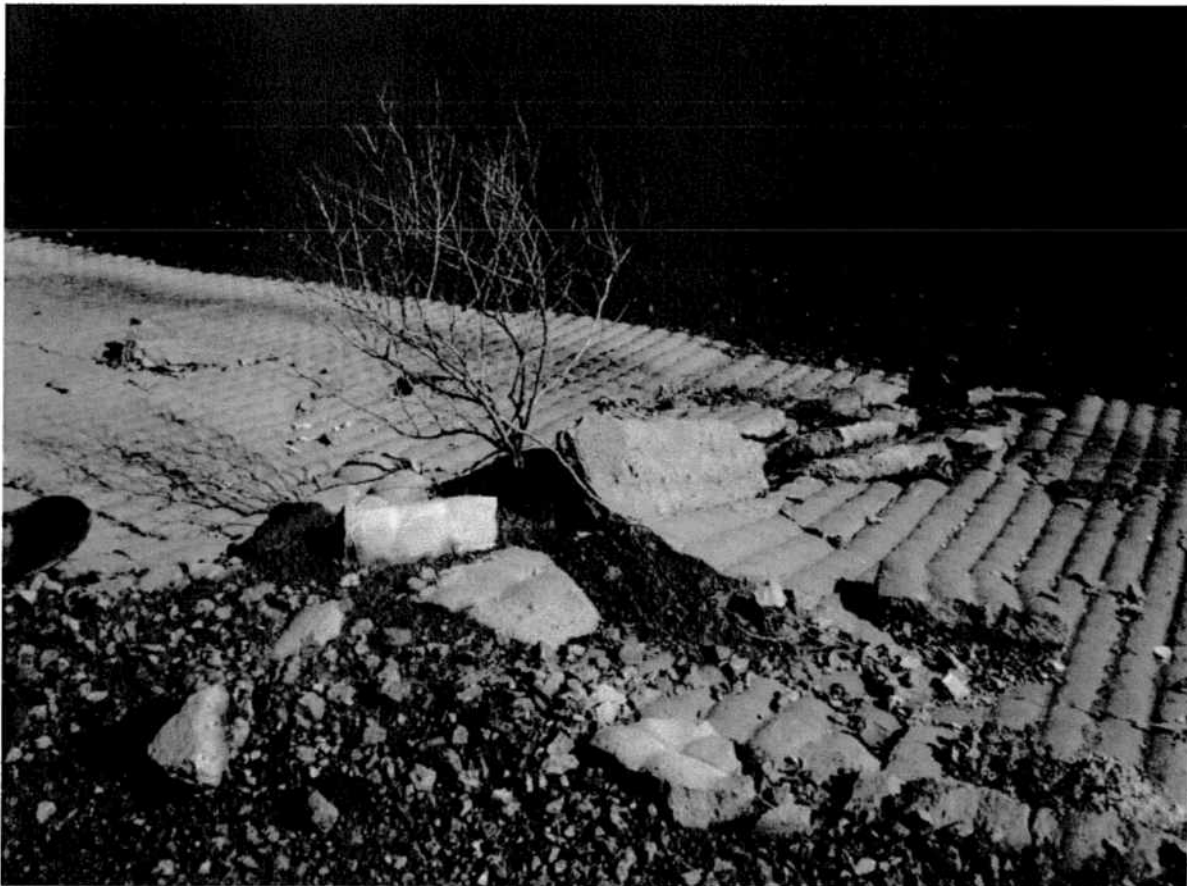
Figure 7: Revetment Damage and Plant in Liner Vent

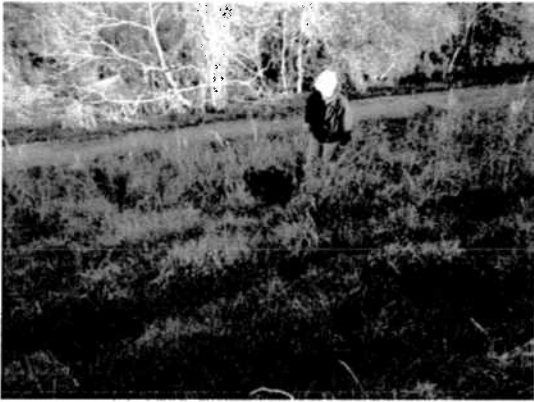
Figure 8: Bush on Downstream Slope

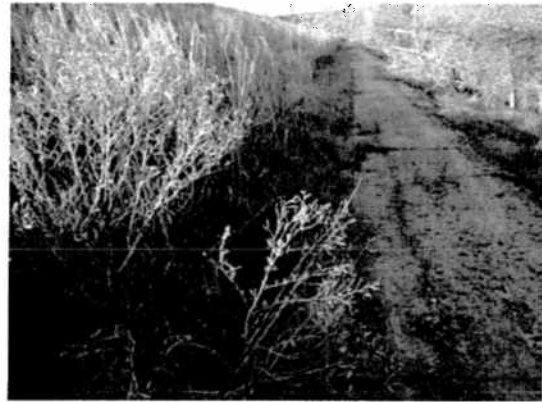
Figure 9: Bush on Downstream Slope

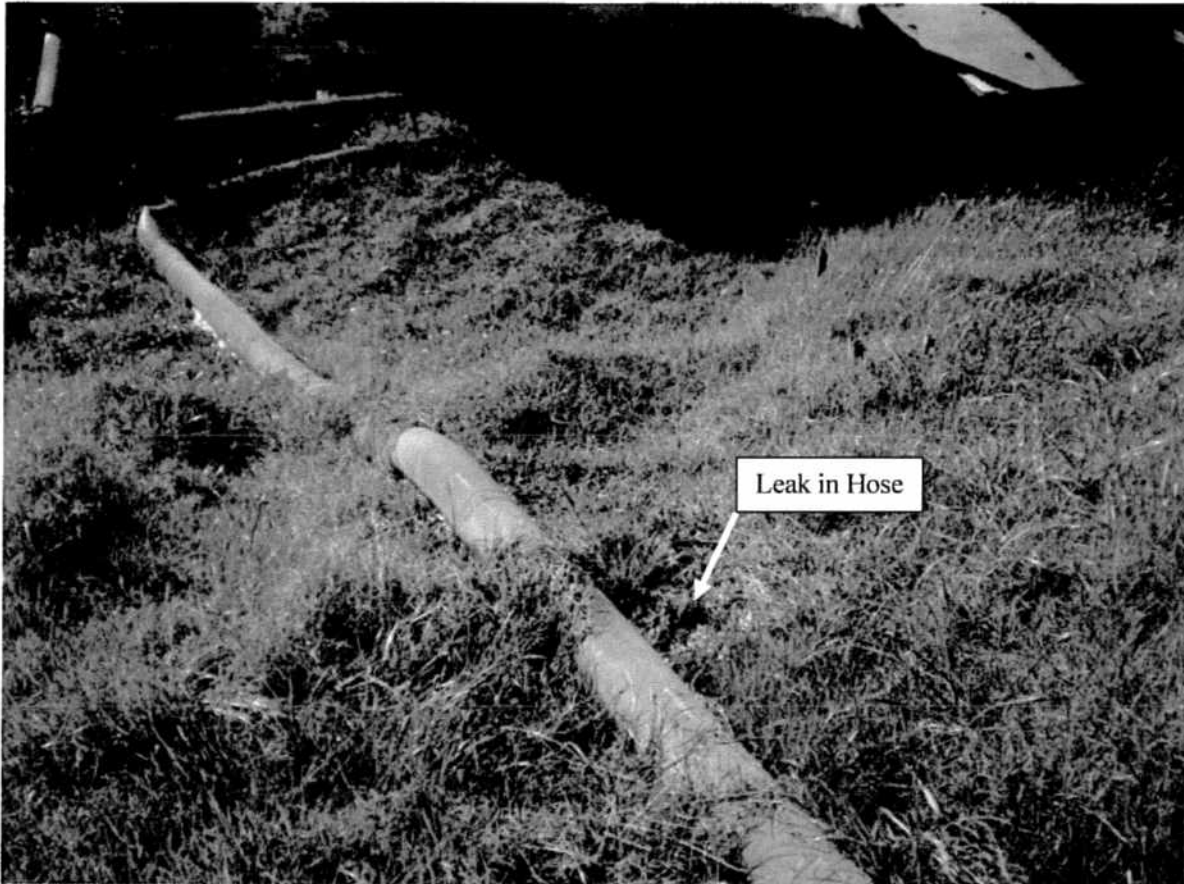
Figure 10 - Leak in Flexible Hose

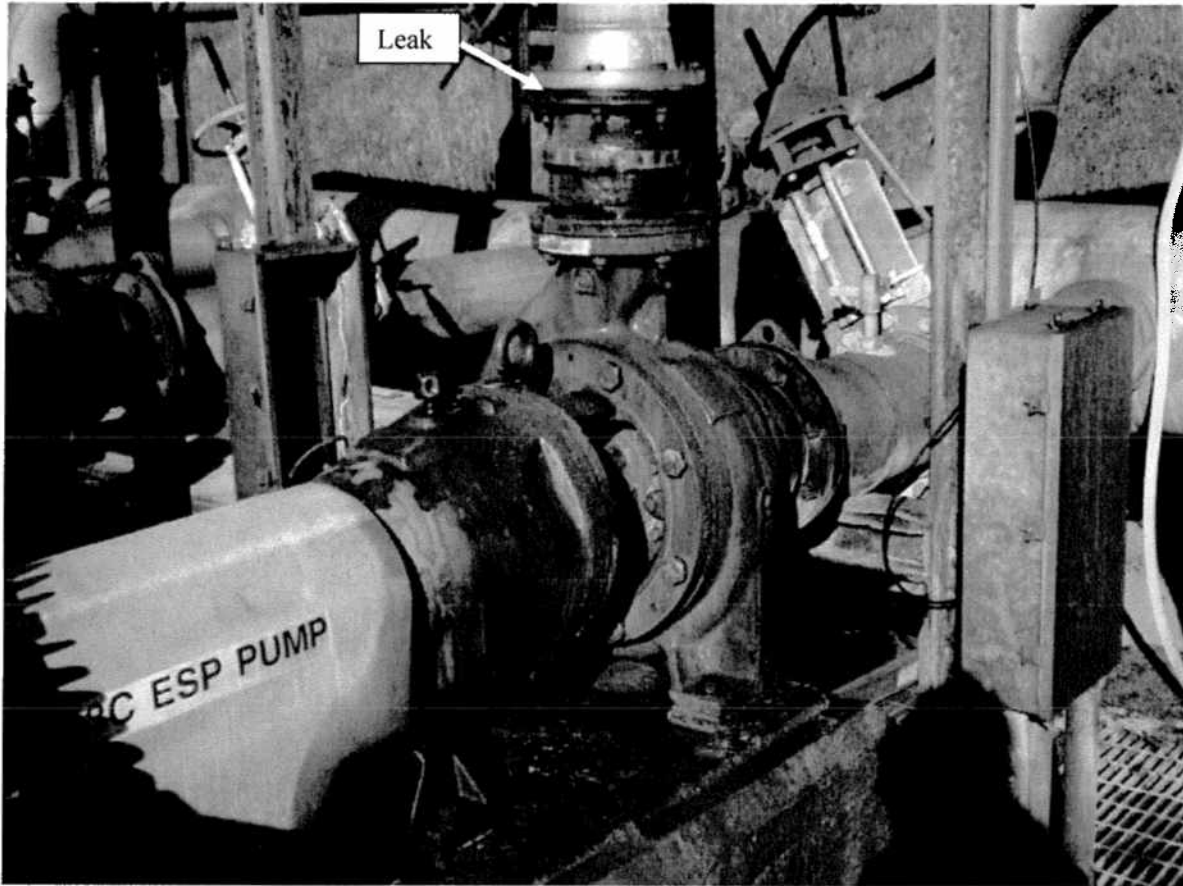
Figure 11: Leak at 3C ESP Pump

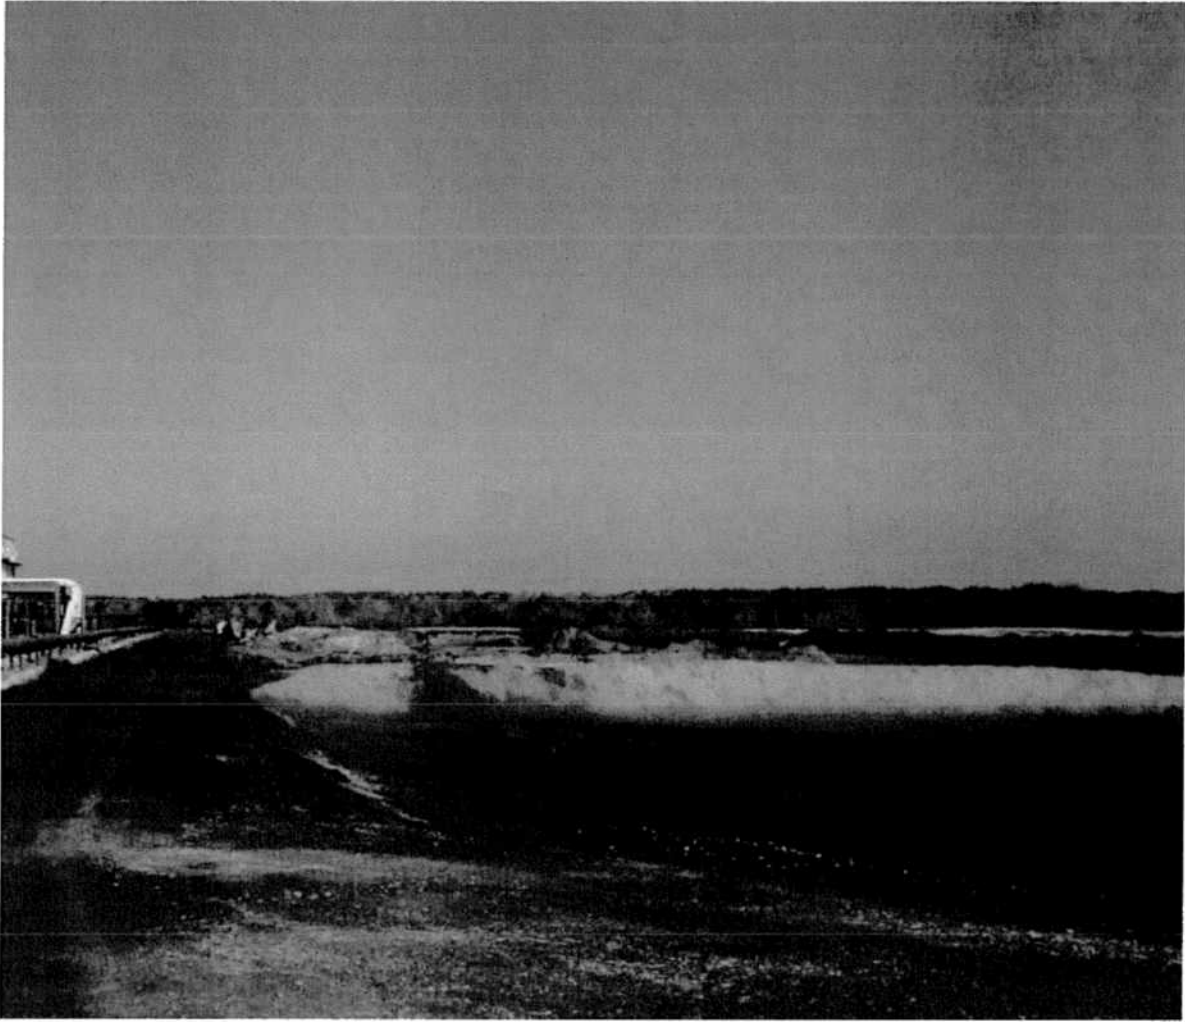
Figure 12: Partially Drained and Excavated West Bottom Ash Pond

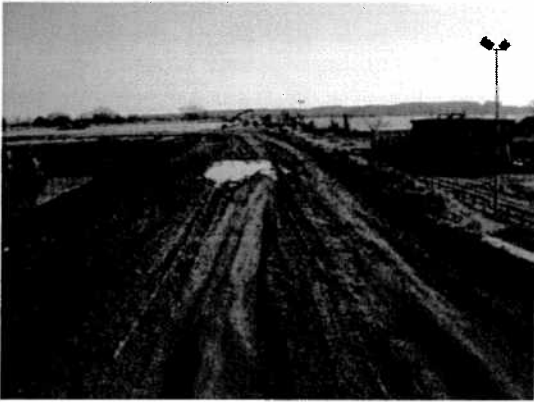
Figure 13: Rutting in Crest from Vehicular Traffic

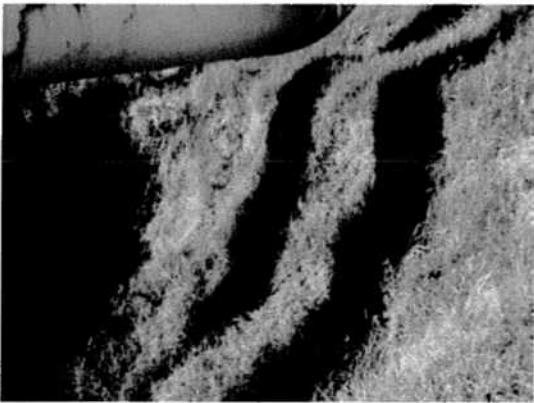
Figure 15: Possible Erosion or Berm Slide

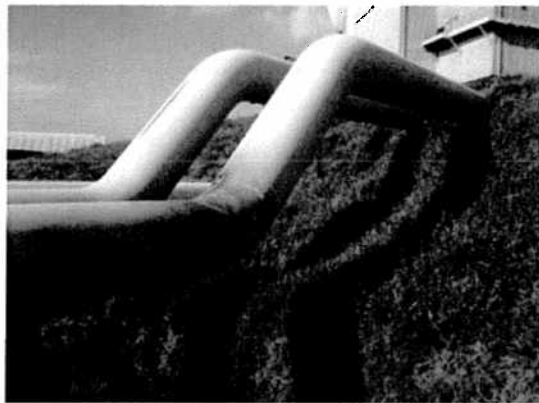
Figure 16: Possible Erosion or Berm Slide

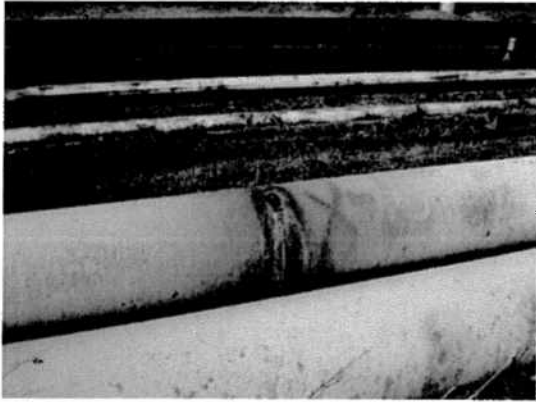
Figure 17: Typical Pipe Seepage/Leak

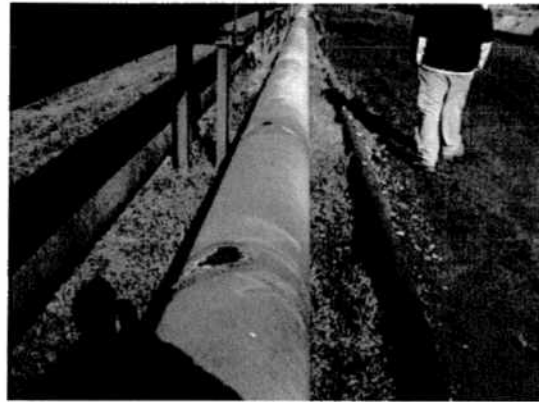
Figure 18: Typical Pipe Seepage/Leak

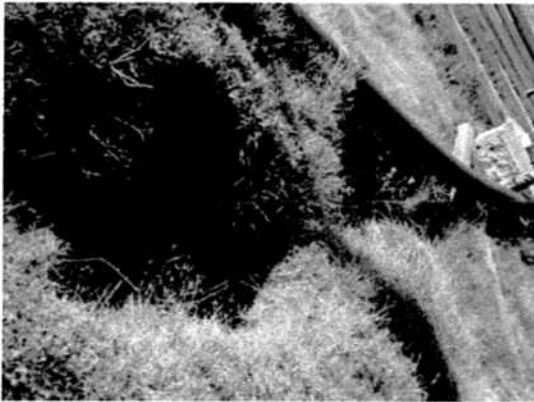
Figure 19: Berm Erosion

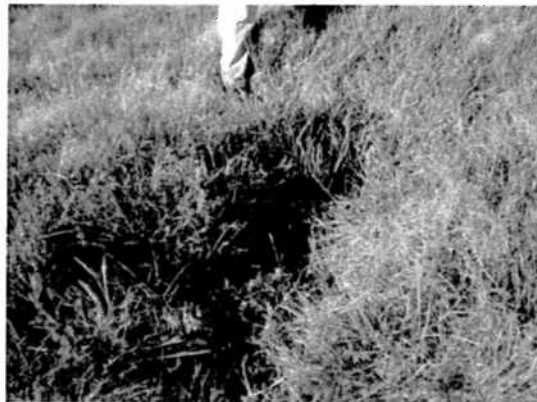
Figure 20: Berm Erosion

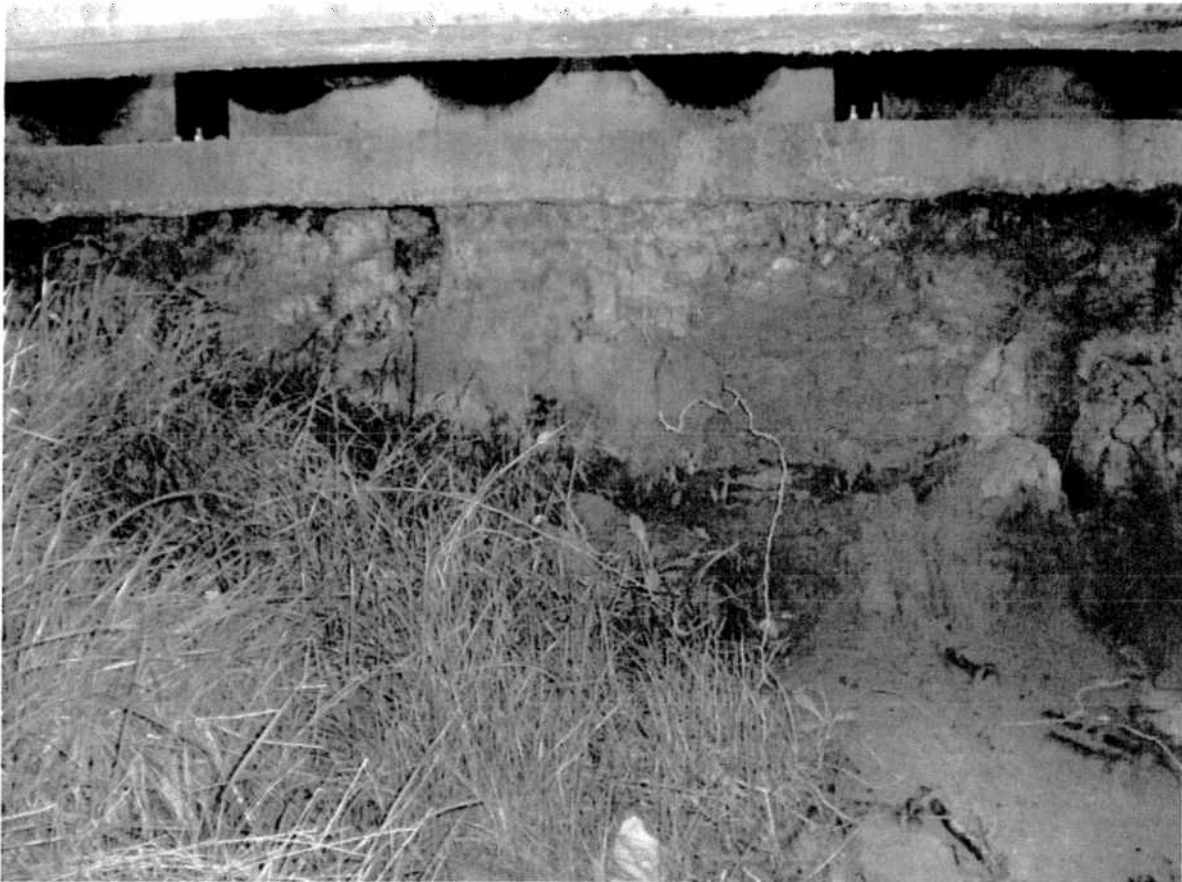
Figure 21: Erosion Under Pipe Rack

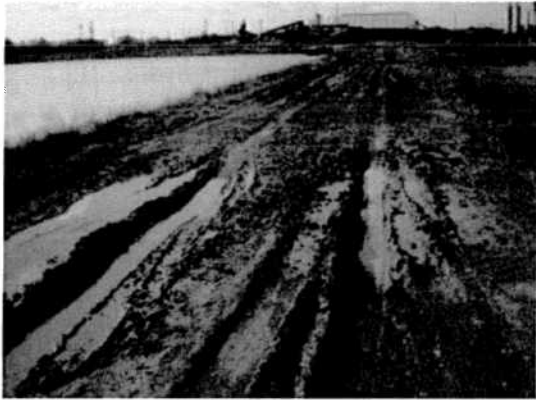
Figure 23: Crest Rutting from Vehicular Traffic

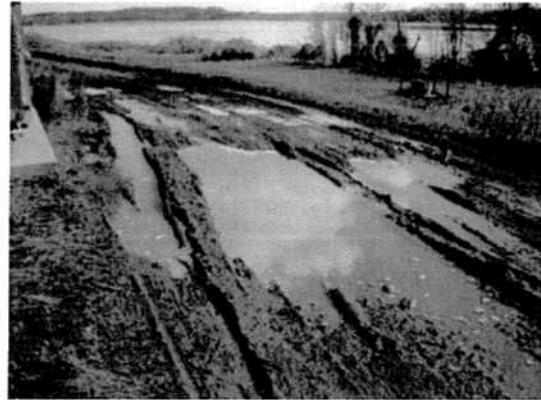
Figure 24: Crest Rutting

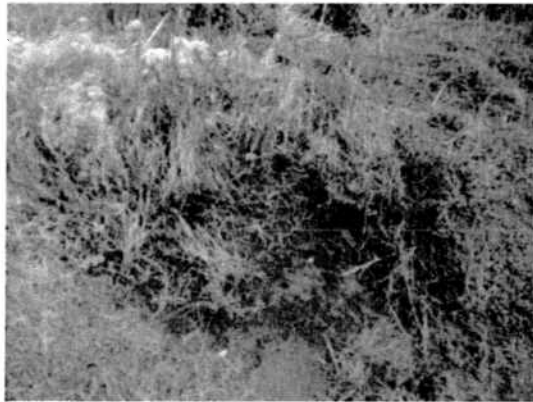
Figure 25: Fuel Spill Near Southwest Pump Station

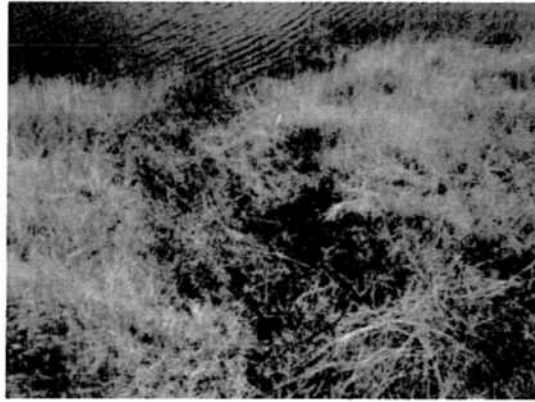
Figure 26: Upstream Embankment Erosion

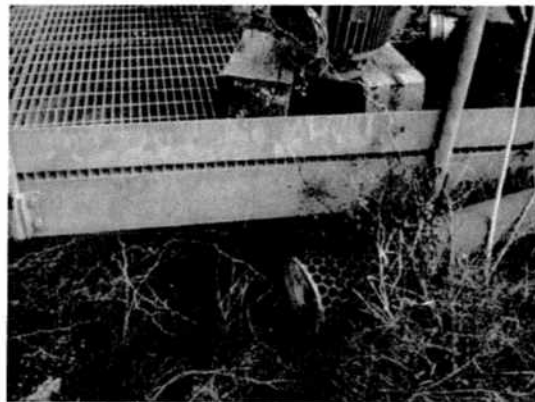
Figure 27: Erosion from Discharge Pipe

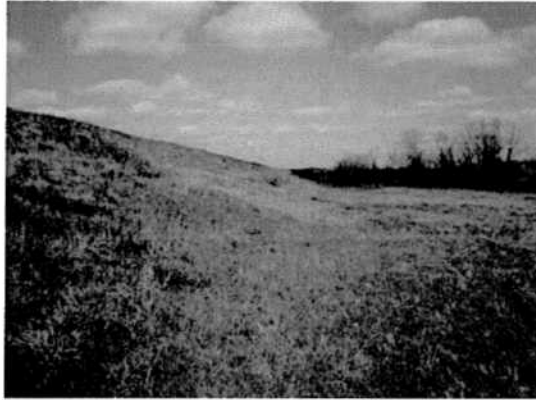
Figure 28: Vegetation on Downstream Side of Impoundment

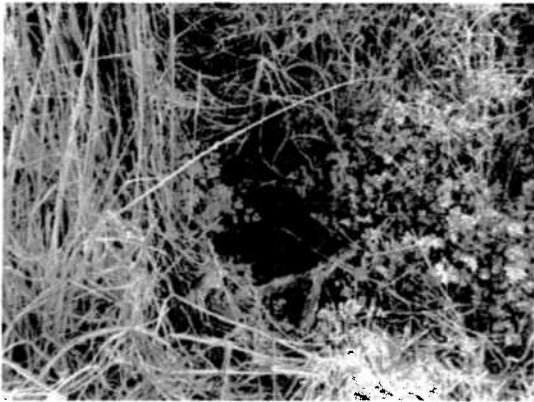
Figure 29: Animal Burrow

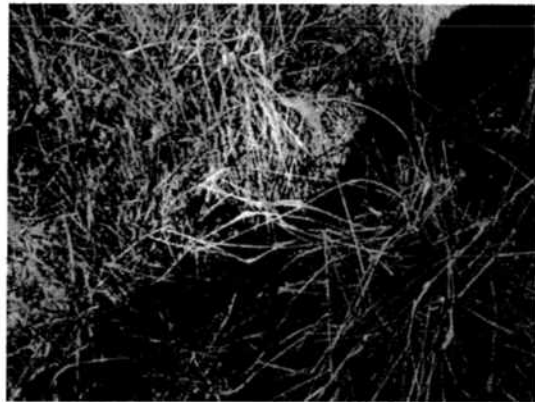
Figure 55: Animal Burrow East LARP

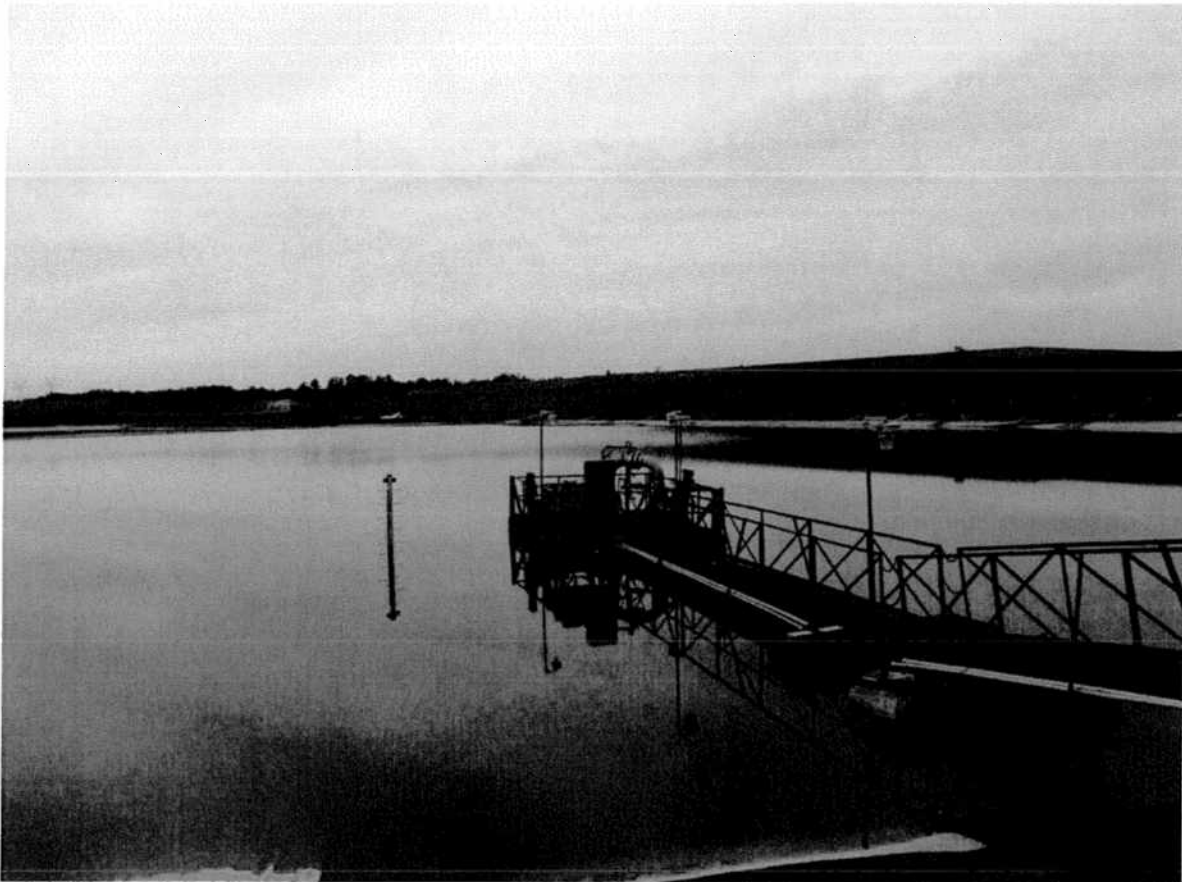
The PDP #4 has 15.34 surface acres with a maximum capacity of 82 million gallons at zero freeboard (Figure 56). The elevation of the top of the dike is 360 feet and the water elevation was 355 feet 11 inches with a freeboard of 4 feet 1 inch.

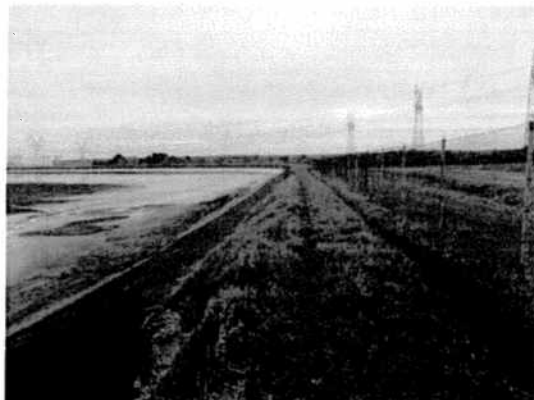
Figure 57: Typical Condition of Crest

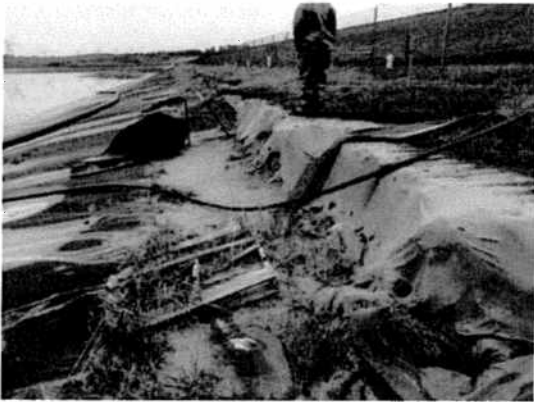
Figure 58: Erosion at Crest of Impoundment

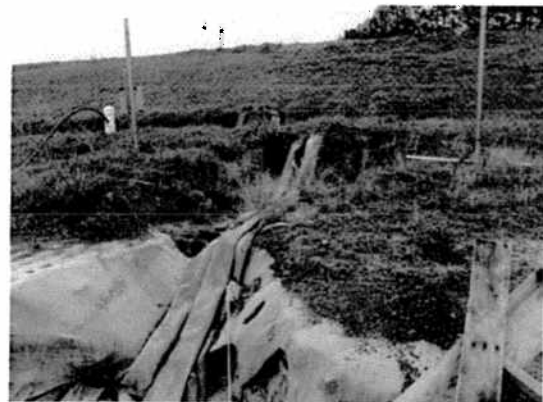
Figure 59: Erosion at Crest of Impoundment

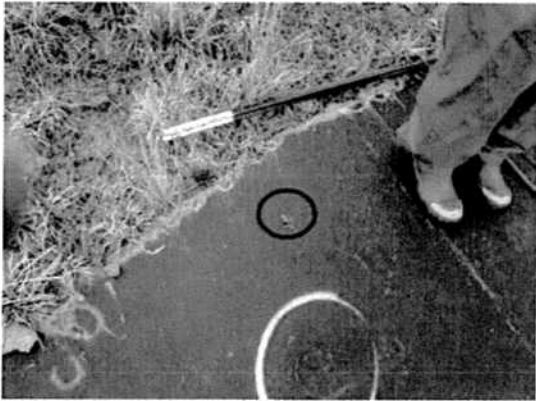
Figure 60: Minor Tear from Picket

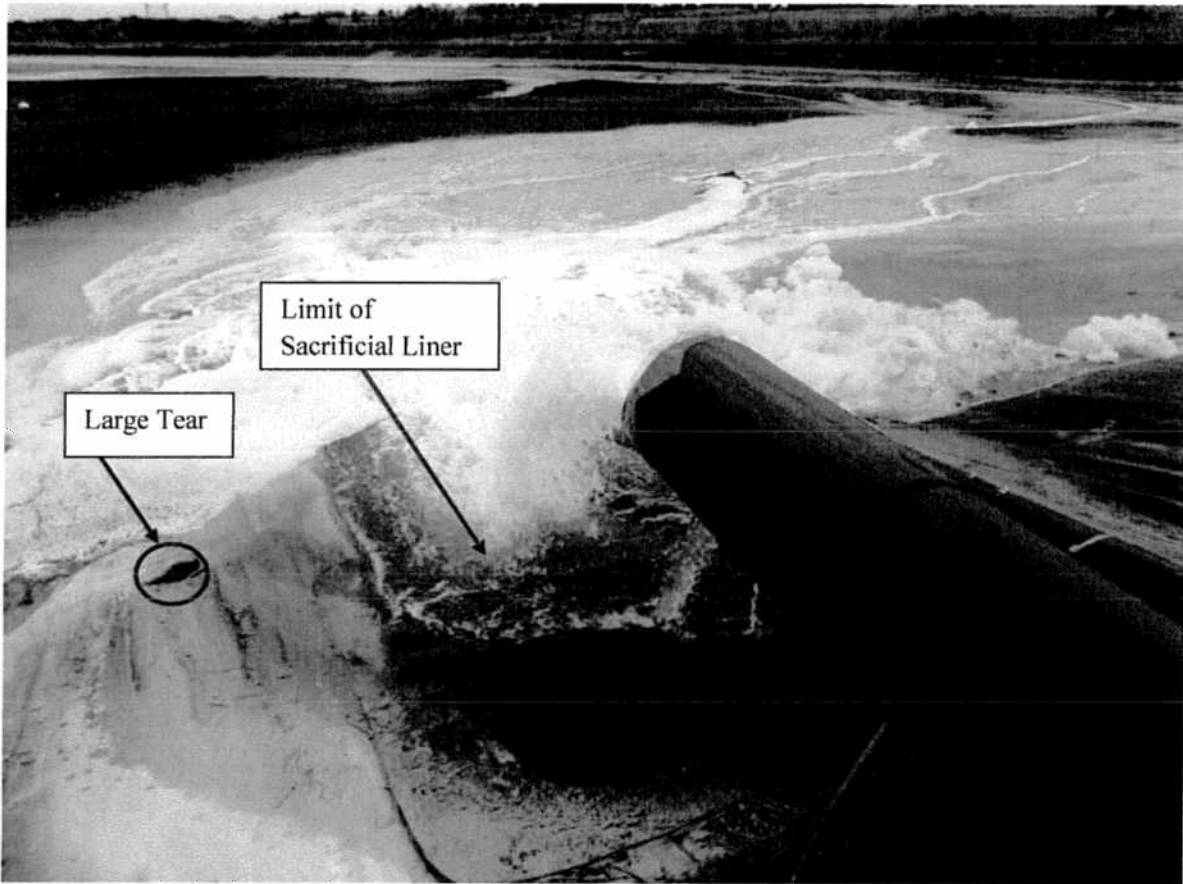
Figure 62: Tear in Liner and Outfall Exceeds Sacrificial Liner

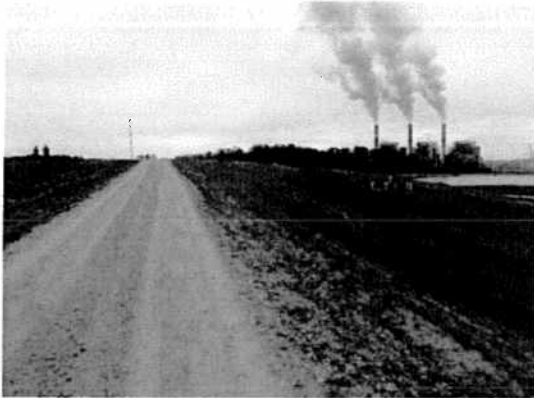
Figure 63: Crest of Pond

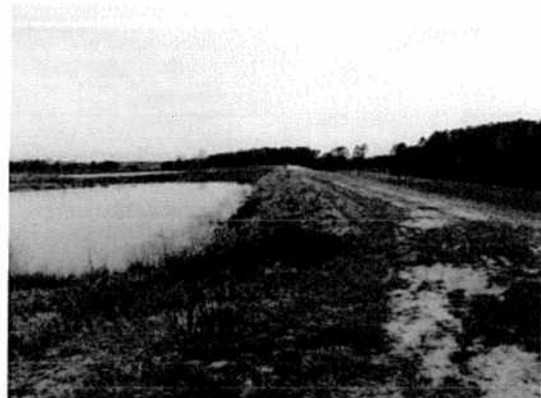
Figure 64: Crest of Pond

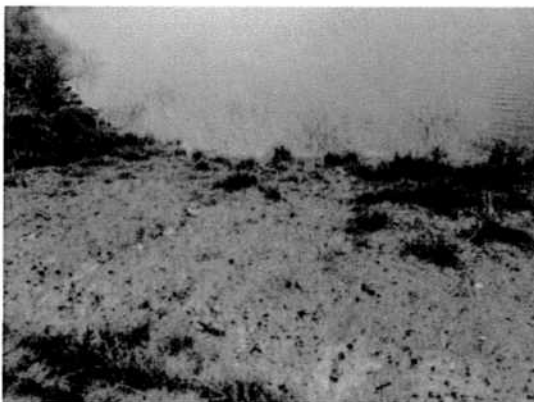
Figure 65: Minor Erosion Rills Upstream Face

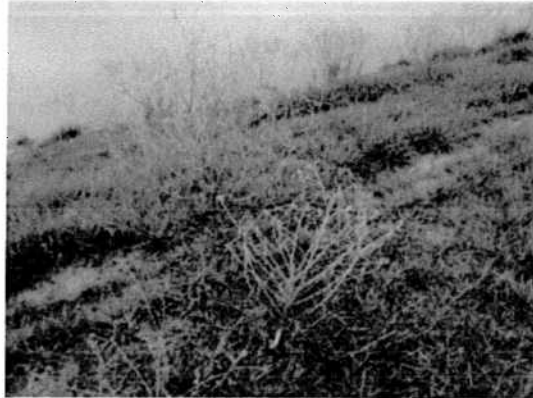
Figure 67: Bushes Growing on Upstream Embankment

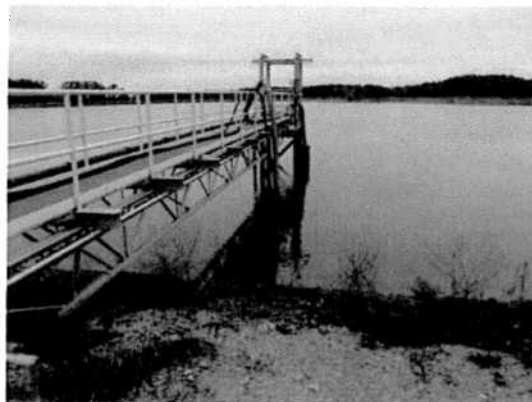
Figure 68: Submersible Pump at Decant Structure

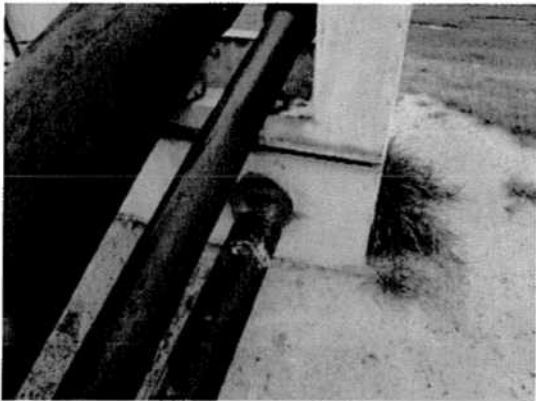
Figure 69: Return Line Southeast Structure

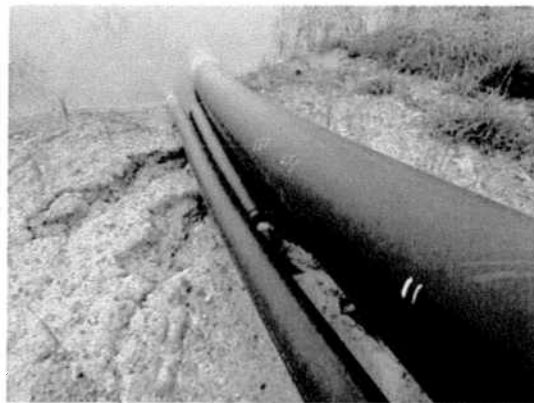
Figure 71: Return Line Northeast Structure

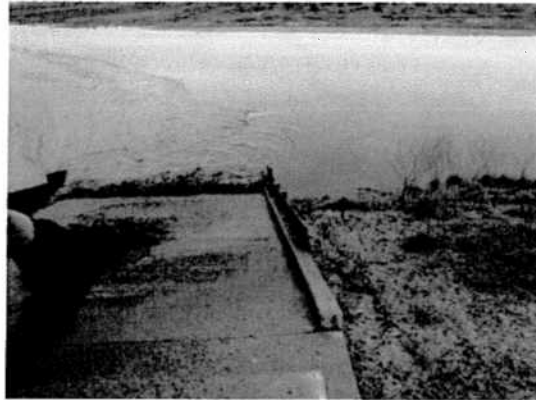
Figure 72: Slurry Channel with Protective Rails

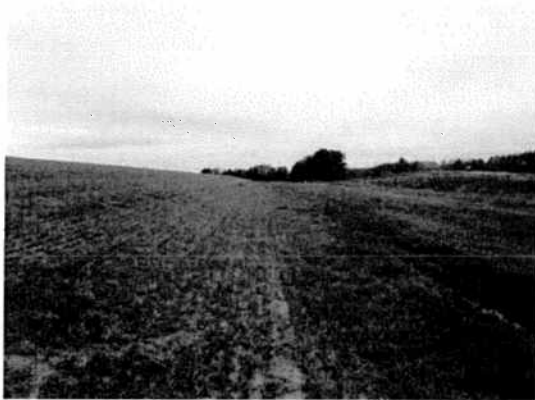
Figure 73: Downstream Side of Impoundment

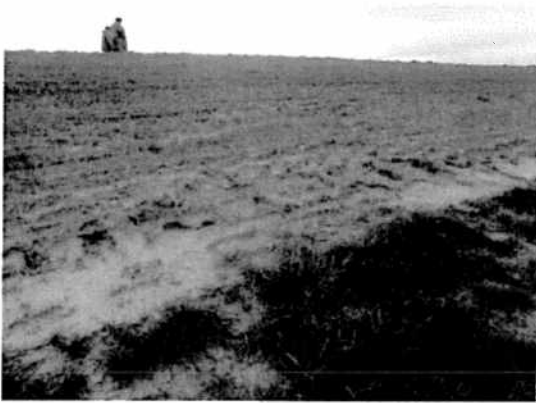
Figure 75: Minor Erosion Rills

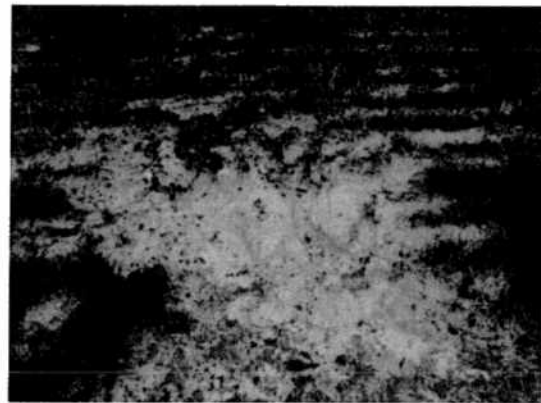
Figure 76: Minor Erosion Rills

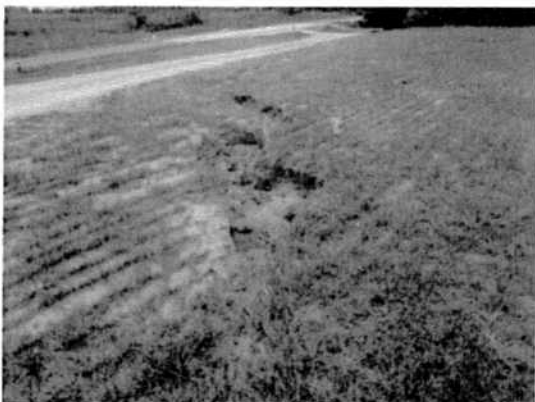
Figure 77: Erosion at South Access Ramp

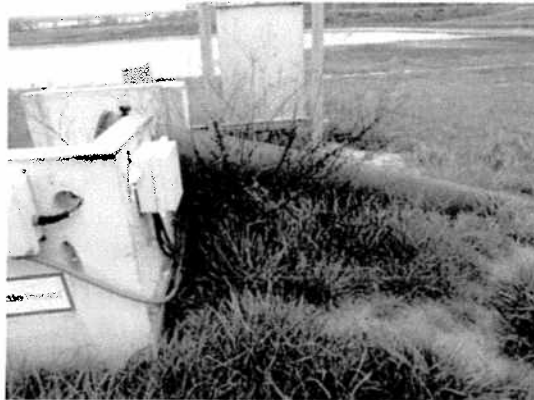
Figure 81: Bush near Southeast Dewatering Access Structure

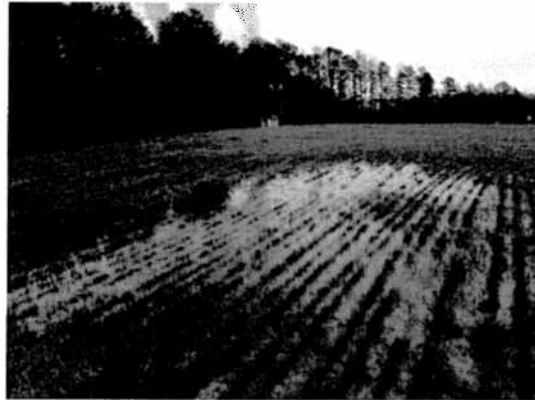
Figure 82: Ponded Water on PDP #3 Cap

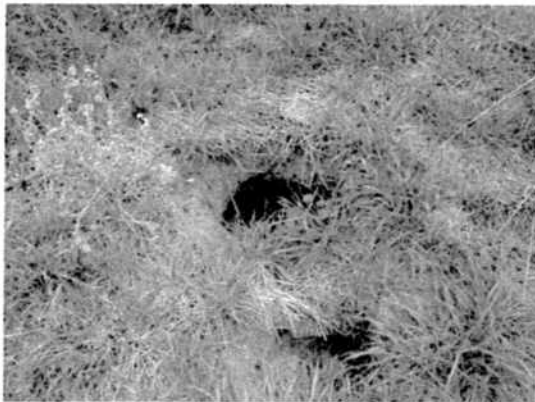
Figure 83: Corrugated Plastic Pipe
