US EPA ARCHIVE DOCUMENT

**Coal Combustion Residue Impoundment
Round 12 - Dam Assessment Report**

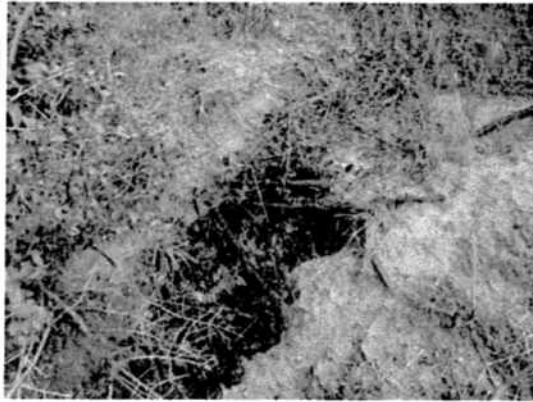
Figure 85: Erosion on Downstream Face of PDP #1 Berm

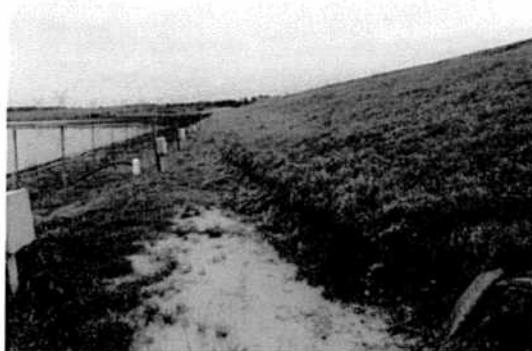
Figure 86: Downstream Toe of PDP #3 Berm

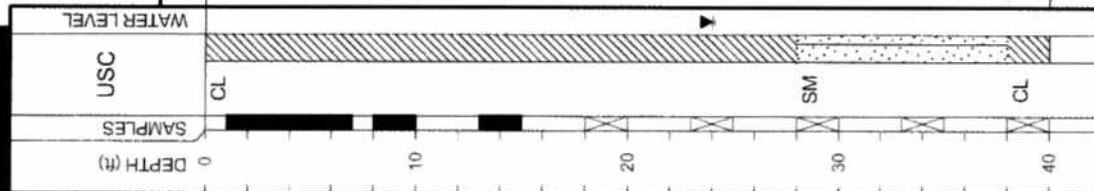
LOG OF BORING B-1
PROJECT: Martin Lake - Luminant East Ash Disposal
Rusk County, Texas
PROJECT NO.: G 2972-08
BORING TYPE: Flight Auger

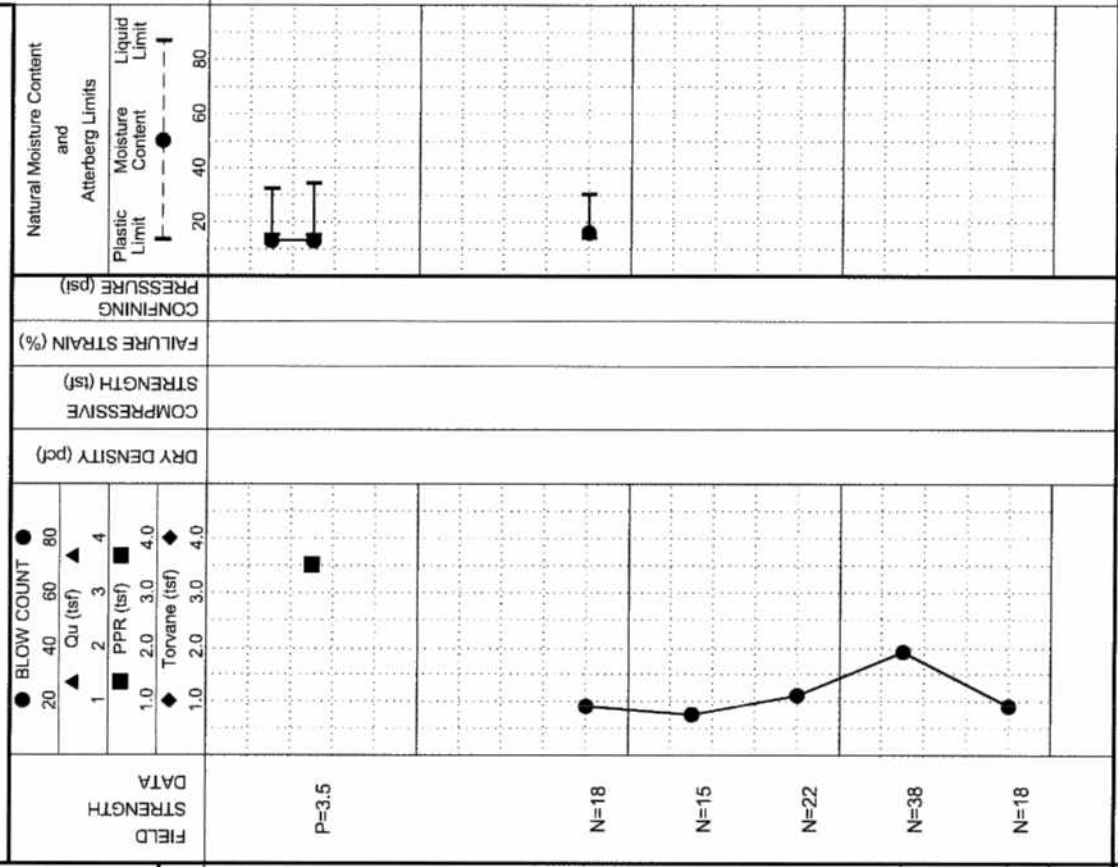
Notes:
 GPS Coordinates: N 32° 15.696', W 94° 33.830'
 Key to Abbreviations:
 N - SPT Data (Blows/Ft)
 P - Pocket Penetrometer (tsf)
 T - Torvane (tsf)
 L - Lab Vane Shear (tsf)

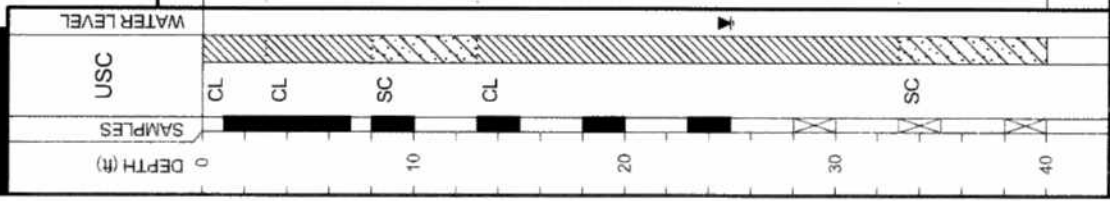
LOG OF BORING B-13
 PROJECT: Martin Lake - Luminant East Ash Disposal
 Rusk County, Texas
 PROJECT NO.: G 2972-08
 BORING TYPE: Flight Auger

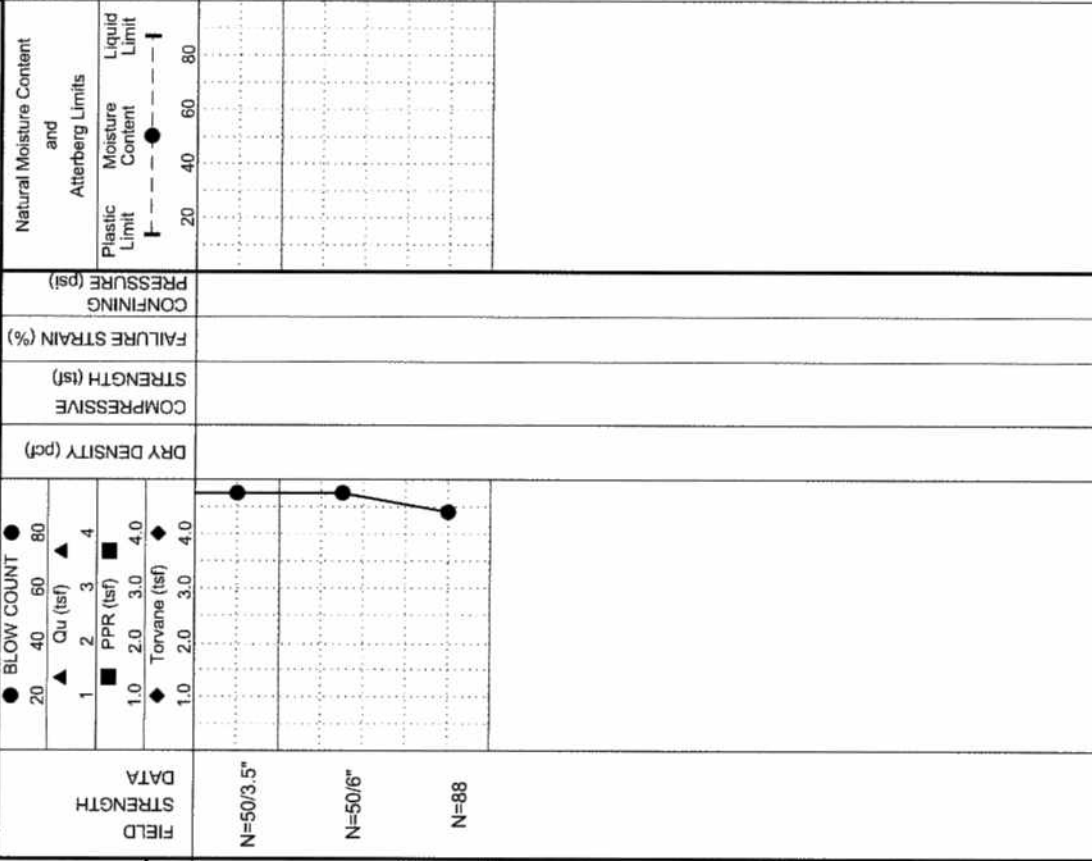
● BLOW COUNT	▲ Qu (tsf)	▲ Plastic Limit	● Liquid Limit
1 2 3 4	1.0 2.0 3.0 4.0	1.0 2.0 3.0 4.0	1.0 2.0 3.0 4.0
PPR (tsf)	Torvane (tsf)		
1.0 2.0 3.0 4.0	1.0 2.0 3.0 4.0

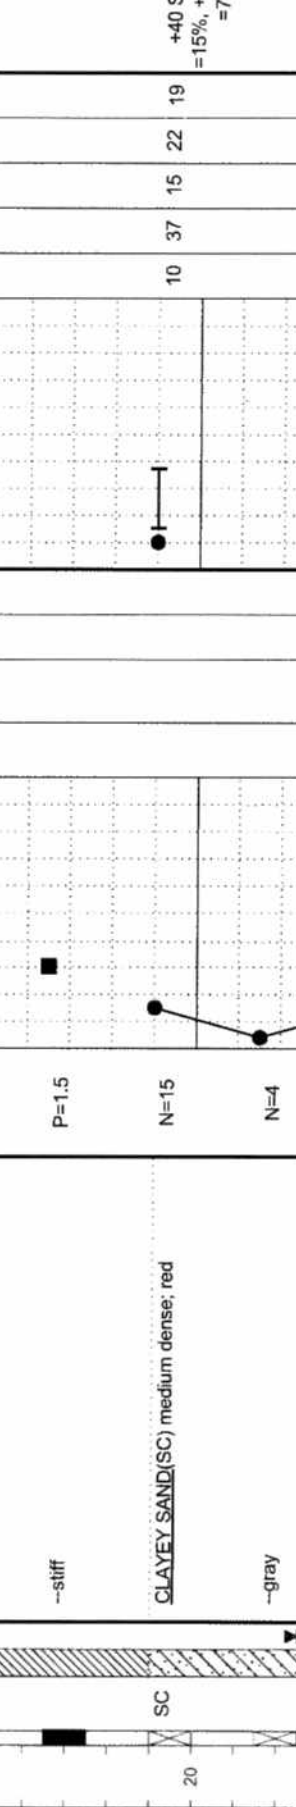
FIELD STRENGTH DATA	DRY DENSITY (pcf)	COMPRESSIVE STRENGTH (tsf)	FAILURE STRAIN (%)	CONFINING PRESSURE (psi)
P=3.5				
P=2.5				
P=3.0				
P=3.5				
P=1.5				
N=15				
N=4				
N=15				
N=13				
N=13

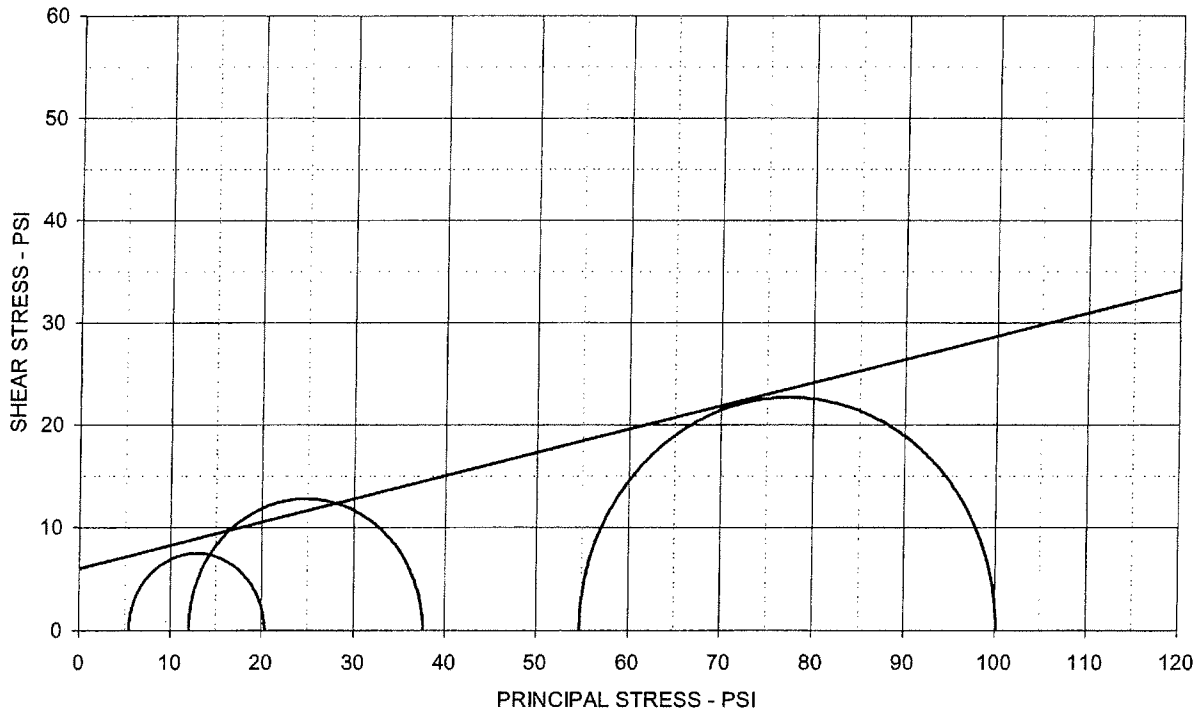
EFFECTIVE STRESS PARAMETERS

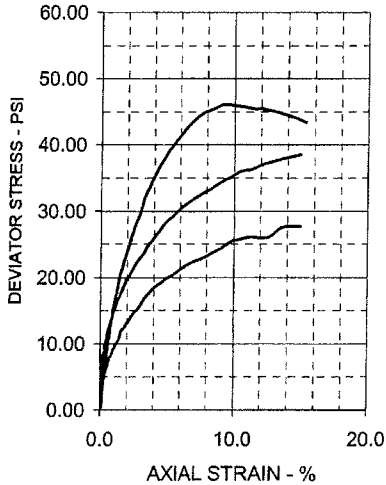
SPECIMEN NO.	1	2	3	4
INITIAL				
Moisture Content - %	15.8	16.6	15.9	
Dry Density - pcf	113.0	115.0	112.5	
Diameter - inches	2.04	2.01	2.06	
Height - inches	4.44	4.44	4.54	
AT TEST				
Final Moisture - %	18.1	18.1	17.6	
Dry Density - pcf	114.0	116.9	115.1	
Calculated Diameter (in.)	2.02	2.00	2.04	
Height - inches	4.40	4.40	4.49	
Effect. Cell Pressure - psi	10.0	20.0	40.0	
Failure Stress - psi	15.00	25.60	45.40	
Total Pore Pressure - psi	54.6	58.0	35.2	
Strain Rate - inches/min.	0.00050	0.00050	0.00050	
Failure Strain - %	2.7	3.9	8.5	
σ_1' Failure - psi	20.41	37.62	100.17	
σ_3' Failure - psi	5.41	12.02	54.77

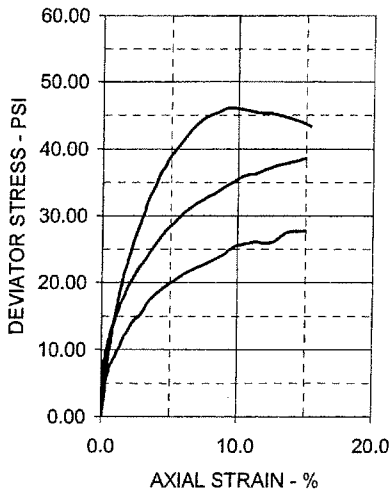
SPECIMEN NO.	1	2	3	4
INITIAL				
Moisture Content - %	15.8	16.6	15.9	
Dry Density - pcf	113.0	115.0	112.5	
Diameter - inches	2.04	2.01	2.06	
Height - inches	4.44	4.44	4.54	
AT TEST				
Final Moisture - %	18.1	18.1	17.6	
Dry Density - pcf	114.0	116.9	115.1	
Calculated Diameter (in.)	2.02	2.00	2.04	
Height - inches	4.40	4.40	4.49	
Effect. Cell Pressure - psi	10.0	20.0	40.0	
Failure Stress - psi	15.00	25.60	45.40	
Total Pore Pressure - psi	54.6	58.0	35.2	
Strain Rate - inches/min.	0.00050	0.00050	0.00050	
Failure Strain - %	2.7	3.9	8.5	
σ_1 Failure - psi	25.00	45.60	85.40	
σ_3 Failure - psi	10.00	20.00	40.00

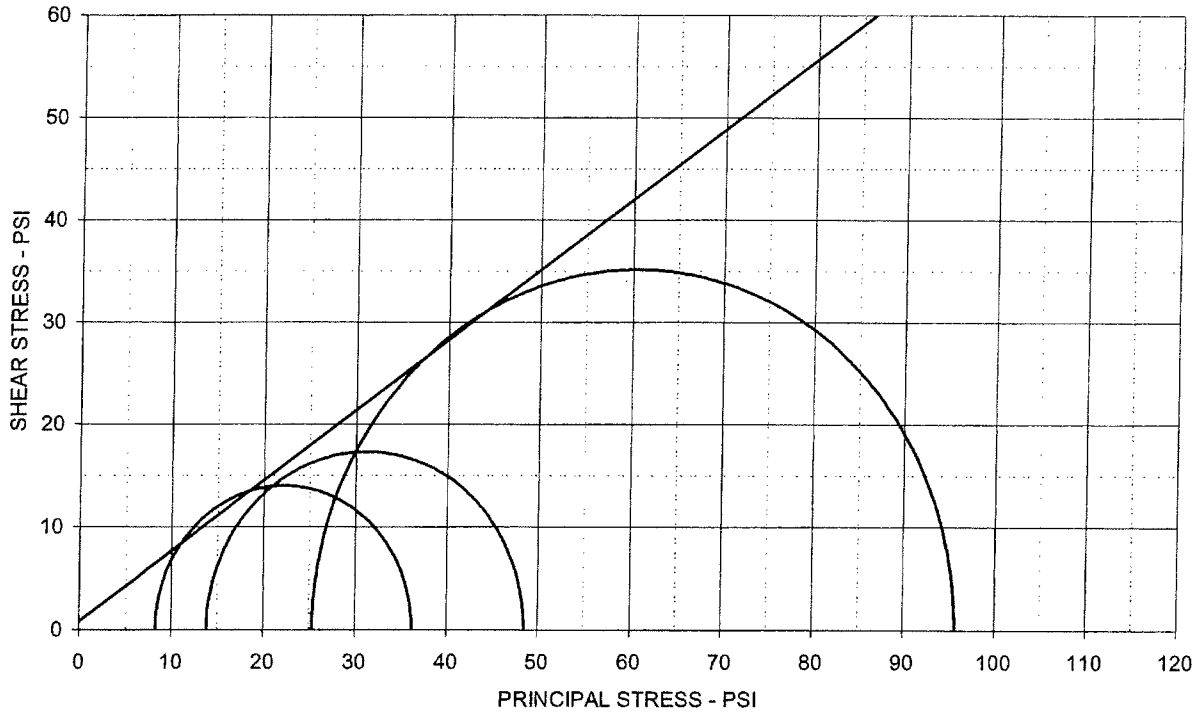
EFFECTIVE STRESS PARAMETERS

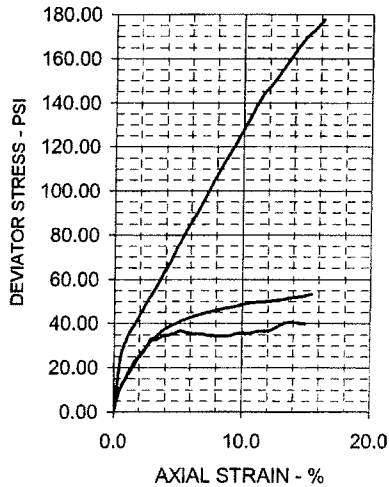
SPECIMEN NO.	1	2	3	4
INITIAL				
Moisture Content - %	16.6	16.0	11.8	
Dry Density - pcf	112.3	112.1	122.3	
Diameter - inches	2.08	2.08	2.11	
Height - inches	4.25	4.40	4.62	
AT TEST				
Final Moisture - %	19.4	18.1	13.5	
Dry Density - pcf	112.6	115.3	124.9	
Calculated Diameter (in.)	2.08	2.07	2.10	
Height - inches	4.24	4.37	4.58	
Effect. Cell Pressure - psi	10.0	20.0	40.0	
Failure Stress - psi	28.02	34.65	70.28	
Total Pore Pressure - psi	51.8	56.1	64.6	
Strain Rate - inches/min.	0.00050	0.00050	0.00050	
Failure Strain - %	2.4	3.4	4.6	
σ_1' Failure - psi	36.26	48.53	95.68	
σ_3' Failure - psi	8.24	13.88	25.40

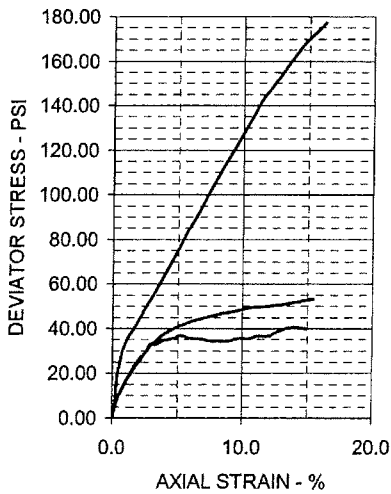
SPECIMEN NO.	1	2	3	4
	INITIAL			
Moisture Content - %	16.6	16.0	11.8	
Dry Density - pcf	112.3	112.1	122.3	
Diameter - inches	2.08	2.08	2.11	
Height - inches	4.25	4.40	4.62	
AT TEST				
Final Moisture - %	19.4	18.1	13.5	
Dry Density - pcf	112.6	115.3	124.9	
Calculated Diameter (in.)	2.08	2.07	2.10	
Height - inches	4.24	4.37	4.58	
Effect. Cell Pressure - psi	10.0	20.0	40.0	
Failure Stress - psi	28.02	34.65	70.28	
Total Pore Pressure - psi	51.8	56.1	64.6	
Strain Rate - inches/min.	0.00050	0.00050	0.00050	
Failure Strain - %	2.4	3.4	4.6	
σ_1 Failure - psi	38.02	54.65	110.28	
σ_3 Failure - psi	10.00	20.00	40.00

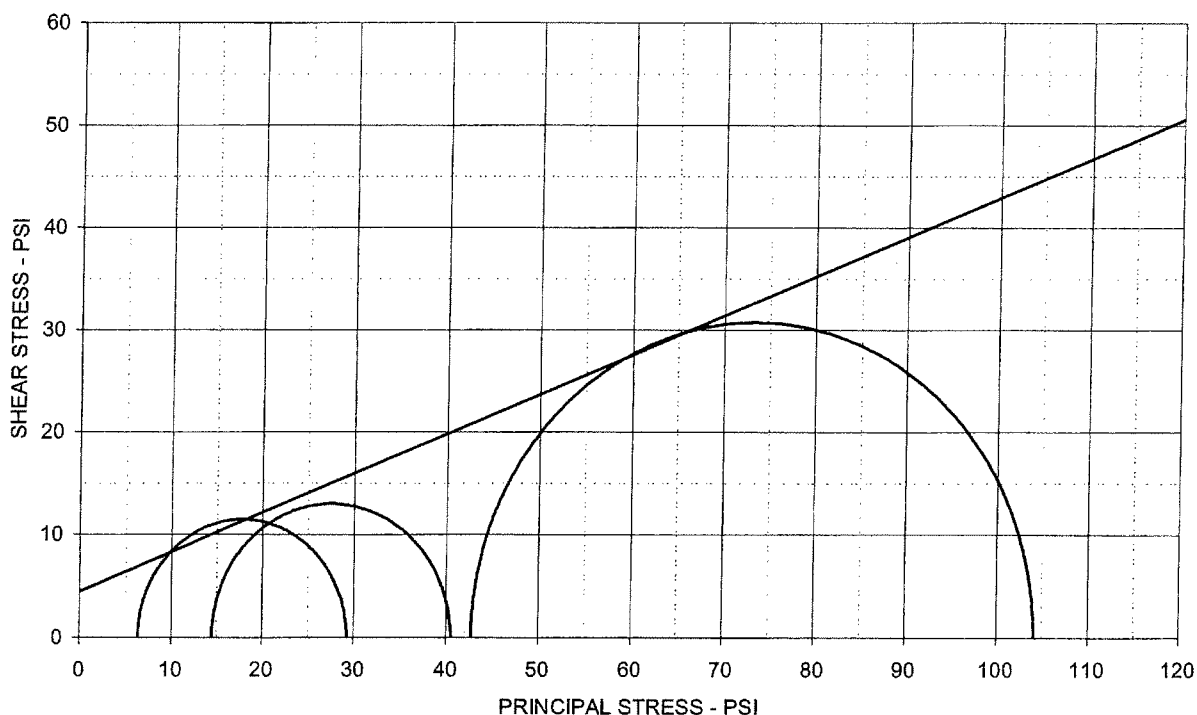
EFFECTIVE STRESS PARAMETERS

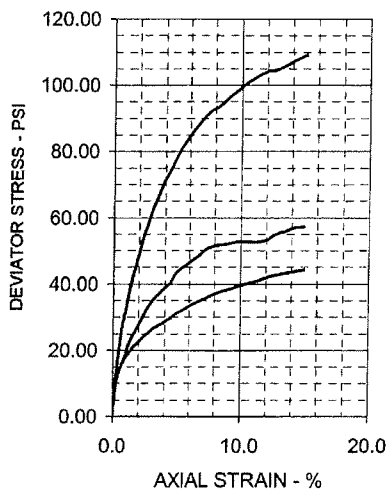
SPECIMEN NO.	1	2	3	4
INITIAL				
Moisture Content - %	16.2	15.5	16.1	
Dry Density - pcf	113.6	113.1	113.3	
Diameter - inches	2.07	2.01	2.10	
Height - inches	4.23	4.25	4.28	
AT TEST				
Final Moisture - %	18.3	18.2	15.8	
Dry Density - pcf	115.2	115.3	115.5	
Calculated Diameter (in.)	2.08	1.99	2.08	
Height - inches	4.24	4.21	4.22	
Effect. Cell Pressure - psi	10.0	20.0	40.0	
Failure Stress - psi	22.94	25.99	61.42	
Total Pore Pressure - psi	53.7	55.5	47.3	
Strain Rate - inches/min.	0.00050	0.00050	0.00050	
Failure Strain - %	1.4	3.0	3.0	
σ_1' Failure - psi	29.29	40.52	104.13	
σ_3' Failure - psi	6.35	14.53	42.71

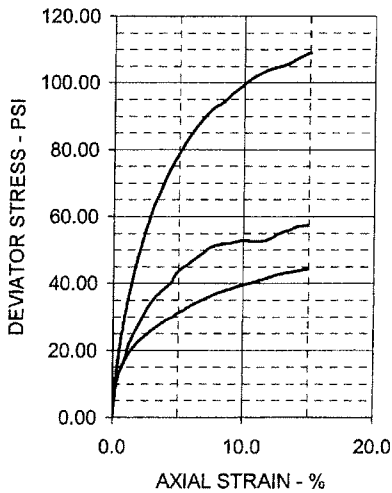
SPECIMEN NO.	1	2	3	4
INITIAL				
Moisture Content - %	16.2	15.5	16.1	
Dry Density - pcf	113.6	113.1	113.3	
Diameter - inches	2.07	2.01	2.10	
Height - inches	4.23	4.25	4.28	
AT TEST				
Final Moisture - %	18.3	18.2	15.8	
Dry Density - pcf	115.2	115.3	115.5	
Calculated Diameter (in.)	2.08	1.99	2.08	
Height - inches	4.24	4.21	4.22	
Effect. Cell Pressure - psi	10.0	20.0	40.0	
Failure Stress - psi	22.94	25.99	61.42	
Total Pore Pressure - psi	53.7	55.5	47.3	
Strain Rate - inches/min.	0.00050	0.00050	0.00050	
Failure Strain - %	1.4	3.0	3.0	
σ_1 Failure - psi	32.94	45.99	101.42	
σ_3 Failure - psi	10.00	20.00	40.00

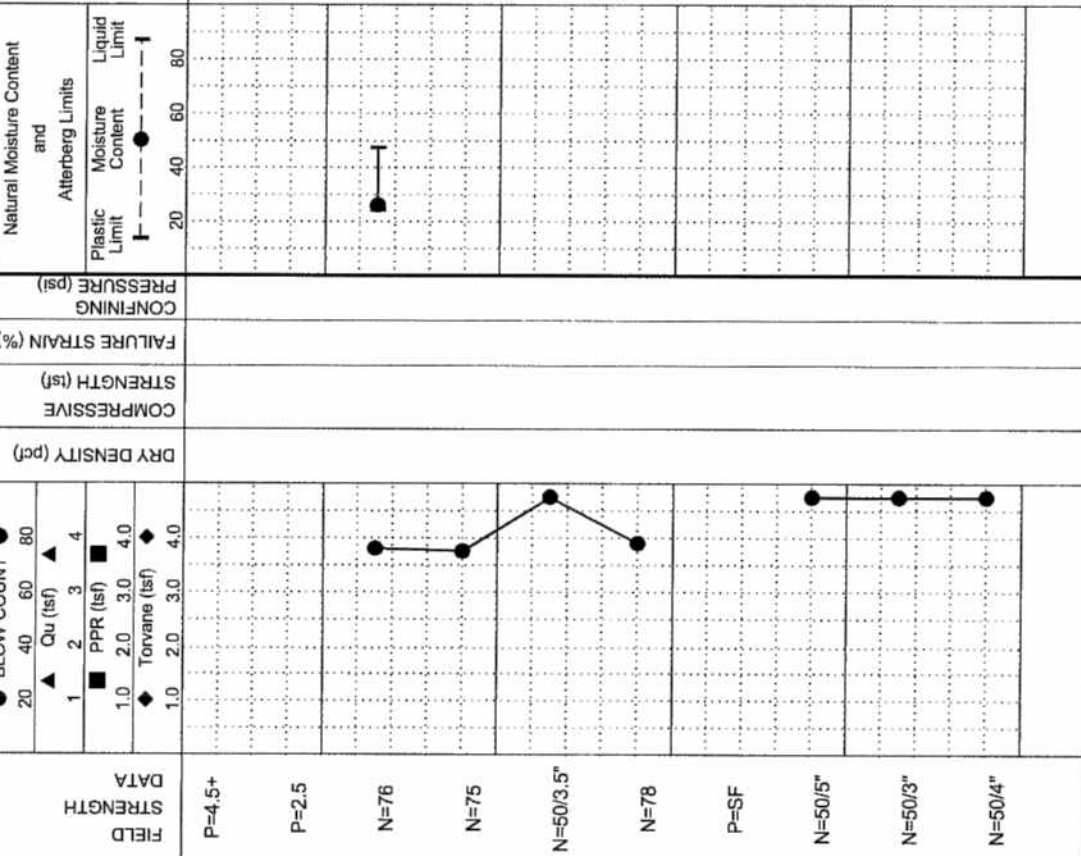
Notes:
GPS Coordinates: N 32°15.752', W 94°35.072'

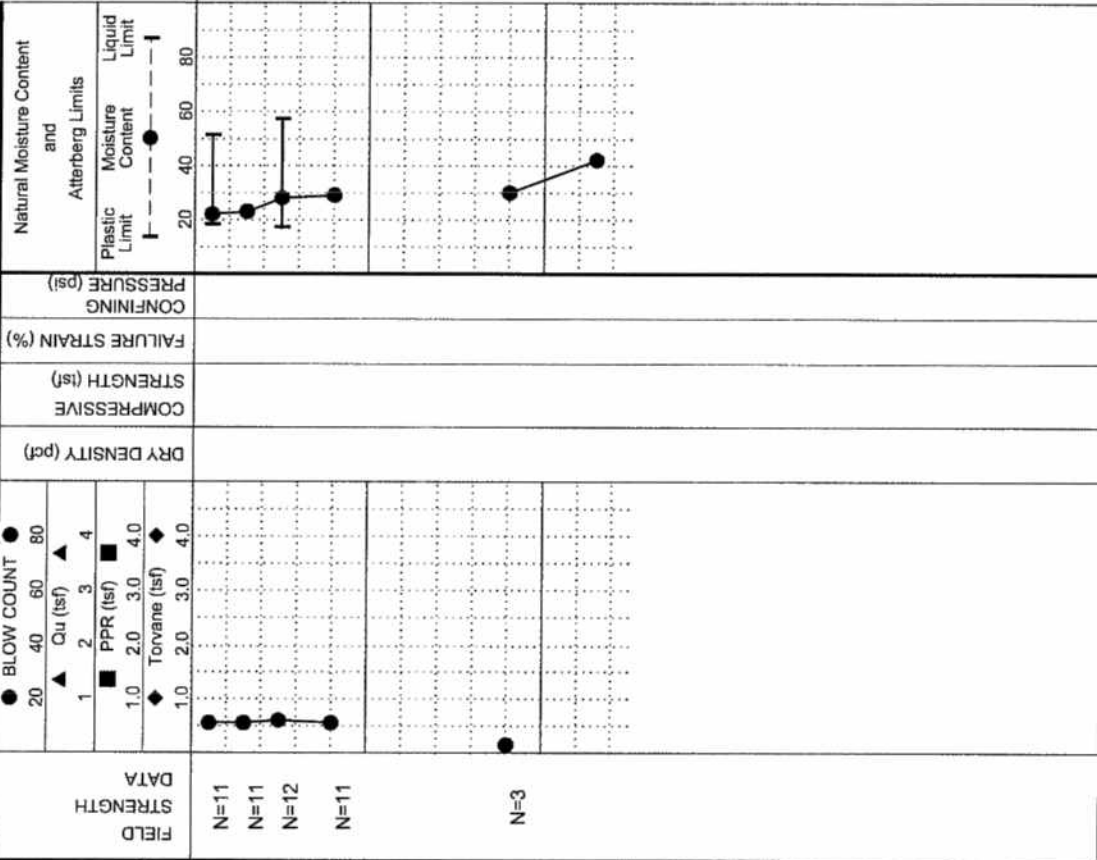
Key to Abbreviations:
N - SPT Data (Blows/FT)
P - Pocket Penetrometer (tsf)
T - Torvane (tsf)
L - Lab Vane Shear (tsf)

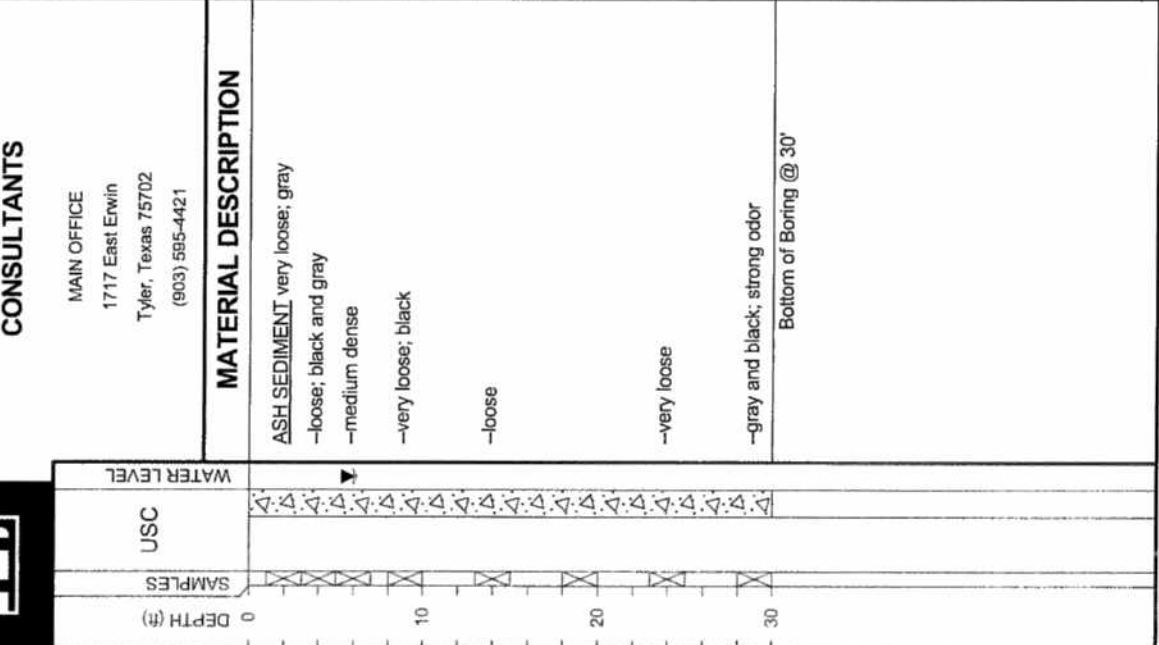
MATERIAL DESCRIPTION
ASH SEDIMENT very loose; gray
-loose; black and gray
-medium dense
-very loose; black
-loose
-very loose
-gray and black; strong odor
Bottom of Boring @ 30'

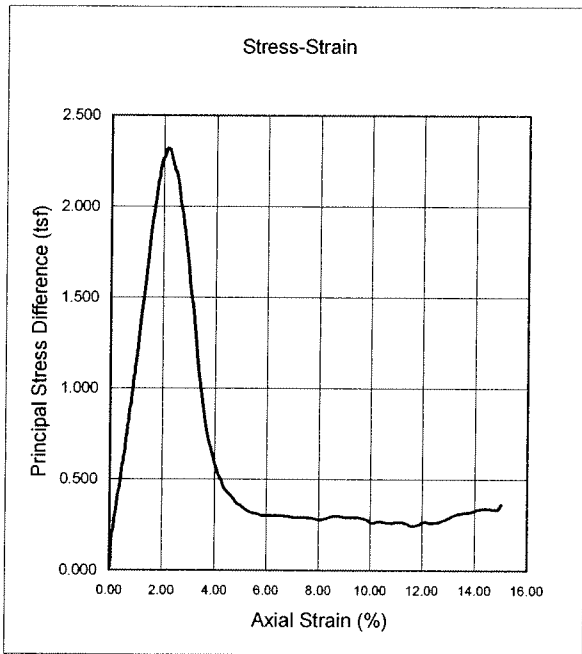
Project No.:	<u>G 2810-08</u>	
Boring No.:	<u>B-7</u>	
Depth, ft.:	<u>5'-7'</u>	
Material:	<u>Black Ash with Gravel</u>	
Initial Height	<u>5.706</u>	<u>Inches</u>
Initial Diameter	<u>2.767</u>	<u>Inches</u>
Moisture Content:	<u>22.9%</u>	<u>%</u>
Dry Density:	<u>97.5</u>	<u>lbs/cu ft</u>
Specific Gravity (Assumed)	<u>2.670</u>	
Volume of Solids:	<u>0.585</u>	
Volume of Voids	<u>0.415</u>	
Void Ratio:	<u>0.709</u>	
Confining Pressure:	<u>6.1</u>	<u>PSI</u>
Pocket Penetr. Reading:	<u>4.5</u>	
Torvane (T)	<u> </u>	
Rate of Strain: (%/ min)	<u>1.0%</u>	
Peak Strain:	<u>2.1</u>	<u>%</u>
Max Stress:	<u>2.32</u>	<u>TSF</u>
Date:	<u>3/11/2008</u>

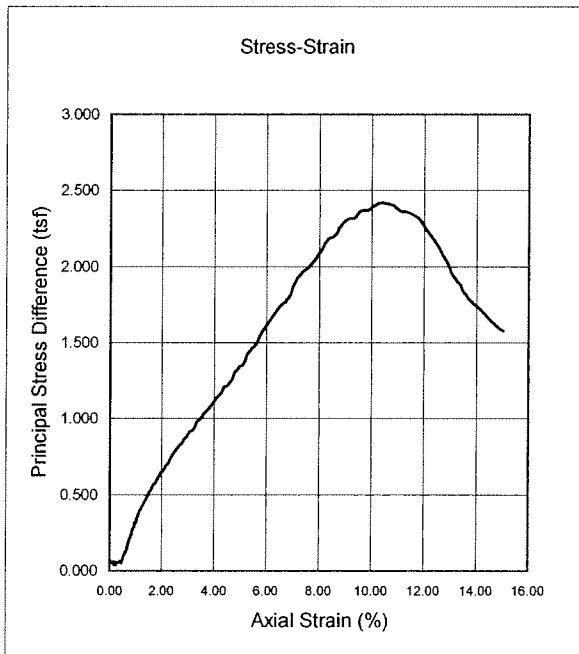
Project No.: G 2810-08
 Boring No.: B-4
 Depth, ft.: 13'-15'
 Material: Red & Gray Laminated Lean Clay
 Initial Height 3.613 Inches
 Initial Diameter 2.667 Inches
Moisture Content: 22.3% %
 Dry Density: 99.4 lbs/cu ft
 Specific Gravity (Assumed) 2.670
 Volume of Solids: 0.596
 Volume of Voids 0.404
 Void Ratio: 0.677
 Confining Pressure: 13 PSI
 Pocket Penetr. Reading: 3.5
 Torvane (T) _____
 Rate of Strain: (%/ min) 1.0%
Peak Strain: 10.3 %
Max Stress: 2.42 TSF
 Date: 5/12/2008

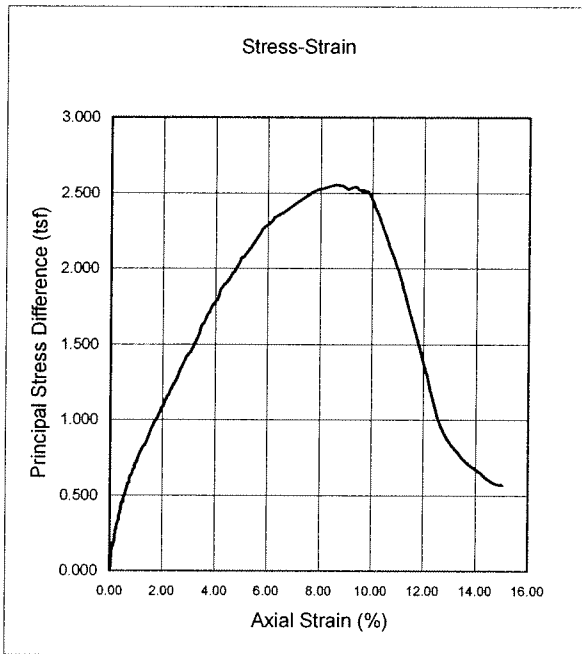
Project No.:	<u>G 2810-08</u>
Boring No.:	<u>B-4</u>
Depth, ft.:	<u>13'-15'</u>
Material:	<u>Light Gray & Red Silty Clayey Sand w/ Ferric seams</u>
Initial Height	<u>5.688</u> Inches
Initial Diameter	<u>2.75</u> Inches
Moisture Content:	<u>21.5%</u> %
Dry Density:	<u>104.6</u> lbs/cu ft
Specific Gravity (Assumed)	<u>2.670</u>
Volume of Solids:	<u>0.628</u>
Volume of Voids	<u>0.372</u>
Void Ratio:	<u>0.593</u>
Confining Pressure:	<u>13</u> PSI
Pocket Penetr. Reading:	<u>3.9</u>
Torvane (T)	<u>1.138</u>
Rate of Strain: (%/ min)	<u>1.0%</u>
Peak Strain:	<u>8.6</u> %
Max Stress:	<u>2.55</u> TSF
Date:	<u>4/11/2008</u>

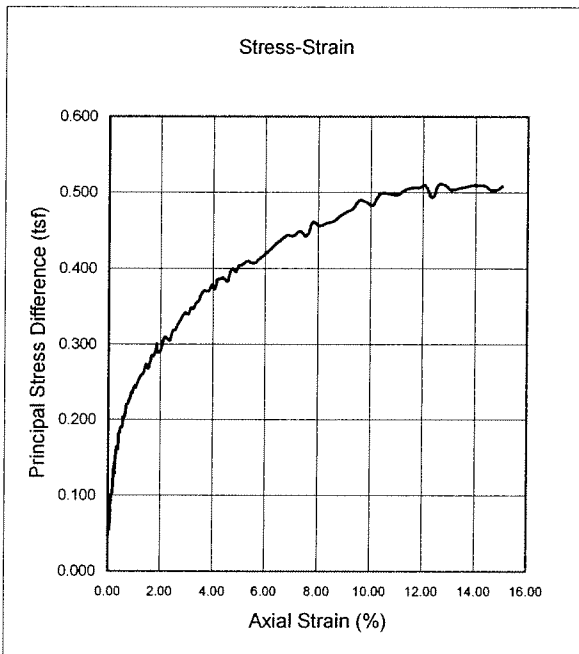
Project No.:	<u>G 2810-08</u>
Boring No.:	<u>B-7</u>
Depth, ft.:	<u>23'-25'</u>
Material:	<u>Black, Red, Tan, & Gray Clay w/ gravel</u>
Initial Height	<u>5.686</u> Inches
Initial Diameter	<u>2.717</u> Inches
Moisture Content:	<u>21.0%</u> %
Dry Density:	<u>103.9</u> lbs/cu ft
Specific Gravity (Assumed)	<u>2.670</u>
Volume of Solids:	<u>0.624</u>
Volume of Voids	<u>0.376</u>
Void Ratio:	<u>0.603</u>
Confining Pressure:	<u>21.7</u> PSI
Pocket Penetr. Reading:	<u> </u>
Torvane (T)	<u> </u>
Rate of Strain: (%/ min)	<u>1.0%</u>
Peak Strain:	<u>12.8</u> %
Max Stress:	<u>0.51</u> TSF
Date:	<u>3/11/2008</u>

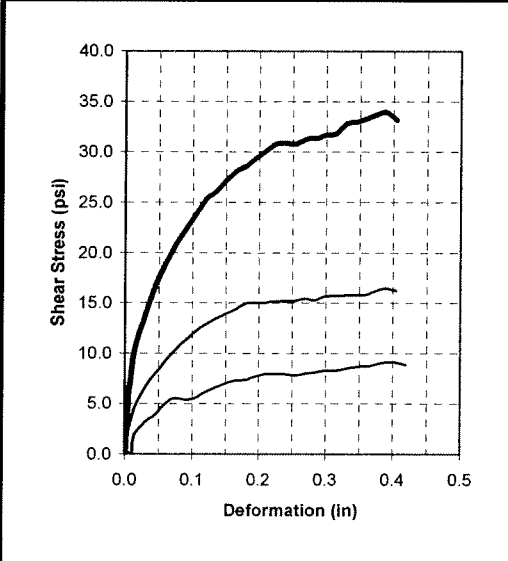
SPECIMEN NO.	1	2	3	4
INITIAL				
Moisture Content - %	52.1	29.3	21.2	
Dry Density - pcf	50.2	71.7	95.2	
Diameter - inches	2.50	2.50	2.50	
Height - inches	1.13	1.13	1.13	
AT TEST				
Final Moisture - %	64.3	25.0	31.6	
Dry Density - pcf	55.8	79.1	117.3	
Height-End of Consol. (in.)	1.02	1.03	0.92	
Height-End of Shear (in.)	0.97	0.99	0.89	
Normal Stress - psi	10.0	20.0	40.0	
Peak Failure Stress-psi	9.2	16.5	34.0	
Post Peak Failure Stress-psi	7.9	14.9	30.8	
Strain Rate - inches/min.	0.00300	0.00300	0.00300	
Peak Failure Strain - %	16.2	15.6	15.6	
Post Peak Failure Strain %	8.4	7.2	9.6

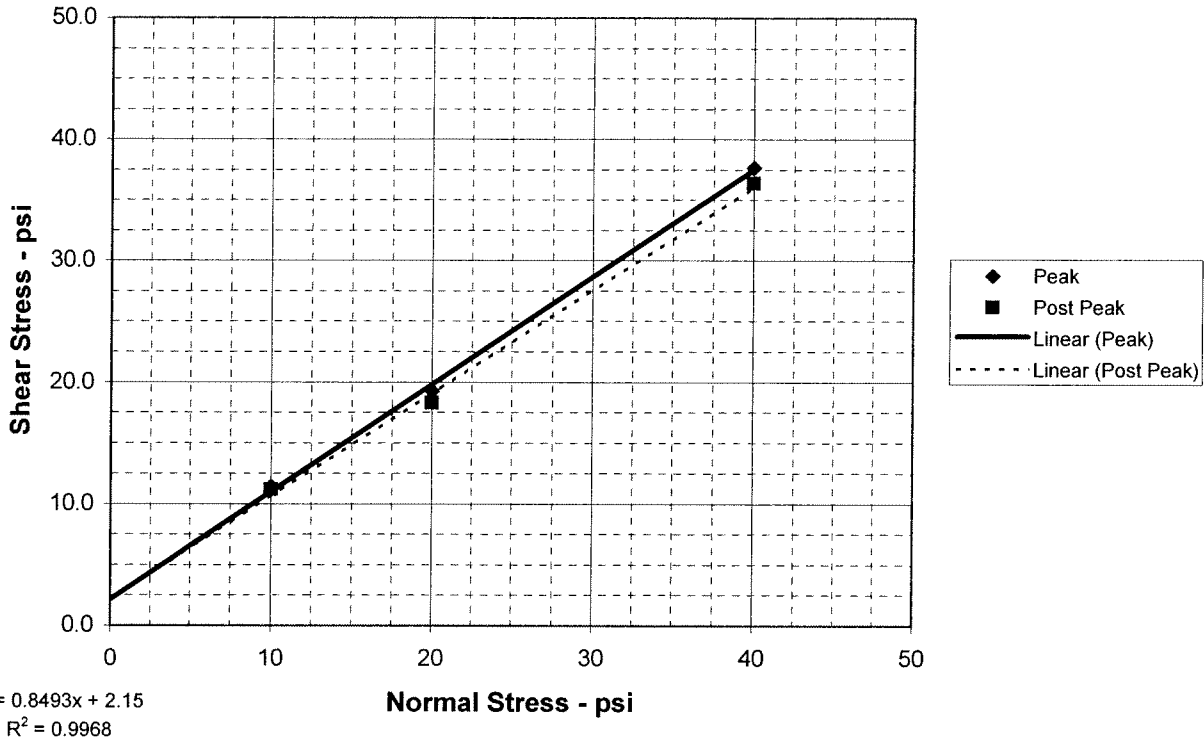
PEAK STRENGTH PARAMETERS	$\phi = 41.4$ deg	$c = 2.2$ psi
POST PEAK STRENGTH PARAMETERS	$\phi = 40.3$ deg	$c = 2.2$ psi

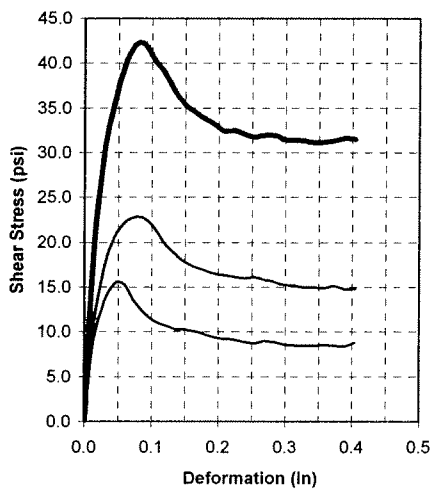
SPECIMEN NO.	1	2	3	4
INITIAL				
Moisture Content - %	0.1	0.1	0.1	
Dry Density - pcf	71.7	71.7	71.7	
Diameter - inches	2.50	2.50	2.50	
Height - inches	1.00	1.00	1.00	
AT TEST				
Final Moisture - %	50.3	37.4	31.6	
Dry Density - pcf	73.4	73.1	73.1	
Height-End of Consol. (in.)	0.98	0.98	0.98	
Height-End of Shear (in.)	1.01	1.01	0.99	
Normal Stress - psi	10.0	20.0	40.0	
Peak Failure Stress-psi	15.4	22.8	42.2	
Post Peak Failure Stress-psi	8.5	14.8	31.2	
Strain Rate - inches/min.	0.00300	0.00300	0.00300	
Peak Failure Strain - %	17.6	3.0	3.6	
Post Peak Failure Strain %	15.0	15.6	13.8

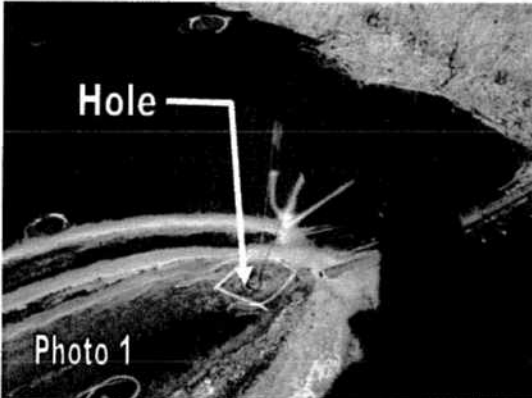
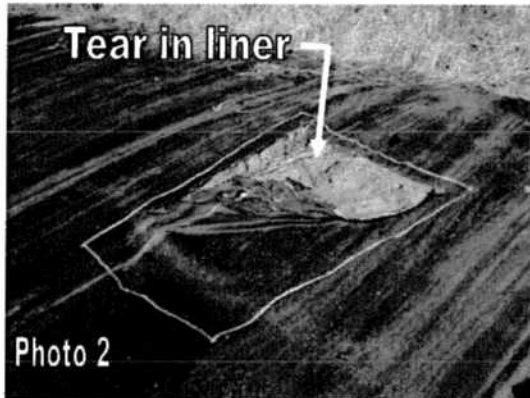
Erosion is present all along the upstream embankment on the northeast side. (Photos 3 & 4) The erosion is believed to be a result of runoff from the construction of PDP5 which is located upstream. The construction of PDP5 is complete and the erosion has not deteriorated since the previous inspection. It is recommended to continue to monitor and repair if it worsens.

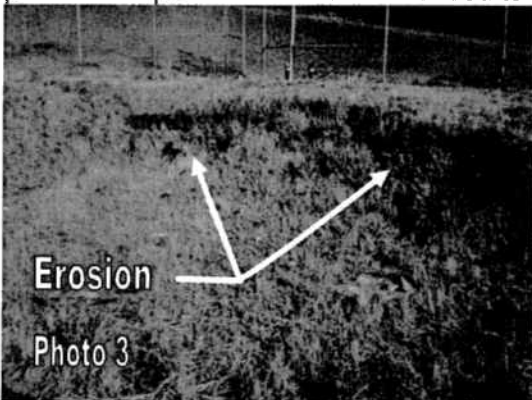
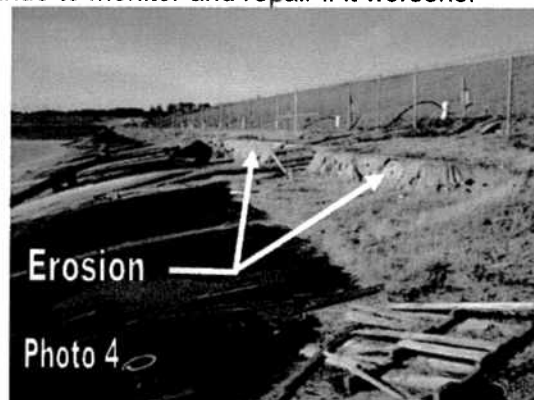
Overall the downstream embankment was in good condition and well vegetated. There was one area near the toe of the embankment on the center of the south side that is bare of vegetation. This needs to be monitored through the winter and ensure that grass fills in this area during the spring growing season (Photo 5). Reseed if the grass is not establish by the end of May.

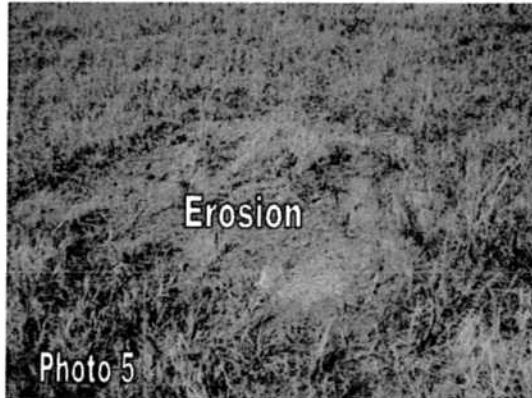
Permanent Disposal Pond 5 (PDP5):

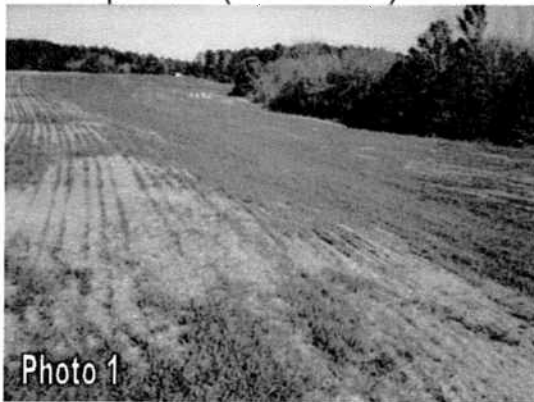
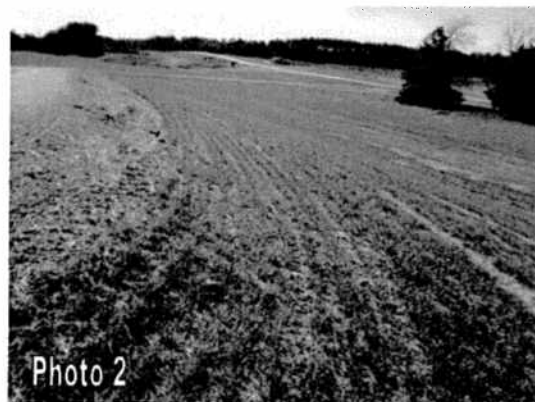
A majority of the upstream slope is not filled in with vegetative cover. This increases the slopes' exposure to erosion and will need to be monitored until the grass becomes established. (Photos 3 & 4)

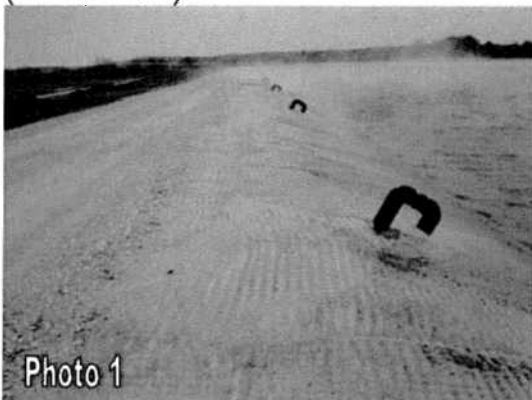
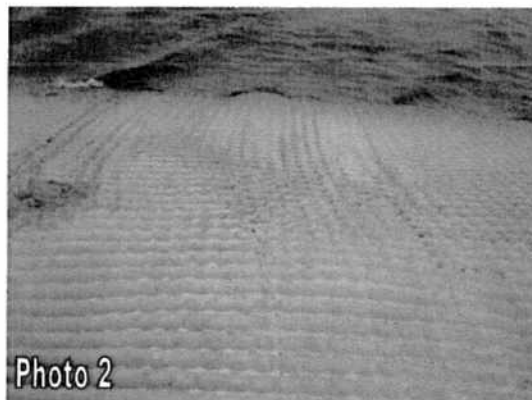
The outfall pipes were in good condition and no leaks were detected. (Photos 3 & 4)

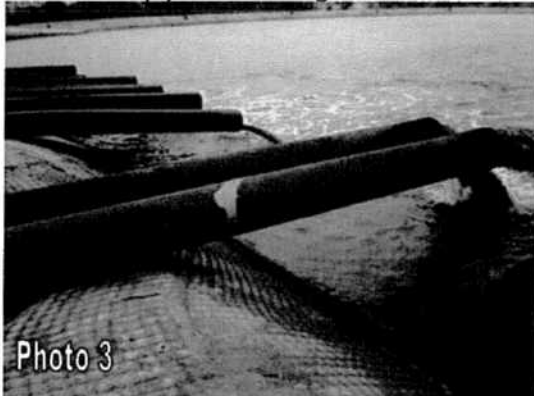
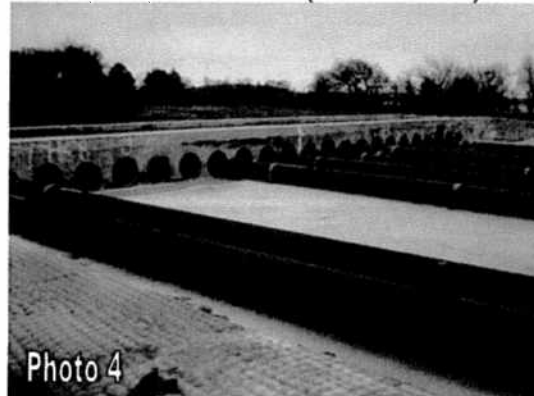
During the construction the downstream embankment on the north side was exposed, but has been revegetated. January 2010 (Photo 5a). January 2011 (Photo 5b).

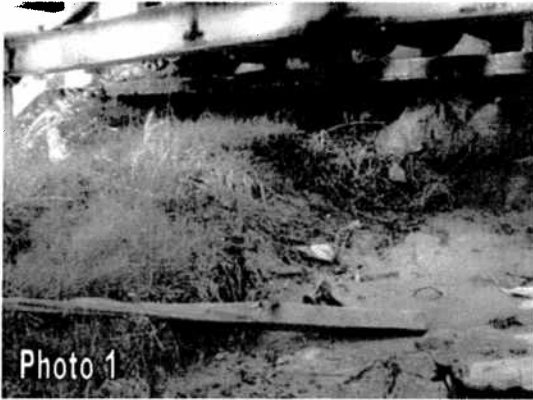
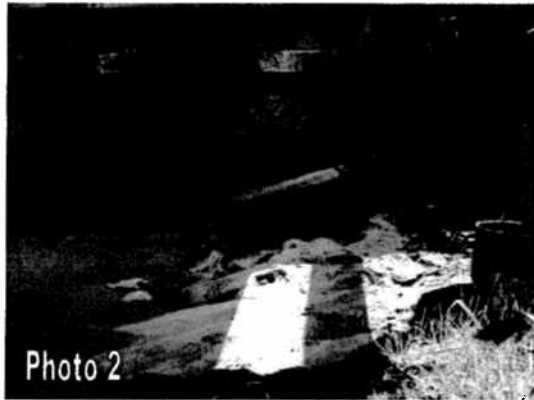
Overall the downstream embankment was in good condition with the exception of a large gully on the center of the west side. This needs to be filled in and re-vegetated. (Photo 3 is the view from the top of the crest and photo 4 is taken from the toe.)

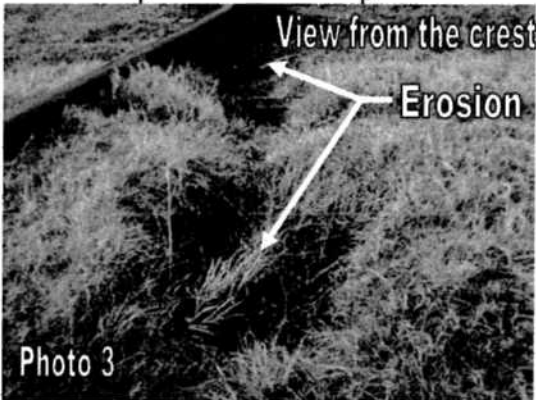
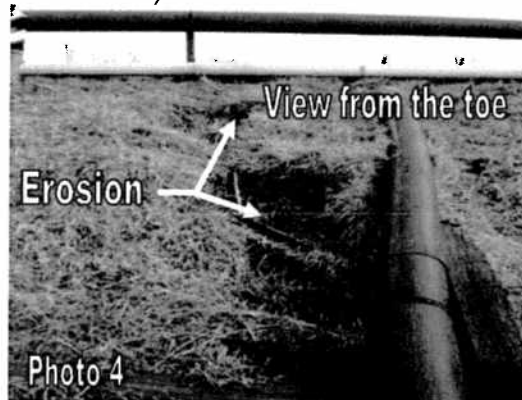
A leak was present on the gate valve on the second (from the west). This needs to be repaired to prevent saturation which could weaken the embankment and possibly result in a slide in this location. Monitor regularly until the repairs are completed. (Photo 5a & 5b)

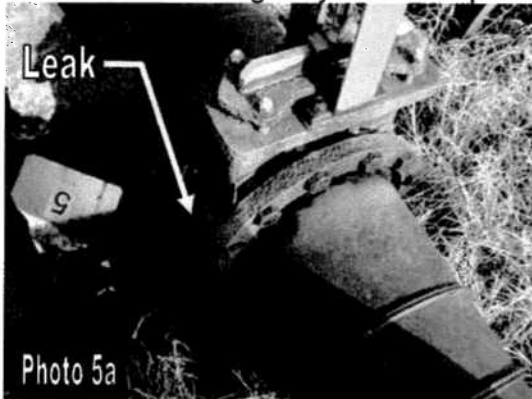
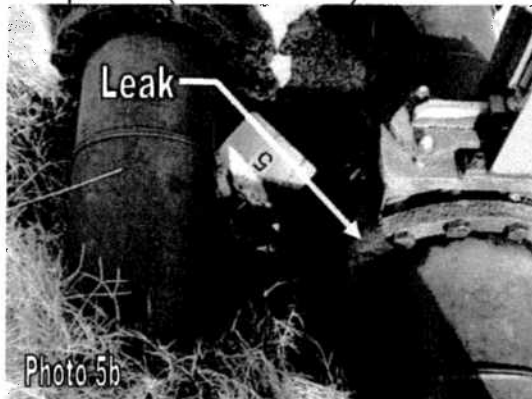
There are steel pipes that are leaking what appears to be sulphur dioxide. These leaks appear to be small and the leaking minimal. Repairs need to be undertaken as soon as possible. (Photo 6 & 7)

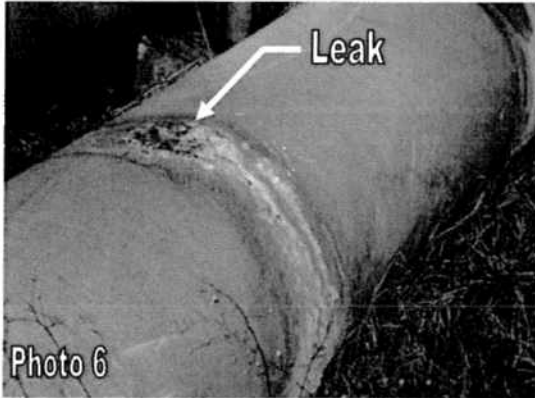
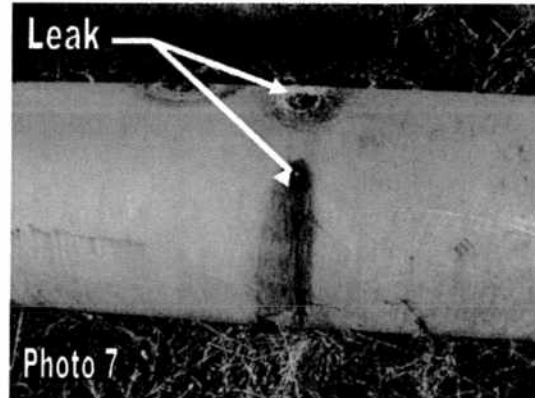
Rutting was present in several locations along the crest (Photos 8 and 9). These need to be repaired to prevent rainfall runoff from collecting and penetrating which can potentially lead to weakening of the embankment. Care should be taken to avoid driving on the crest when it is soft when possible. See SK-3 for all locations.

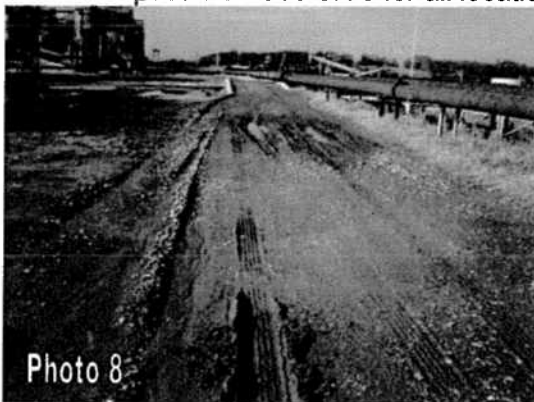
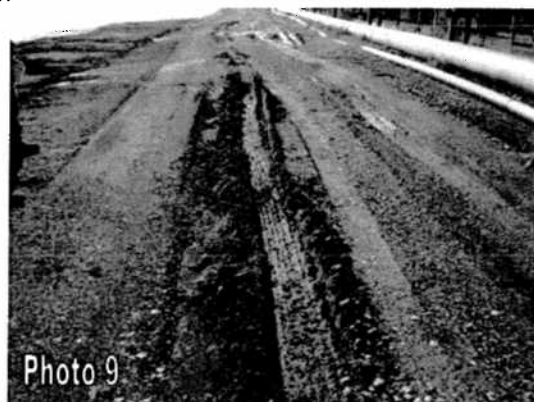
Emergency Sludge Pond:

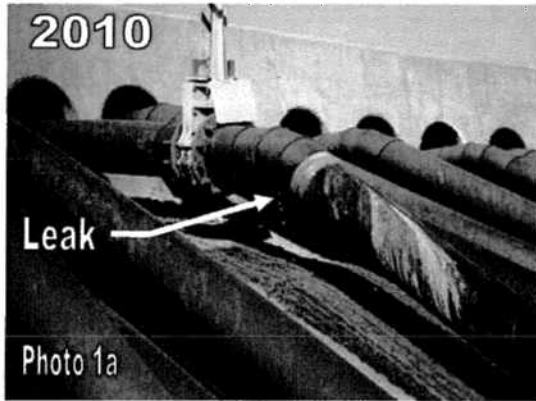
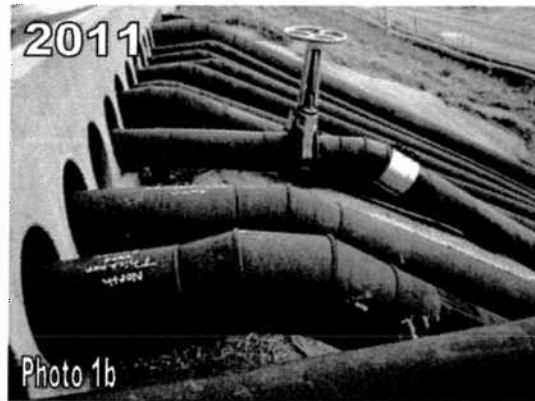
There were two areas on the downstream embankment adjacent to the pump station where erosion has occurred. Both are well vegetated and have not degraded since the previous inspection. Continue to monitor and repair if the erosion worsens. (Photos 2 & 3)

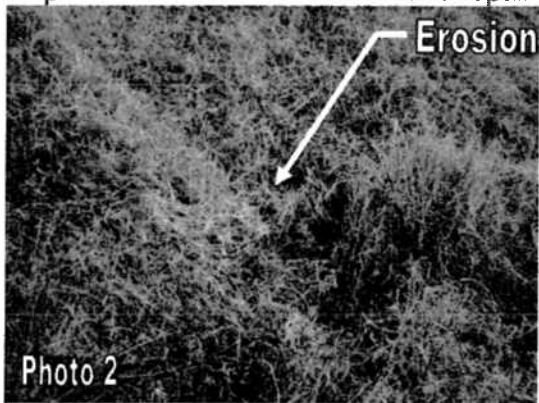
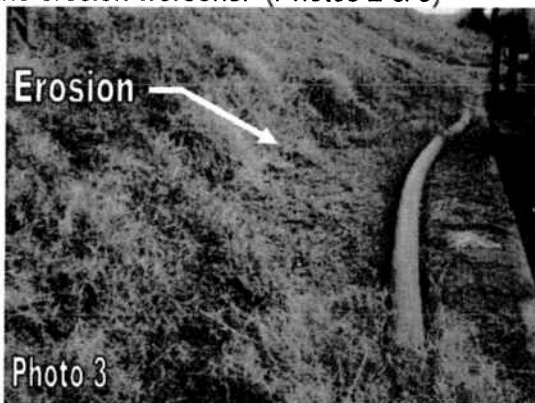
Other action items include filling in the burrow on the north side of the northeast corner (Photo 4) and removing the small shrub on the north side on the downstream slope near where it merges with the East Bottom Ash Pond (Photo 5). There was some rutting on the crest. These need to be repaired to prevent water from collecting and penetrating the embankment. See SK-3 for the locations.

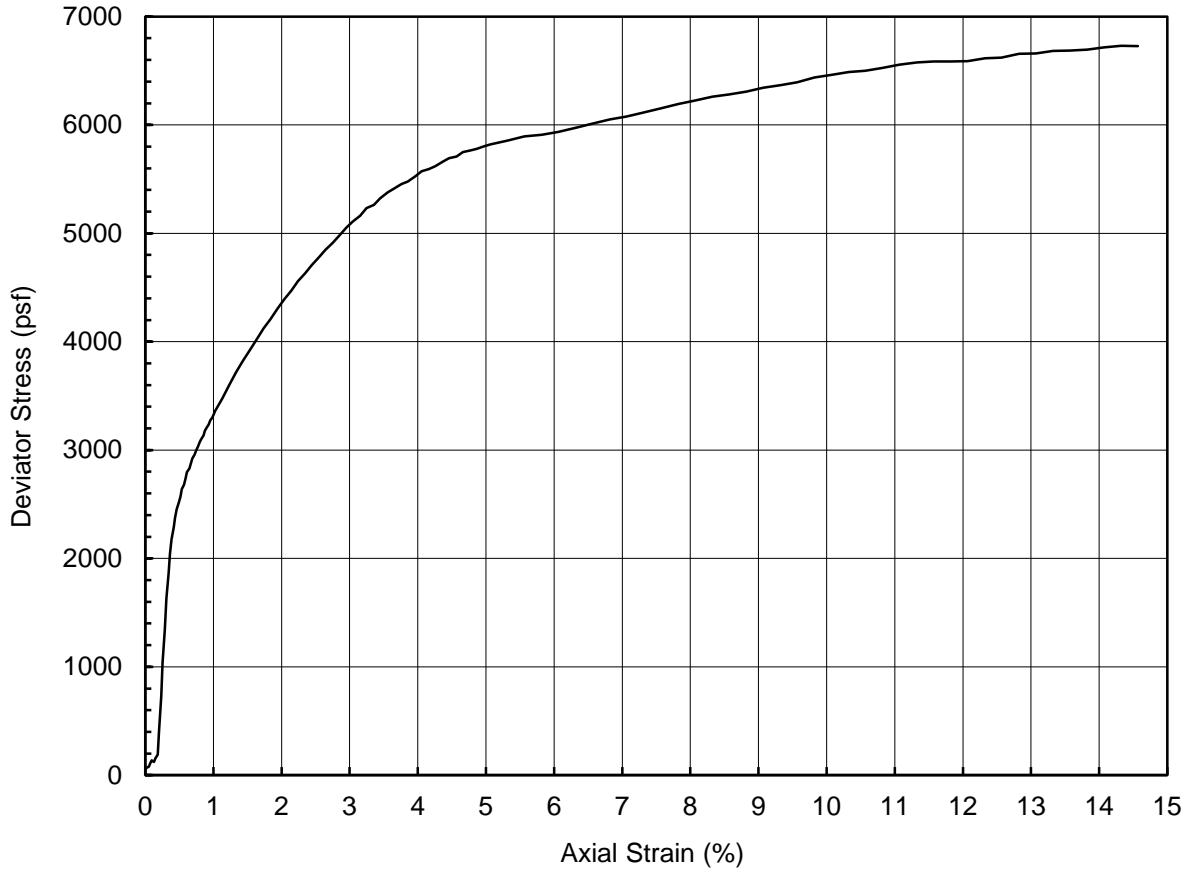
Specimen Description	Reddish Yellow Clay (visual classification)			
LL		PI	LI	USCS

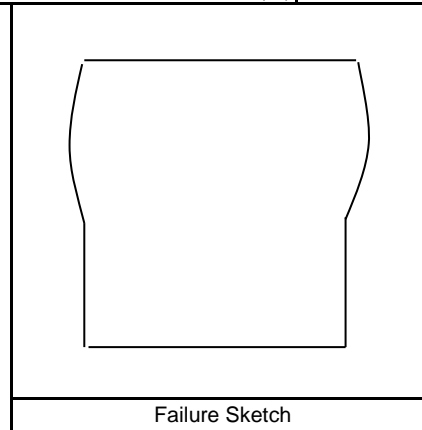
Performed by	PN
Date	12-Nov-12
Check	HR
Review	SBK
