US EPA ARCHIVE DOCUMENT

**Coal Combustion Residue Impoundment
Round 12 - Dam Assessment Report**

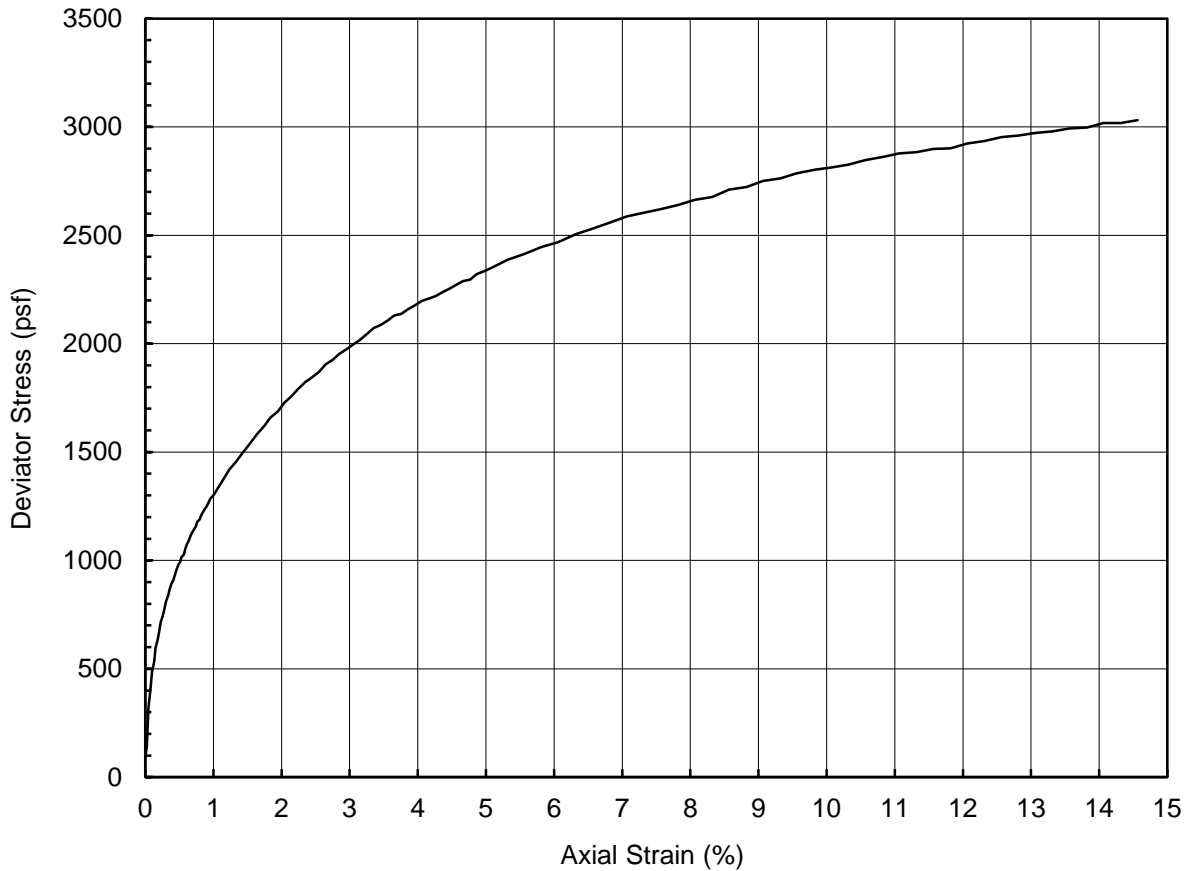
Specimen Description					Reddish Yellow Clay (visual classification)				
LL		PI		LI		USCS

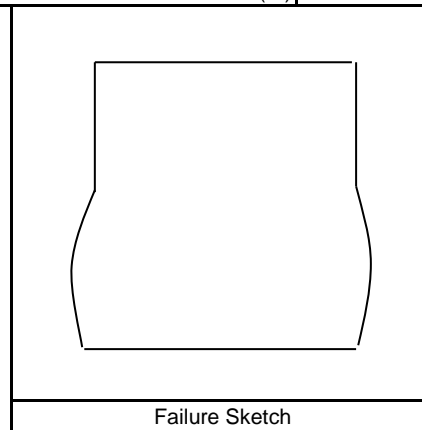
Performed by	PN
Date	13-Nov-12
Check	HR
Review	SBK

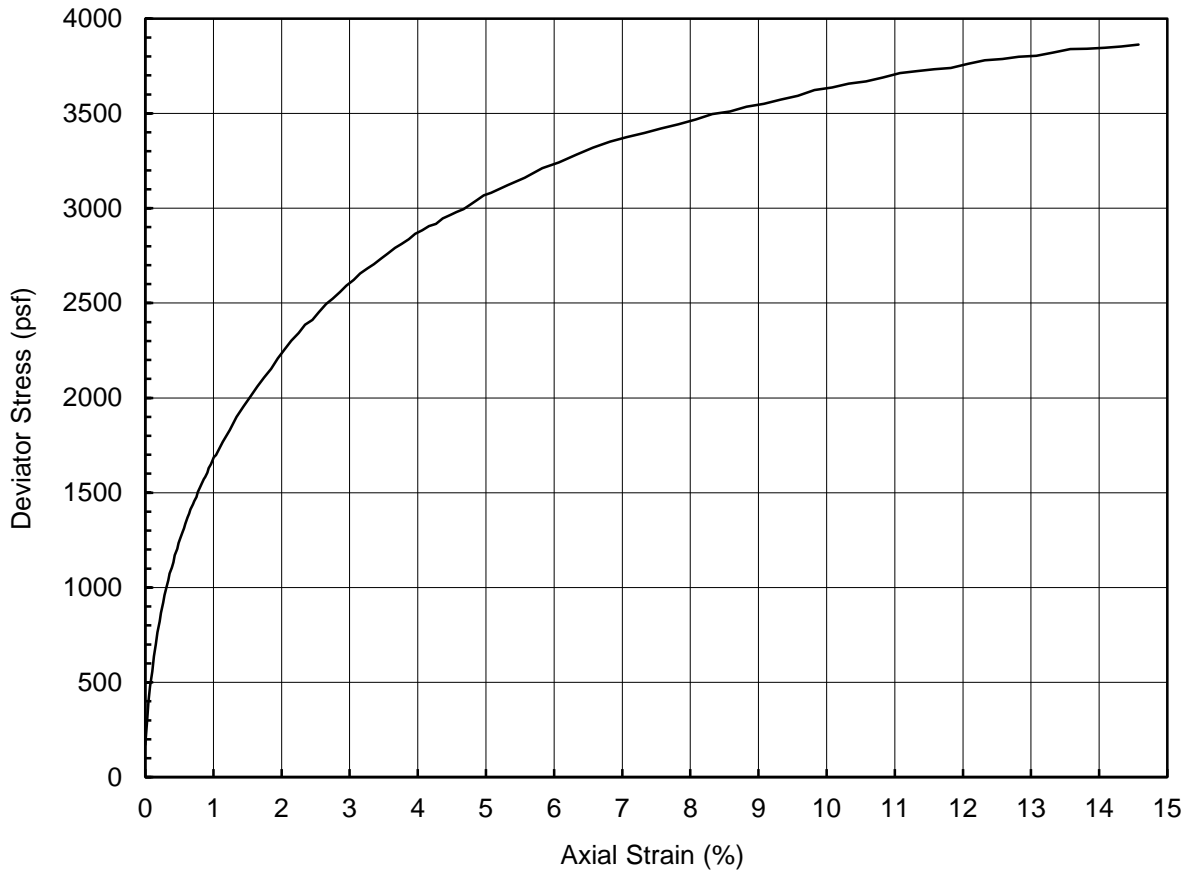
Specimen Description					Reddish Gray Clay (visual classification)				
LL		PI		LI		USCS

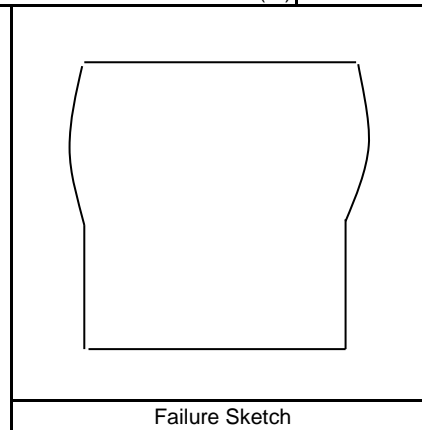
Performed by	PN
Date	13-Nov-12
Check	HR
Review	SBK

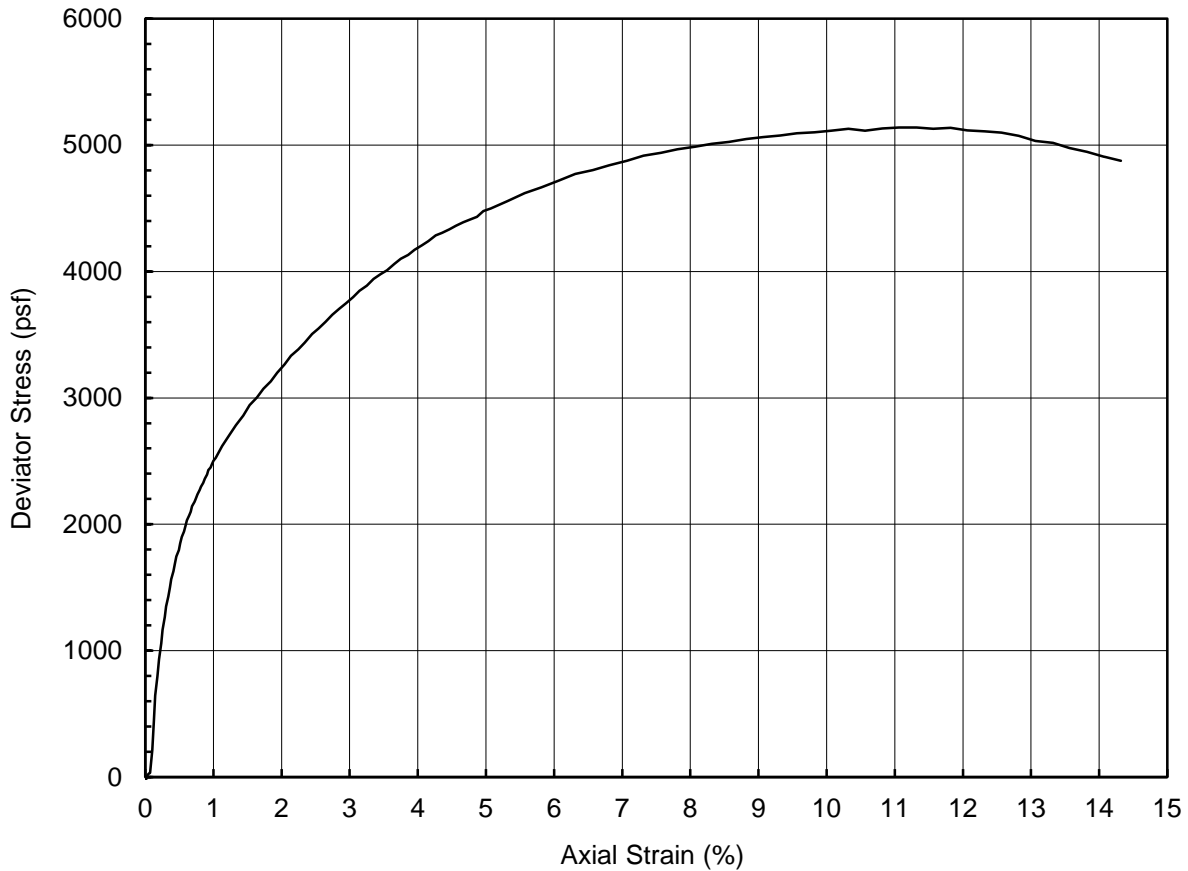
Specimen Description	Reddish Gray Clay (visual classification)			
LL		PI	LI	USCS

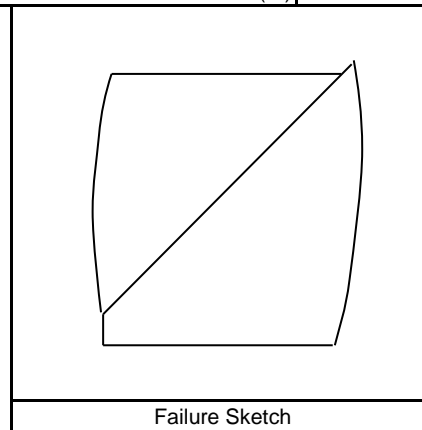
Performed by	PN
Date	13-Nov-12
Check	HR
Review	SBK

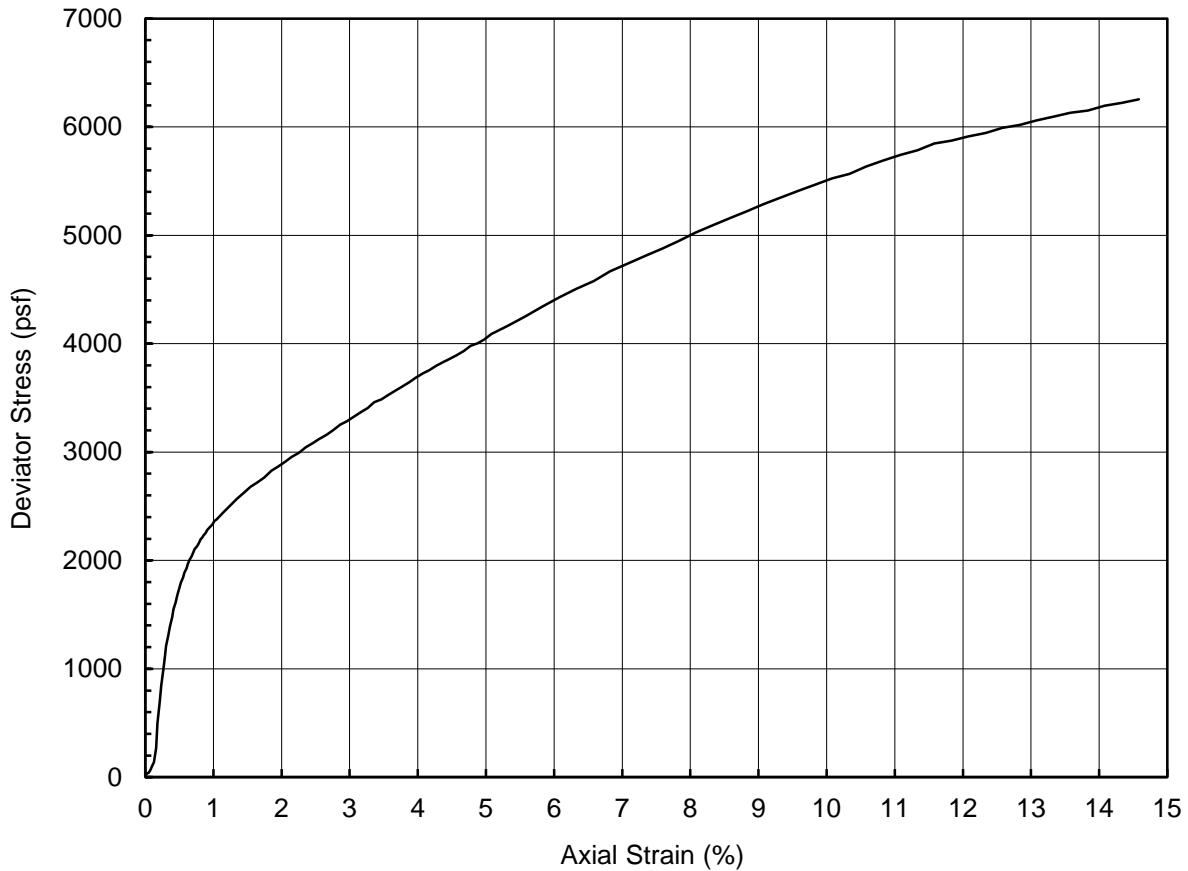
Specimen Description					Reddish Yellow Clay (visual classification)				
LL		PI		LI		USCS

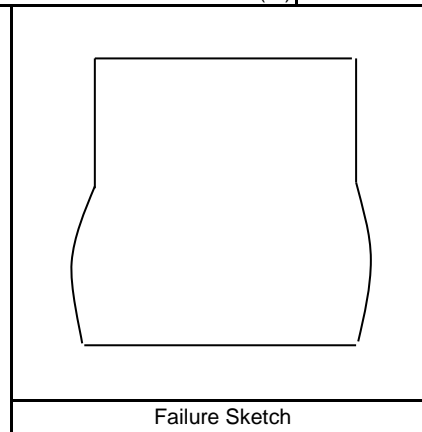
Performed by	PN
Date	13-Nov-12
Check	HR
Review	SBK

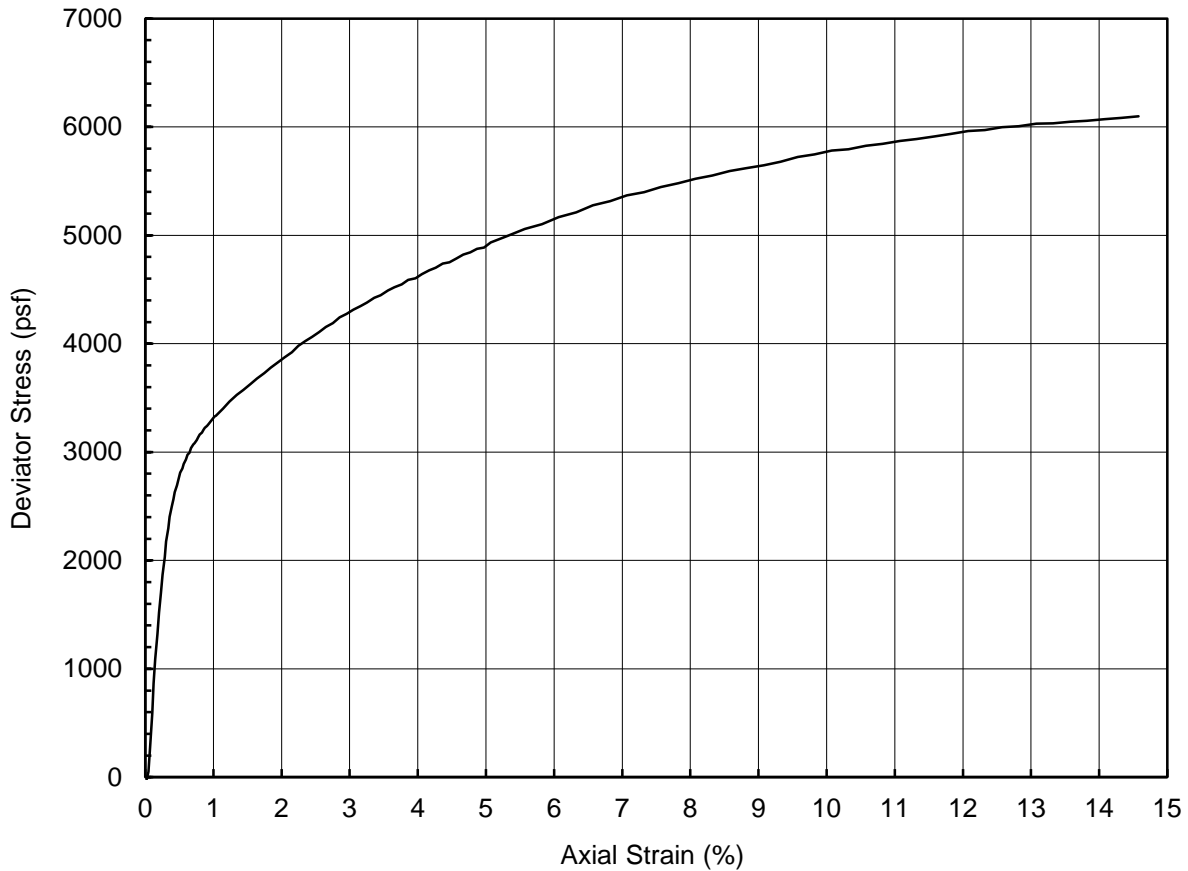
Specimen Description		Grayish Brown Fat Clay					
LL	59	PI	42	LI	0.1	USCS	CH

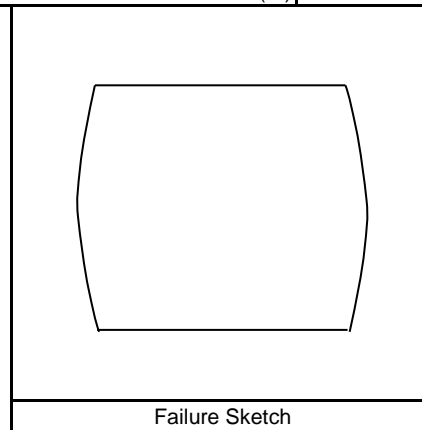
Performed by	PN
Date	15-Nov-12
Check	HR
Review	JF

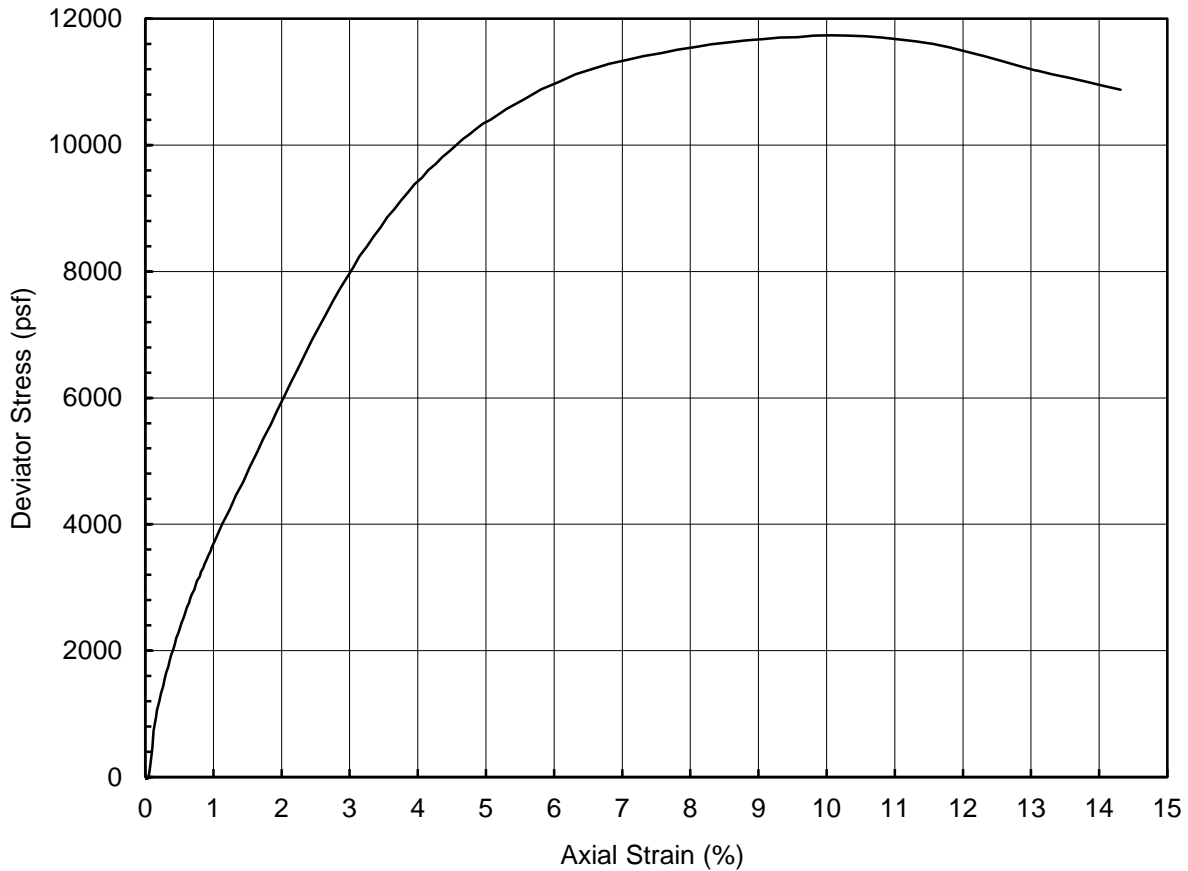
Specimen Description		Grayish Brown Lean Clay					
LL	31	PI	15	LI	0.0	USCS	CL

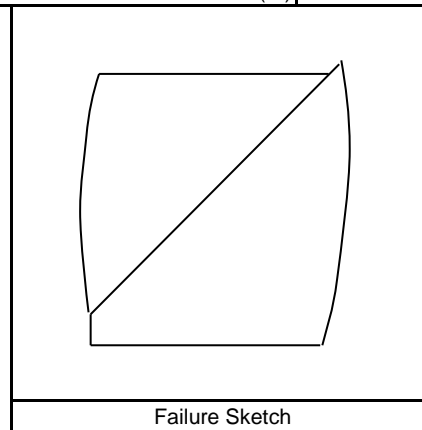
Performed by	PN
Date	15-Nov-12
Check	HR
Review	JF

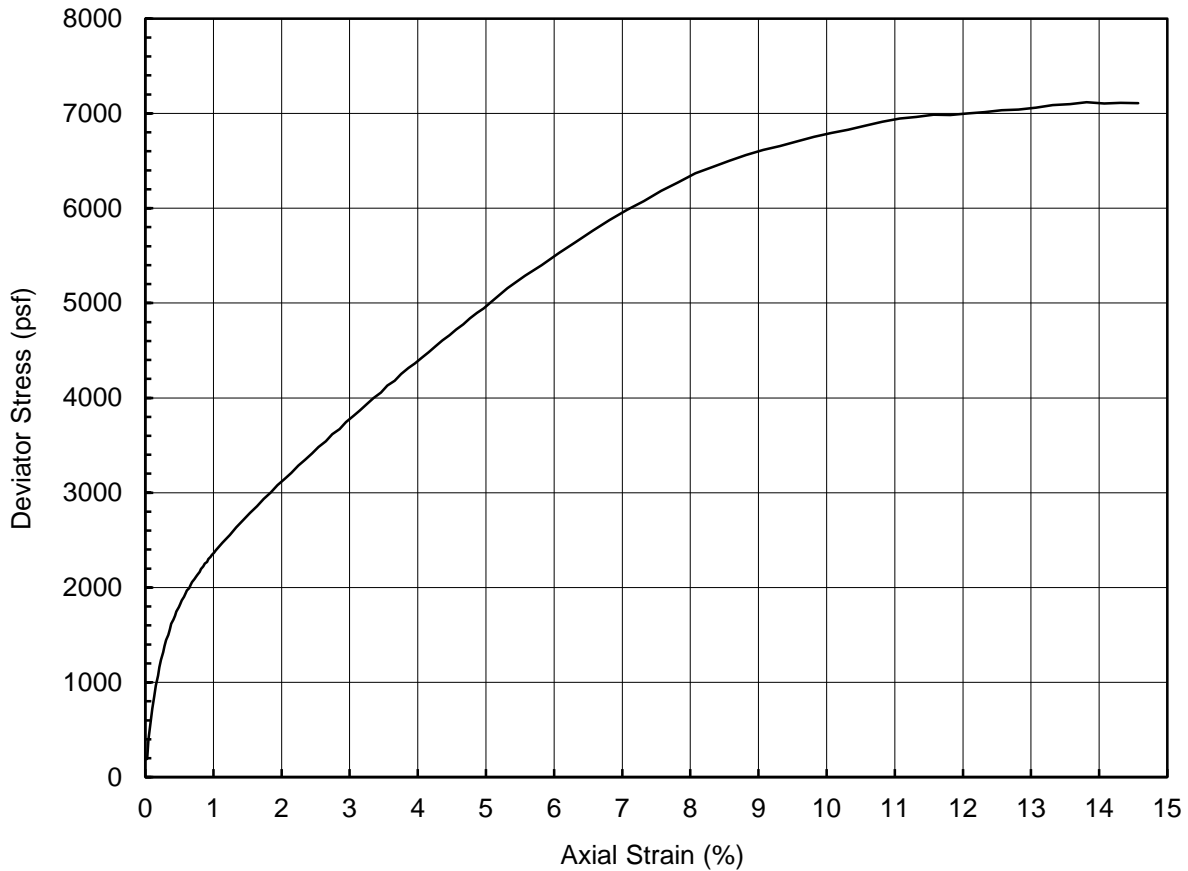
Specimen Description		Reddish Yellow Lean Clay					
LL	28	PI	13	LI	0.0	USCS	CL

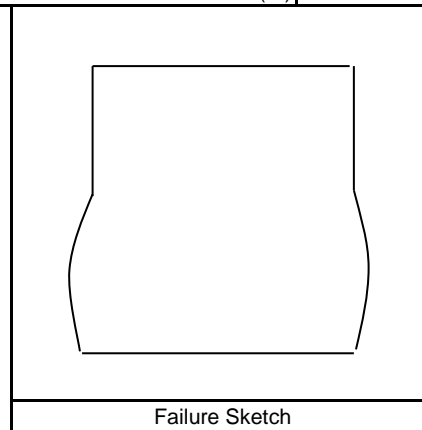
Performed by	PN
Date	16-Nov-12
Check	HR
Review	JF

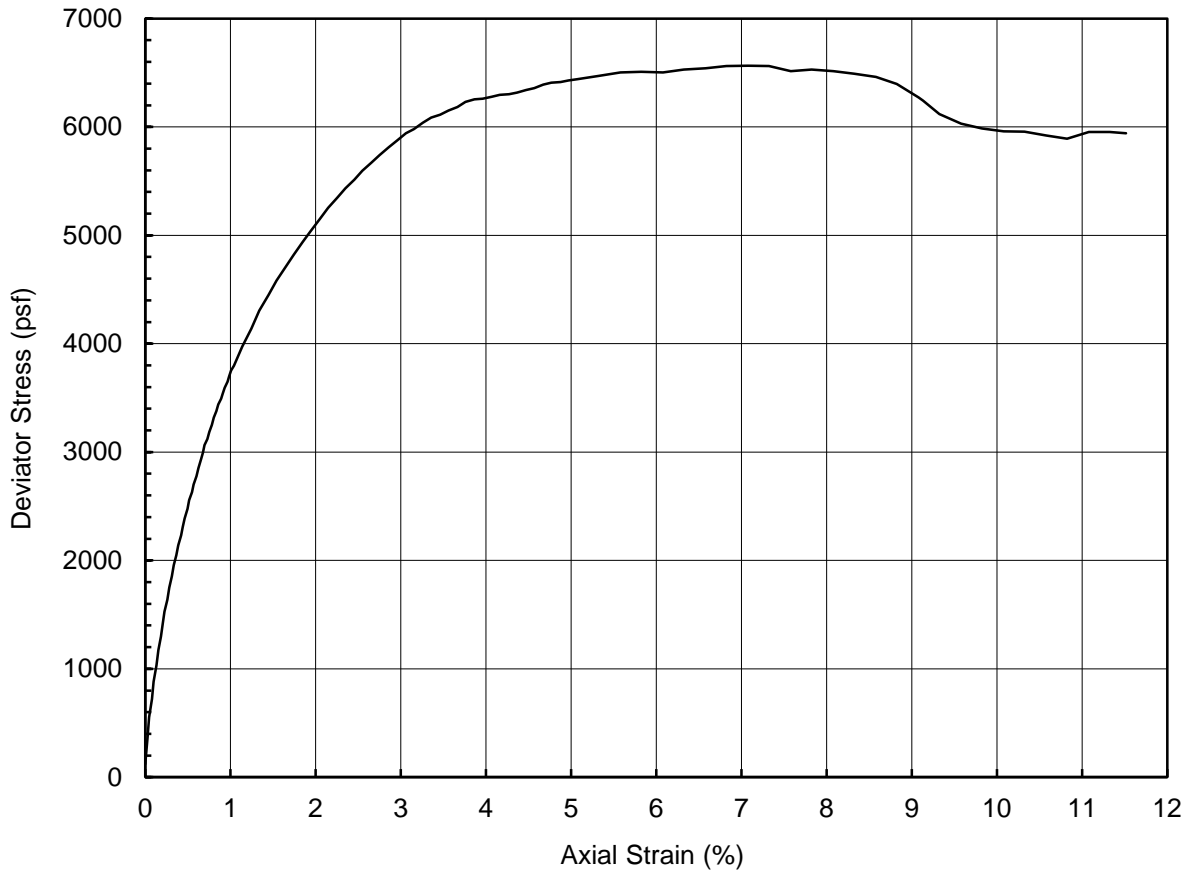
Specimen Description		Grayish Brown Lean Clay					
LL	41	PI	26	LI	0.3	USCS	CL

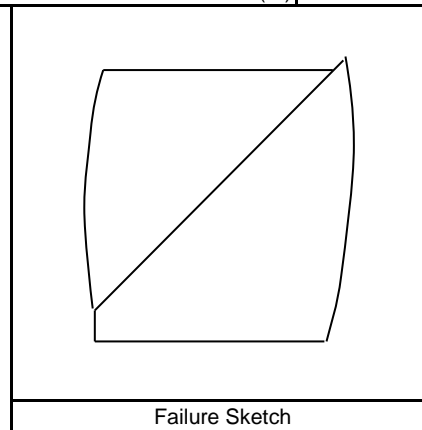
Performed by	PN
Date	16-Nov-12
Check	HR
Review	JF

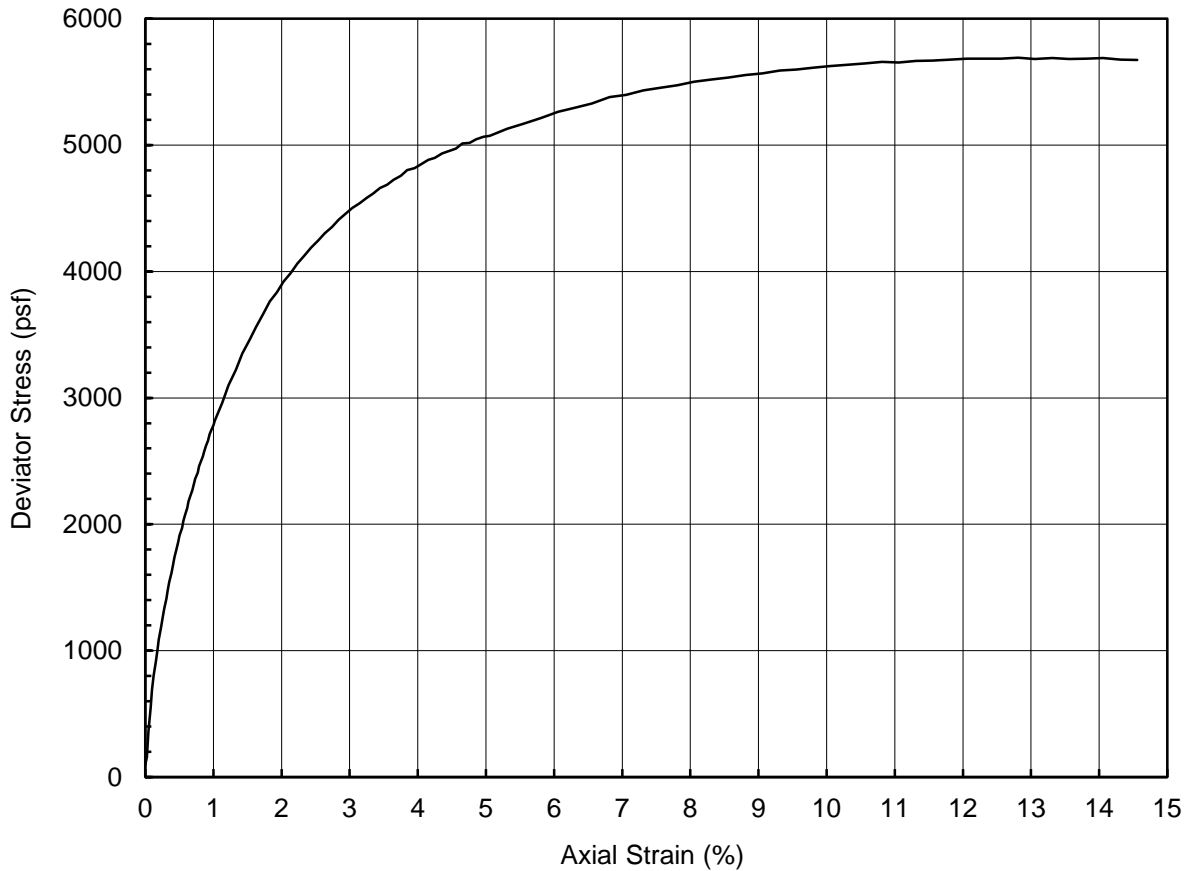
Specimen Description		Reddish Gray Lean Clay					
LL	36	PI	22	LI	0.5	USCS	CL

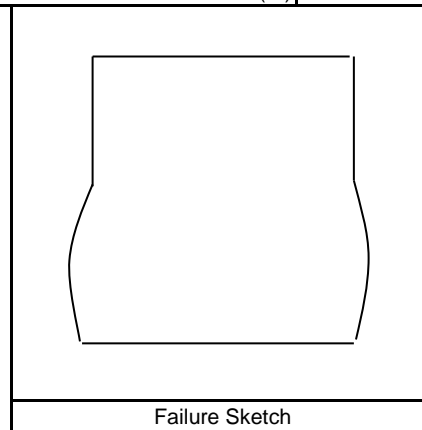
Performed by	PN
Date	16-Nov-12
Check	HR
Review	JF

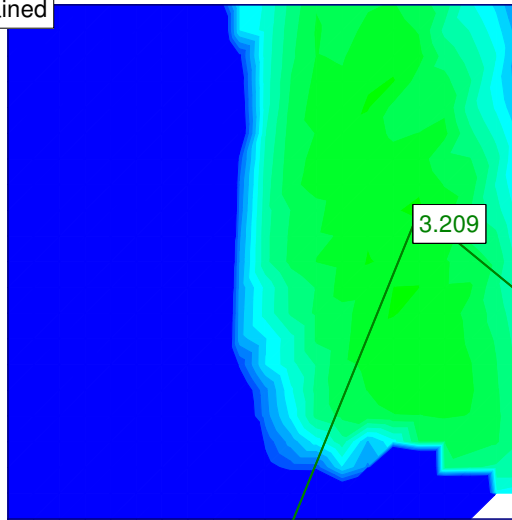
Results
 spencer
 Surface Type: Circular
 Search Method: Grid Search
 Radius Increment: 10
 Composite Surfaces: Disabled
 Reverse Curvature: Create Tension Crack
 Minimum Elevation: Not Defined
 Minimum Depth: Not Defined
 Every available surface
 3.209
 Factor of Safety: 3.209
 Center: 67.802, 373.820
 Radius: 71.007
 Left Slip Surface Endpoint: 41.034, 308.052
 Right Slip Surface Endpoint: 122.722, 328.811

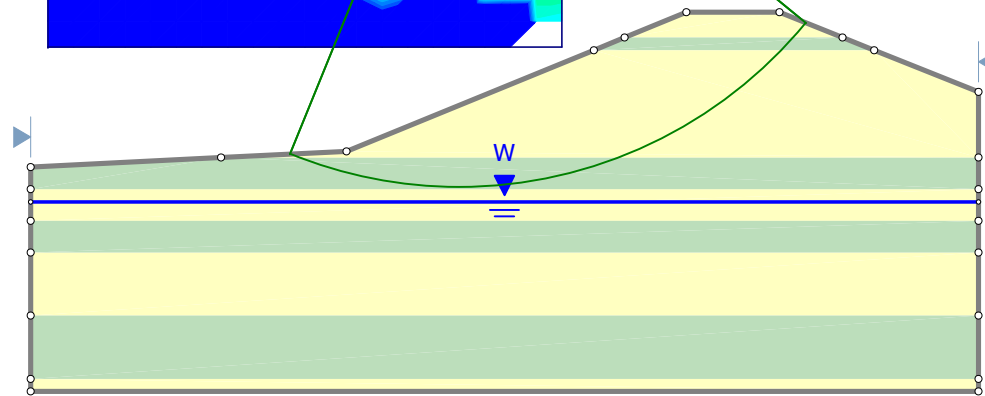
Material Name	Color	Unit Weight (lbs/ft3)	Strength Type	Cohesion (psf)	Phi (deg)	Water Surface	Hu Type
Sandy Clay/Clayey Sand		125	Mohr-Coulomb	1750	0	Water Surface	Constant
Sand		120	Mohr-Coulomb	0	30	Water Surface	Constant

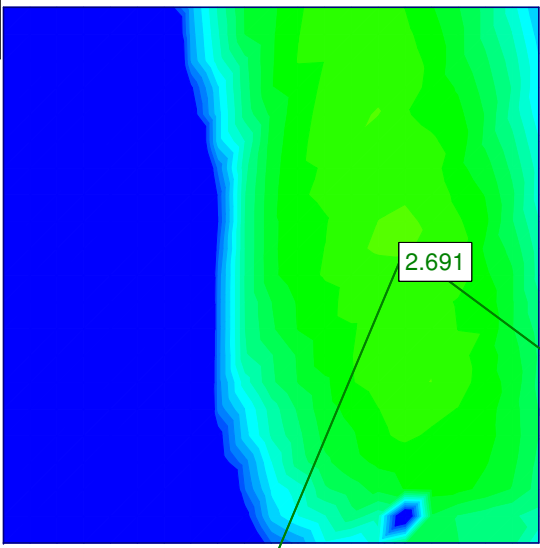
Luminant - Martin Lake Scrubber Pond
 Scrubber Pond__North Slope_Empty_drained

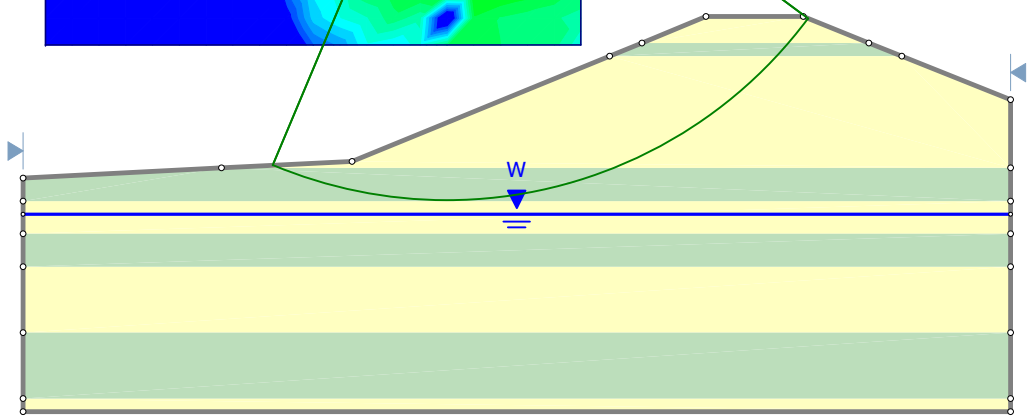
Material Name	Color	Unit Weight (lbs/ft3)	Strength Type	Cohesion (psf)	Phi (deg)	Water Surface	Hu Type
Sandy Clay/Clayey Sand	Yellow	125	Mohr-Coulomb	1000	14	Water Surface	Constant
Sand	Green	120	Mohr-Coulomb	0	30	Water Surface	Constant

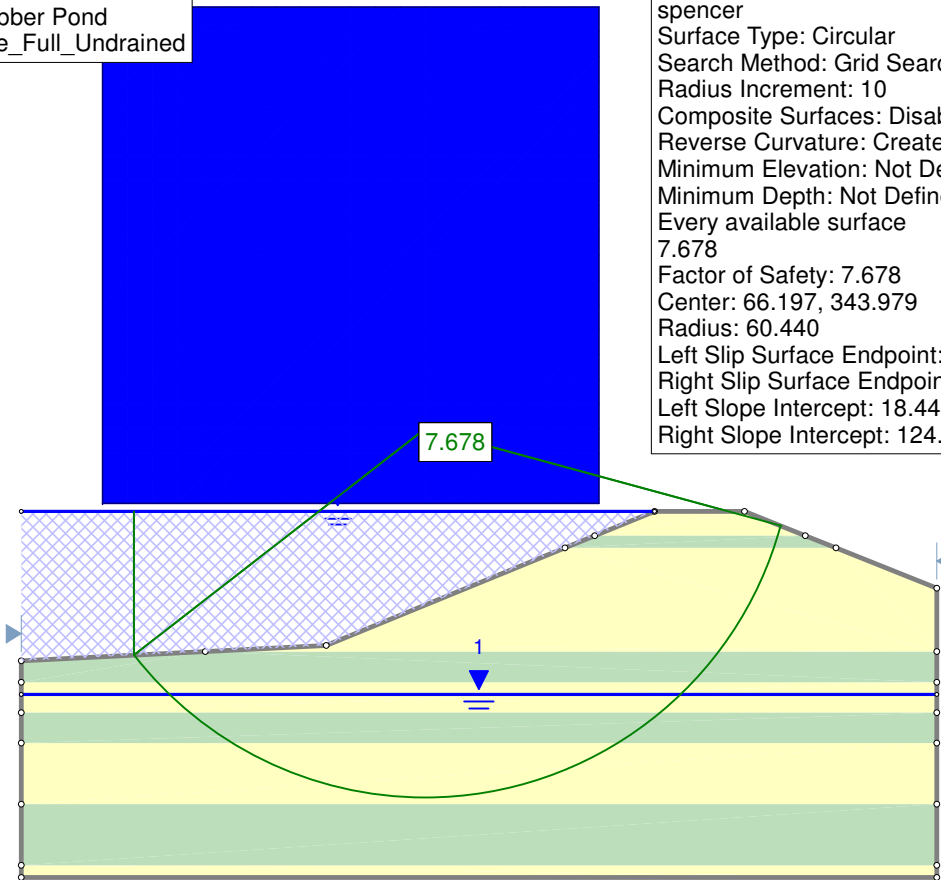
Results
 spencer
 Surface Type: Circular
 Search Method: Grid Search
 Radius Increment: 10
 Composite Surfaces: Disabled
 Reverse Curvature: Create Tension Crack
 Minimum Elevation: Not Defined
 Minimum Depth: Not Defined
 Every available surface
 7.678
 Factor of Safety: 7.678
 Center: 66.197, 343.979
 Radius: 60.440
 Left Slip Surface Endpoint: 18.449, 306.922
 Right Slip Surface Endpoint: 124.512, 328.095
 Left Slope Intercept: 18.449 330.500
 Right Slope Intercept: 124.512 328.095

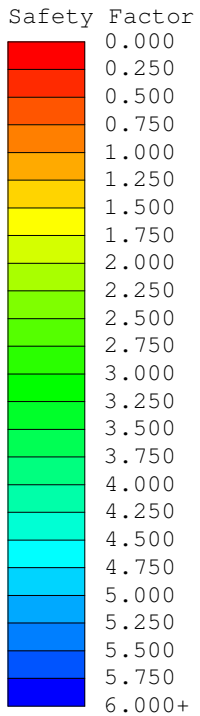
Luminant - Martin Lake Scrubber Pond
 Scrubber Pond__North Slope_Full_drained

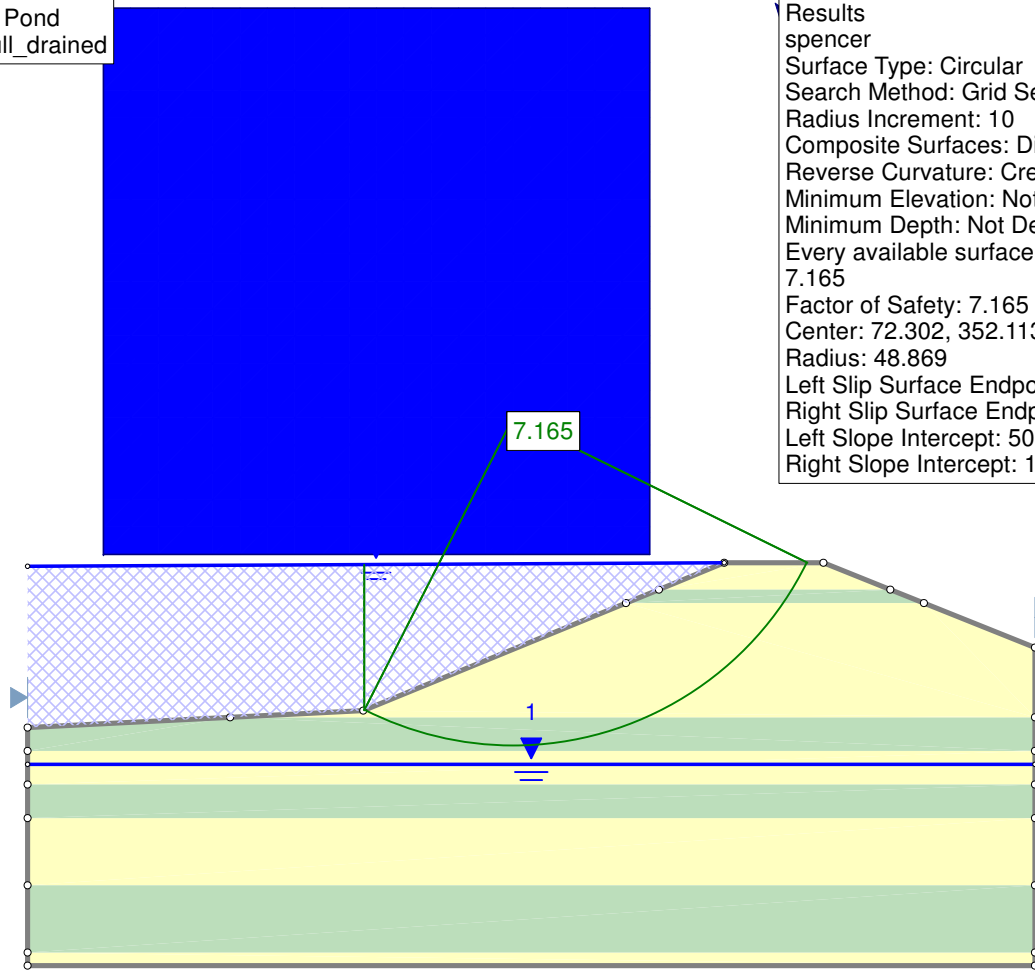
Material Name	Color	Unit Weight (lbs/ft ³)	Strength Type	Cohesion (psf)	Phi (deg)	Water Surface	Hu Type
Sandy Clay/Clayey Sand		125	Mohr-Coulomb	1000	14	Piezometric Line 1	Constant
Sand		120	Mohr-Coulomb	0	30	Piezometric Line 1	Constant

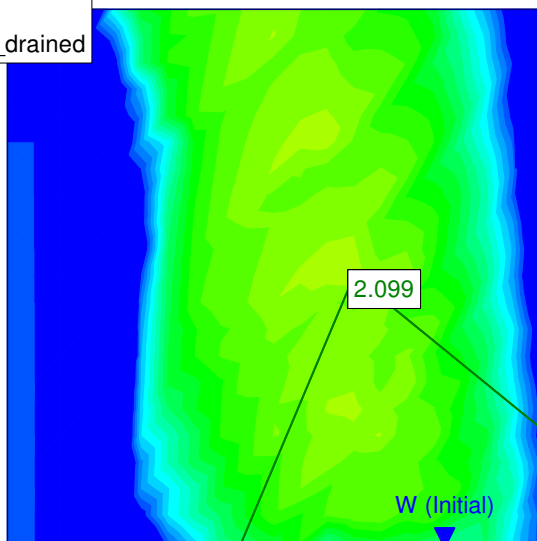
Results
 spencer
 Surface Type: Circular
 Search Method: Grid Search
 Radius Increment: 10
 Composite Surfaces: Disabled
 Reverse Curvature: Create Tension Crack
 Minimum Elevation: Not Defined
 Minimum Depth: Not Defined
 Every available surface
 2.099
 Factor of Safety: 2.099
 Center: 69.127, 372.900
 Radius: 70.331
 Left Slip Surface Endpoint: 41.810, 308.091
 Right Slip Surface Endpoint: 123.629, 328.448

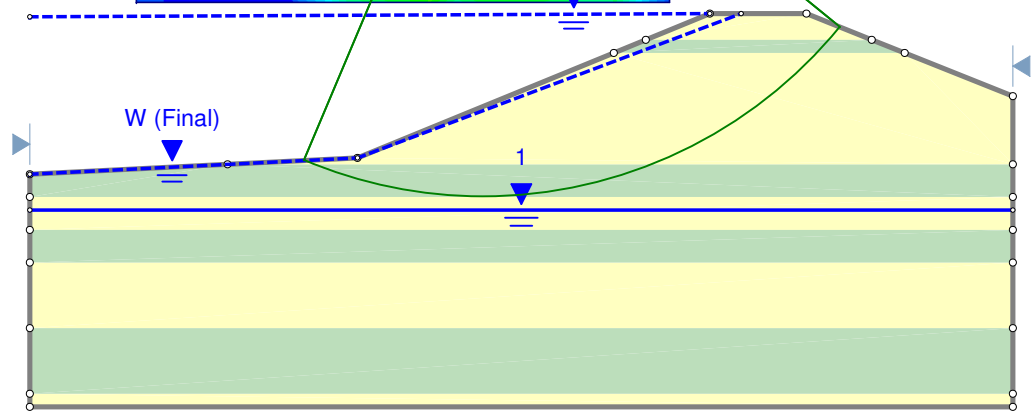
Material Name	Color	Unit Weight (lbs/ft3)	Strength Type	Cohesion (psf)	Phi (deg)	Rapid Drawdown (RD) Undrained Strength	RD Cr (psf)	RD PhiR (deg)	Water Surface	Hu Type
Sandy Clay/Clayey Sand		125	Mohr-Coulomb	1000	14	Yes	0	0	Piezometric Line 1	Constant
Sand		120	Mohr-Coulomb	0	30	No			Piezometric Line 1	Constant

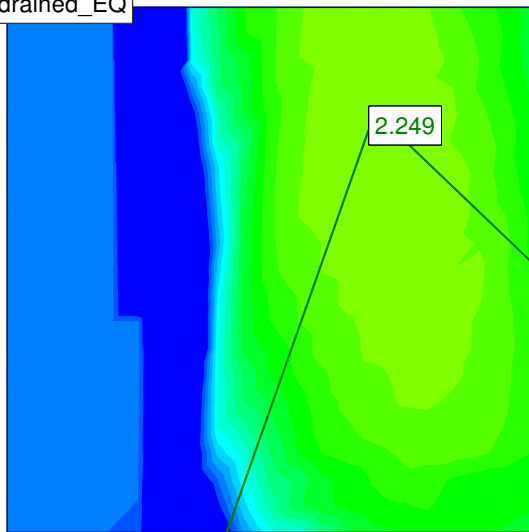
Results
 spencer
 Surface Type: Circular
 Search Method: Grid Search
 Radius Increment: 10
 Composite Surfaces: Disabled
 Reverse Curvature: Create Tension Crack
 Minimum Elevation: Not Defined
 Minimum Depth: Not Defined
 Every available surface
 2.249
 Factor of Safety: 2.249
 Center: 58.765, 389.187
 Radius: 86.602
 Left Slip Surface Endpoint: 30.004, 307.500
 Right Slip Surface Endpoint: 121.371, 329.351

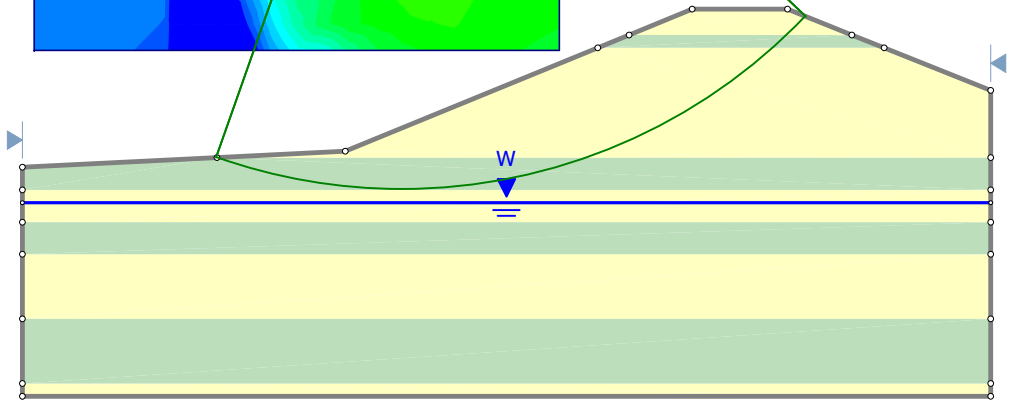
Material Name	Color	Unit Weight (lbs/ft ³)	Strength Type	Cohesion (psf)	Phi (deg)	Water Surface	Hu Type
Sandy Clay/Clayey Sand		125	Mohr-Coulomb	1000	14	Water Surface	Constant
Sand		120	Mohr-Coulomb	0	30	Water Surface	Constant

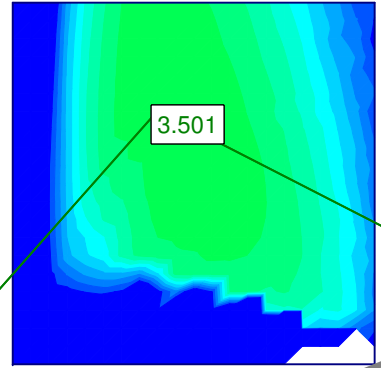
Results
 spencer
 Surface Type: Circular
 Search Method: Grid Search
 Radius Increment: 10
 Composite Surfaces: Disabled
 Reverse Curvature: Create Tension Crack
 Minimum Elevation: Not Defined
 Minimum Depth: Not Defined
 Every available surface
 3.501
 Factor of Safety: 3.501
 Center: 56.067, 362.614
 Radius: 75.190
 Left Slip Surface Endpoint: 6.179, 306.358
 Right Slip Surface Endpoint: 122.976, 328.310

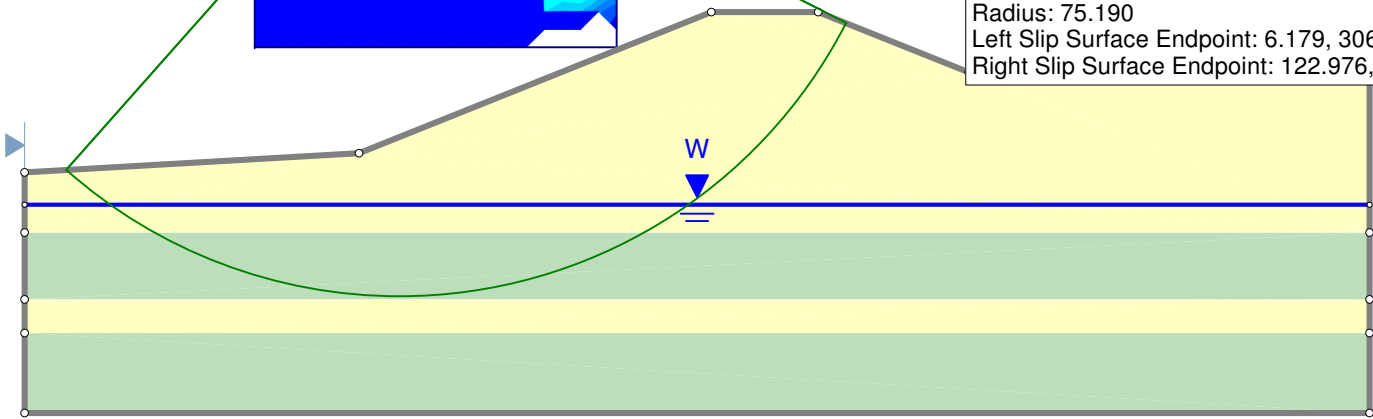
Material Name	Color	Unit Weight (lbs/ft ³)	Strength Type	Cohesion (psf)	Phi (deg)	Water Surface	Hu Type
Sandy Clay/Silty Sand		125	Mohr-Coulomb	1750	0	Water Surface	Constant
Sand		120	Mohr-Coulomb	0	30	Water Surface	Constant

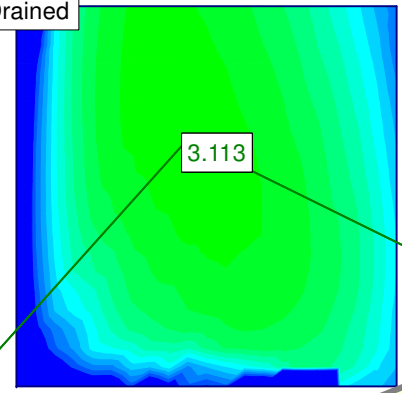
Results
 spencer
 Surface Type: Circular
 Search Method: Grid Search
 Radius Increment: 10
 Composite Surfaces: Disabled
 Reverse Curvature: Create Tension Crack
 Minimum Elevation: Not Defined
 Minimum Depth: Not Defined
 Every available surface
 3.113
 Factor of Safety: 3.113
 Center: 58.774, 359.907
 Radius: 71.552
 Left Slip Surface Endpoint: 11.003, 306.638
 Right Slip Surface Endpoint: 122.972, 328.311

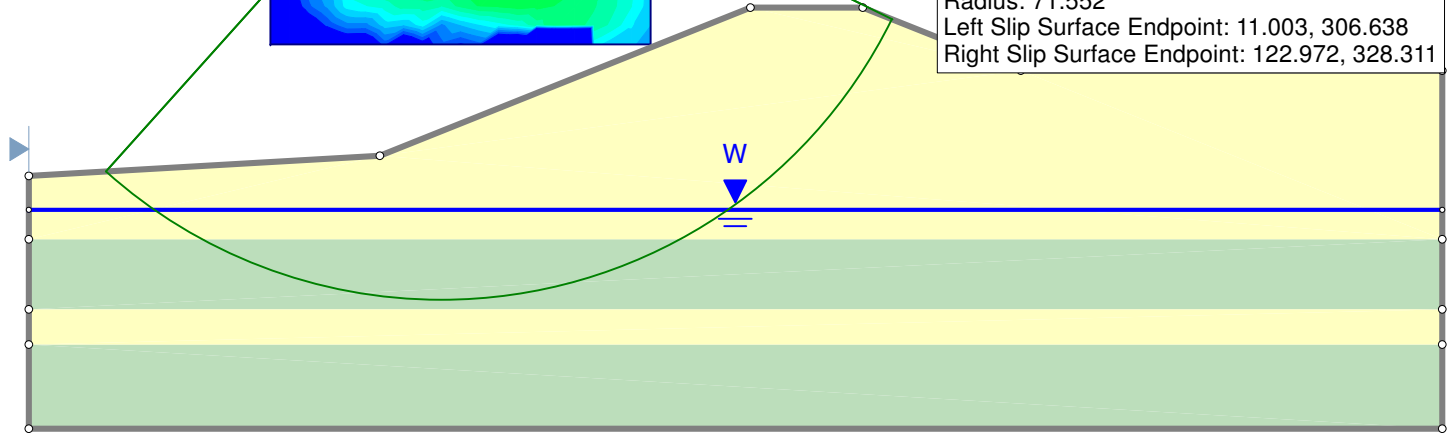
Material Name	Color	Unit Weight (lbs/ft3)	Strength Type	Cohesion (psf)	Phi (deg)	Water Surface	Hu Type
Sandy Clay/Silty Sand		125	Mohr-Coulomb	1000	14	Water Surface	Constant
Sand		120	Mohr-Coulomb	0	30	Water Surface	Constant

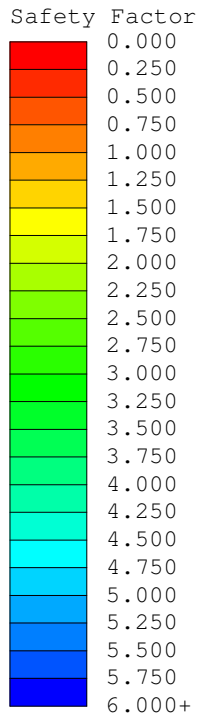
Luminant - Martin Lake Emergency Ash Pond
West Ash Pond -North Slope -Full_Undrained

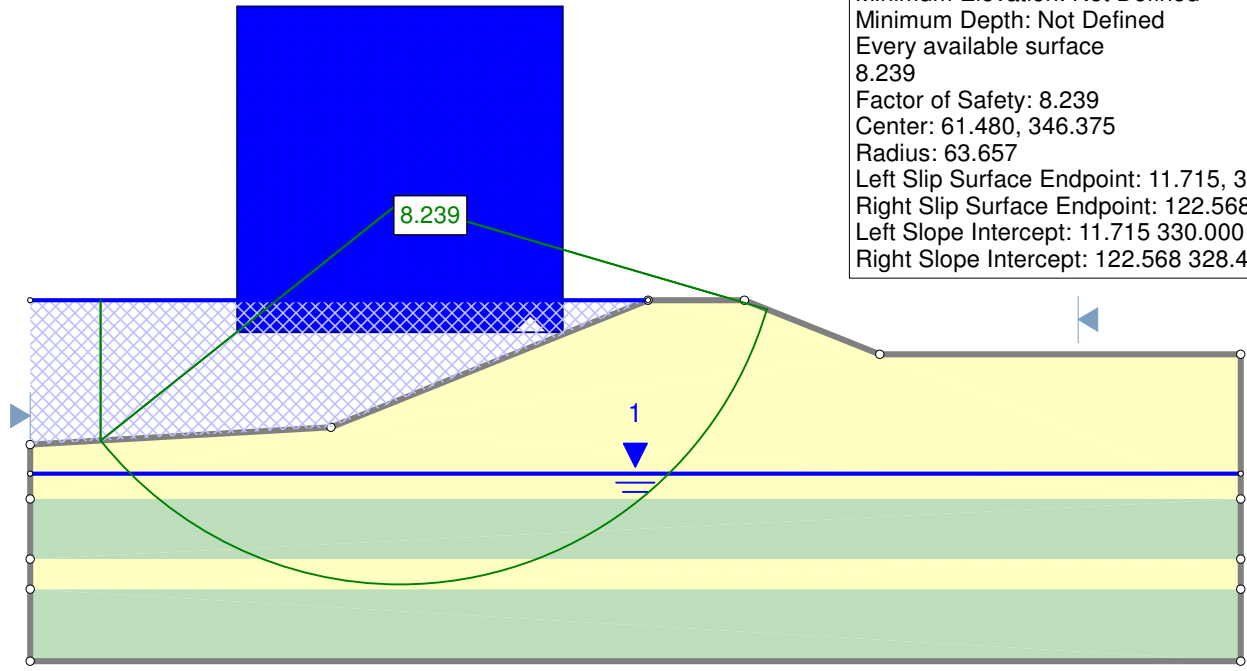
Material Name	Color	Unit Weight (lbs/ft3)	Strength Type	Cohesion (psf)	Phi (deg)	Water Surface	Hu Type
Sandy Clay/Silty Sand		125	Mohr-Coulomb	1750	0	Piezometric Line 1	Constant
Sand		120	Mohr-Coulomb	0	30	Piezometric Line 1	Constant

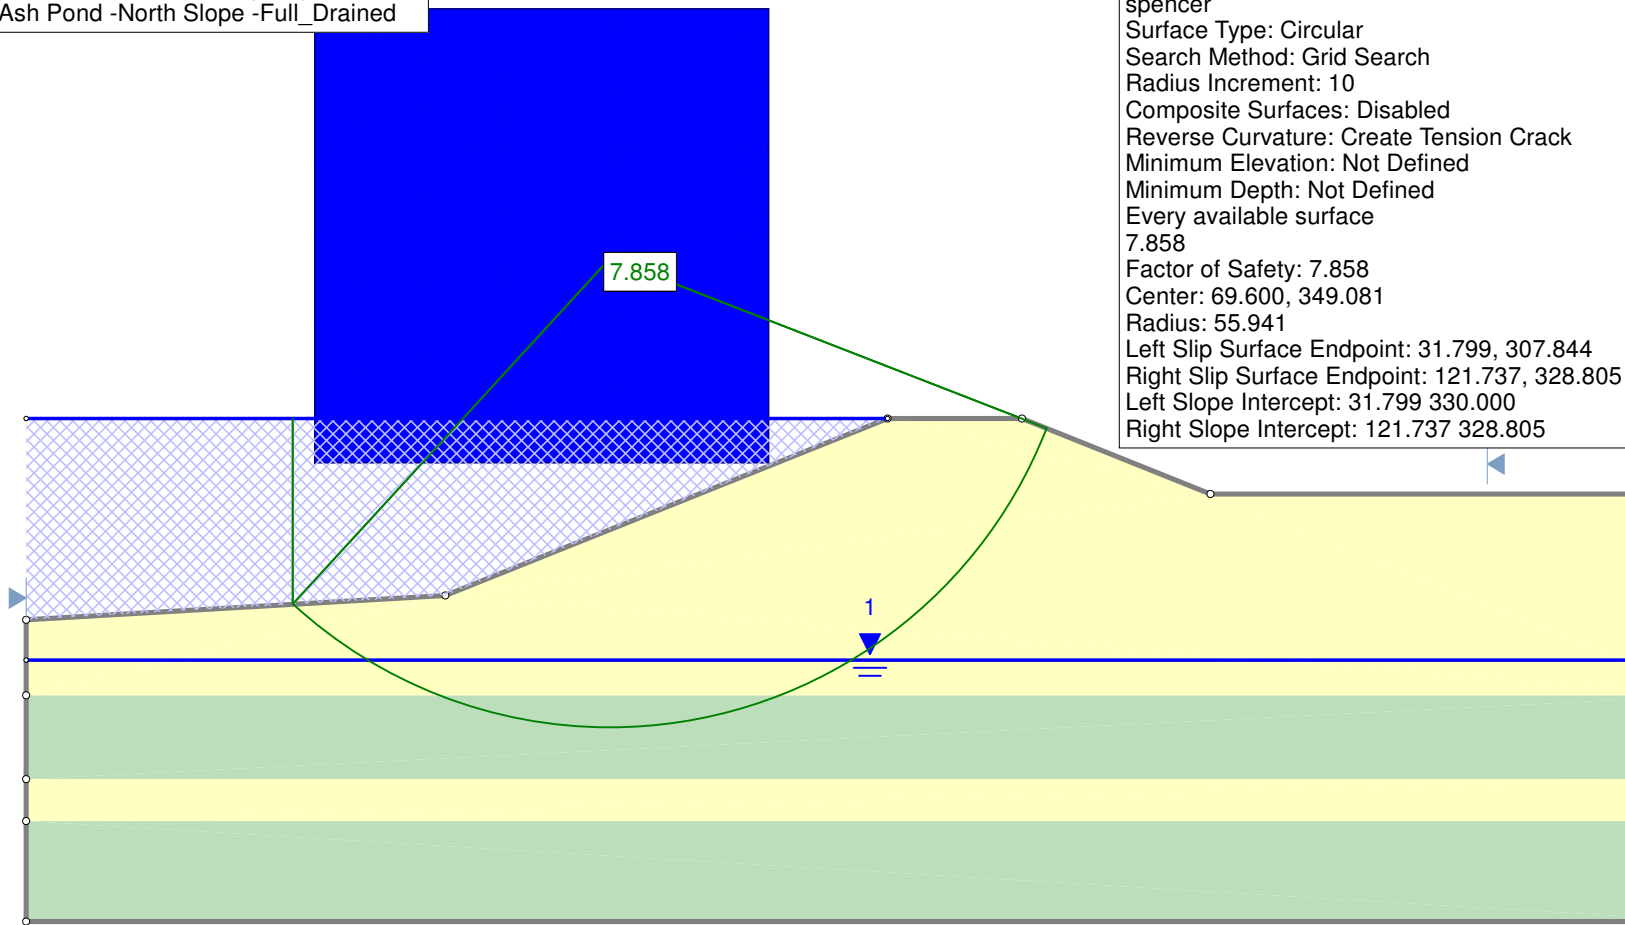
Results
 spencer
 Surface Type: Circular
 Search Method: Grid Search
 Radius Increment: 10
 Composite Surfaces: Disabled
 Reverse Curvature: Create Tension Crack
 Minimum Elevation: Not Defined
 Minimum Depth: Not Defined
 Every available surface
 7.858
 Factor of Safety: 7.858
 Center: 69.600, 349.081
 Radius: 55.941
 Left Slip Surface Endpoint: 31.799, 307.844
 Right Slip Surface Endpoint: 121.737, 328.805
 Left Slope Intercept: 31.799 330.000
 Right Slope Intercept: 121.737 328.805

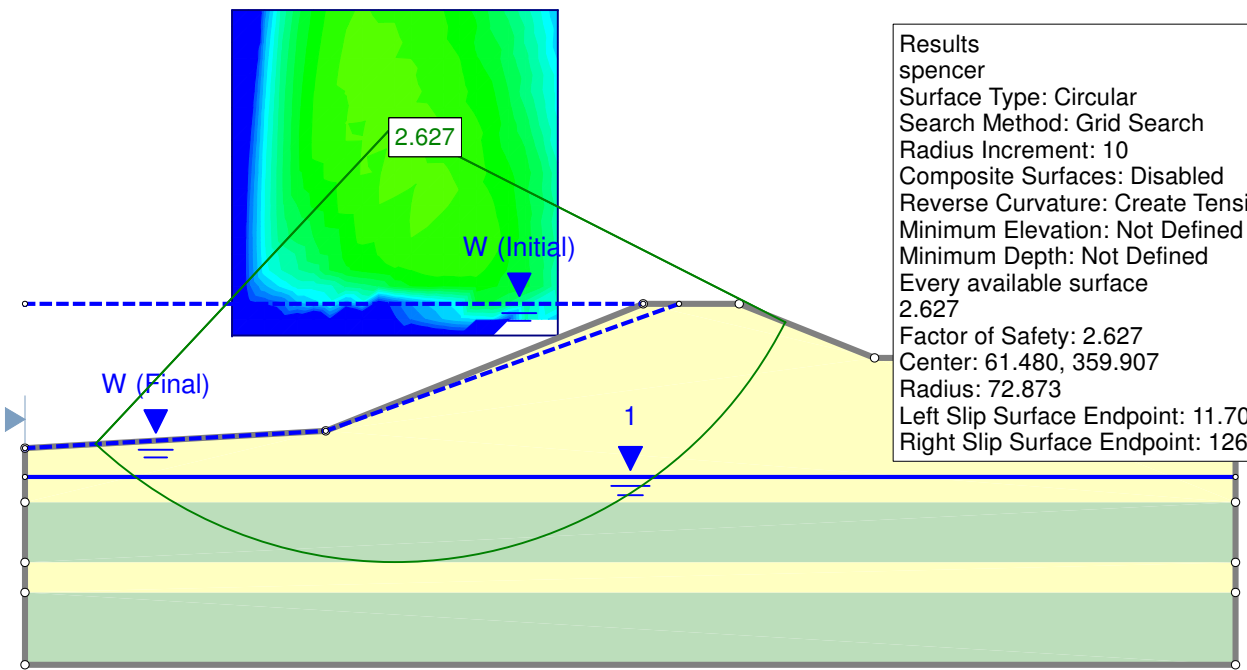
Results
 spencer
 Surface Type: Circular
 Search Method: Grid Search
 Radius Increment: 10
 Composite Surfaces: Disabled
 Reverse Curvature: Create Tension Crack
 Minimum Elevation: Not Defined
 Minimum Depth: Not Defined
 Every available surface
 2.627
 Factor of Safety: 2.627
 Center: 61.480, 359.907
 Radius: 72.873
 Left Slip Surface Endpoint: 11.709, 306.679
 Right Slip Surface Endpoint: 126.458, 326.917

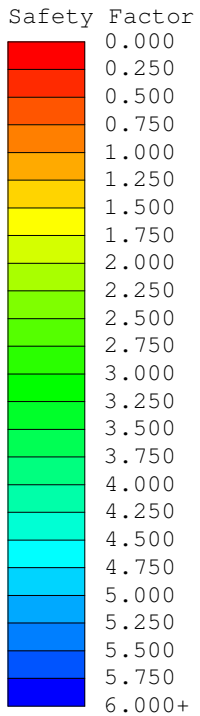
Luminant - Martin Lake Emergency Ash Pond
West Ash Pond -West Slope -Full_Undrained
