US EPA ARCHIVE DOCUMENT

**Coal Combustion Residue Impoundment
Round 12 - Dam Assessment Report**

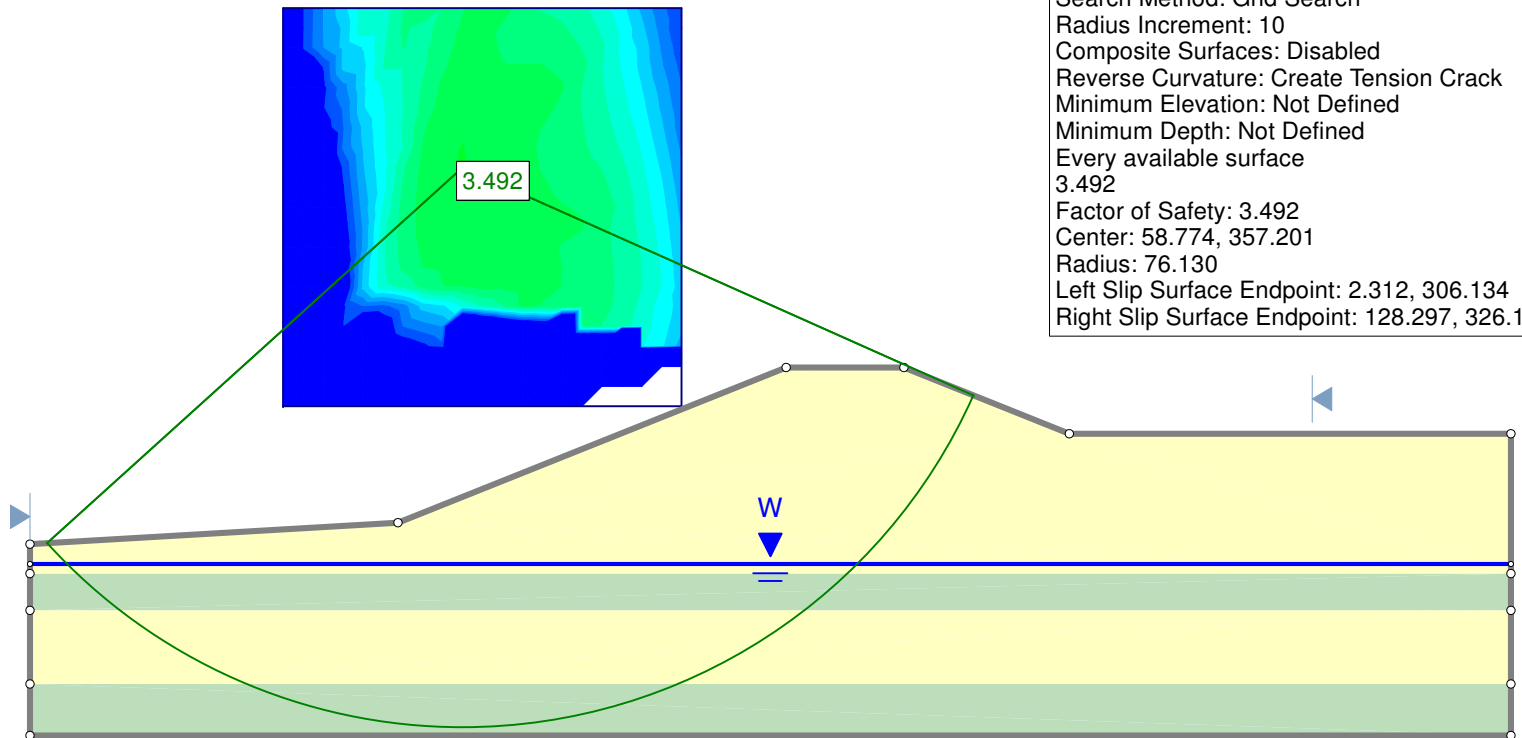
Material Name	Color	Unit Weight (lbs/ft3)	Strength Type	Cohesion (psf)	Phi (deg)	Water Surface	Hu Type
Sandy Clay/Silty Sand		125	Mohr-Coulomb	1750	0	Water Surface	Constant
Sand		120	Mohr-Coulomb	0	30	Water Surface	Constant

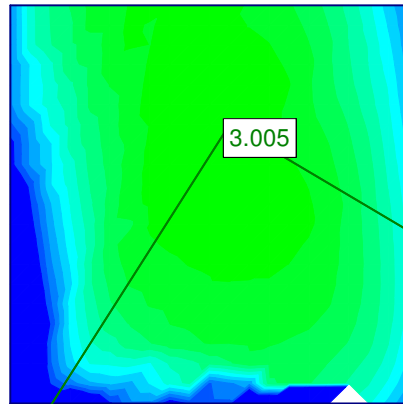
Results
 spencer
 Surface Type: Circular
 Search Method: Grid Search
 Radius Increment: 10
 Composite Surfaces: Disabled
 Reverse Curvature: Create Tension Crack
 Minimum Elevation: Not Defined
 Minimum Depth: Not Defined
 Every available surface
 3.005
 Factor of Safety: 3.005
 Center: 64.187, 362.614
 Radius: 65.095
 Left Slip Surface Endpoint: 29.239, 307.696
 Right Slip Surface Endpoint: 120.186, 329.426

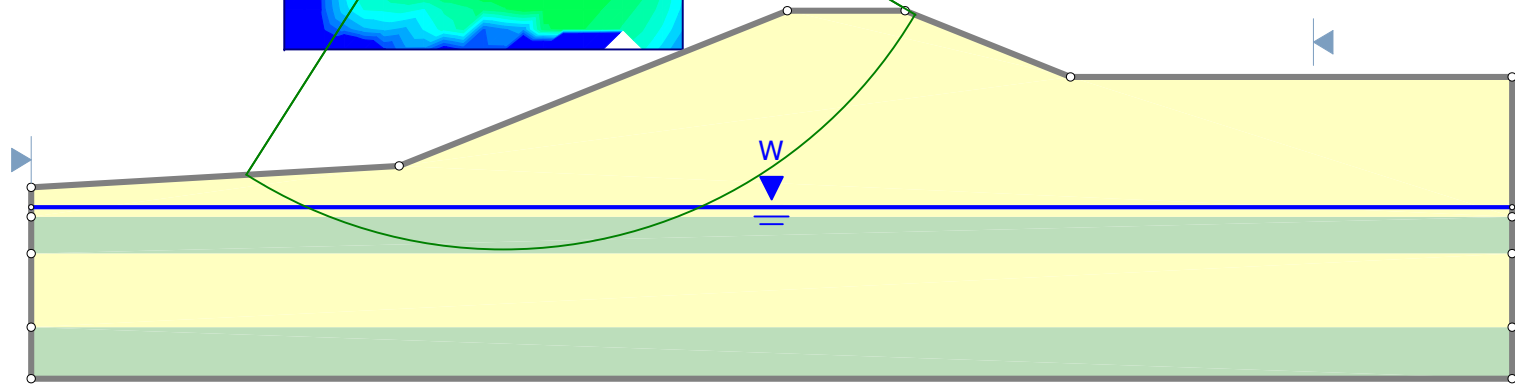
Material Name	Color	Unit Weight (lbs/ft3)	Strength Type	Cohesion (psf)	Phi (deg)	Water Surface	Hu Type
Sandy Clay/Silty Sand		125	Mohr-Coulomb	1000	14	Water Surface	Constant
Sand		120	Mohr-Coulomb	0	30	Water Surface	Constant

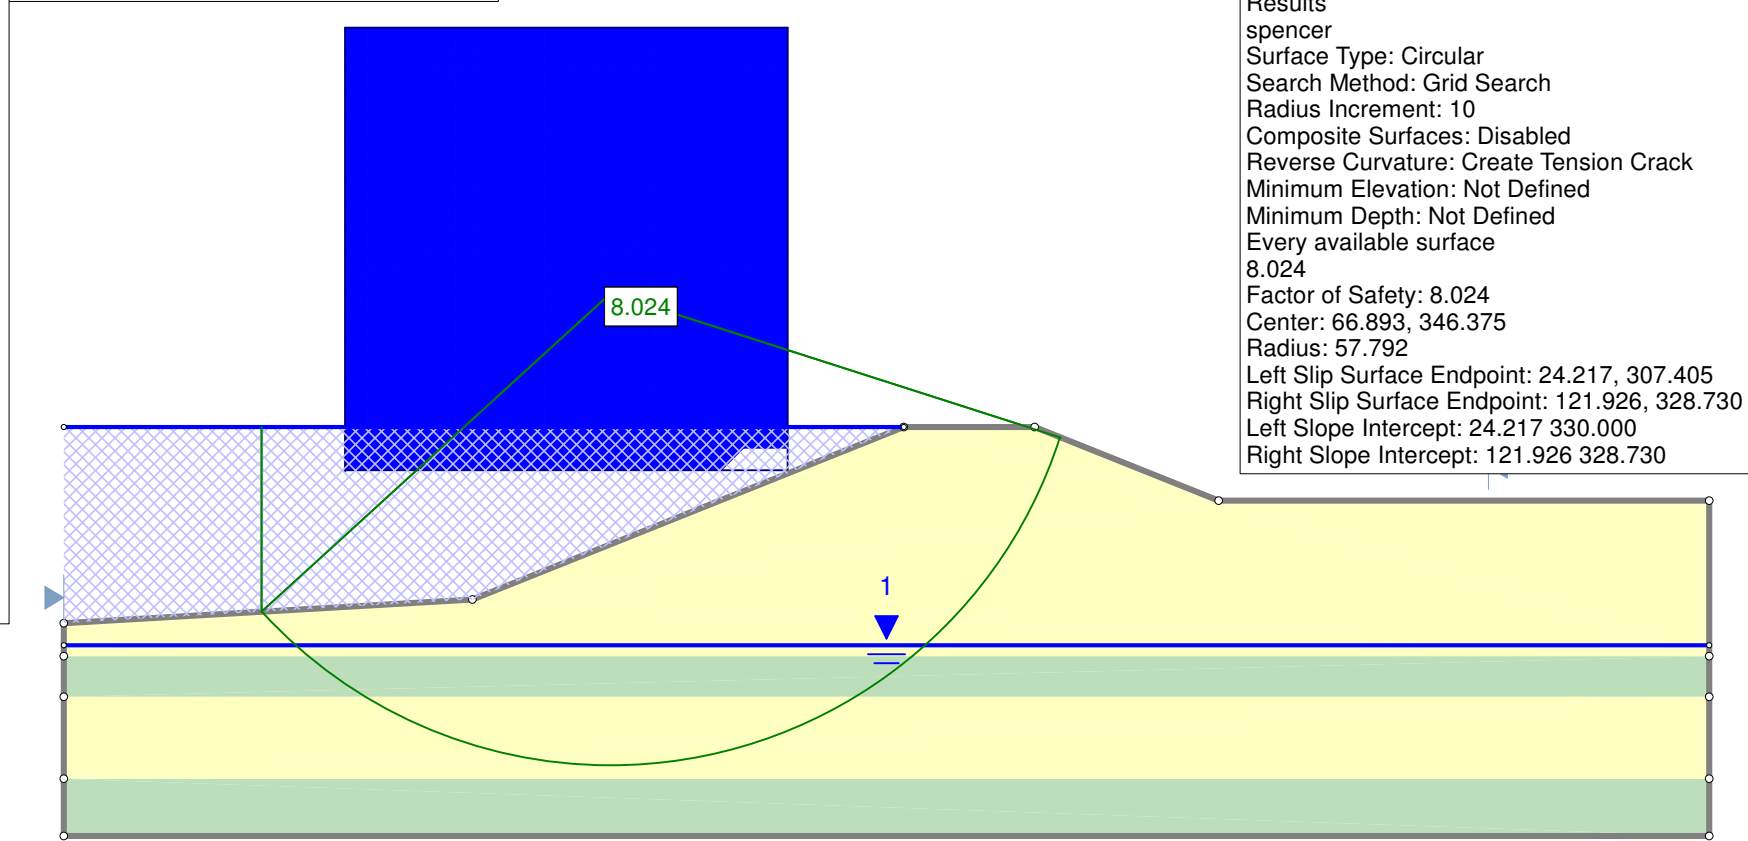
Results
spencer
Surface Type: Circular
Search Method: Grid Search
Radius Increment: 10
Composite Surfaces: Disabled
Reverse Curvature: Create Tension Crack
Minimum Elevation: Not Defined
Minimum Depth: Not Defined
Every available surface
8.024
Factor of Safety: 8.024
Center: 66.893, 346.375
Radius: 57.792
Left Slip Surface Endpoint: 24.217, 307.405
Right Slip Surface Endpoint: 121.926, 328.730
Left Slope Intercept: 24.217 330.000
Right Slope Intercept: 121.926 328.730

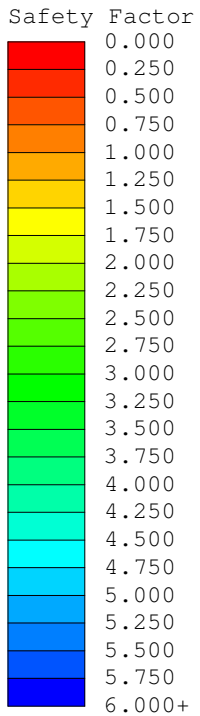
Luminant - Martin Lake Emergency Ash Pond
West Ash Pond -West Slope -Full_Drained

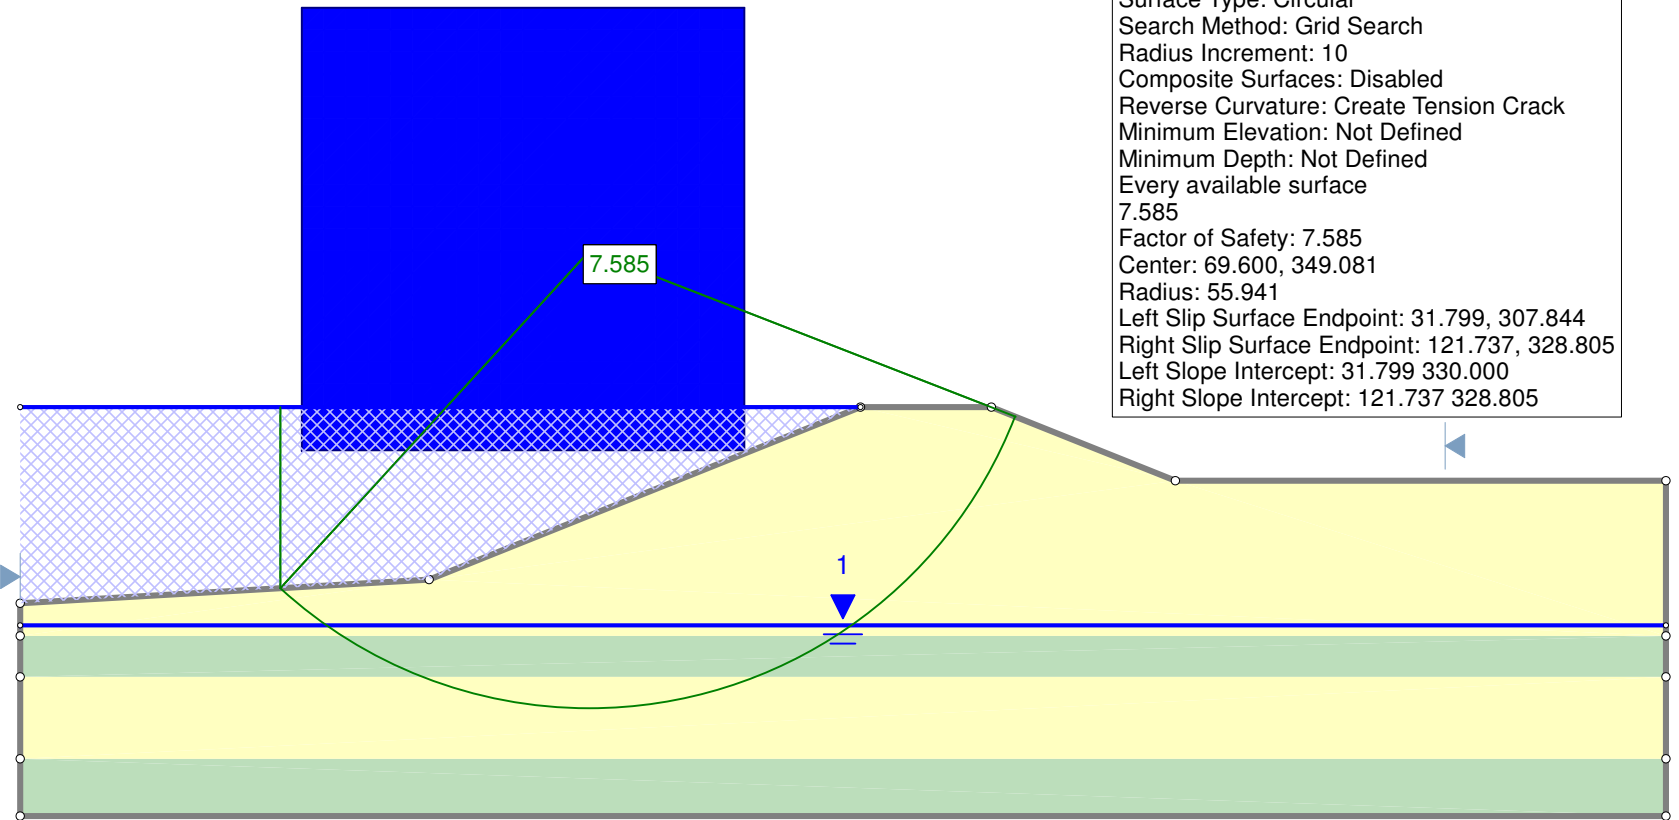
Material Name	Color	Unit Weight (lbs/ft ³)	Strength Type	Cohesion (psf)	Phi (deg)	Water Surface	Hu Type
Sandy Clay/Silty Sand		125	Mohr-Coulomb	1000	14	Piezometric Line 1	Constant
Sand		120	Mohr-Coulomb	0	30	Piezometric Line 1	Constant

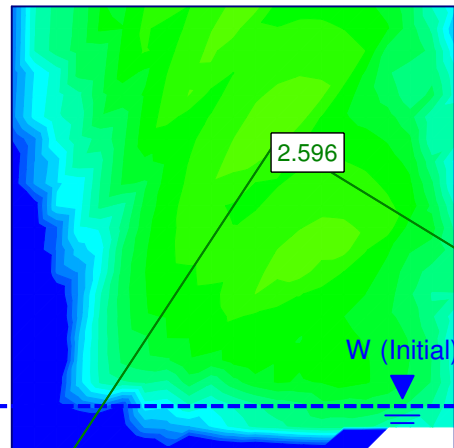
Results
 spencer
 Surface Type: Circular
 Search Method: Grid Search
 Radius Increment: 10
 Composite Surfaces: Disabled
 Reverse Curvature: Create Tension Crack
 Minimum Elevation: Not Defined
 Minimum Depth: Not Defined
 Every available surface
 2.596
 Factor of Safety: 2.596
 Center: 66.893, 362.614
 Radius: 65.617
 Left Slip Surface Endpoint: 30.842, 307.789
 Right Slip Surface Endpoint: 122.858, 328.357

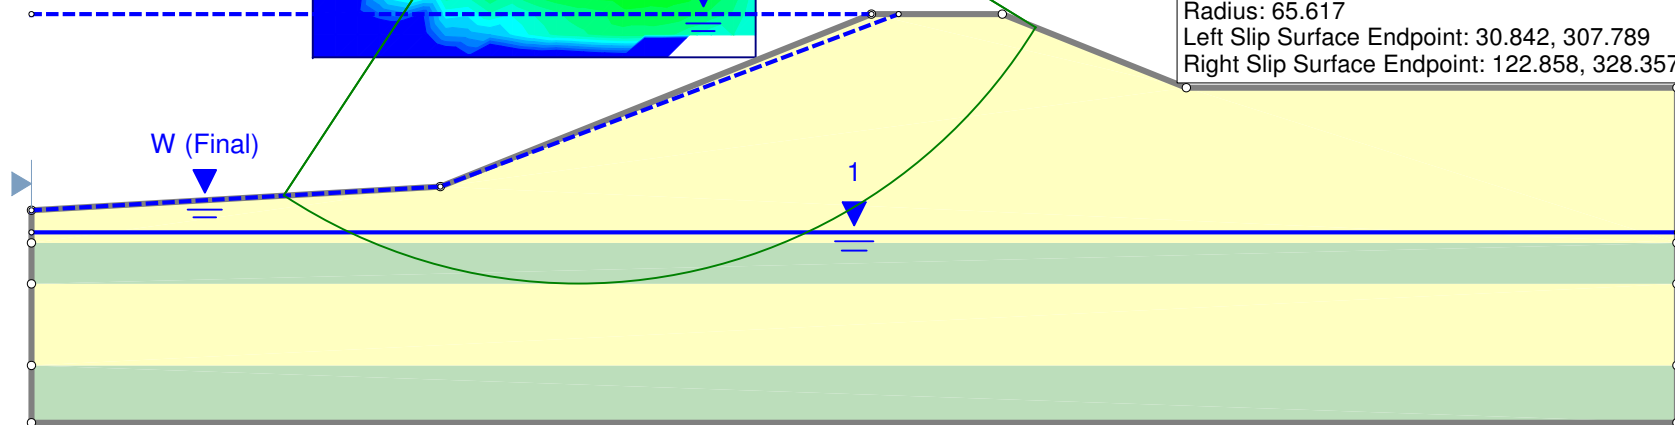
Material Name	Color	Unit Weight (lbs/ft ³)	Strength Type	Cohesion (psf)	Phi (deg)	Rapid Drawdown (RD) Undrained Strength	RD Cr (psf)	RD PhiR (deg)	Water Surface	Hu Type
Sandy Clay/Silty Sand		125	Mohr-Coulomb	1000	14	Yes	0	0	Piezometric Line 1	Constant
Sand		120	Mohr-Coulomb	0	30	No			Piezometric Line 1	Constant

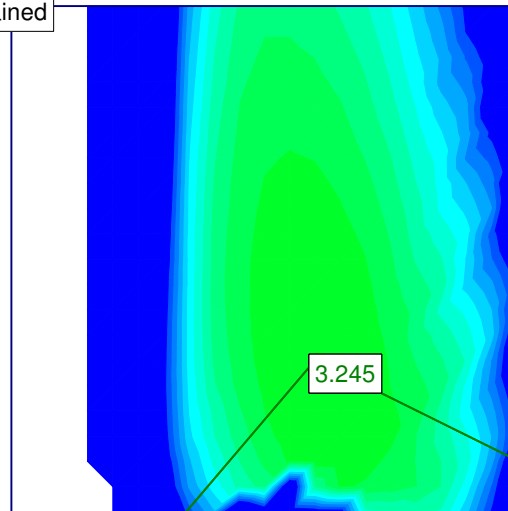
Results
 spencer
 Surface Type: Circular
 Search Method: Grid Search
 Radius Increment: 10
 Composite Surfaces: Disabled
 Reverse Curvature: Create Tension Crack
 Minimum Elevation: Not Defined
 Minimum Depth: Not Defined
 Every available surface
 3.245
 Factor of Safety: 3.245
 Center: 76.562, 393.356
 Radius: 75.170
 Left Slip Surface Endpoint: 27.848, 336.108
 Right Slip Surface Endpoint: 143.926, 360.000

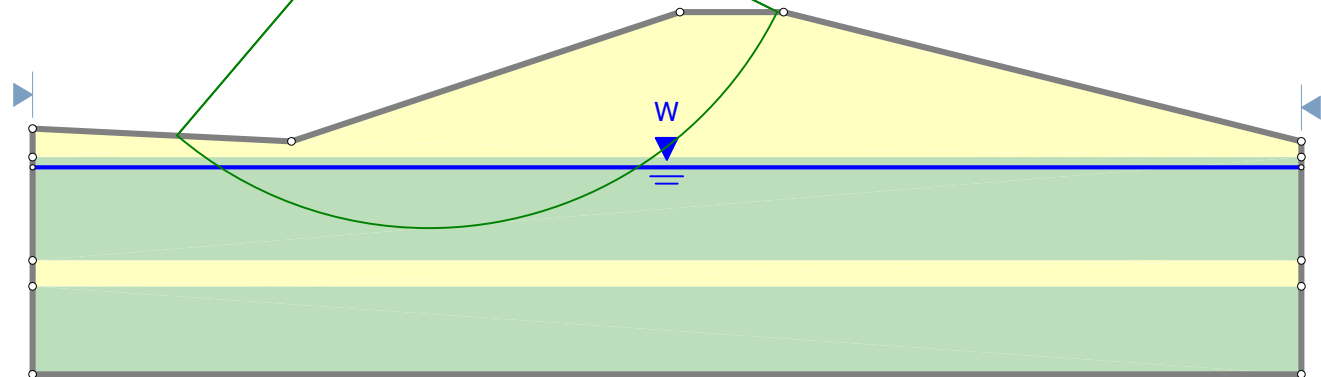
Material Name	Color	Unit Weight (lbs/ft3)	Strength Type	Cohesion (psf)	Phi (deg)	Water Surface	Hu Type
Sandy Clay/Clayey Sand		125	Mohr-Coulomb	1750	0	Water Surface	Constant
Sand		120	Mohr-Coulomb	0.02	30	Water Surface	Constant

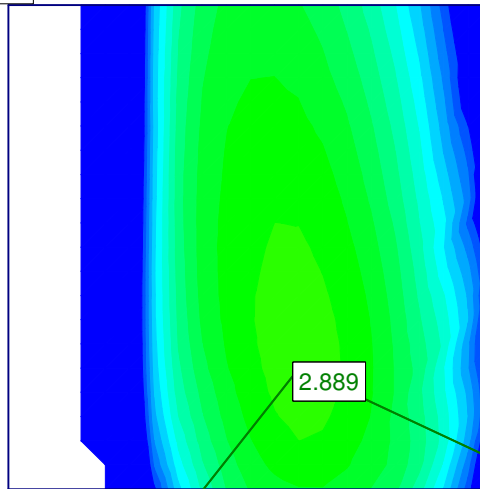
Results
 spencer
 Surface Type: Circular
 Search Method: Grid Search
 Radius Increment: 10
 Composite Surfaces: Disabled
 Reverse Curvature: Create Tension Crack
 Minimum Elevation: Not Defined
 Minimum Depth: Not Defined
 Every available surface
 2.889
 Factor of Safety: 2.889
 Center: 76.562, 388.470
 Radius: 67.152
 Left Slip Surface Endpoint: 34.968, 335.752
 Right Slip Surface Endpoint: 137.380, 360.000

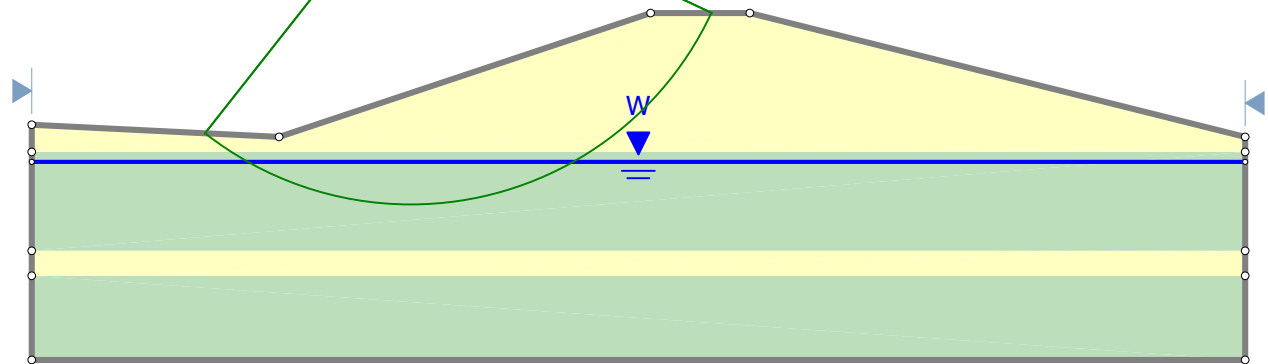
Material Name	Color	Unit Weight (lbs/ft ³)	Strength Type	Cohesion (psf)	Phi (deg)	Water Surface	Hu Type
Sandy Clay/Clayey Sand		125	Mohr-Coulomb	1000	14	Water Surface	Constant
Sand		120	Mohr-Coulomb	0	30	Water Surface	Constant

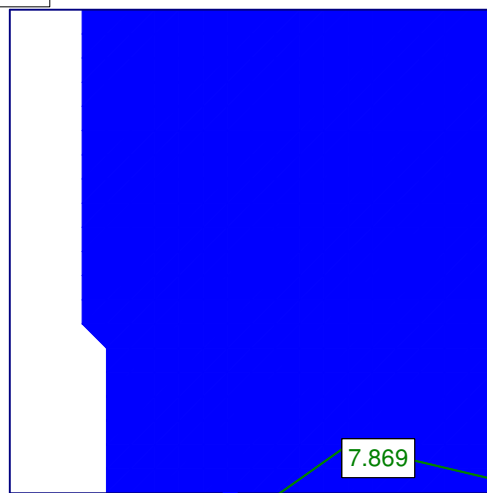
Results
 spencer
 Surface Type: Circular
 Search Method: Grid Search
 Radius Increment: 10
 Composite Surfaces: Disabled
 Reverse Curvature: Create Tension Crack
 Minimum Elevation: Not Defined
 Minimum Depth: Not Defined
 Every available surface
 7.869
 Factor of Safety: 7.869
 Center: 86.335, 373.811
 Radius: 65.645
 Left Slip Surface Endpoint: 32.772, 335.861
 Right Slip Surface Endpoint: 150.216, 358.696
 Left Slope Intercept: 32.772 360.000
 Right Slope Intercept: 150.216 358.696

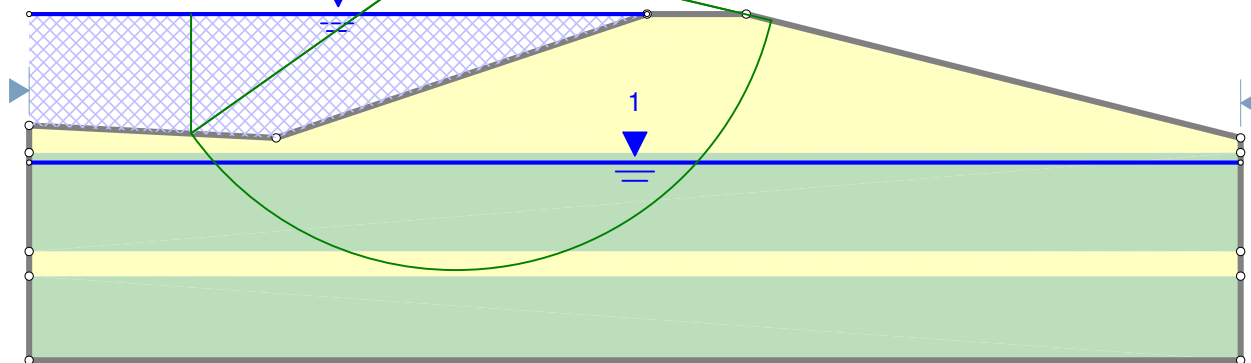
Material Name	Color	Unit Weight (lbs/ft ³)	Strength Type	Cohesion (psf)	Phi (deg)	Water Surface	Hu Type
Sandy Clay/Clayey Sand		125	Mohr-Coulomb	1750	0	Piezometric Line 1	Constant
Sand		120	Mohr-Coulomb	0.02	30	Piezometric Line 1	Constant

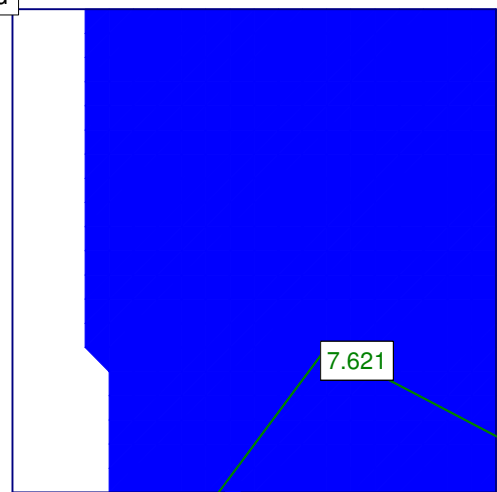
Results
 spencer
 Surface Type: Circular
 Search Method: Grid Search
 Radius Increment: 10
 Composite Surfaces: Disabled
 Reverse Curvature: Create Tension Crack
 Minimum Elevation: Not Defined
 Minimum Depth: Not Defined
 Every available surface
 7.621
 Factor of Safety: 7.621
 Center: 81.449, 393.356
 Radius: 72.089
 Left Slip Surface Endpoint: 38.331, 335.583
 Right Slip Surface Endpoint: 145.315, 359.921
 Left Slope Intercept: 38.331 360.000
 Right Slope Intercept: 145.315 359.921

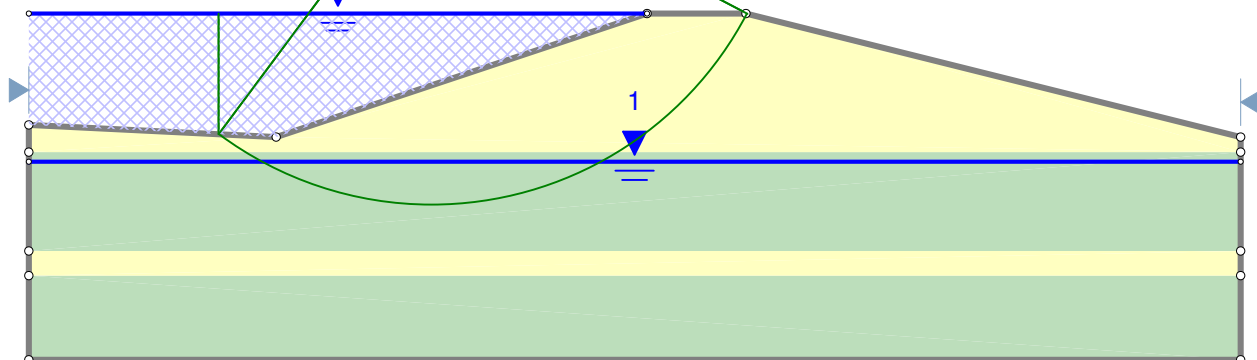
Material Name	Color	Unit Weight (lbs/ft3)	Strength Type	Cohesion (psf)	Phi (deg)	Water Surface	Hu Type
Sandy Clay/Clayey Sand		125	Mohr-Coulomb	1000	14	Piezometric Line 1	Constant
Sand		120	Mohr-Coulomb	0	30	Piezometric Line 1	Constant

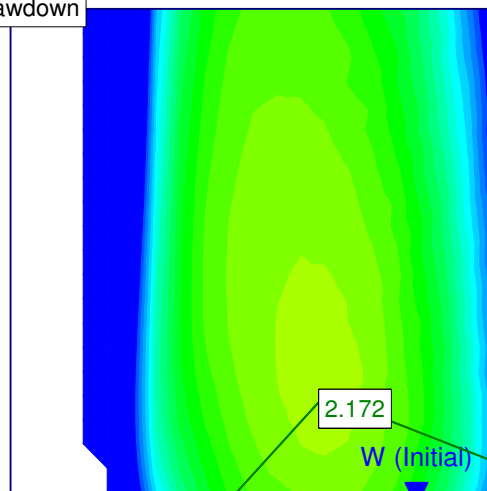
Results
 spencer
 Surface Type: Circular
 Search Method: Grid Search
 Radius Increment: 10
 Composite Surfaces: Disabled
 Reverse Curvature: Create Tension Crack
 Minimum Elevation: Not Defined
 Minimum Depth: Not Defined
 Every available surface
 2.172
 Factor of Safety: 2.172
 Center: 81.449, 383.584
 Radius: 64.864
 Left Slip Surface Endpoint: 37.792, 335.610
 Right Slip Surface Endpoint: 141.873, 360.000

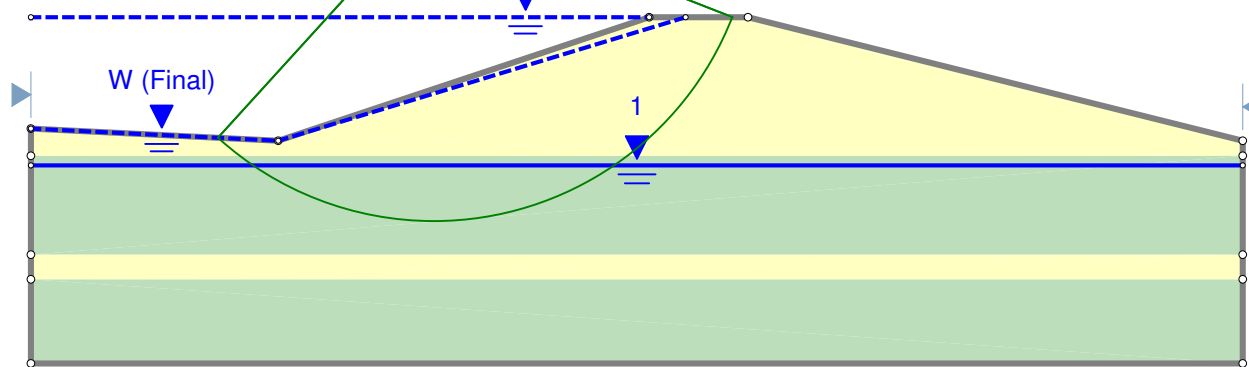
Material Name	Color	Unit Weight (lbs/ft3)	Strength Type	Cohesion (psf)	Phi (deg)	Rapid Drawdown (RD) Undrained Strength	RD Cr (psf)	RD PhiR (deg)	Water Surface	Hu Type
Sandy Clay/Clayey Sand		125	Mohr-Coulomb	1000	14	Yes	0	0	Piezometric Line 1	Constant
Sand		120	Mohr-Coulomb	0.02	30	No			Piezometric Line 1	Constant
