SUBJECT: EPA Comments on "Assessment of Dam Safety of Coal Combustion Surface  
Impoundments: Luminant Generation Co., LLC – Monticello Steam Electric Station,  
Mount Pleasant, TX

DATE: April 7, 2014

US EPA  
 DAM SAFETY ASSESSMENT  
 OF CCW IMPOUNDMENTS  
 LUMINANT ENERGY  
 MONTICELLO STEAM  
 ELECTRIC STATION  
 TITUS COUNTY, TEXAS

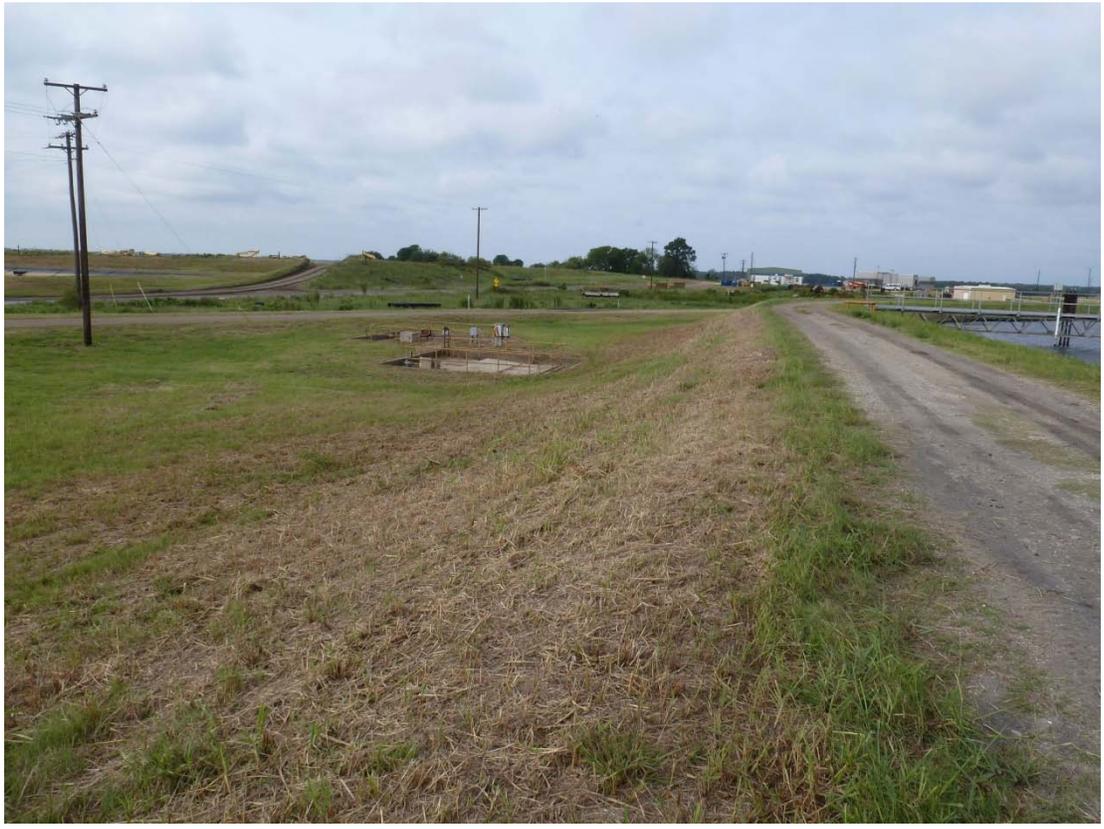
Photo Number:  
1

Description:  
Southern embankment of the South Pond.

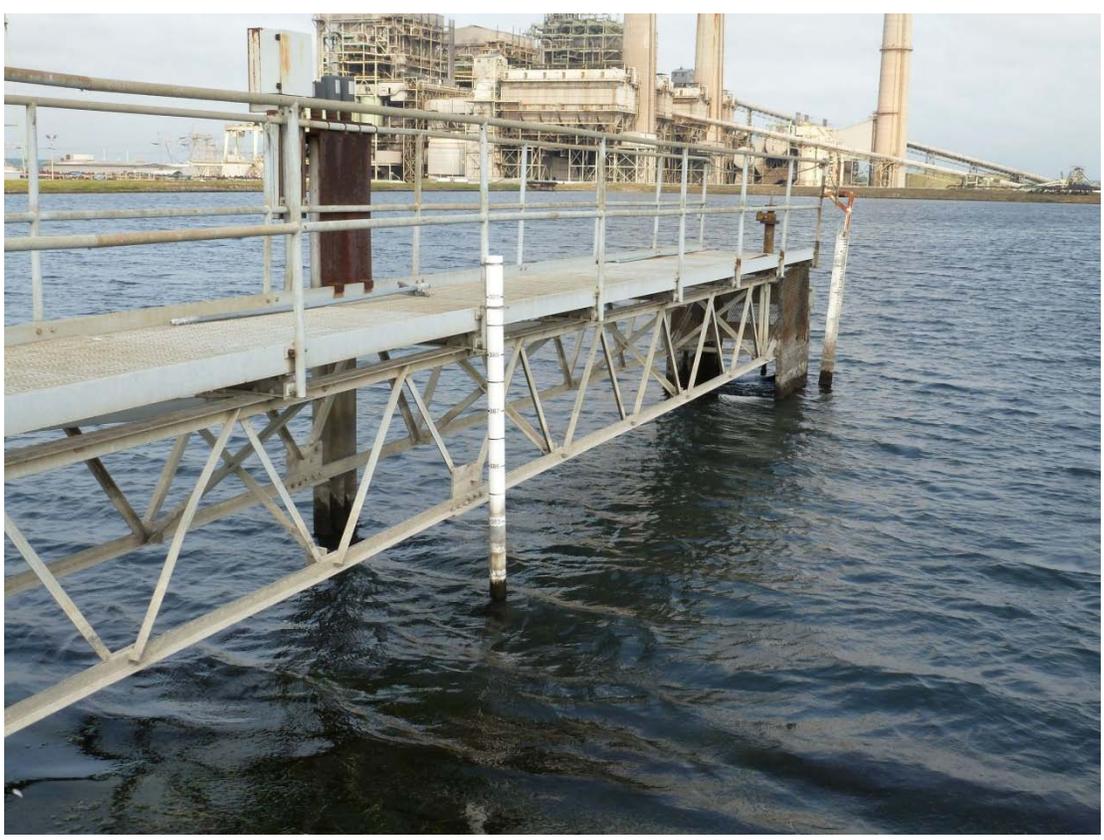
Photo Number:  
2

Description:  
Access walkway to gate operator in the South Pond. Note staff gages.

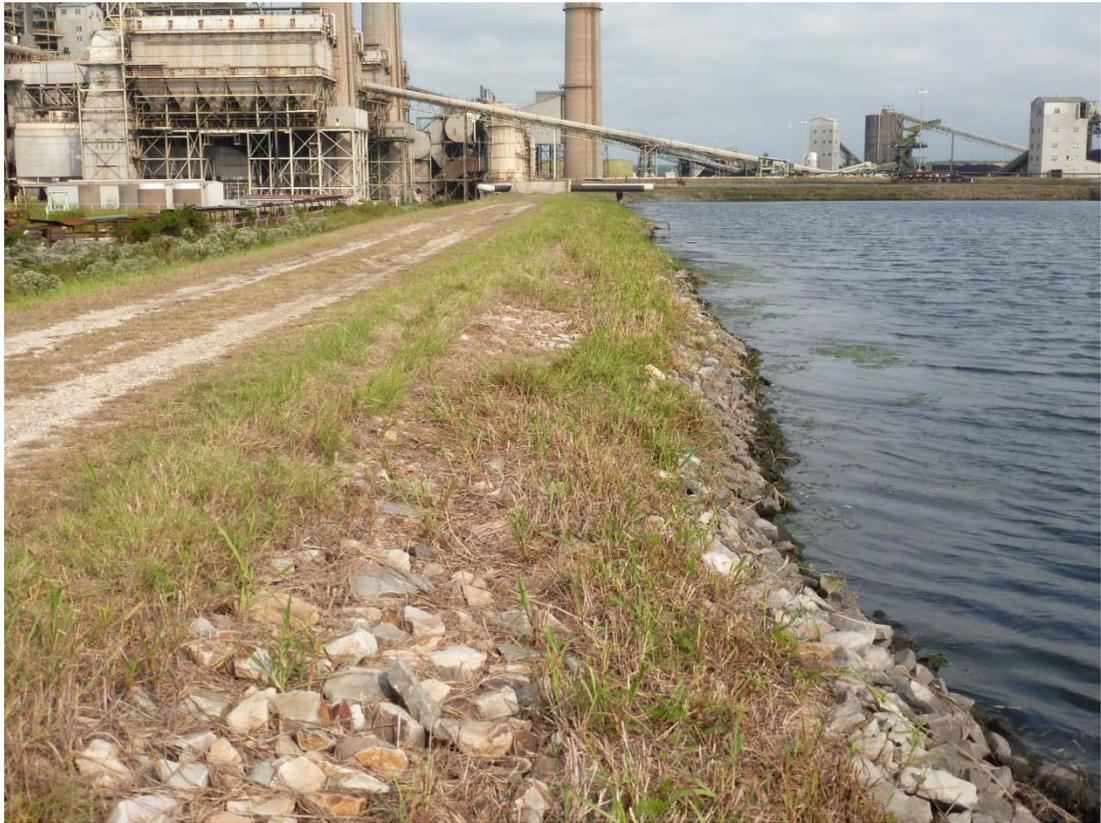
Photo Number:  
3

Description:  
Inboard face of the eastern embankment of the South Pond. Note riprap facing.

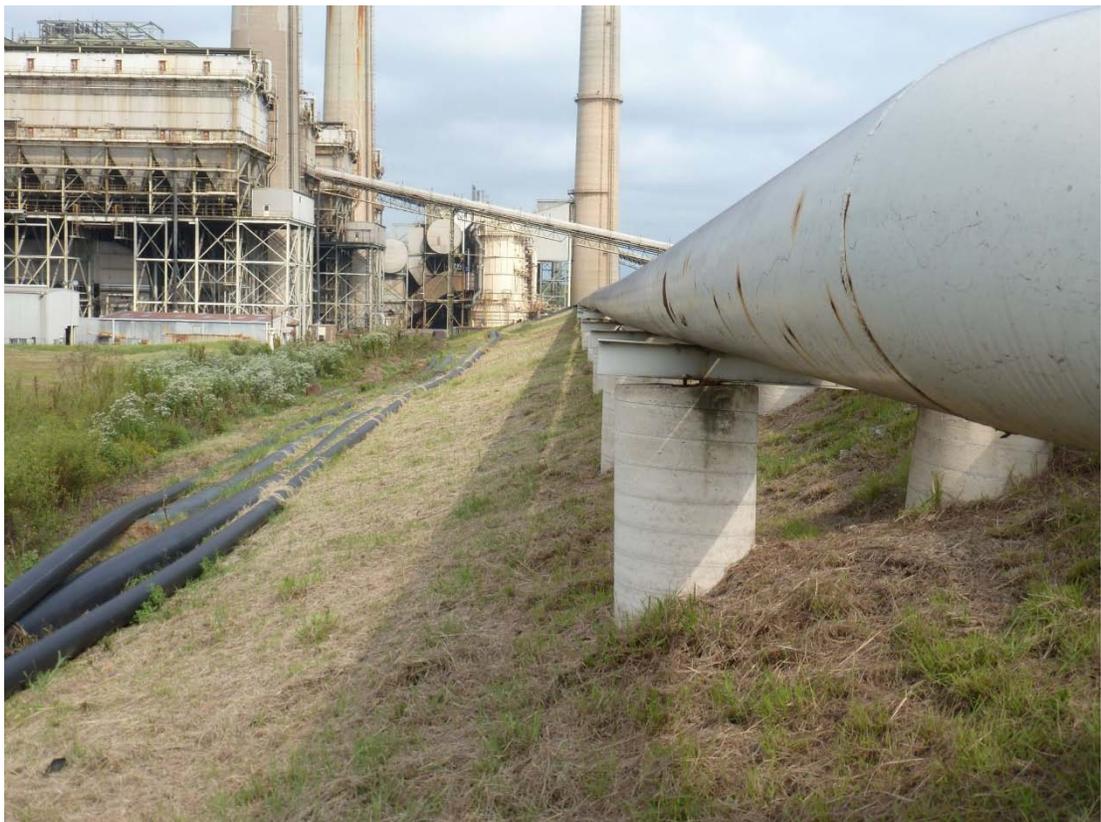
Photo Number:  
4

- Some erosion was observed beneath the pipes located on the west side of the western embankment. This erosion has been noted previously.
- Minor sloughing/sliding was observed near the toe of the western embankment.

Description:  
Western embankment of South Pond. Minor rutting observed below pipes.

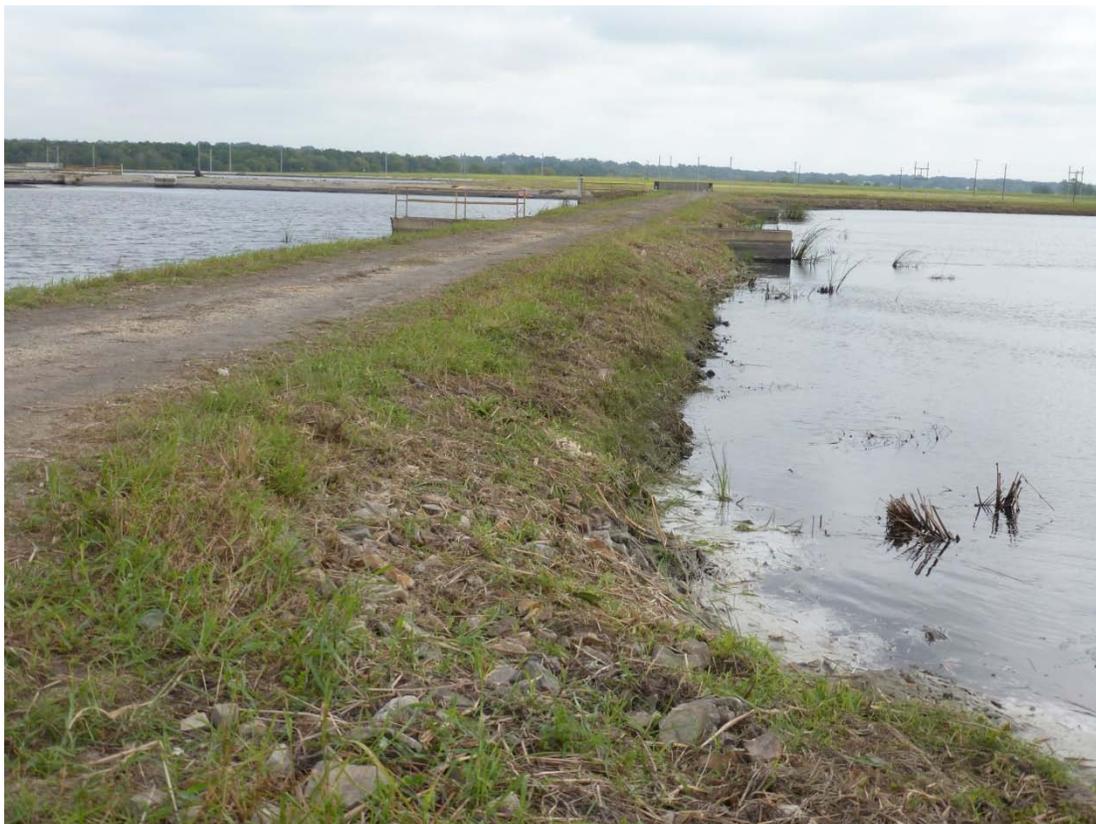
Photo Number:  
5

Description:  
Dividing dike between the North and South Ponds. Note equalizing channel.

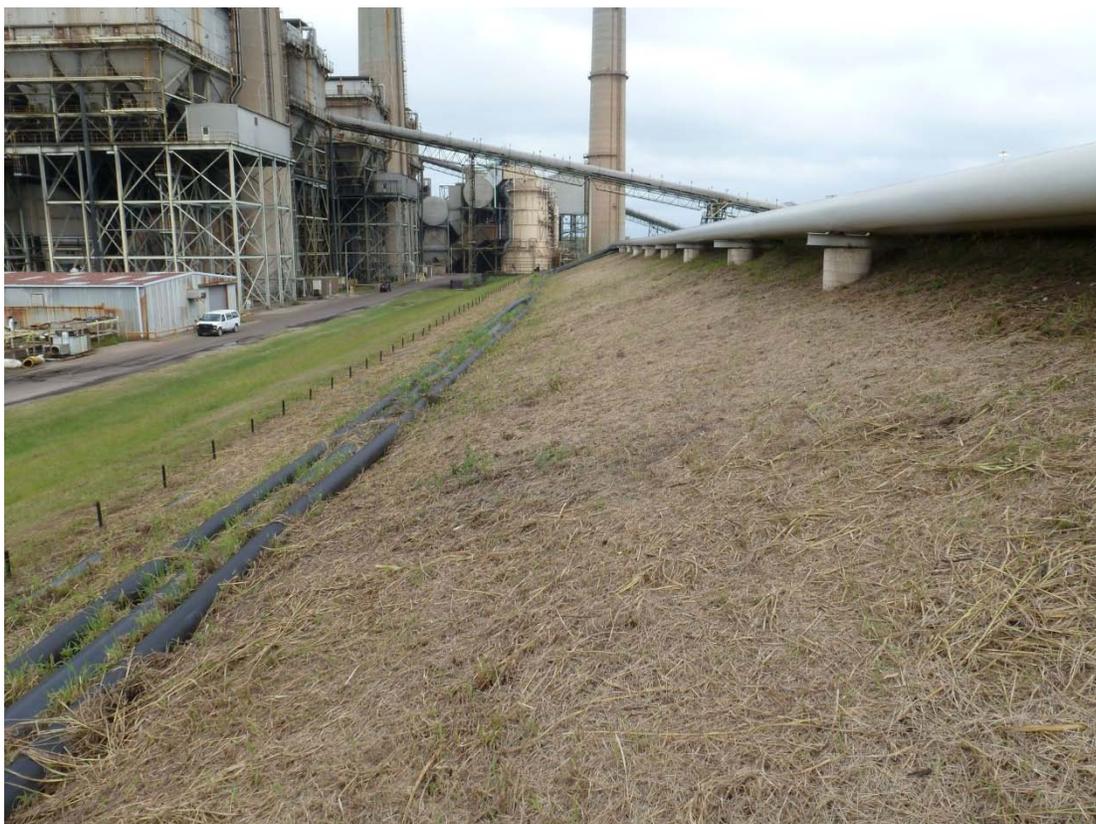
Photo Number:  
6

Description:  
Western embankment of North Pond

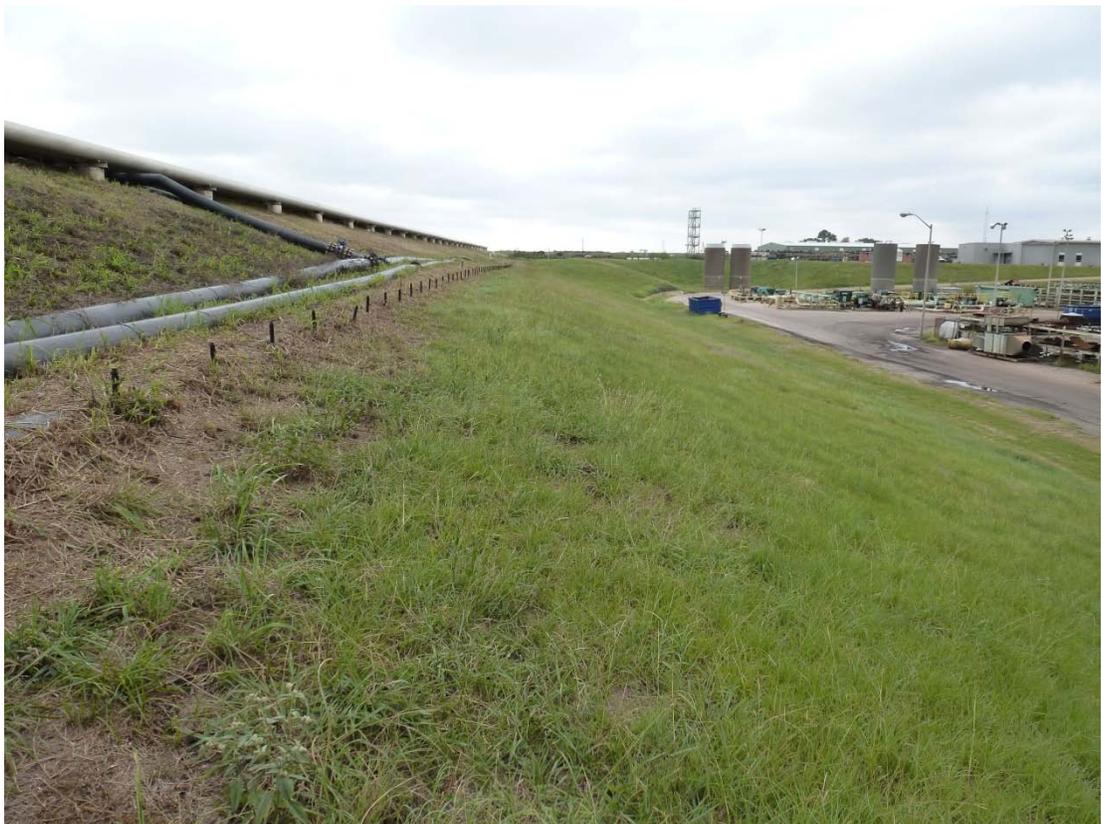
Photo Number:  
7

- The outboard slope of the northwest corner of the northern embankment appears to be steeper than the design slope of 2.5H:1V. Additionally, sliding, sloughing or possibly excavation of the embankment material was observed. Luminant representatives noted that additional fill may have been placed against the original embankment along the north side of the North and Settling Ponds and the material movement could be within the additional fill, not the embankment. The slide/slough was noted in the previous inspection reports.

Description:  
Northwest corner of the North Pond. Some erosion and slides. Owner noted that the material is additional fill placed against the original embankment. Slides have also been noted in previous inspection reports

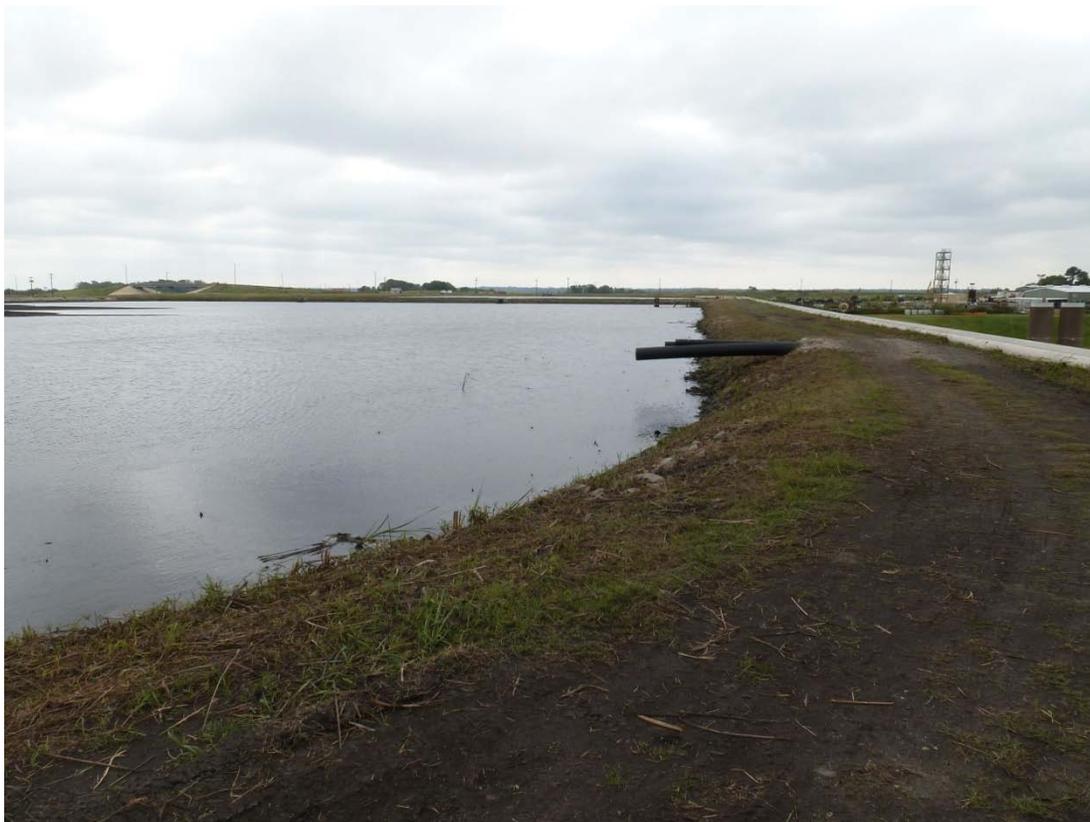
Photo Number:  
9

Description:  
Crest and interior of the North Pond.

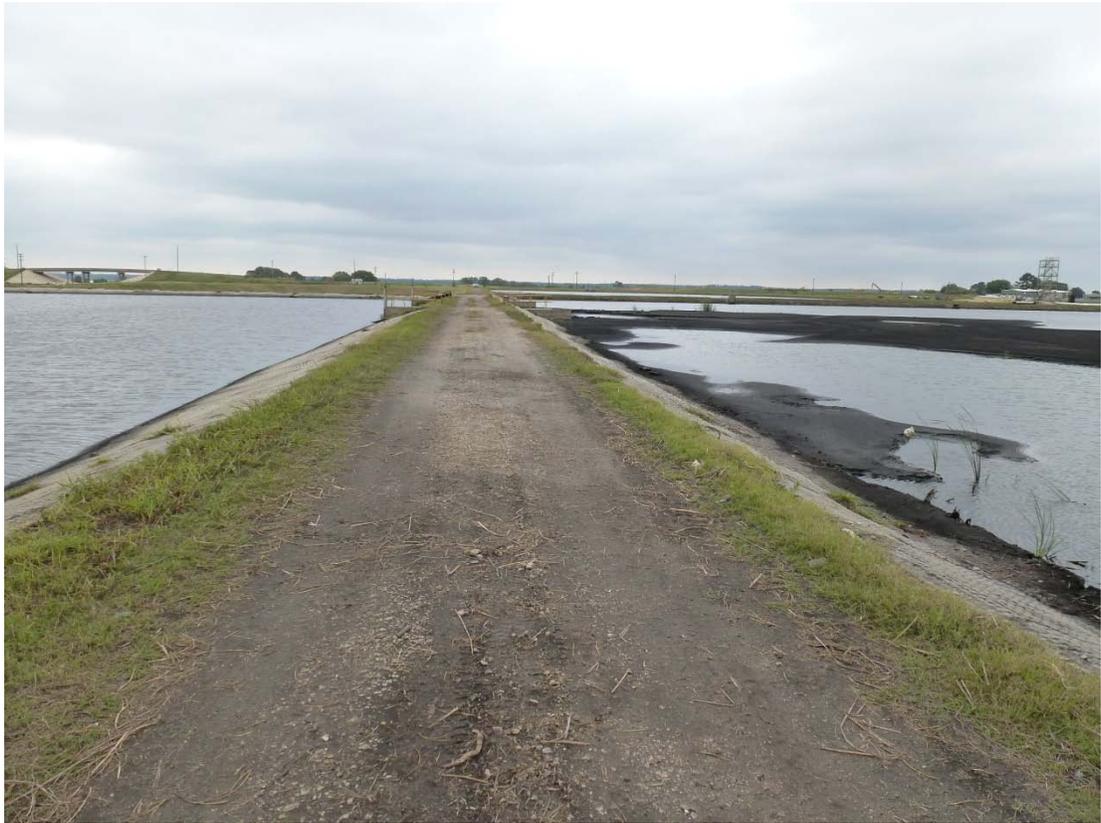
Photo Number:  
11

Description:  
Northwest corner of the Settling Pond. Note concrete revetment. Inflow piping in background.

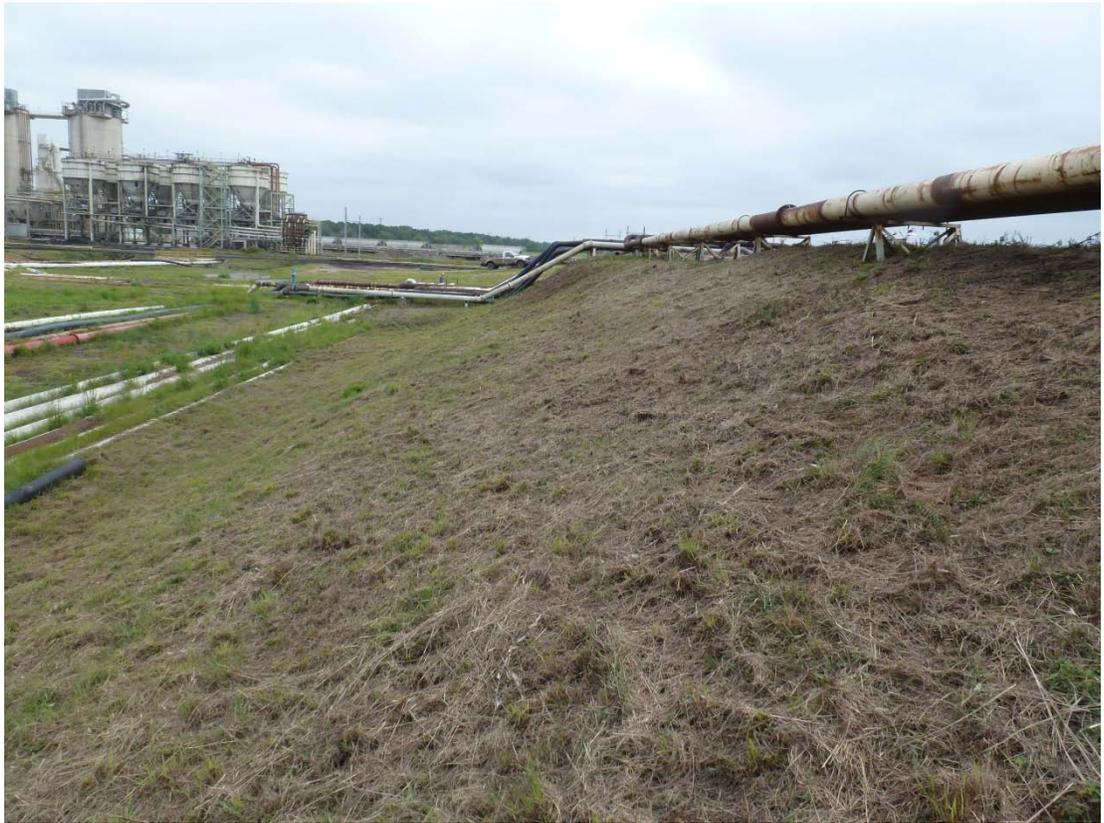
Photo Number:  
13

- Sluice water enters the pond through inflow pipes located above the water line on the northern embankment.
- Erosion gullies were observed on the northern embankment.
- The concrete revetment on the inside slopes of the pond has cracked in the southeast corner.
- Some water is retained in the Runoff Collection Pond located to the south of the Settling Pond at the toe of the southern embankment.
- Evidence of prior releases, failures or patchwork of the impoundment was not observed.

Description:  
Small erosion gully at the crest of the Settling Pond.

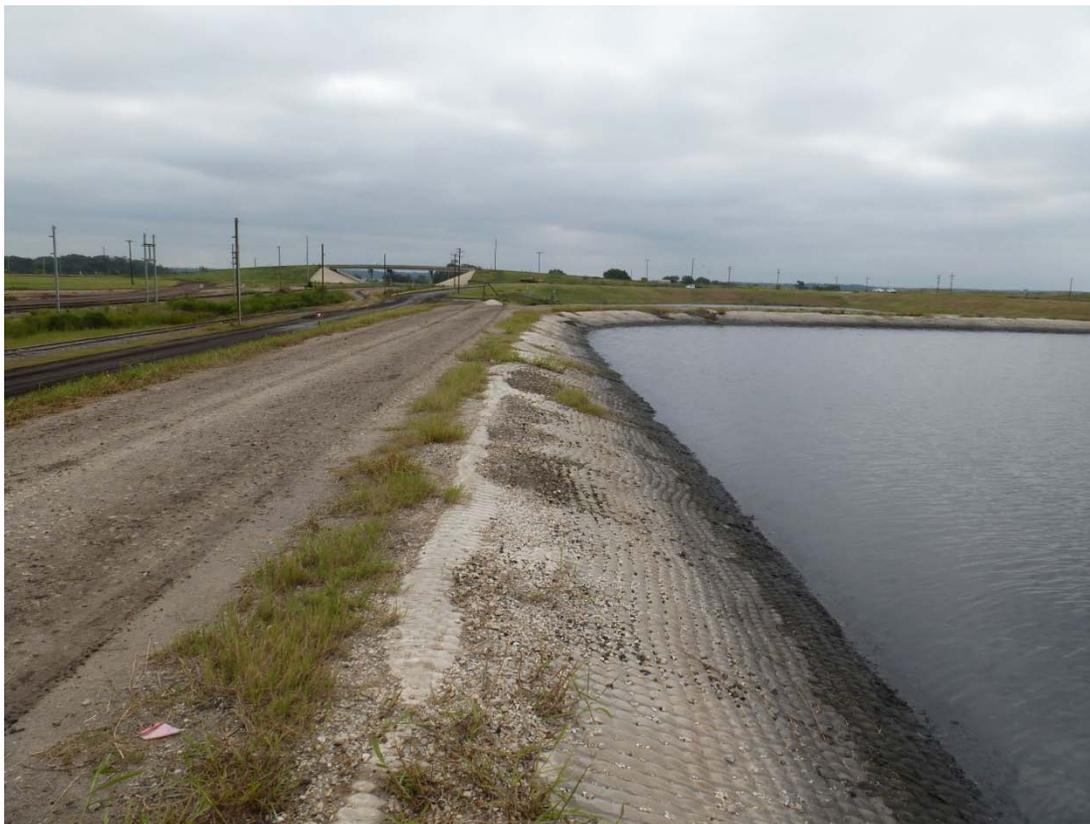
Photo Number:  
17

Description:  
Inboard face of the southern embankment of the Settling Pond. Runoff Collection Pond is visible to the left (south).

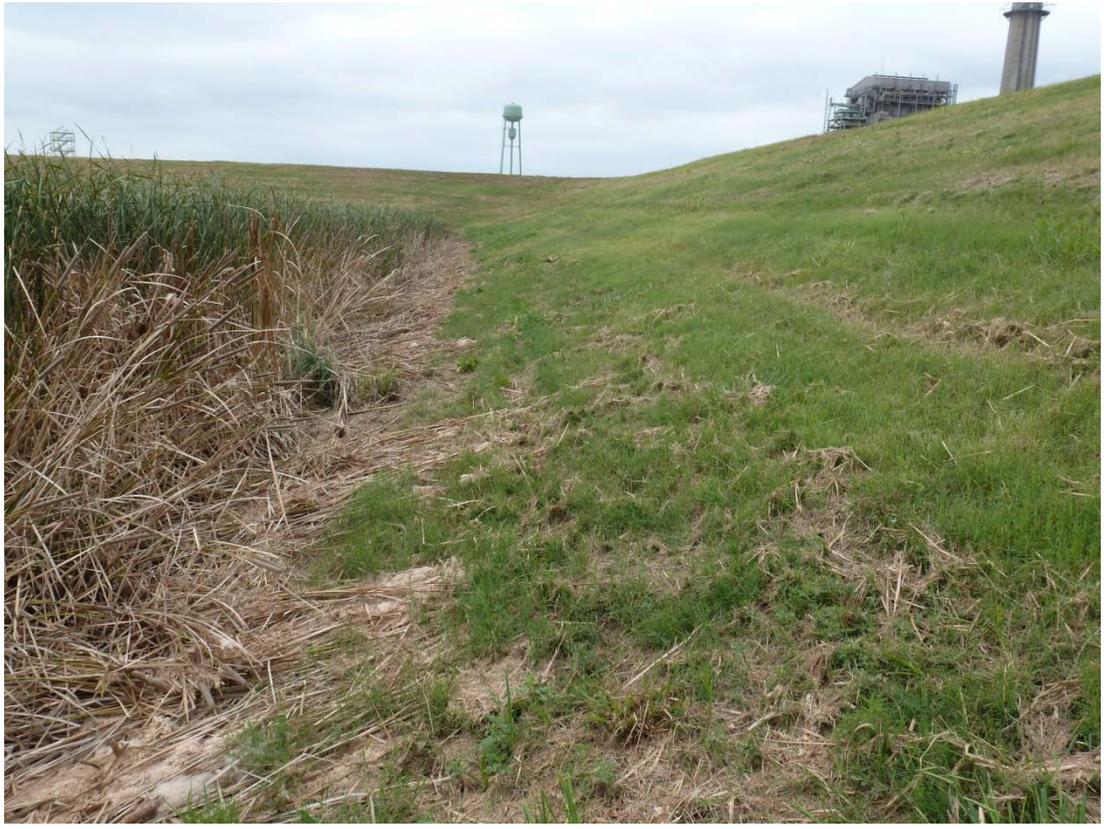
Photo Number:  
19

Description:  
Outboard face of the southern embankment of the Settling Pond. This embankment serves as the dividing dike between the Settling and Runoff Collection Ponds.

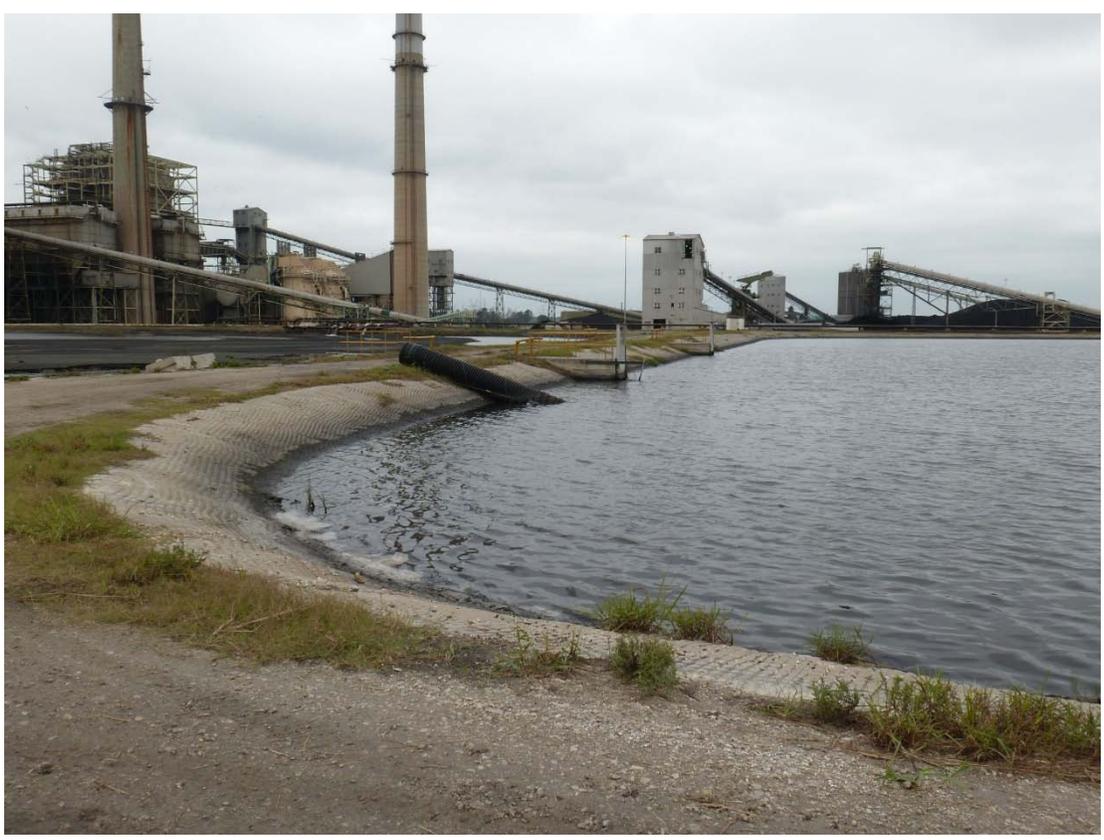
Photo Number:  
20

Description:  
Southwest corner of the Settling Pond.

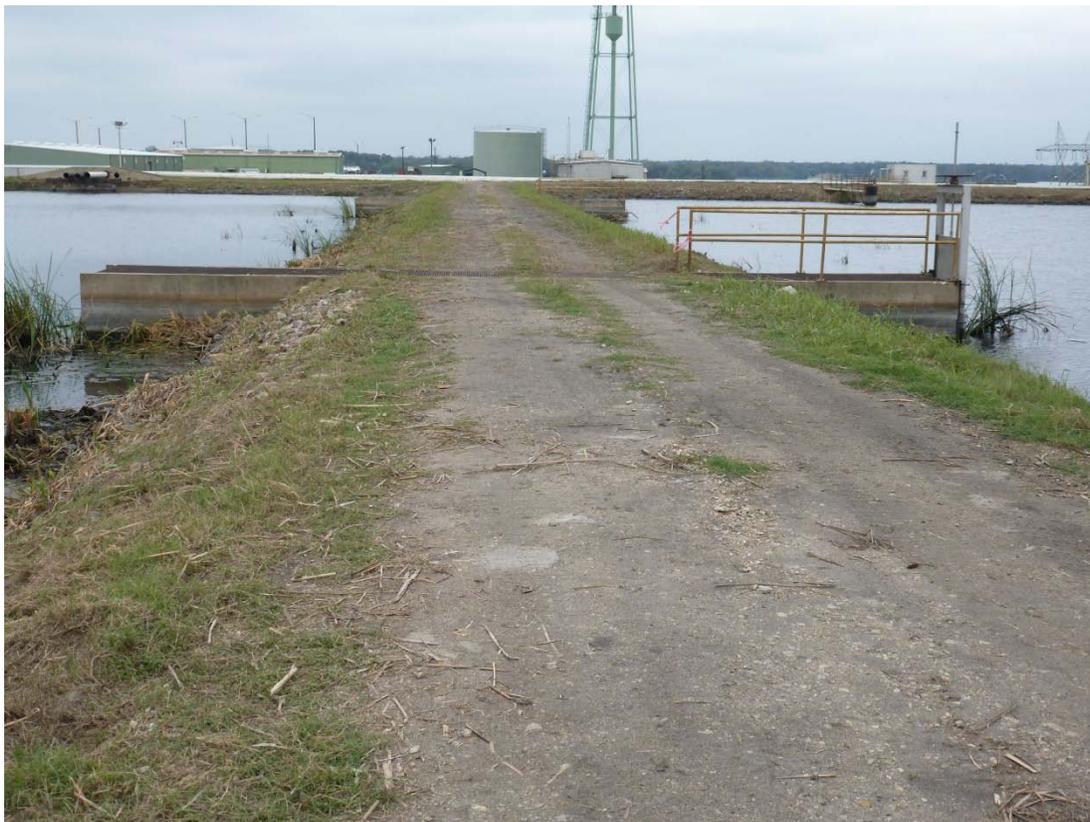
Photo Number:  
21

Description:  
Dividing dike between the North and South Ponds.

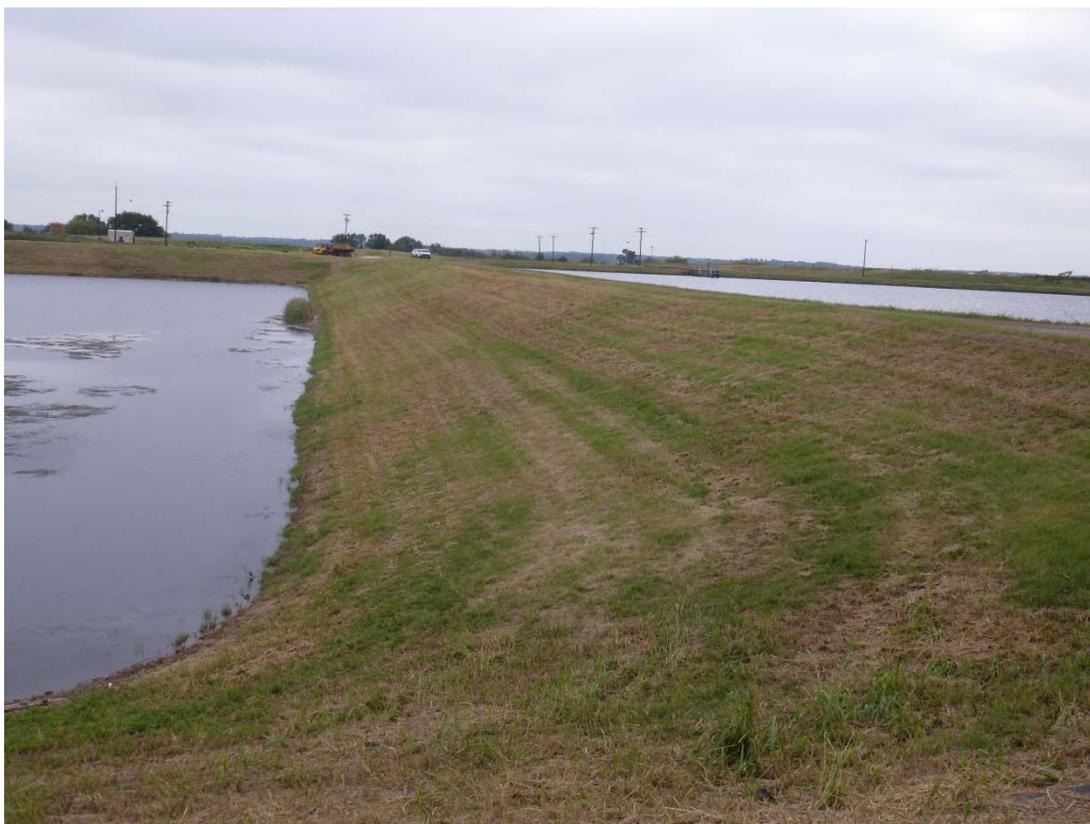
Photo Number:  
22

Description:  
Outboard face of the eastern embankment of the South Pond and the interior of the Runoff Collection Pond.

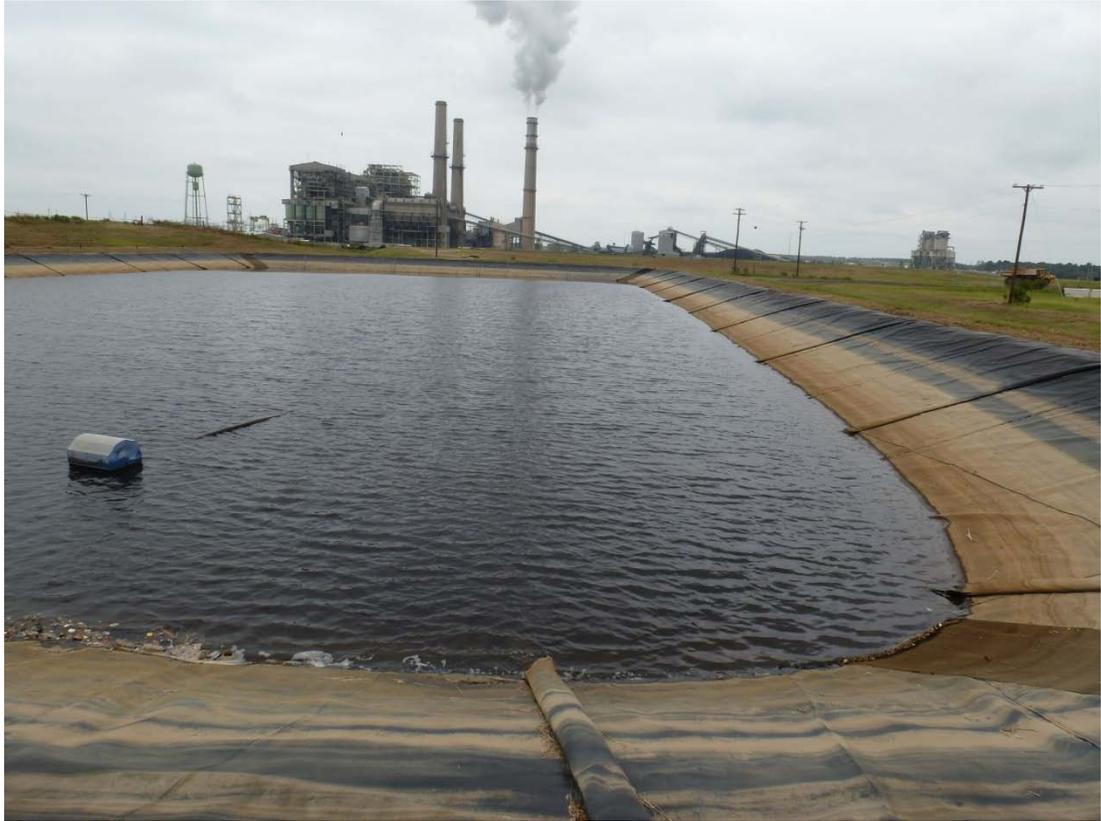
Orientation:  
N  
 Description:  
Interior of the  
Scrubber Pond.

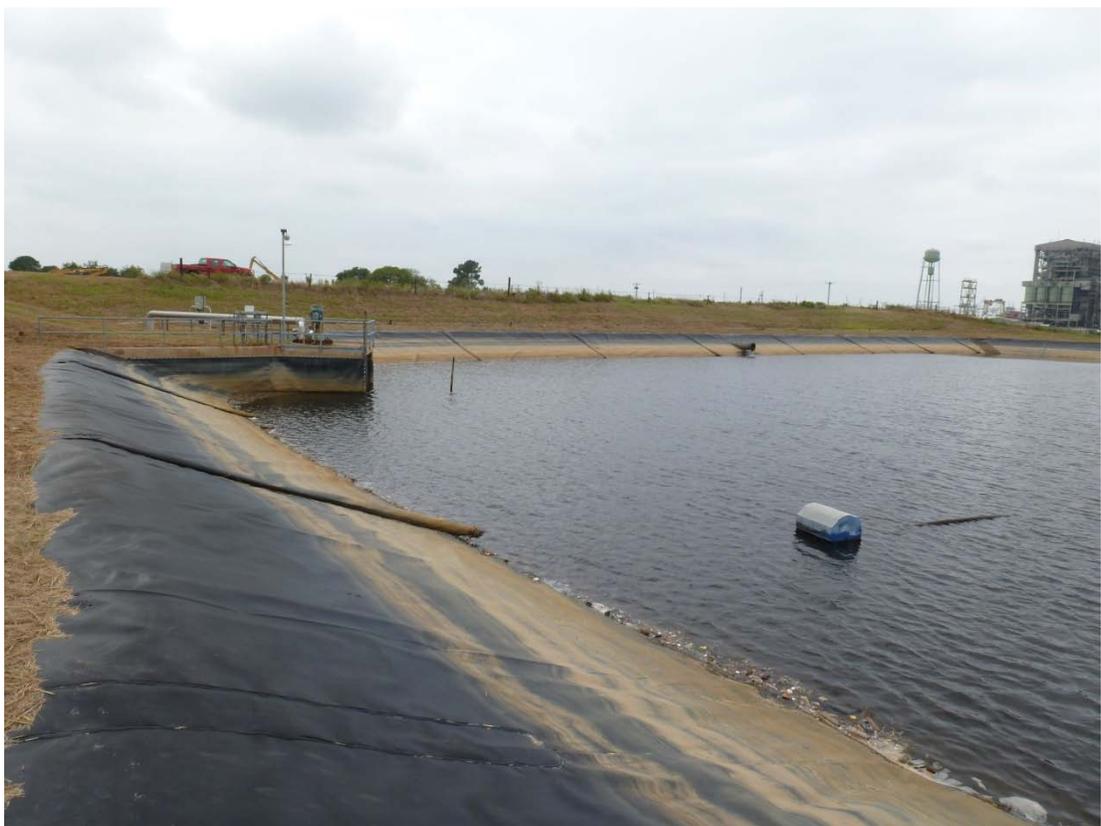
Orientation:  
W  
 Description:  
Southern  
inboard face of  
the Scrubber  
Pond.

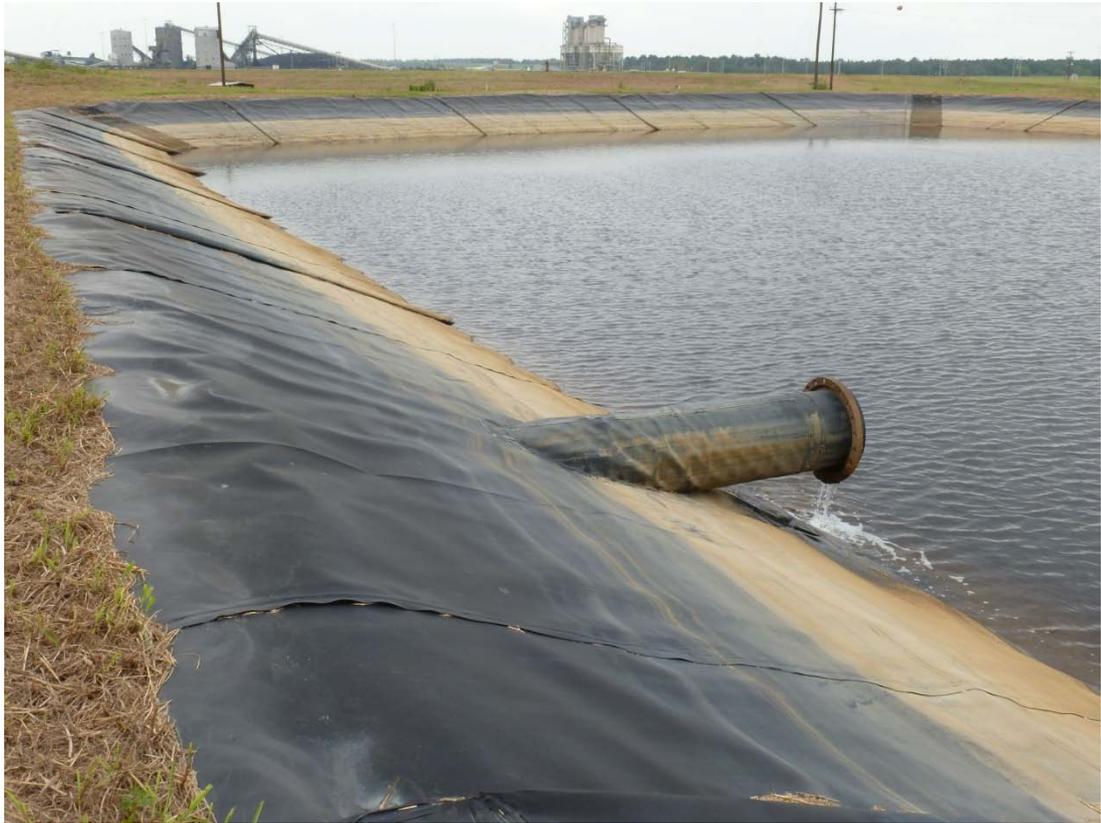
Photo Number:  
25

Description:  
Eastern inboard face of Scrubber Pond and inflow pipe.

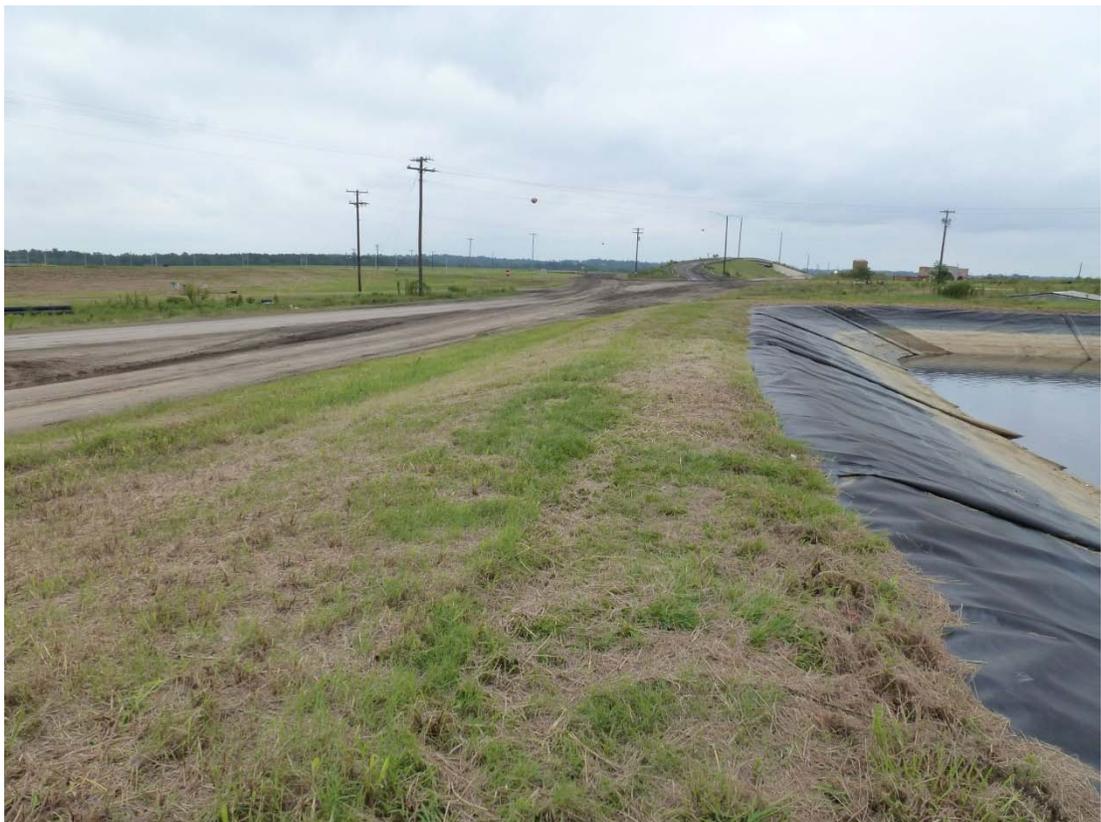
Photo Number:  
26

Description:  
Northern embankment of the Scrubber Pond.

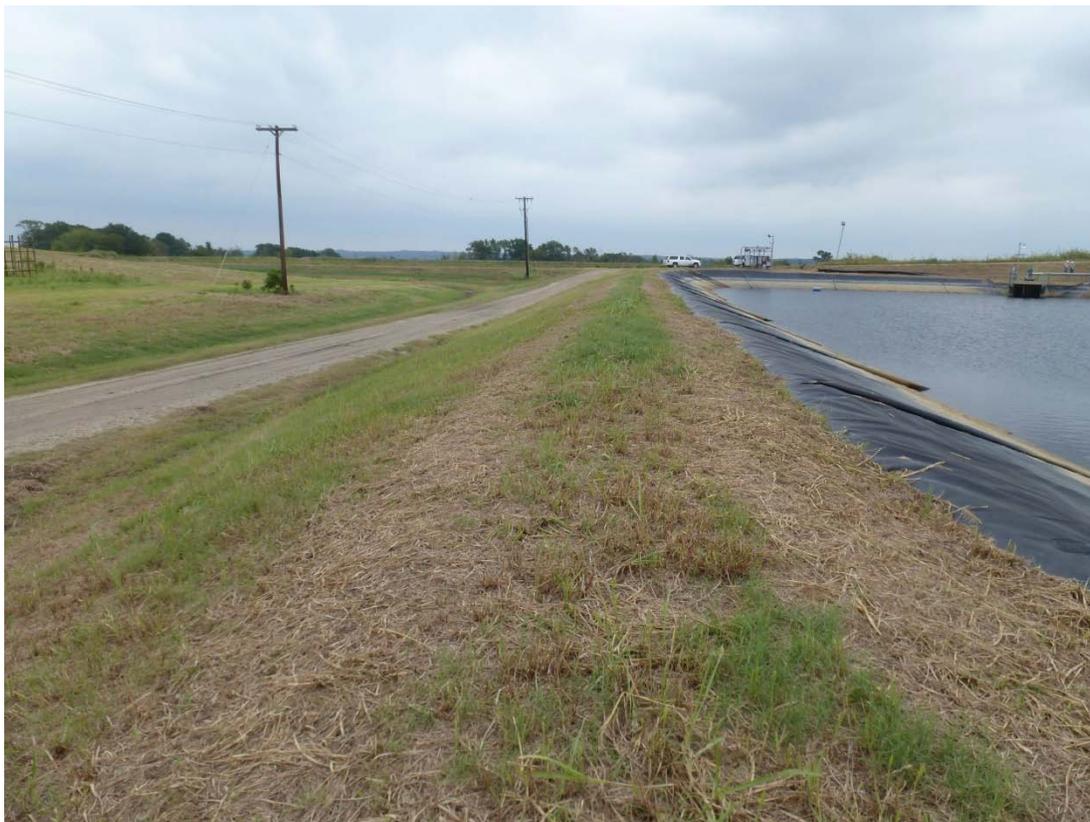
Photo Number:  
27

Description:  
Interior of abandoned Scrubber Pond and southern embankment of the "New" Scrubber Pond.
