Dam Safety Assessment of CCW Impoundments

Luminant Generation Co., LLC/MONTICELLO STEAM ELECTRIC STATION

United States Environmental Protection Agency
Washington, DC

June 3, 2014

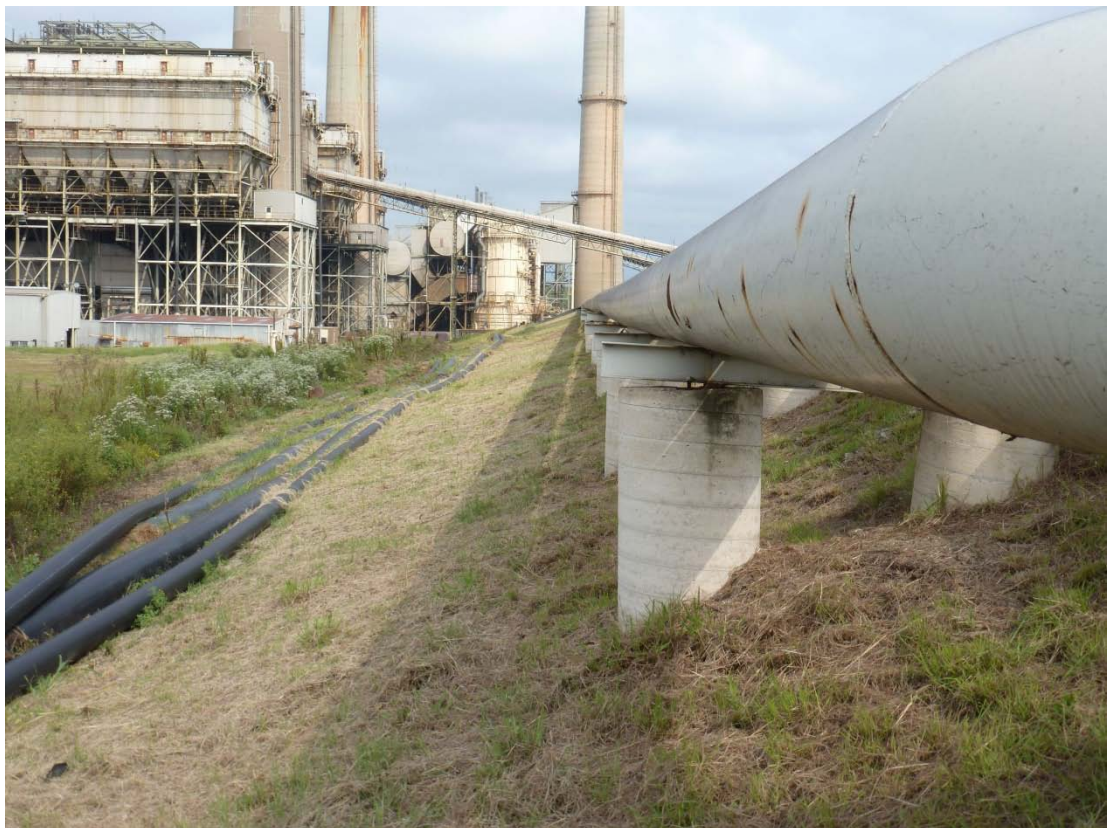
Photo Number:
4

Description:
Western embankment of South Pond. Minor rutting observed below pipes.

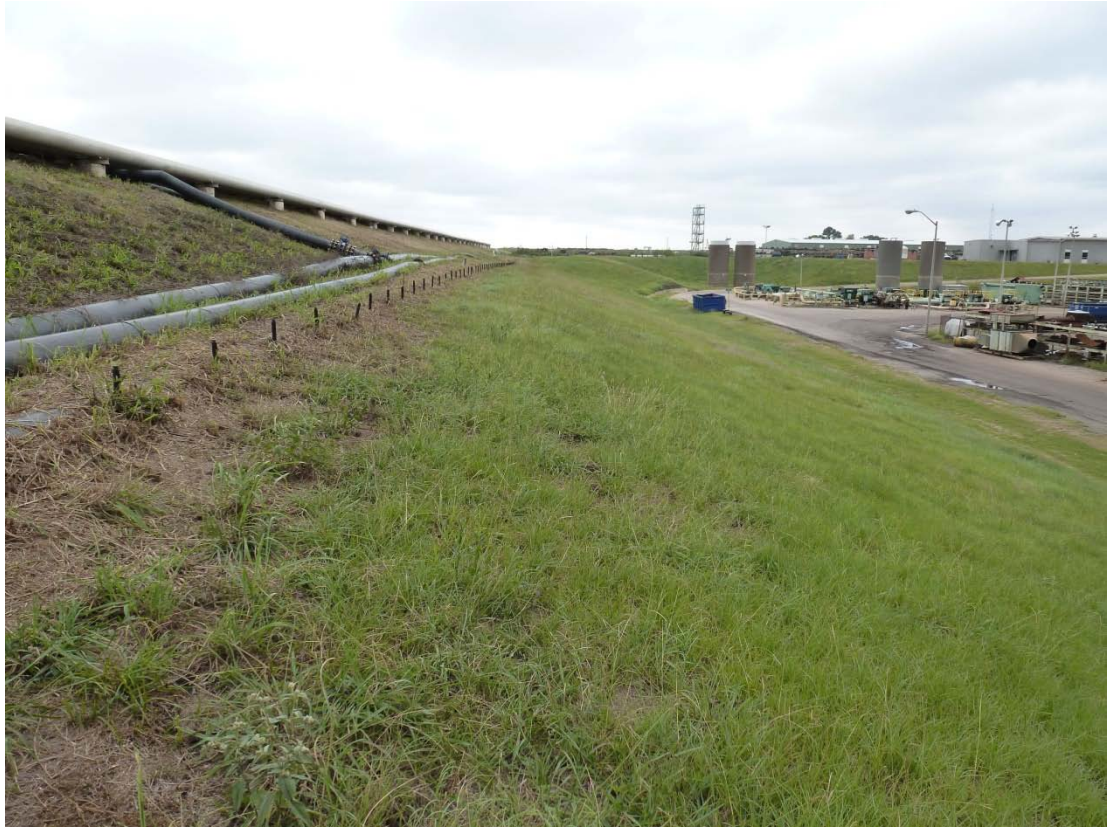
Date:
9/18/12
 Photo Number:
7
 Photographer:
NJA

Orientation:
S
 Description:
Western
embankment of
North Pond.

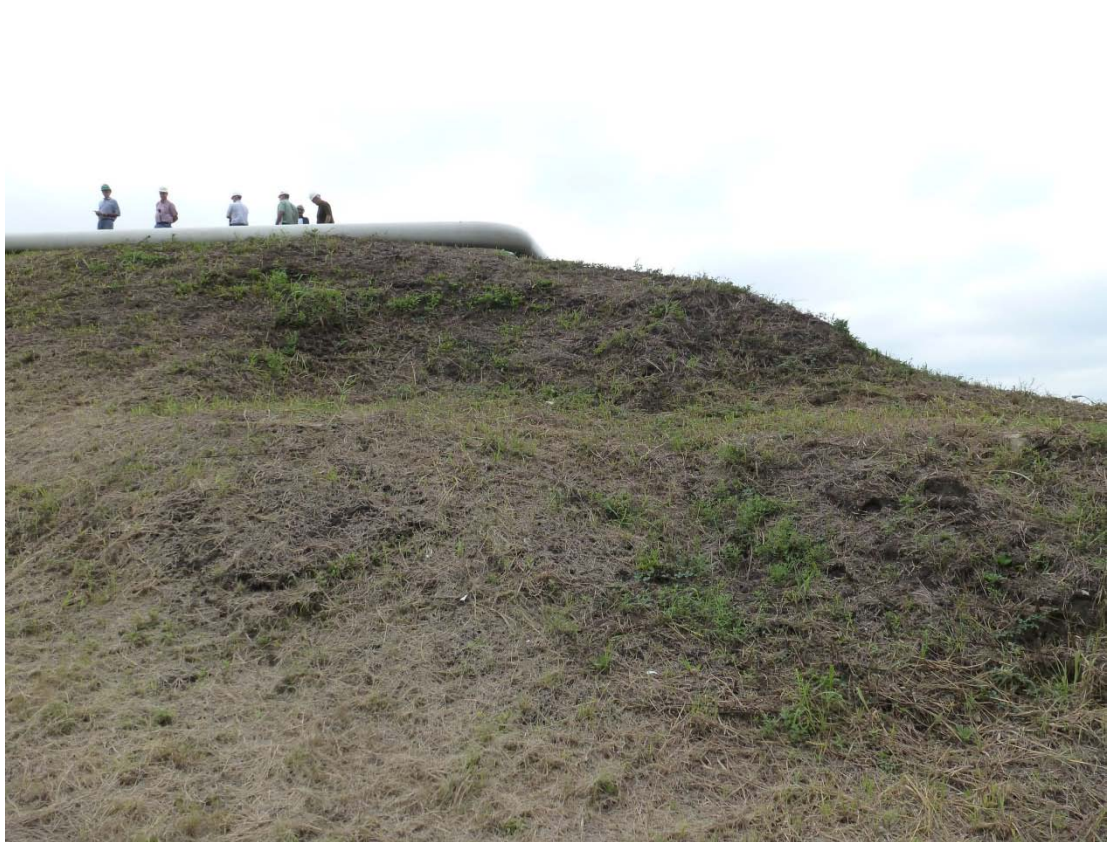
Date:
9/18/12
 Photo Number:
8
 Photographer:
NJA

Orientation:
S
 Description:
Northwest
corner of the
North Pond.
Some erosion
and slides.
Owner noted
that the
material is
additional fill
placed against
the original
embankment.
Slides have also
been noted in
previous
inspection
reports
