SUBJECT: EPA Comments on "Assessment of Dam Safety of Coal Combustion Surface  
Impoundments: Luminant Generation Co., LLC – Oak Grove Steam Electric Station,  
Franklin, TX

DATE: April 7, 2014

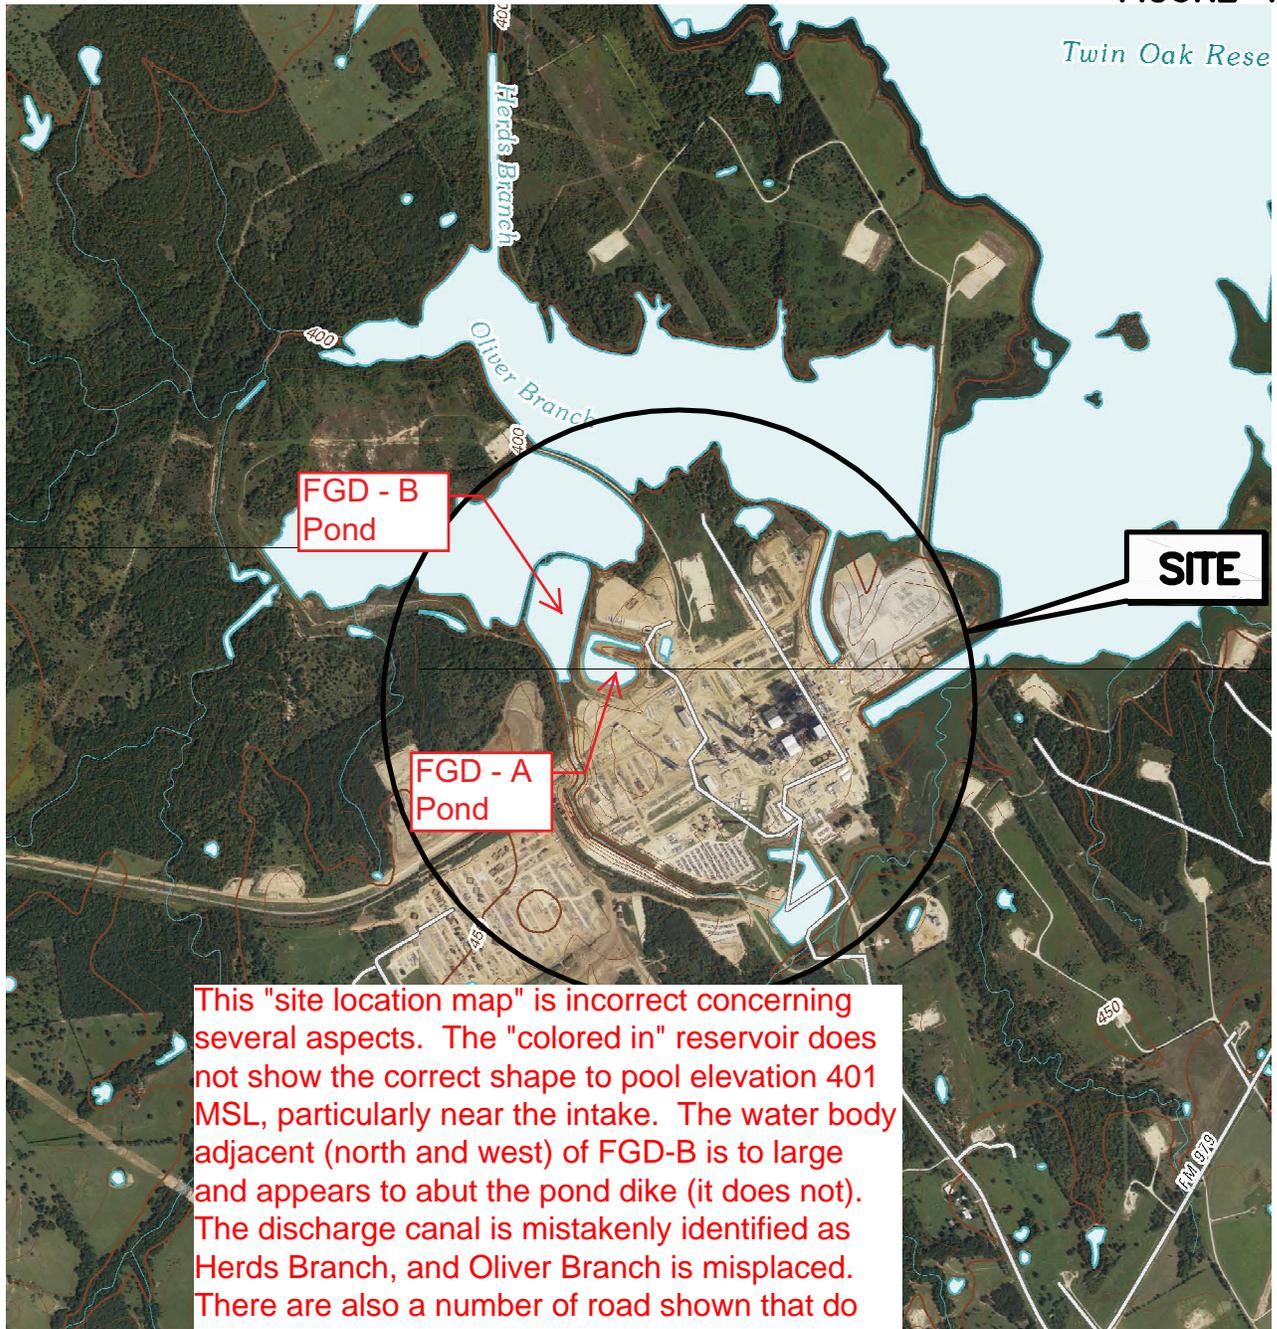
FIGURE 1

This should be updated with a more recent aerial.
