# **Dam Safety Assessment of CCW Impoundments**

## **Luminant Generation Co., LLC/OAK GROVE STEAM ELECTRIC STATION**

February 10, 2014

Luminant Generation Co., LLC./Oak Grove Steam  
Electric Station

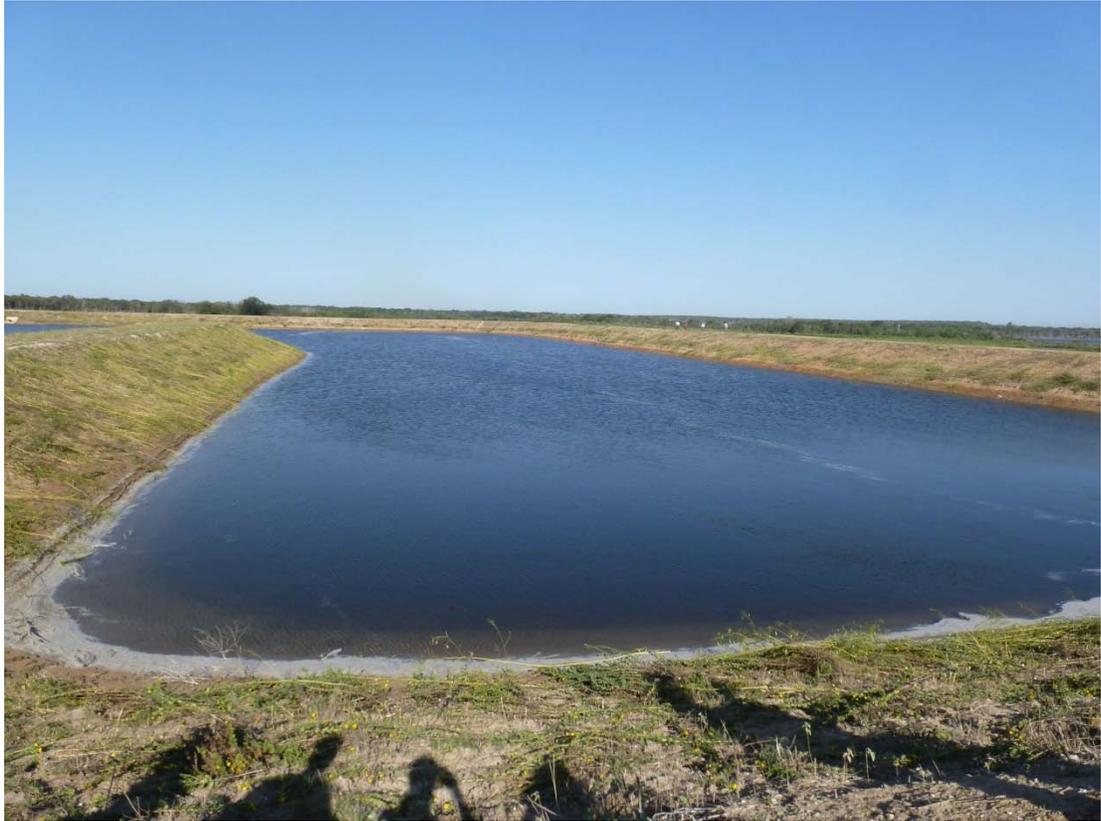
Photo Number:  
1

Description:  
FGD-A Pond  
"Dividing Dike"

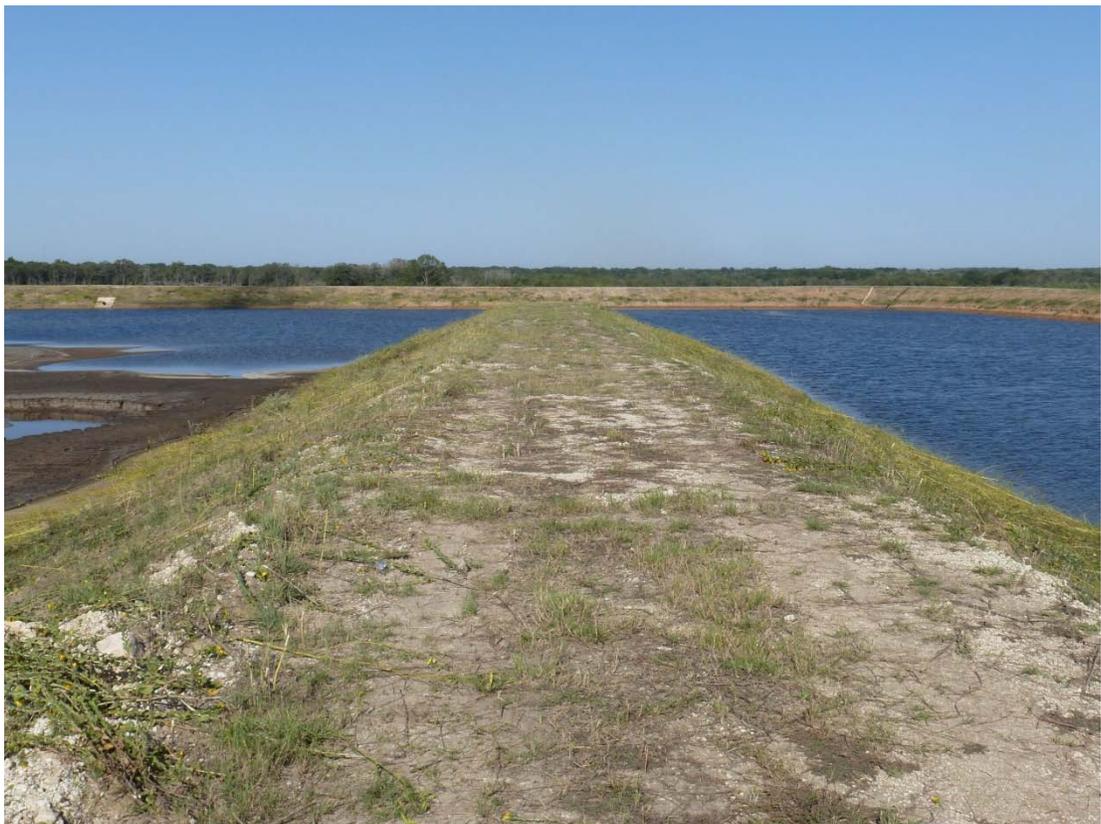
Photo Number:  
2

Description:  
FGD-A Pond.  
Southeast abutment of the "Dividing Dike" and the Pond's Eastern embankment.  
Note exposed liner.

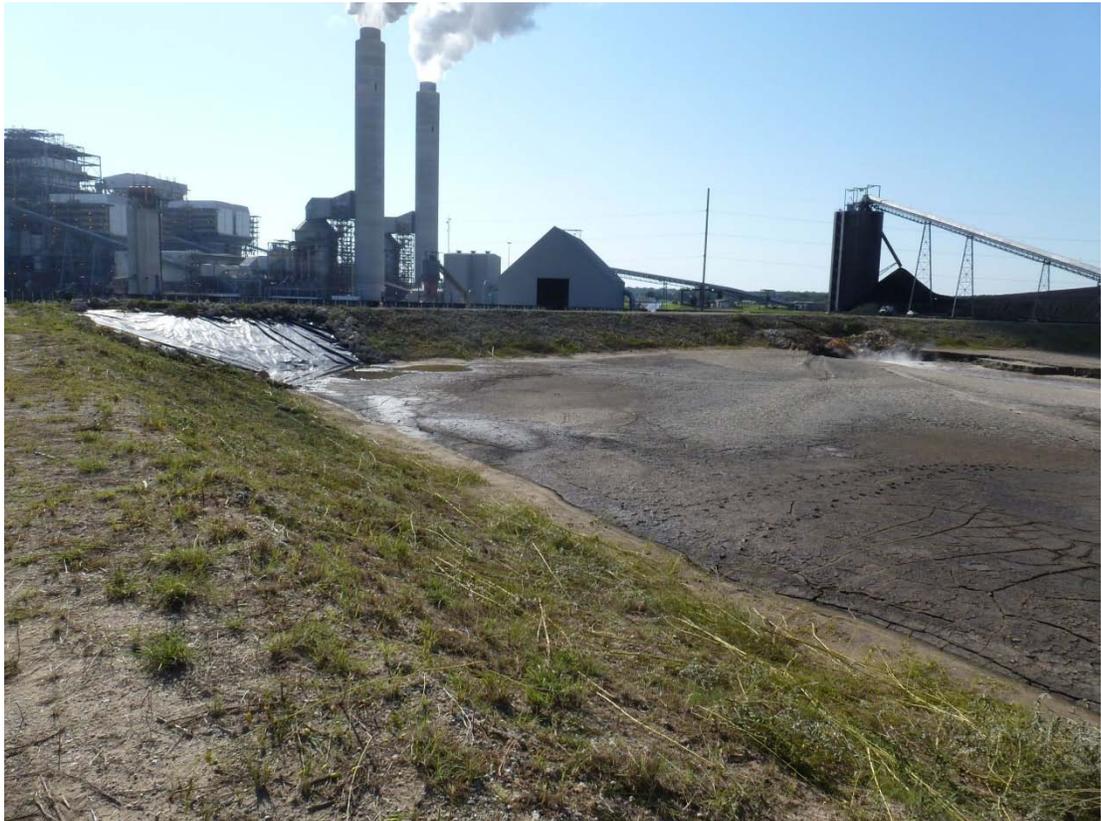
Photo Number:  
3

Description:  
CCW discharge into FGD-A Pond.

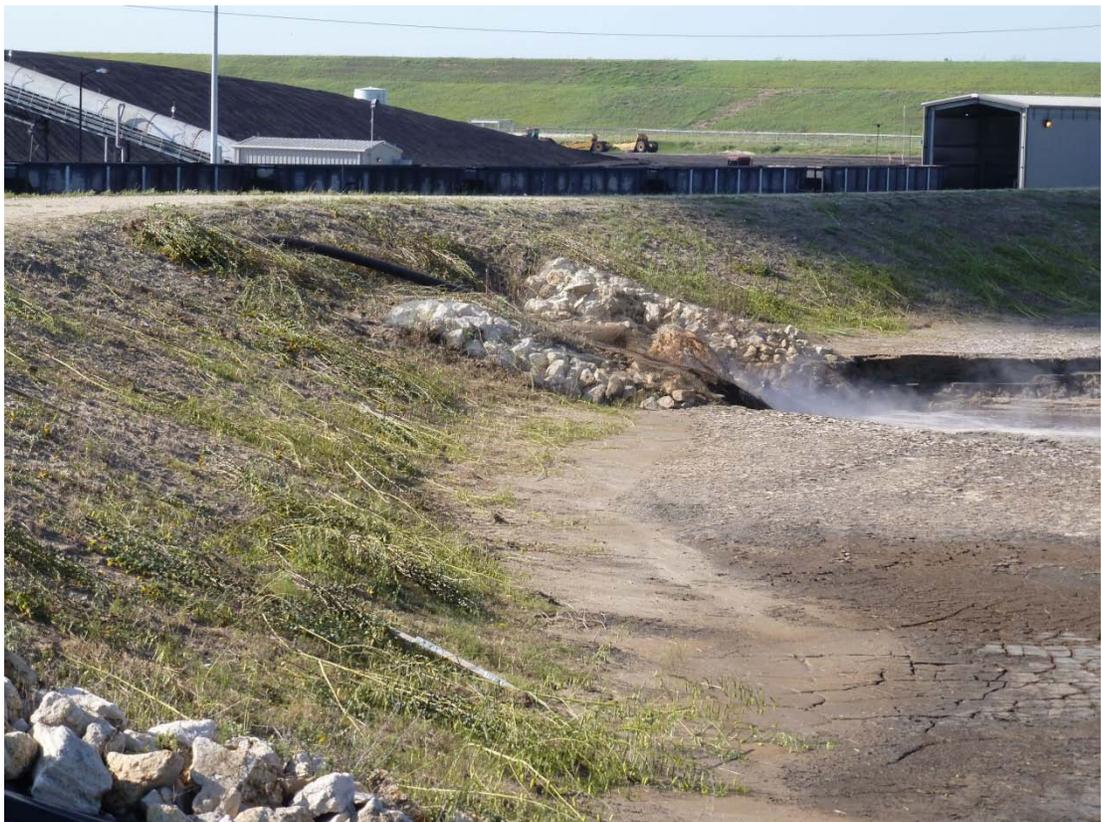
Photo Number:  
4

- FGD wastewater enters the pond through pipes installed through the southern half of the Pond's eastern embankment.
- Minor erosion gullies in the clay liner cover material was observed in several locations on the eastern embankment and the "dividing dike".
- Minor erosion of the cover material was also observed along the water-line, primarily on the Pond's northern embankment.
- An HDPE liner is exposed at the southeast abutment of the "dividing dike" and the eastern embankment.
- An animal burrow was observed adjacent to one of the inflow pipes on the outboard face of the eastern embankment.
- Damage at the outboard toe and face of the Pond's western embankment was observed. Luminant personnel reported that the damage was caused by wild boars.
- No evidence of prior releases, failures or patchwork of the impoundment was observed.

Orientation: W  
 Description: FGD-A Pond. Erosion gully on inboard face of Eastern embankment. Photo is typical of several observed gullies.

- Evaluate the seismic stability of the embankments and liquefaction potential of the embankments and underlying native soils given a 2,500 year earthquake.
- Repair eroded cover material.
- Fill the animal burrow.

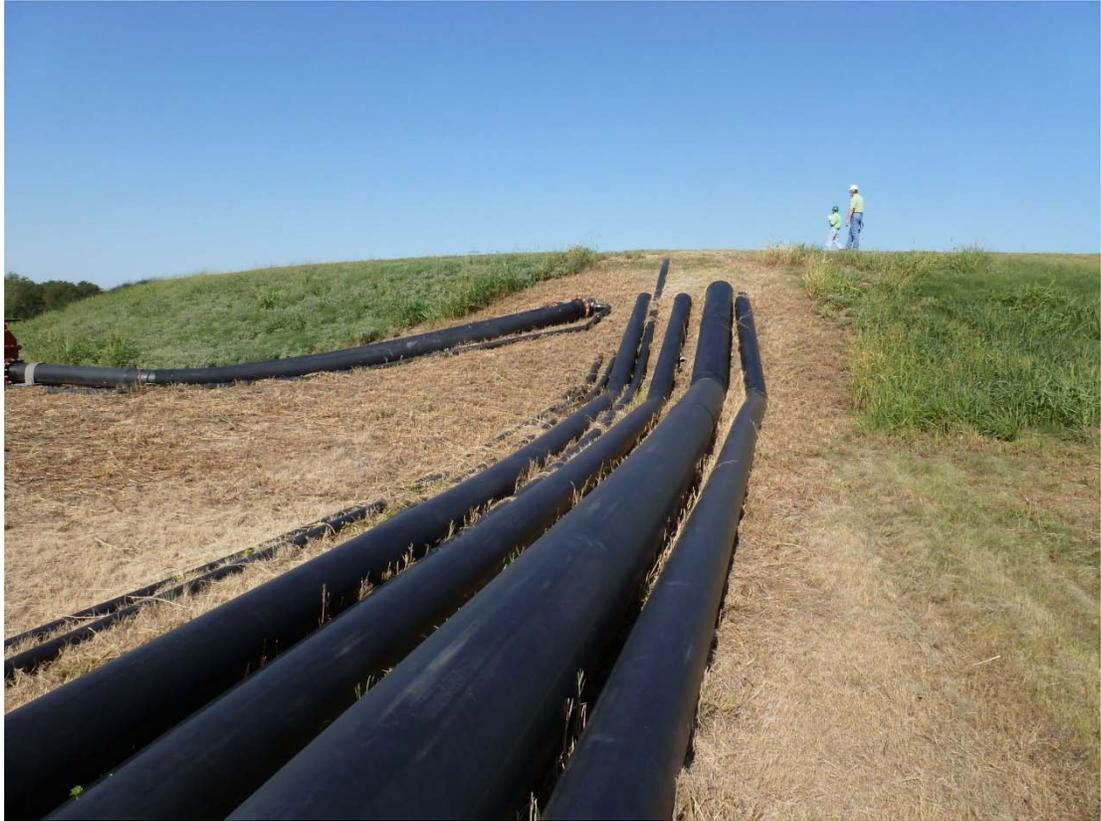
- Erosion of cover material down to the HDPE in one location of the eastern embankment of FGD-B Pond.
- The animal burrow observed adjacent to one of the inflow pipes on the outboard face of FGD-A Pond.
- Damage to outboard face of the western embankment of the FGD-A Pond from wild boars.
- Erosion of cover material at multiple locations along the waterline in both the FGD-A and FGD-B Ponds.

Date:  
9/19/12Photo Number:  
7Photographer:  
RCGOrientation:  
WDescription:  
FGD-A Pond.  
Animal burrow  
adjacent to  
inflow piping.

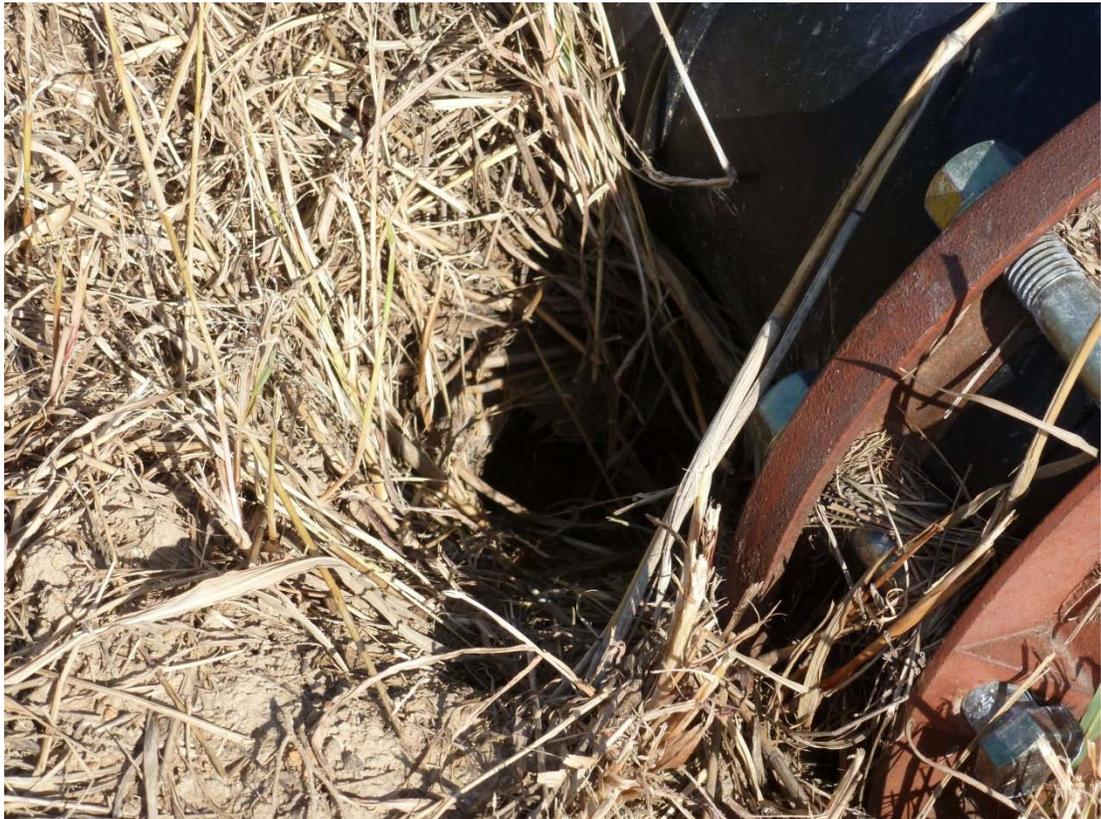
Description:  
FGD-A Pond.  
Discharge end  
of inflow piping.

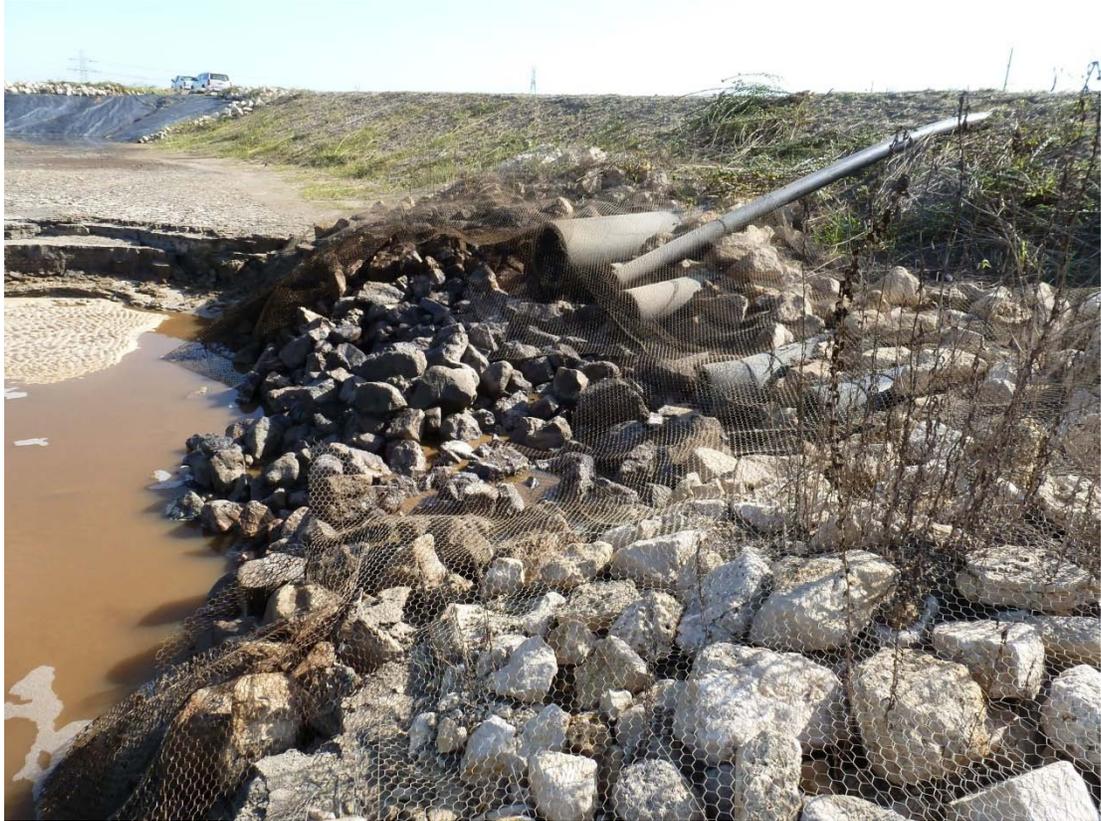
Photo Number:  
9

Description:  
FGD-A Pond.  
Outboard face  
of Southwest  
corner of  
embankment.

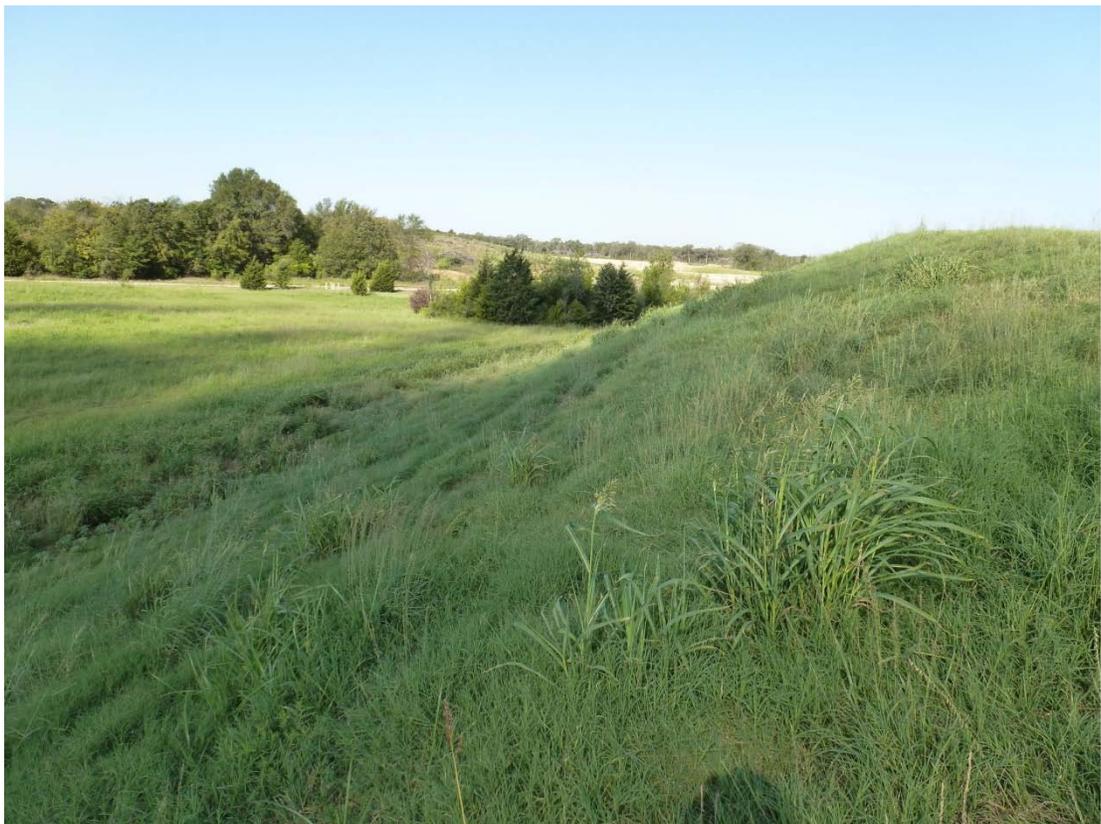
Photo Number:  
10

Description:  
FGD-A Pond.  
Wild hog damage to outboard face of Western embankment. Several locations of hog damage observed.

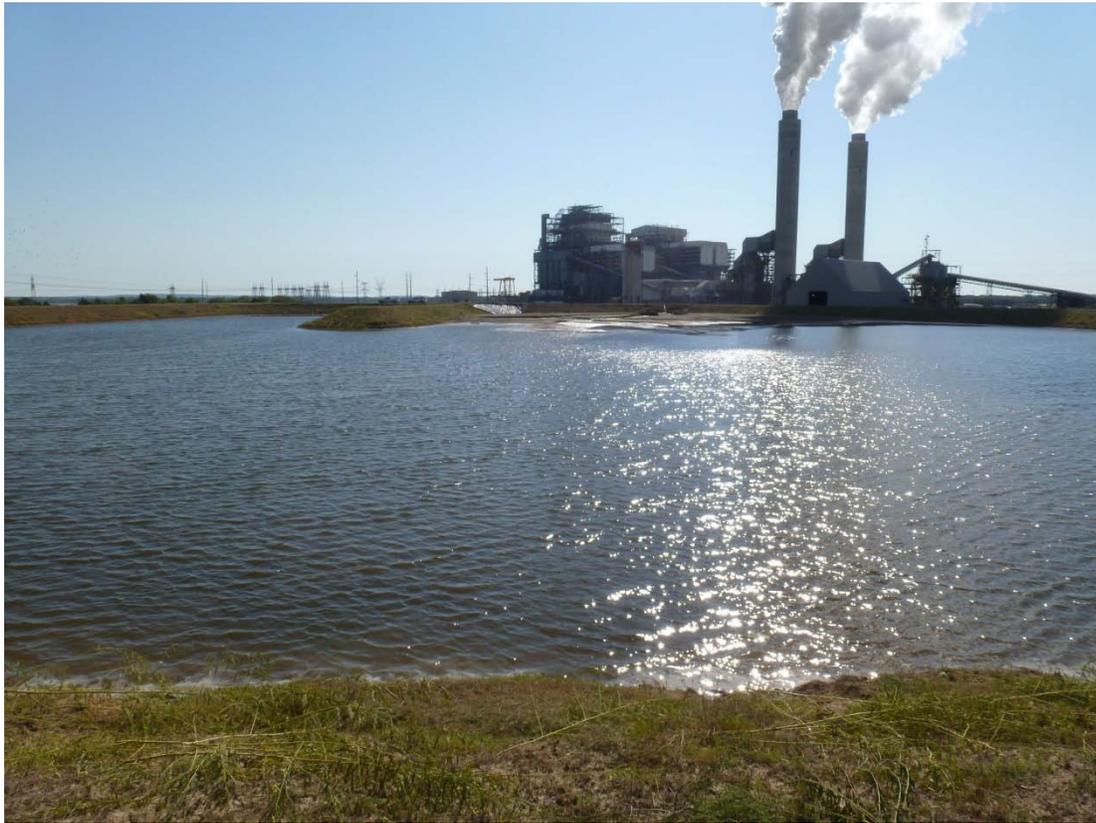
Photo Number:  
13

Description:  
FGD-A Pond.  
Inboard faces of Western and Northern embankments.  
Note erosion of liner cover near water line

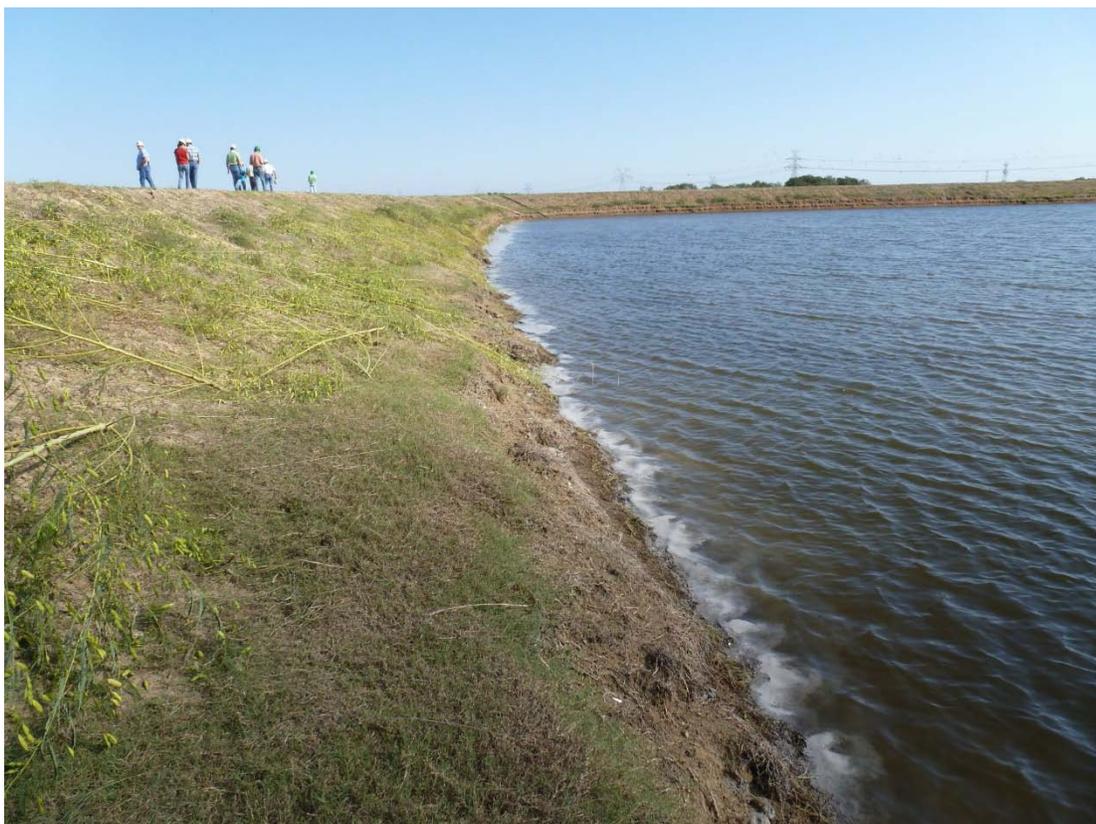
Photo Number:  
14

Description:  
FGD-A Pond.  
Inboard face of  
Northern  
embankment.  
Note erosion of  
liner cover near  
water line

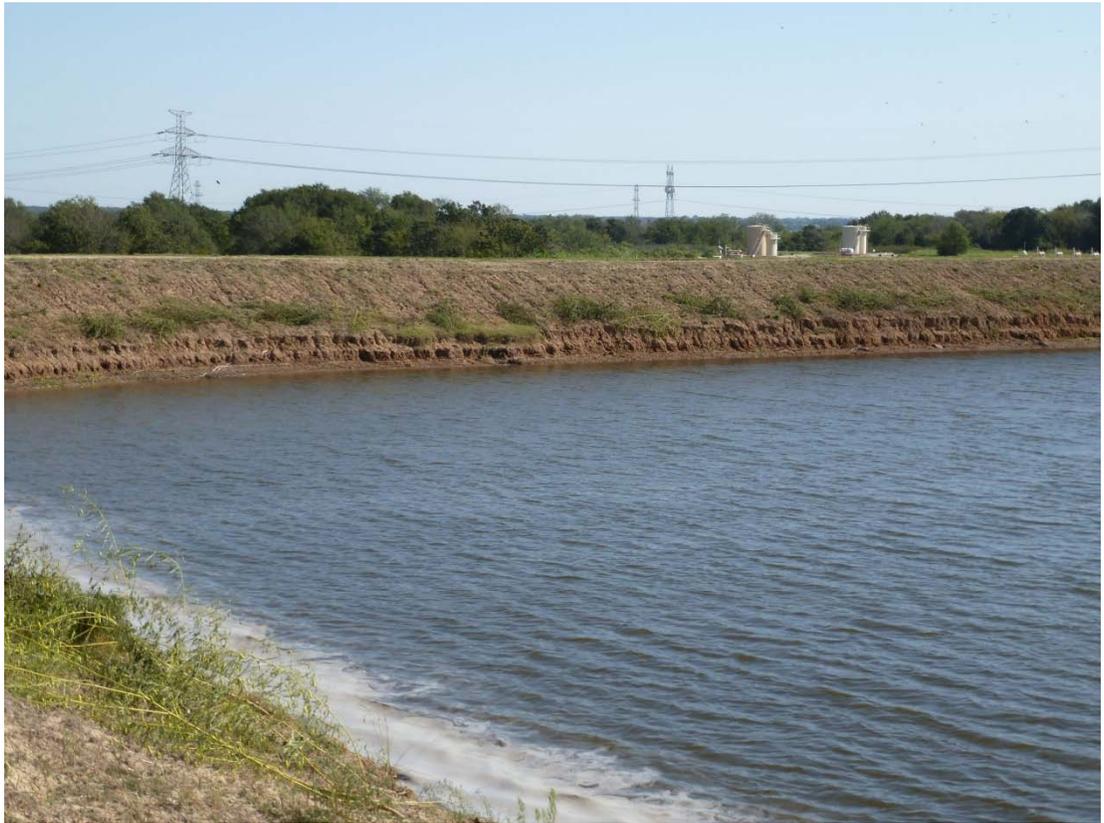
Photo Number:  
15

Description:  
FGD-A Pond.  
Outboard face  
of Northern  
embankment.

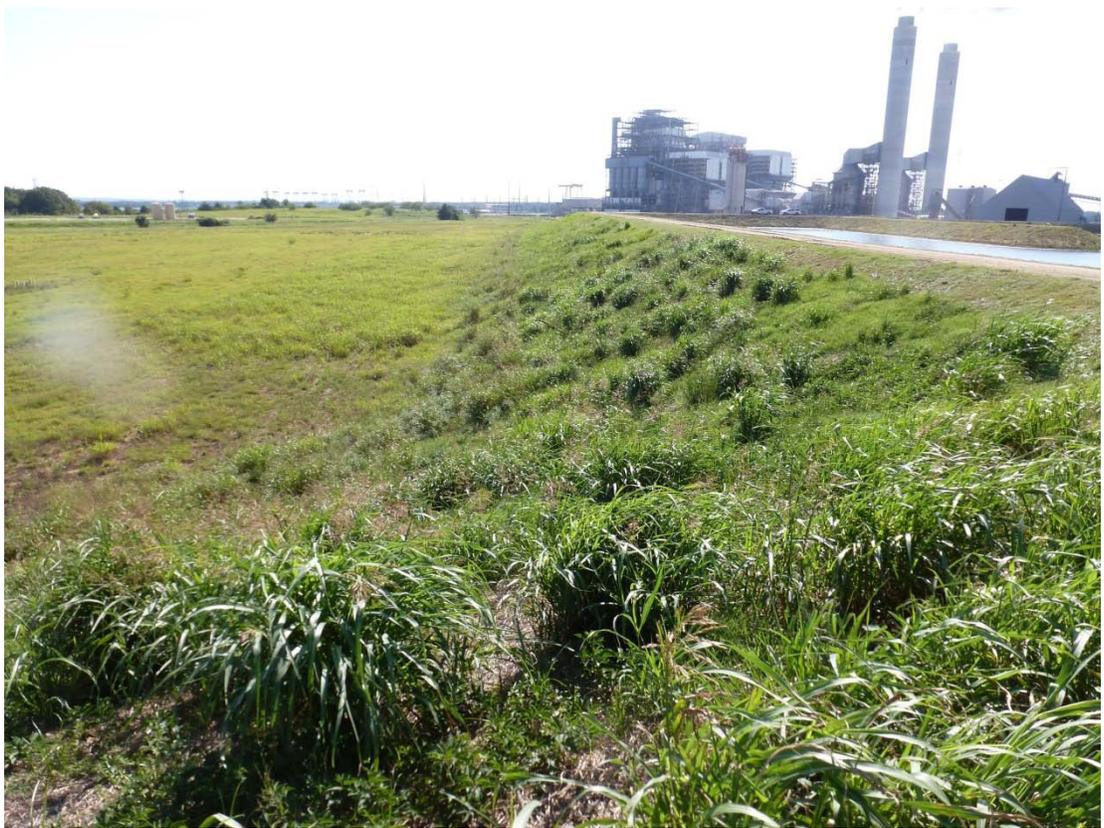
Photo Number:  
16

Description:  
FGD-A Pond.  
Crest of  
Northern  
embankment.  
Condition  
shown in photo  
is typical of  
entire crest.

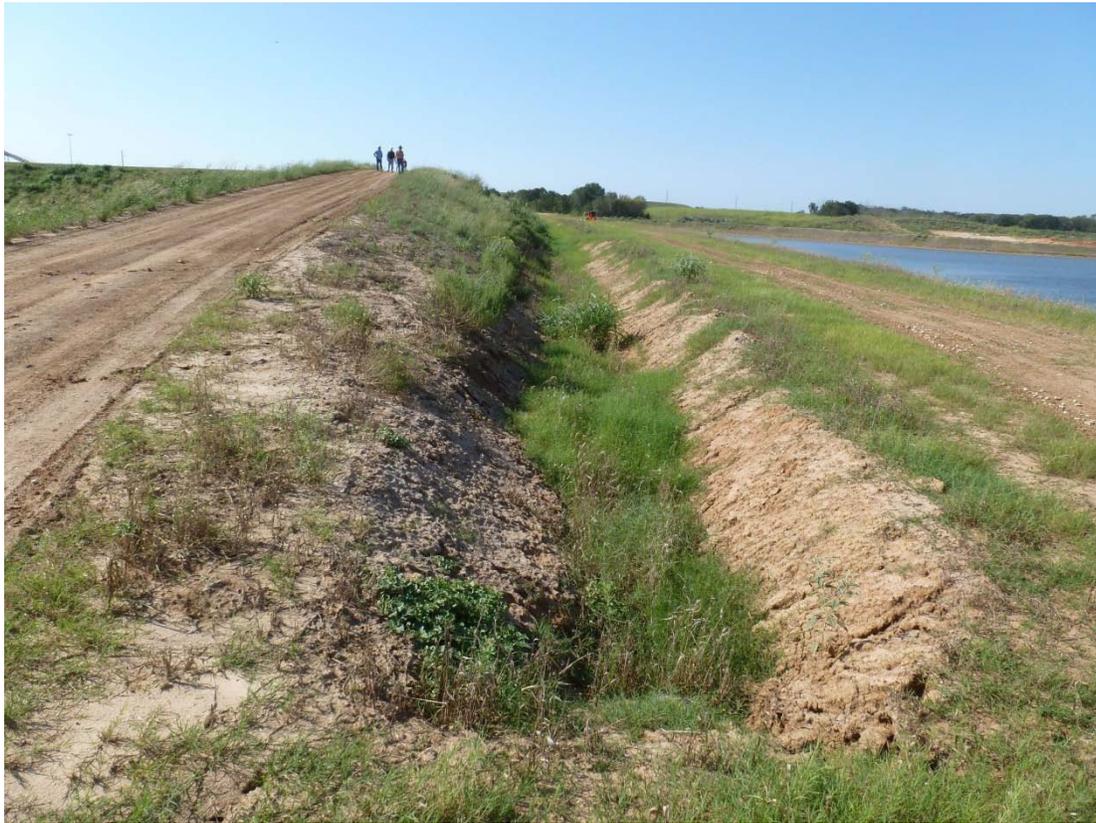
Photo Number:  
19

Description:  
FGD-B Pond. Outboard face, northeast corner.

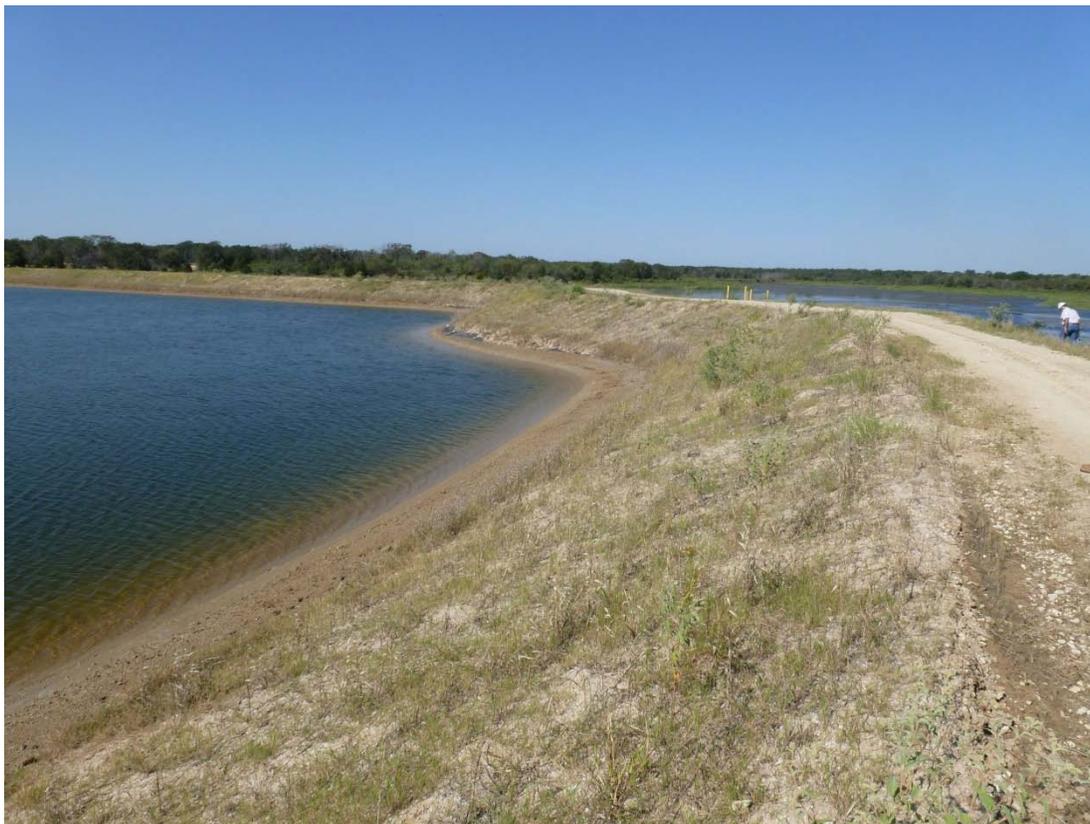
Photo Number:  
21

Description:  
FGD-B Pond.  
Outboard face  
of Northern  
embankment.  
Note reservoir  
adjacent to the  
impoundment.  
The reservoir  
does not abut  
any  
embankment.

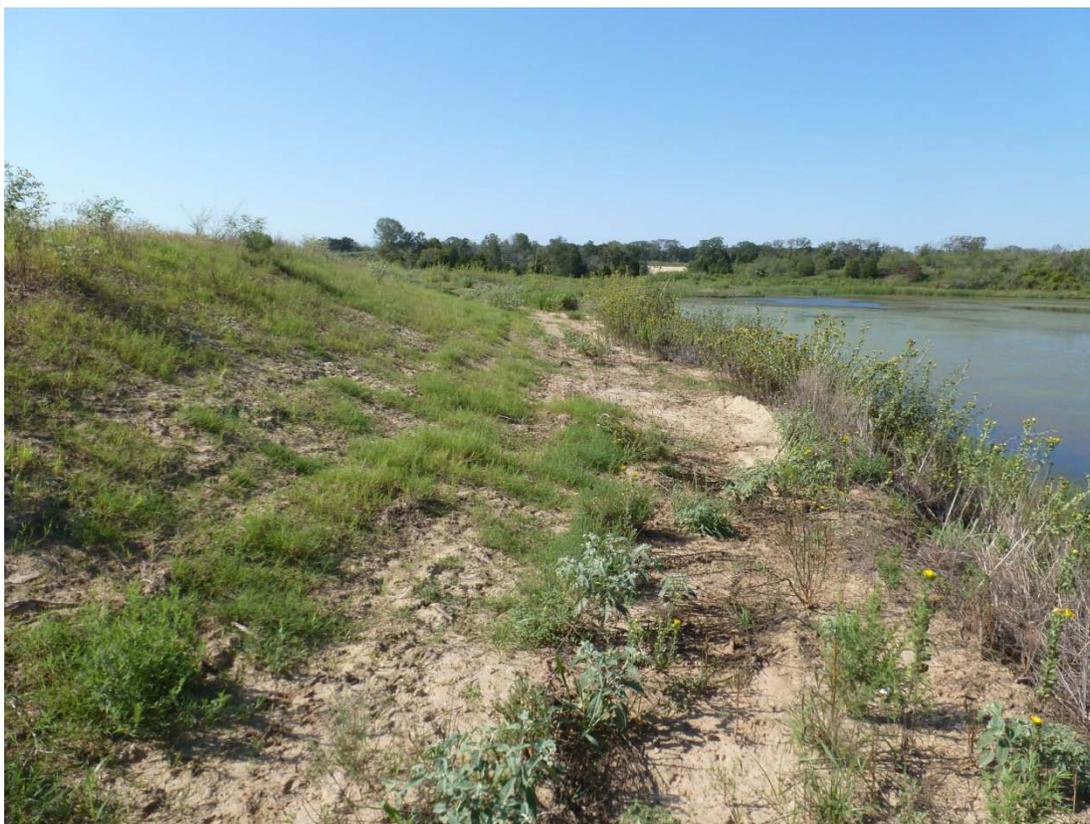
Photo Number:  
22

- Erosion of the HDPE's cover material was observed along the water-line throughout the impoundment. A small section of liner was exposed near the northwest corner of the impoundment.
- The vegetative cover planted when construction of the impoundment was completed earlier in 2012 has not grown significantly due to drought conditions after planting.
- A deep erosion gully was observed on the eastern embankment. The liner's cover material was fully eroded and the liner was exposed at this location.
- No evidence of prior releases, failures or patchwork of the impoundment was observed.

Description:  
FGD-B Pond.  
Inboard face of  
Northern  
embankment.  
Note exposed  
liner.

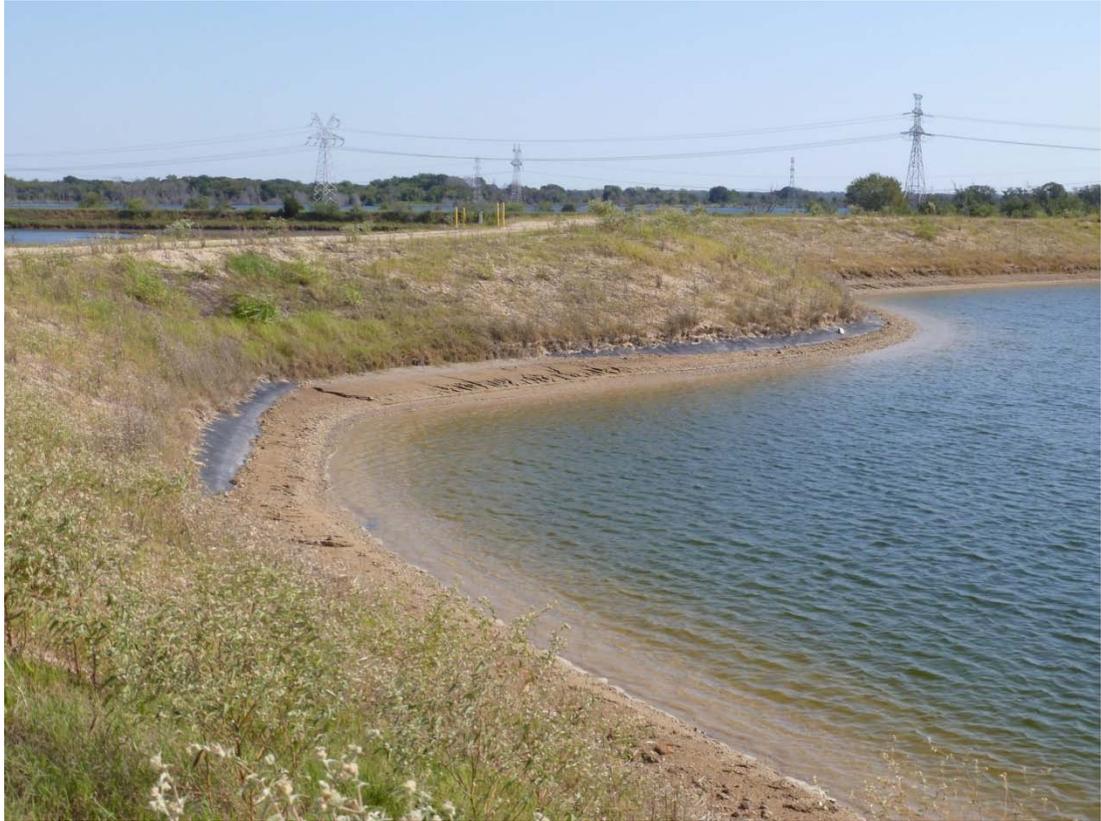
Photo Number:  
23

Description:  
FGD-B Pond.  
Outboard face of  
Western  
embankment.

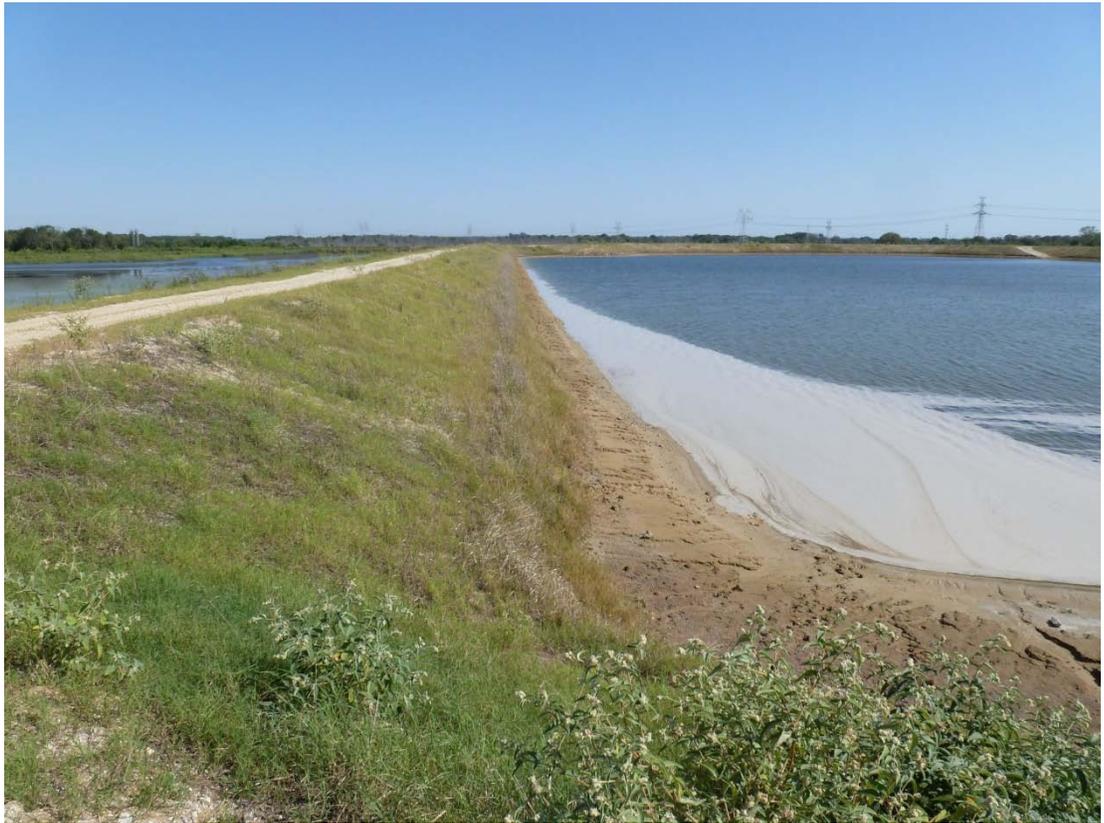
Photo Number:  
25

Description:  
FGD-B Pond.  
Inboard face of  
Southern  
embankment.

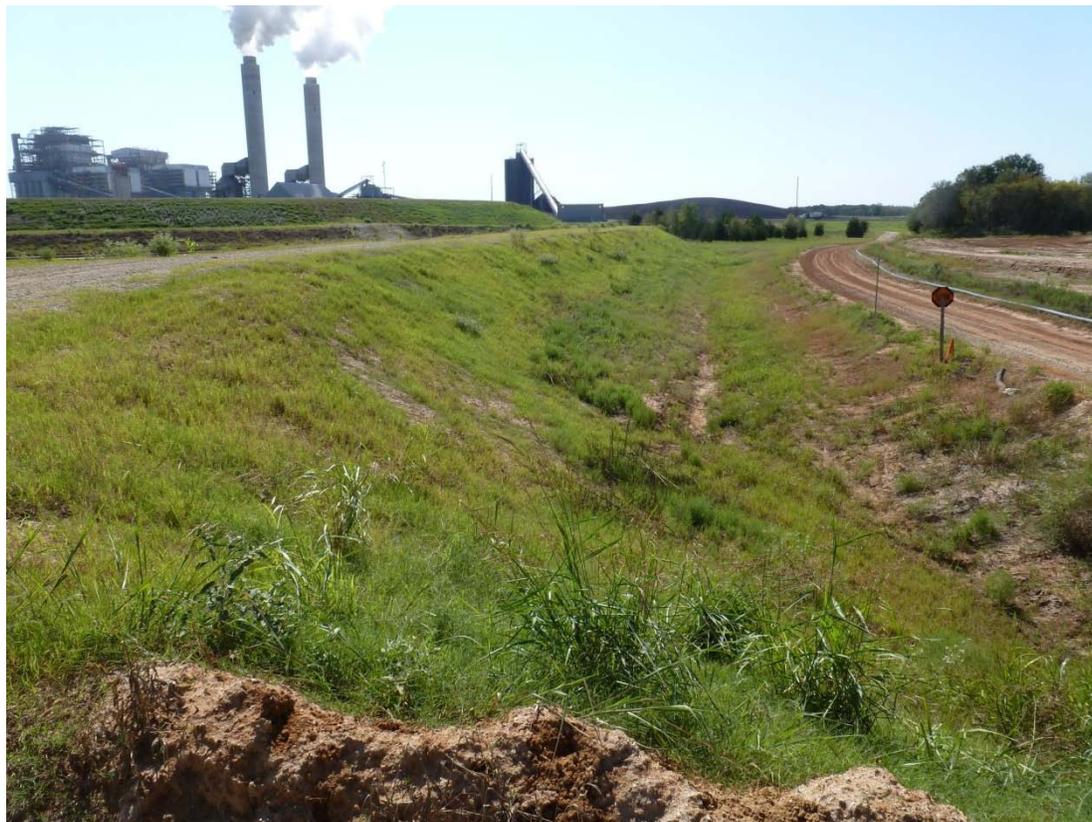
Photo Number:  
27

Description:  
FGD-B Pond.  
Discharge end  
of overflow/  
decant pipe  
from FGD-A  
Pond.

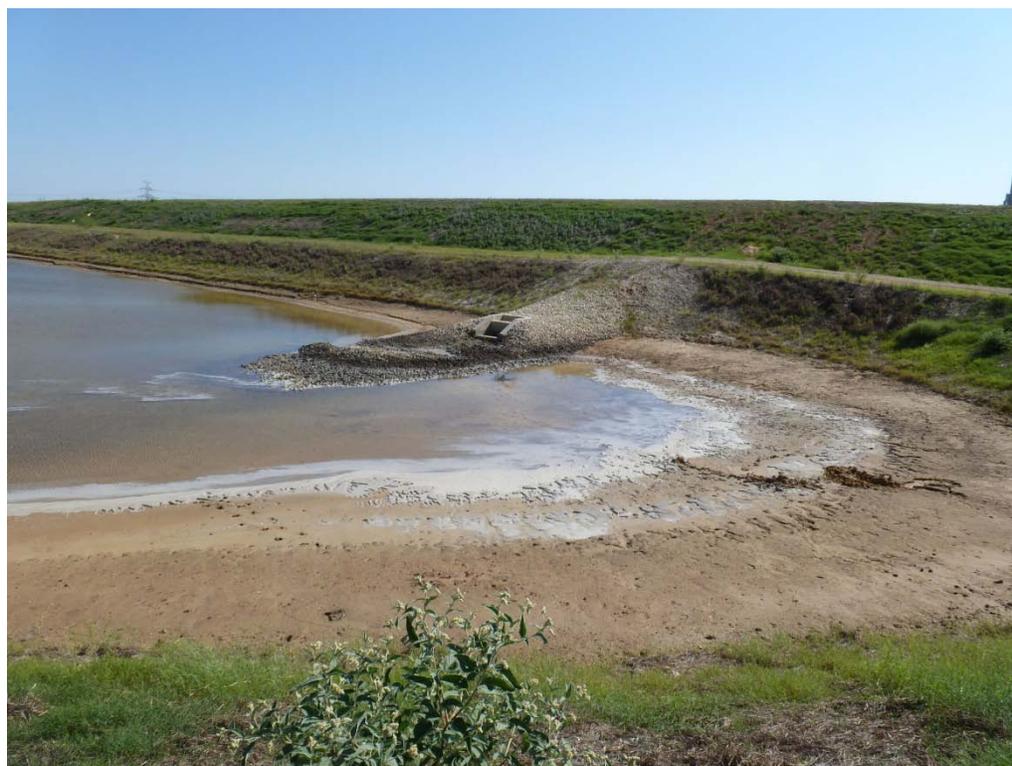
Photo Number:  
28

Description:  
Outboard face of the Western embankment of FGD-A. Note valve-box for control valve on overflow/decant pipe.

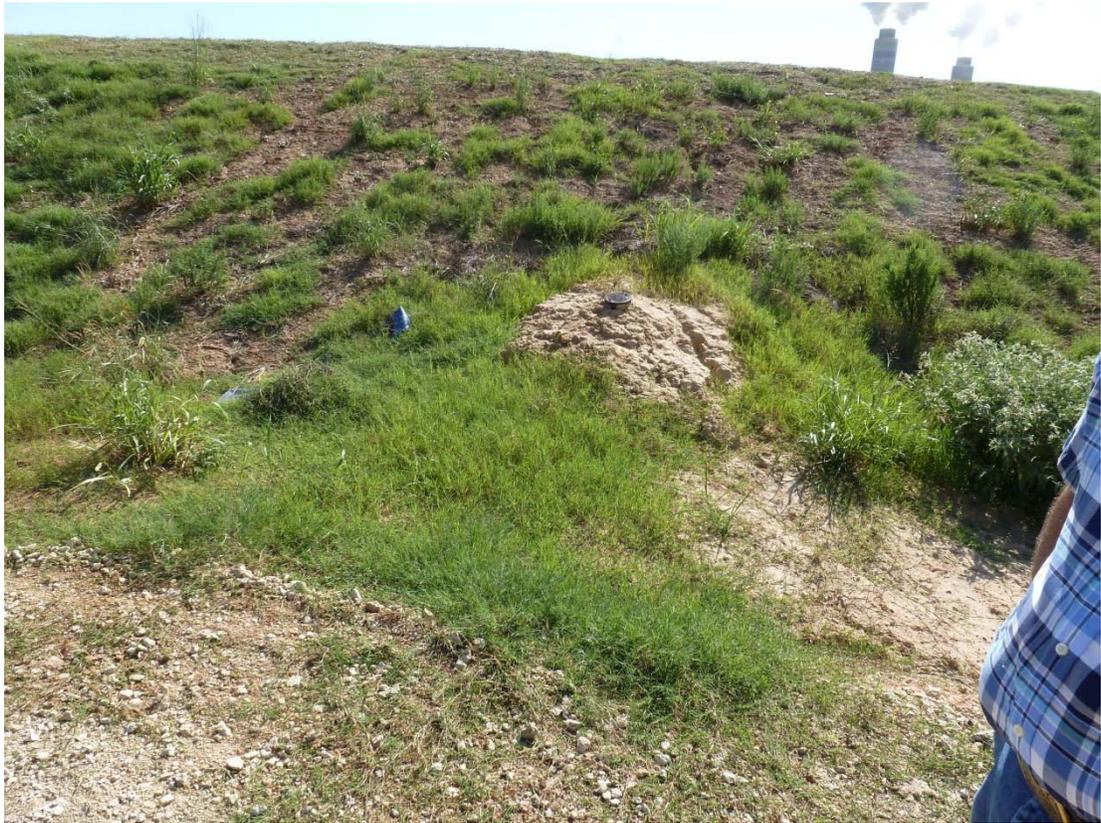
Photo Number:  
29

Description:  
FGD-B Pond.  
Inboard face of Eastern embankment.

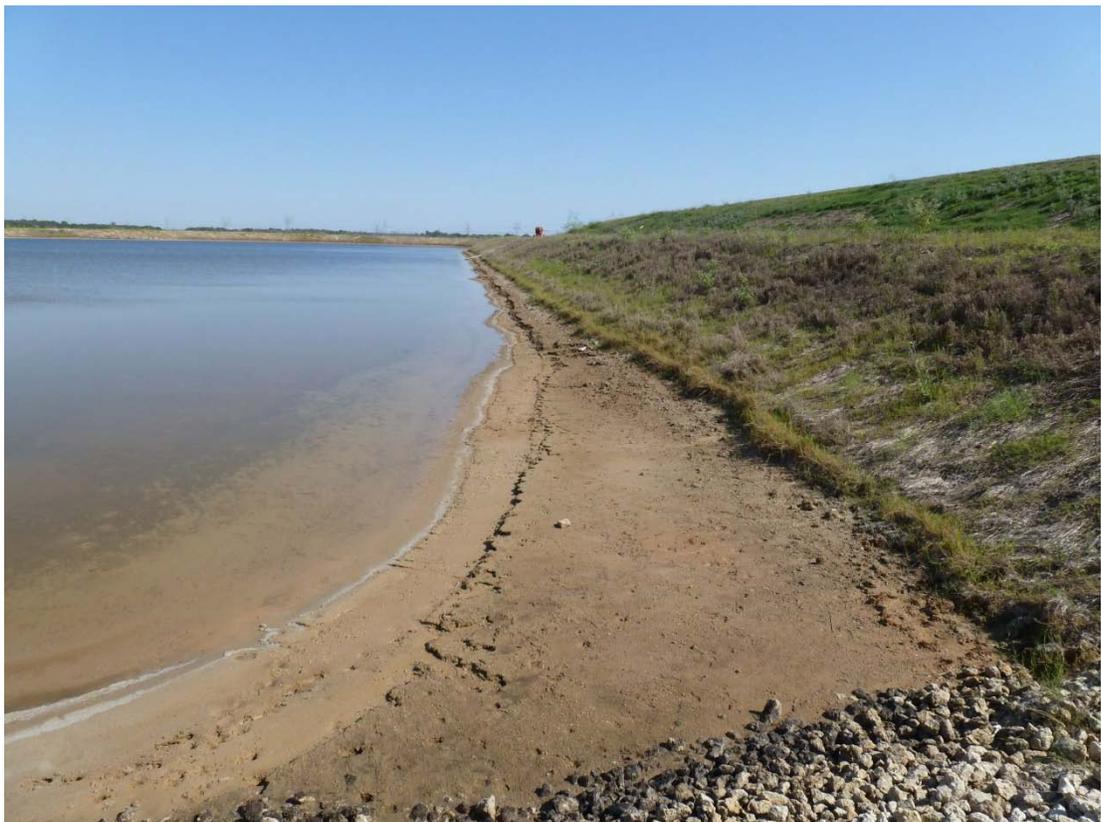
Photo Number:  
30

Description:  
Outboard face of the Western embankment of FGD-A Pond as observed from crest of FGD-B Pond.

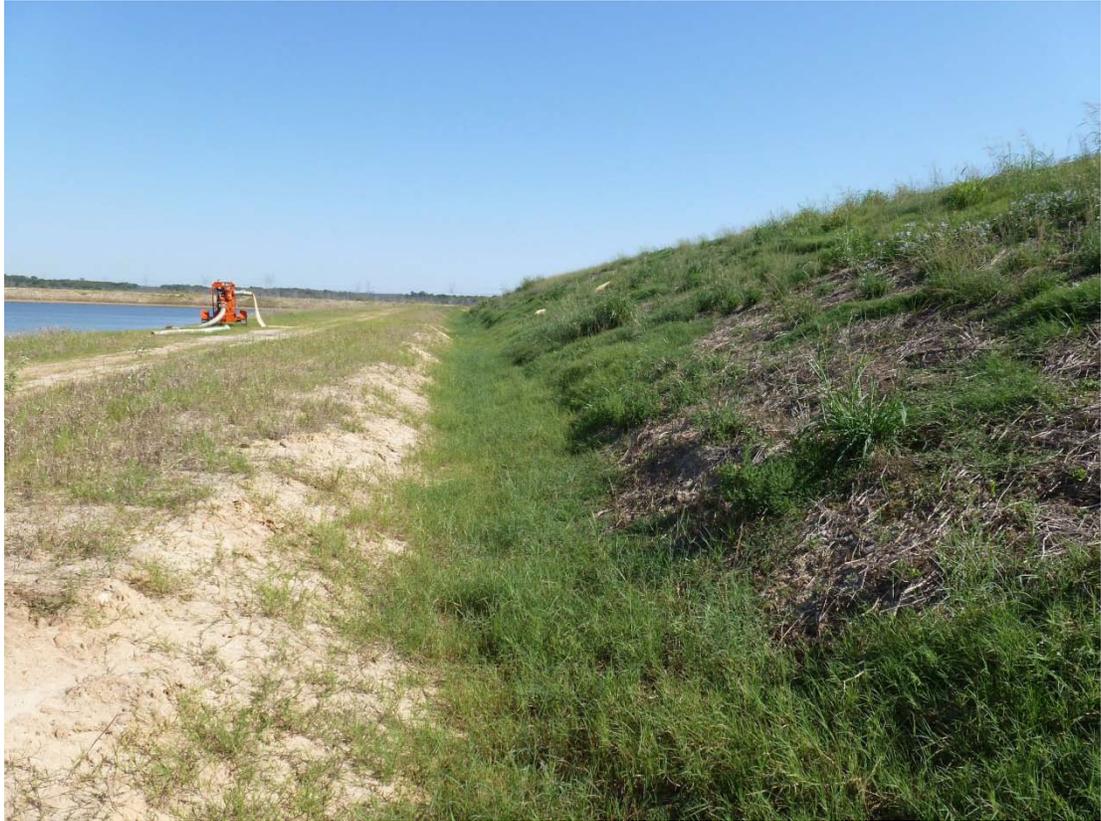
Photo Number:  
31

- Inflow to the pond is limited to overflow from the FGD-A Pond through a 12-inch HDPE pipe in the western embankment of FGD-A Pond. No water was observed entering the Pond during the assessment.
- Minor erosion gullies were observed on the outboard face of the northern embankment. Heavy vegetative growth was also observed on portions of this embankment.
- The Twin Oaks Reservoir (owned by Luminant) is located north of the impoundment. The reservoir does not directly abut the Pond's embankment; it abuts the natural ground upon which the FGD-B Pond embankment is constructed.

Description:  
FGD-B Pond. Deep erosion gully on the inboard face of the Eastern Embankment.
