Dam Safety Assessment of CCW Impoundments
Luminant/OAK GROVE STEAM ELECTRIC STATION

United States Environmental Protection Agency
Washington, DC

June 3, 2014

Dam Safety Assessment of CCW Impoundments

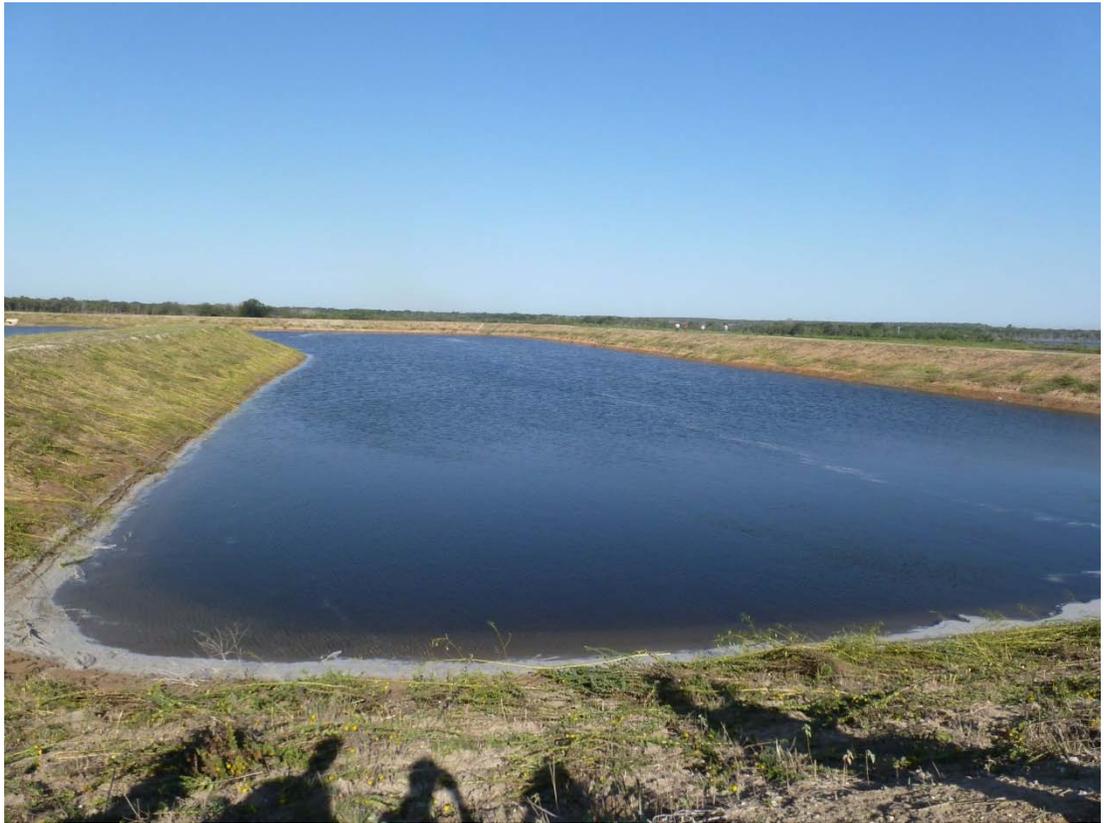
Photo Number:
1

Description:
FGD-A Pond.
Interior of
impoundment.
Note Pond
"Dividing Dike".

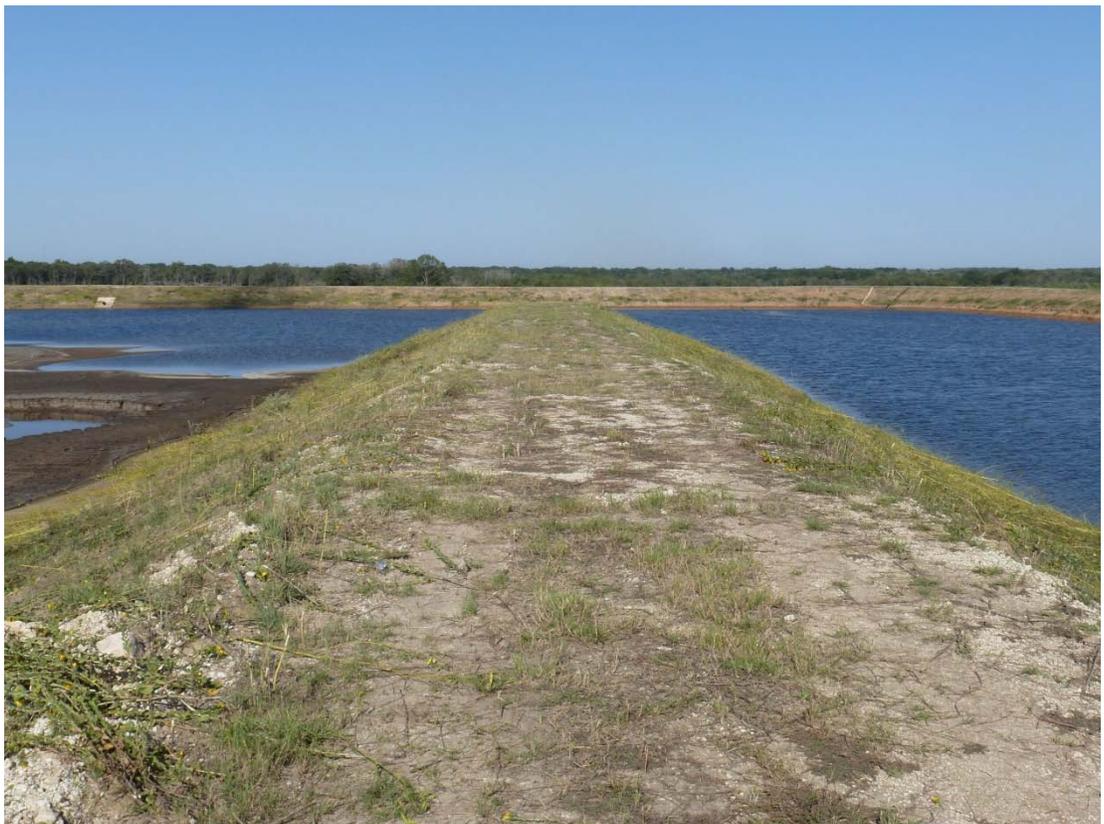
Photo Number:
2

Description:
FGD-A Pond
"Dividing Dike"

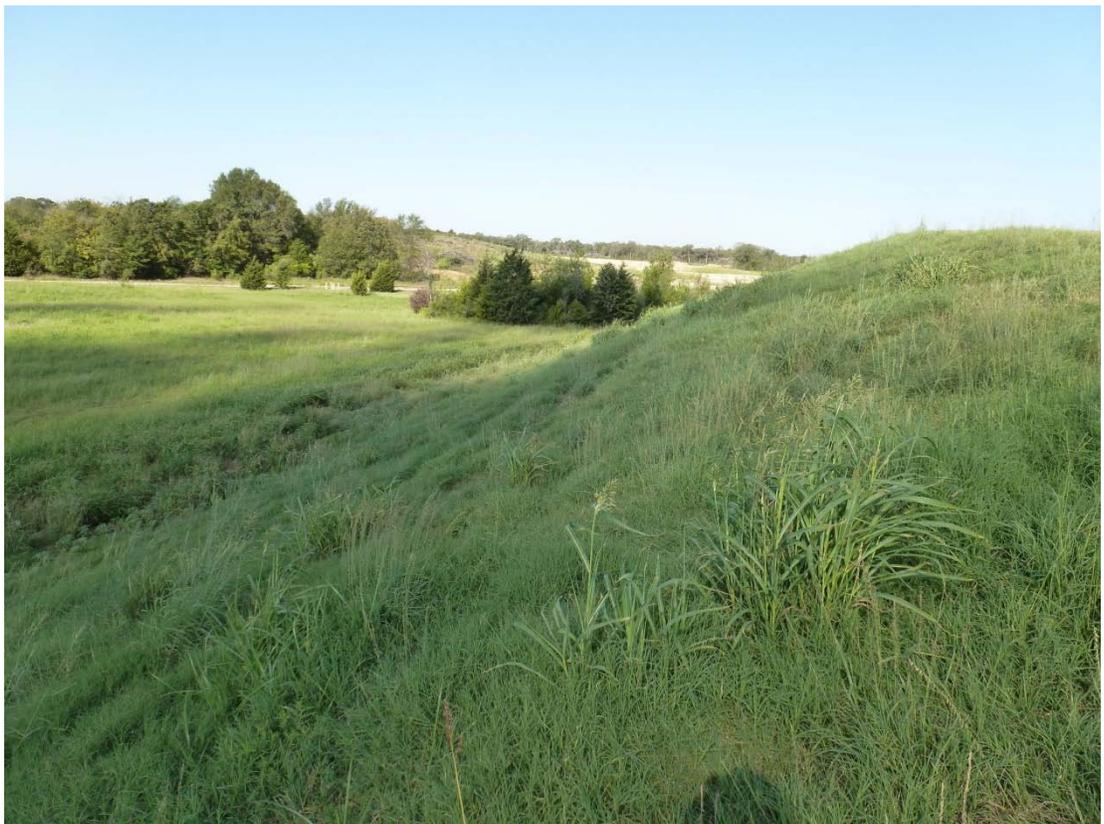
Photo Number:
10

Description:
FGD-A Pond.
Outboard face
of Southwest
corner of
embankment.

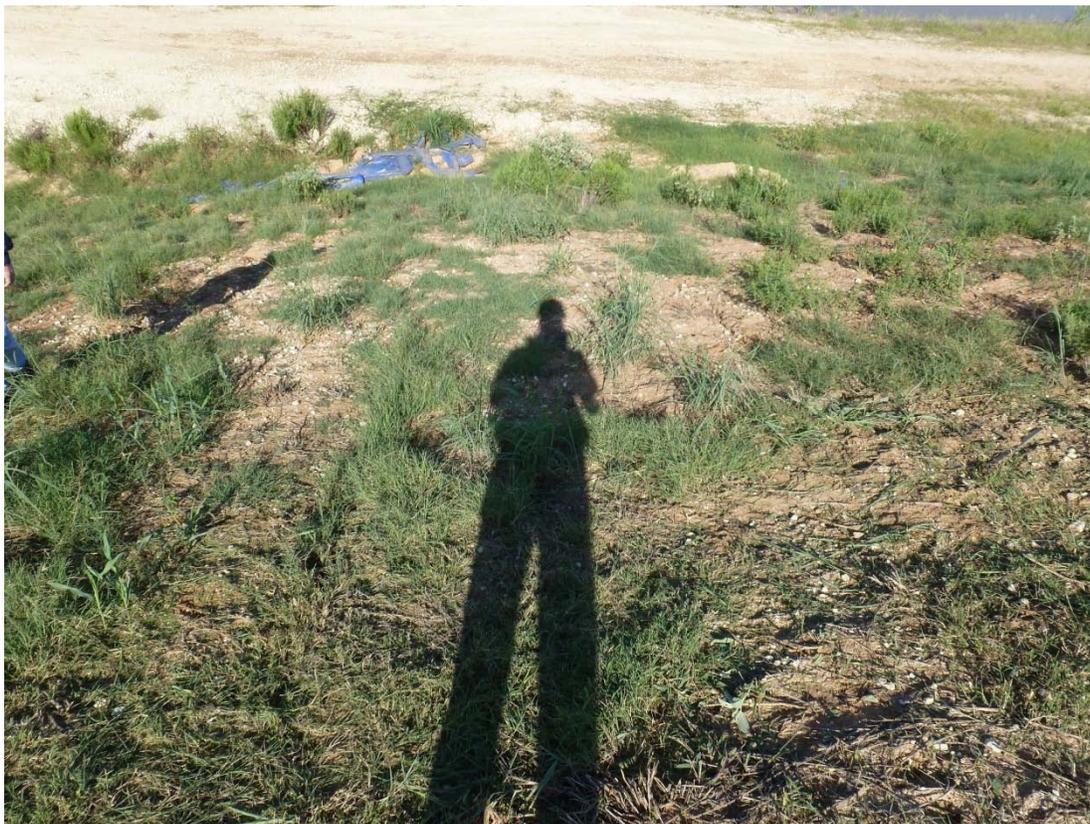
Photo Number:
11

Description:
FGD-A Pond.
Wild hog damage to outboard face of Western embankment. Several locations of hog damage observed.

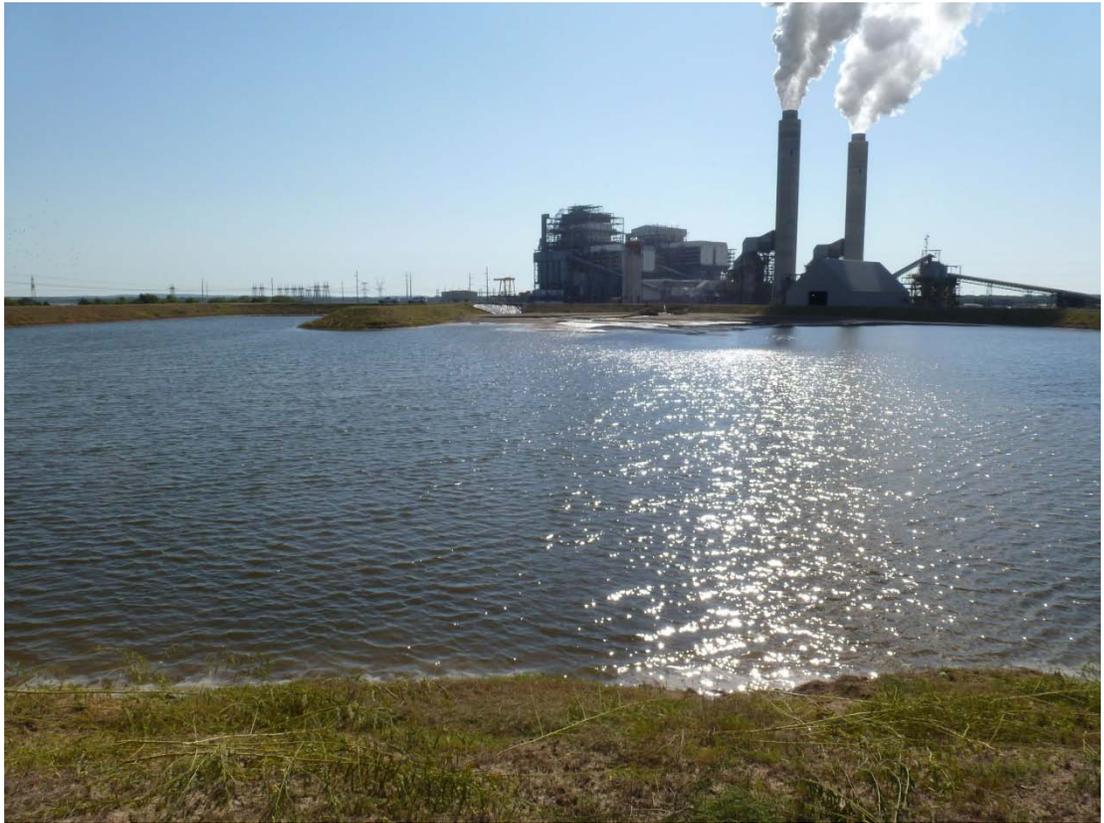
Description:
FGD-A Pond.
Inboard faces of Western and Northern embankments.
Note erosion of liner cover near water line

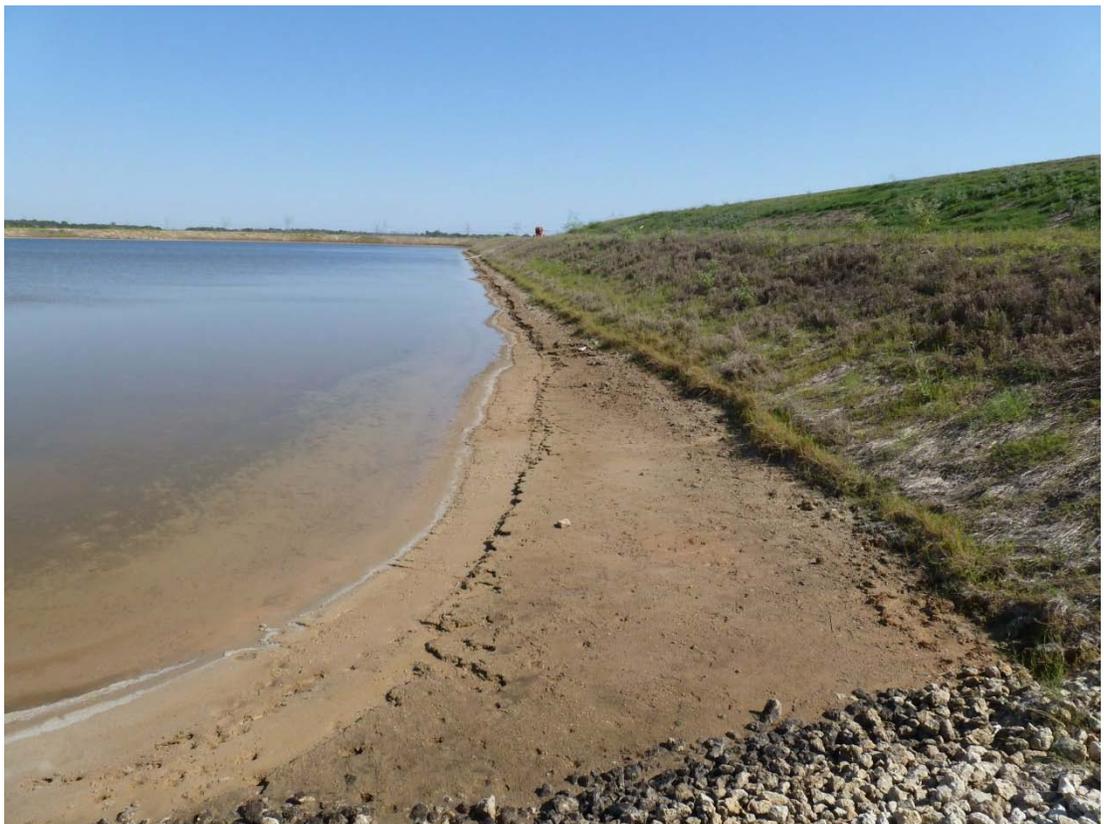
Photo Number:
30

Description:
FGD-B Pond. Inboard face of Eastern embankment.
