Coal Combustion Waste Impoundment

Round 7 - Dam Assessment Report

George Neal North Energy Center

MidAmerican Energy
Sergeant Bluff, Iowa

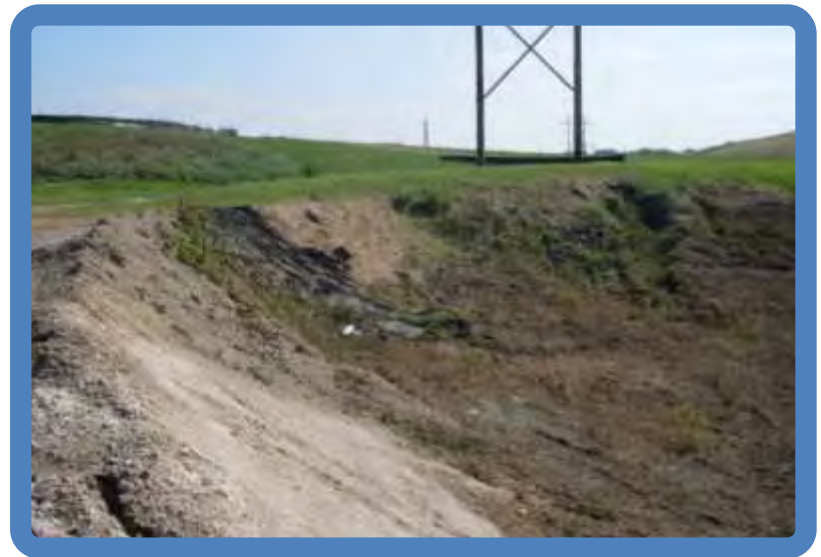
Photo 2.12
Pond 3A dike outside slope (SW segment viewed SE)
-note erosion repair area

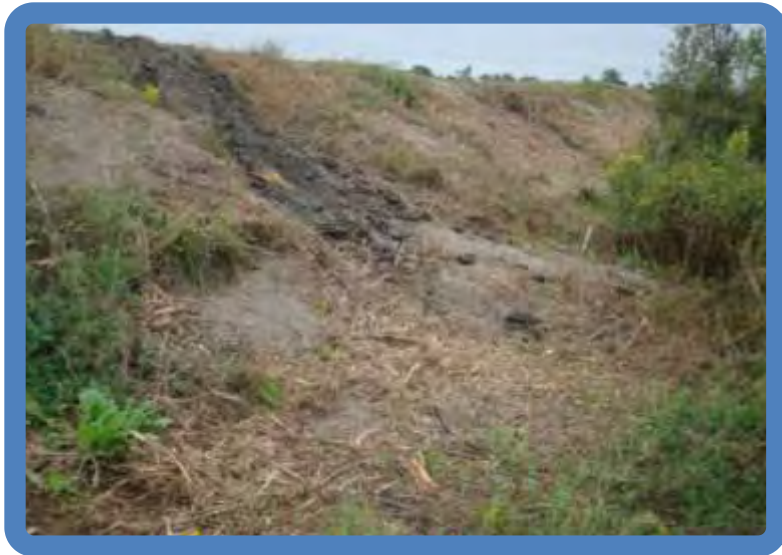
Photo 3.3

Pond 3B South dike outside slope (S side viewed NE)
-note erosion repair

The other repair issue concerns raising the low dike section around much of Pond 3B South. It is recommended that the need for raising the low dike be reconsidered with HWS' assistance, to review and evaluate: the cause of the dike being low in this section, whether settlement or subsidence is currently taking place, whether adding fill to the embankment section will rejuvenate or initiate additional settlement or subsidence, whether the outlet pipe would be impacted by additional settlement or subsidence in the deeper part of the embankment section, and whether the additional freeboard gained by raising the low dike is actually needed for hydrologic safety.
