Coal Combustion Waste Impoundment

Round 7 - Dam Assessment Report

George Neal North Energy Center

MidAmerican Energy
Sergeant Bluff, Iowa

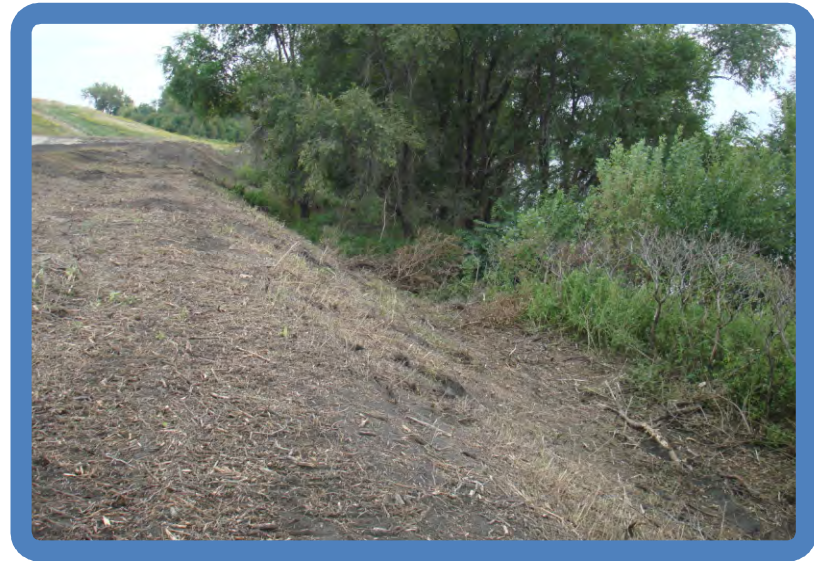
MidAmerican also plans to remove a relatively large berm of material, determined to be bottom ash and coal residuals, observed on the outside slope of the perimeter dike on the west (southwest) side of Pond 1 next to the Missouri River. After permits are obtained from the U.S. Army Corps of Engineers and the Iowa Department of Natural Resources the excavated material will be placed within Pond 1. This action is appropriate to limit potential erosion of the coal combustion residue into the river. (MidAmerican has indicated that permit application(s) will be submitted to appropriate regulatory agencies by April 15, 2011, and the project will be completed by November 30, 2011.)

Photo 1.5
Pond 1 dike outside slope (SW side viewed SE)-note berm

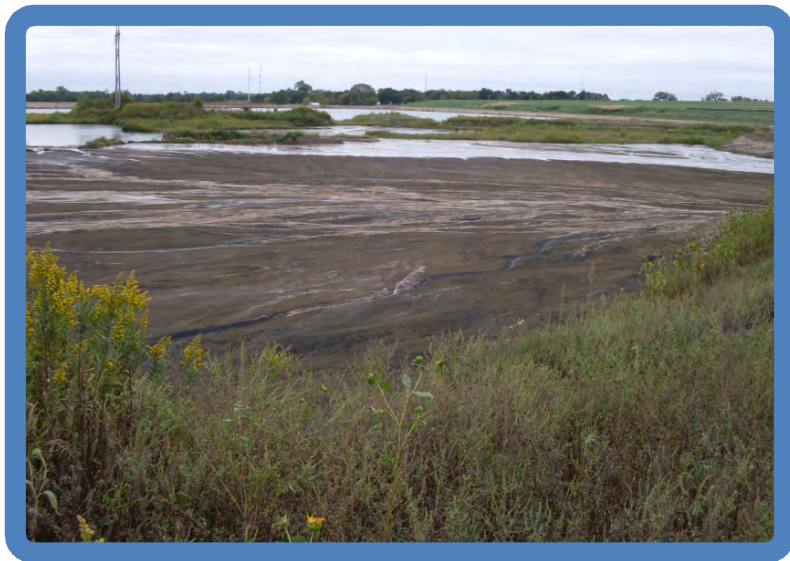
Photo 2.12
Pond 3A dike outside slope (SW segment viewed SE)
-note erosion repair area

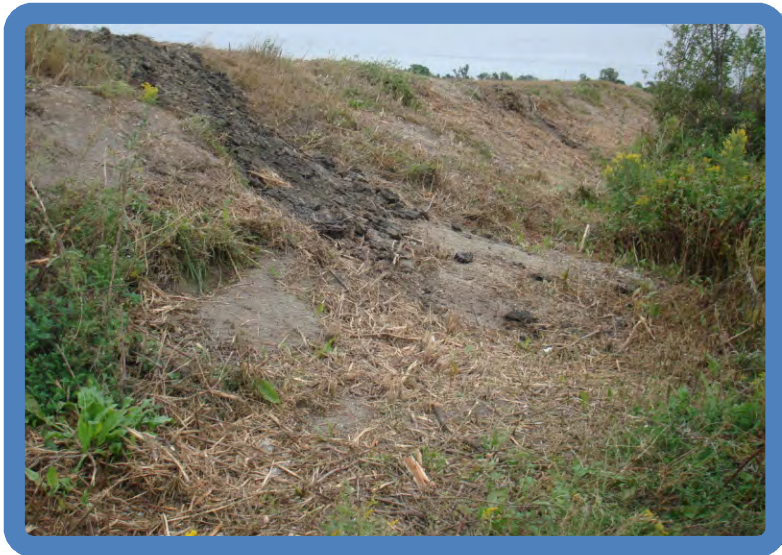
Photo 3.3

MidAmerican additionally has plans to restore embankment height back up to the design top elevation along the low section of the perimeter dike observed around much of Pond 3B South, as recommended by HWS. This would provide more freeboard above maximum operating pool level than has been available with the lower-than-design dike top elevation. However, from a stability point of view it does not appear necessary to raise the dike, unless it is continuing to settle; the amount of freeboard available between the recommended maximum operating pool elevation (1079.5 feet) and the existing low dike elevation (1082.89 feet) is actually greater than the freeboard available between the recommended maximum operating pool elevation (1082 feet) and the design dike top elevation (1085 feet) considered the minimum at Pond 2, Pond 3A, and Pond 3B North, although the actual top elevation of the dike around these ponds is typically higher than the design top elevation by more than 1.5 foot to more than 3 feet. The potential risk

Pond 3B South dike outside slope (S side viewed NE)
-note erosion repair

The other repair issue concerns raising the low dike section around much of Pond 3B South. It is recommended that the need for raising the low dike be reconsidered with HWS' assistance, to review and evaluate: the cause of the dike being low in this section, whether settlement or subsidence is currently taking place, whether adding fill to the embankment section will rejuvenate or initiate additional settlement or subsidence, whether the outlet pipe would be impacted by additional settlement or subsidence in the deeper part of the embankment section, and whether the additional freeboard gained by raising the low dike is actually needed for hydrologic safety (see Subsection 1.1.5).

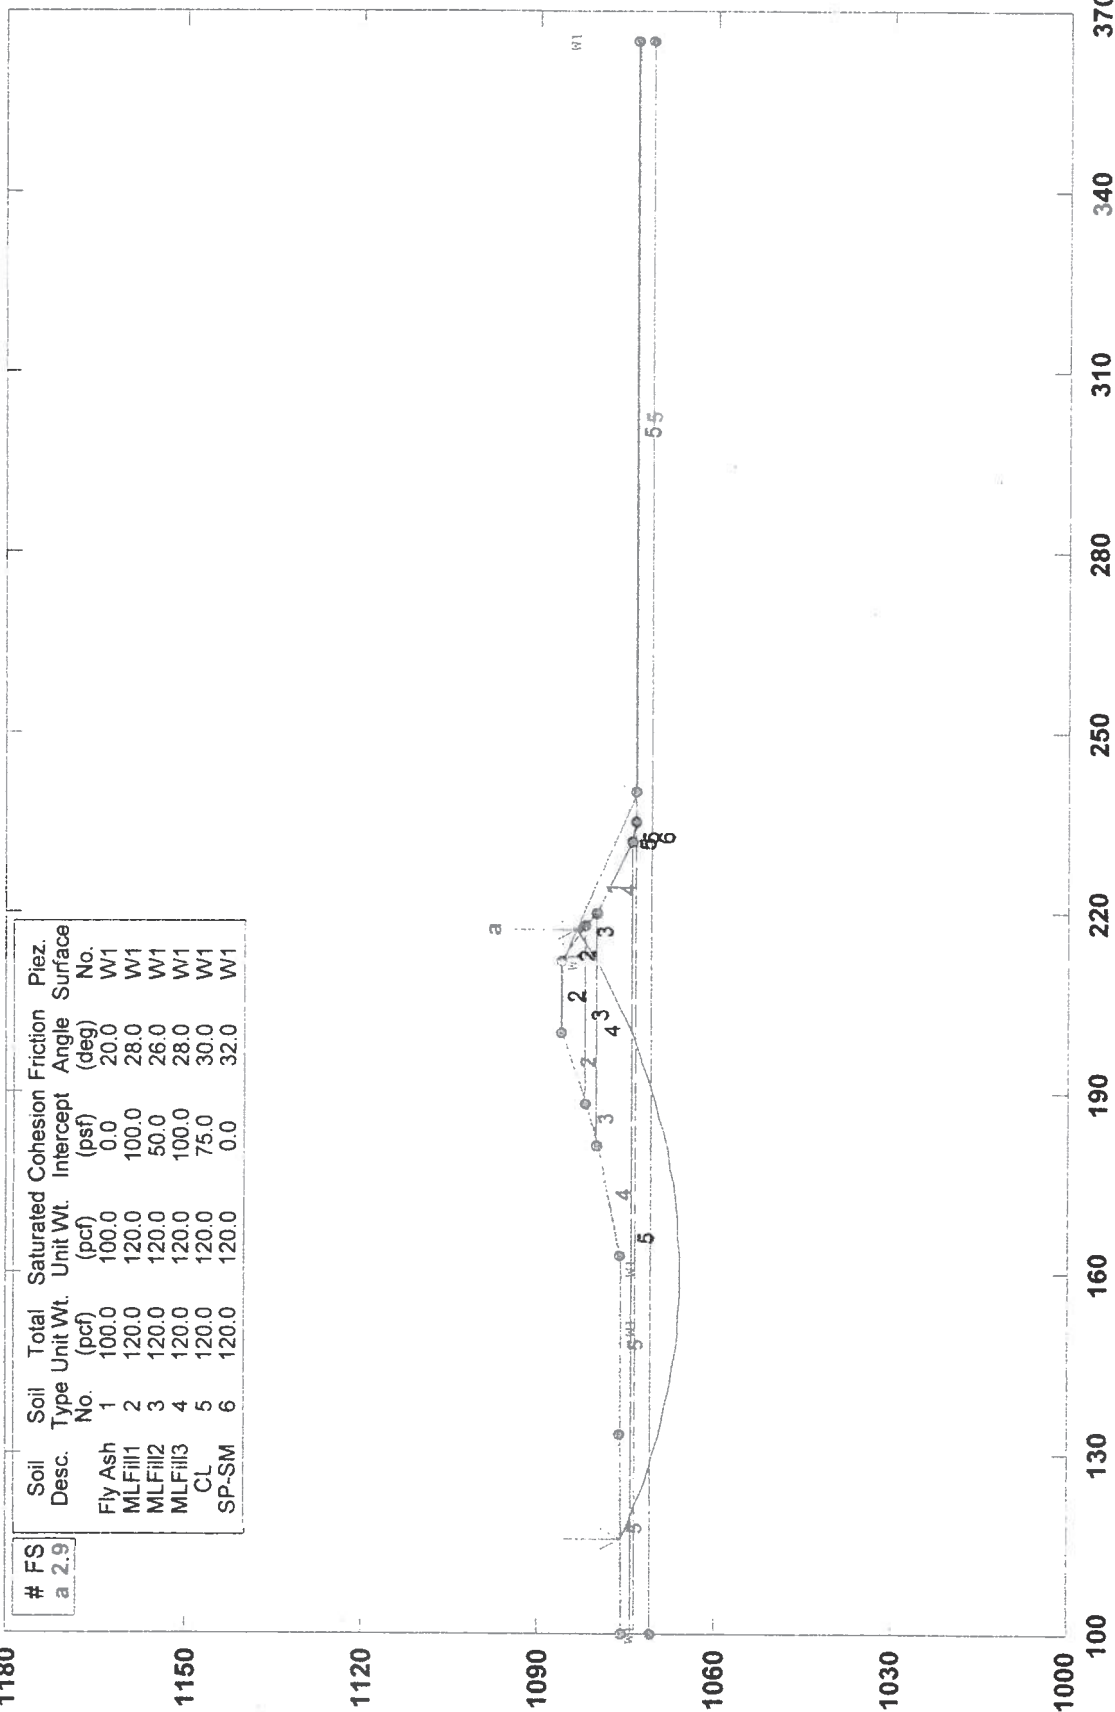
Mid American Energy Fly Ash Containment Section A-A Drained

GSTABL7 v.2 FSmin=2.9

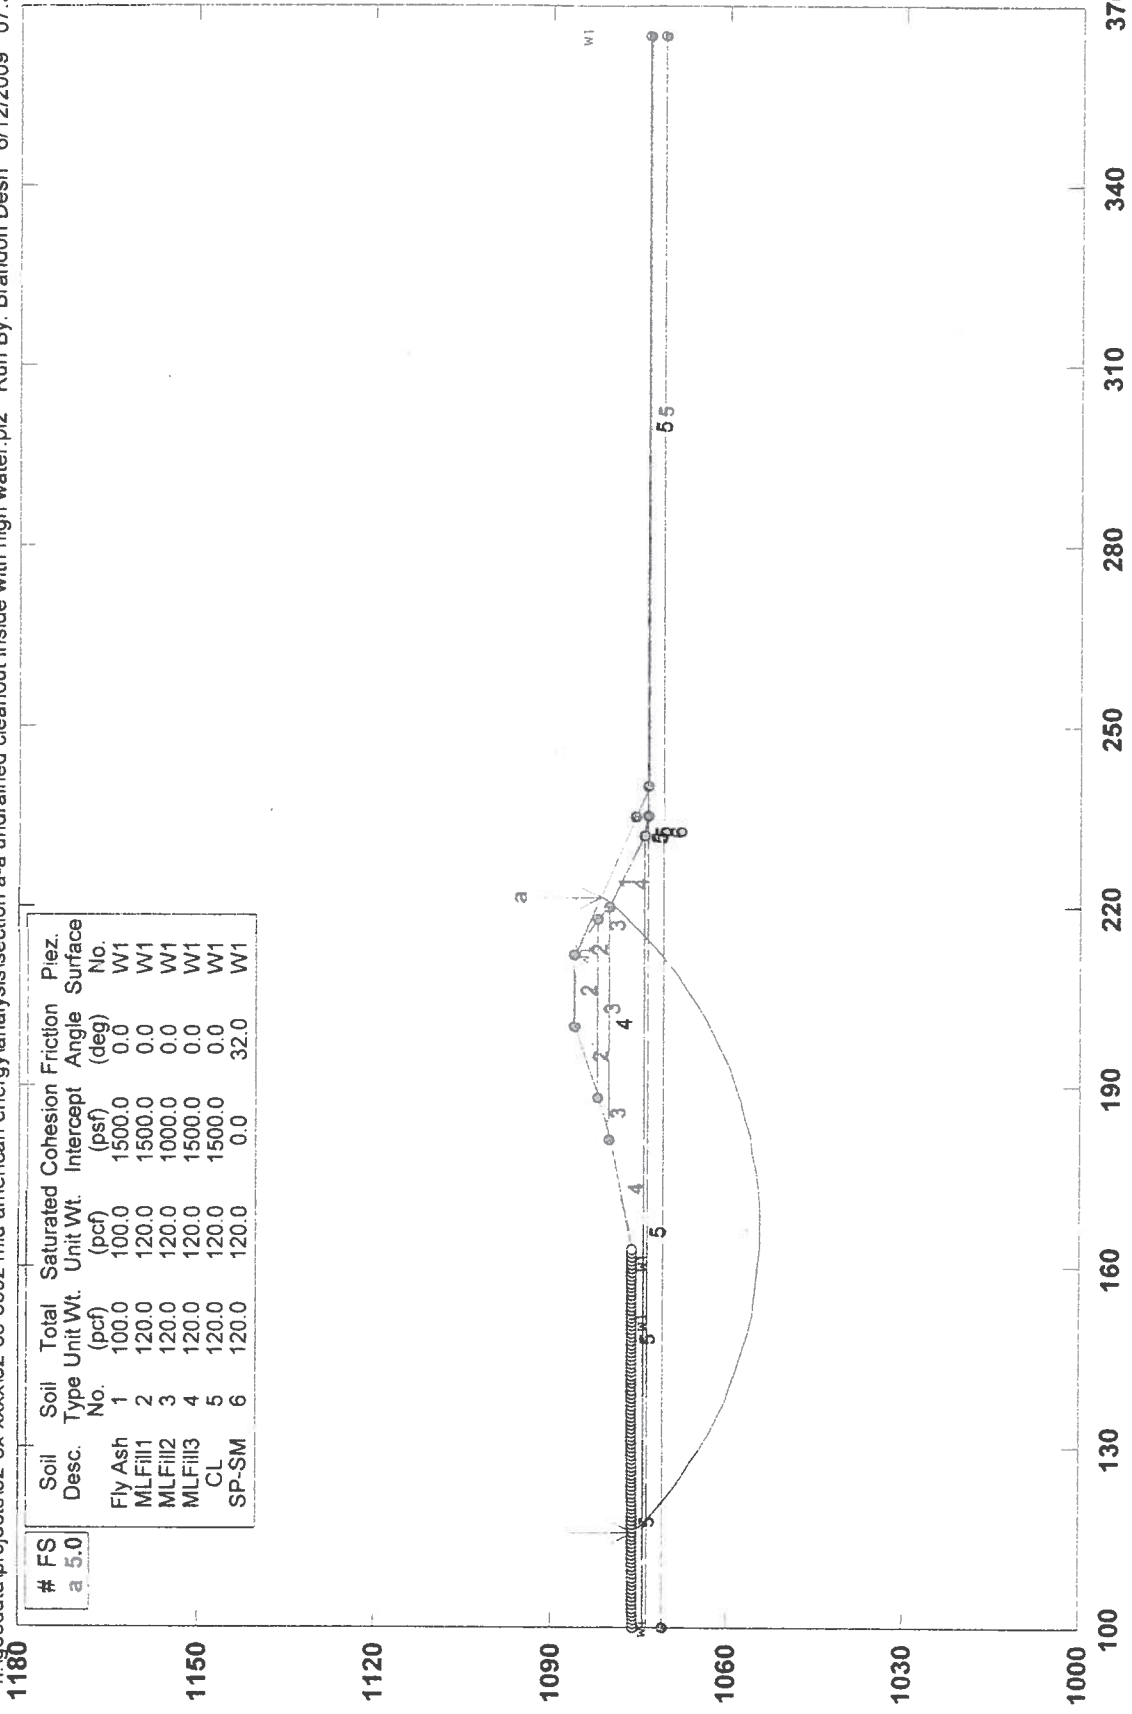
Mid American Energy Fly Ash Containment Section A-A Undrained

GSTABL7 v.2 FSmin=5.0
Safety Factors Are Calculated By The Modified Bishop Method

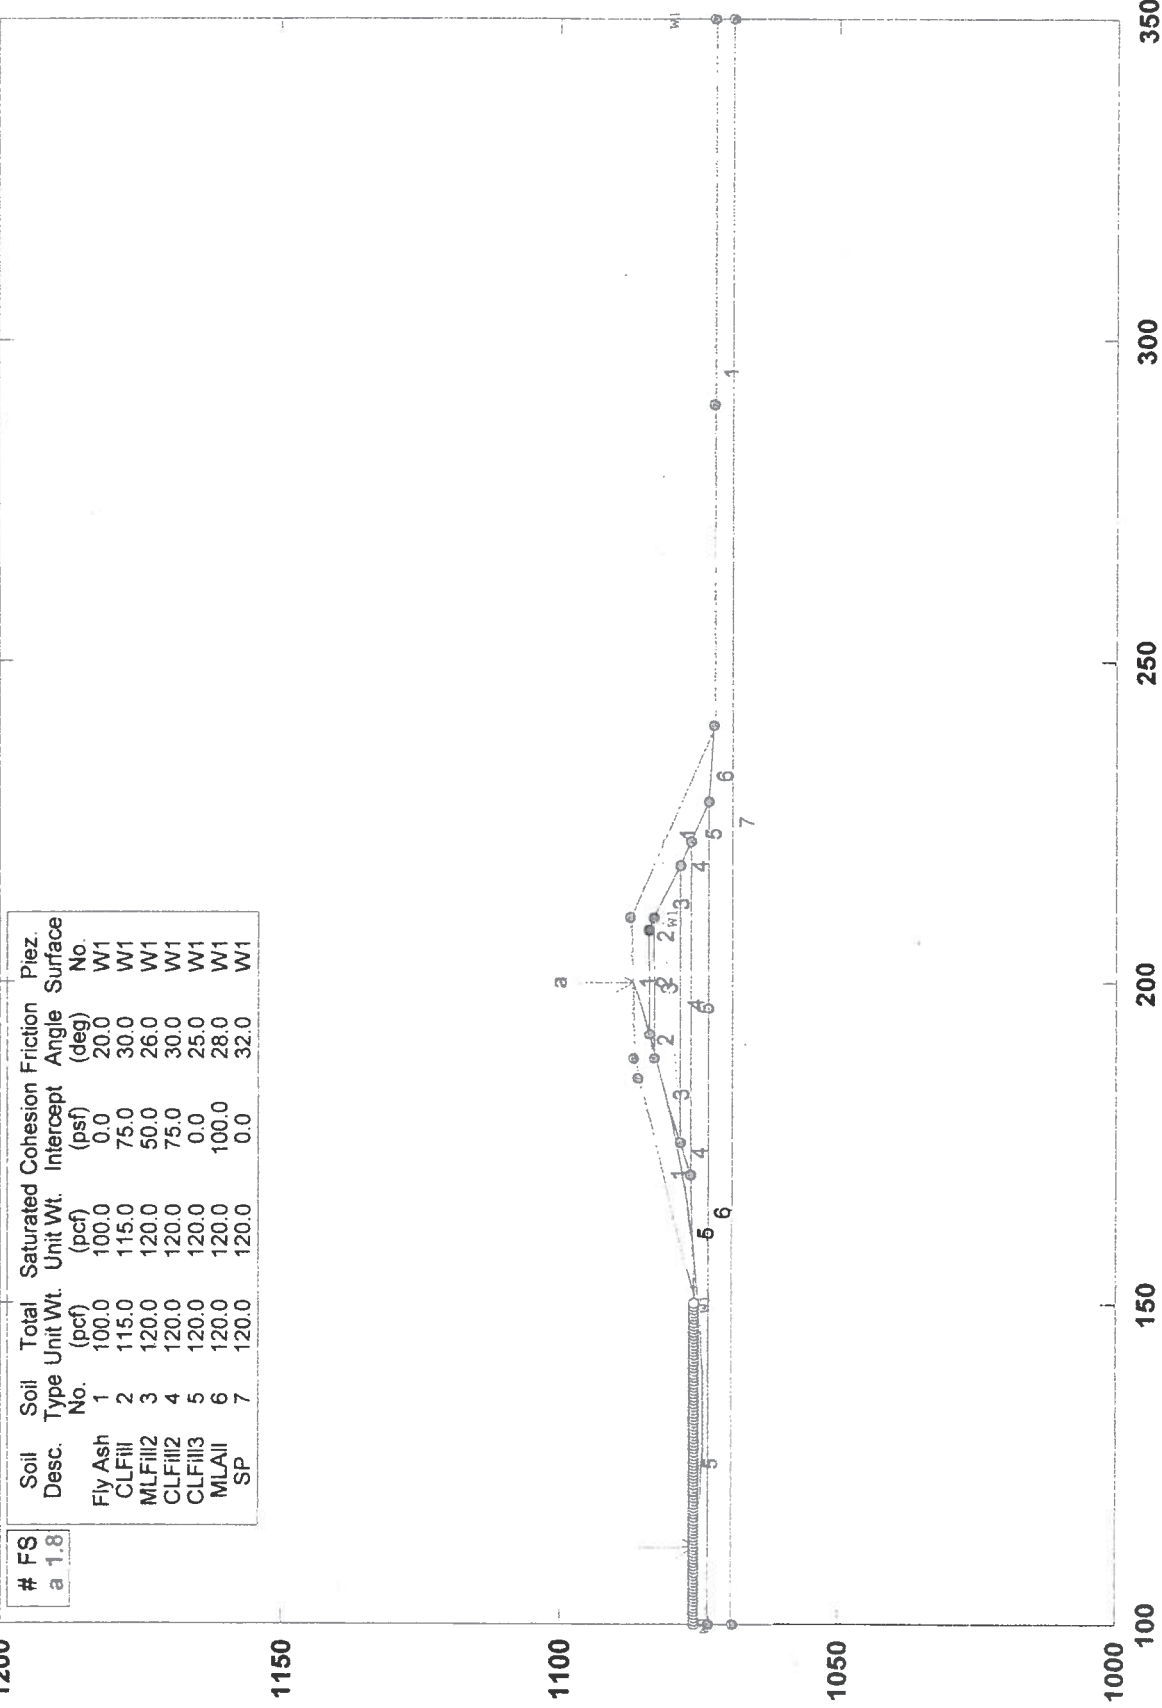
Mid American Energy Fly Ash Containment Section B-B Drained

GSTABL7 v.2 FSmin=1.8
Safety Factors Are Calculated By The Modified Bishop Method

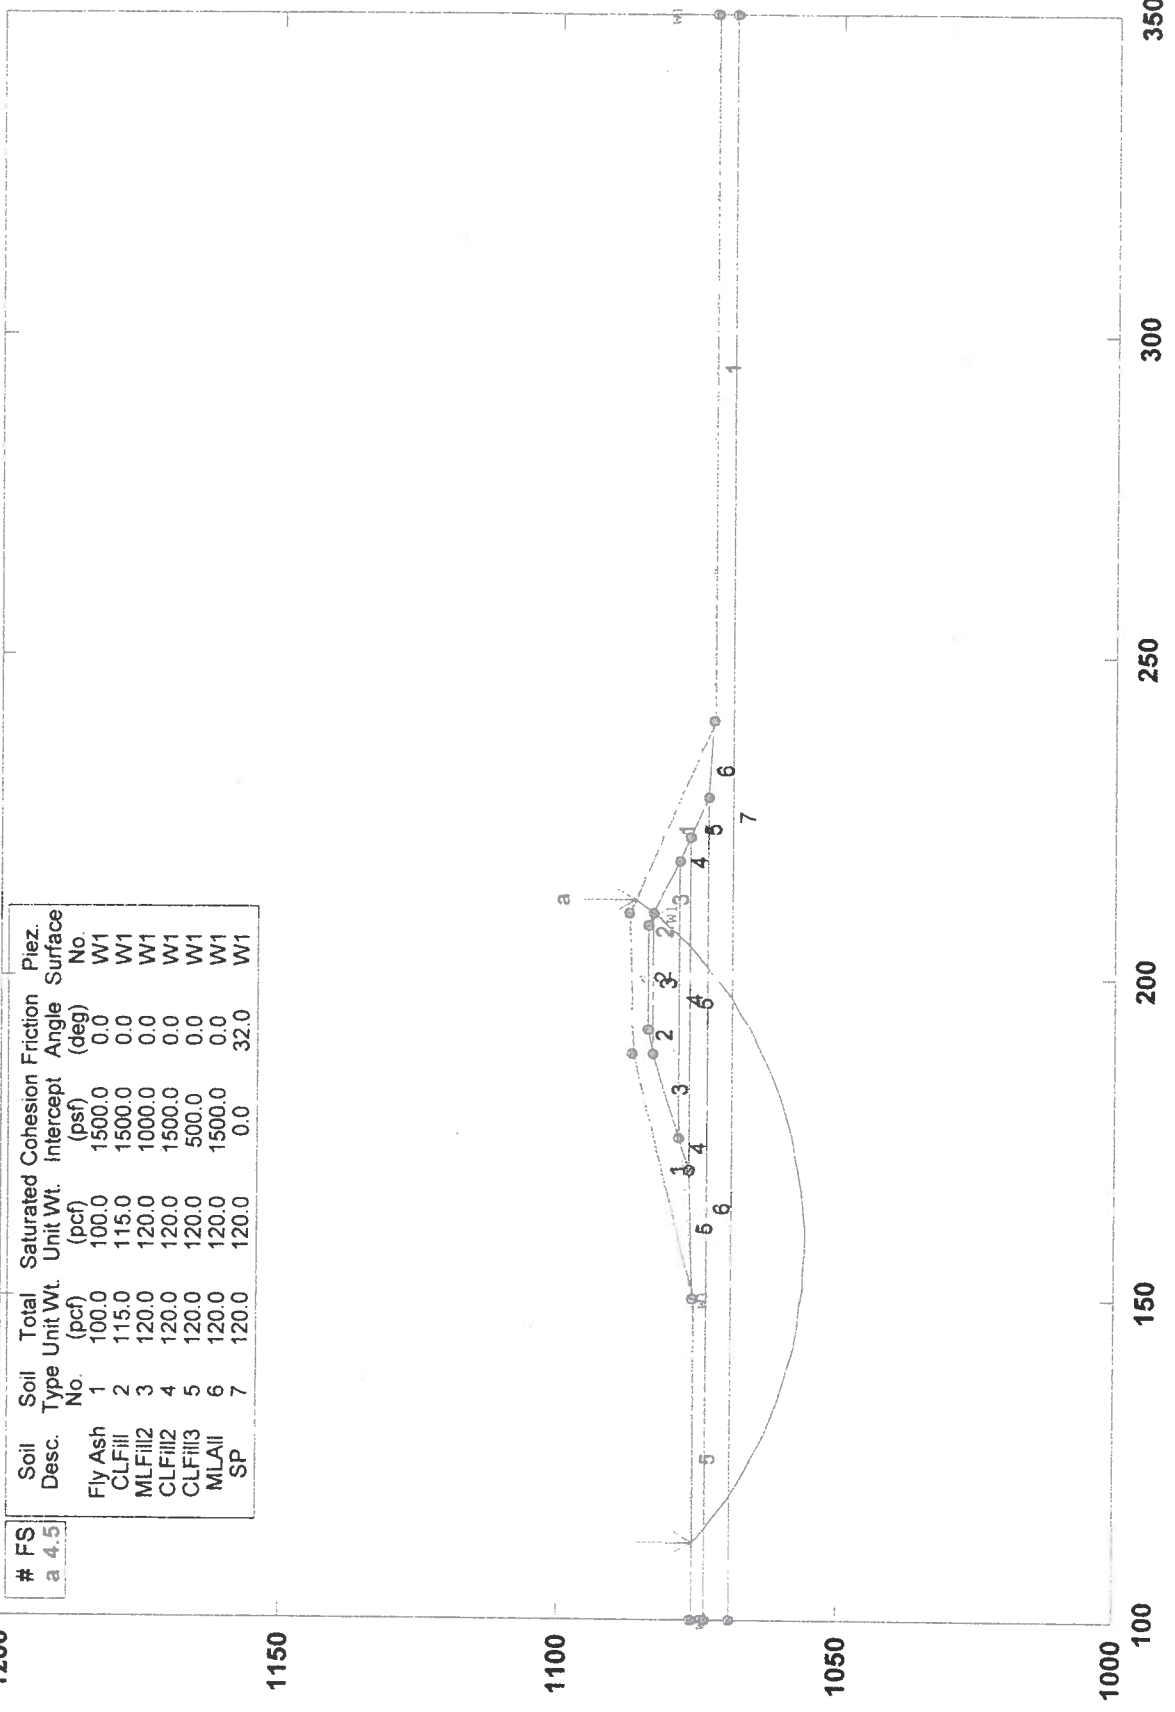
Mid American Energy Fly Ash Containment Section B-B Undrained

GSTABL7 v.2 FSmin=4.5
Safety Factors Are Calculated By The Modified Bishop Method

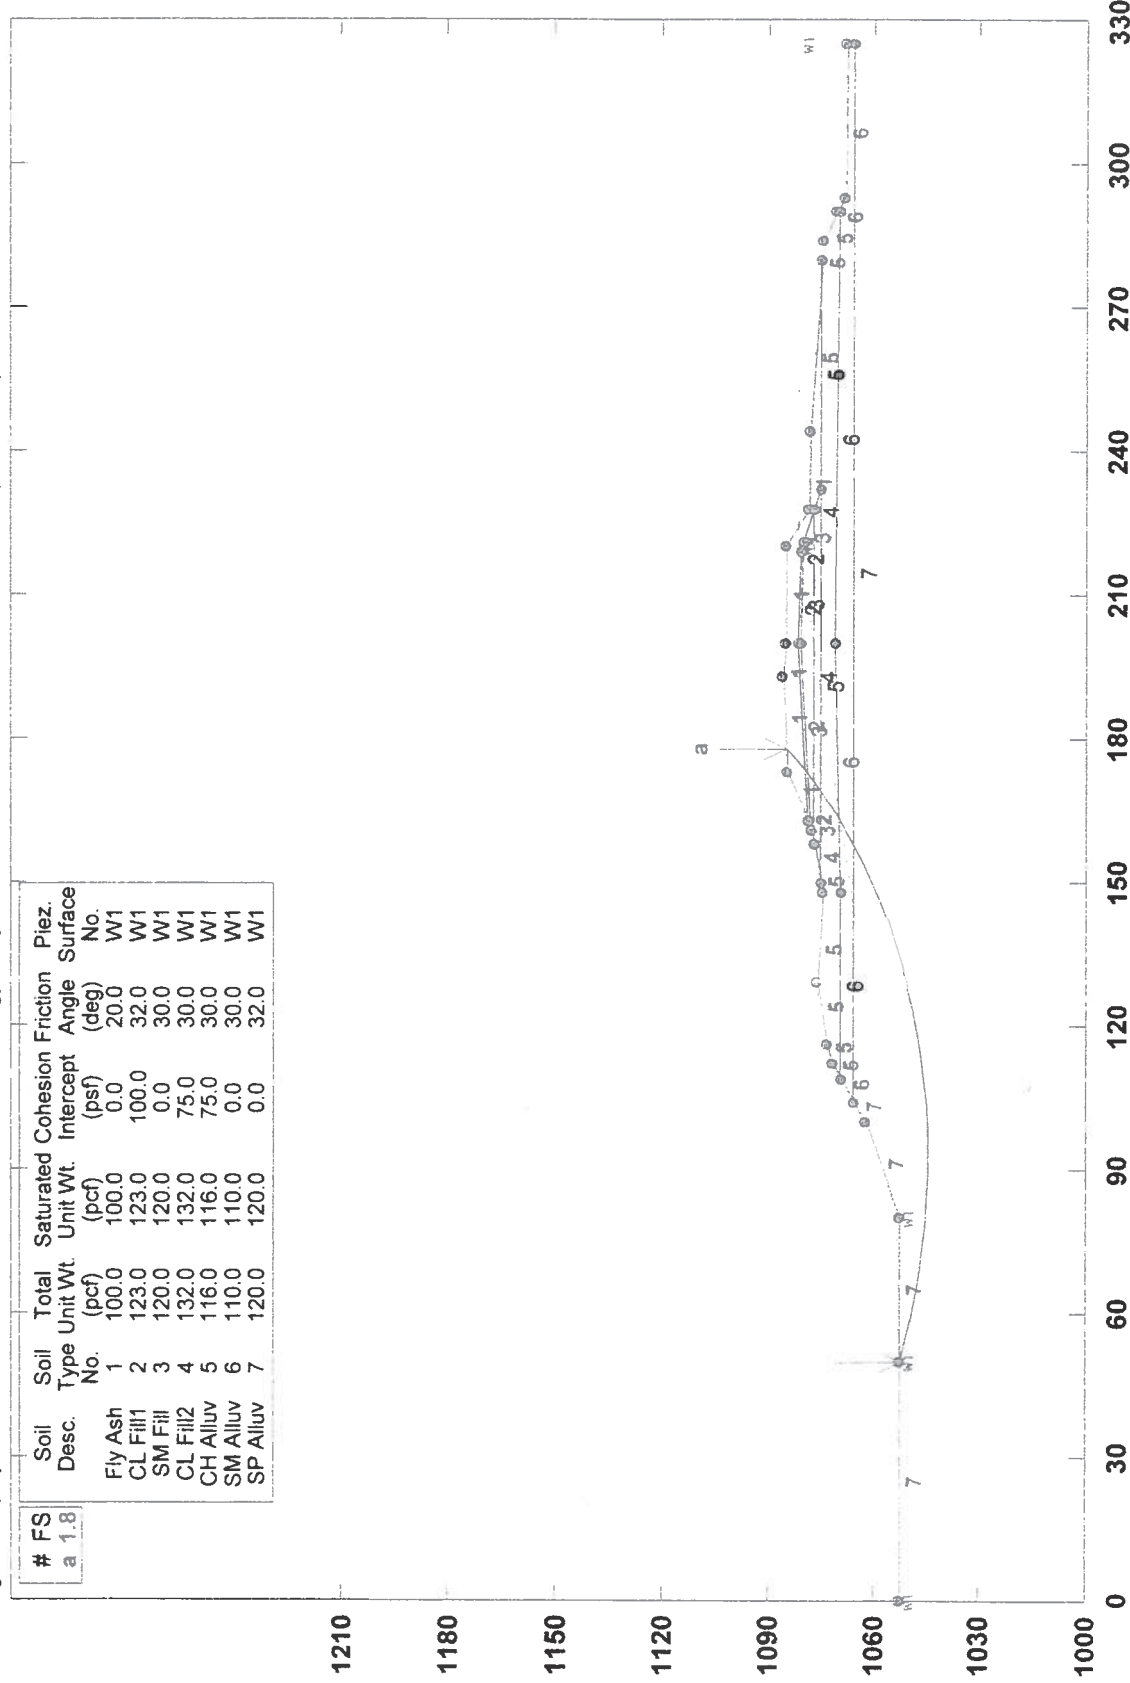
Mid American Energy Fly Ash Containment Section E-E Drained Analysis

GSTABL7 v.2 FSmin=1.8
Safety Factors Are Calculated By The Modified Bishop Method

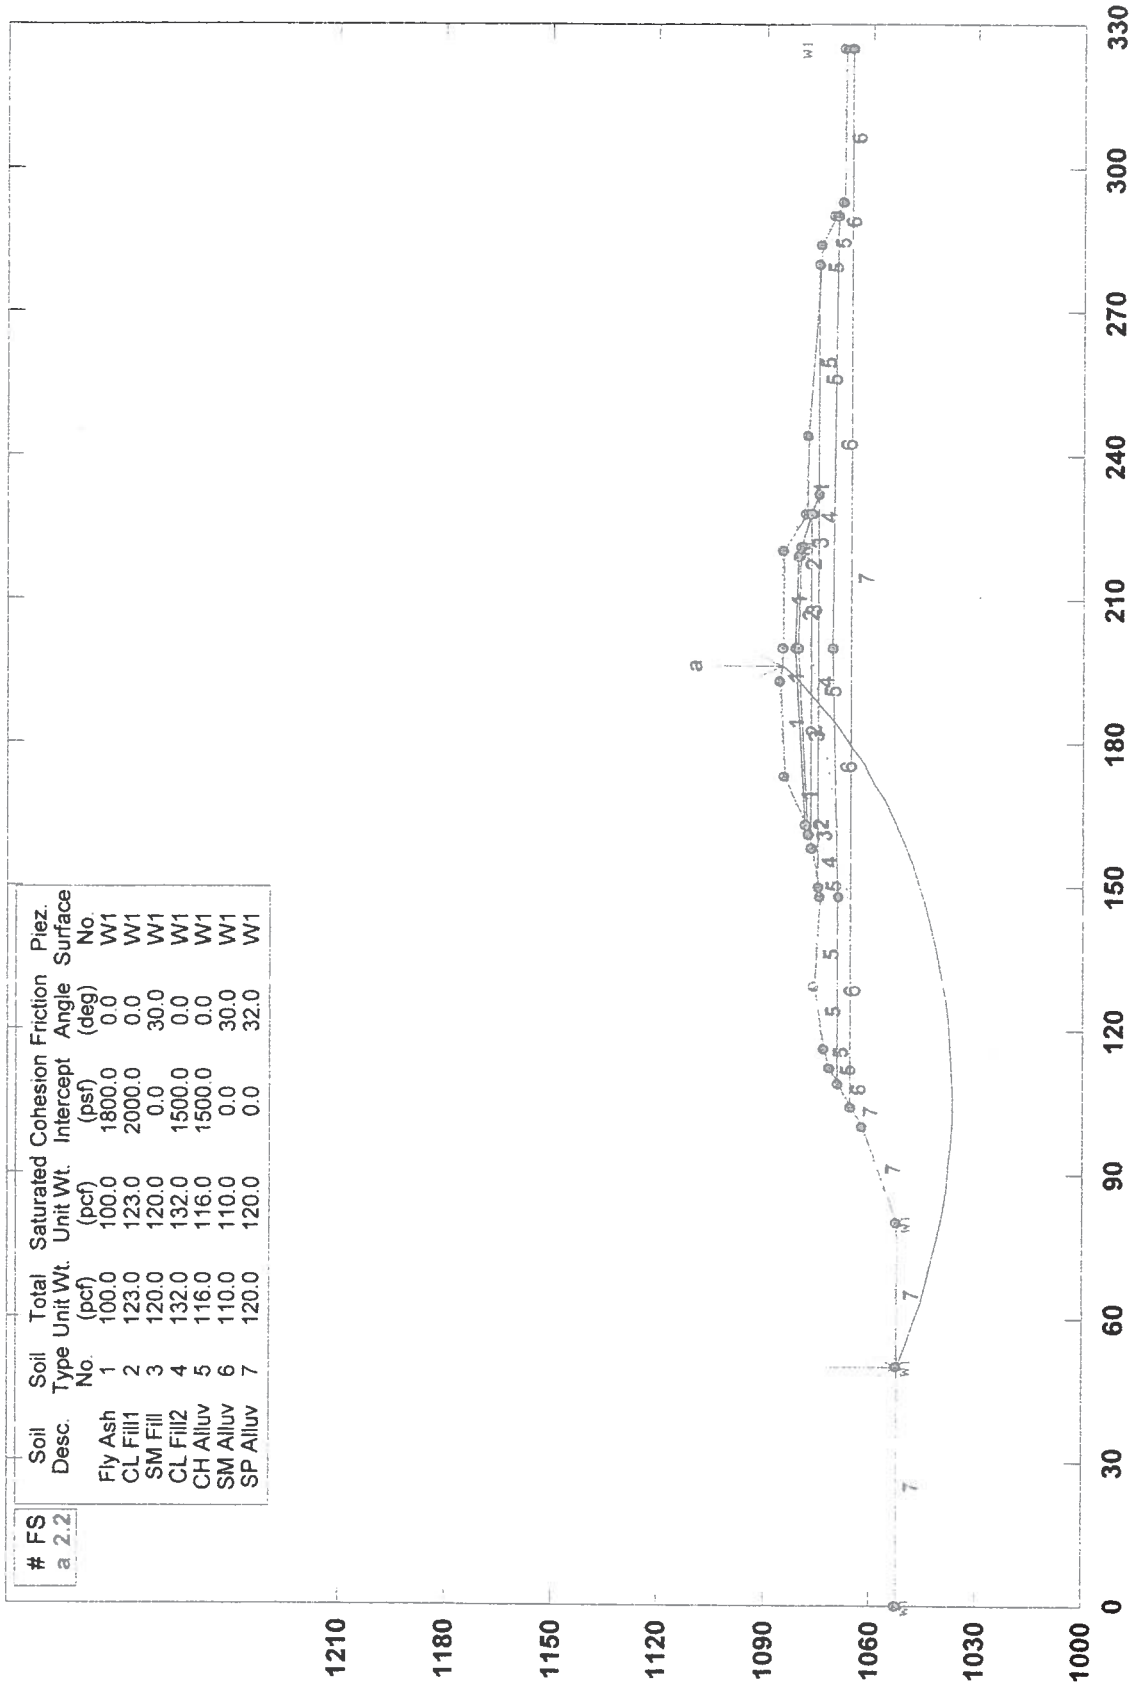
Mid American Energy Fly Ash Containment Section E-E Undrained Analysis

GSTABL7 v.2 FSmin=2.2
