Subject: EPA Comments on MidAmerican Energy Co, Riverside Generating Station,
Bettendorf, IA
Round 7 Draft Assessment Report

Re: Comments to Draft Coal Combustion Waste Impoundment Round 7 Dam Assessment Reports for Neal North Energy Center (Site #13), Walter Scott Energy Center (Site #14), Riverside Generating Station (Site #15), and Louisa Generating Station (Site #16)

Re: Comments to Draft Coal Combustion Waste Impoundment Round 7 Dam
Assessment Report for Riverside Generating Station (Site #15)

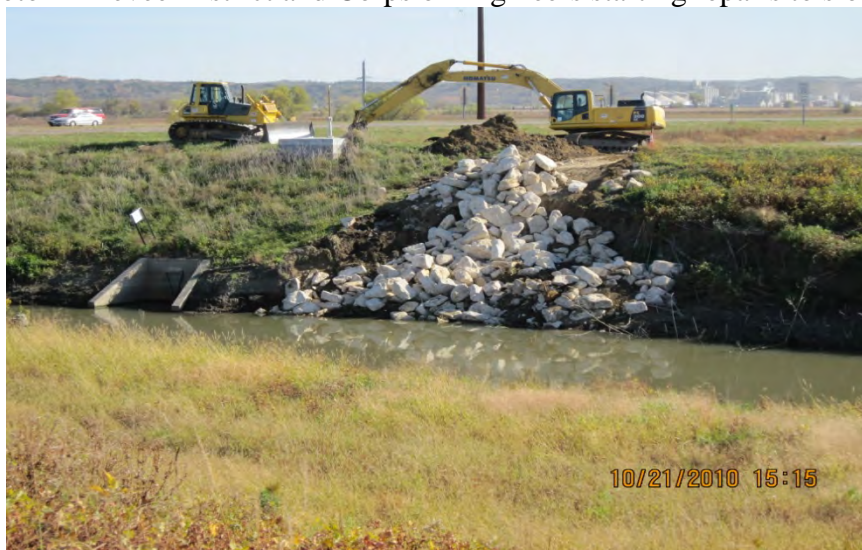
Photo 1 - Levee District and Corps of Engineers starting repairs to slough

The Mills and Pottawattamie (M&P) Missouri River Levee District and the U.S. Army Corps of Engineers completed these repairs in February 2011 as shown in the photographs below. Large rip-rap was utilized to fill and stabilize the eroded portion of the levee, followed by a cover layer of soil and seeding.

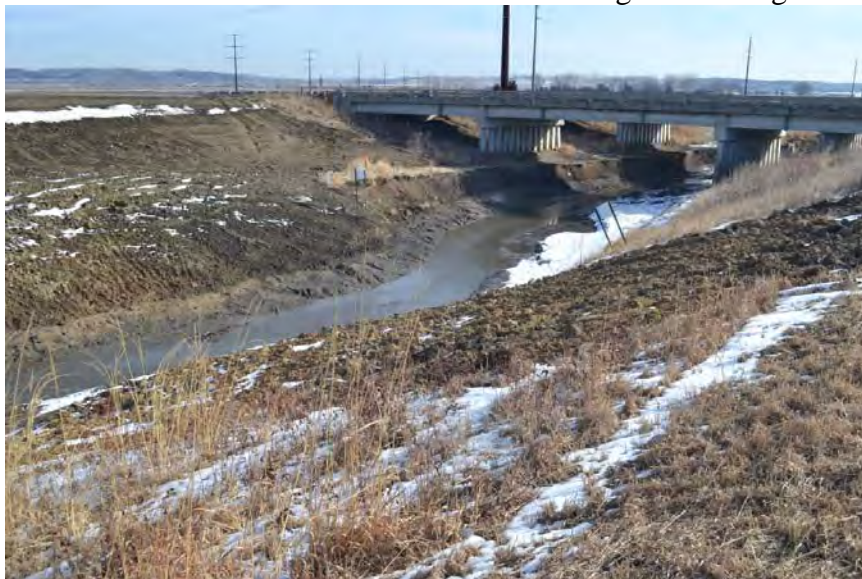
Photo 2 – Same area with final cover over slough area and graded

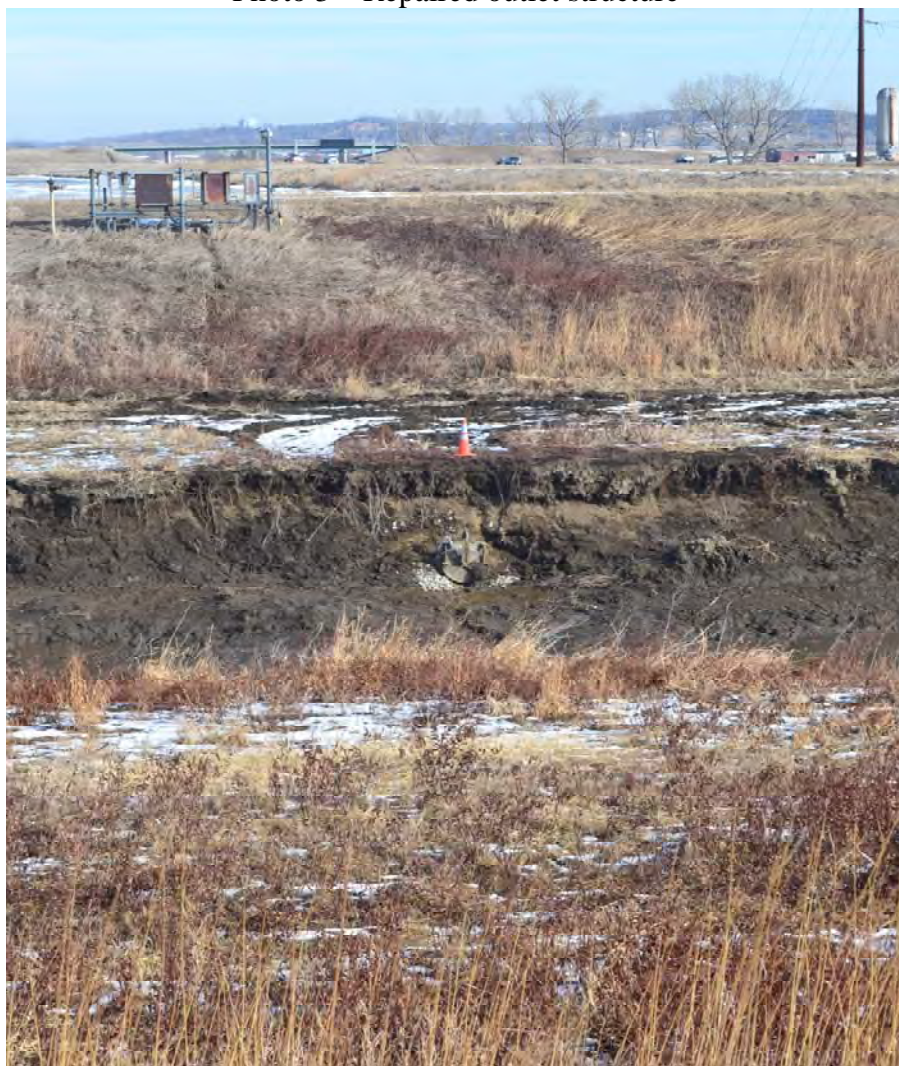
Photo 3 – Repaired outlet structure

Section 1.1.5: The report indicates that the damaged end of the outlet structure should be repaired to restore the structure to serviceable condition. The M&P Missouri River Levee District and Corps of Engineers are in the process of repairing these structures which were damaged by their previous subcontractor during straightening of the Pony Creek drainage way. Photograph 3 below shows the current status of the repairs. The photo was taken facing north showing the repaired discharge structure (located immediately below the orange cone) in the south bank of the North Surface Impoundment. This update also applies to section 1.2.5.

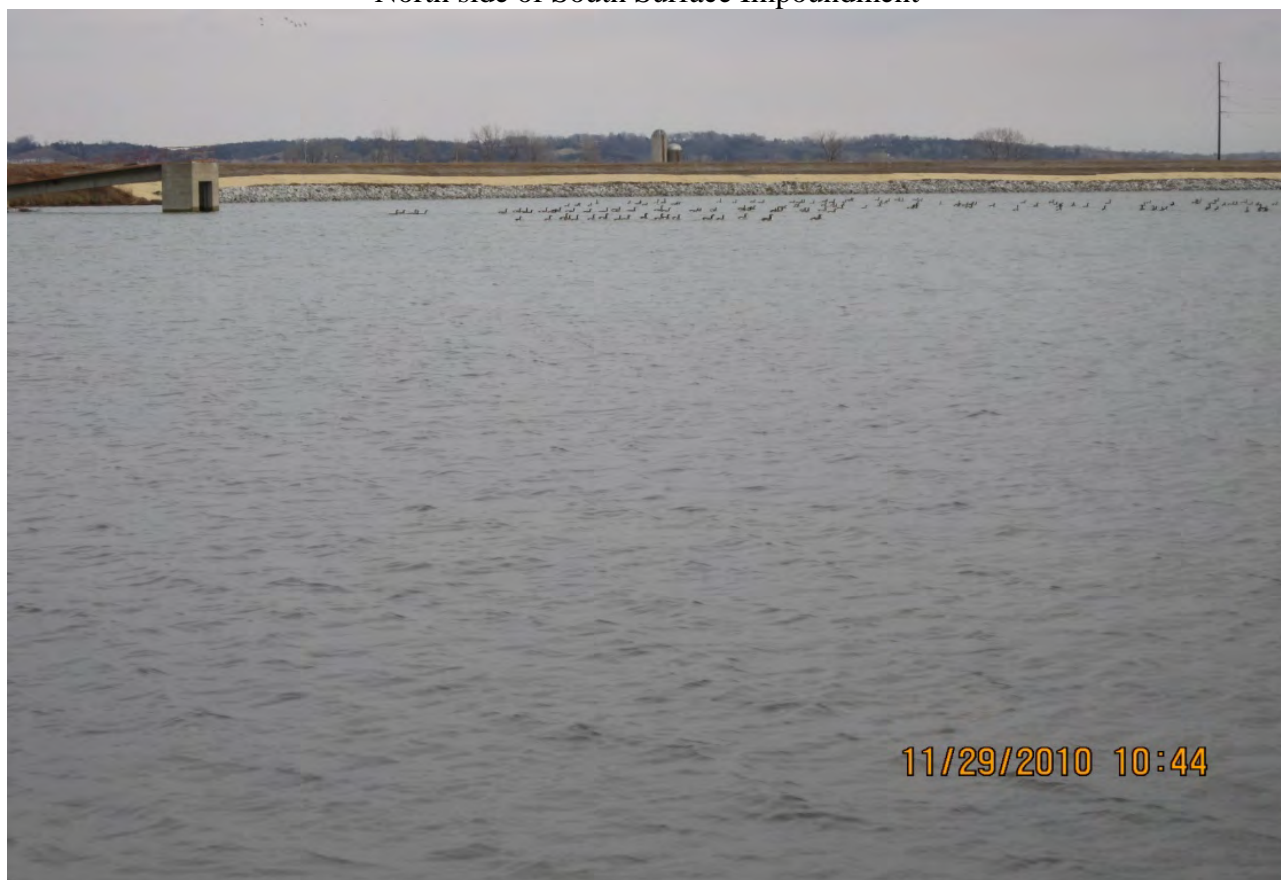
Photo 4 – Placed rip-rap to protect wave erosion action
North side of South Surface Impoundment

Section 1.2.6: The facility continues to make periodic inspections and repairs as necessary to address pond-side slope erosion caused by wave actions on the South Surface Impoundment on the north and south sides. The facility is also monitoring wave action on the northeast corner of the North Surface Impoundment and will make a further assessment on placement of rip rap for wave erosion protection in late spring 2011. Photographs 4-7 detail the repairs made to the South Surface Impoundment following the on-site inspection in September 2010.

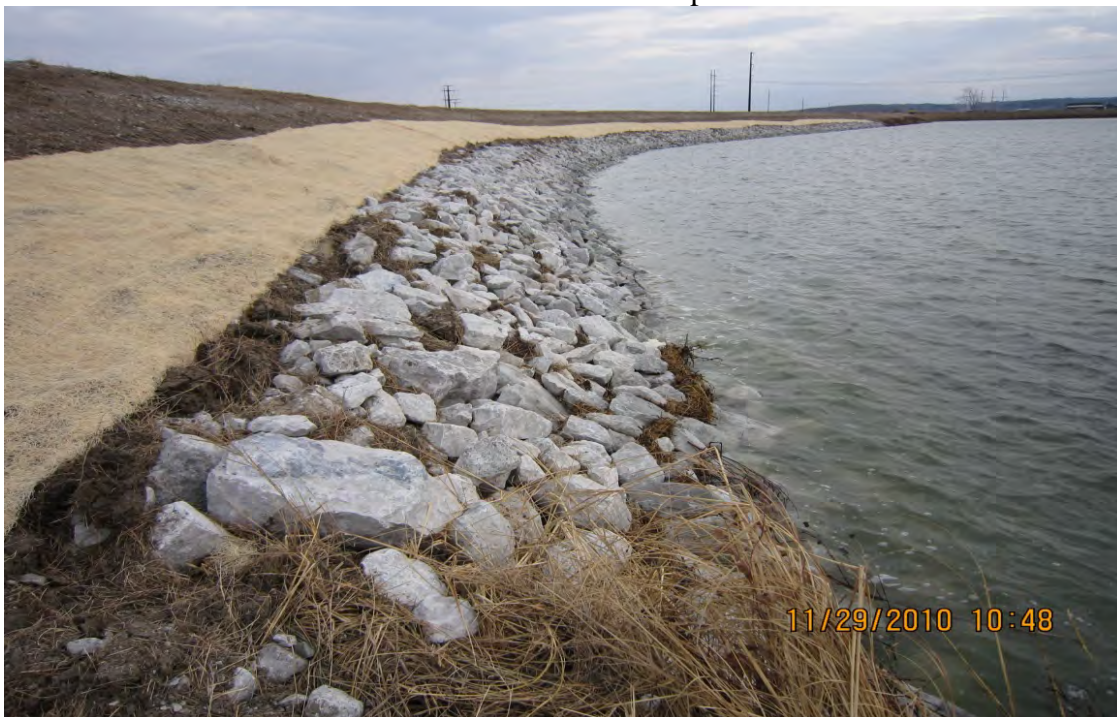
Photo 5 - Close up view of rip-rap protection
North side of South Surface Impoundment

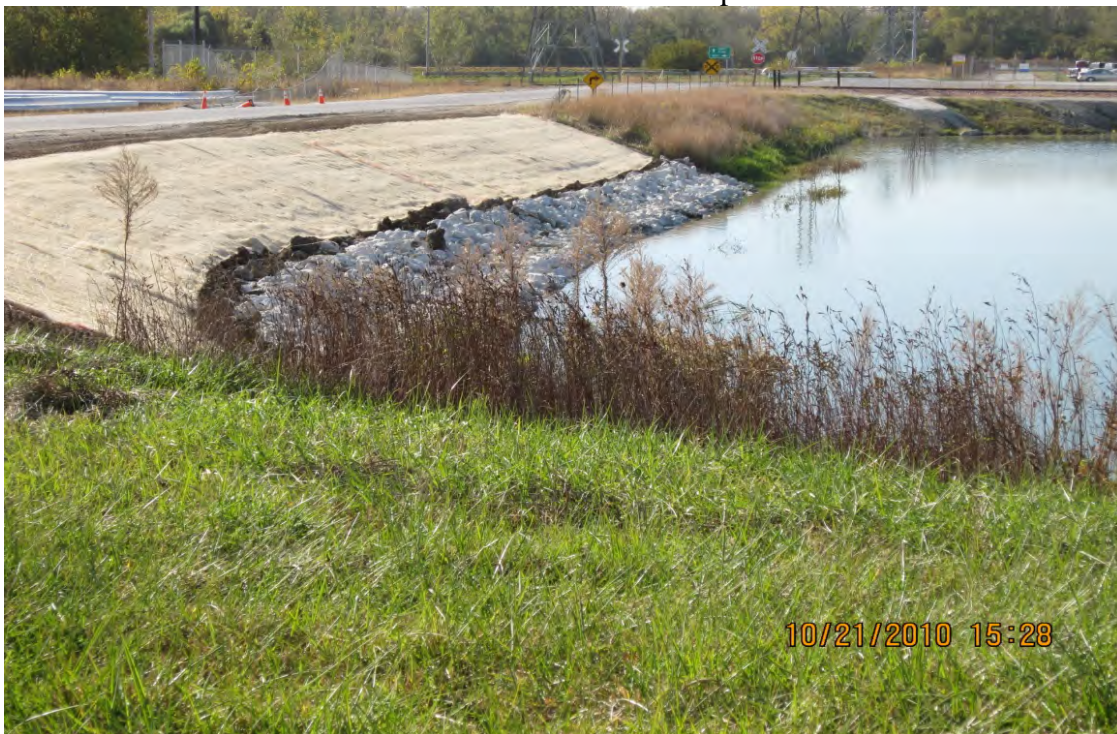
Photo 6 – Placed rip-rap to protect wave erosion action
Southwest side of South Surface Impoundment

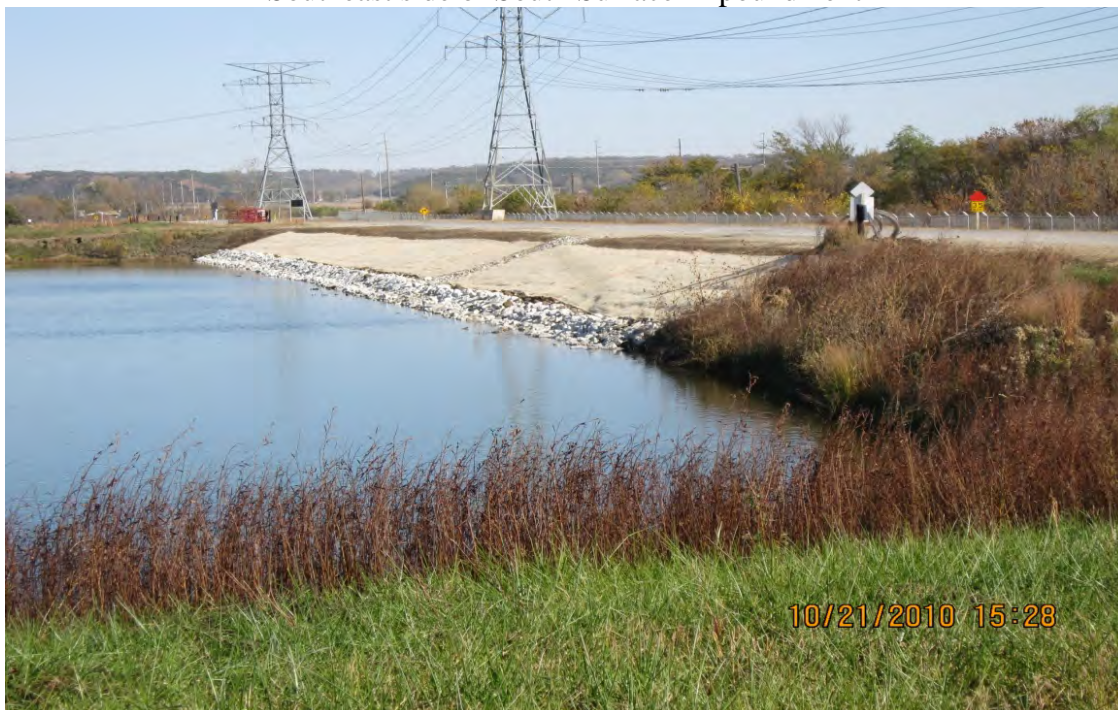
Photo 7 – Placed rip-rap to protect wave erosion action
Southeast side of South Surface Impoundment

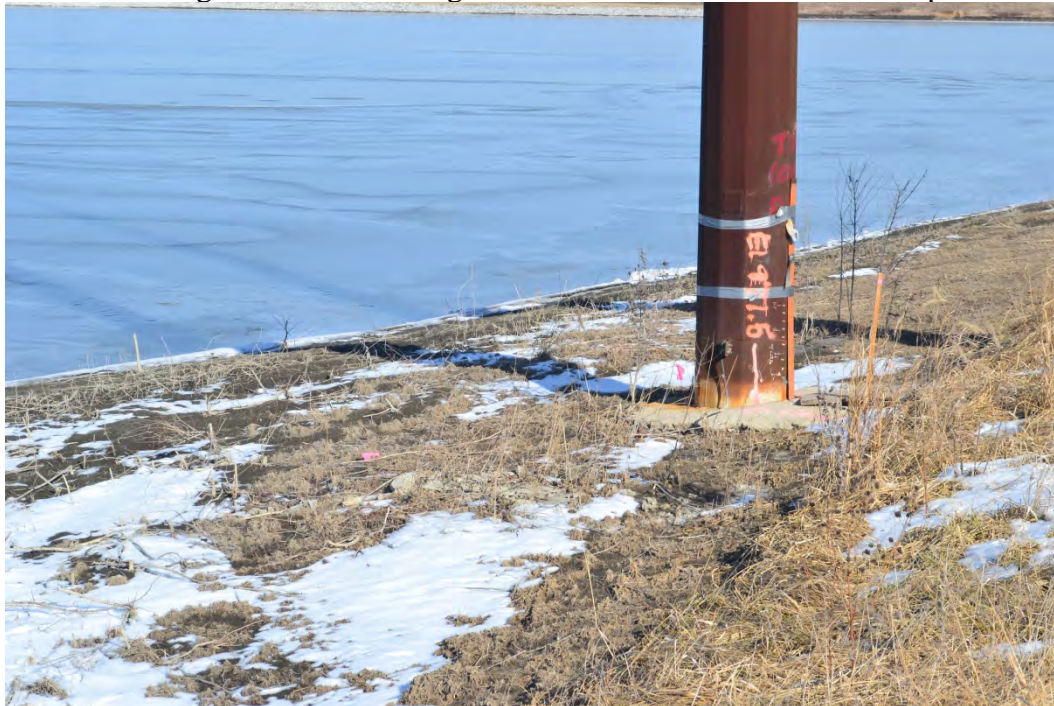
Section 6.1.1: Please delete the phrase “Hearsay evidence from MidAmerican staff is that”, and replace it with “According to MidAmerican staff.” Additionally, the high water levels observed during the on-site inspection have in fact dropped considerably. At elevation 971.5’, the water level surrounded the base of the pole shown in Photograph 8. At that elevation there was still approximately 2’ of freeboard remaining to the lowest point on the levee structure. As can be seen in

the photo, the water level has dropped several feet, and it is estimated that there is now approximately 5' of freeboard in the surface impoundments.

Photo 8 – Facing northwest showing southeast bank of South Surface Impoundment

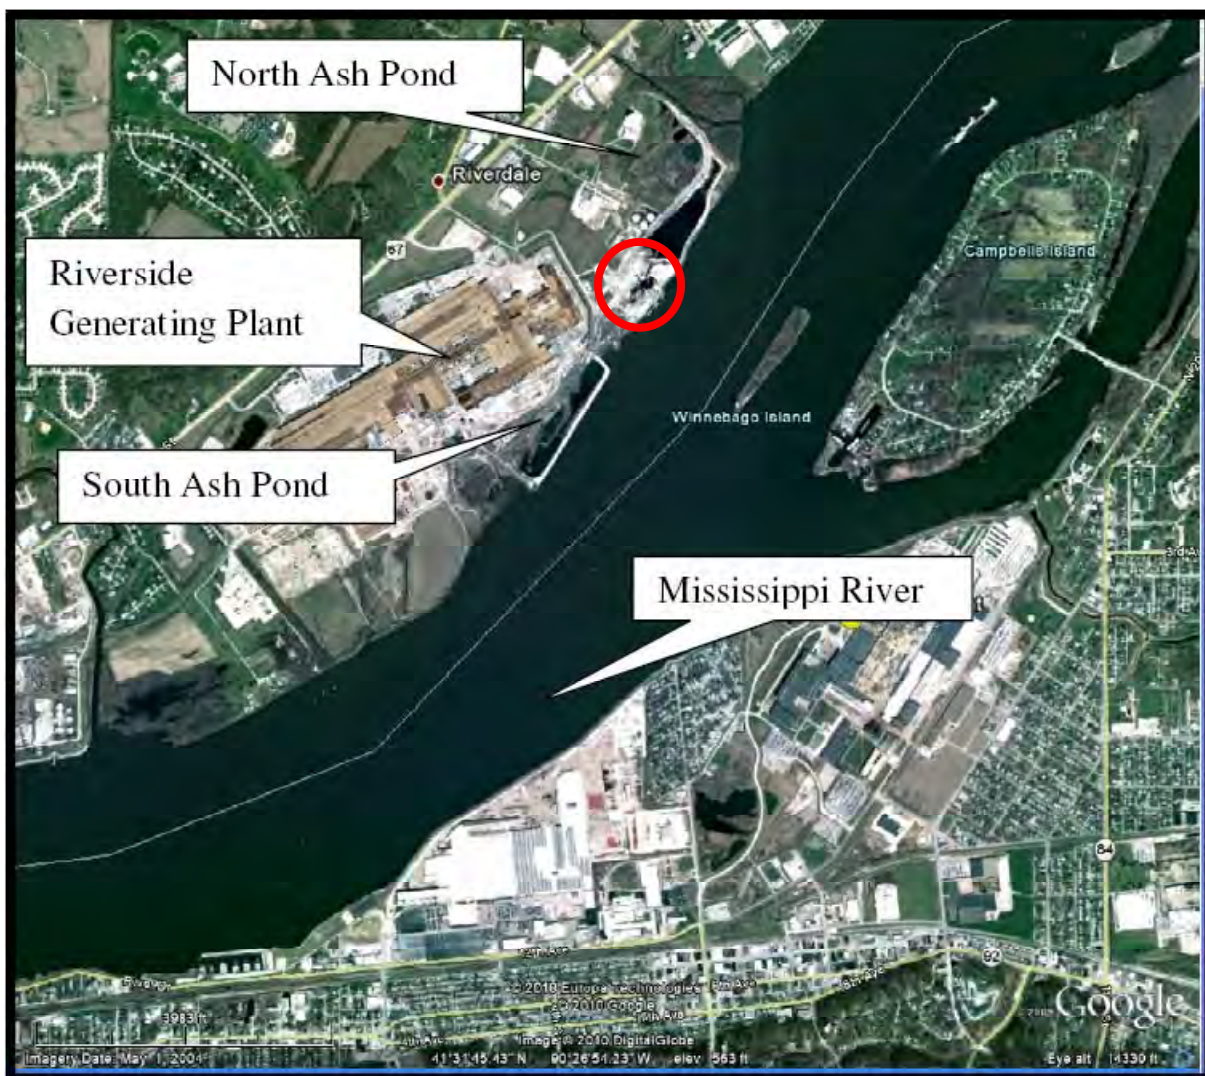
Figure 2.1-2: The photo incorrectly labels Alcoa as the Riverside Generating Plant. Riverside is actually just north of the South Surface Impoundment (South Ash Pond) as shown in the red circle below.

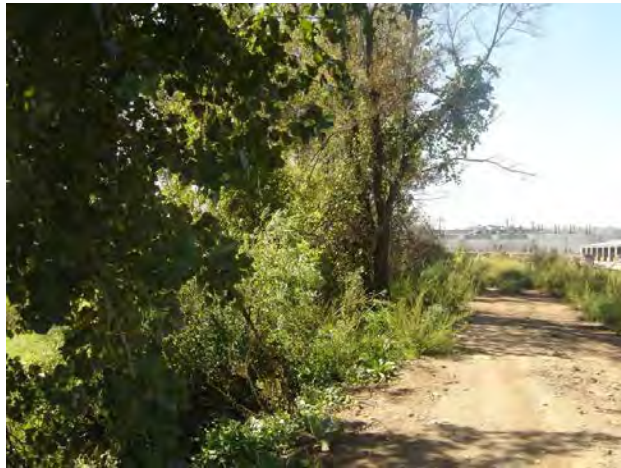
September 2010

Crest and Upstream/Inside Slope of North Surface Impoundment

The final draft report provides an assessment of “**Fair**” for the North Surface Impoundment. It was recommended that MidAmerican perform maintenance on the North Surface Impoundment embankments to remove any thick, woody-stemmed vegetation, dense brush and trees covering the upstream and downstream slope. Since the on-site inspection was conducted in September 2010, MidAmerican has implemented those recommendations. MidAmerican also plans on establishing a grassed condition on the embankments over the spring and summer of this year. As a result, MidAmerican respectfully requests that the ranking for the North Surface Impoundment be changed to “**Satisfactory**” in the final report. The photographs supporting this request are provided below.

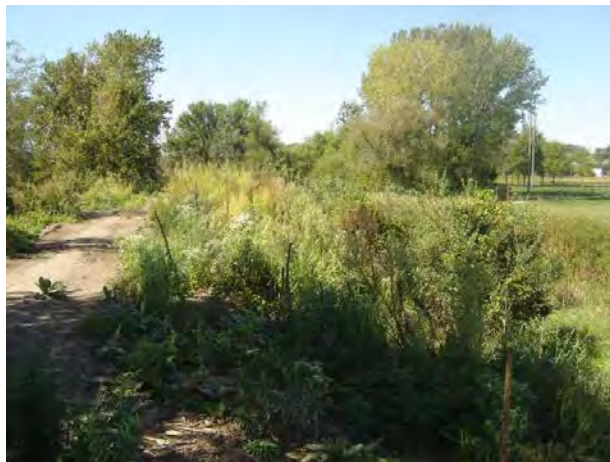
September 2010

Crest and Downstream/Outside Slope of North Surface Impoundment
