Re: Responses to Recommendations in Final Coal Combustion Waste Impoundment
Round 7 - Dam Assessment Report for Riverside Generating Station

Riverside Generating Station Recommendations

Re: Interim Report - Results of Global Stability Analyses Revisions
South Ash Containment Pond Embankments
Riverside Generating Station
Bettendorf, Iowa
Terracon Project No. 07105081/02105081G

Re: Geotechnical Report Addendum No. 2
Revised Global Stability Analyses
South Ash Containment Pond Embankments
Riverside Generating Station
Bettendorf, Iowa
Terracon Project No. 07105081/02105081G

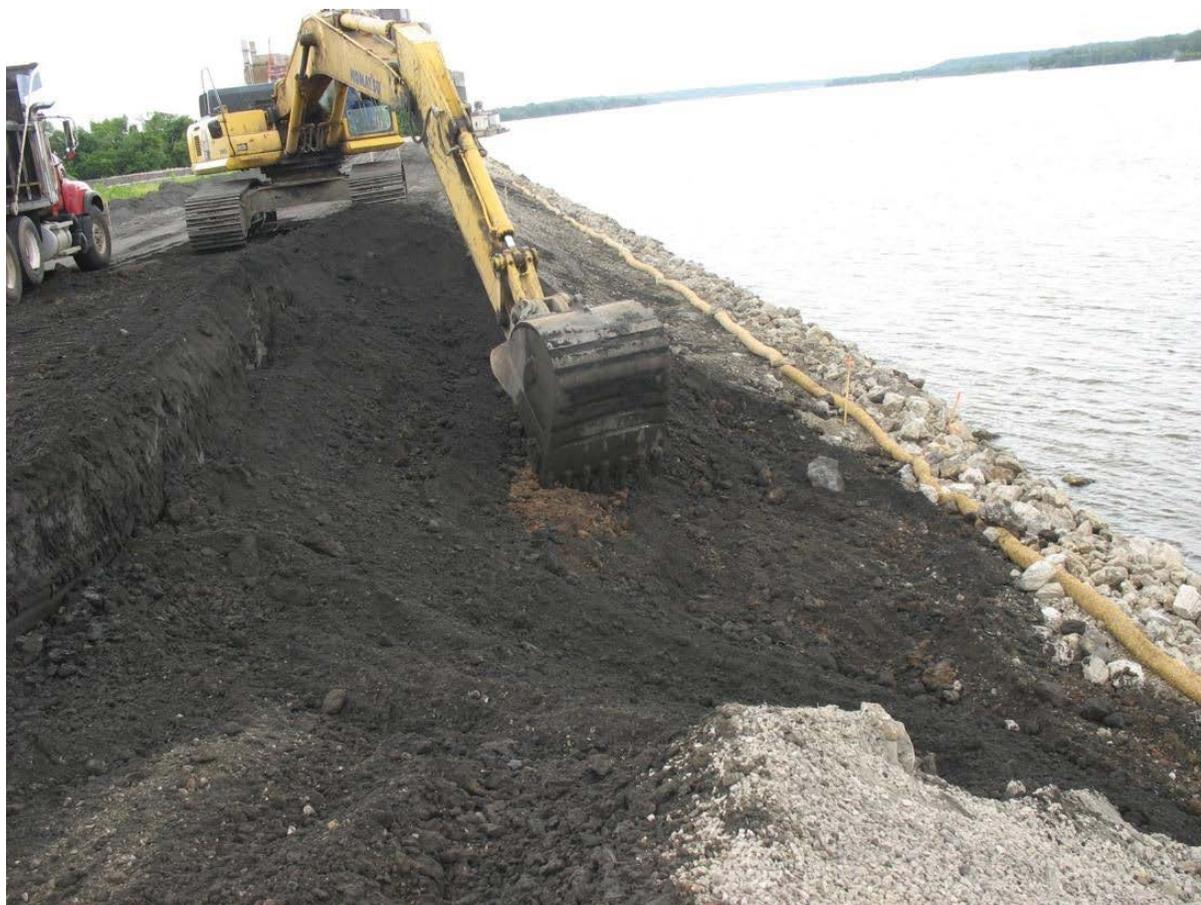
Excavating embankment at about Station 11+50

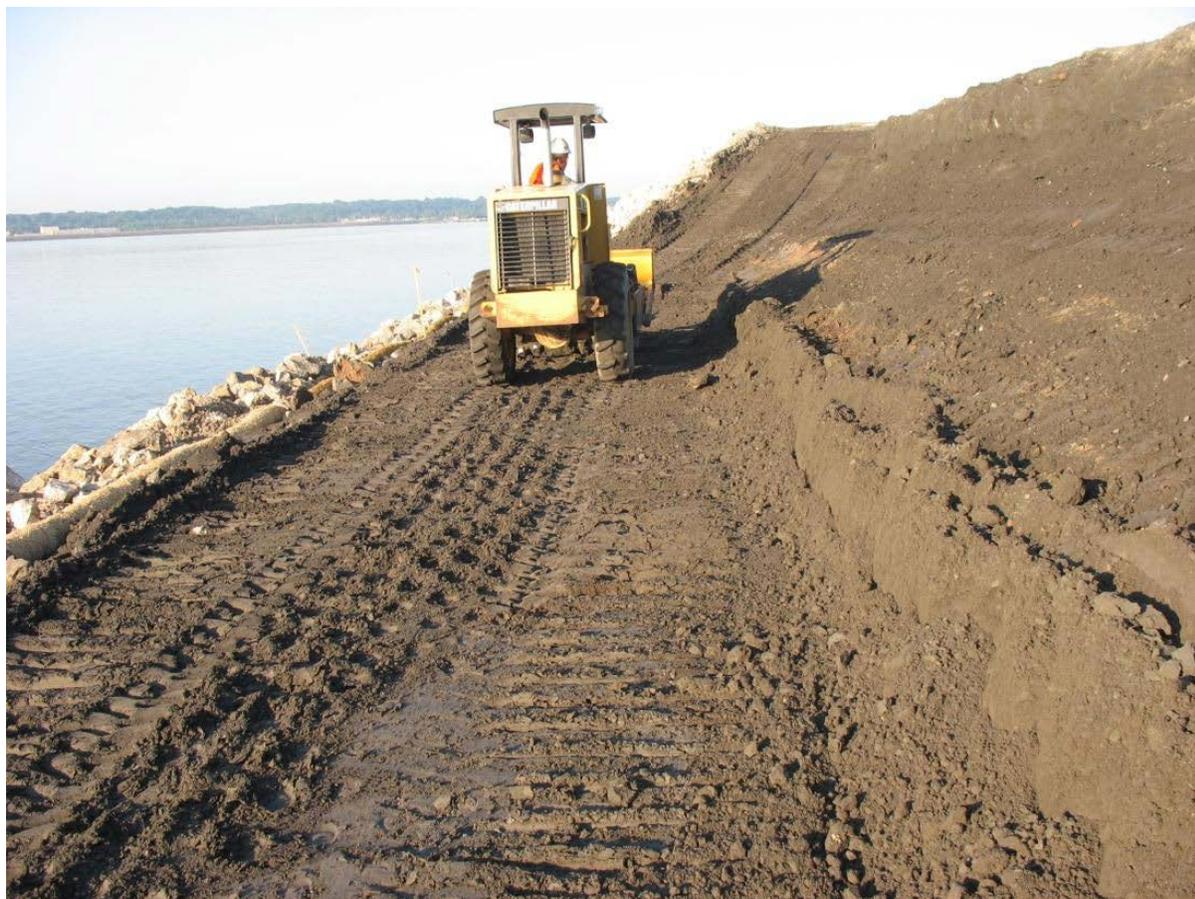
Proof rolling base of excavation at about Station 12+50

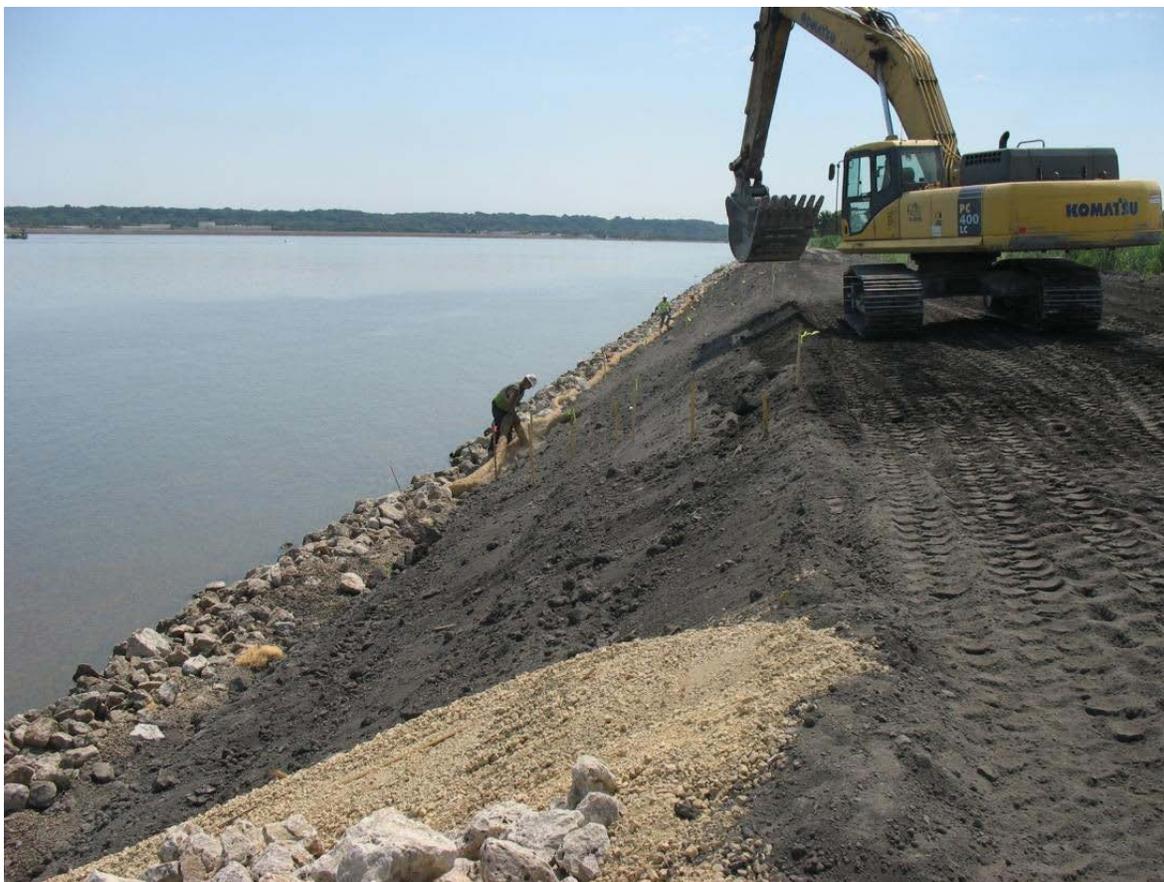
Dressing up slope before placement of bedding material

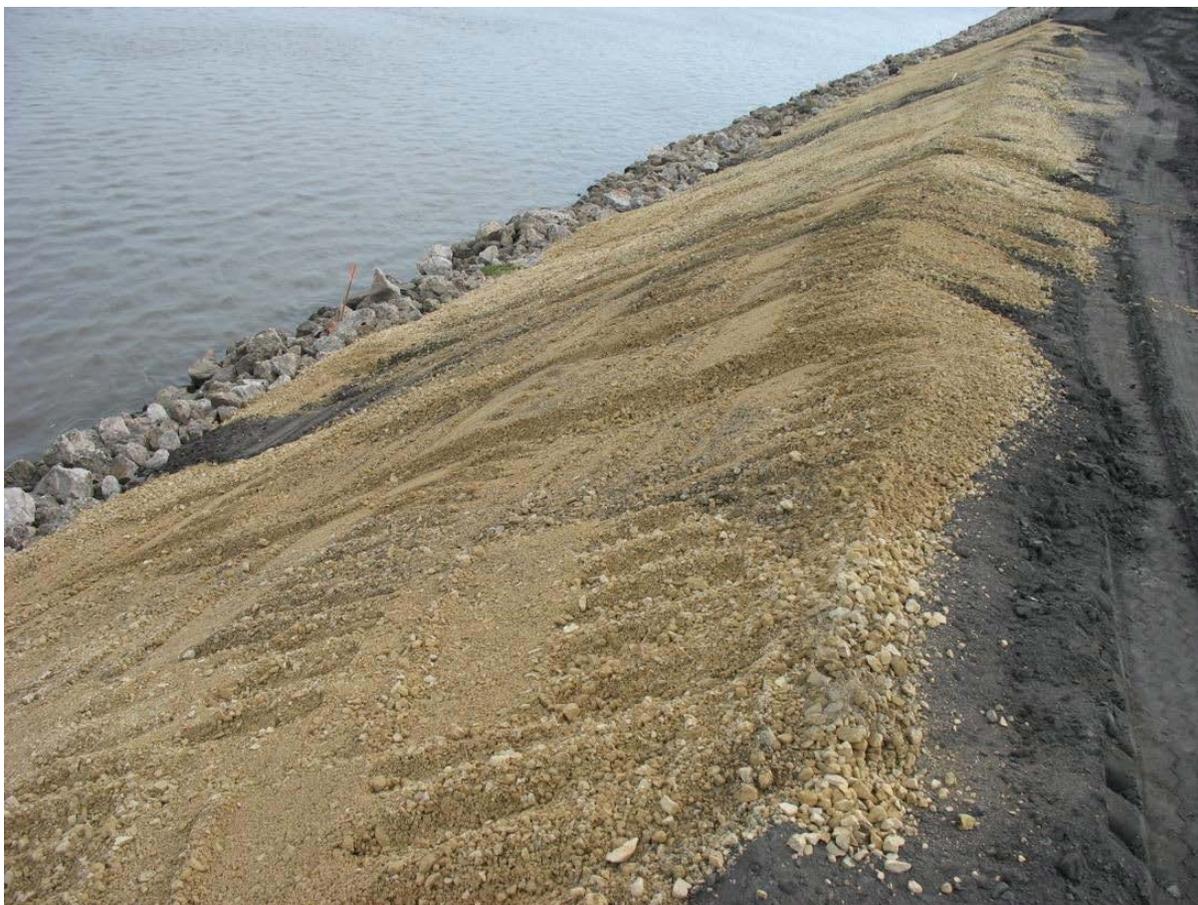
Bedding material on improved slope
Direction Looking: South

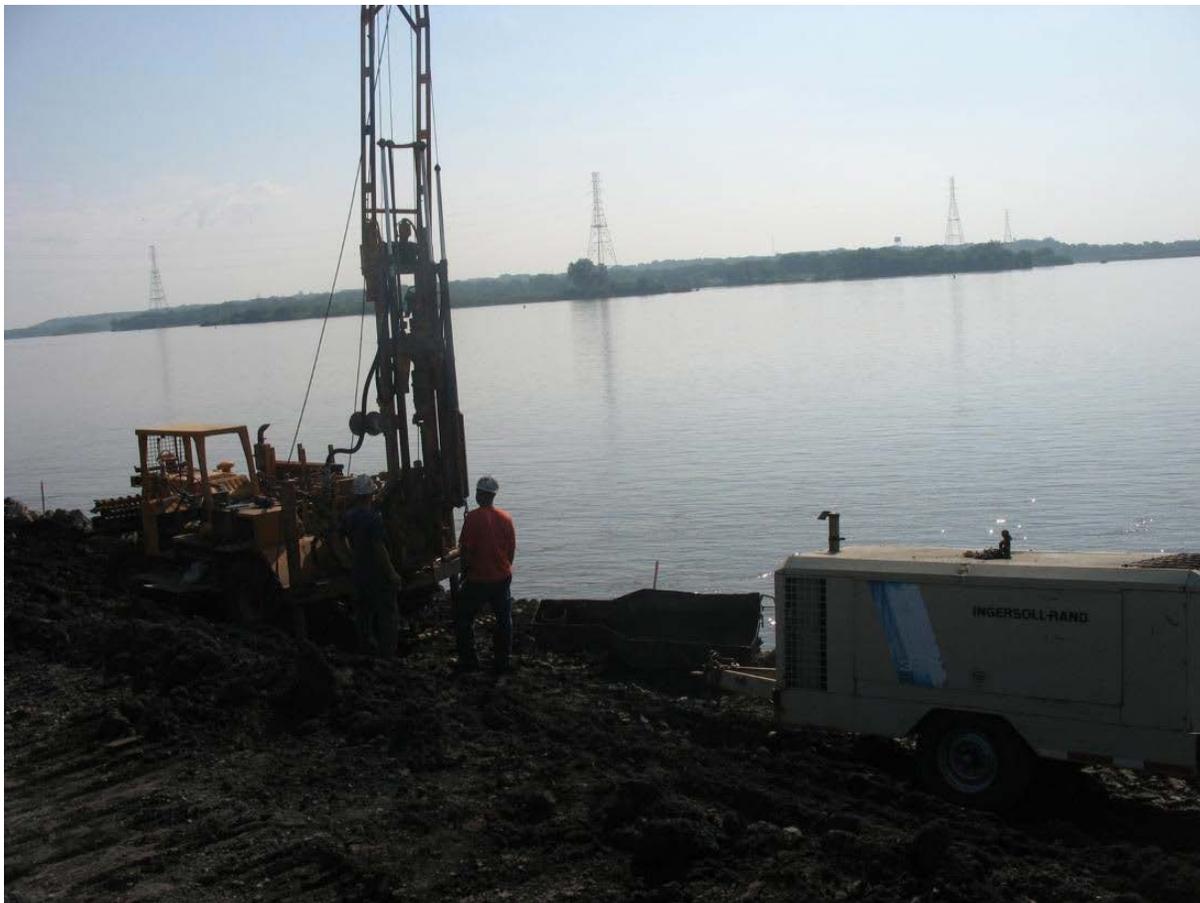
Additional borings being drilled at about Station 7+55 at toe of levee
Direction Looking: Northeast
Date: 07/26/2011

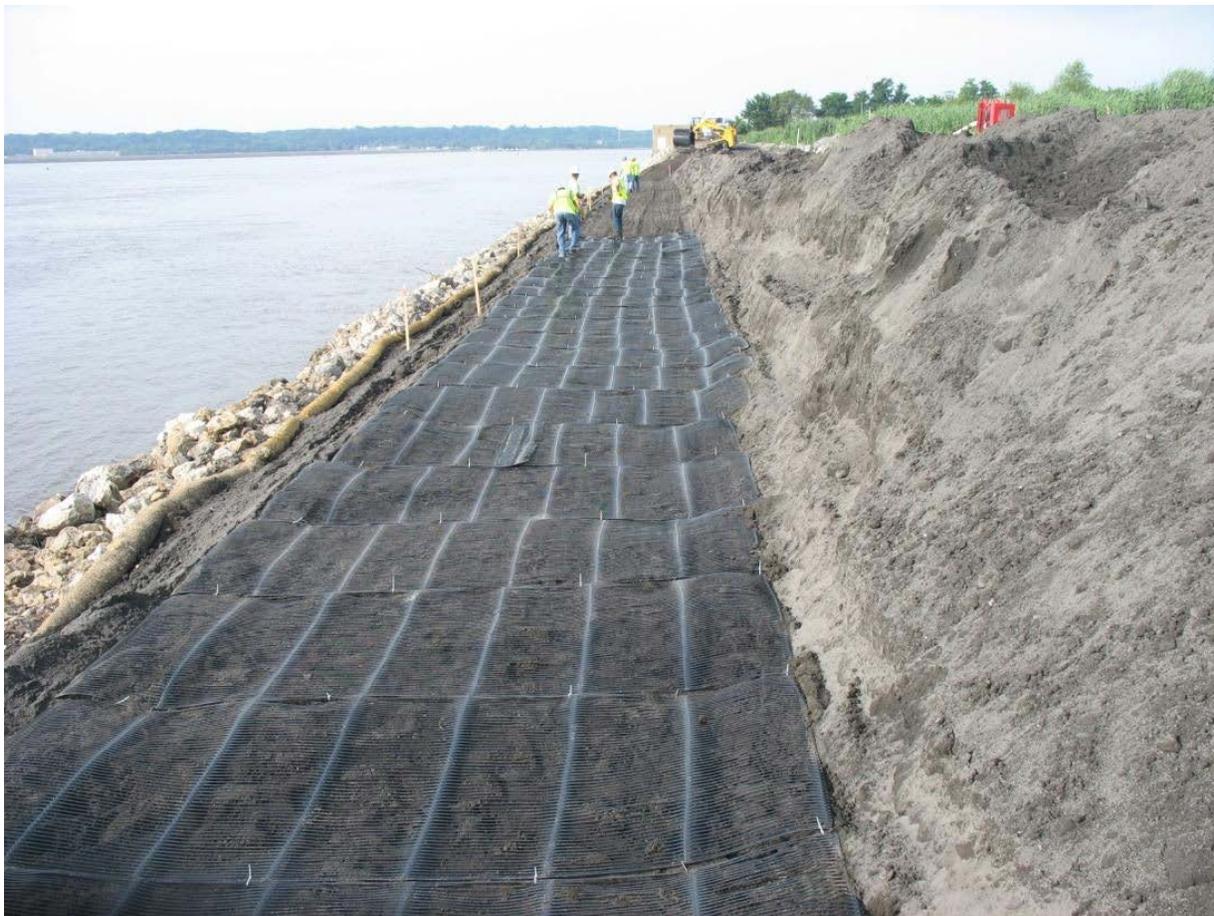
Geogrid placed at elevation 566' from about Station 6+00 to about Station 8+95
Direction Looking: South

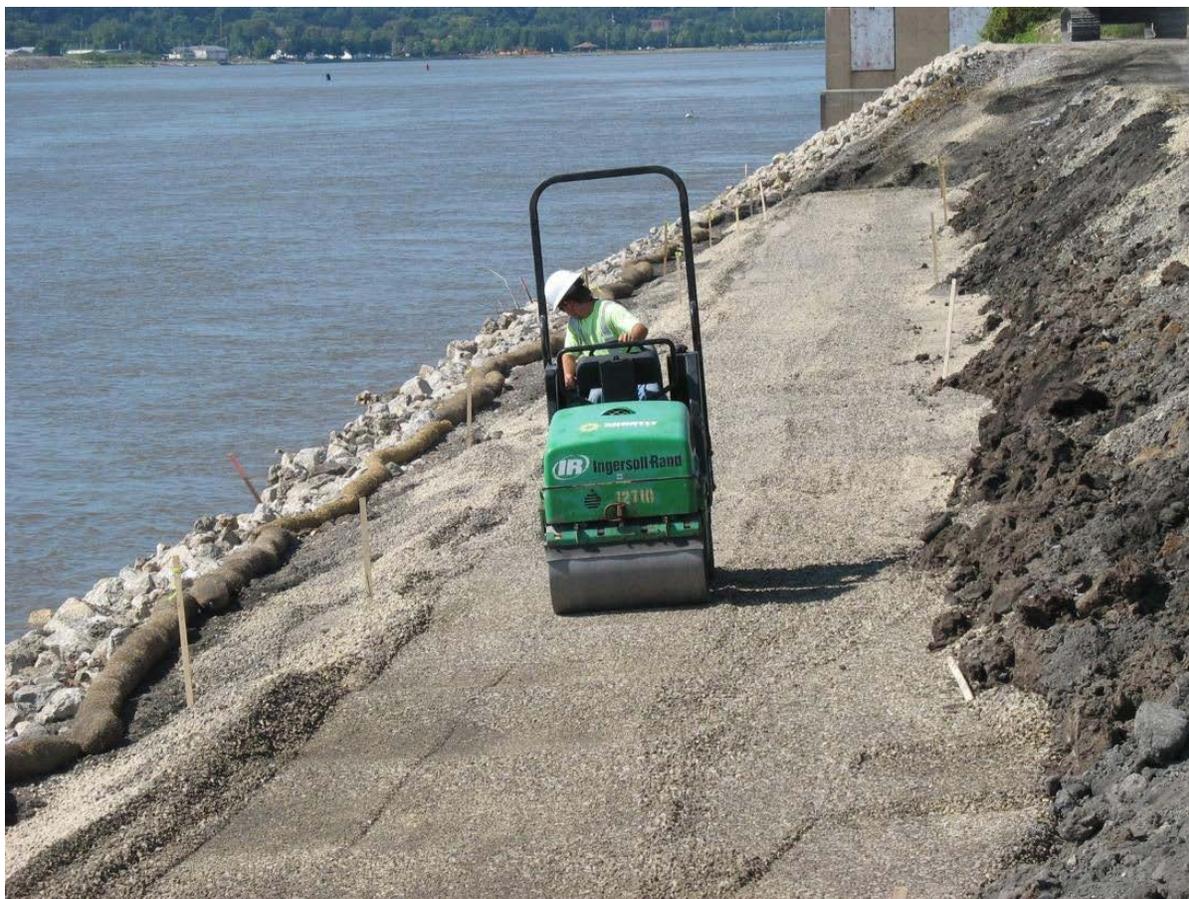
Compacting clean stone backfill at about elevation 566'

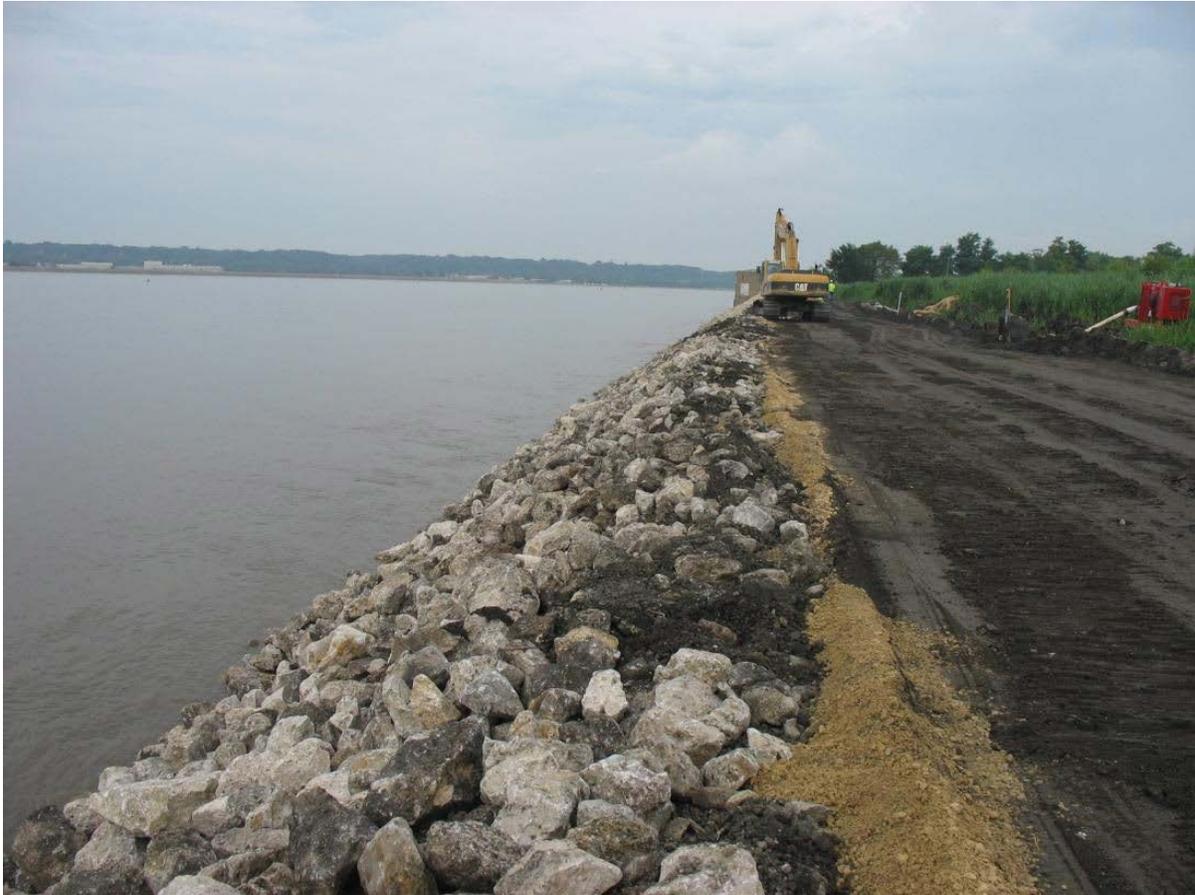
Improved slope at about Station 8+00
Direction Looking: South

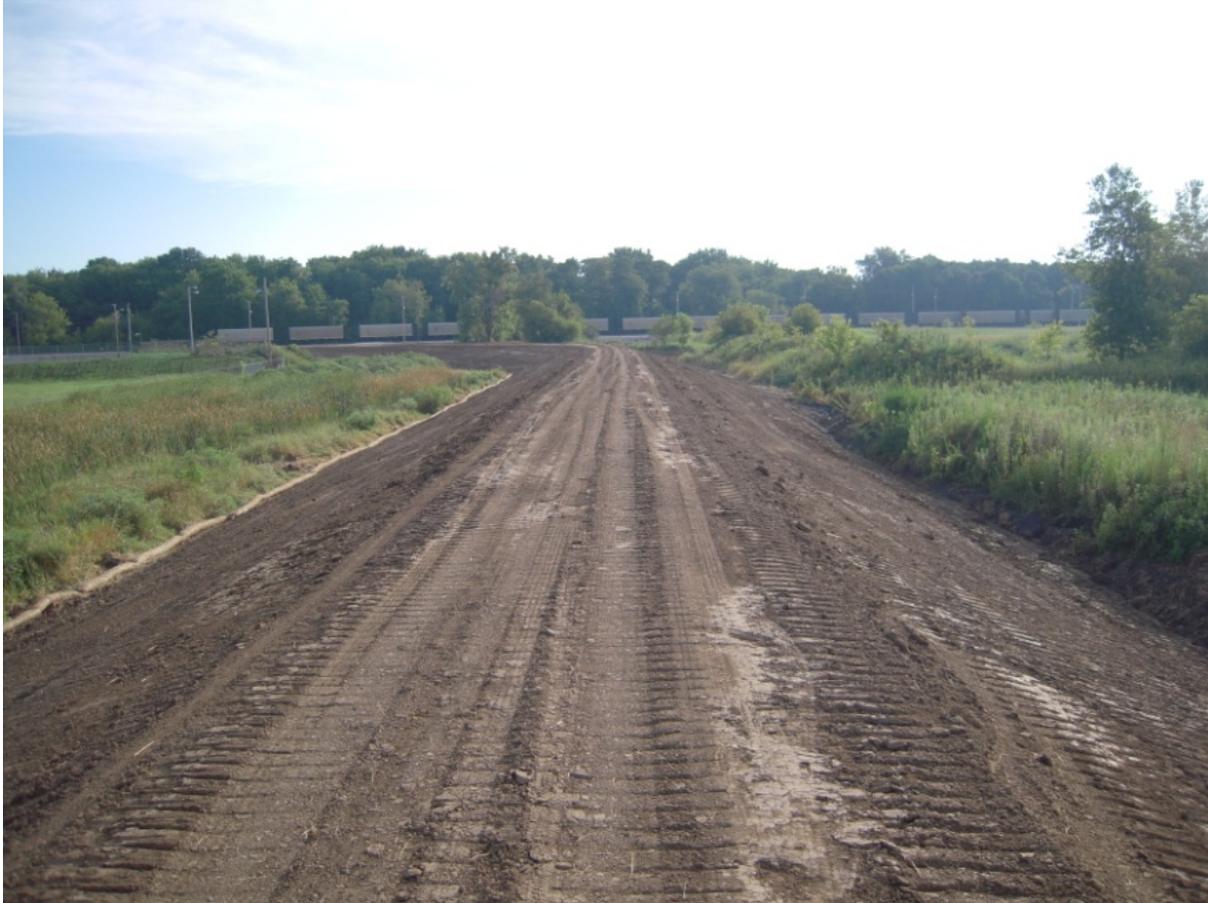
North Pond Embankment after removal of stumps and dressing up
Direction: Looking North Date: 8/15/2011

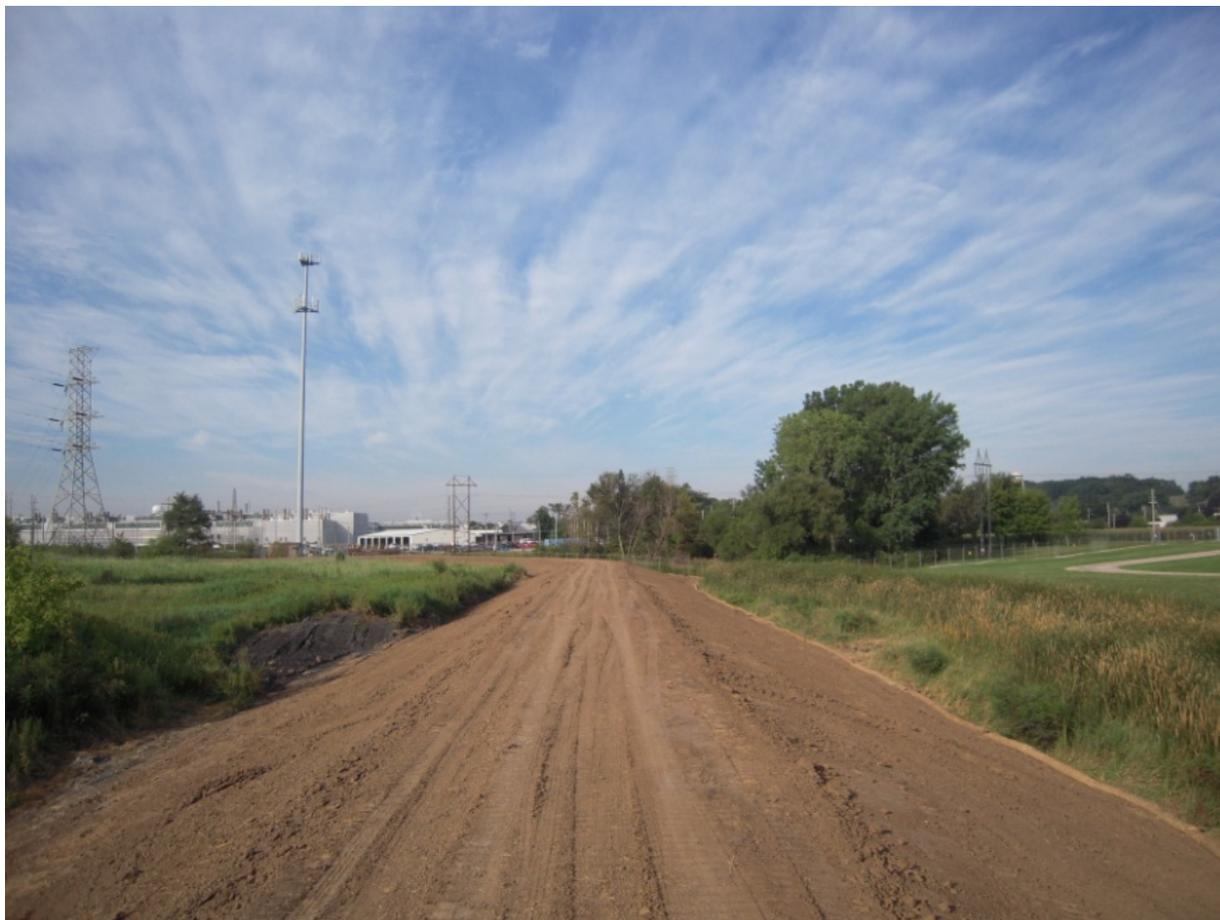
North Pond Embankment after removal of stumps and dressing up
Direction: Looking Southeast Date: 8/15/2011

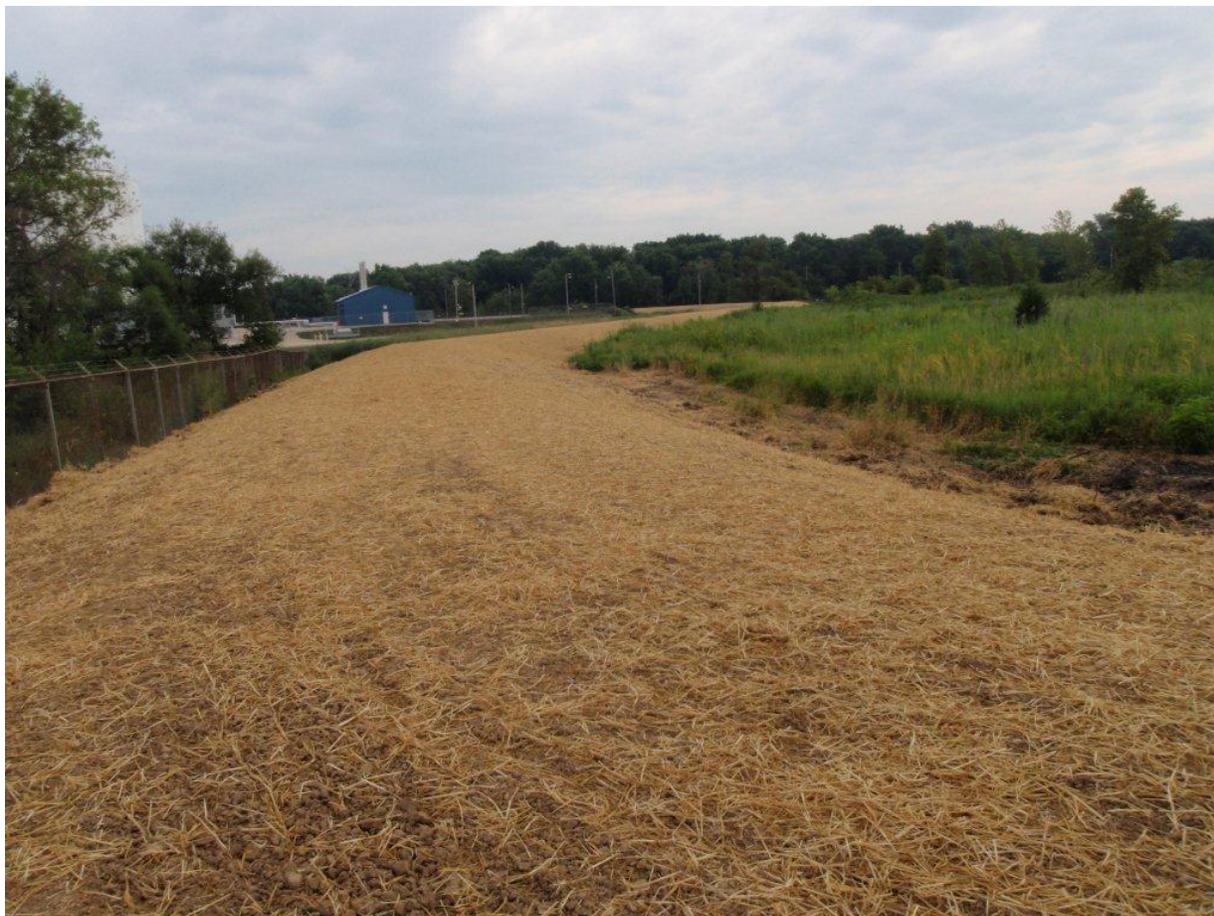
North Pond Embankment after seeding

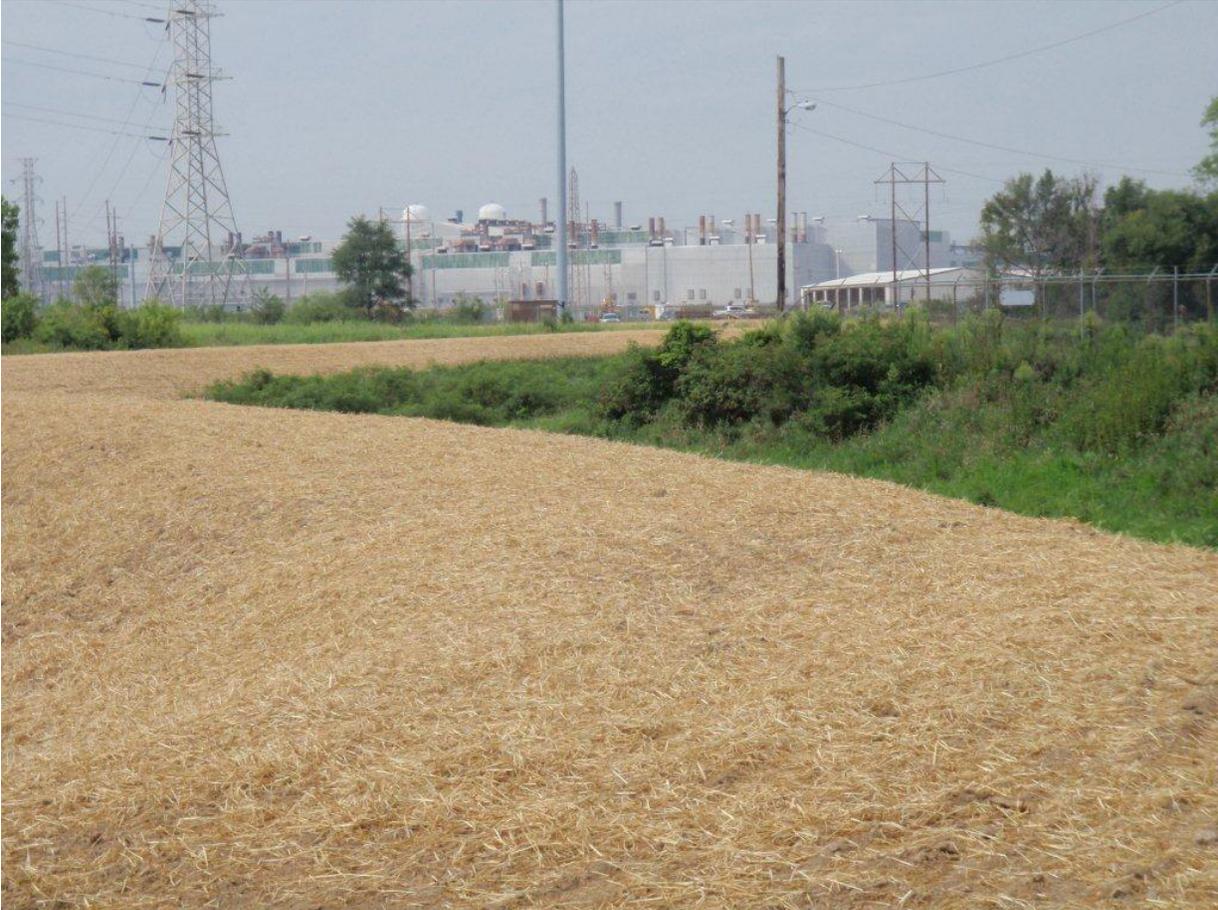
North Pond Embankment after seeding
