Subject: EPA Comments on MidAmerican Energy Co, Walter Scott Junior Energy Center,  
Council Bluffs, IA  
Round 7 Draft Assessment Report

Re: Comments to Draft Coal Combustion Waste Impoundment Round 7 Dam Assessment Reports for Neal North Energy Center (Site #13), Walter Scott Energy Center (Site #14), Riverside Generating Station (Site #15 ), and Louisa Generating Station (Site #16)

#### **Walter Scott Energy Center Draft Report Comments**

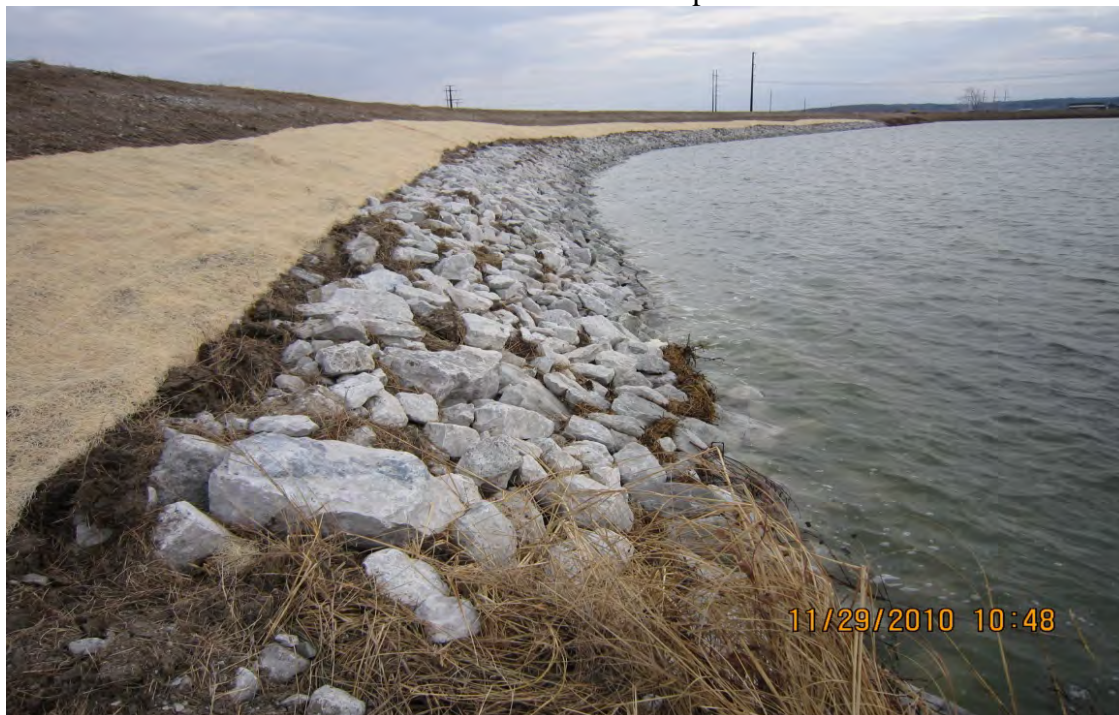
Photo 5 - Close up view of rip-rap protection  
North side of South Surface Impoundment

**Section 1.2.6:** The facility continues to make periodic inspections and repairs as necessary to address pond-side slope erosion caused by wave actions on the South Surface Impoundment on the north and south sides. The facility is also monitoring wave action on the northeast corner of the North Surface Impoundment and will make a further assessment on placement of rip rap for wave erosion protection in late spring 2011. Photographs 4-7 detail the repairs made to the South Surface Impoundment following the on-site inspection in September 2010.

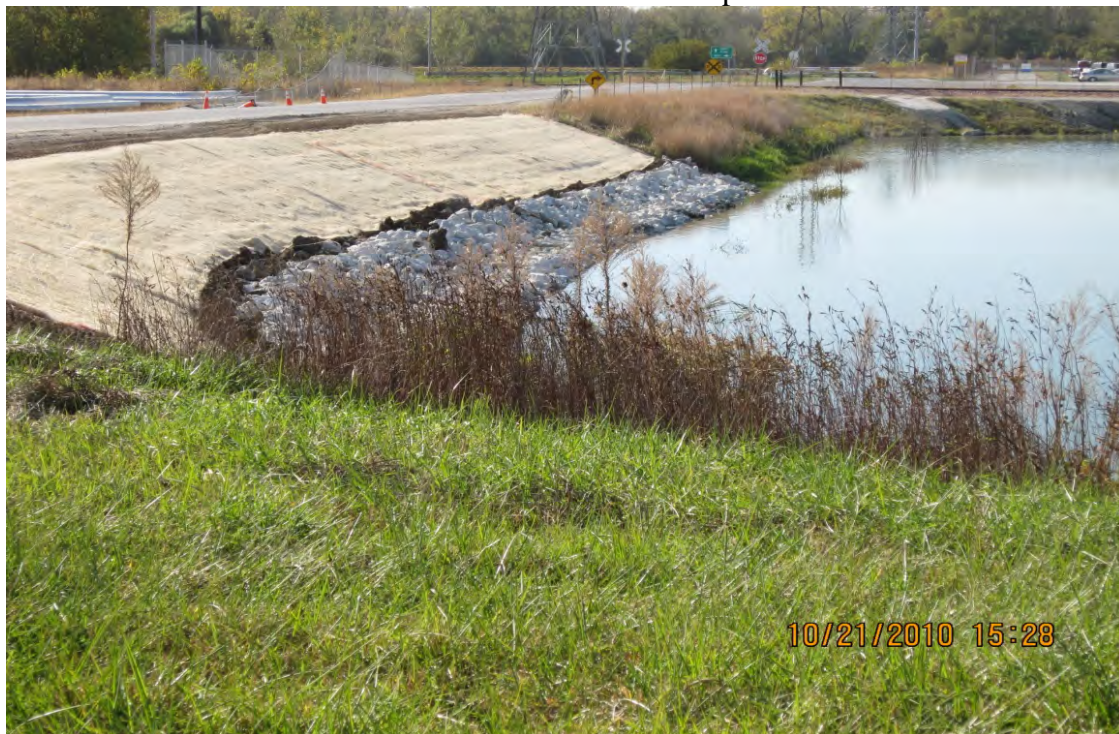
Photo 6 – Placed rip-rap to protect wave erosion action  
Southwest side of South Surface Impoundment
